## **Appendix F      Geotechnical Assessment**

Subject: **EIR-LEVEL GEOTECHNICAL ASSESSMENT**  
Brea Central Property, City of Brea  
County of Orange, California

In accordance with your request, Alta California Geotechnical, Inc. (Alta) is pleased to submit this geotechnical assessment in support of EIR submittals for the Brea Central Property, in the City of Brea, County of Orange, California. An initial geotechnical subsurface investigation was previously conducted onsite by Pacific Soils Engineering, Inc. (PSE, 1999) that included the excavation, logging, and sampling of bucket-auger borings and backhoe trenches. We reviewed the technical documents that are tabulated in Appendix A.

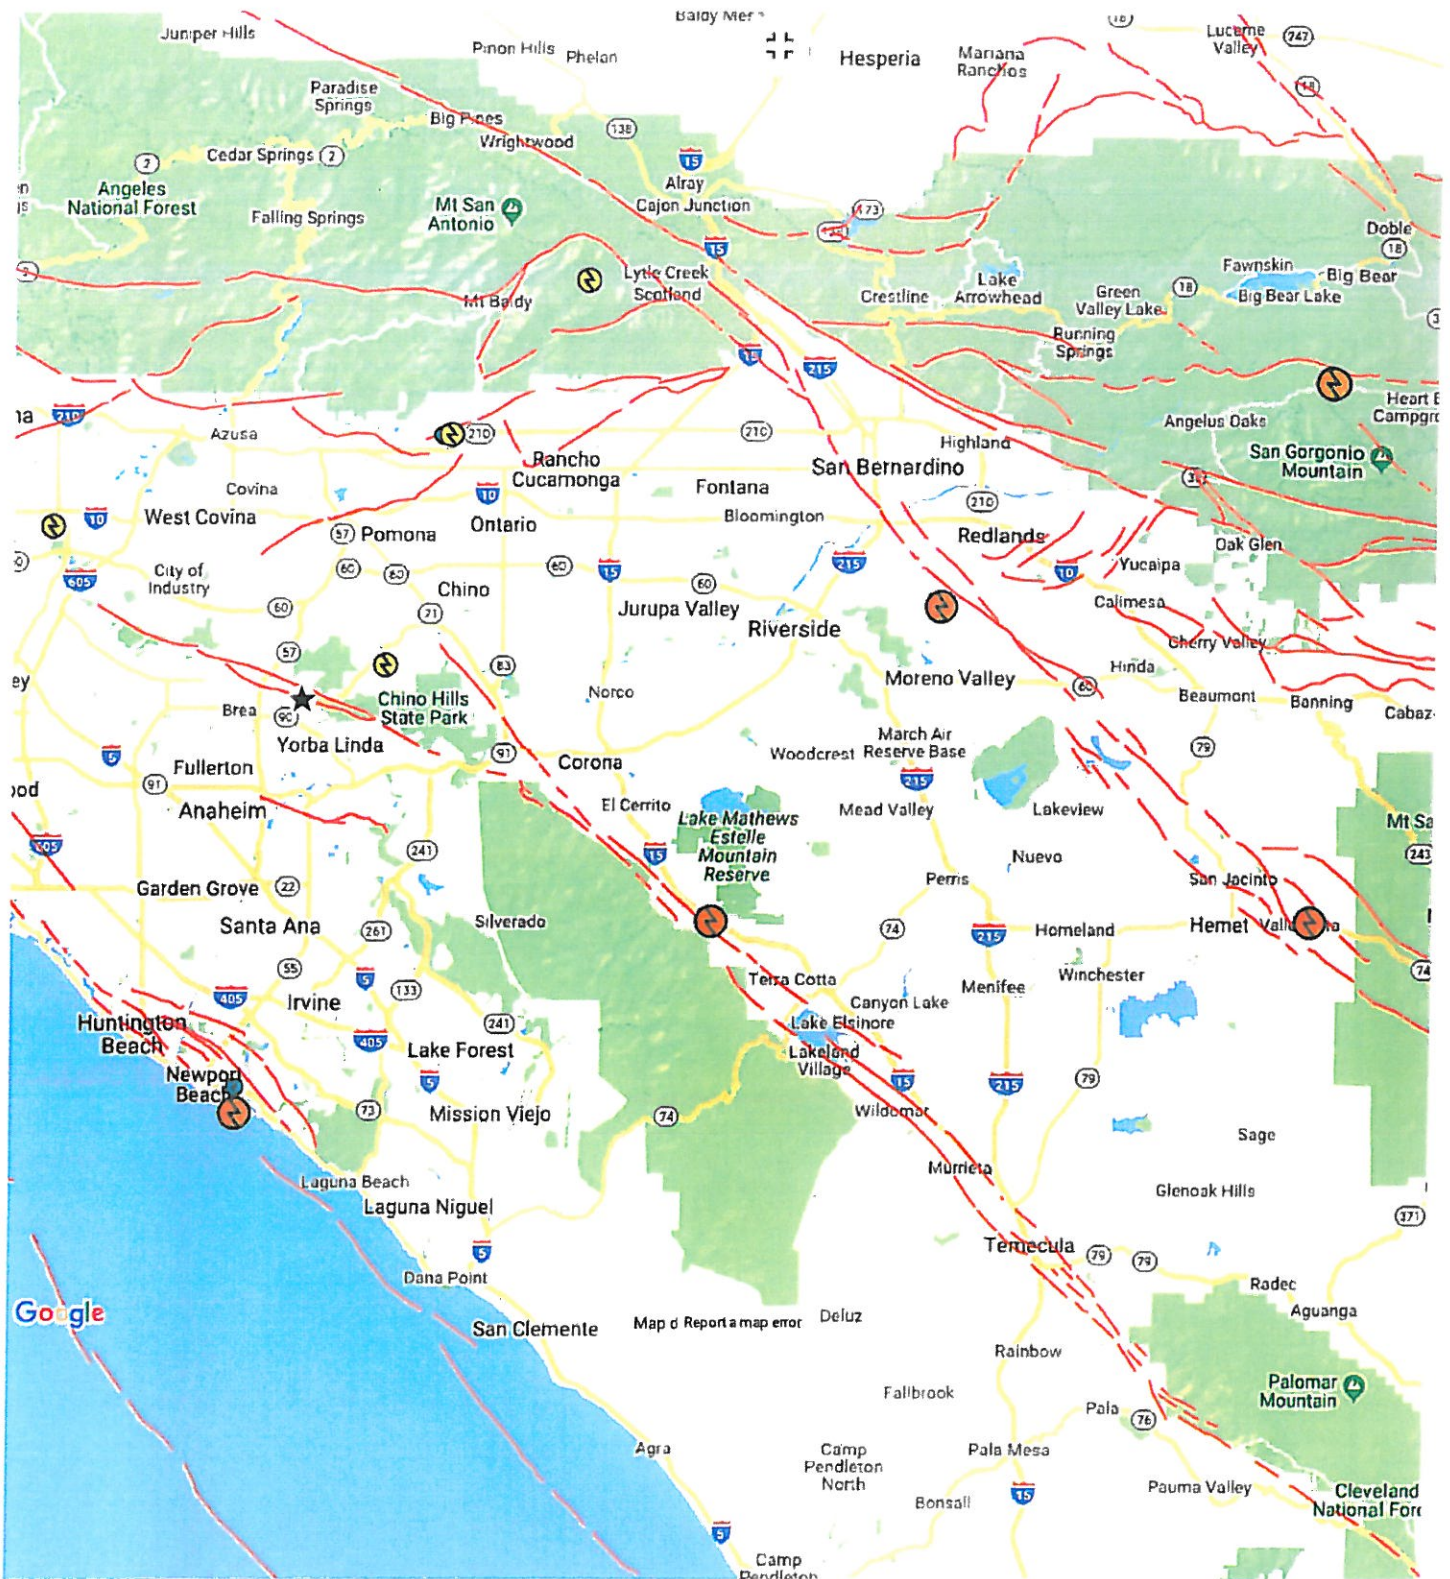
# REGIONAL FAULT MAP

★ - Brea Central Property
