**Appendix N – Hazardous Materials Survey Report (ACM/Lead), Liberty Island
Ranch (Liberty Farms Property), Blackburn Consulting, November 2017.**

**HAZARDOUS MATERIALS SURVEY REPORT
(ACM/LEAD)**

Liberty Island Ranch

Subject: **HAZARDOUS MATERIALS SURVEY REPORT**
Liberty Island Ranch
APN 042-140-230 and APN 042-140-240
Dixon, California

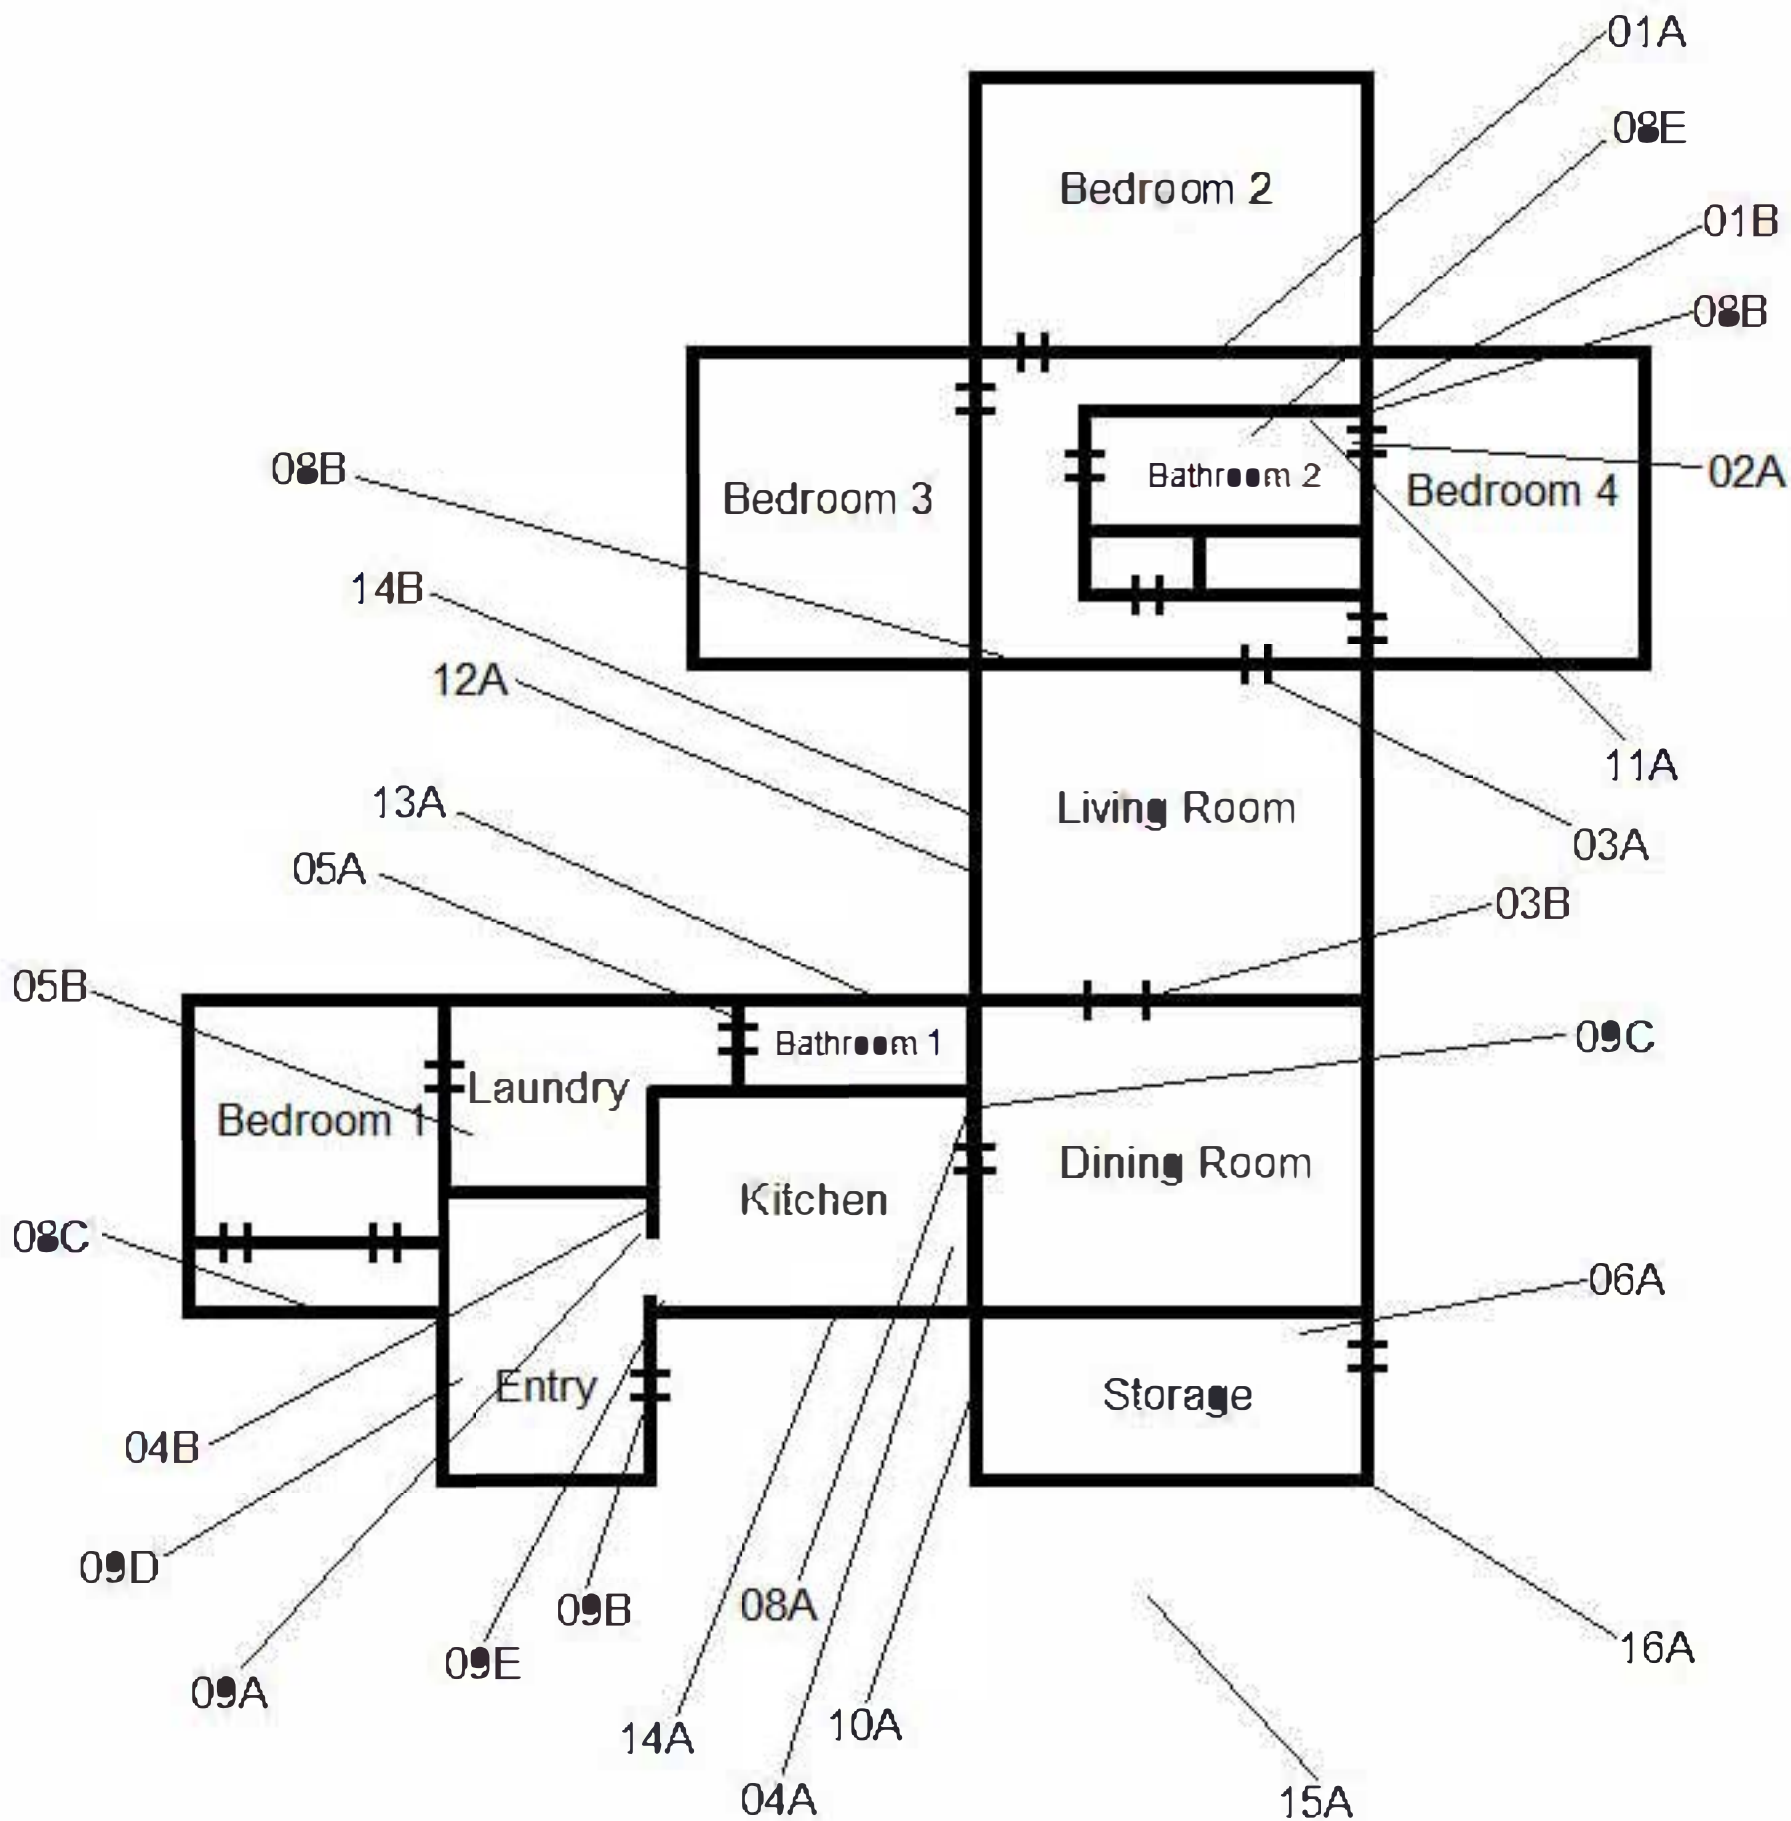
R1

Sample Numbers are Preceded by ECG-17.4478

Residence 1 is a single story single family residence on a raised foundation. Interior finishes include vinyl floor tiles, sheet vinyl flooring, ceramic floor tile, drywall wall and ceiling systems, and brick and mortar walls. The roof is pitched and has 3-tab asphaltic shingles. Please note that above ceiling was inaccessible. The gray HVAC tape contains asbestos and the cementitious flu pipe is assumed to contain asbestos. Please note that any roof mastic is also assumed to contain asbestos.

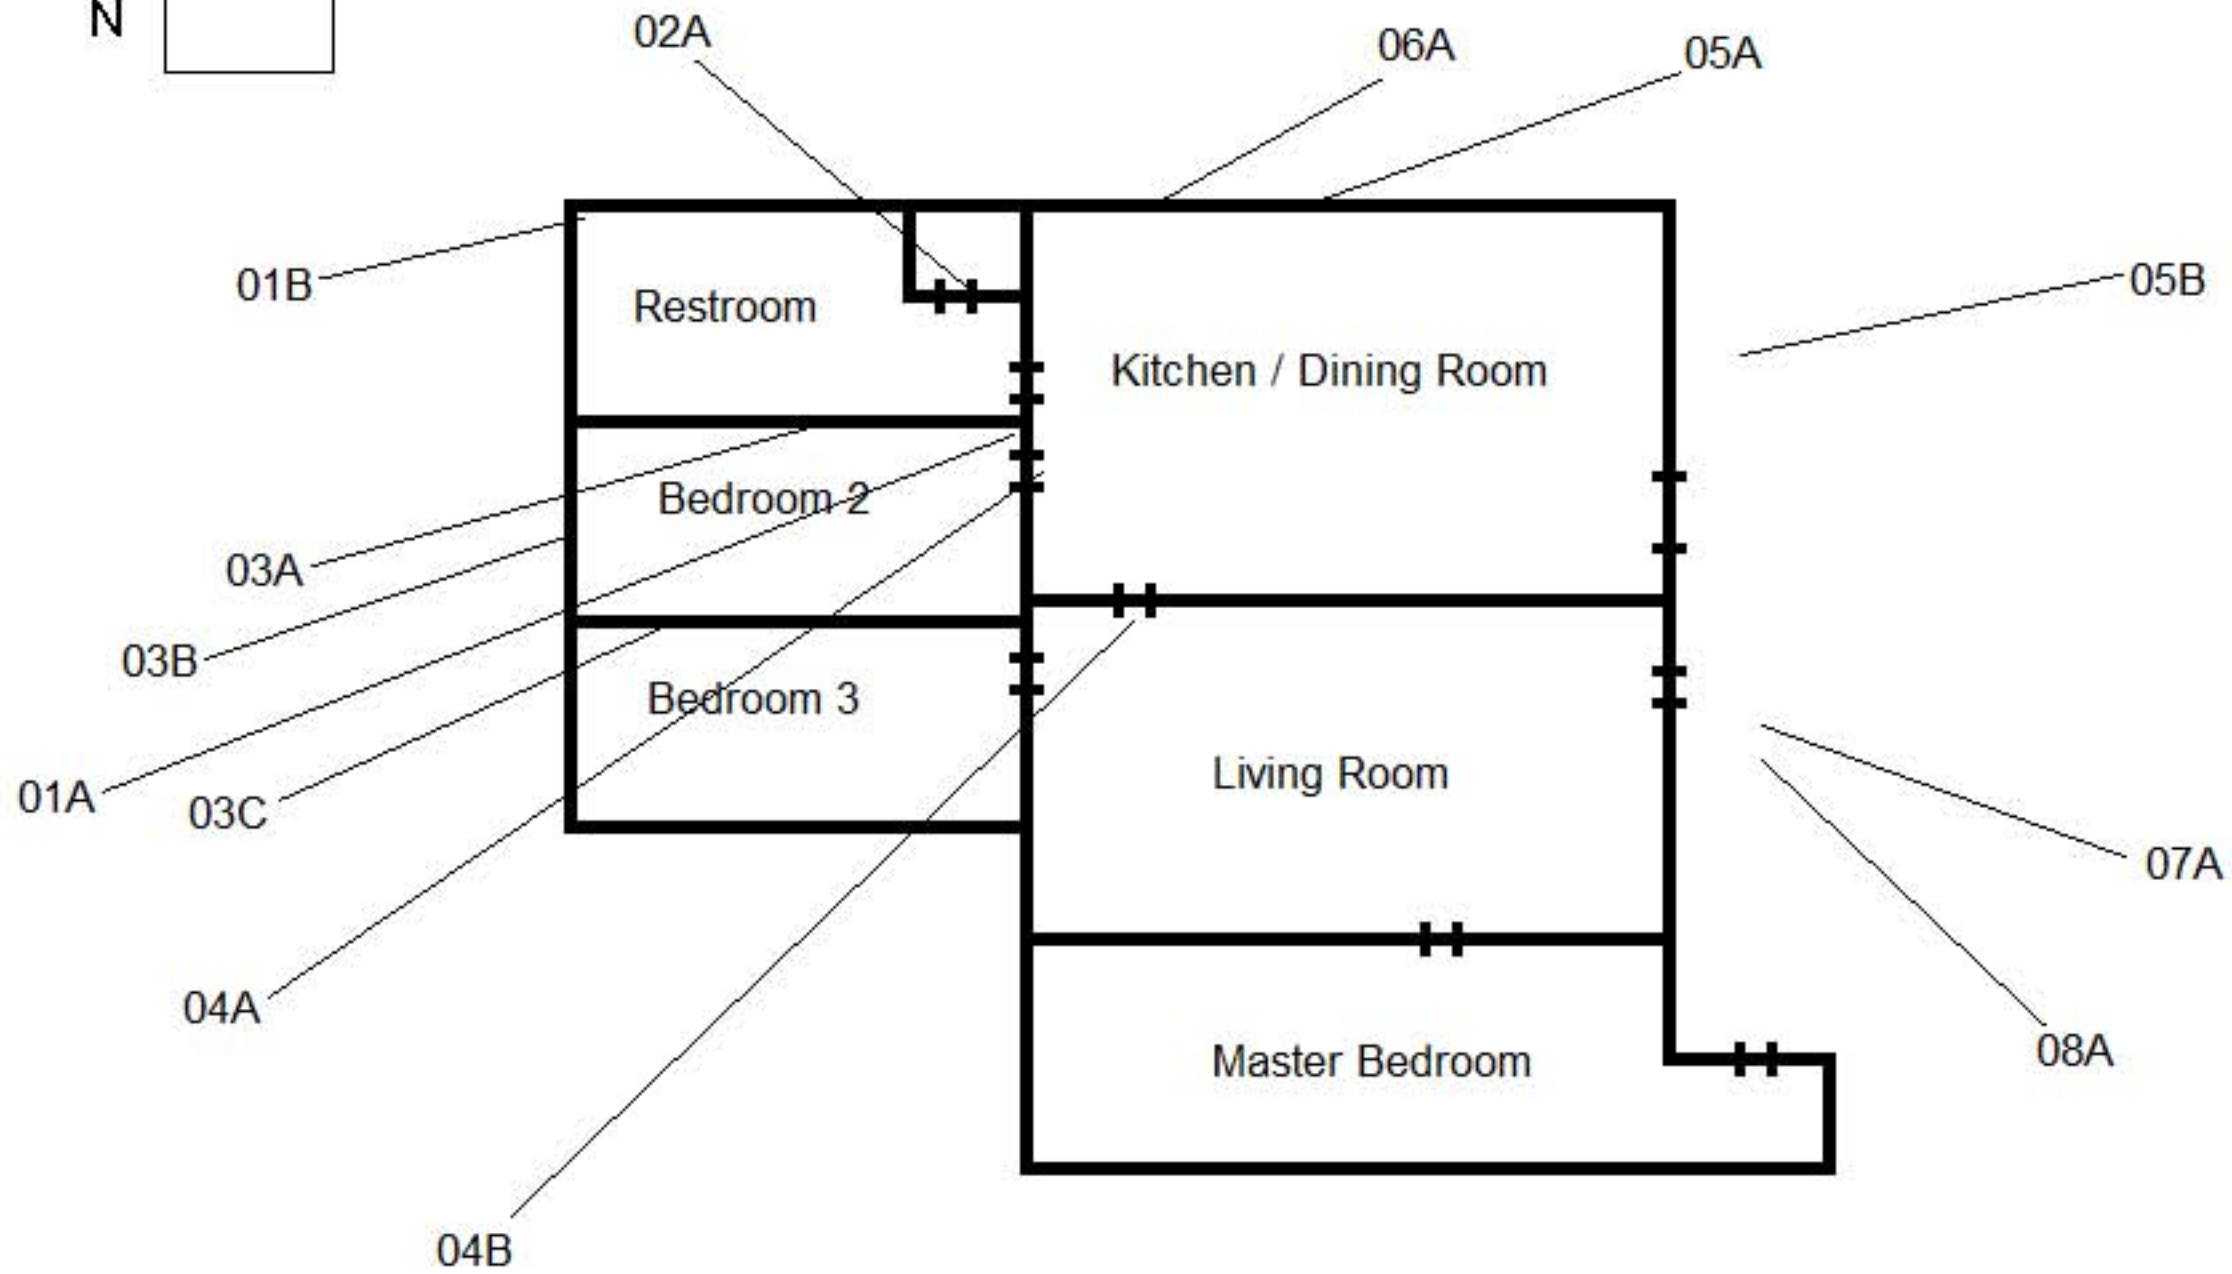
R2

Sample Numbers are Preceded by ECG-17-4478

Asbestos Bulk Sample Locations
Collected by Andrew Roed
on August 24, 2017
Project Number 17-4478

Residence 2 is a single story, wood framed, single family residence on a raised foundation. Interior finishes includes various sheet vinyl flooring and painted drywall with joint compound walls and ceilings systems. Exterior finishes include painted wood siding and trim. The roof is pitched and is comprised of 3-tab asphaltic shingles. Please note that above ceiling was inaccessible. The cementitious flu pipe is assumed to contain asbestos. The sheet vinyl flooring, knockdown texture, drywall with joint compound, and the roof mastic all contained asbestos.

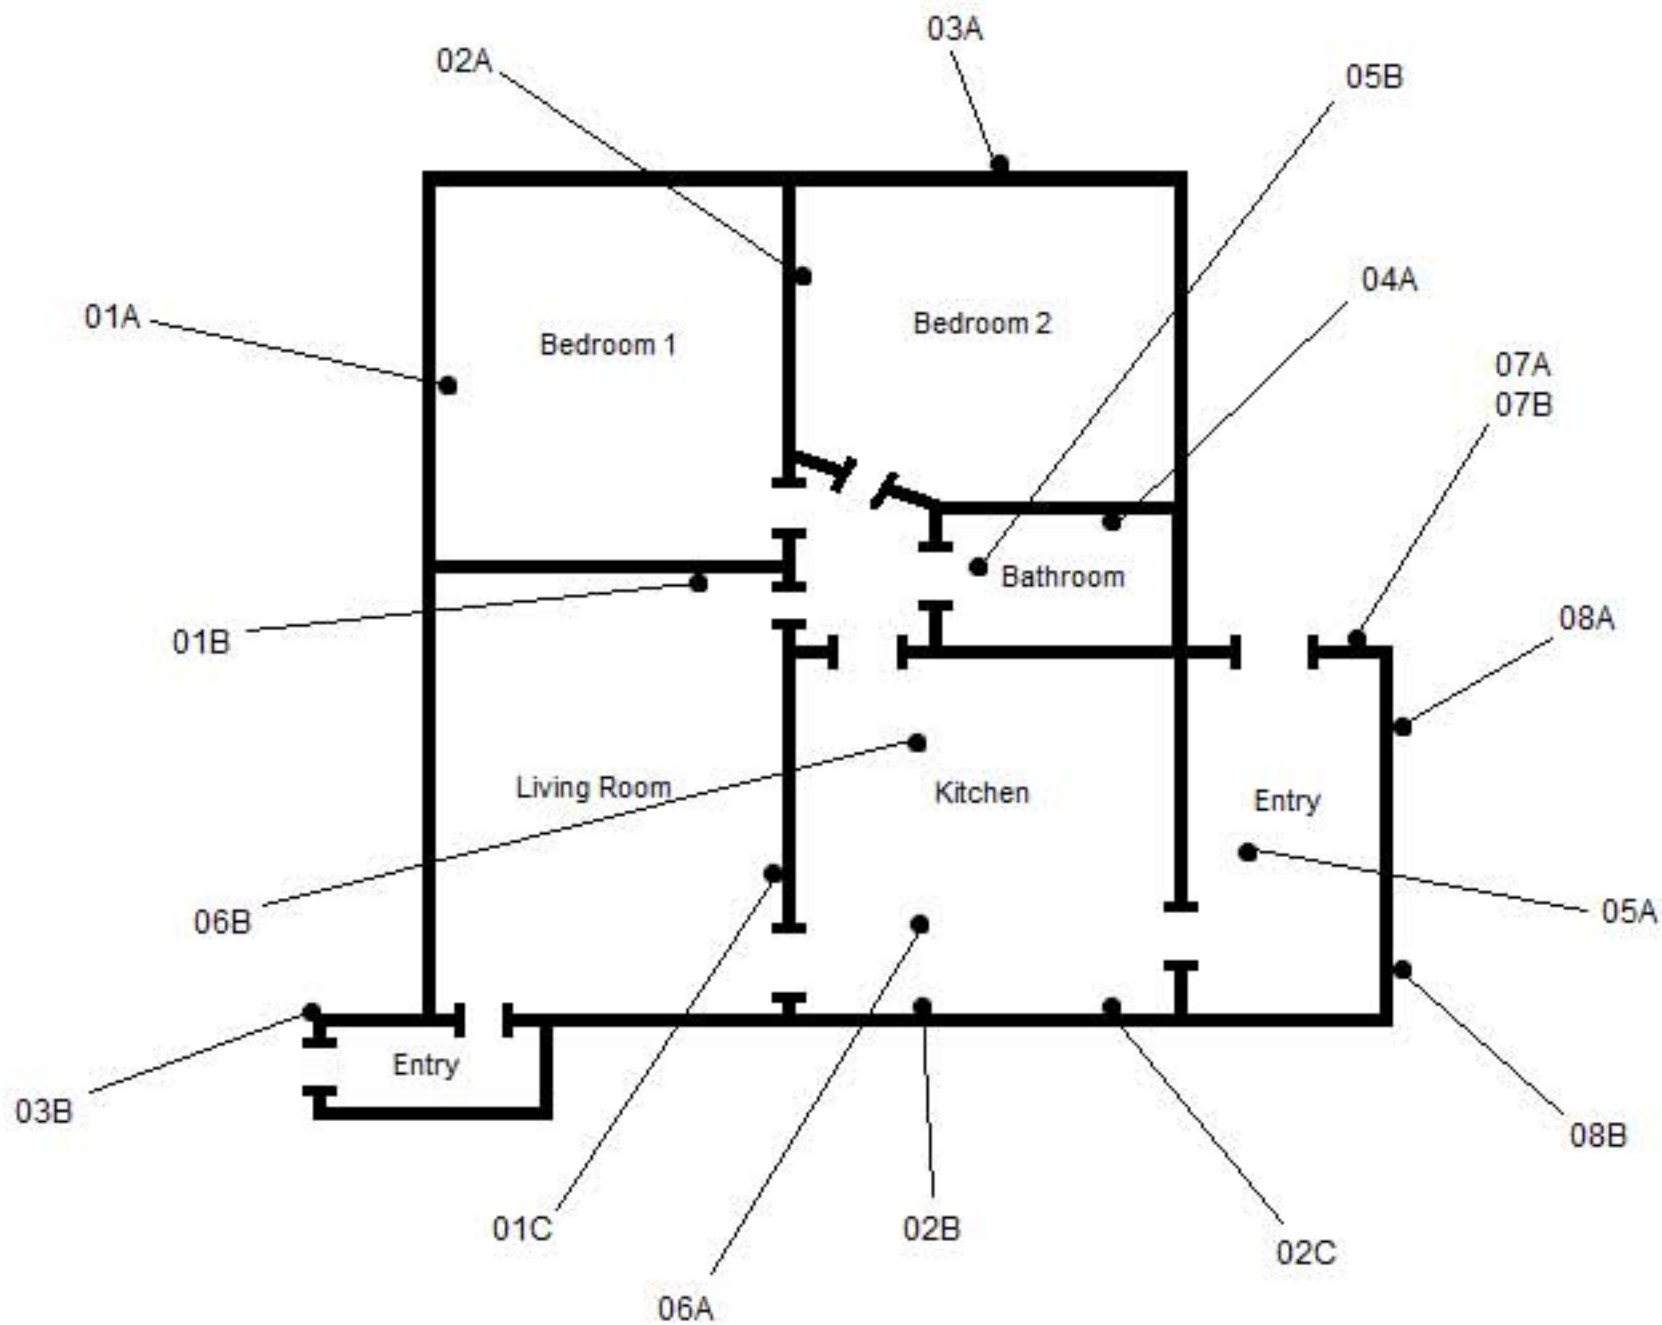
R5

Sample Numbers are Preceded by ECG-17-4478

Asbestos Bulk Sample Locations
Collected by Andy Roed
on September 12 & 13, 2017
Project Number 17-4478

Residence 5 is a single story, wood framed, single family residence on a raised foundation. Interior finishes includes various sheet vinyl flooring and drywall with joint compound walls and ceilings systems. Exterior finishes include painted cementitious siding. The roof is a pitched and comprised of a combination of 3-tab asphaltic shingles and metal. The drywall and joint compound, knockdown texture, roof mastic (assumed), exterior cementitious tiles, and the cementitious flu pipe (assumed) all contain asbestos.

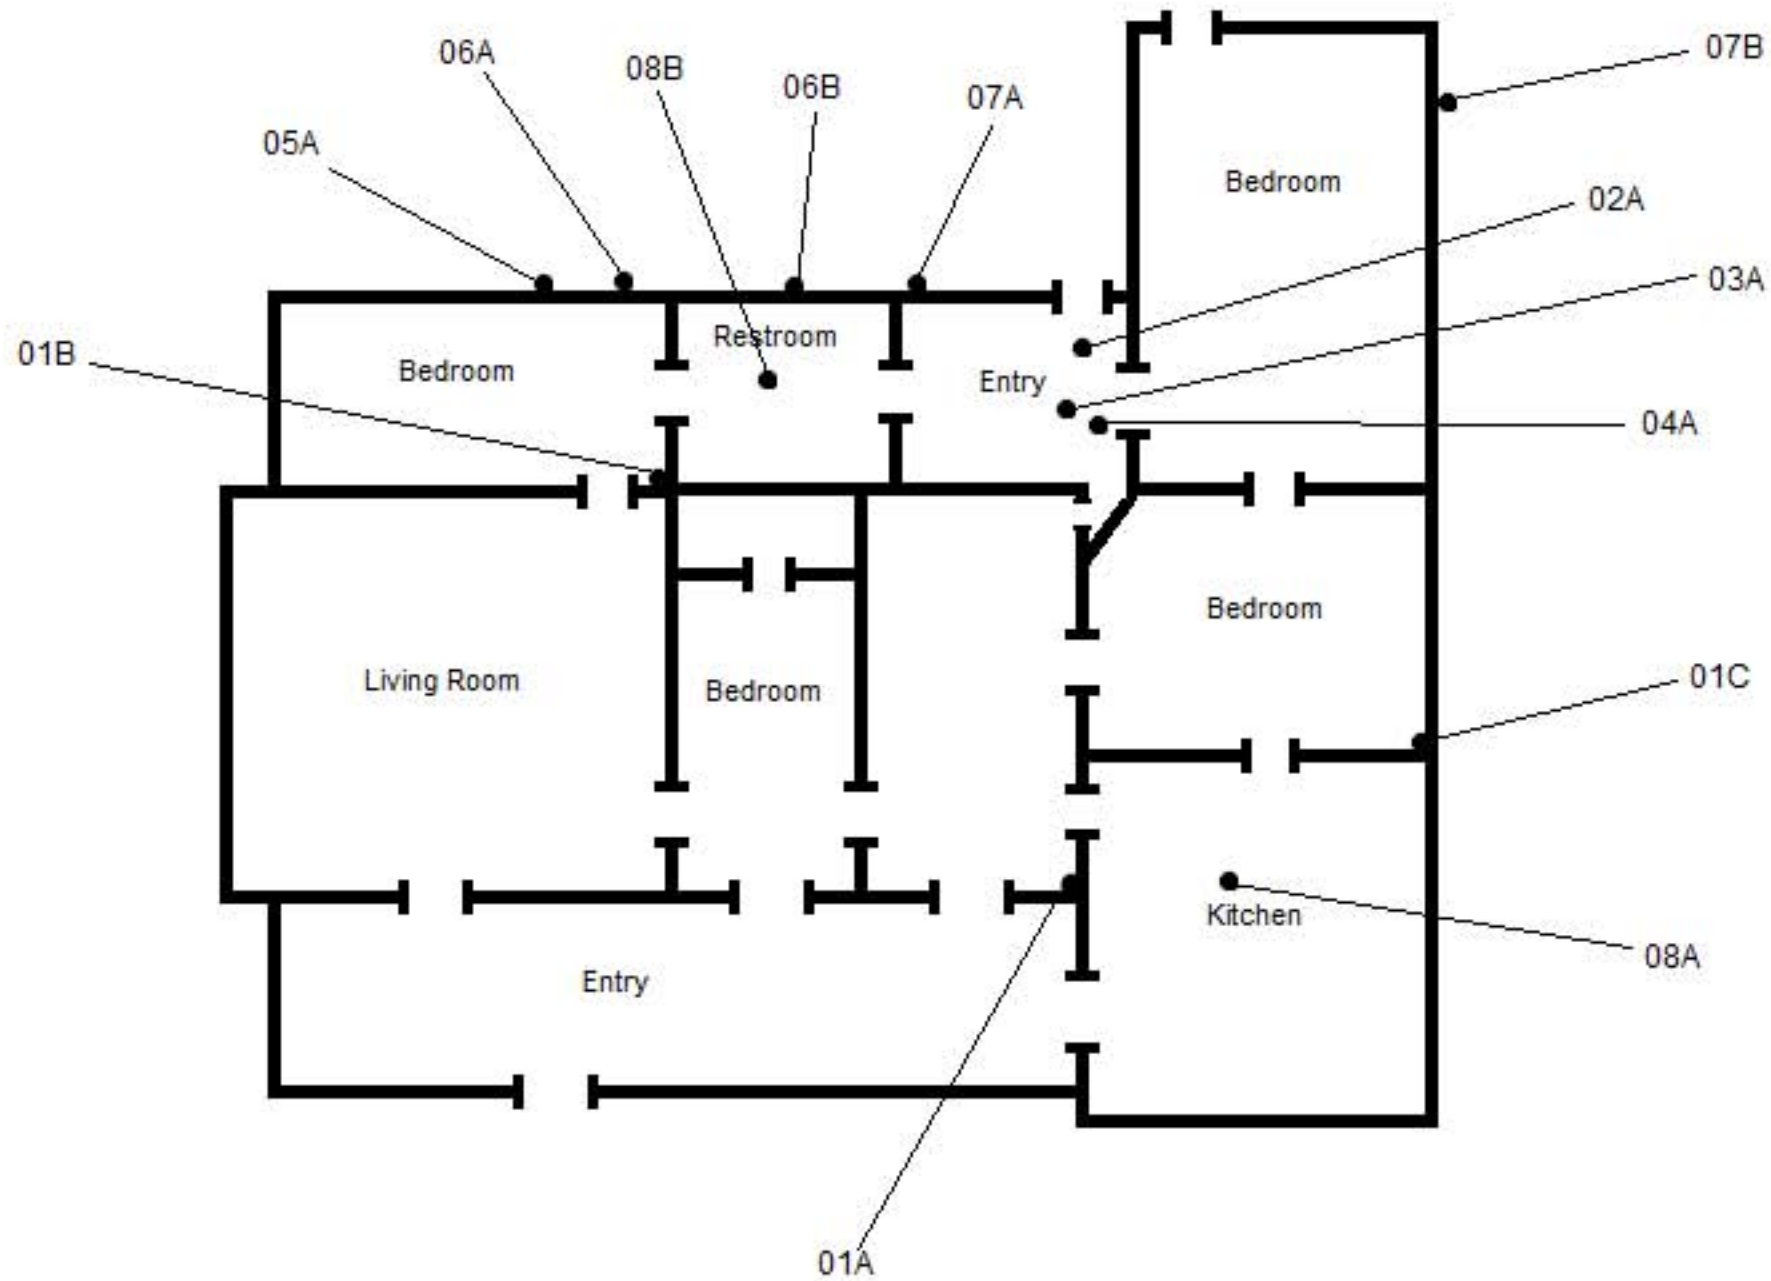
R7

Sample Numbers are Preceded by ECG-17-4478

Asbestos Bulk Sample Locations
Collected by Andy Roed
on September 12 & 13, 2017
Project Number 17-4478

Residence 7 is a single story, wood framed, single family residence on a raised foundation. Interior finishes includes various sheet vinyl flooring and drywall with joint compound walls and ceilings systems. Exterior finishes include painted cementitious siding. The roof is a pitched and comprised of 3-tab asphaltic shingles. The drywall and joint compound, roof mastic (assumed), exterior cementitious tiles, and the cementitious flu pipe (assumed) all contain asbestos.

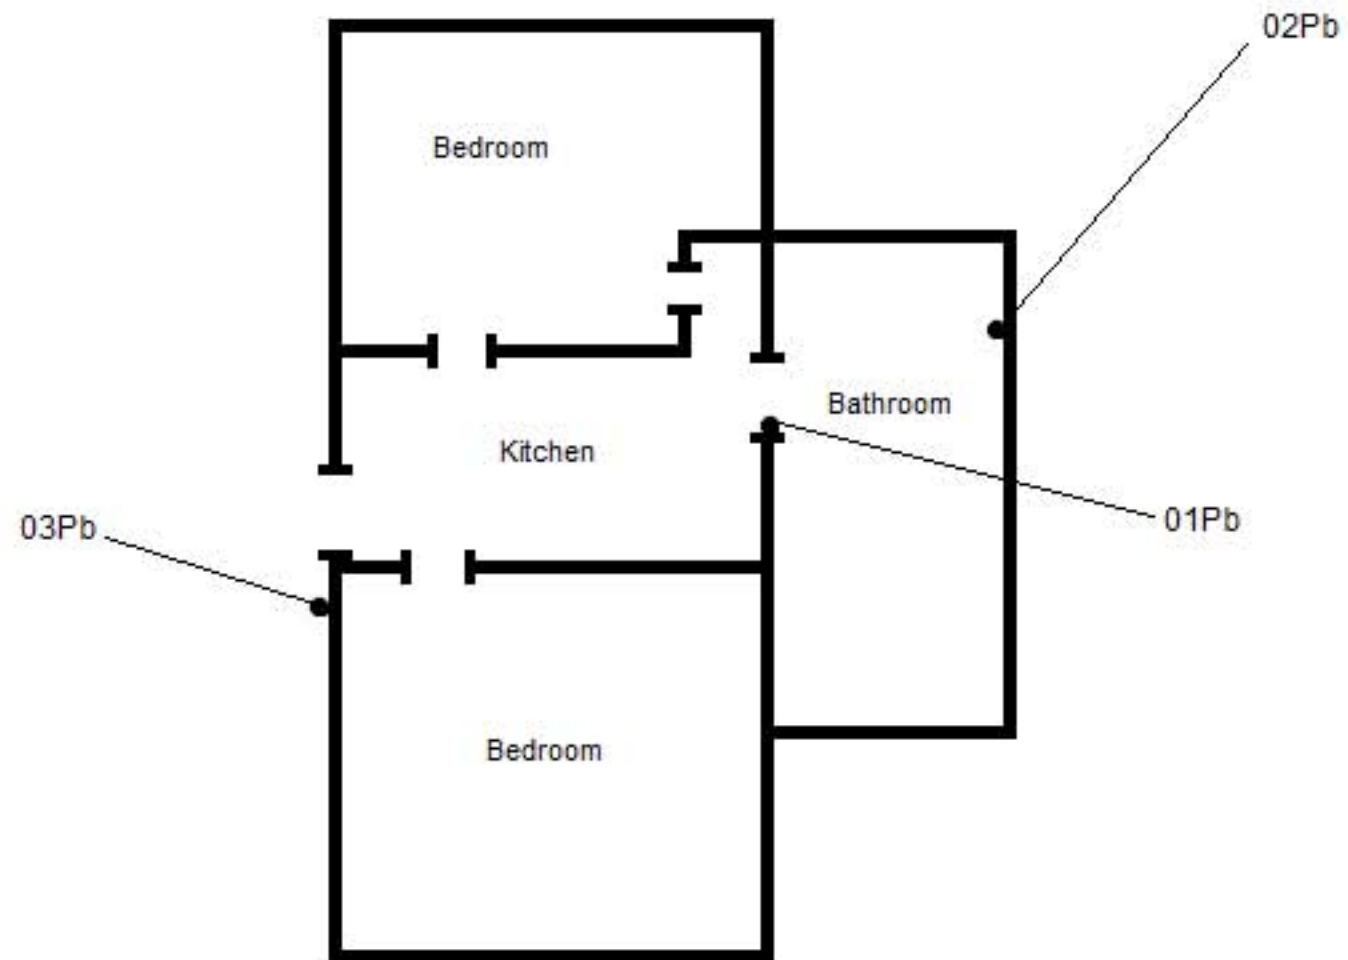
R3

Sample Numbers are Preceded by ECG-17-4478

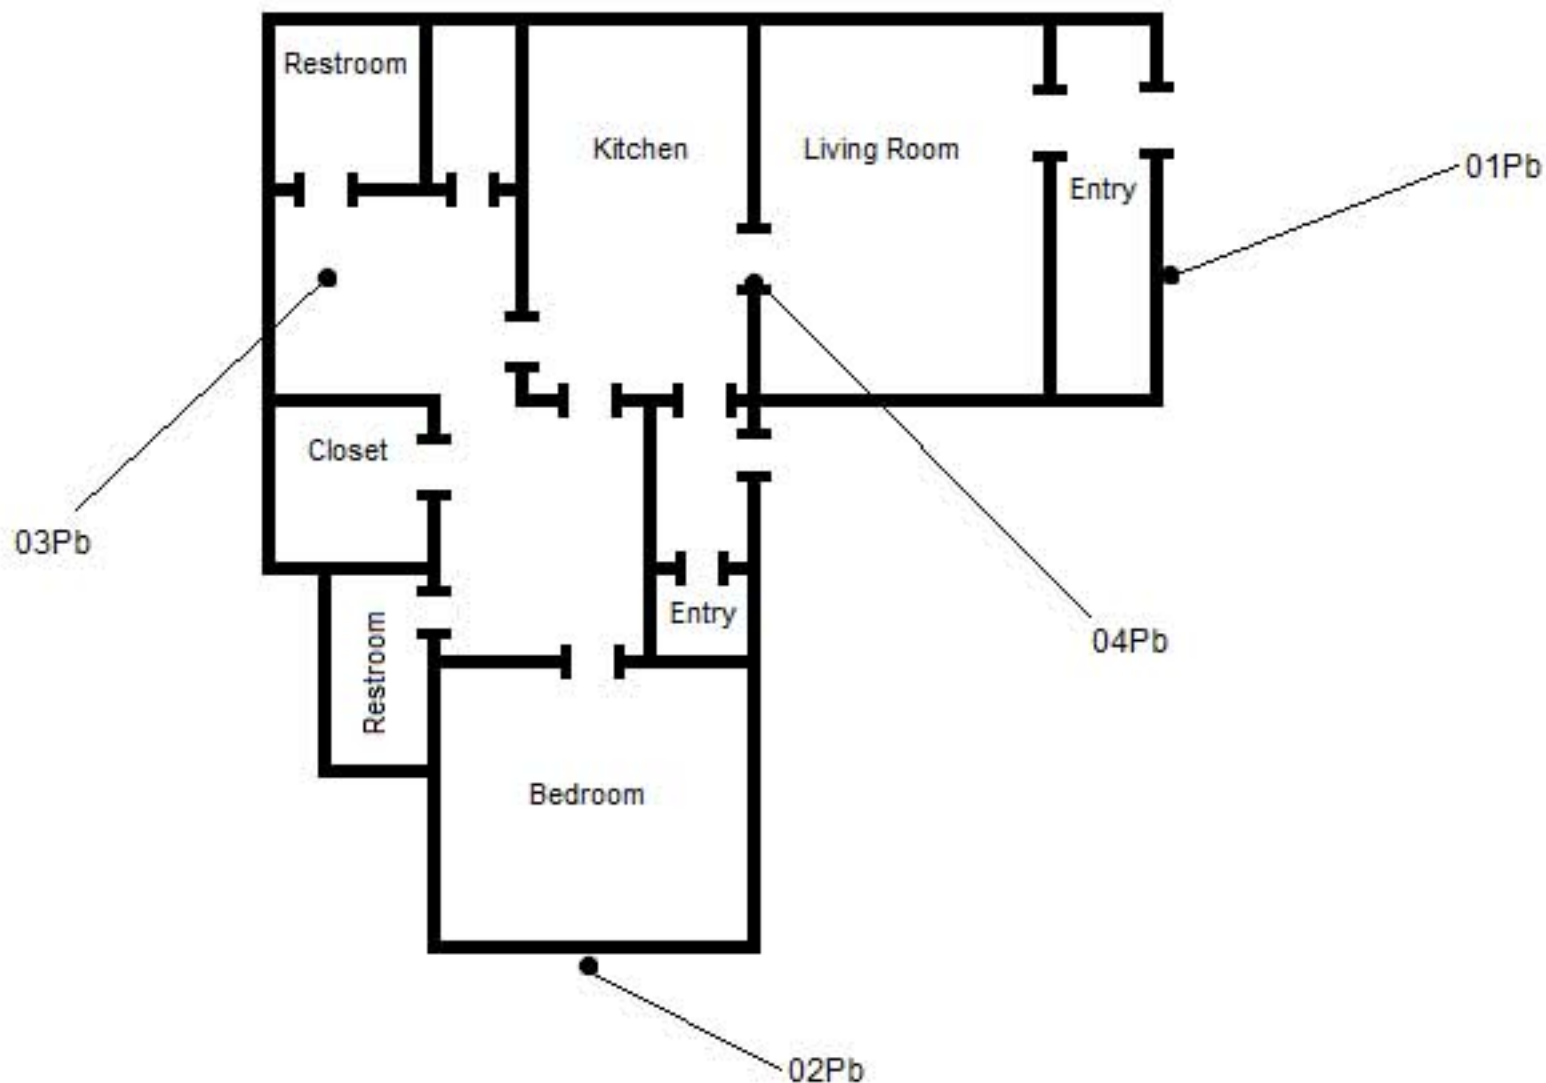
R8

Sample Numbers are Preceded by ECG-17-4478

Lead Bulk Sample Locations
Collected by Andy Roed
on September 12 & 13, 2017
Project Number 17-4478
