**REPORT OF GEOTECHNICAL INVESTIGATION
UPDATE**

Proposed Breeze Townhome Project
1200 Block of S. Nevada Street
Oceanside, California

JOB NO. 15-10805
28 September 2018

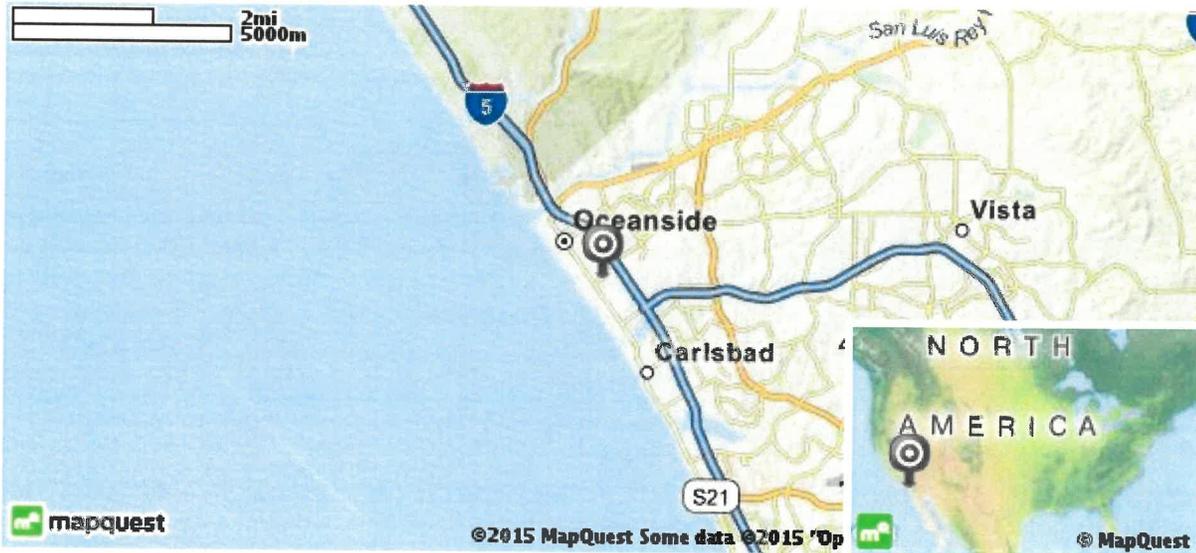
Site Soil Classification Site Class C – “Very Dense Soil and Soft Rock”

$S_s = 1.173 \text{ g}$	$S_{MS} = 1.173 \text{ g}$	$S_{DS} = 0.782 \text{ g}$
$S_1 = 0.451 \text{ g}$	$S_{M1} = 0.608 \text{ g}$	$S_{D1} = 0.406 \text{ g}$
