Interim ACM-LBP Survey

Re: CITADEL Project No. 1097.1002.0
Environmentally-Regulated Materials Survey Report (Interim Report)
Pre-Demolition Asbestos and Lead Survey
333 South San Vicente Boulevard
Los Angeles, California 90048

Environmentally-Regulated Materials Survey Report (Interim Report)

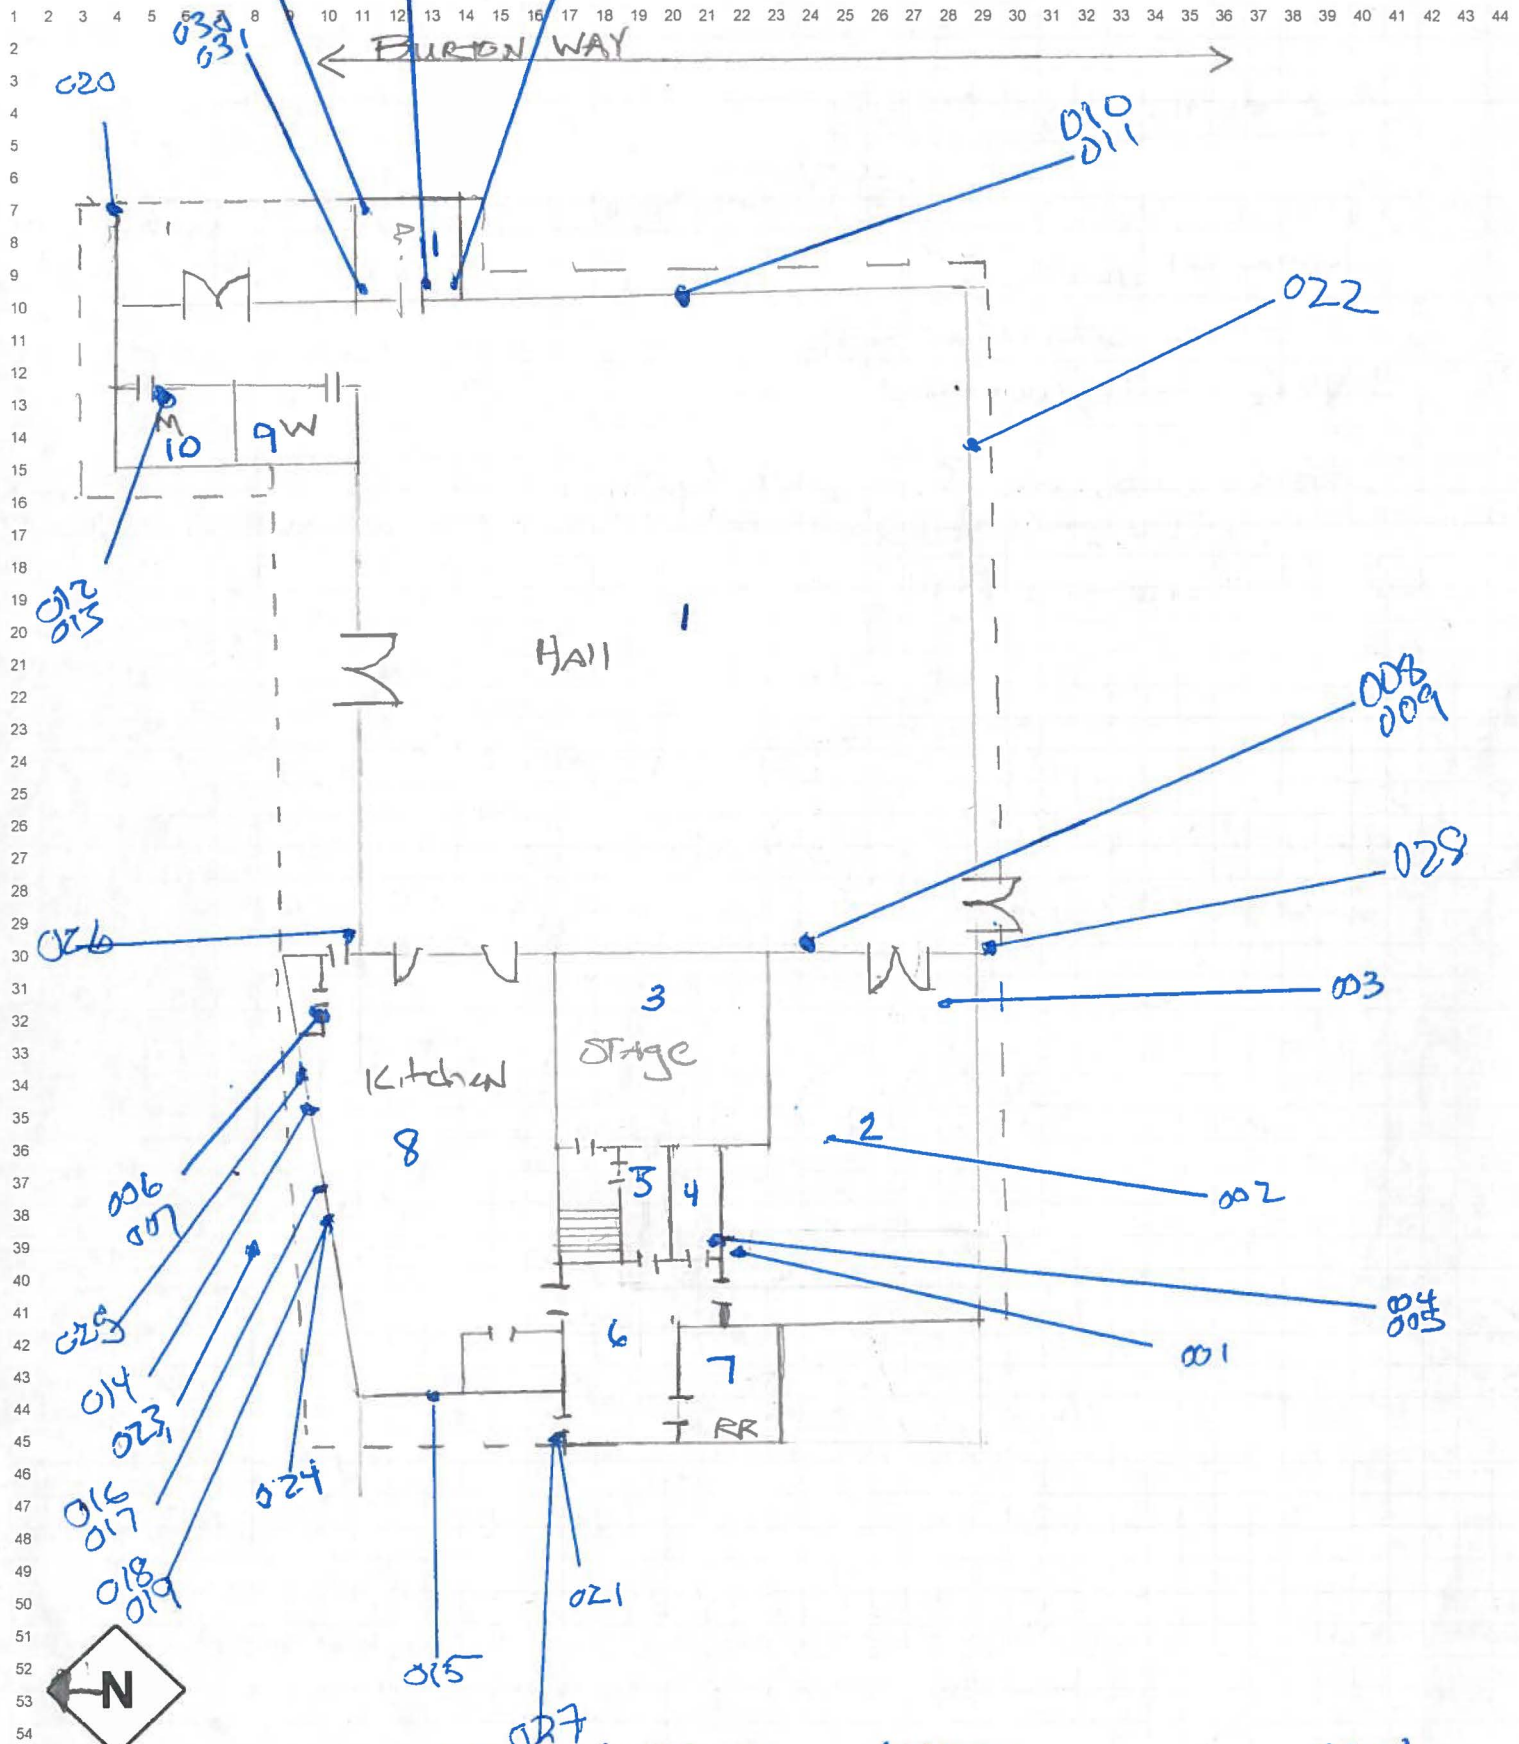
Project No.: 1097.1002 Client: WRSSR Date: 8/14/17
 Project ID: Our copy of Mt Lebanon Drawing: Church Hall
 Floor: 1st Floor
 Site Address: _____
 Inspector: Jeffrey Klein

50 SF RPM
