**PRELIMINARY GEOTECHNICAL EVALUATION  
COLTON REGIONAL SOCCER COMPLEX AND  
GUYAUX LANDFILL REDEVELOPMENT  
COLTON, CALIFORNIA**

May 18, 2016  
Project No. 209667002

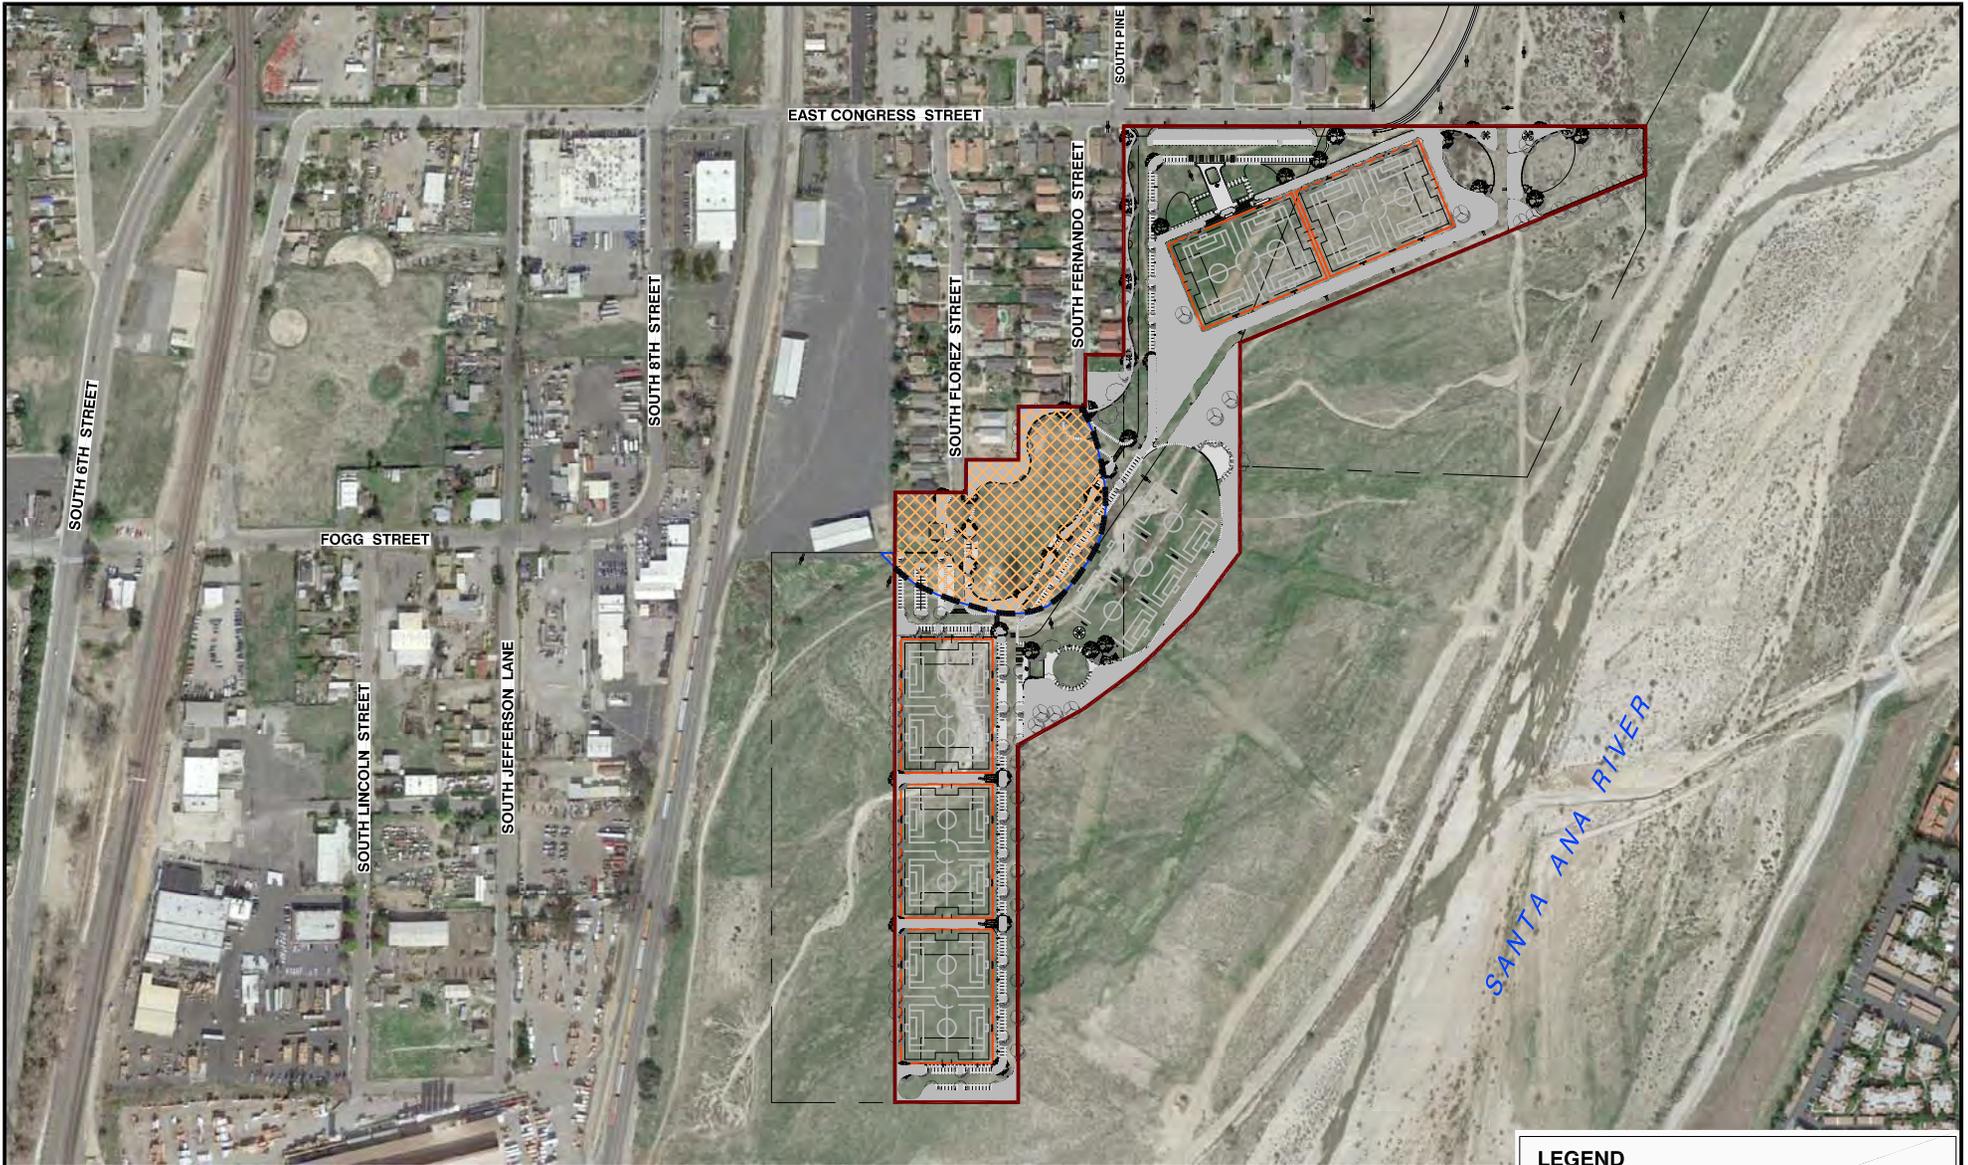
<b>Ninyo &amp; Moore</b>		<b>SITE PLAN</b>	FIGURE
PROJECT NO.	DATE	COLTON REGIONAL SOCCER COMPLEX AND GUYAUX LANDFILL REDEVELOPMENT COLTON, CALIFORNIA	<b>2</b>
209667002	5/16

REFERENCE: GOOGLE EARTH AERIAL PHOTO, 2016.

LANDFILL BOUNDARY

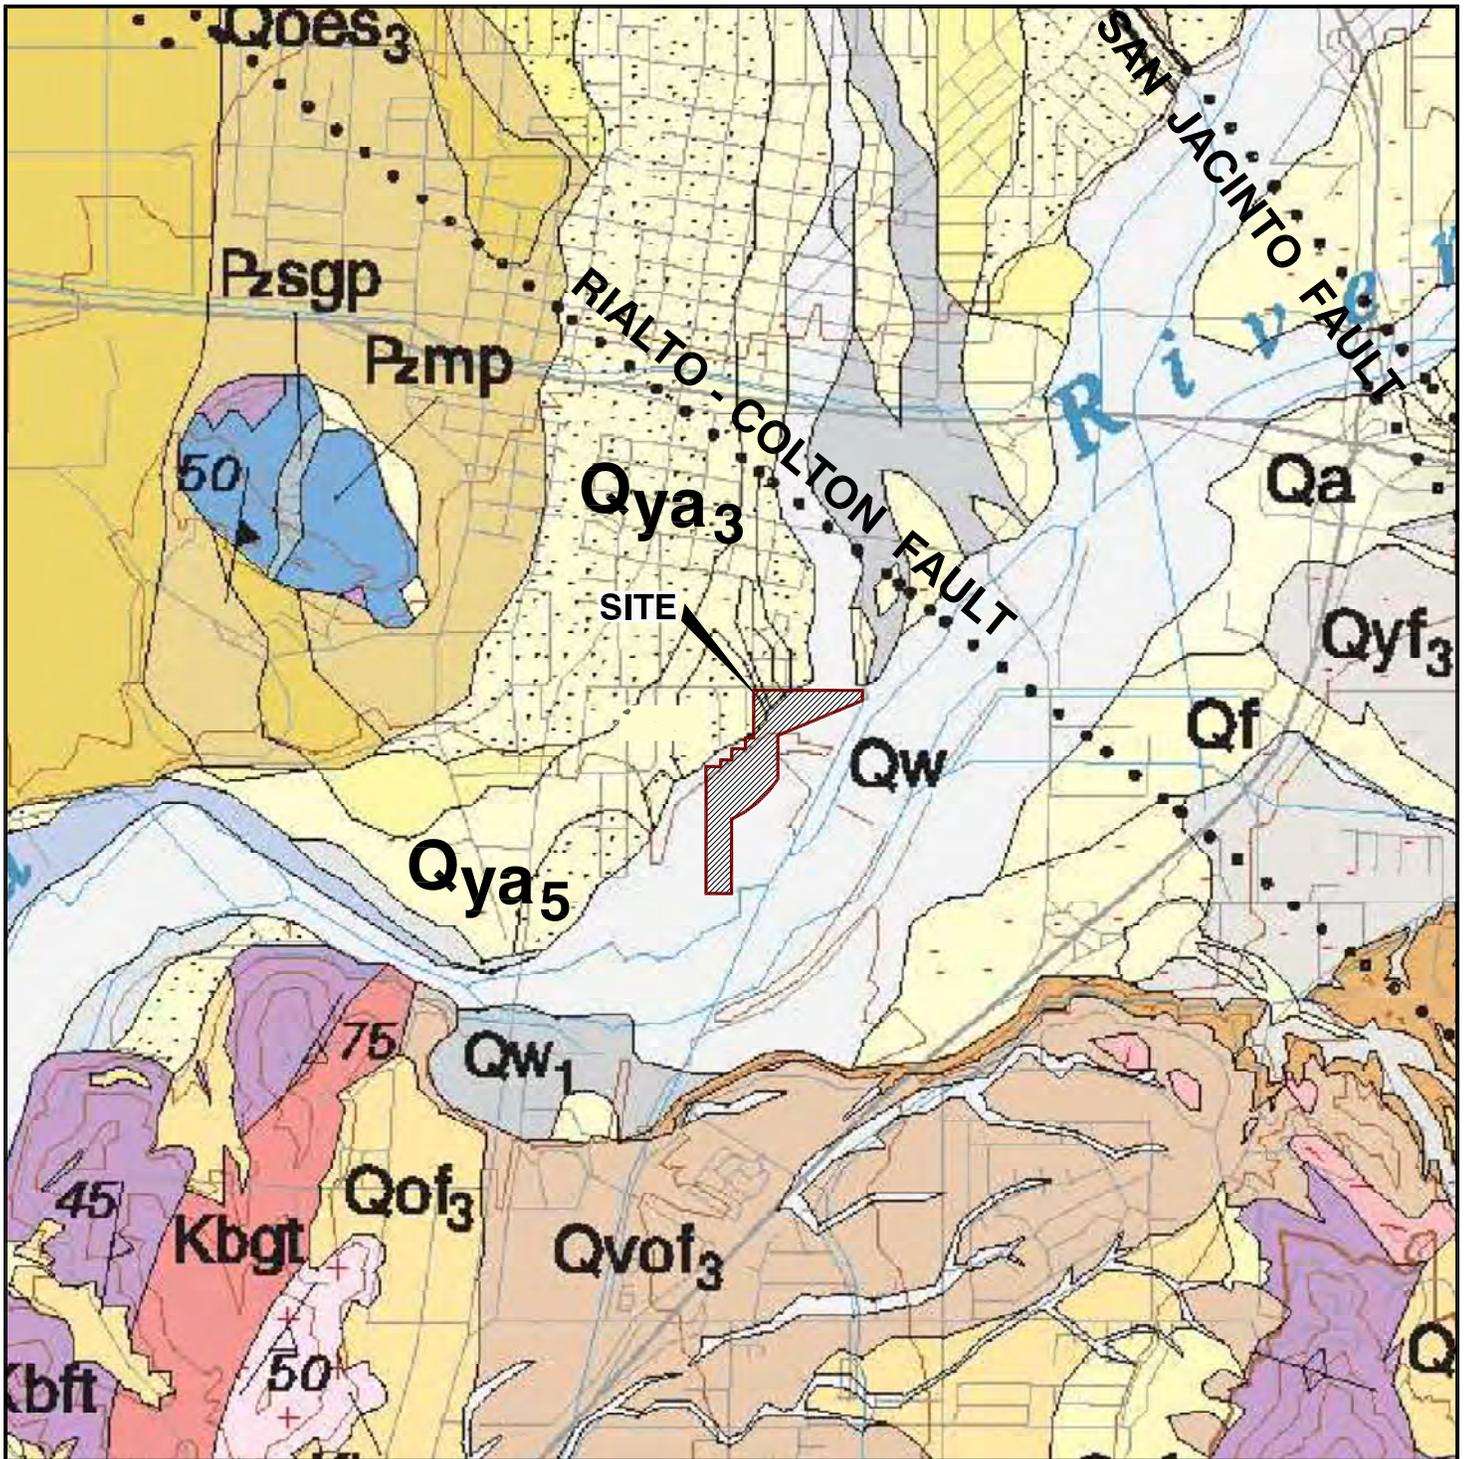
**3**

REFERENCE: MORTON, D.M. AND MILLER, F.K., 2006, GEOLOGIC MAP OF THE SAN BERNARDINO AND SANTA ANA 30'X60' QUADRANGLE, CALIFORNIA.

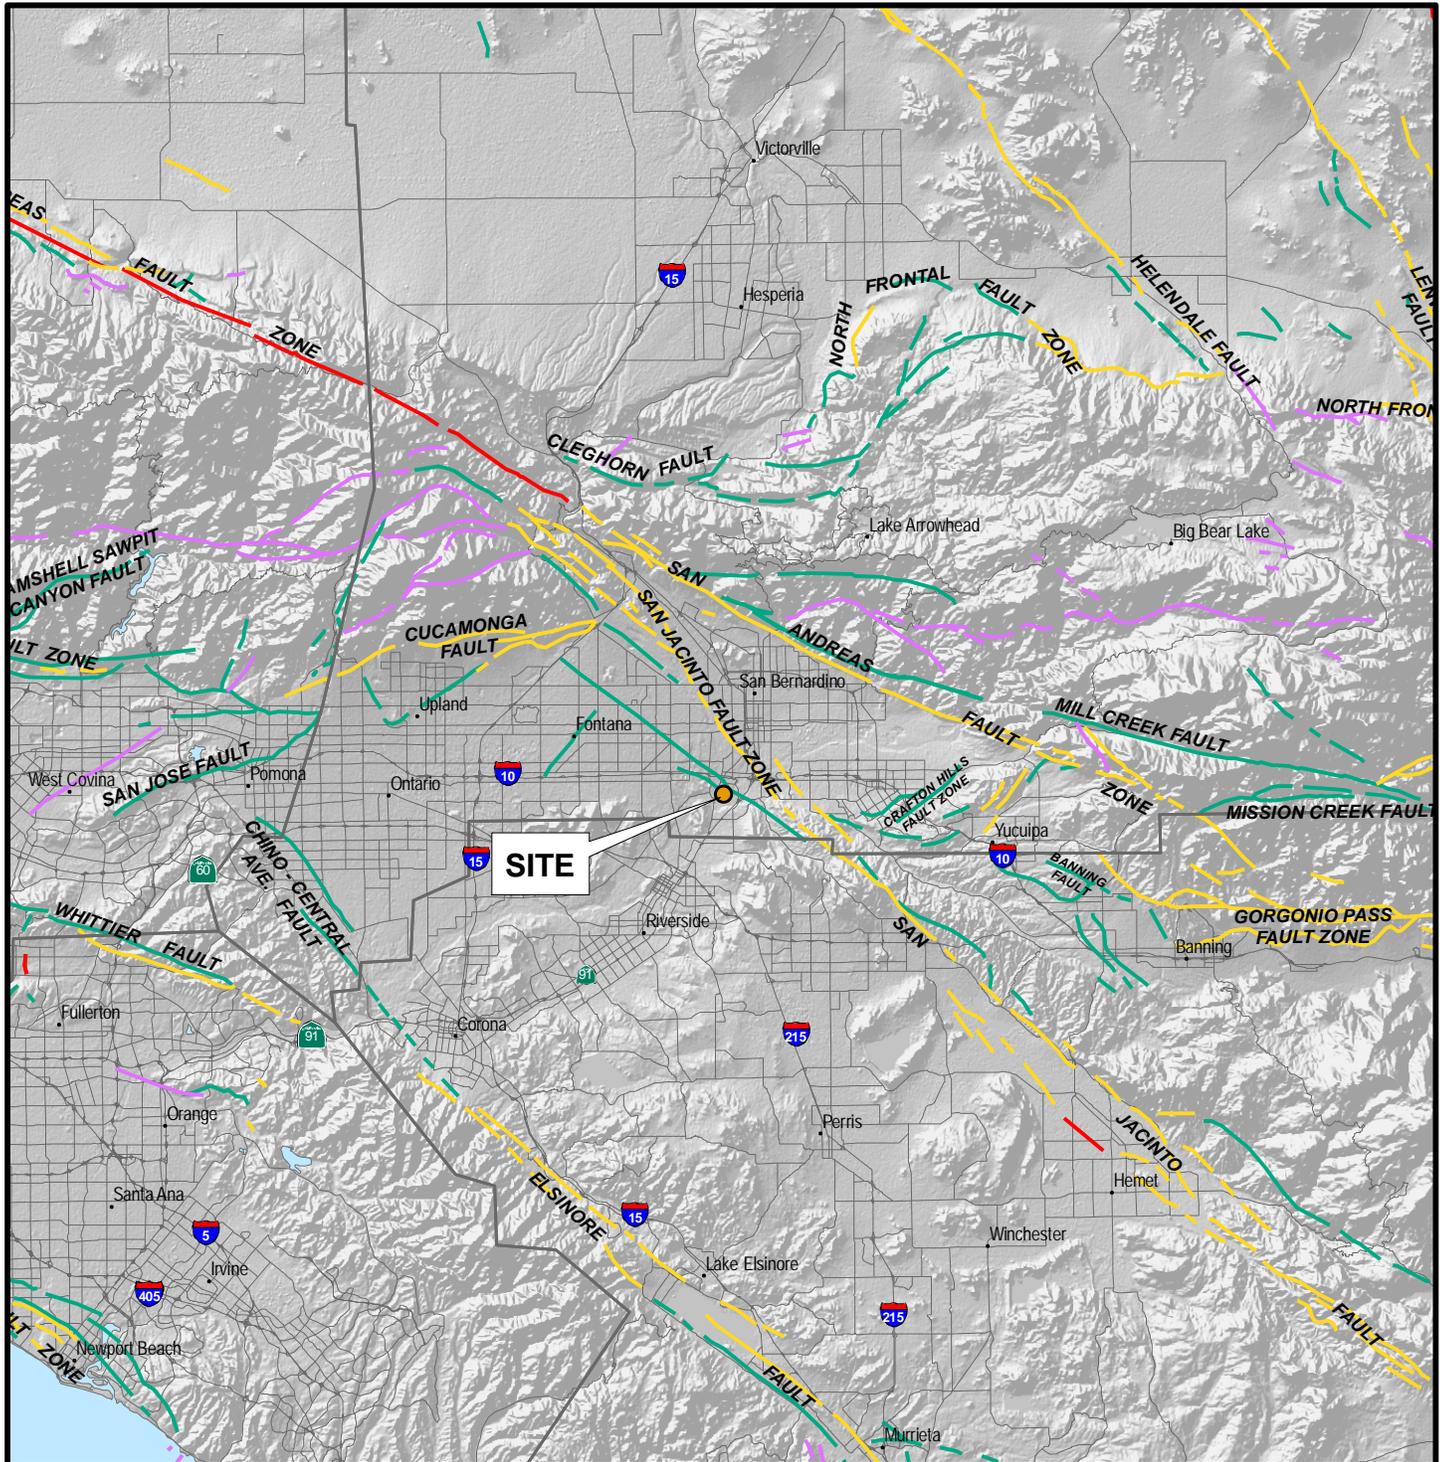
<b>Ninyo &amp; Moore</b>		<b>FAULT LOCATIONS</b>	FIGURE
PROJECT NO.	DATE	COLTON REGIONAL SOCCER COMPLEX AND GUYAUX LANDFILL REDEVELOPMENT COLTON, CALIFORNIA	<b>4</b>
209667002	5/16

GIS DATA SOURCE: CALIFORNIA GEOLOGICAL SURVEY (CGS); ENVIRONMENTAL SYSTEMS RESEARCH INSTITUTE (ESRI)  
 REFERENCE: JENNINGS, 2010, FAULT ACTIVITY MAP OF CALIFORNIA AND ADJACENT AREAS

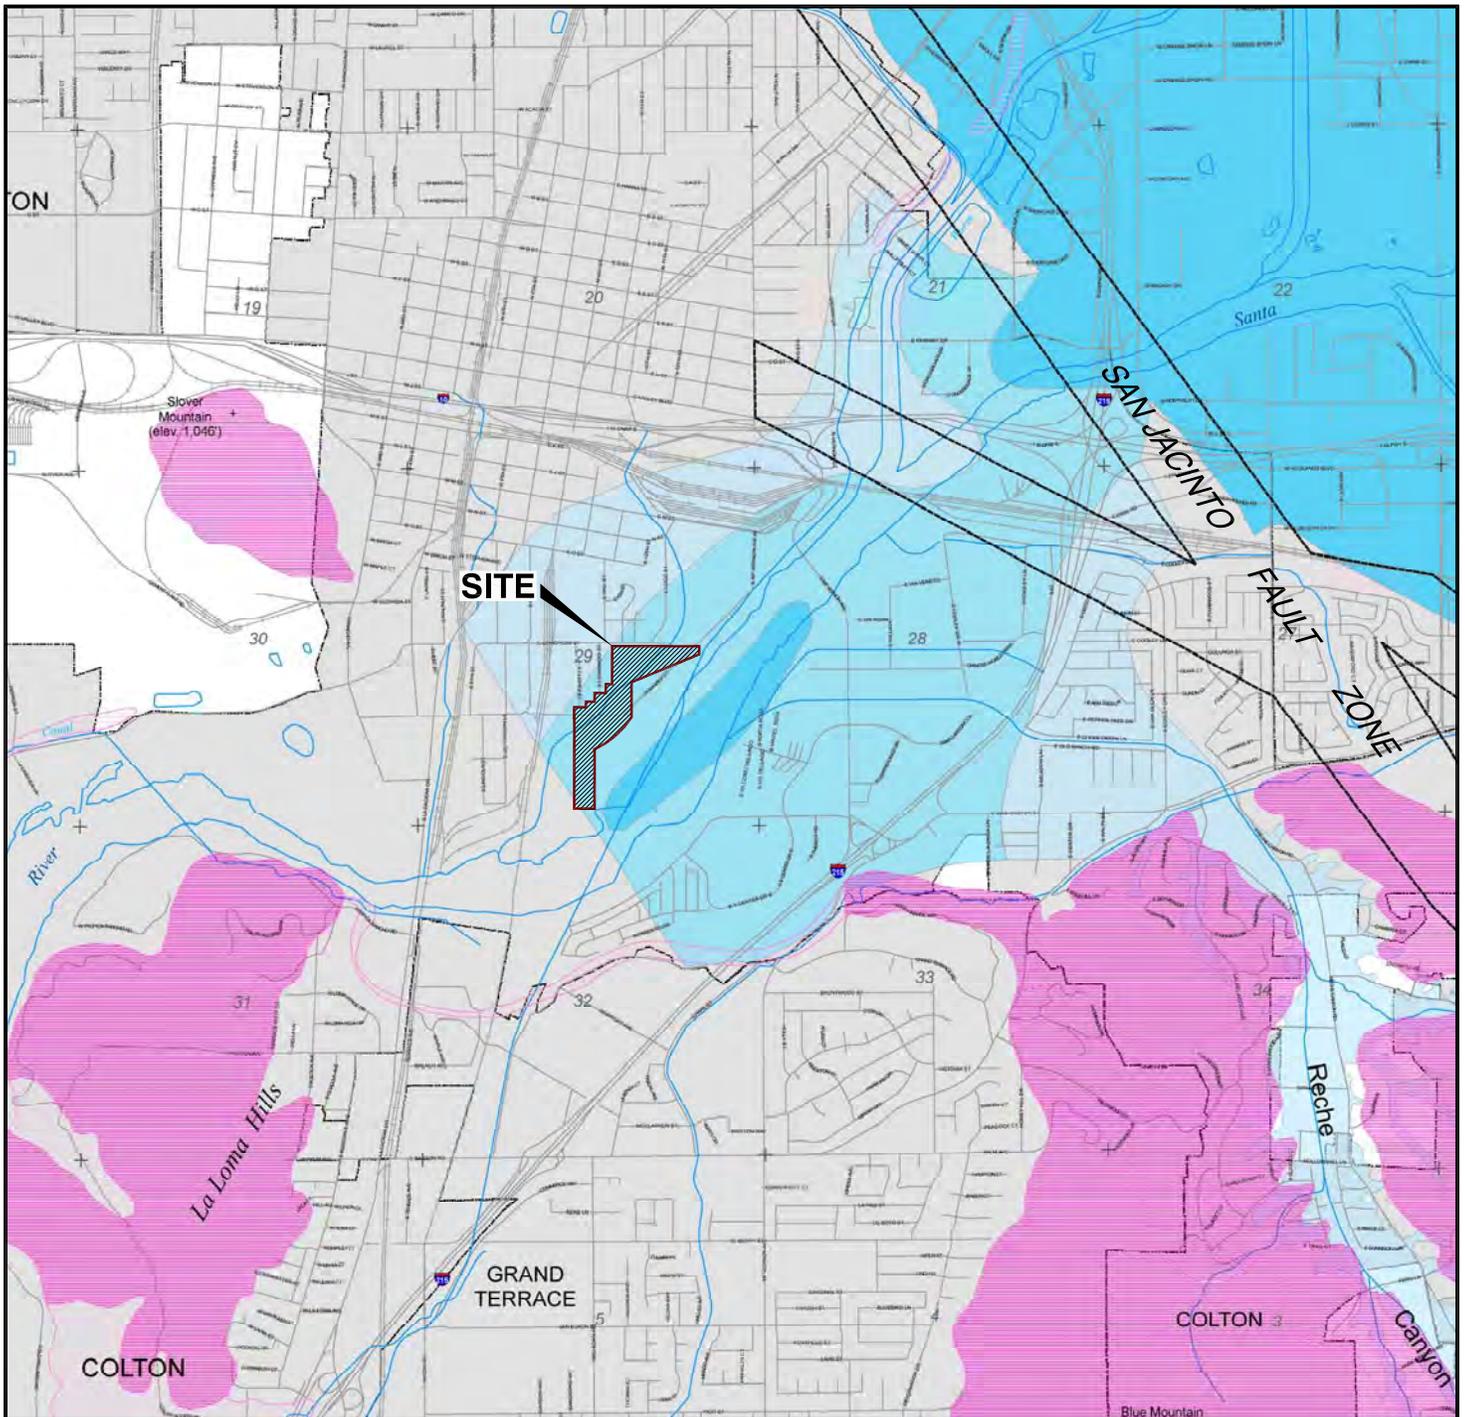
**SEISMIC HAZARDS**

REFERENCE: SAN BERNARDINO COUNTY LAND USE PLAN, GENERAL PLAN, GEOLOGIC HAZARD OVERLAYS.

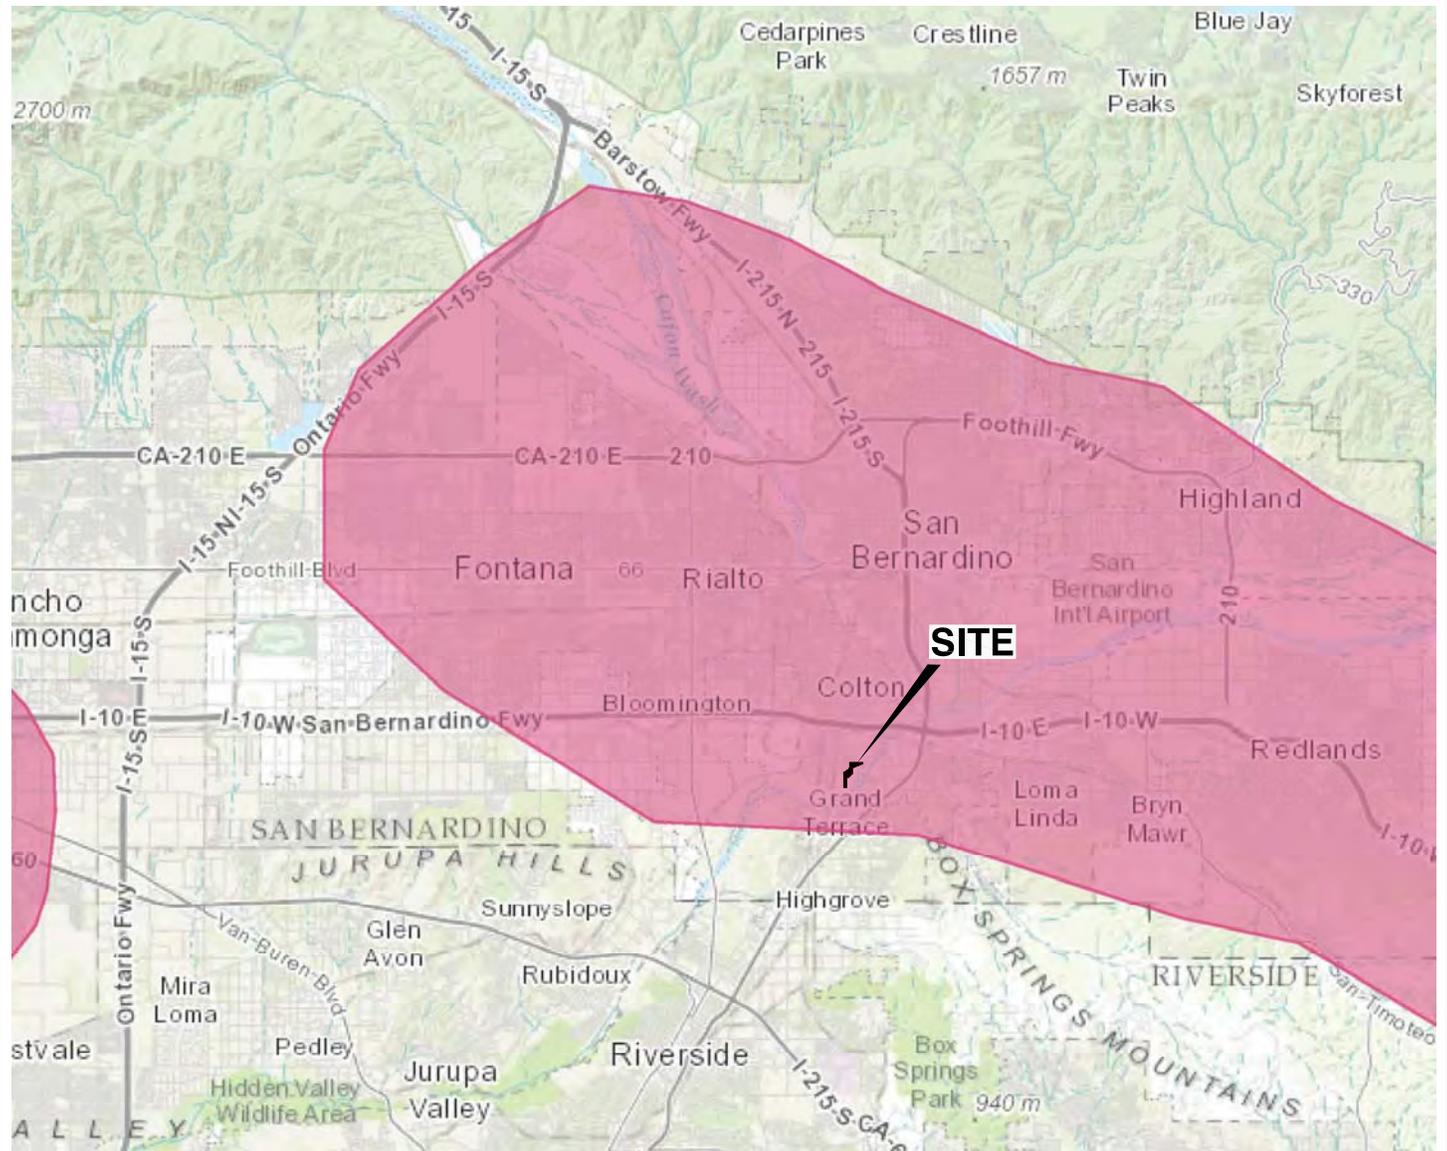
REFERENCE: UNITED STATES GEOLOGICAL SURVEY, 2015, AREAS OF LAND SUBSIDENCE IN CALIFORNIA, WEBSITE: [HTTP://CA.WATER.USGS.GOV/LAND\\_SUBSIDENCE/CALIFORNIA-SUBSIDENCE-AREAS.HTML](http://ca.water.usgs.gov/land_subsidence/california-subsidence-areas.html)
