**UPDATED GEOTECHNICAL EVALUATION REPORT FOR CEQA  
PROPOSED LAGUNA NIGUEL TOWN CENTER  
30102 PACIFIC ISLAND DRIVE  
LAGUNA NIGUEL, CALIFORNIA**

Subject: Updated Geotechnical Evaluation Report for CEQA  
Proposed Laguna Niguel Town Center  
30102 Pacific Island Drive (Crown Valley Parkway at Alicia Parkway)  
Laguna Niguel, California  
GPI Project No. 2952.I

This updated report presents the results of a preliminary geotechnical and geologic/seismic hazards study performed by Geotechnical Professionals Inc. (GPI) for the proposed Laguna Niguel Town Center development in Laguna Niguel, California. The purpose of this study and report is to support due diligence efforts by providing geotechnical and geologic input for the Environmental Impact Report for the project. This includes addressing the geotechnical related issues listed in Appendix G, Environmental Checklist Form, of the State California Environmental Quality Act CEQA Guidelines (see Appendix D). The location of the site is shown on Figure 1, Site Location Map. The layout of the site with existing and proposed conditions is shown on Figures 2 and 3, Existing Site Plan and Proposed Site Plan, respectively. A Site Geologic

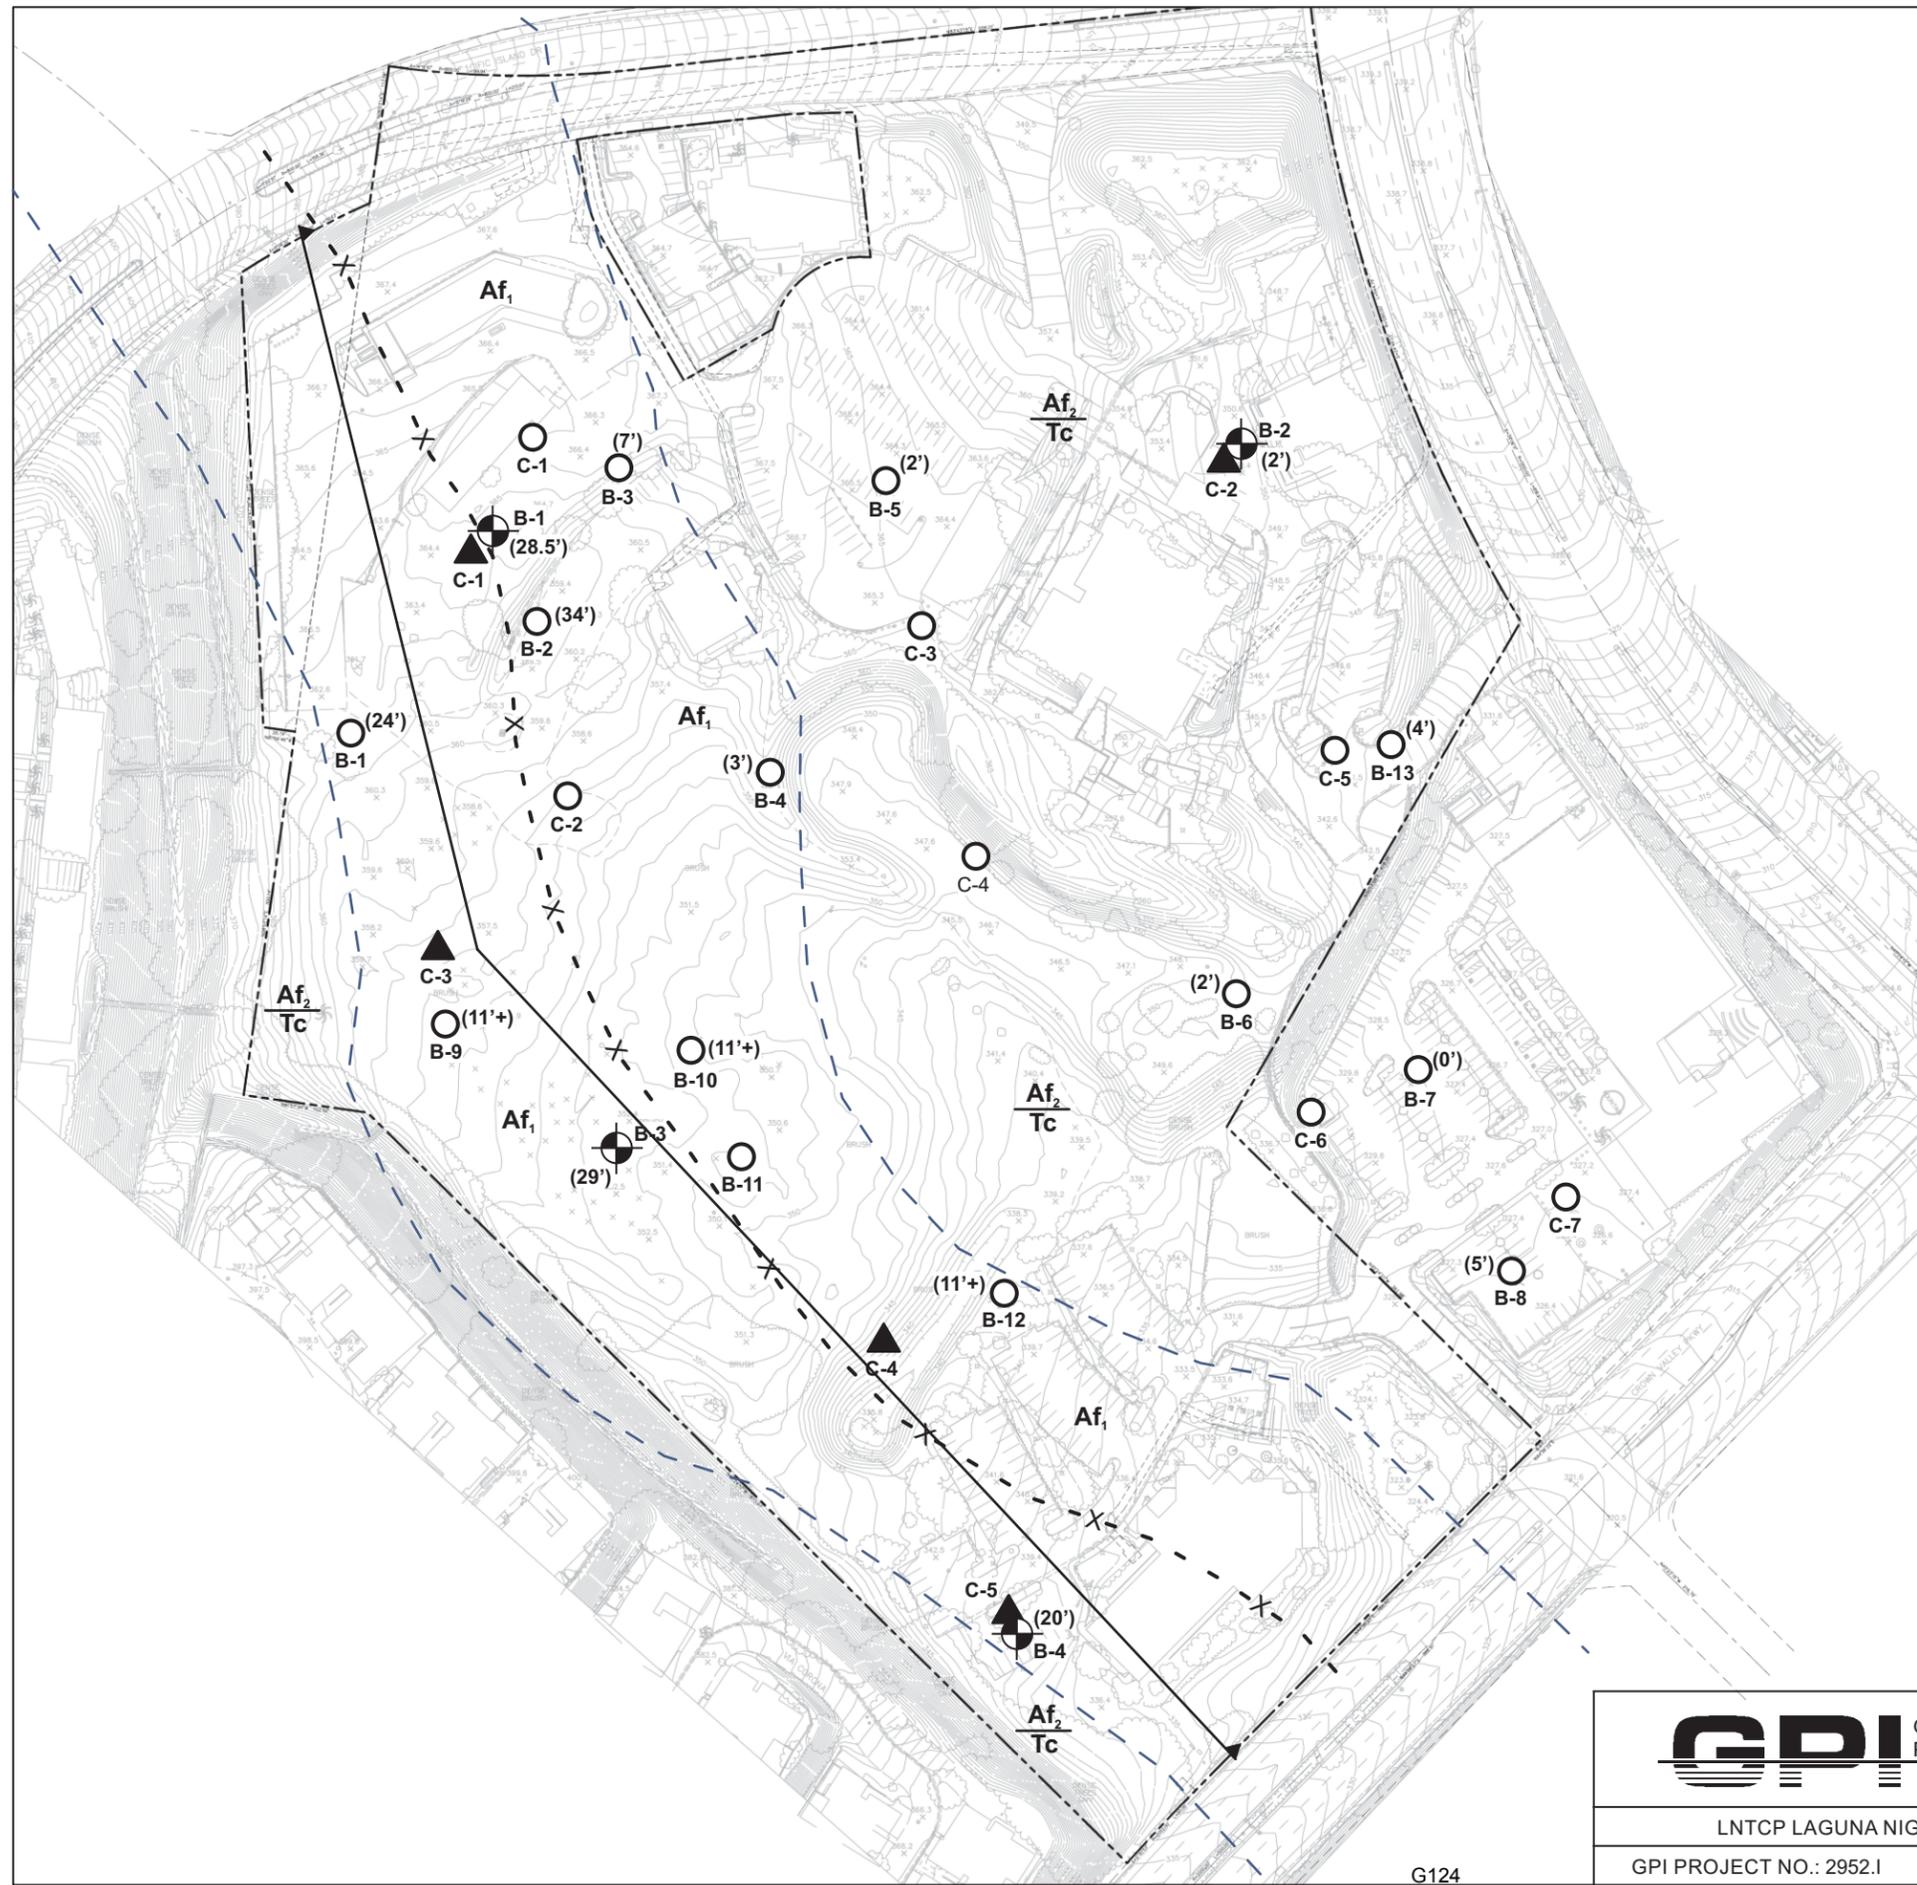
**SITE GEOLOGIC MAP**

- Af<sub>1</sub>** APPROXIMATE LIMITS OF FILL PLACED DURING PREVIOUS GRADING (CIRCA 1980-1981)
- Af<sub>2</sub>** APPROXIMATE LIMITS OF FILL PLACED DURING PREVIOUS GRADING OF EXISTING STRUCTURES AND PARKING AREAS
- Tc** CAPISTRANO FORMATION
- B-5**

APPROXIMATE LOCATION AND NUMBER OF PRIOR EXPLORATION BY OTHERS (2005)
- (5')** APPROXIMATE DEPTH OF FILL (FEET)
- X- -X-** APPROXIMATE BOTTOM OF FILLED CANYON AND POSSIBLY OF CANYON SUBDRAINS
- - -** GEOLOGIC CONTACT
- ▲** SUBSURFACE CROSS SECTION
