## EXHIBIT F

Landslide Hazard Evaluation  
Wappo Land Company Vineyard Block A  
Assessor's Parcel Number (APN) 030-220-044  
Napa County, California

Project Number: 5492.07.06.2

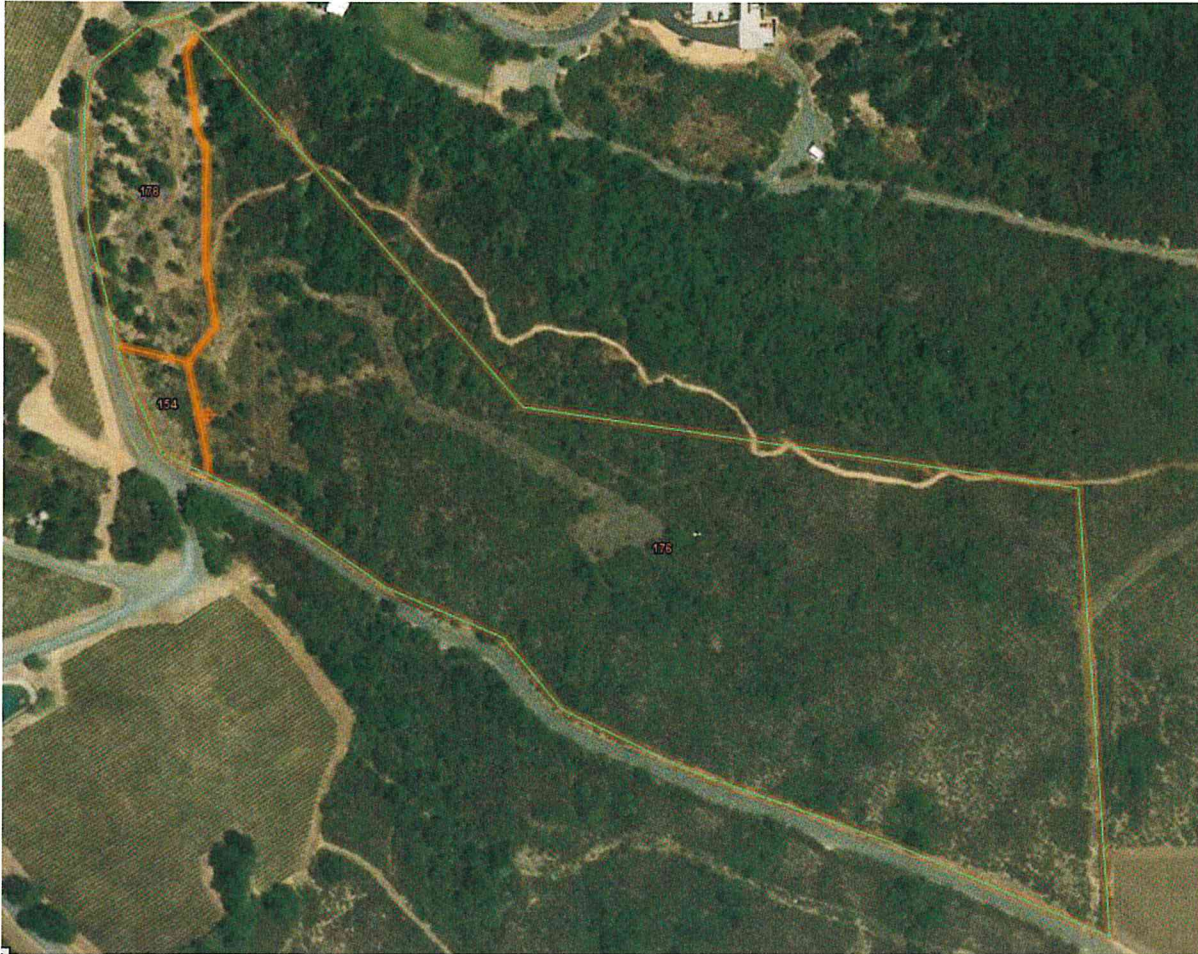
Based on our geologic review we compiled the image and table below indicating the soil types and depth of materials. This information was collected from the NRCS Web Soil Survey listed above.
