# **COASTAL HAZARDS MEMORANDUM**

## **Re: Final Dana Point Harbor Hotels Development Coastal Hazards**

Anchor QEA has prepared this updated memorandum to address additional coastal hazards comments on the Dana Point Harbor Revitalization Plan provided by the City of Dana Point specific to the hotel development. This technical memorandum presents the analysis and results of the additional coastal hazards evaluation conducted for the proposed development at the hotel Site, including the following:

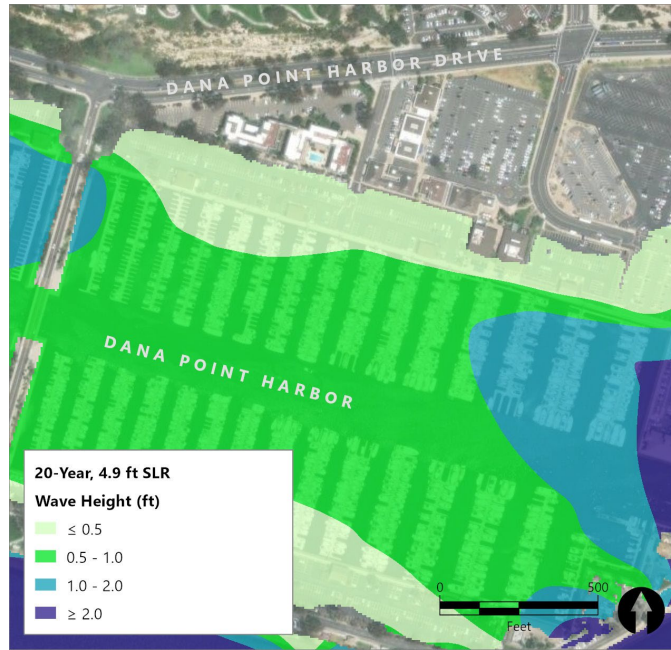
**Figure 4**  
**20-Year Wave Heights, 4.9 Feet SLR (conservatively above the anticipated +4.5 Feet SLR by 2100)**

- With no SLR, wave heights are less than 0.5 feet along the seawall in front of the Site (Figures 2 and 3).
- No flooding is expected without SLR.
- With 4.9 feet (1.5 meters) of SLR, wave heights are 0.5 to 1 foot along the seawall in front of the Site (Figures 4 and 5). This is a slightly more conservative estimate than the 2024 OPC intermediate-high estimate of +4.5 feet of SLR by 2100, but it is the closest scenario available from the CoSMoS modeling effort.
- With 4.9 feet of SLR, flooding is expected for existing Site conditions, with depths predominately between 2 and 3 feet; however, flood depths could exceed 3 feet in areas near the seawall, based on Light Detection and Ranging data used by CoSMoS for the area (Figures 6 and 7).

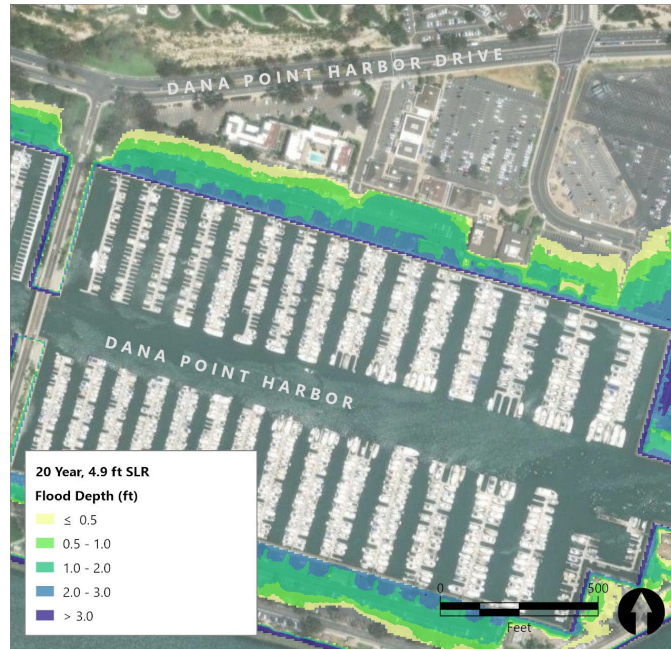
**Figure 6**  
**Flood Depths for 20-Year Waves, 4.9 Feet SLR (conservatively above the anticipated +4.5 Feet SLR by 2100)**
