October 23, 2019  
Project No. 101125002

Subject: Asbestos Sampling Report  
12322 & 12434 East 4<sup>th</sup> Street  
Rancho Cucamonga, California

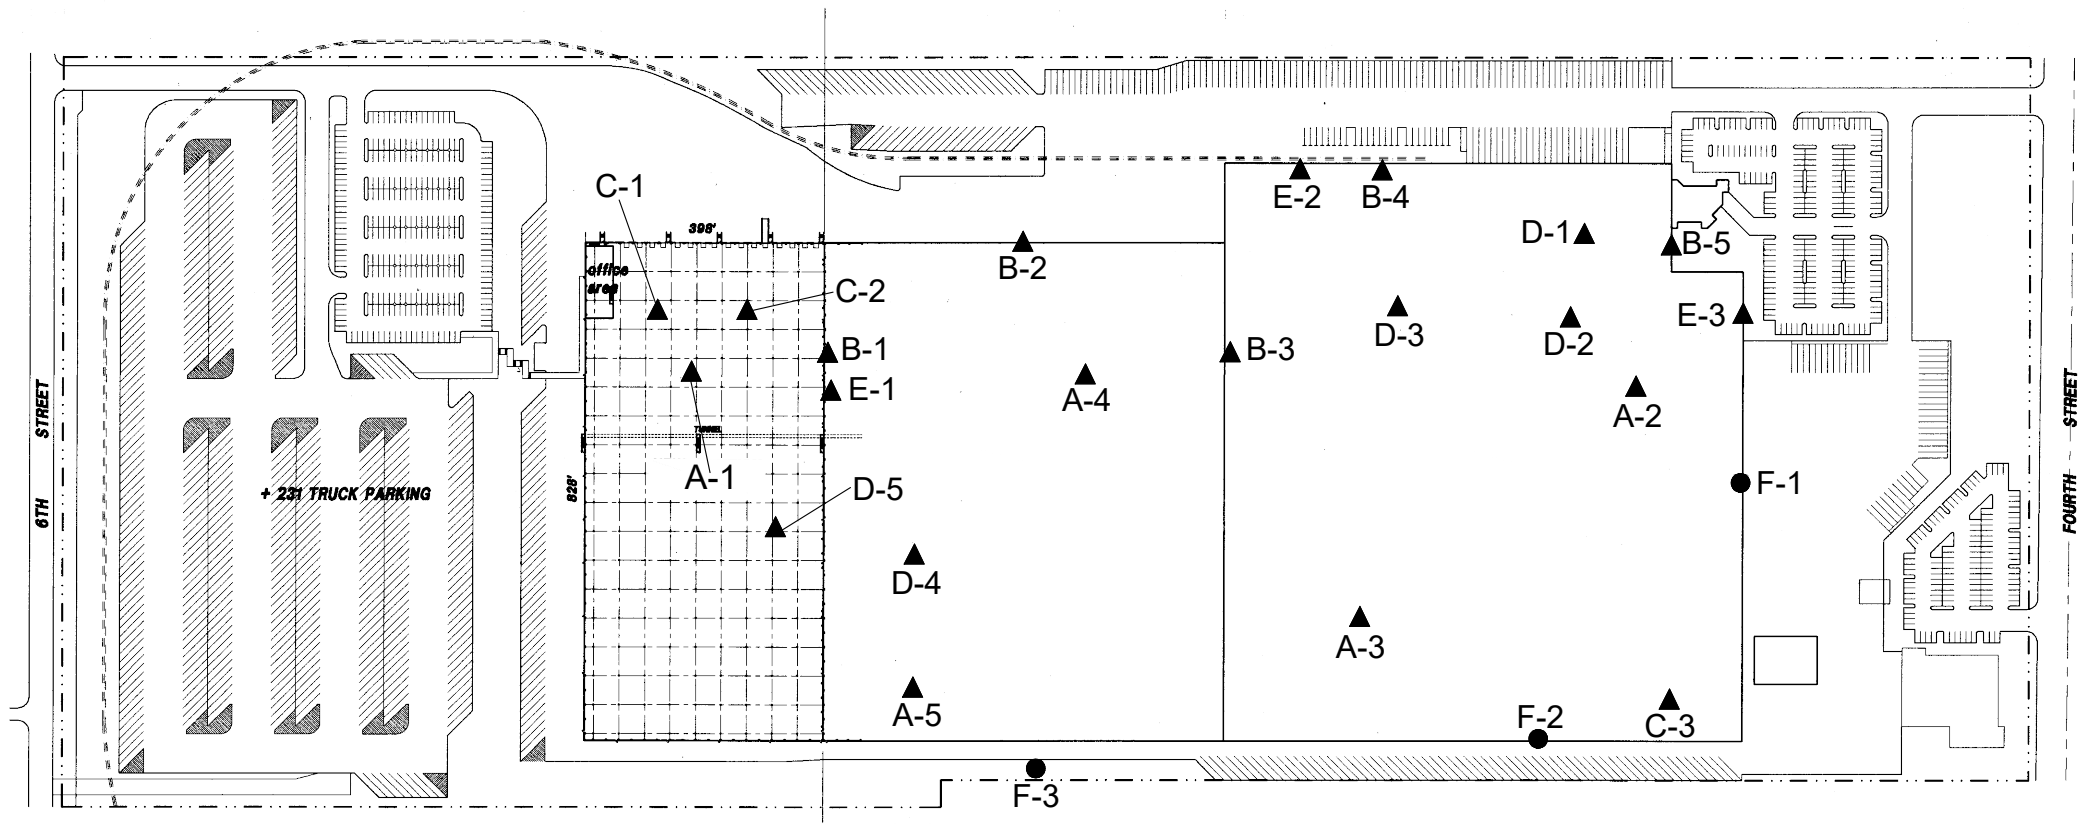
PROJECT NO. 101125002	SAMPLE LOCATION MAP, BUILDING 1, 2, 3 - ROOFS	FIGURE <b>2</b>
	DATE 10/19

- ▲ A-1 Roof Sample Location and Designation  
(Red Where Positive for Asbestos)
- F-1 Sample Location and Designation  
(Red Where Positive for Asbestos)

A total of 346 bulk samples were collected of suspect materials. The identified homogeneous areas of suspect materials are summarized in Table 1. The sample locations are shown in Figures 2 through 19.

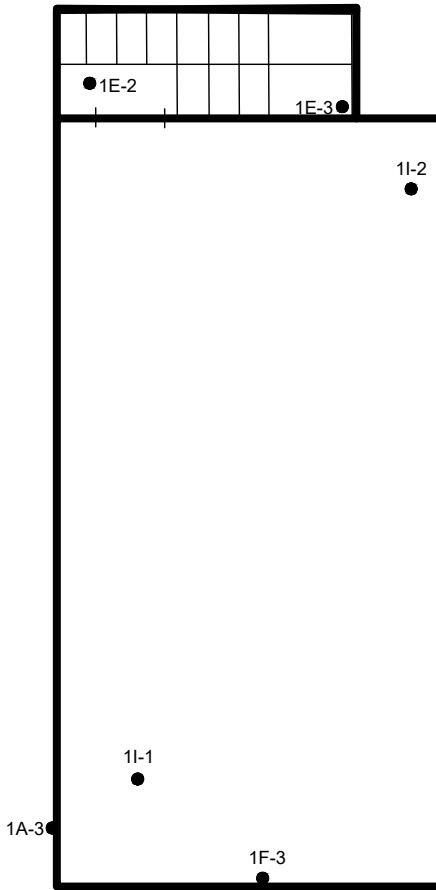
FIGURE  
4

● Sample Location and Designation  
 (Red Where Positive For Asbestos)

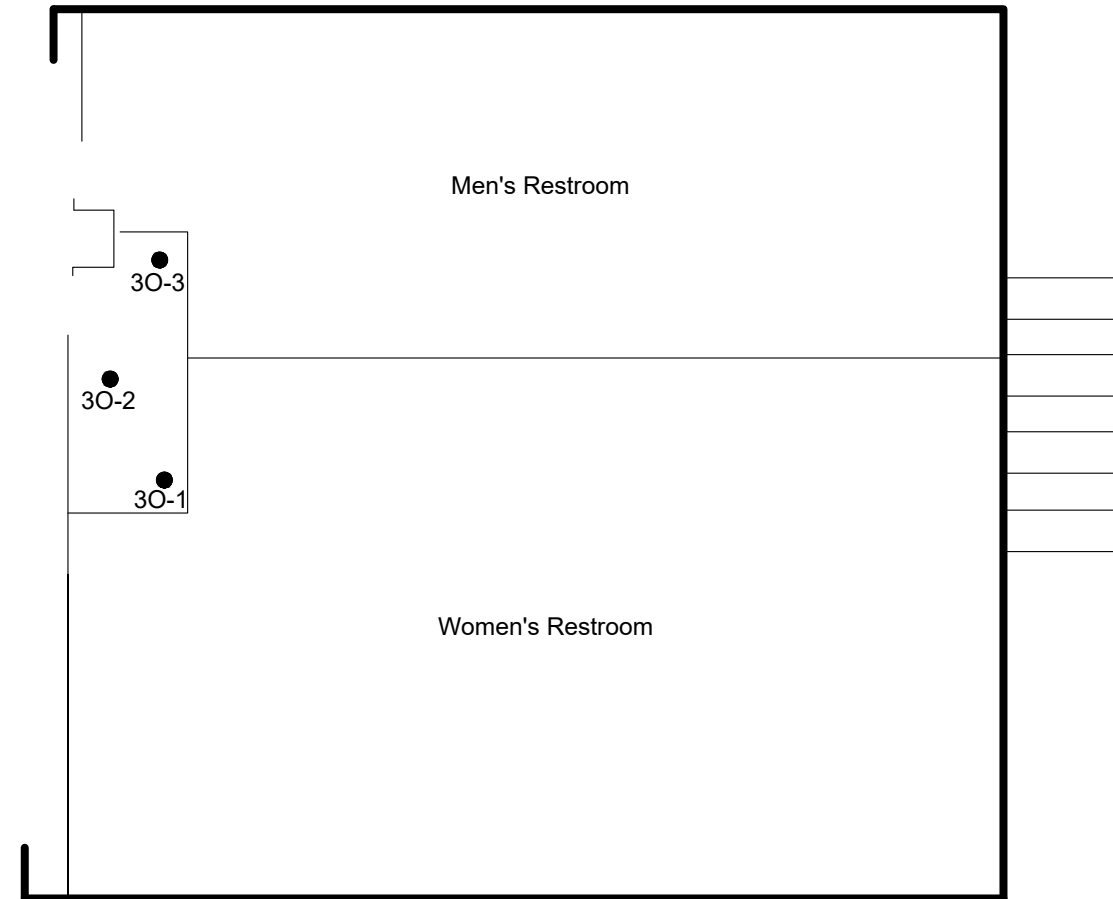
PROJECT NO. 101125002	SAMPLE LOCATION MAP - BUILDING #3, OFFICE #1, 1ST FLOOR	FIGURE 10
	DATE 10/19

● Sample Location and Designation  
(Red Where Positive For Asbestos)
