We have evaluated the proposed voluntary seismic retrofit and ADA upgrade of the Barry Building, an Historic-Cultural Monument (HCM) located at 11973 San Vicente Boulevard. We reviewed seismic retrofit recommendations by Englekirk Structural Engineers in their report dated June 2022; and ADA upgrade recommendations by Gruen Associates in "Barry Building ADA Upgrade Requirements," dated June 2021. We reviewed the recommendations for compliance with the Secretary of the Interior's Standards for Rehabilitation ("the Standards") as required by the City of Los Angeles Cultural Heritage Ordinance. Our evaluation included a site visit to observe existing conditions and identify extant character-defining features; review of the property's HCM designation and other documentation of the property's history and development; and review of the proposed voluntary seismic retrofit scheme. We have determined that the proposed seismic retrofit would not destroy historic materials and features that characterize the property and would be compatible with the historic features, size, scale and proportion; and therefore would meet the Standards. The ADA upgrade as proposed would destroy some historic mat

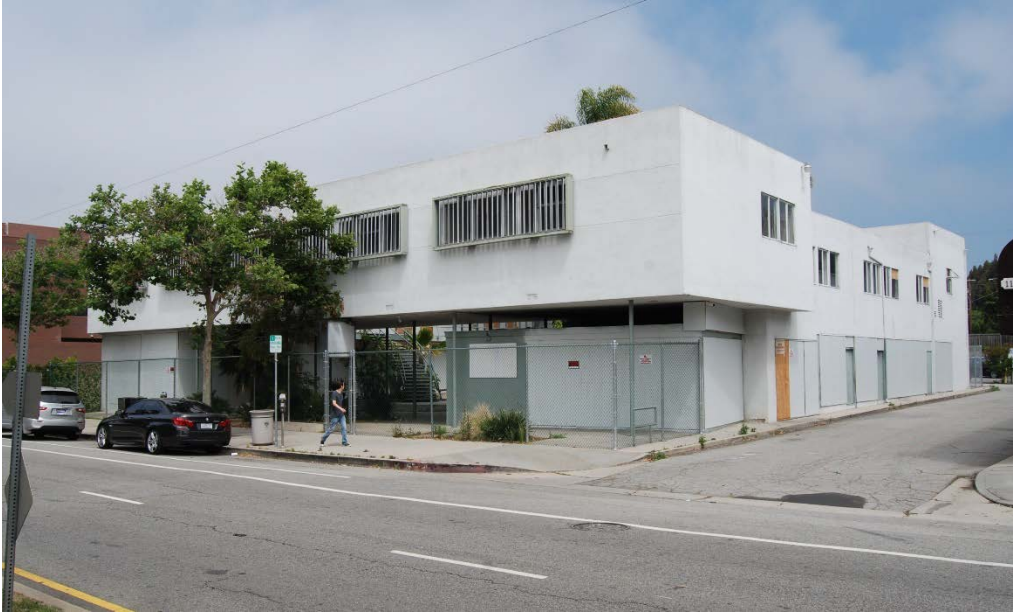
Figure 1: Barry Building, exterior, view of south and east façades looking northwest, May 2017 (HRG).

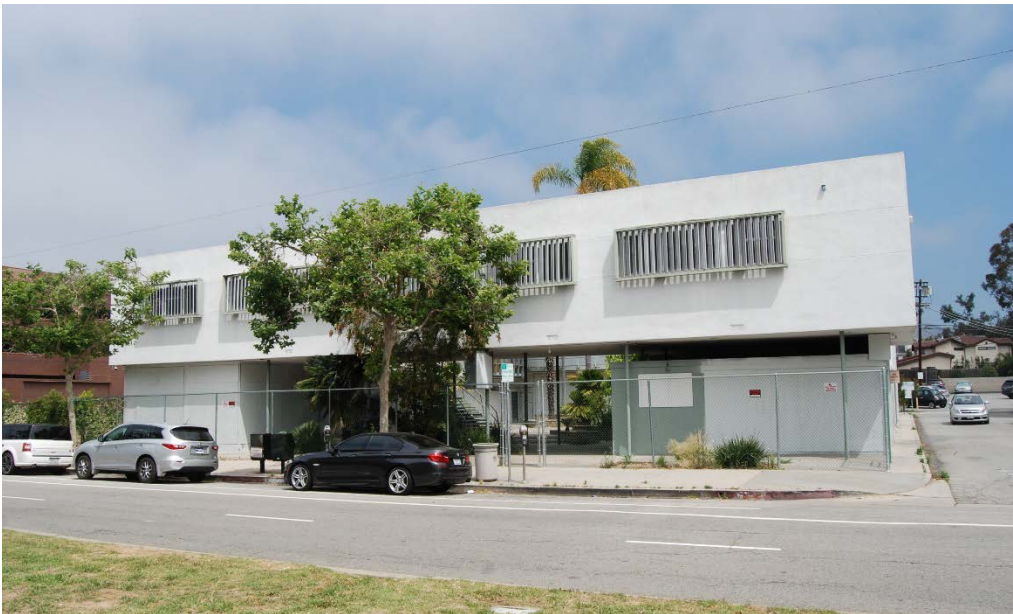
Figure 2: Barry Building, south façade, view looking northwest, May 2017 (HRG).

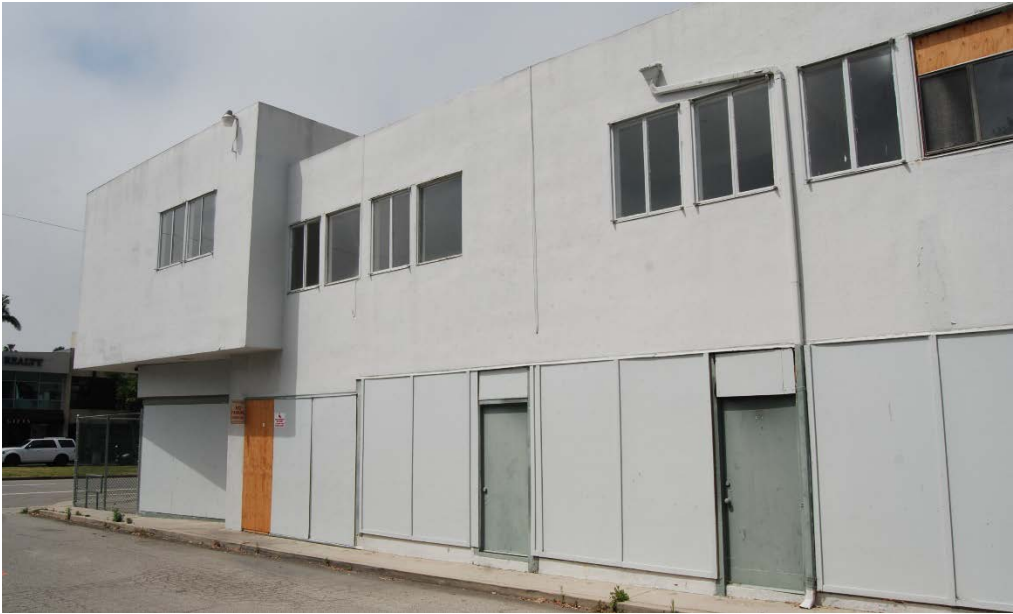
Figure 7: Barry Building, east façade, view looking southwest, May 2017 (HRG).

The recommended ADA upgrade as proposed would potentially remove distinctive materials and alter features that characterize the property by modifying or replacing exterior doors on the east façade; adding panels to the floating stair risers; replacing existing stair handrails and balcony guardrails; widening all tenant doorways and replacing hardware; modifying the bottom rails of glazed doors; removing or infilling mail slots; and replacing some windows. The cumulative effect of these alterations would negatively impact the building's historic integrity and significance, and would not meet Standard 2.

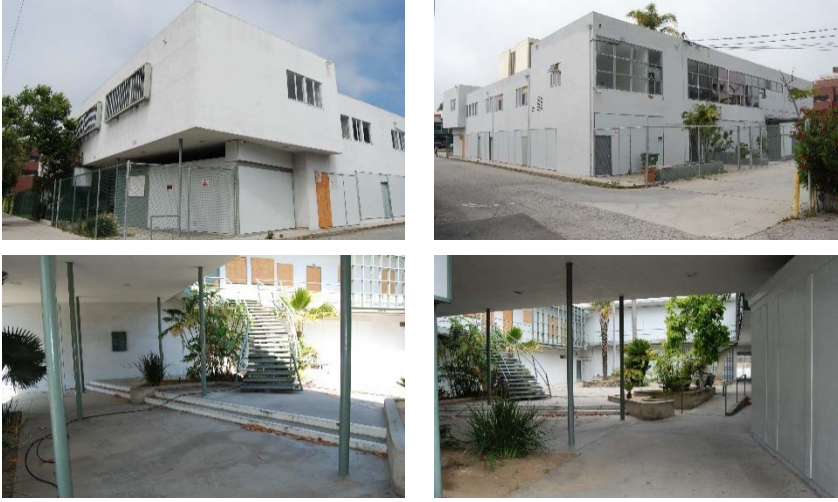
Massing	<p>Hollow square plan</p> <p>Central garden courtyard</p> <p>Two-story height</p> <p>Sculptural rectangular volumes</p> <p>"Floating" overhanging second-story volume at south façade supported on slender, steel pipe piloti; ground floor below open to courtyard</p> <p>Staggered floor and roof planes</p>

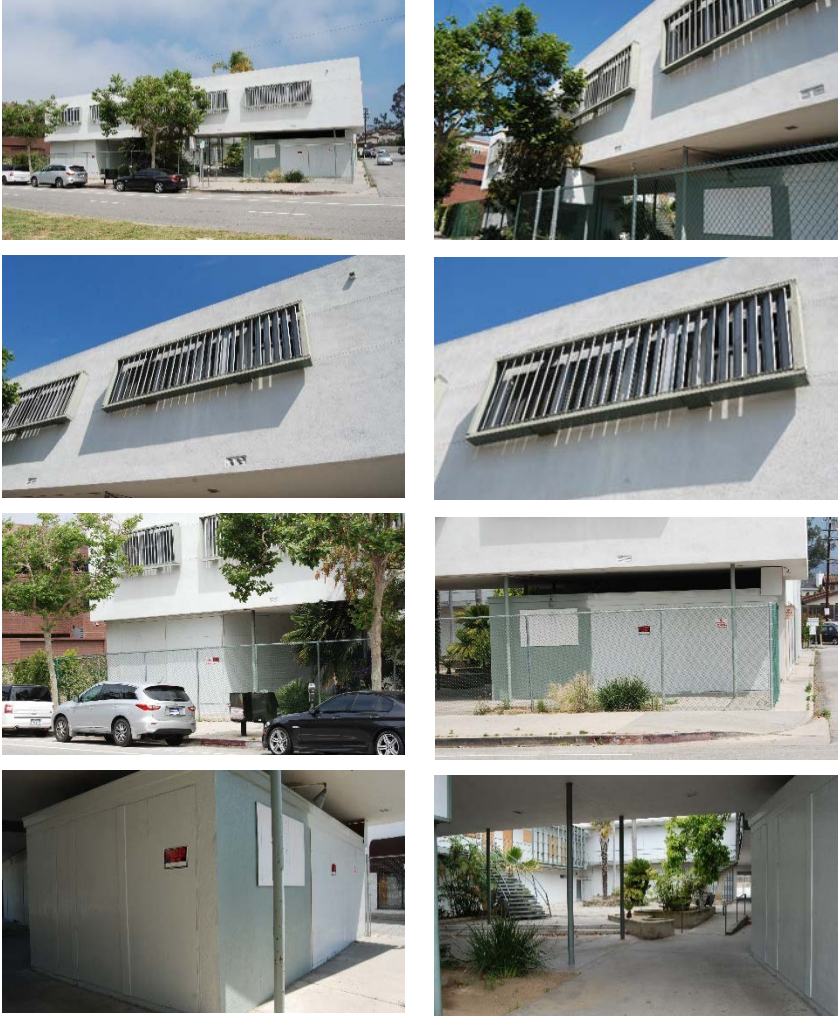
Exterior			
Location	Character-Defining Features	Notes	Photographs
South (Primary) Façade	Asymmetrical composition Smooth cement plaster veneer "Floating," overhanging second story volume raised on slender, steel pipe piloti Ground floor open to courtyard Plaster soffit with square, recessed lights Skewed, freestanding volume at ground floor at southeast corner Fixed wood-framed window walls Louvered metal window grilles in wood frames Angled concrete steps to courtyard	Window walls are currently covered with plywood

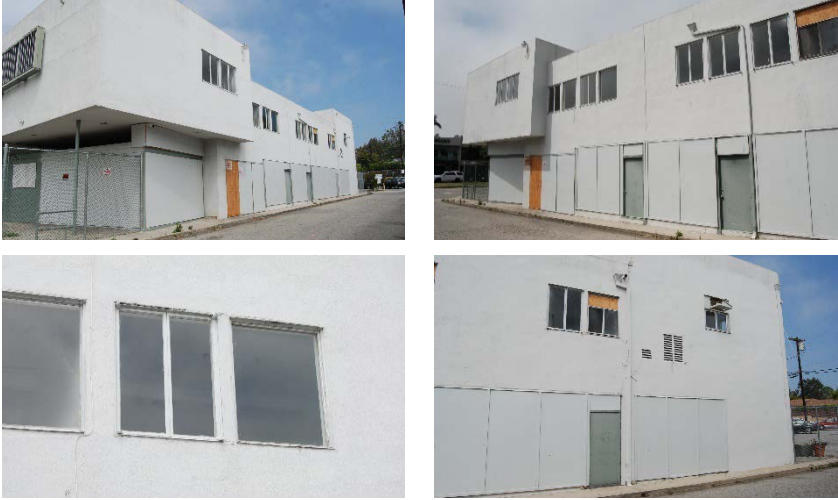
<i>Exterior</i>			
Location	Character-Defining Features	Notes	Photographs
East Façade	Asymmetrical composition Smooth cement plaster veneer Projecting, overhanging second-story volume Steel sash casement windows Fixed wood-framed window walls Wood-veneered flush doors with metal hardware	Some windows have been replaced with fixed glass or aluminum sliders Window walls are currently covered with plywood

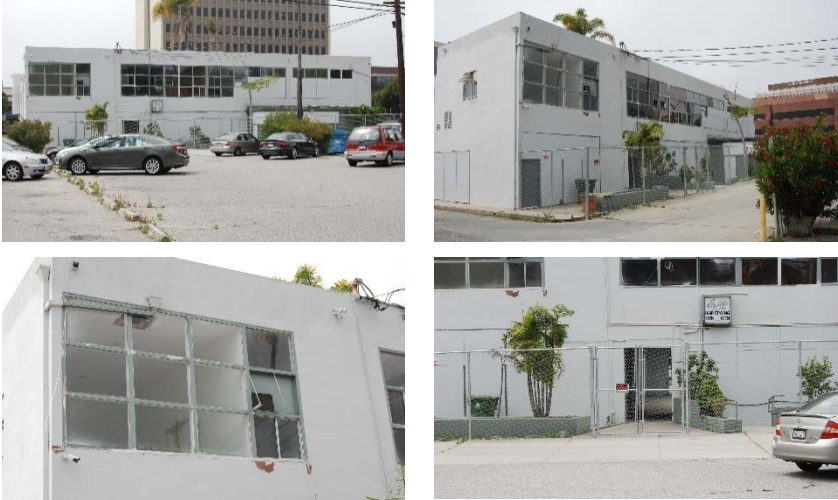
North Façade	Asymmetrical composition Smooth cement plaster veneer Fixed wood-framed window walls and windows Wood-veneered flush doors with metal hardware Passage to courtyard	Window walls and some windows are currently covered with plywood CMU receiving/storage room is a later addition

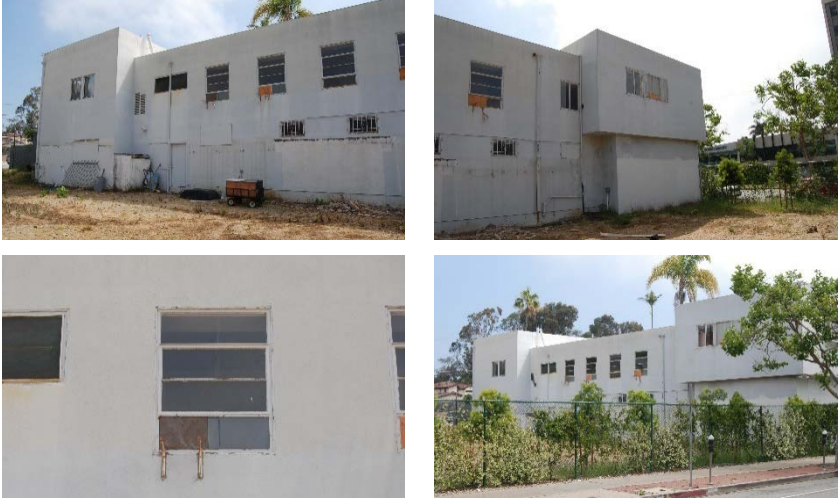
<i>Exterior</i>			
Location	Character-Defining Features	Notes	Photographs
West Façade	Asymmetrical composition Projecting end volumes Smooth cement plaster veneer Steel sash casement and hopper windows

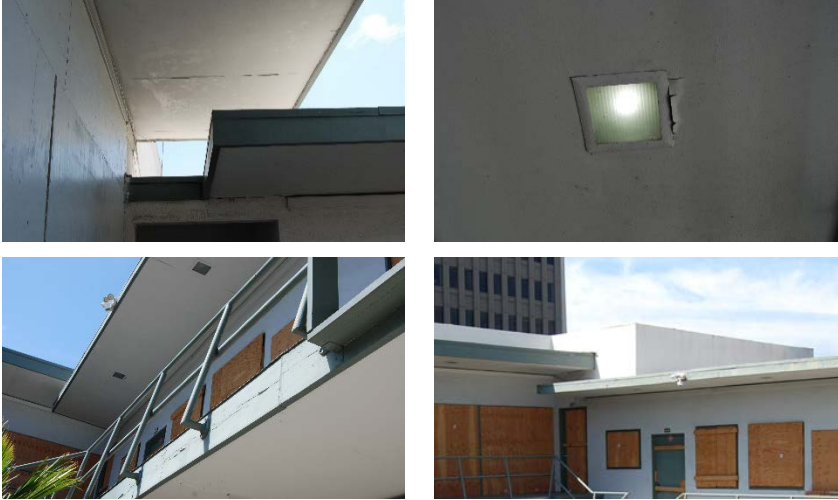
Roof	Flat roofs with parapets Cantilevered canopies with plaster soffits, wood fascias and square, recessed light fixtures

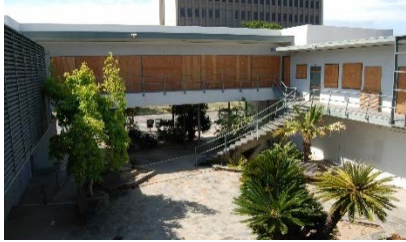
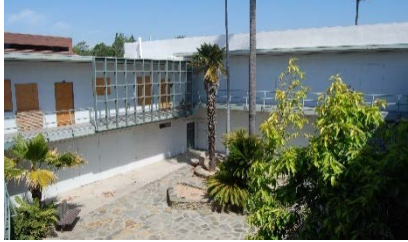
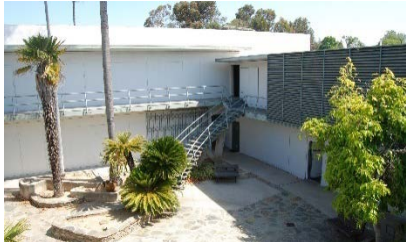
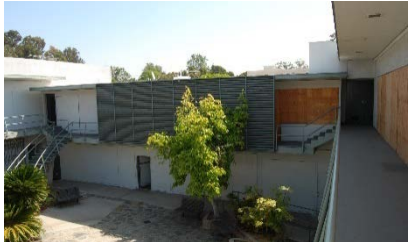
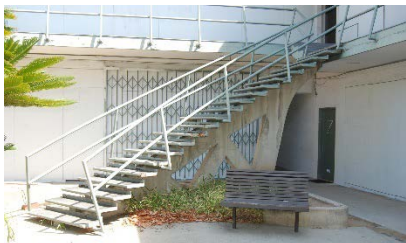
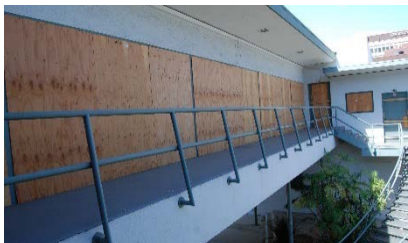
<i>Exterior</i>			
Location	Character-Defining Features	Notes	Photographs
Courtyard	<p>Location, configuration and spatial relationships</p> <p>Asymmetrical composition</p> <p>Walls veneered in smooth cement plaster</p> <p>Fixed wood-framed window walls and windows</p> <p>Wood-veneered flush doors with metal hardware</p> <p>Curvilinear steel-and-concrete “floating” stairs with steel pipe handrails</p> <p>Cantilevered balconies with canted, steel pipe guardrails and plaster soffits with square recessed light fixtures</p> <p>Wood lattice and louvered metal screens</p> <p>Wall-mounted building directory</p> <p>Wall-mounted suite numbers</p> <p>Concrete walks</p> <p>Planters with lush landscaping</p>	<p>Window walls and windows are currently covered with plywood</p> <p>Flagstone paving in center of courtyard is a later addition</p>

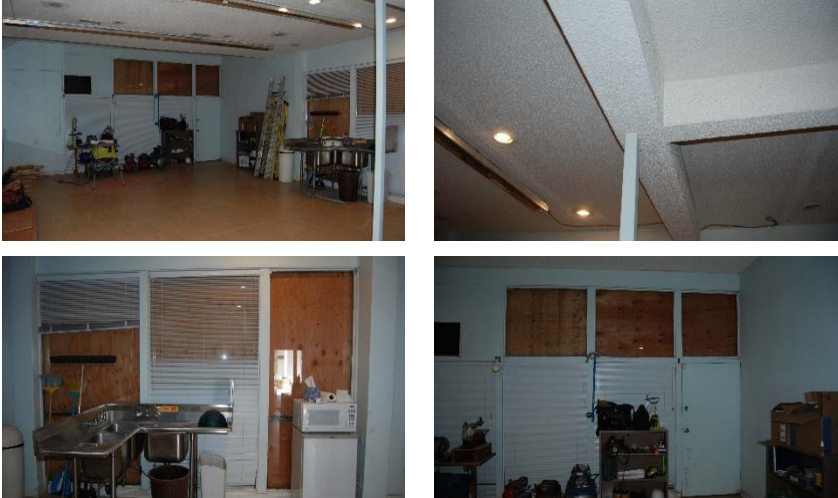
<i>Interior</i>			
Space	Character-Defining Features	Notes	Photographs
General	Acoustical ceiling finish Plaster walls Wood-veneered flush doors with metal hardware	Interiors have been reconfigured and refinished over time
