GEOLOGICAL, GEOTECHNICAL, AND
HYDROGEOLOGICAL REVIEW
PORTUGUESE BEND LANDSLIDE REMEDIATION PROJECT
RANCHO PALOS VERDES, CALIFORNIA

by
Haley & Aldrich, Inc.
San Diego, California

File No. 0135399-001
January 2023

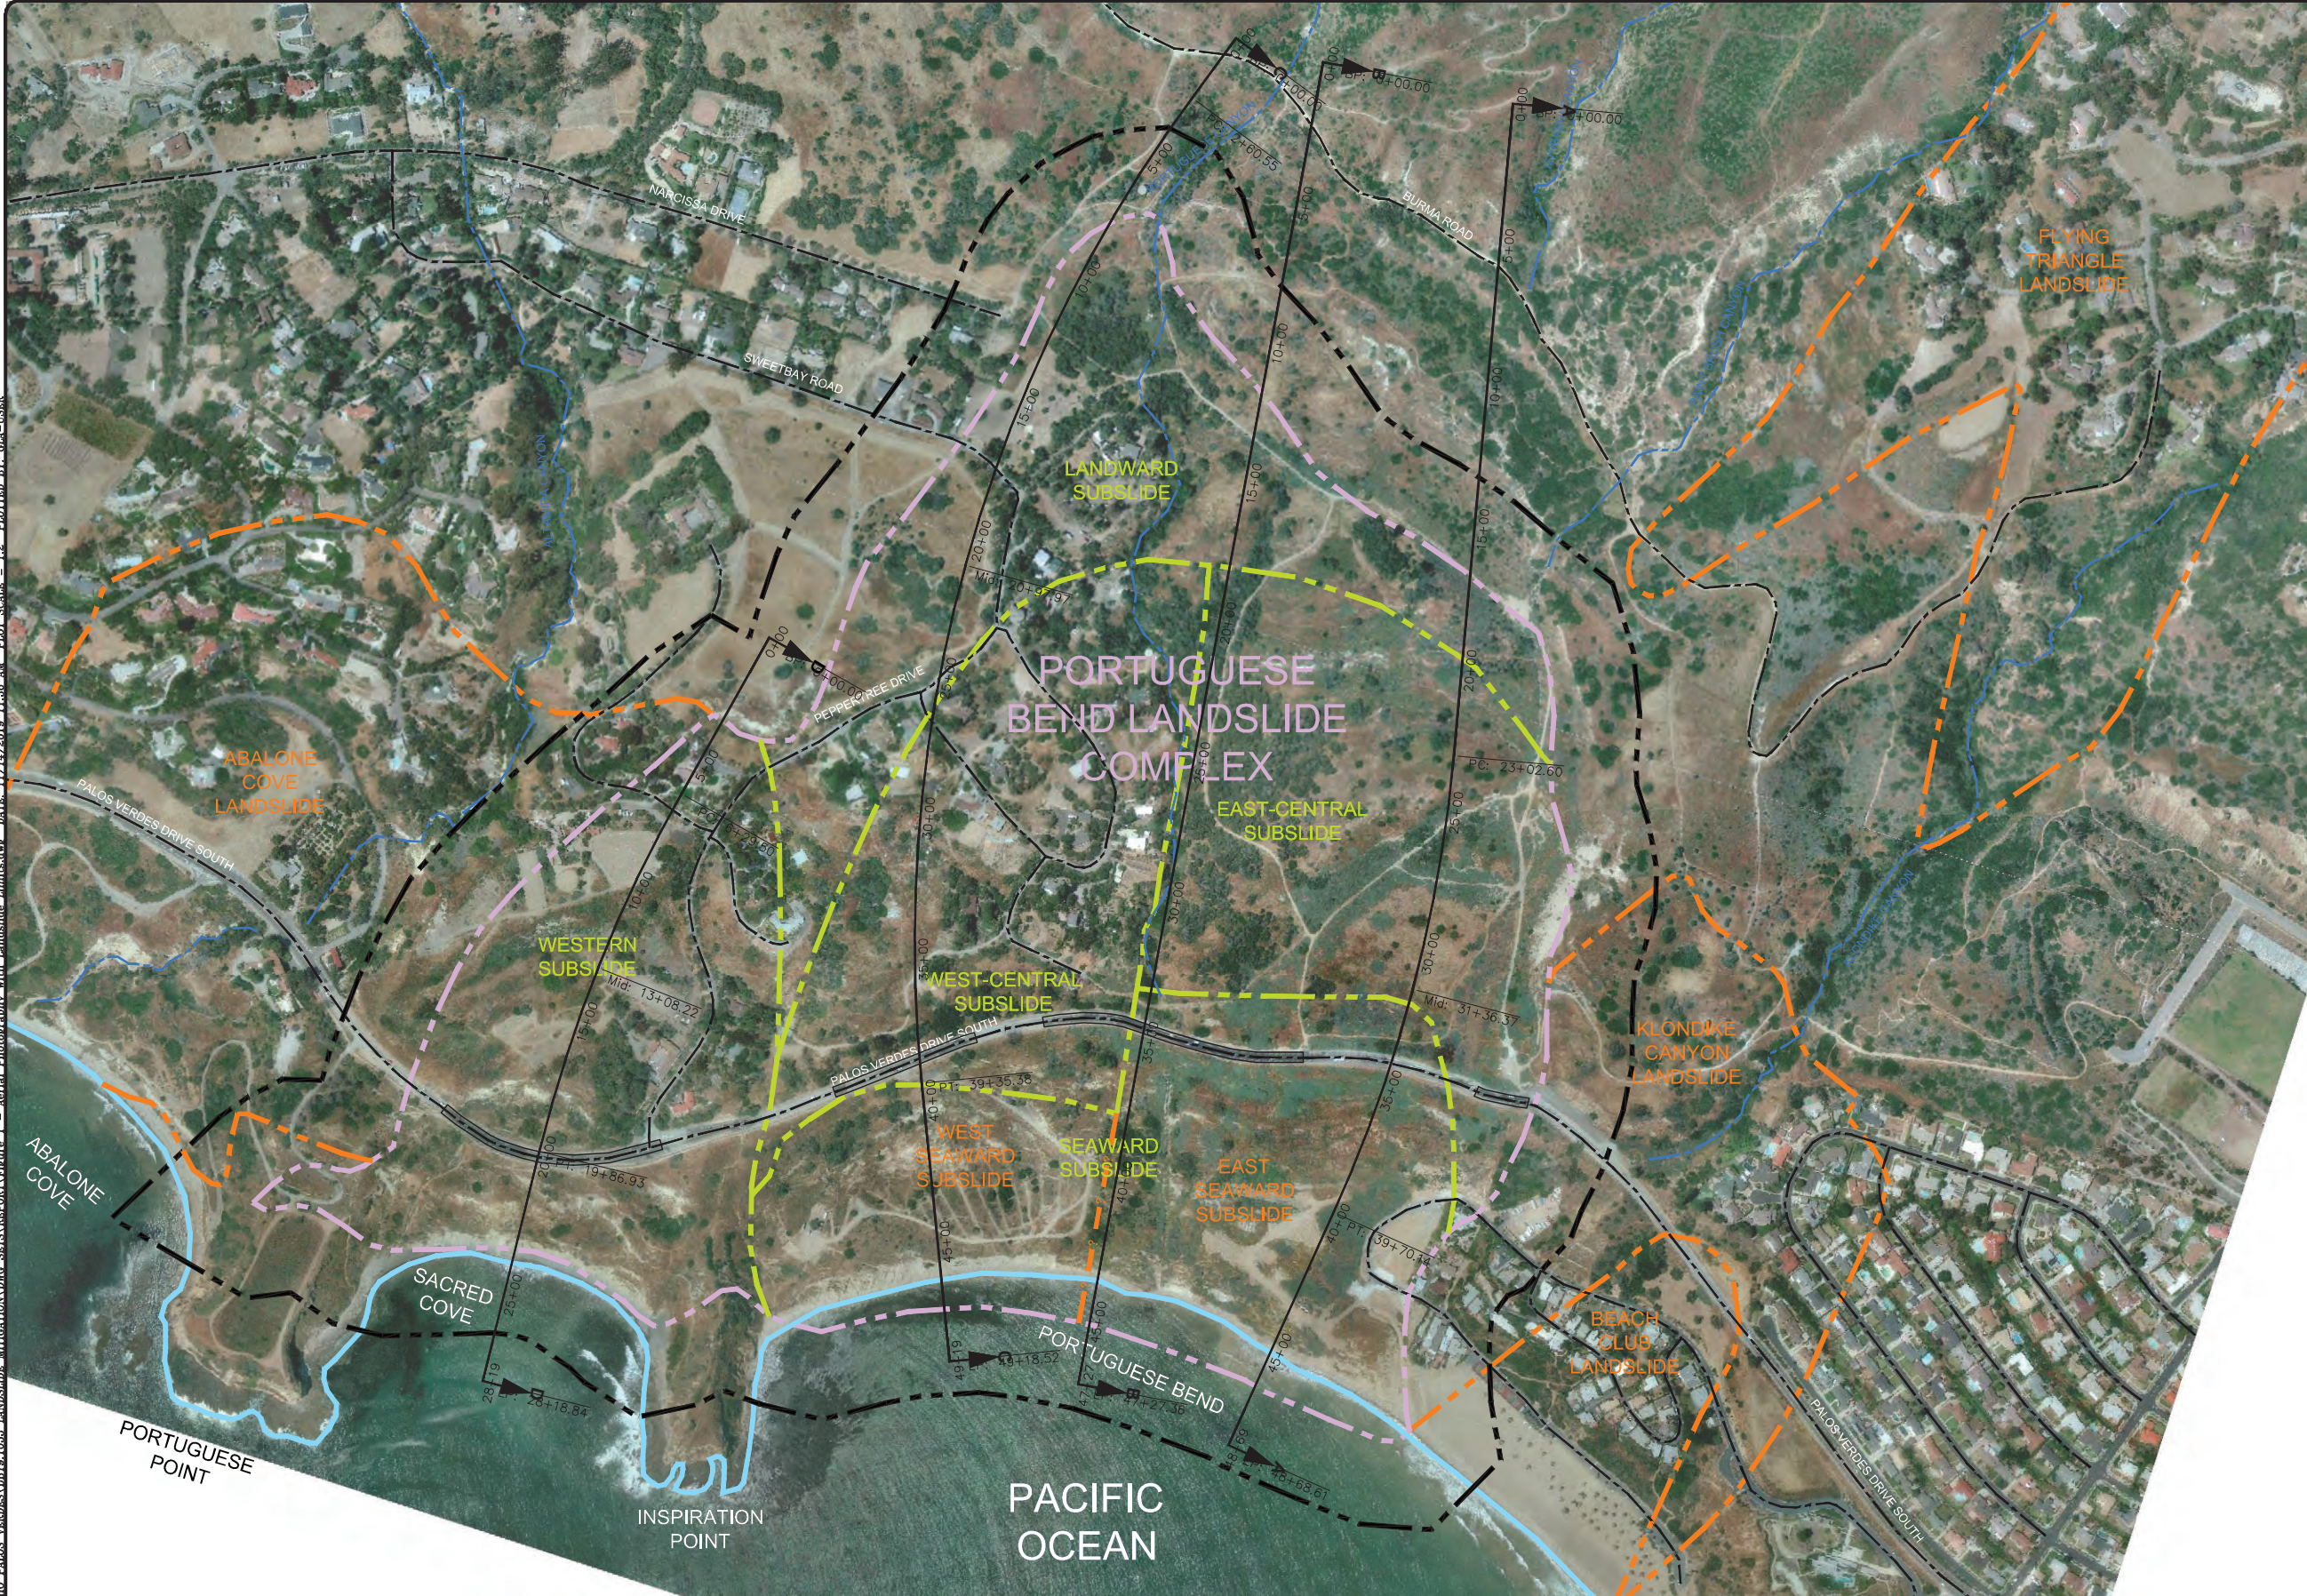
FIGURE NO. 1
 PROJECT NO. DB19.1055

AERIAL PHOTOGRAPHY WITH LANDSLIDE LIMITS

Movement of the PBL was triggered by roadwork by Los Angeles County road crews who were constructing an extension of Crenshaw Boulevard from Crest Road, through Portuguese Bend, to Palos Verdes Drive South, as previously noted. Approximately 160,000 cubic yards of soil, which had been excavated for the road, had been relocated on the head of the ancient landslide. In August 1956, the PBL broke a water line that caused flooding and subsequent significant land movement. Many homes began to move downslope, and roads on the PBL had to be rerouted. Many residents left their homes as a result of this landslide. Approximately 100 homes were damaged, while more than 50 were totaled. The Portuguese Bend club house, restaurant, and pool were destroyed. (Maureen Megowan Real Estate, webpage date and reference of data unknown; Geophile.net, Palos Verdes fieldtrip #3). A map of the City of Rancho Palos Verdes and Site is shown on Figure 1 by Geo-Logic Associates ([Geo-Logic], 2019) in Appendix A.

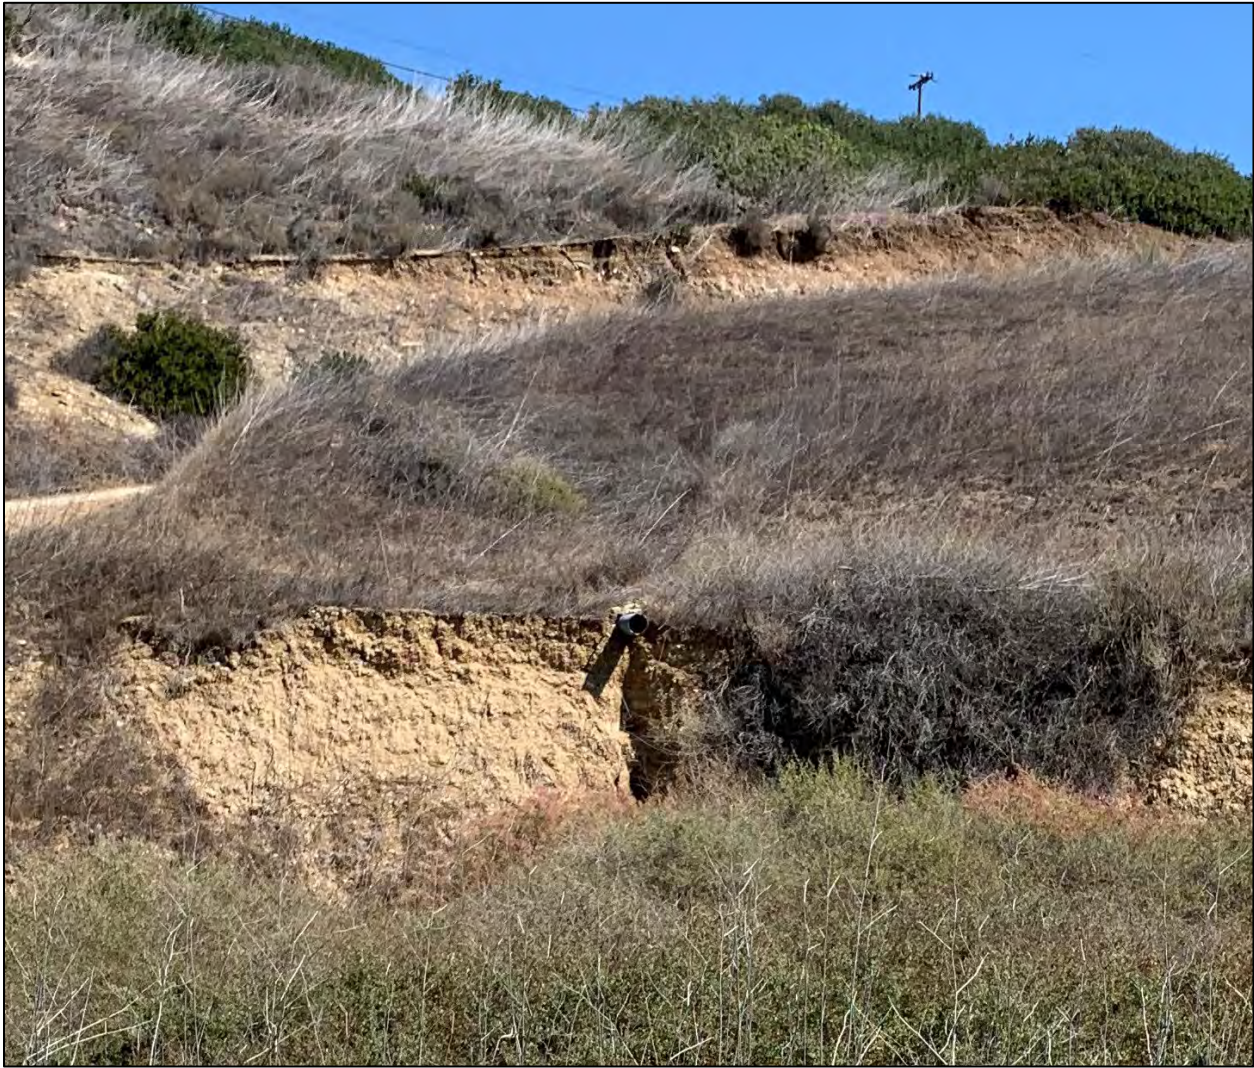
Figure H-2: Culvert or water conveyance along the north flank scarp draining into the Portuguese Bend Landslide.
