**Report of Geotechnical Evaluation for Entitlement Documents**

**Proposed High-Rise Development Project**

**1520 North Cahuenga Boulevard  
Hollywood District  
Los Angeles, California**

**Project 4953-17-1121**

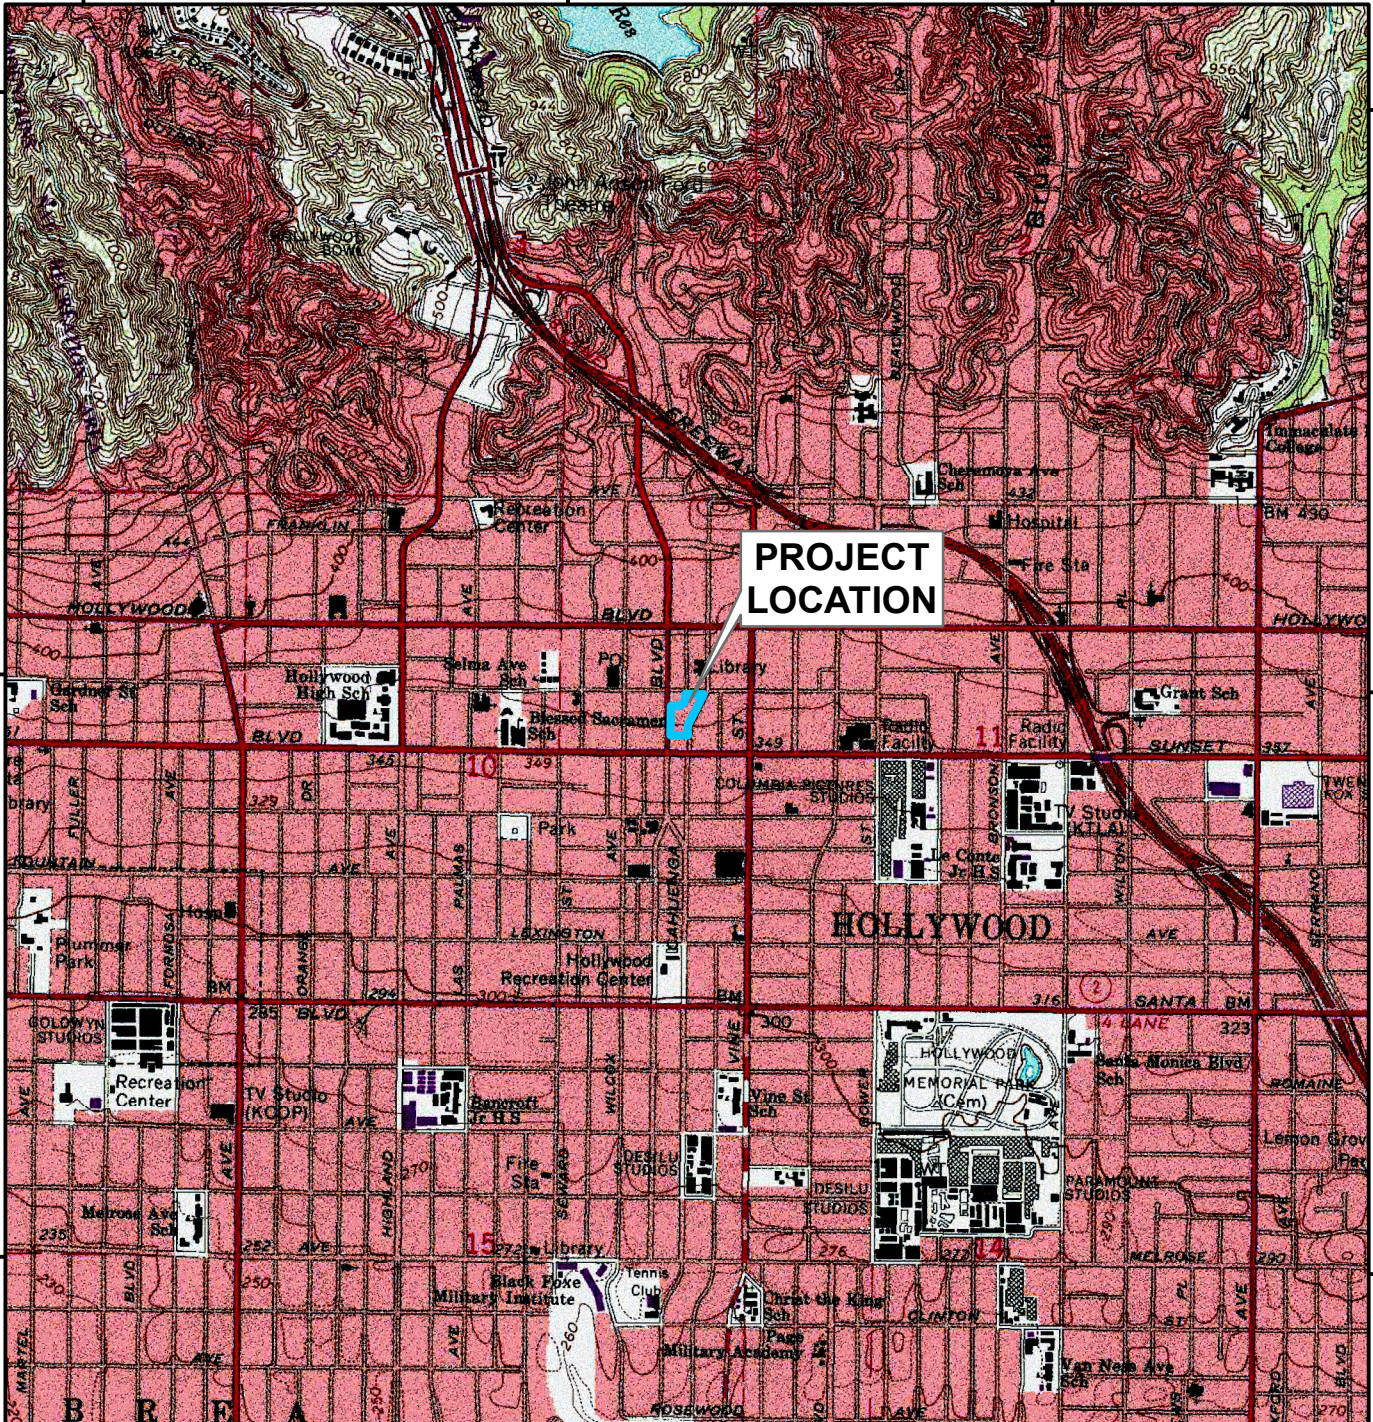
**PROJECT LOCATION**

Base: USGS topographic map of the Hollywood 7.5 minute Quadrangle (1966, revised 1995)

The site is situated in Los Angeles at an approximate elevation of 367 feet above mean sea level (AMSL) (NAVD 88). The location of the site in relation to the regional topography is shown on Figure 1, Site Vicinity Map. The limits of the project site are shown on Figure 2. Local geology is shown on Figure 3, Local Geologic Map. The regional geologic conditions around the project site, including the distribution of geologic units, are shown in Figure 4, Regional Geologic Map. The project site in relation to major regional faults and earthquake epicenters is shown on Figure 5, Regional Fault and Seismicity Map.

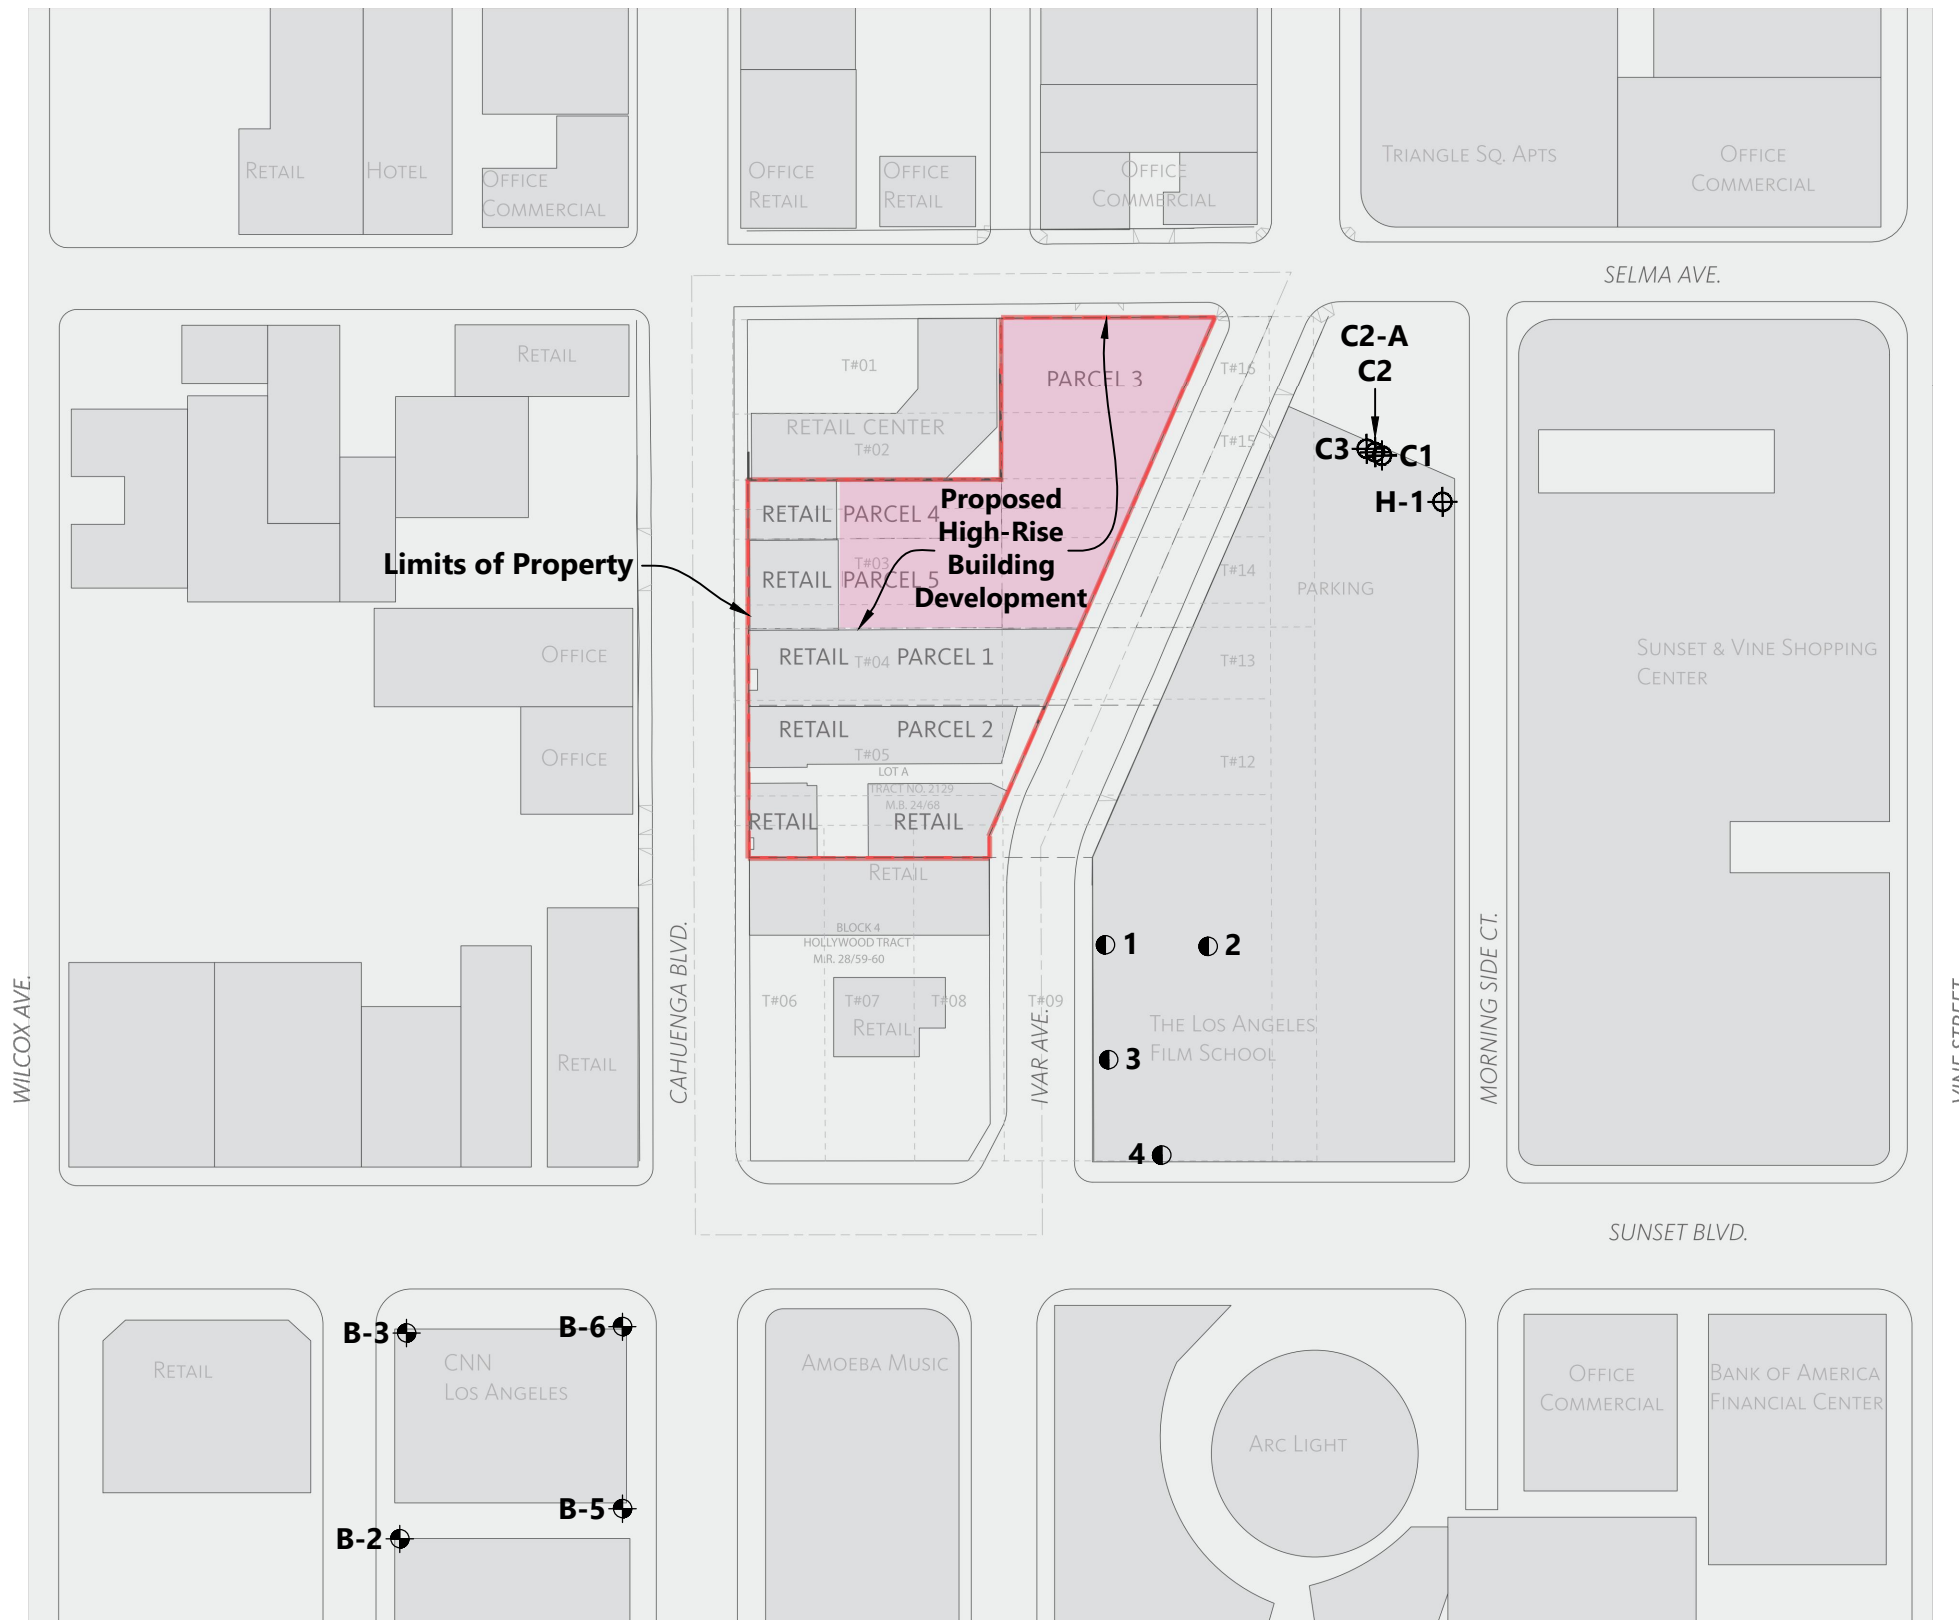
**Figure 2**  
**Plot Plan**

- B-6** ⊕ Prior Boring Location (Leroy Crandall and Associates, Project No. A-67219)
- 4** ● Prior Boring Location (Leroy Crandall and Associates, Project No. 62383)
- H-1** ⊕ Prior Boring Location (Law/Crandall, Project No. 7012-8-0504)

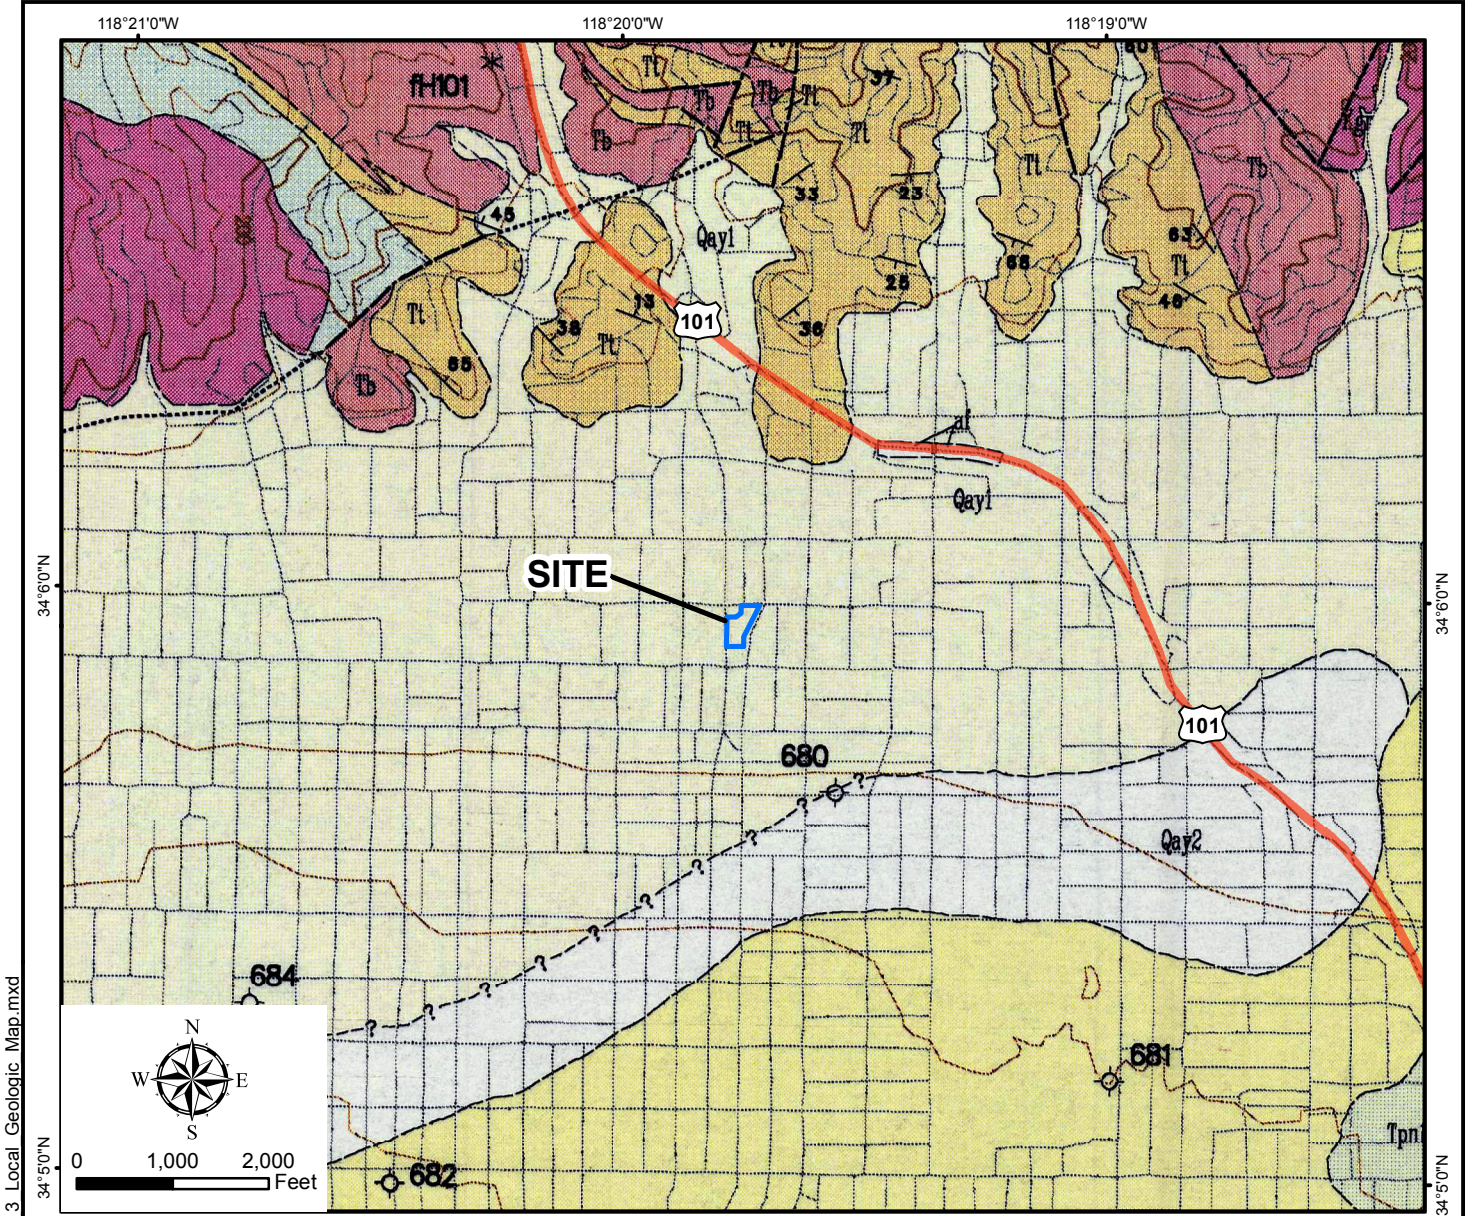
**Figure 3**  
**Local Geology Map**

Reference:  
Yerkes, R. F., 1997, Preliminary geologic map of the Hollywood 7.5' quadrangle Southern California, USGS OFR 97-255, scale 1:24,000
