# Update to the Revised Report Geotechnical Investigation

## Leucadia Mixed-Use 1900-1950 North Coast Highway, Encinitas, California

NOVA Project 2019189  
April 13, 2021

Subject: Update to the Revised Report  
Geotechnical Investigation  
Leucadia Mixed-Use  
1950 North Coast Highway, Encinitas, California

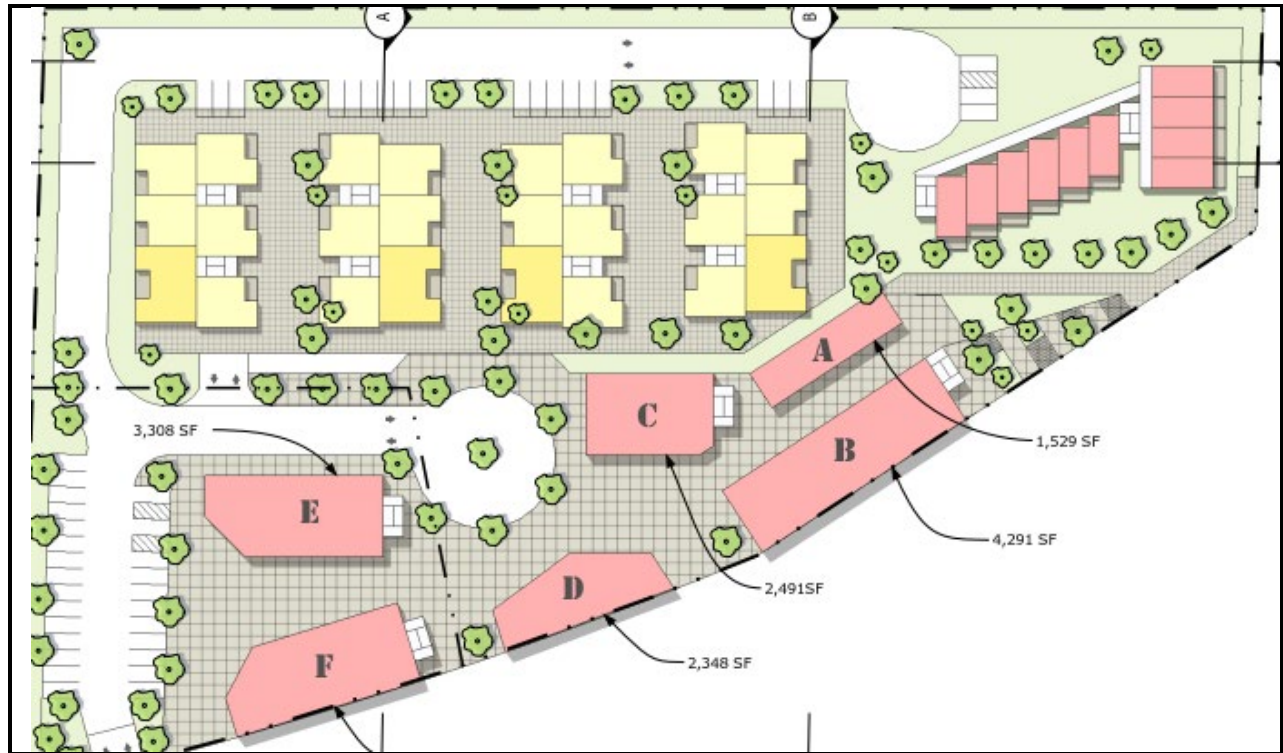
**Figure 2-3. Concept Plan 3**  
 (source: SDA 2019)

Figure 2-3 (following page) shows a sketch of the Conceptual Plan 3 (SDA 2019).

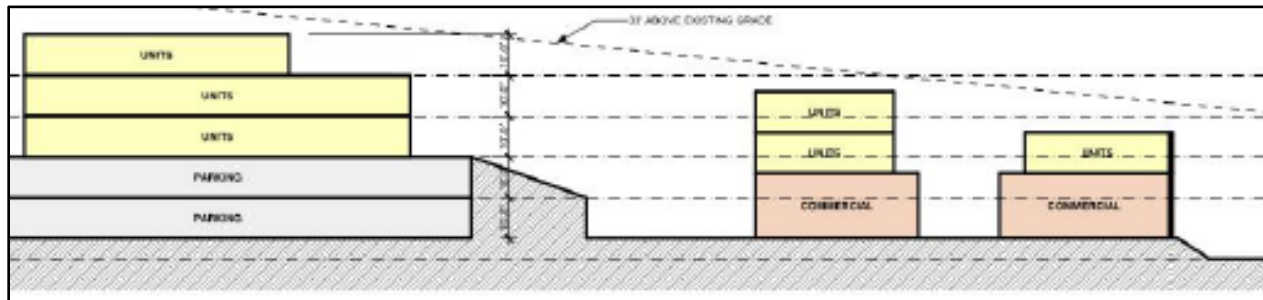
**Figure 2-4. Elevation View, East-West Section**  
 (source: SDA 2019, Section A-A)

Figure 2-4 provides an elevation view of the development, indicating the extent of below-grade construction that is anticipated.

The parking structure is developed to two levels beneath the residential structures as indicated on Figure 2-4, with excavations ranging between 15 feet and 32 feet below ground surface (bgs). SDA 2019 indicates the majority of the site is in cut, and will result in a significant amount of soil being removed from the property.

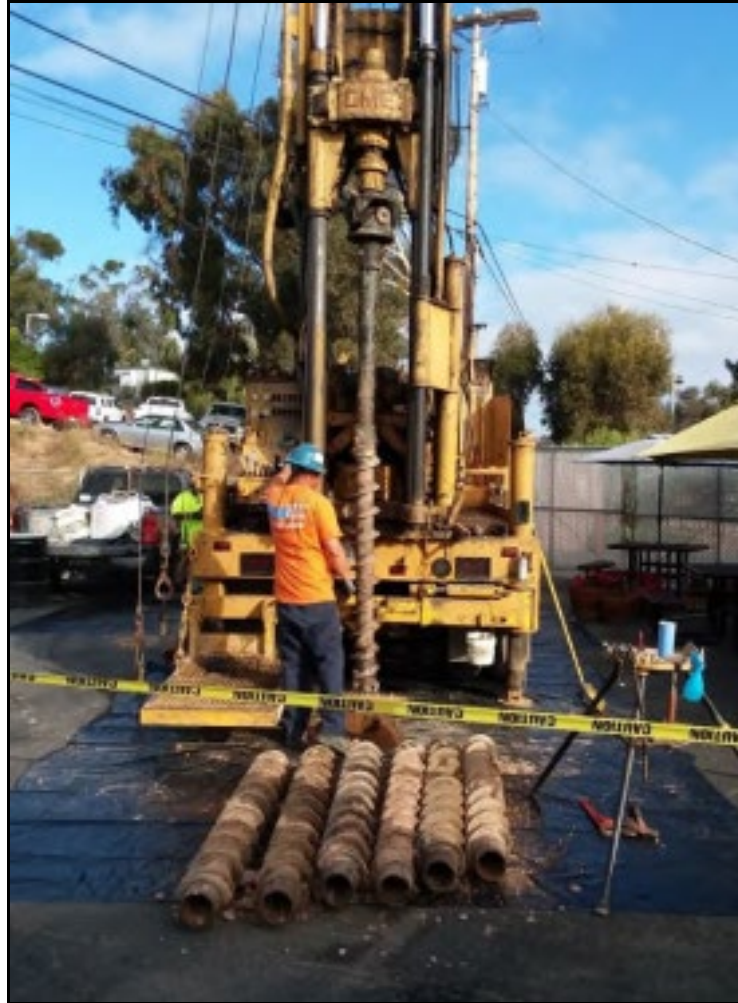
**Figure 3-2. Drilling Operations, September 17, 2019**

The borings were advanced by a CME 95 truck-mounted drilling rig utilizing hollow-stem auger drilling equipment. Boring locations were determined in the field by the geologist. Figure 3-2 (following page) depicts drilling operations. Table 3-1 abstracts the indications of the borings.

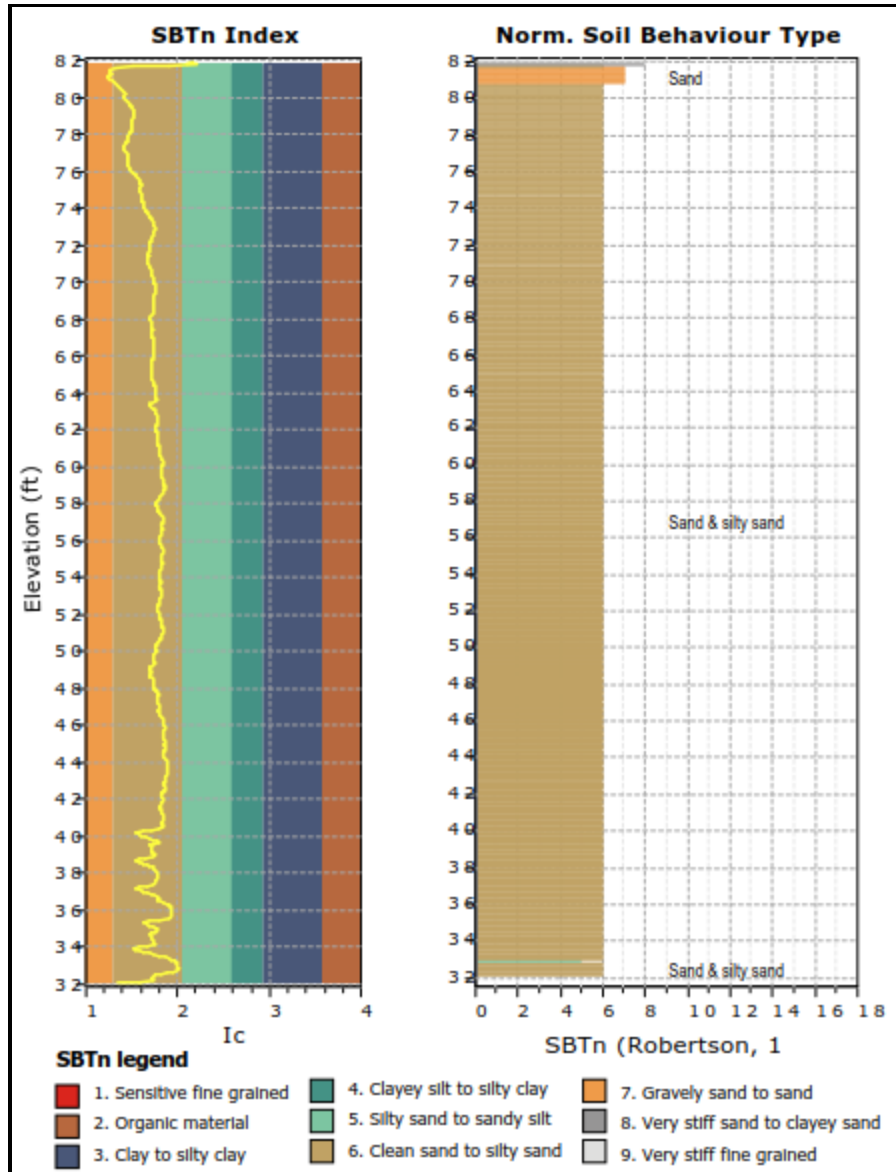
Figure 3-3. Subsurface Profile at CPT-1

Figure 3-3 (following page) reproduces the profile developed by CPT-1, from which it can be seen that sands dominate the subsurface. Both soundings correlate well with the borings.

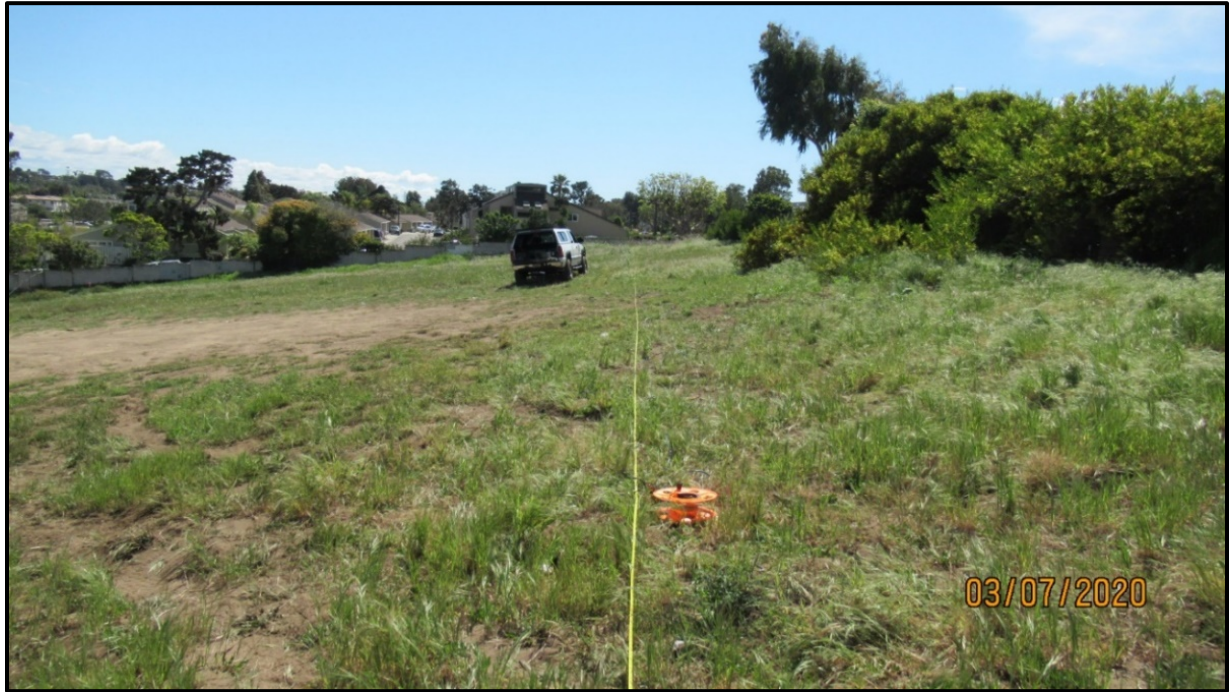
**Figure 3-4. Seismic Survey Line, View towards the South**

A 24-channel Geometrics StrataVisor NZXP model signal-enhancement refraction seismograph was used in conjunction with 24 4.5-Hz geophones spaced at regular intervals. For the MASW survey, two seismic records were obtained by multiple hammer strikes of a 16-pound sledge hammer on steel plates positioned 25 feet from the end of each terminus of the seismic line. Vibrations were recorded using a one second record length at a sampling rate of 0.5 milliseconds.

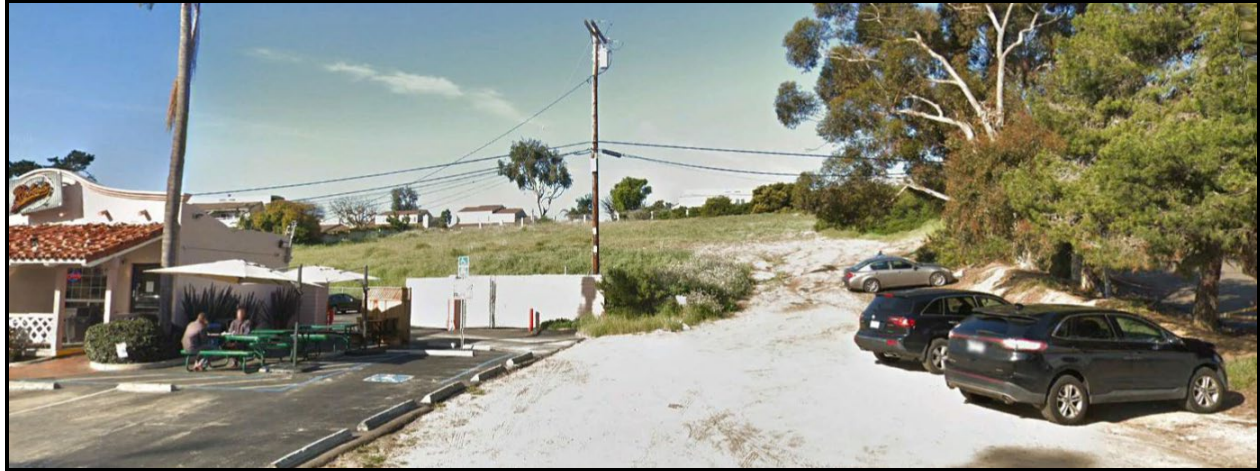
**Figure 4-2. Surface Conditions**

The western edge of the site is a north-south trending ridge with elevations between +88 feet and 95 feet msl. This ridge slopes to the east across Parcels 21 and 06 (the southern parcels) at a surface gradient of about 10%, descending about 30 feet to Highway 101. On Parcel 20, the parking lot areas have been graded into the slope, creating two benched areas, with slopes on the east and west.

Figure 4-2 (following page) depicts surface conditions looking west from Parcel 06 to 21.

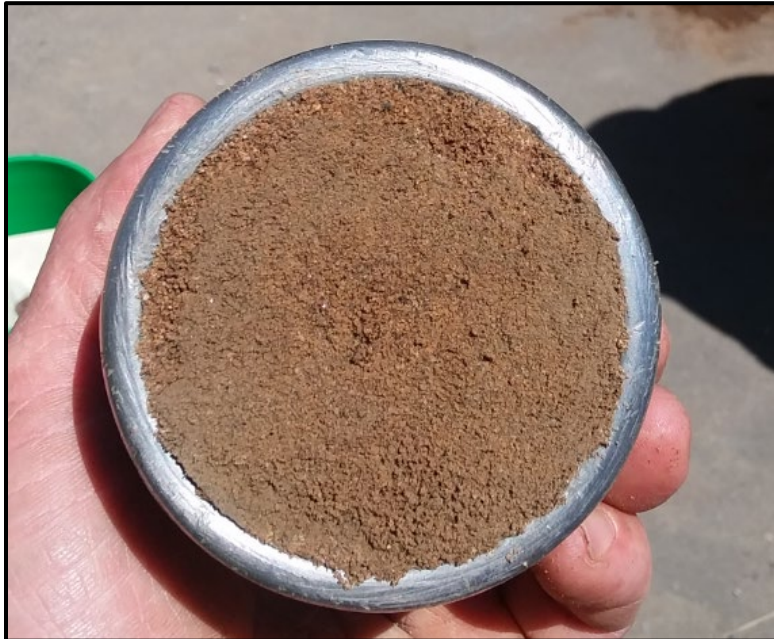
Figure 4-3. Near Surface Unit 2 Paralic Sandstone

These friable poorly-graded sandy zones may affect shoring and other construction. Figures 4-3 and 4-4 (following page) depict the cemented and friable sandstone lenses.

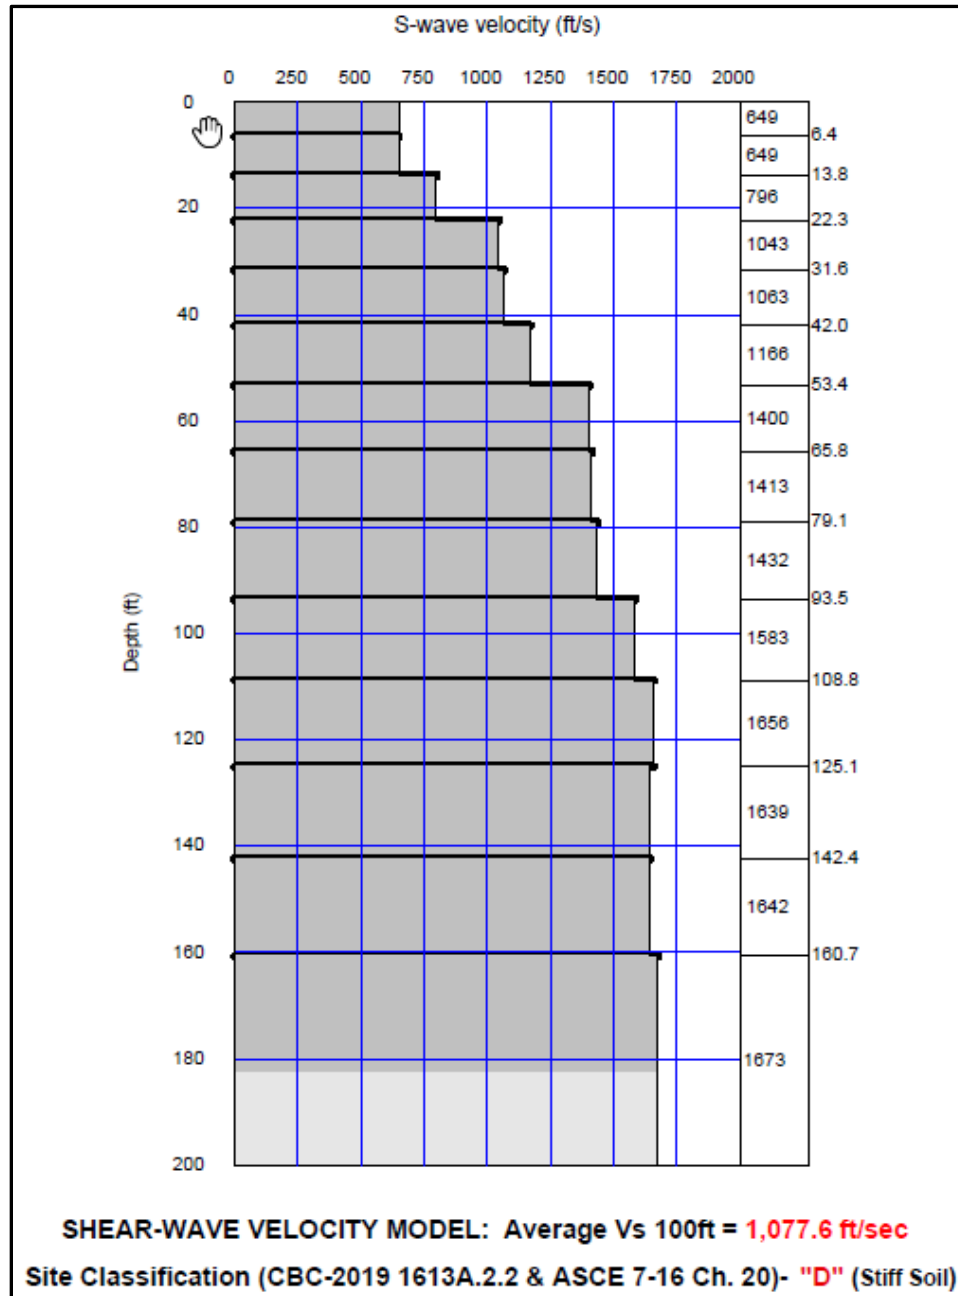
Figure 4-6. Seismic Shear Wave Velocity Profile

Shear wave velocity measurements obtained from this survey correlate well with the data obtained from the borings. Analysis of the data indicates that the weighted average shear wave velocity in the upper 100 feet ('V100') beneath the limits of the planned building is  $V_{100} = 1,077.6$  feet per second.

Figure 4-6 plots average shear wave velocities over different intervals of the subsurface to a depth of 200 feet below ground surface. Considering the weighted average of the shear wave velocity in the top 100 feet as determined along traverse SW-1, the site may be classified as Site Class D after ASCE 7-16, Table 20.3-1.

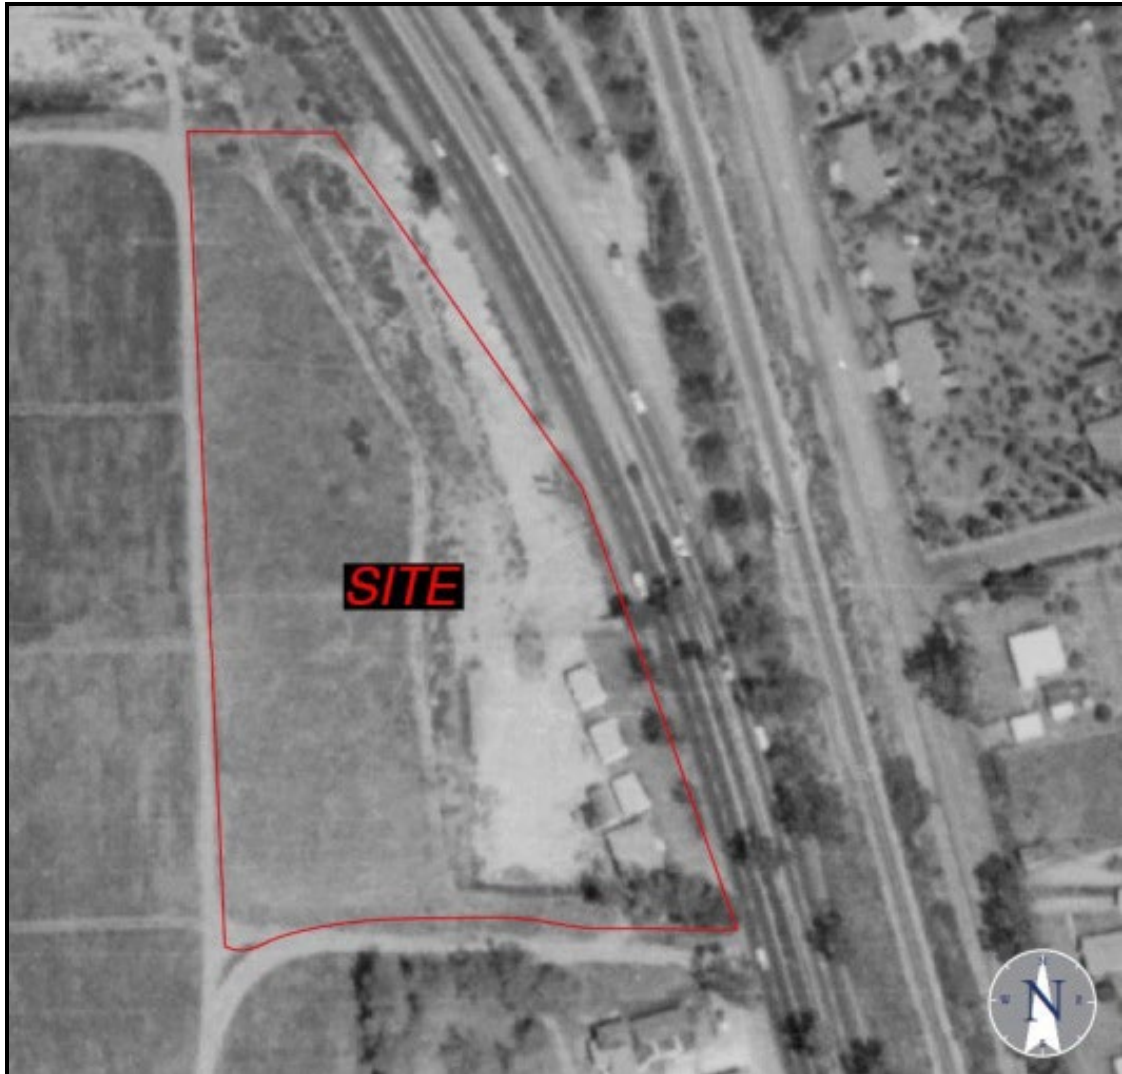
**Figure 4-9. 1964 Aerial Photo**

Figure 4-9 shows the site condition in 1964. Evident in review of this figure is that the parking lot behind the buildings on the southeast corner of the site was expanded by cutting into the slope to the west.

In addition to the parking lot cuts, in the northern portion of the site adjacent to Highway 101, the photo indicates cutting of the lower lying area between the road and the ascending slope to the west. This area is the existing right-of-way with wet and dry utilities installed within it.

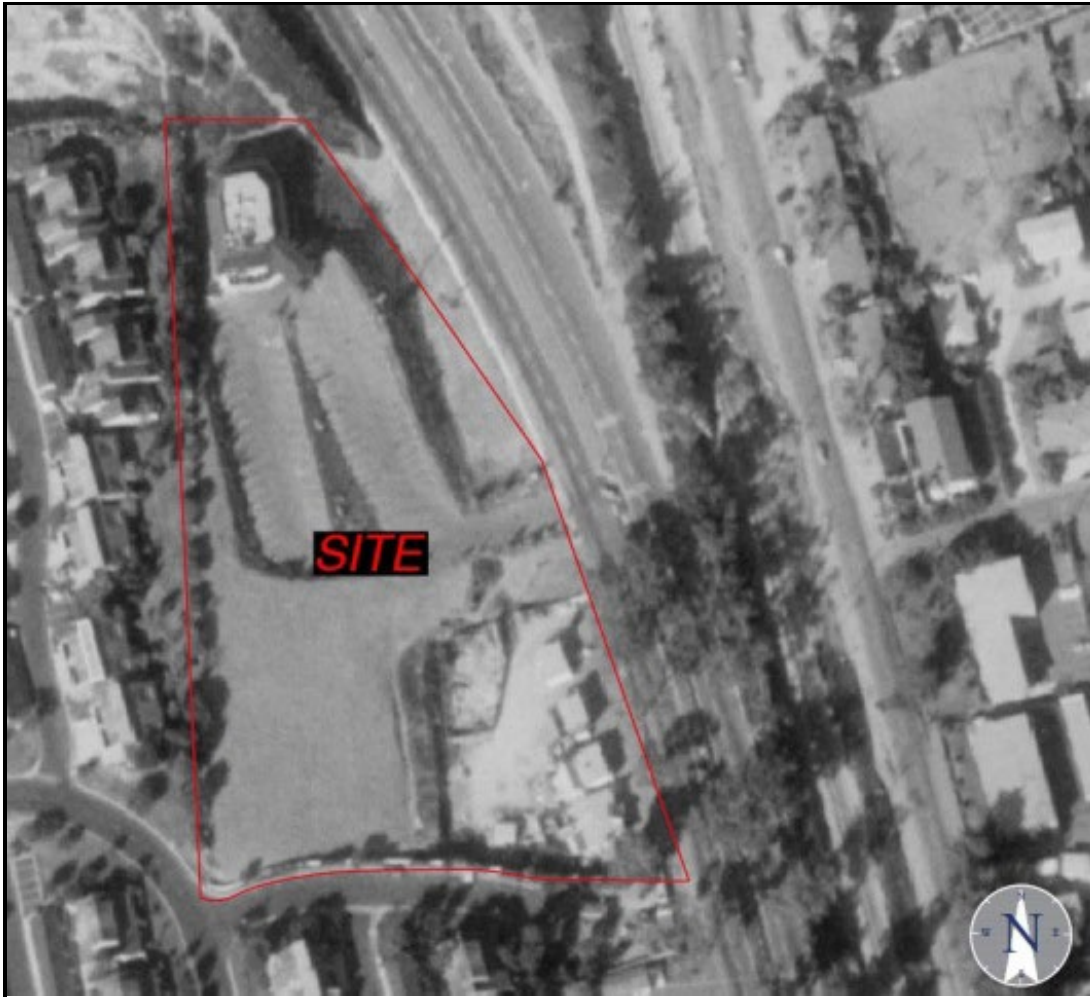
**Figure 4-10. 1980 Aerial Photo**

Figure 4-10 shows the site in 1980. Evident in this figure is the southeast parking lot graded to the present day configuration with cut slopes exceeding 25%. Also evident in the north, are two parking lots serving the restaurant in the northern portion of the site that were cut into the natural slope, creating manmade cut slopes steeper than 25% in order to accommodate parking.

Figure 4-10 may be compared to Figure 4-7 (and Plate 3), from which it can be seen that the graded slopes are those identified in Figure 4-7 as having grades exceeding 25%.

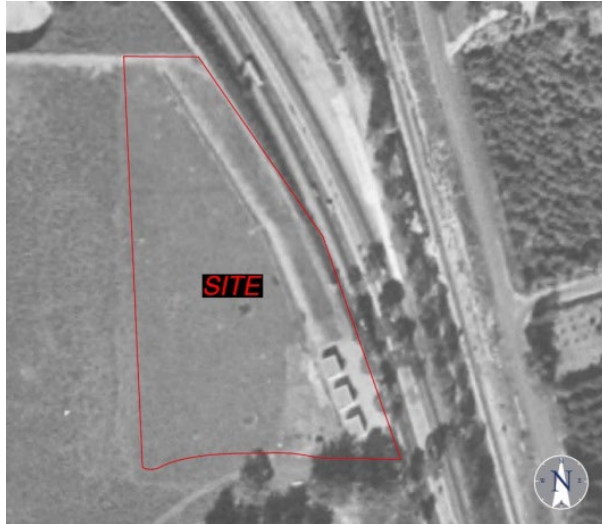
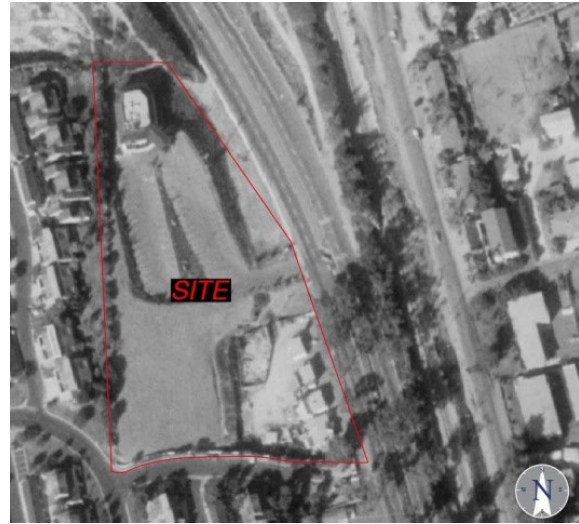
For further comparison, Figure 4-11a and Figure 4-11b (following page) juxtapose 1947 and 1980 photos for the purpose of presenting 'before grading' and 'after grading' site conditions. It appears clear that grading has altered the site over the period 1947 to 1980.

Figure 4-11a. 1947 Site Condition

Figure 4-11b. 1980 Site Condition

In 2019, grading for the Encinitas Beach Resort required a large back cut which encroached into the north end of the subject site to accommodate the resort structures. Figure 4-12 presents this portion of the Encinitas Beach Resort Grading Plan next to the Slope Analysis figure. The red dotted line on the grading plan indicates the top of the back cut on the subject property. This back cut had been made by the time the topographic map was created for the Slope Analysis, and the area on the north end of the property exceeding 25% slope was made by this back cut. It is apparent by review of the 1947 aerial photo (Figure 4-11a), that this steep slope is not a natural feature.

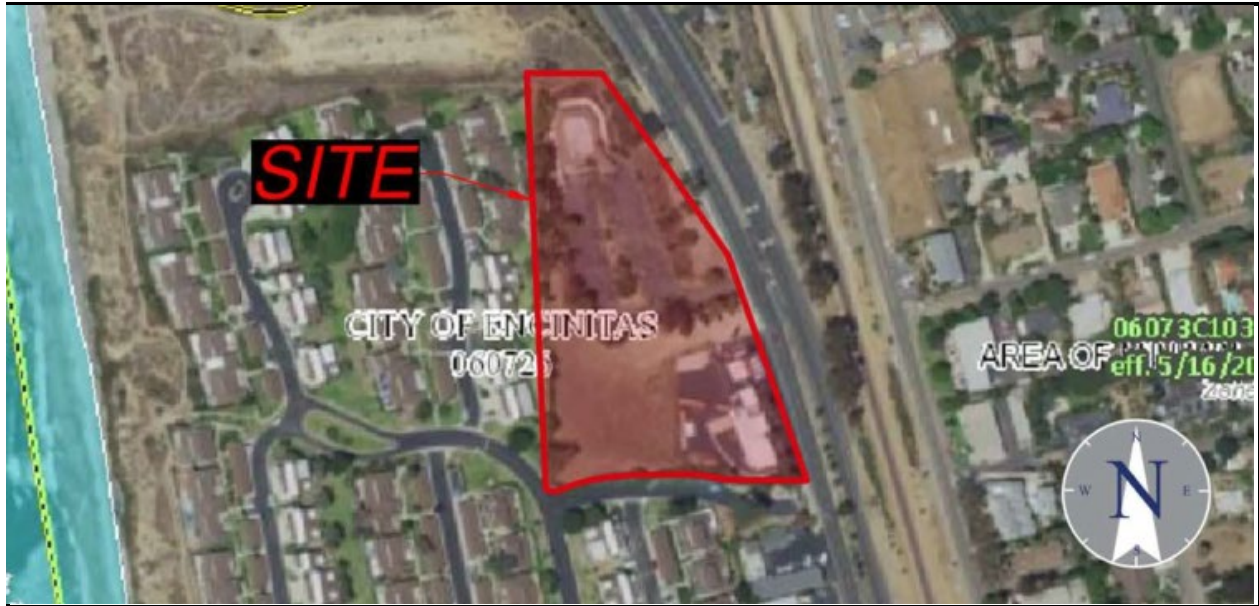
**Figure 5-3. Flood Mapping of the Site Area**  
(source: adapted from FEMA Map 06073C19037G, May 2012)

The project site is located within a FEMA-designated flood zone, designated as Flood "Zone X" Zone X is an "*area of minimal flood hazard*." Figure 5-3 (following page) reproduces this mapping.

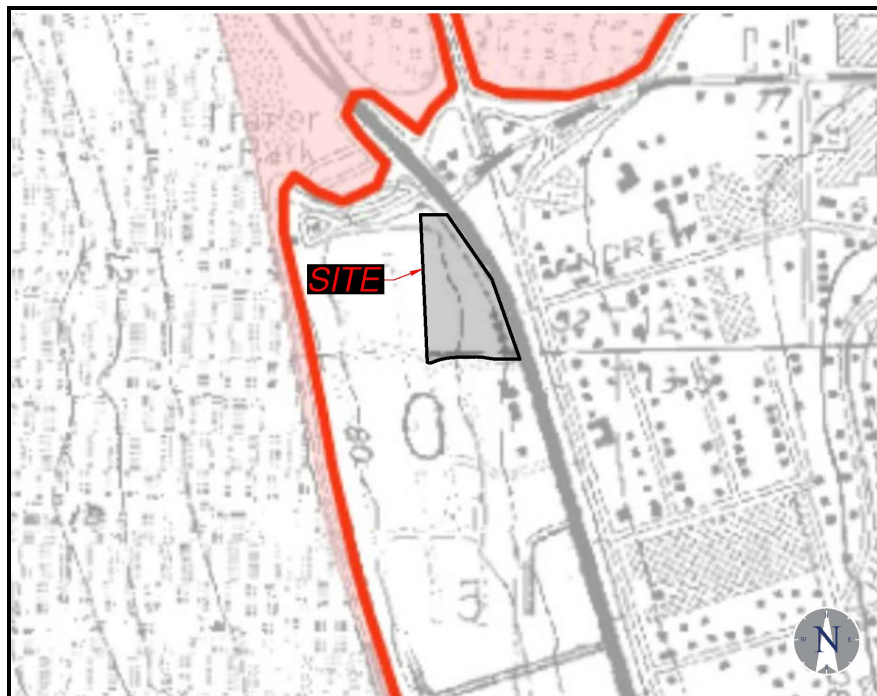
**Figure 5-4. Tsunami Inundation Mapping of the Site Area**  
(source: CEMA, 2009)

Figure 5-4 (following page) maps potential tsunami inundation in the site area. As may be seen by review of this graphic, the site is not at risk for inundation by a tsunami.

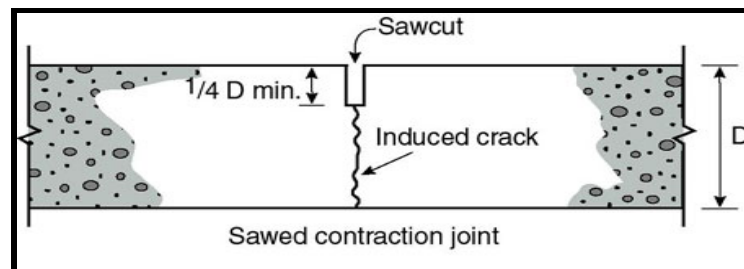
Figure 6-1. Sawed Contraction Joint

To reduce the potential for excessive cracking, concrete slabs-on-grade should be provided with construction or 'weakened plane' joints at frequent intervals. Joints should be laid out to form approximately square panels and never exceeding a length to width ratio of 1.5 to 1. Proper joint spacing and depth are essential to effective control of random cracking. Joints are commonly spaced at distances equal to 24 to 30 times the slab thickness. Joint spacing that is greater than 15 feet should include the use of load transfer devices (dowels or diamond plates). Contraction/control joints must be established to a depth of  $\frac{1}{4}$  the slab thickness as depicted in Figure 6-1.

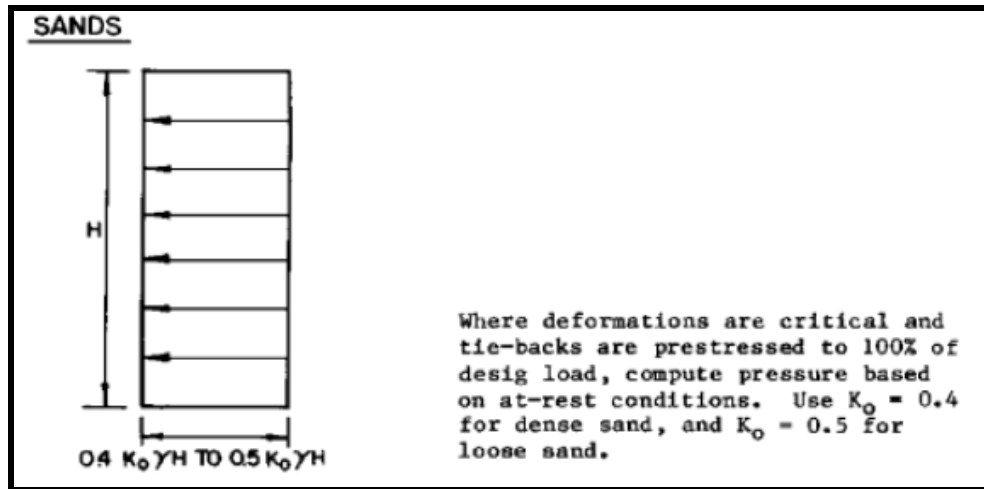
**Figure 7-1. 'At Rest' Wall Pressure Distribution in Sands**

Designed to resist the Condition 1 'at rest' (i.e., 'K<sub>o</sub>') earth pressures employs a rectangular wall pressure distribution that is more conservative than the Condition 2 loading. Figure 7-1 (following page) provides this load distribution, reproducing published guidance of relevance to this design circumstance.

Design for the 'at rest' wall pressure diagram depicted in Figure 7-1 using the parameters would yield:

$$P = 0.45 \times 0.43 \times 120 \times H = 23H$$

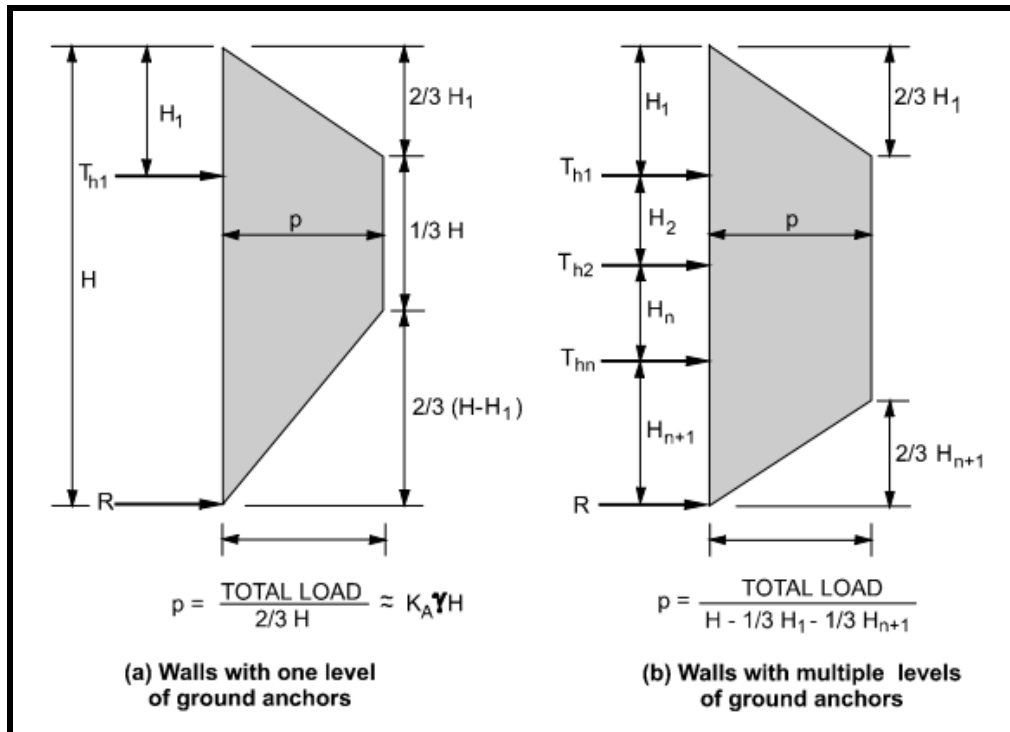
**Figure 7-2. 'Active' Lateral Earth Pressures**

As such, NOVA recommends that wall design be completed using active earth pressures as described by the trapezoidal active earth pressure distribution of Figure 7-2(a) (following page). The magnitude of the maximum trapezoidal pressure may be calculated as:

NOVA recommends employing the trapezoidal distribution of Figure 7-2(a), using 21H for determination of the maximum wall pressure.

It should be noted that the pressure distribution of Figure 7-2(a) are empirical, derived from experience. As may be seen by review of Figure 7-2(a), the recommendation for this pressure distribution follows guidance provided by FHWA 1999. It should be understood that other empirical pressure distributions may be preferred by others. However, it is NOVA's experience that the pressure distribution of Figure 6 works well to predict wall loads/anchor loads in this area.

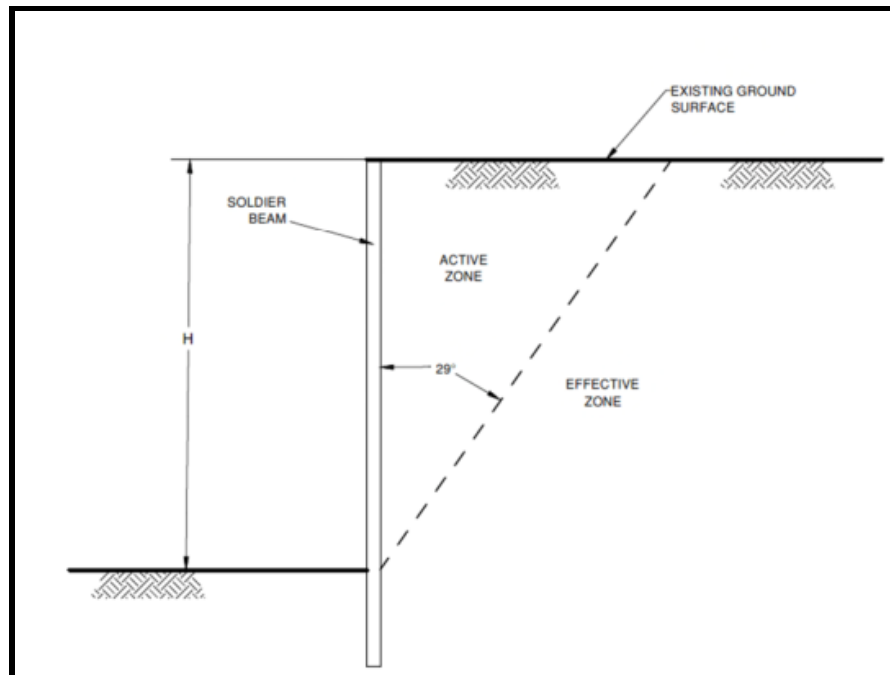
**Figure 7-3. Recommended Effective Zone for Tieback Anchors**

Design should assume that the failure wedge adjacent to the shoring is defined by a plane drawn at  $29^\circ$  from the vertical from the toe of the wall. Figure 7-3 depicts this wedge graphically.

Tieback anchors should extend at least 20 feet beyond the failure wedge (i.e., the “bonded” zone) depicted in Figure 7-3. The intent of this provision is to provide global stability for the shored wall. The bonded length should commence at least 5 feet beyond the failure wedge).

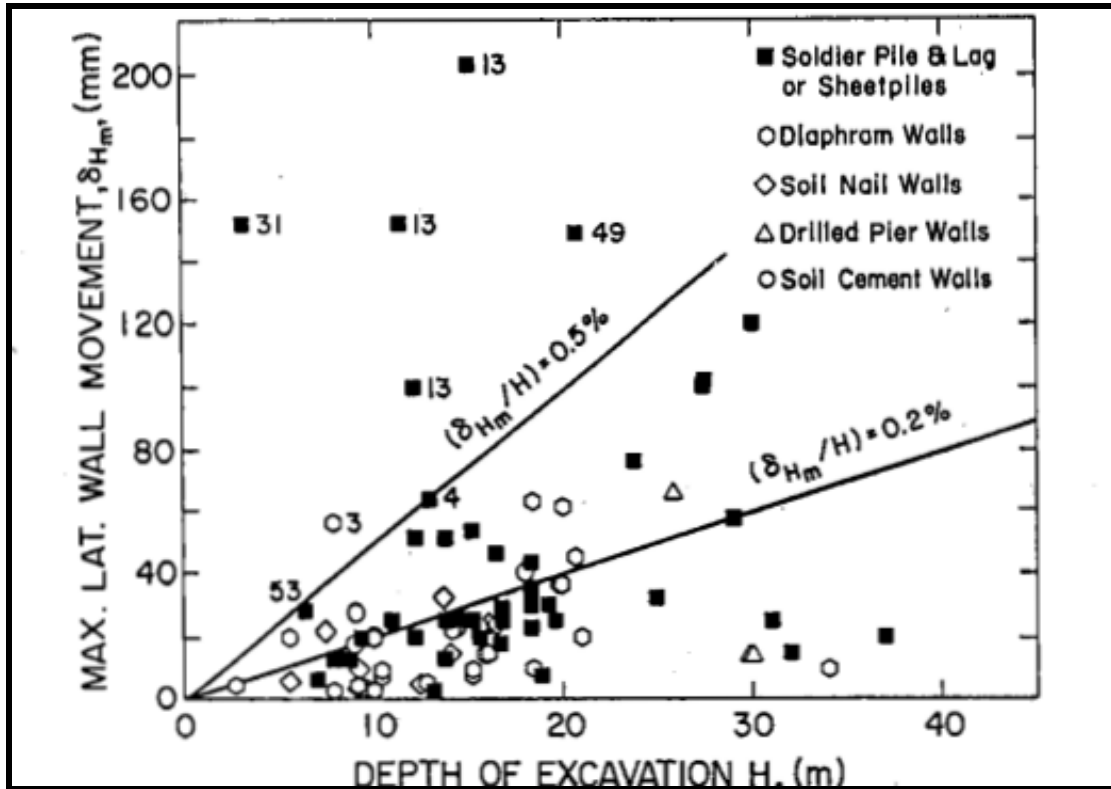
Figure 7-4. Observed Maximum Lateral Movements for In Situ Walls in Stiff Clays, Residual Soils and Sands (source: Clough and O'Rourke 1990)

Design for a Condition 1 wall will limit wall movement, though the 'at rest' wall condition will not eliminate all wall movement. Because of the reliance on a wide variety of parameters, including workmanship, it is difficult to rigorously predict wall performance during the design stage. Expectations in this regard are primarily empirical. Figure 7-4 (following page) provides a published summary of project experiences.

A wall designed for Condition 1 might expect to have a horizontal movement ( $\delta_{Hm}$ ) of about 0.2% of the wall height (H). Assuming H ~25 feet, the design might anticipate  $\delta_{Hm} \sim 0.5$ -inch.

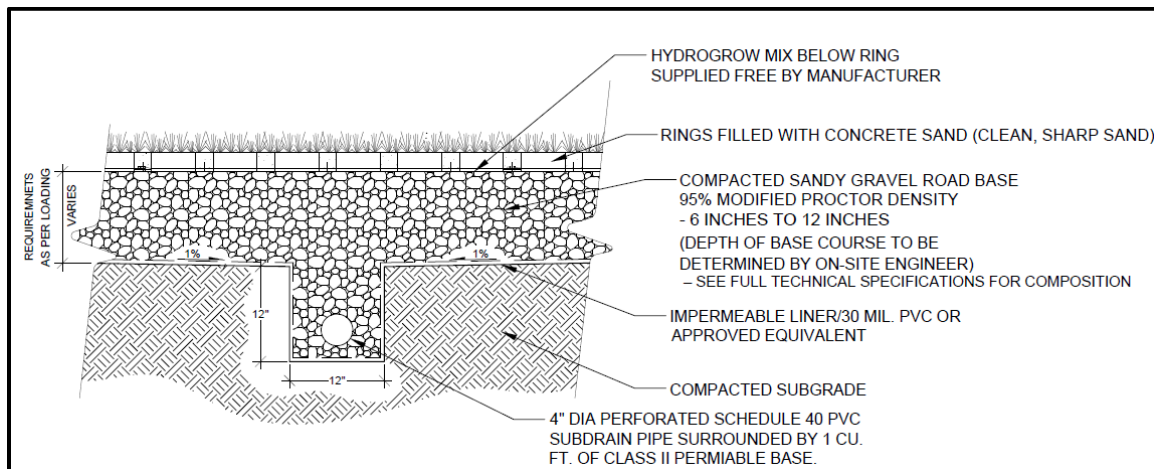
**Figure 9-2. Design to Control Infiltration**

Water retained by the liner can be collected by a subdrain. The lined subgrade soils should be sloped at least one percent towards the subdrain. A 4-inch diameter, Schedule 40, perforated PVC pipe encapsulated with Caltrans Class II permeable base (or equivalent) should be suitable as a subdrain. This piping should connect to solid PVC pipe to convey the stormwater to a suitable outlet structure, i.e. area drain or storm drain structure.

Figure 9-2 depicts a design to control infiltrating surface water that reflects the above recommendations.

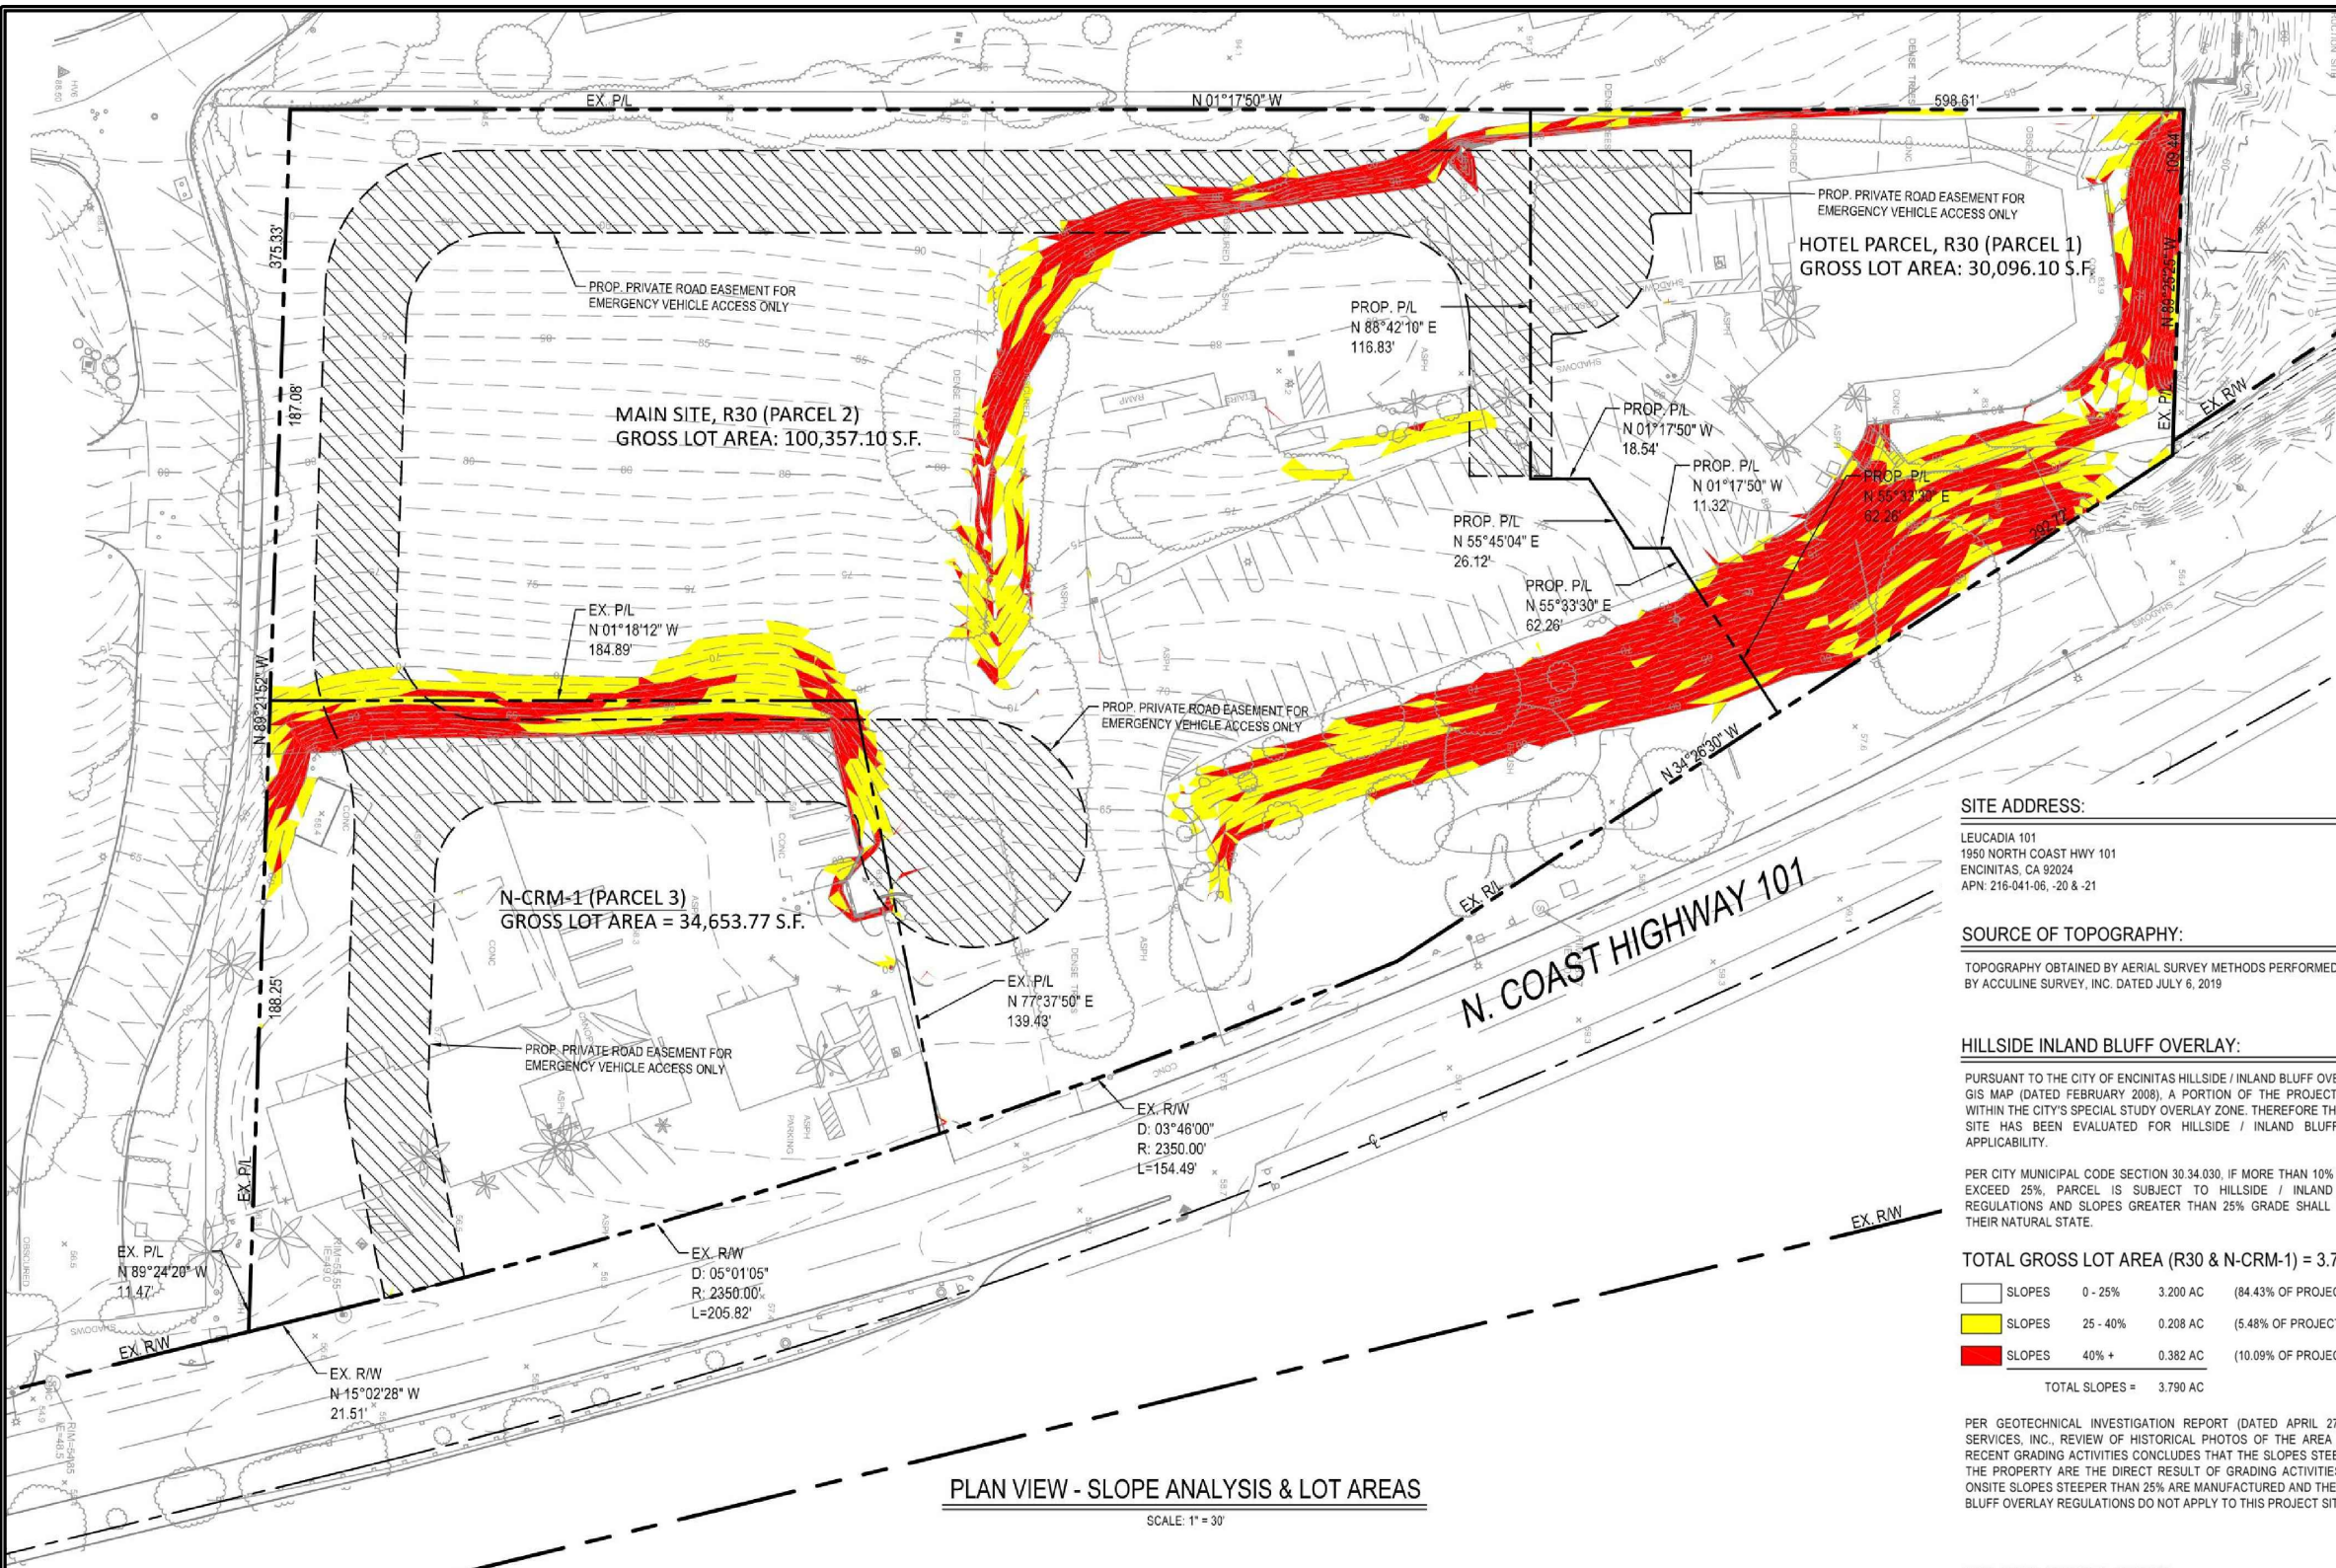
PLAN VIEW - SLOPE ANALYSIS & LOT AREAS
