# Update to the Revised Report Geotechnical Investigation

## Leucadia Mixed-Use 1900-1950 North Coast Highway, Encinitas, California

NOVA Project 2019189  
April 13, 2021

Subject: Update to the Revised Report  
Geotechnical Investigation  
Leucadia Mixed-Use  
1950 North Coast Highway, Encinitas, California

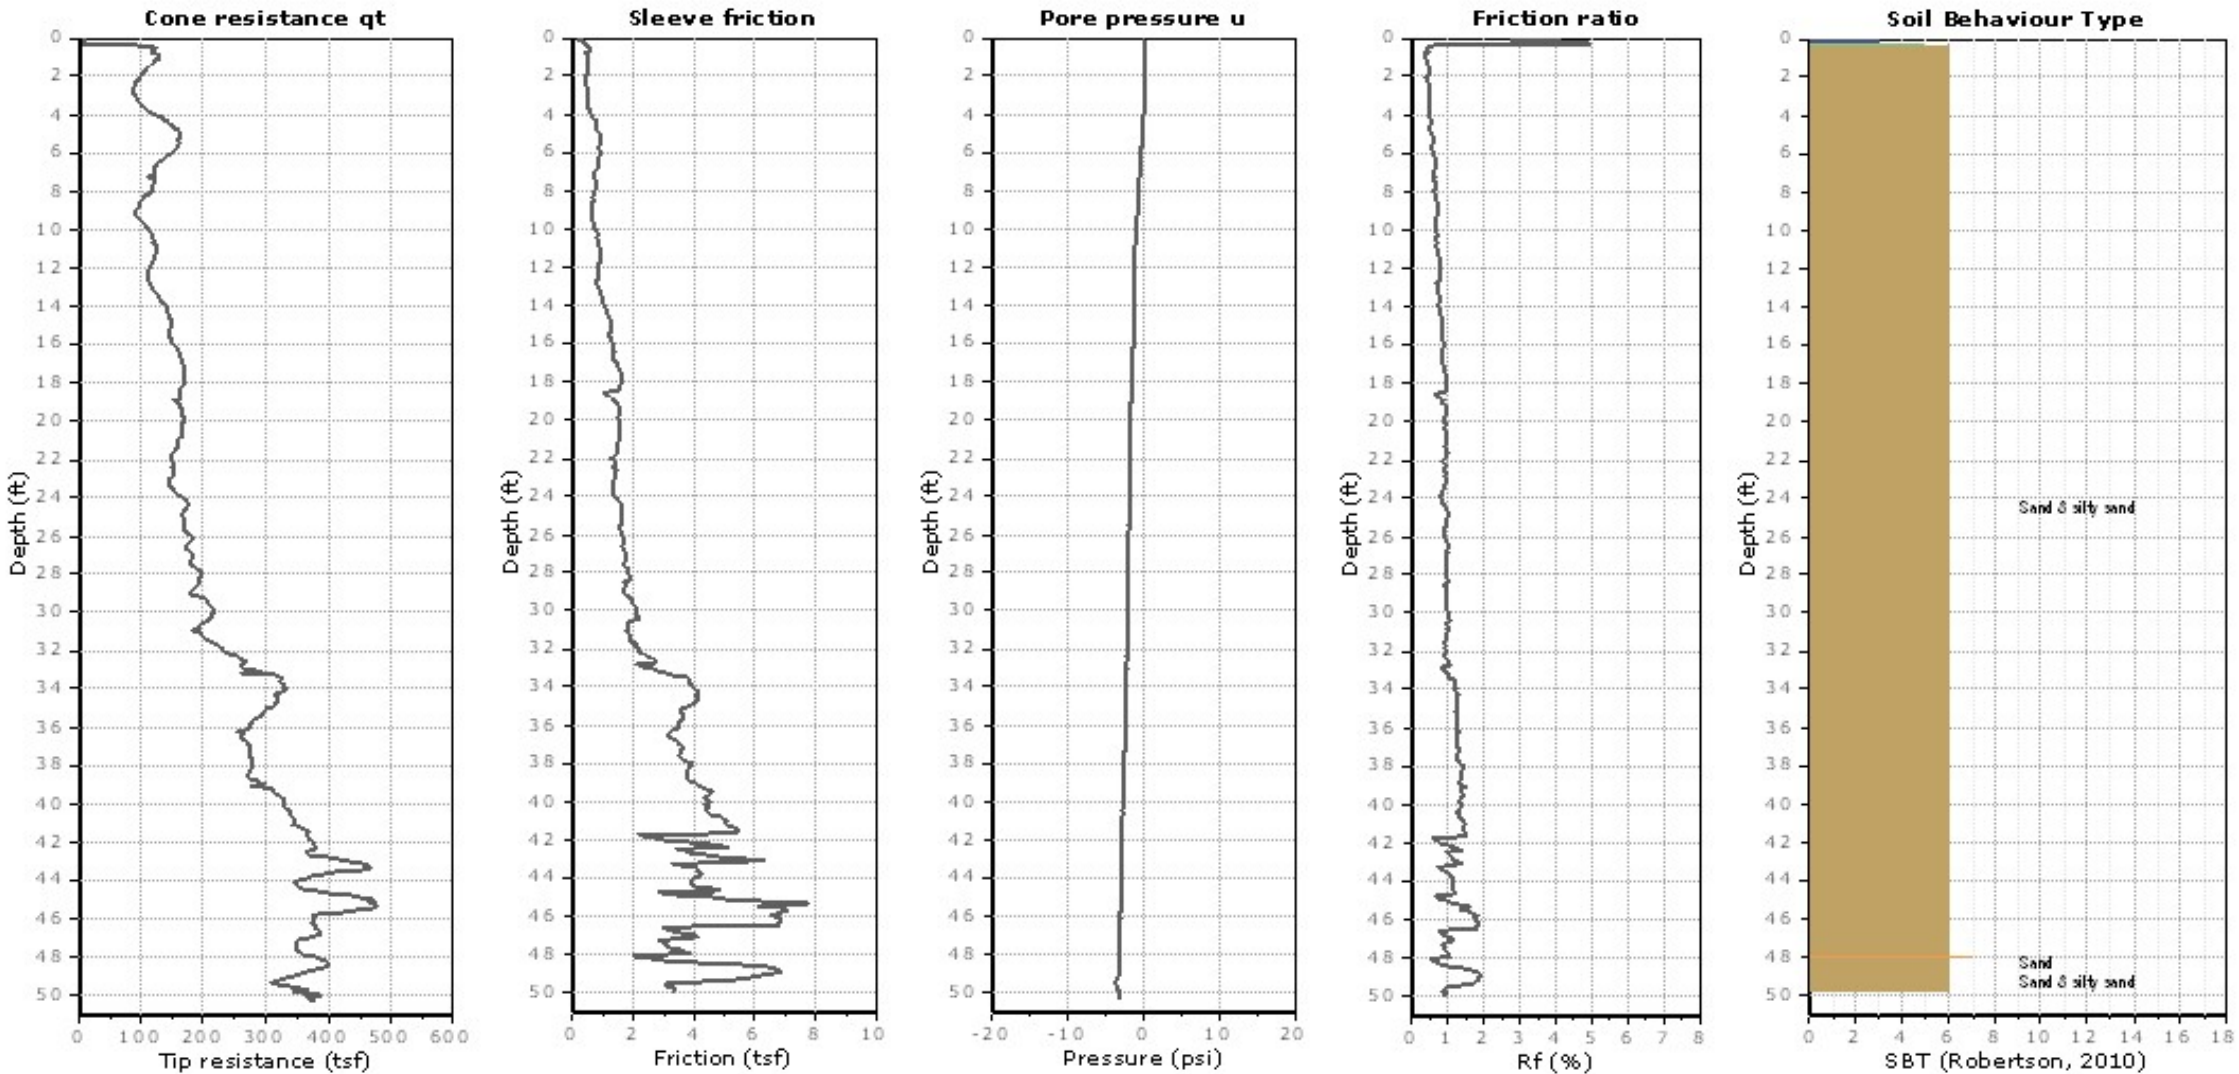
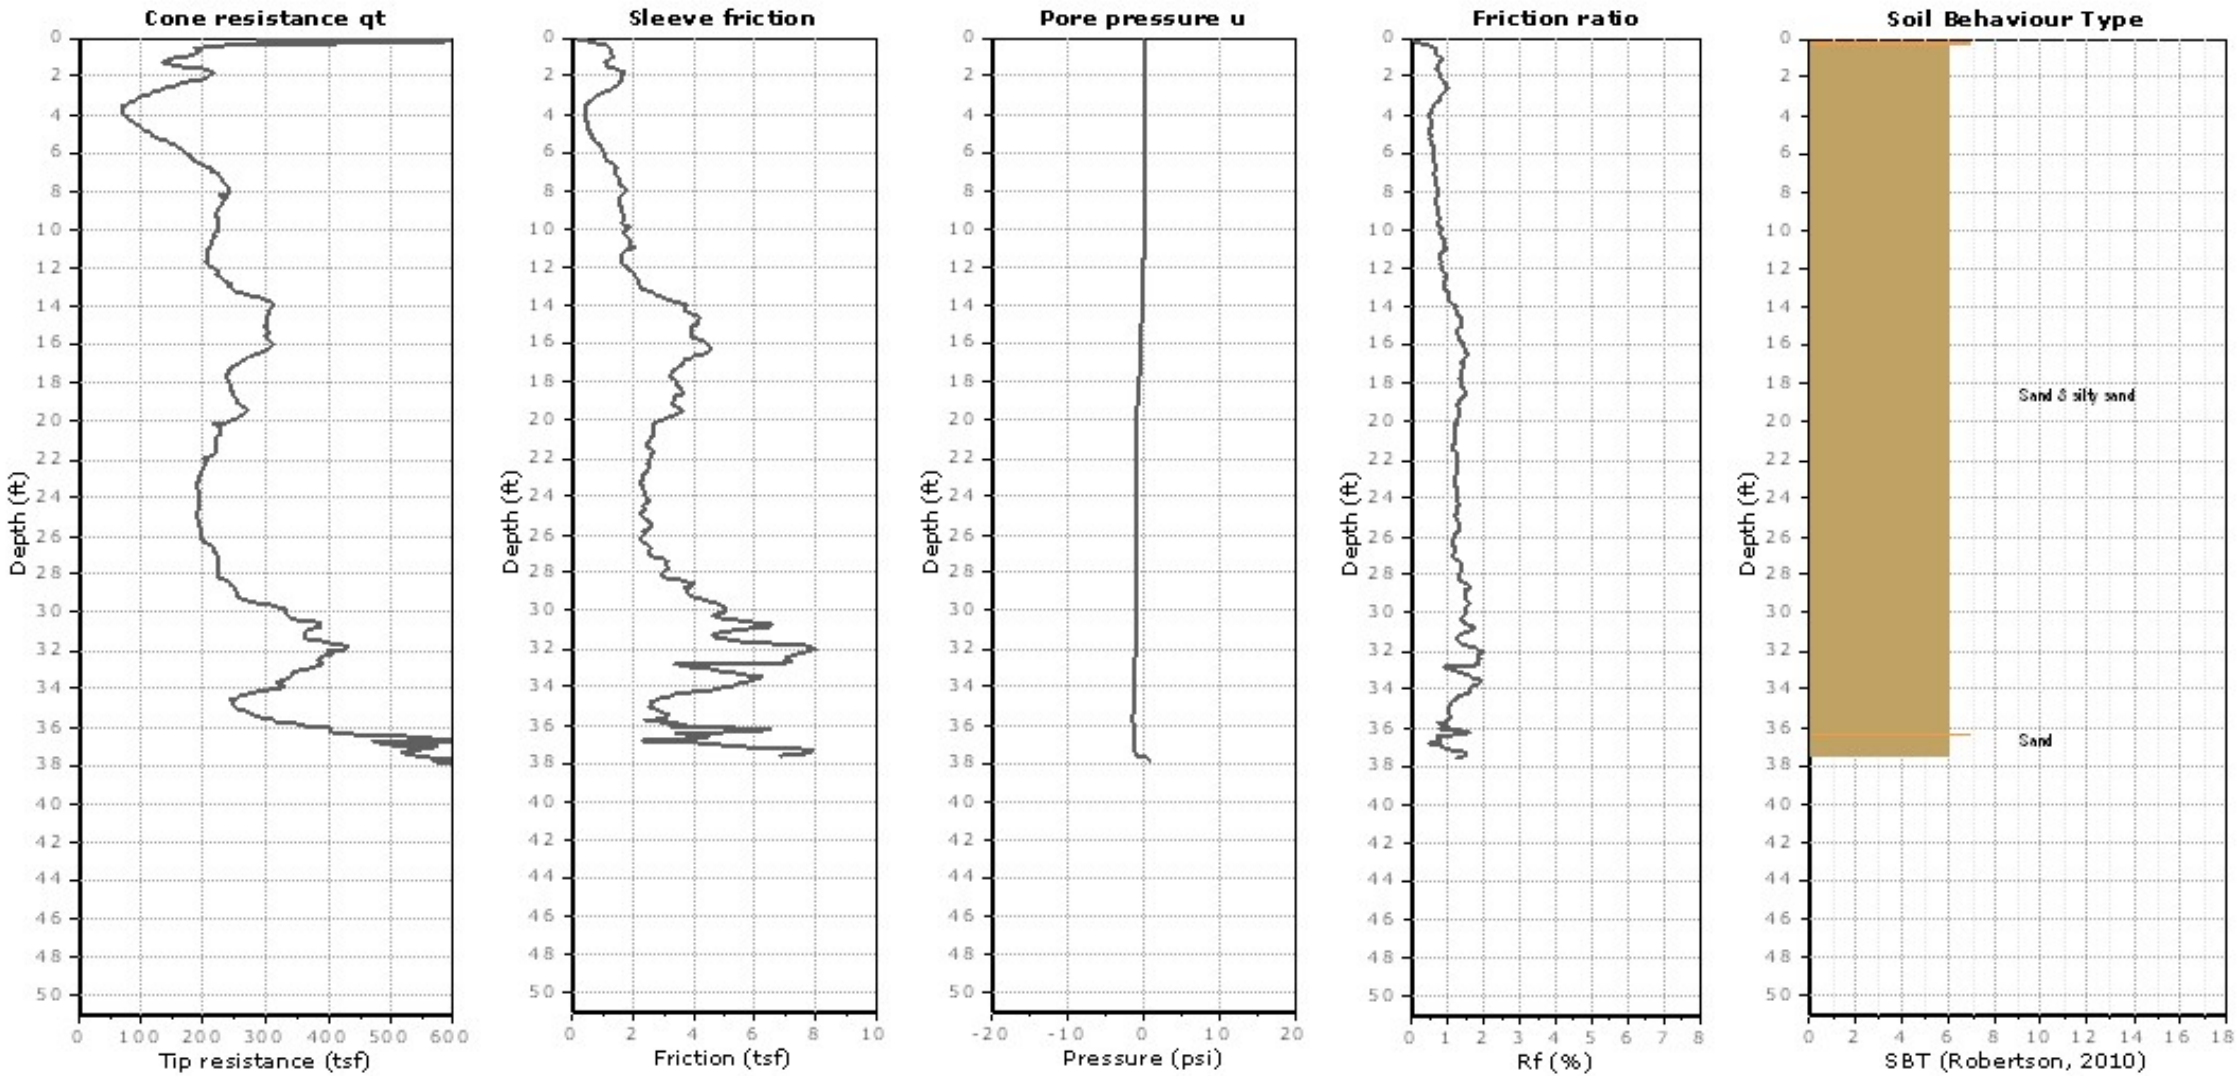
## **LOGS OF THE CPT SOUNDINGS**

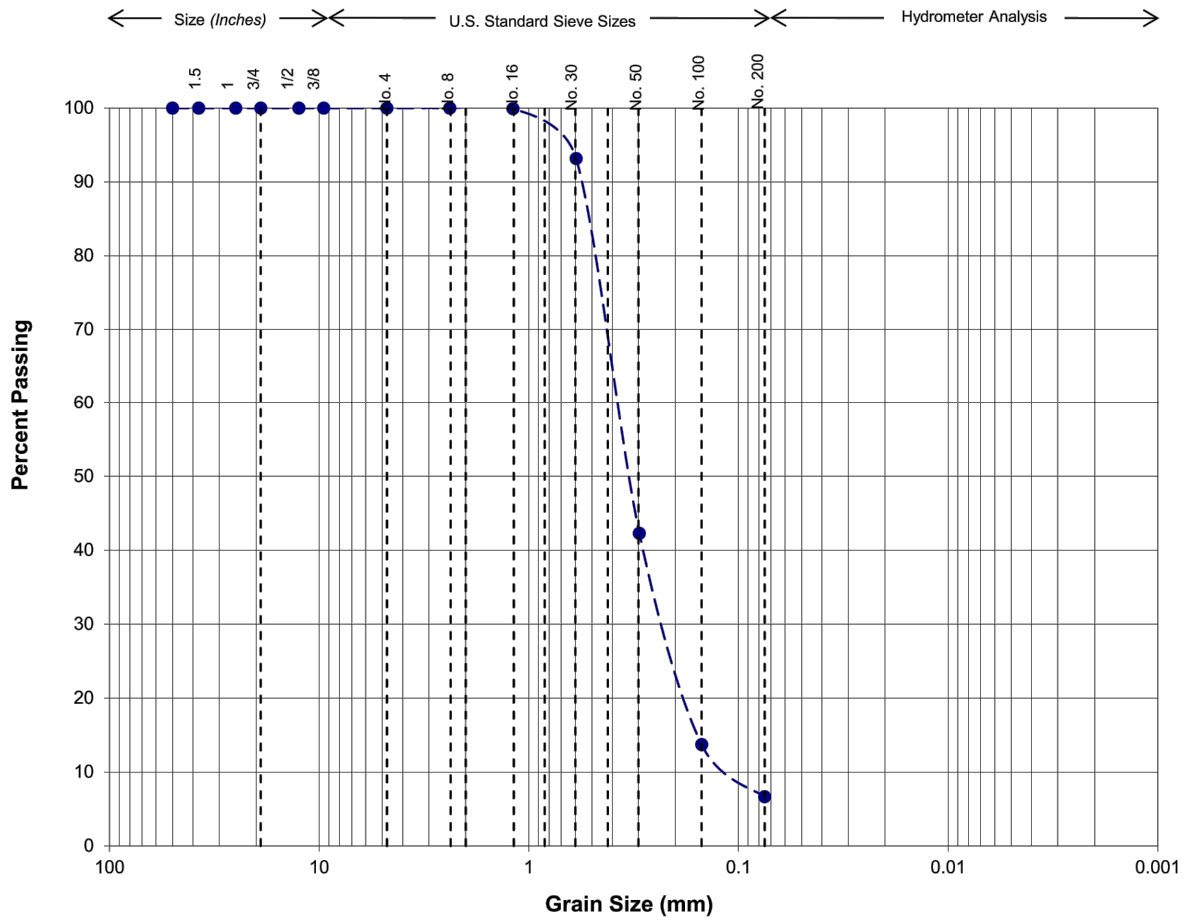
APPENDIX: D.2

Sample Location: B-2  
 Depth (ft): 15  
 USCS Soil Type: SP-SM  
 Passing No. 200 (%): 7

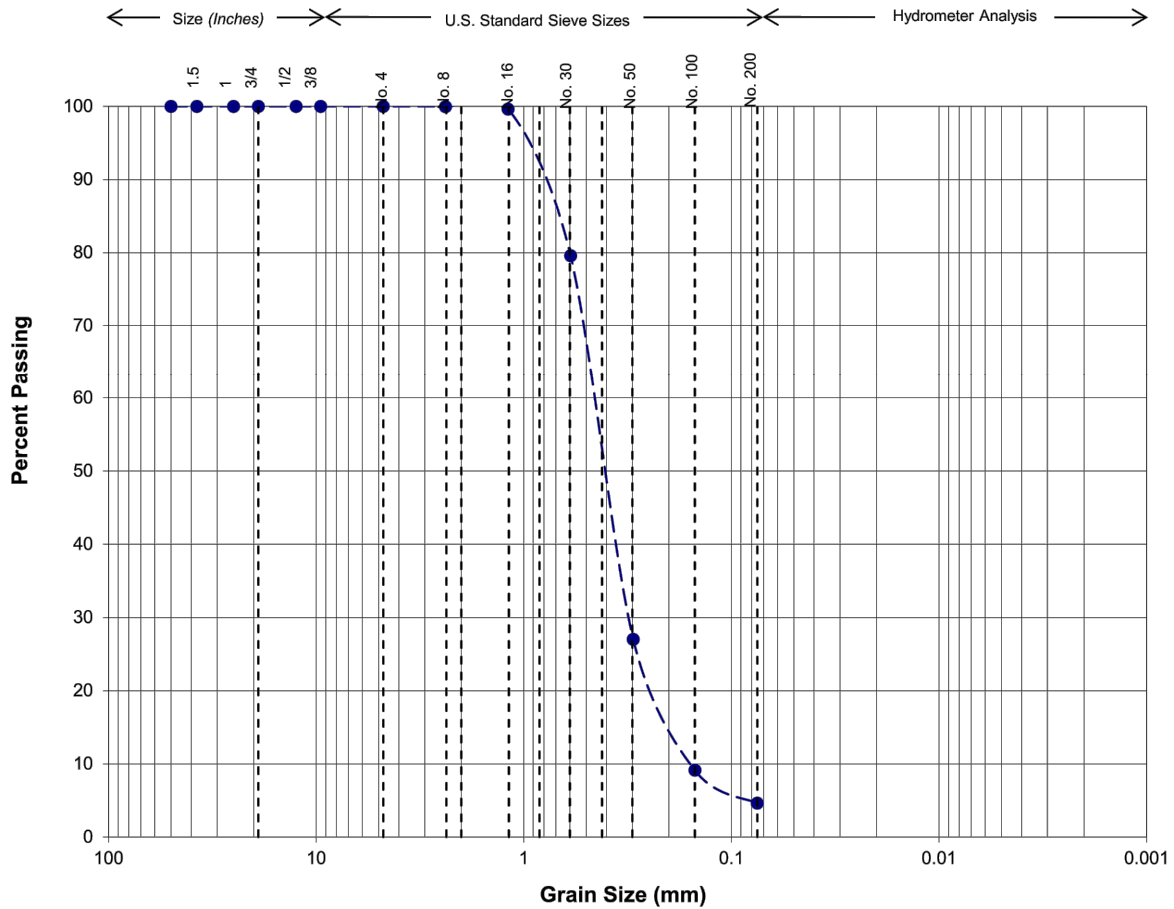
APPENDIX: D.3

Sample Location: B-2  
 Depth (ft): 20  
 USCS Soil Type: SP  
 Passing No. 200 (%): 5

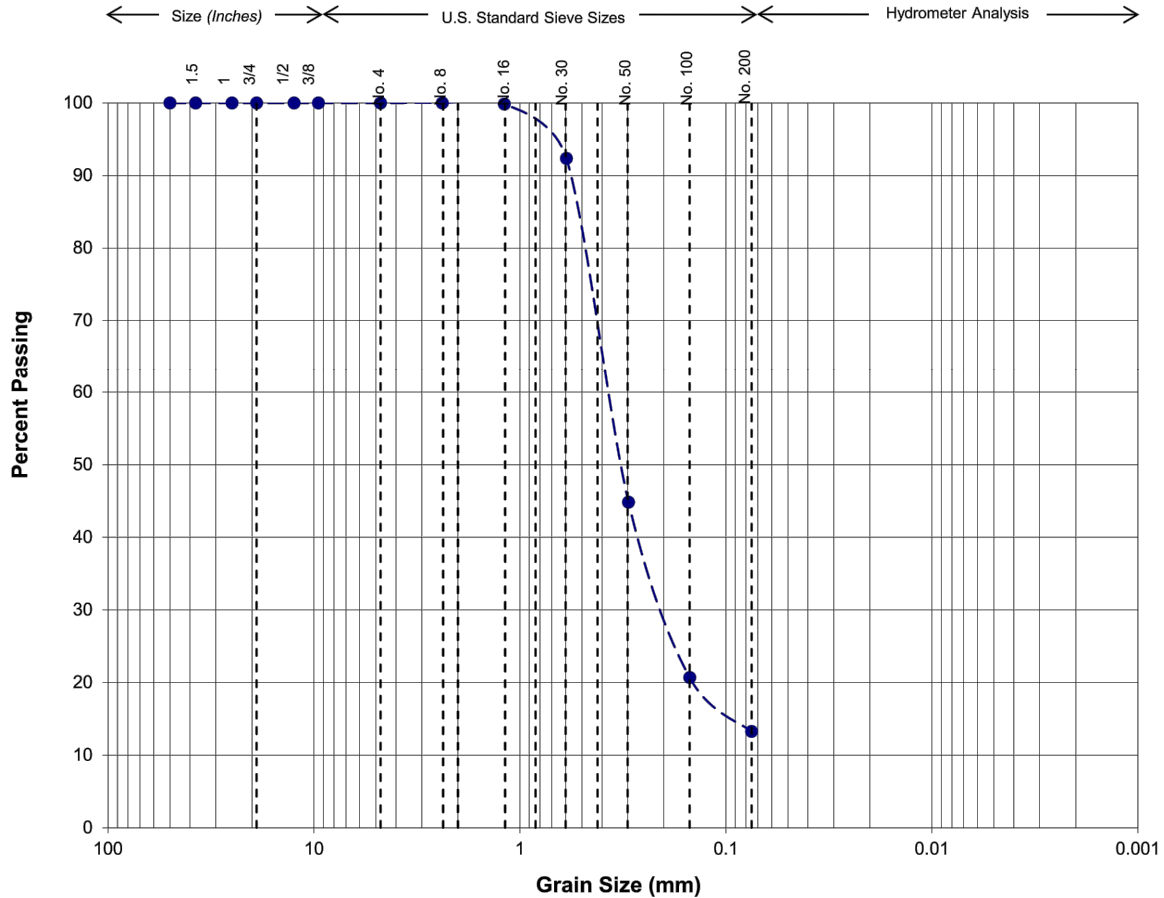
APPENDIX: D.4

Sample Location: B-3  
 Depth (ft): 5  
 USCS Soil Type: SP-SM  
 Passing No. 200 (%): 13

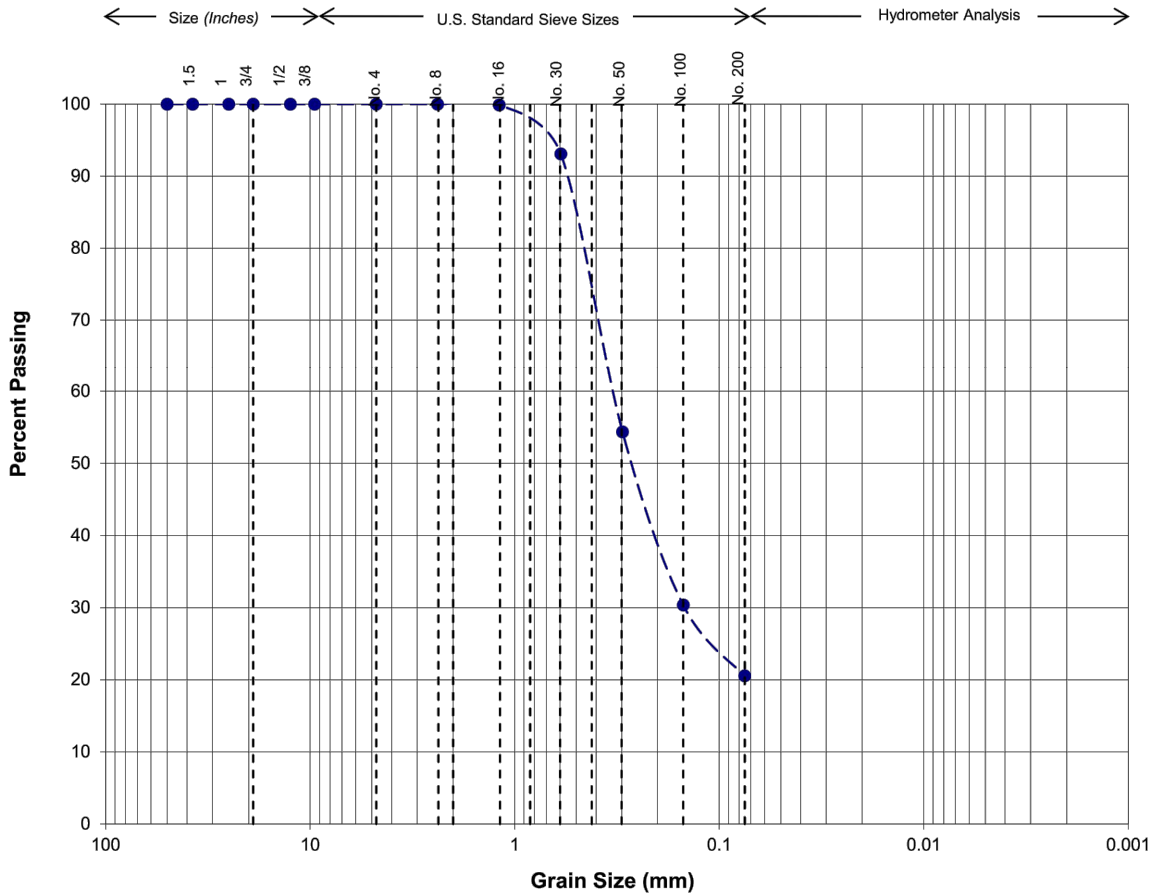
APPENDIX: D.5

Sample Location: B-4  
 Depth (ft): 5  
 USCS Soil Type: SM  
 Passing No. 200 (%): 21

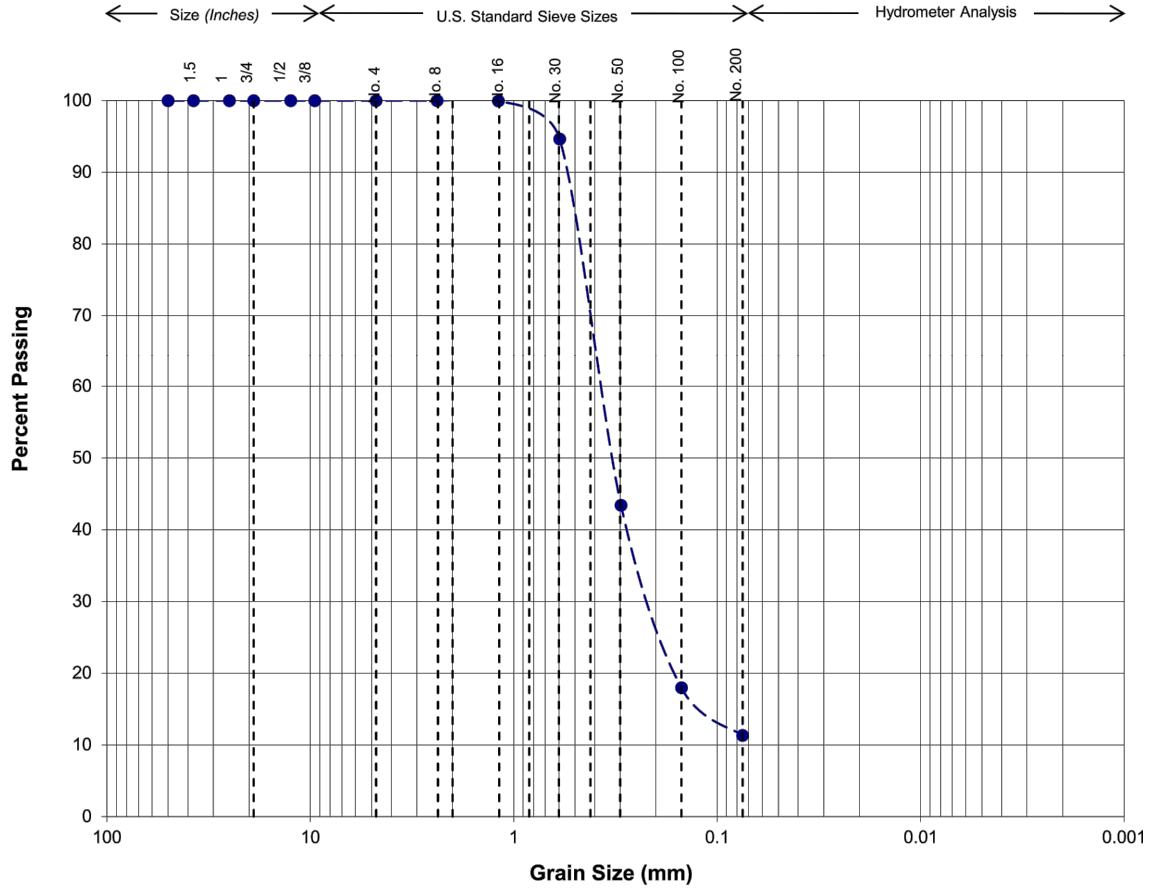
APPENDIX: D.6

Sample Location: B-4  
 Depth (ft): 10  
 USCS Soil Type: SP-SM  
 Passing No. 200 (%): 11

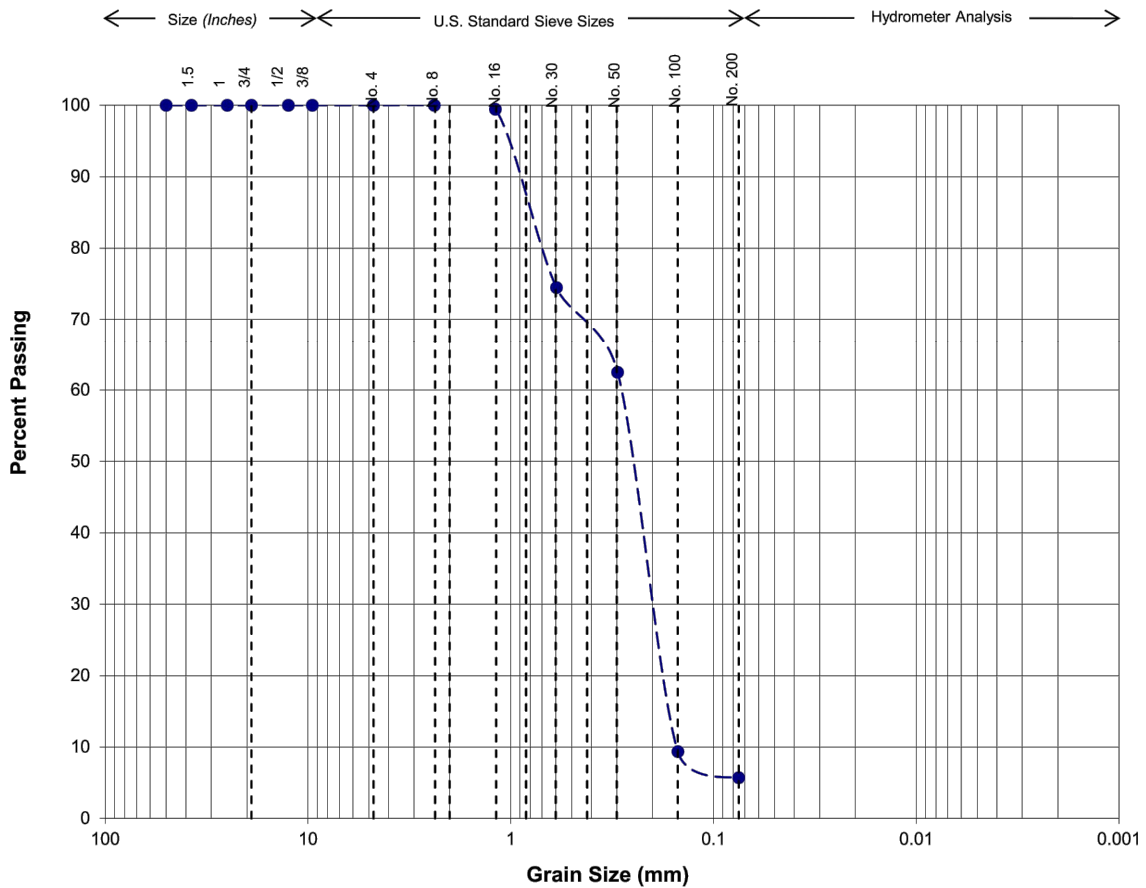
APPENDIX: D.7

Sample Location: B-4  
 Depth (ft): 15  
 USCS Soil Type: SP-SM  
 Passing No. 200 (%): 6

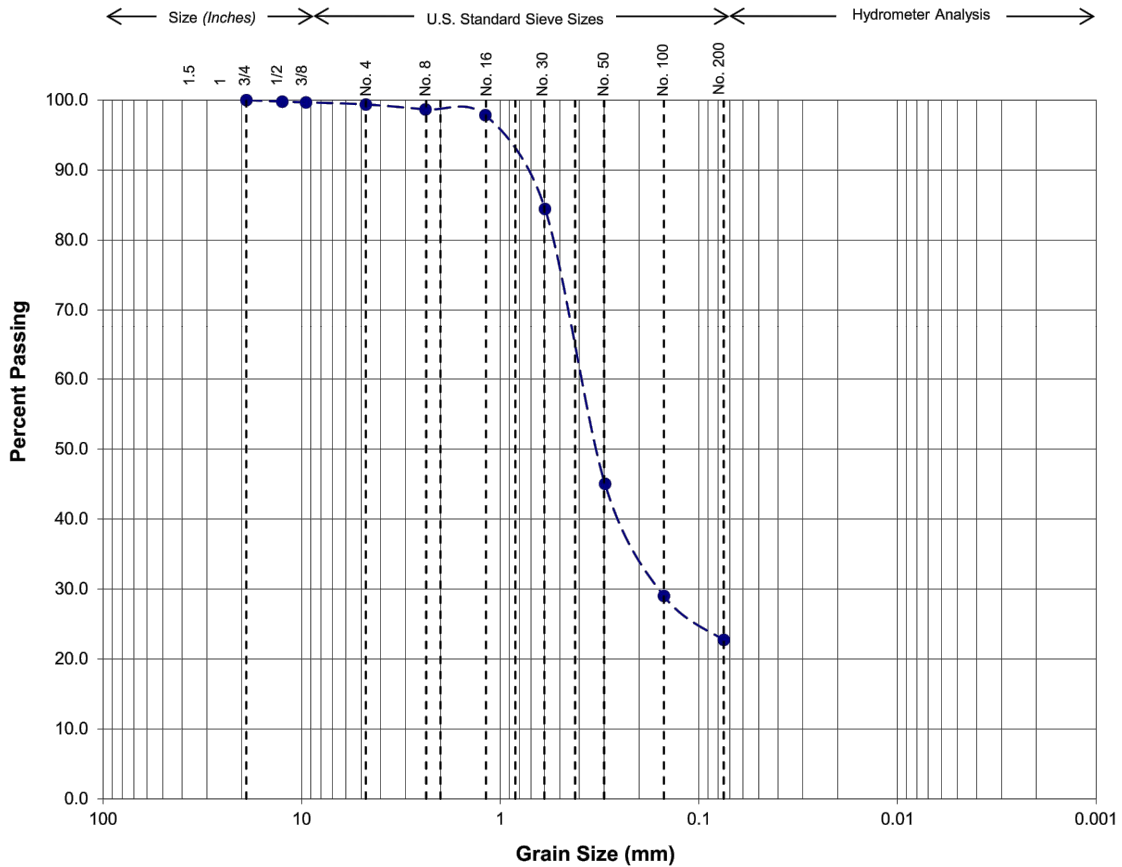
APPENDIX: D.8

Sample Location: B-5  
 Depth (ft): 0 - 2.5  
 USCS Soil Type: SM  
 Passing No. 200 (%): 23

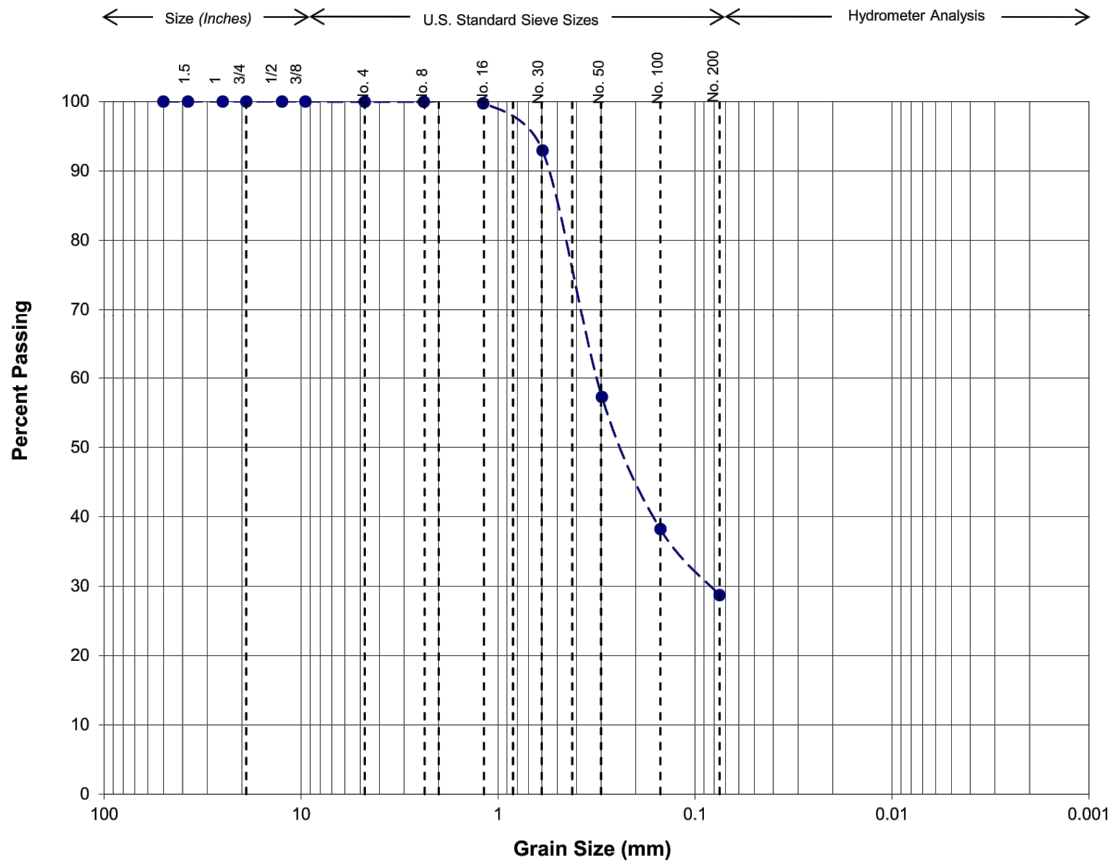
APPENDIX: D.9

Sample Location: B-5  
 Depth (ft): 5  
 USCS Soil Type: SM  
 Passing No. 200 (%): 29

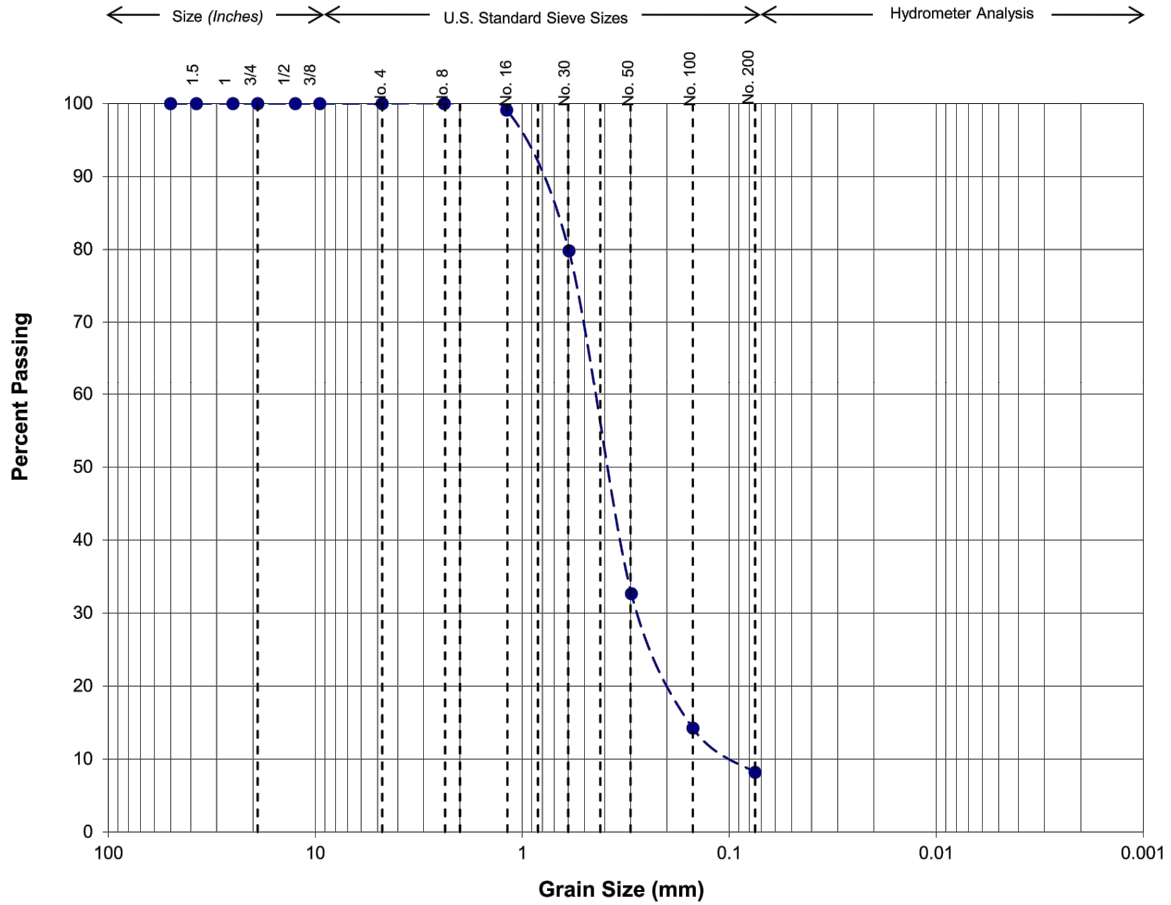
BY: HAP	DATE: APR 2021	PROJECT: 2019189	APPENDIX: D.10
---------	----------------	------------------	----------------

Sample Location: B-7  
 Depth (ft): 5  
 USCS Soil Type: SP-SM  
 Passing No. 200 (%): 8

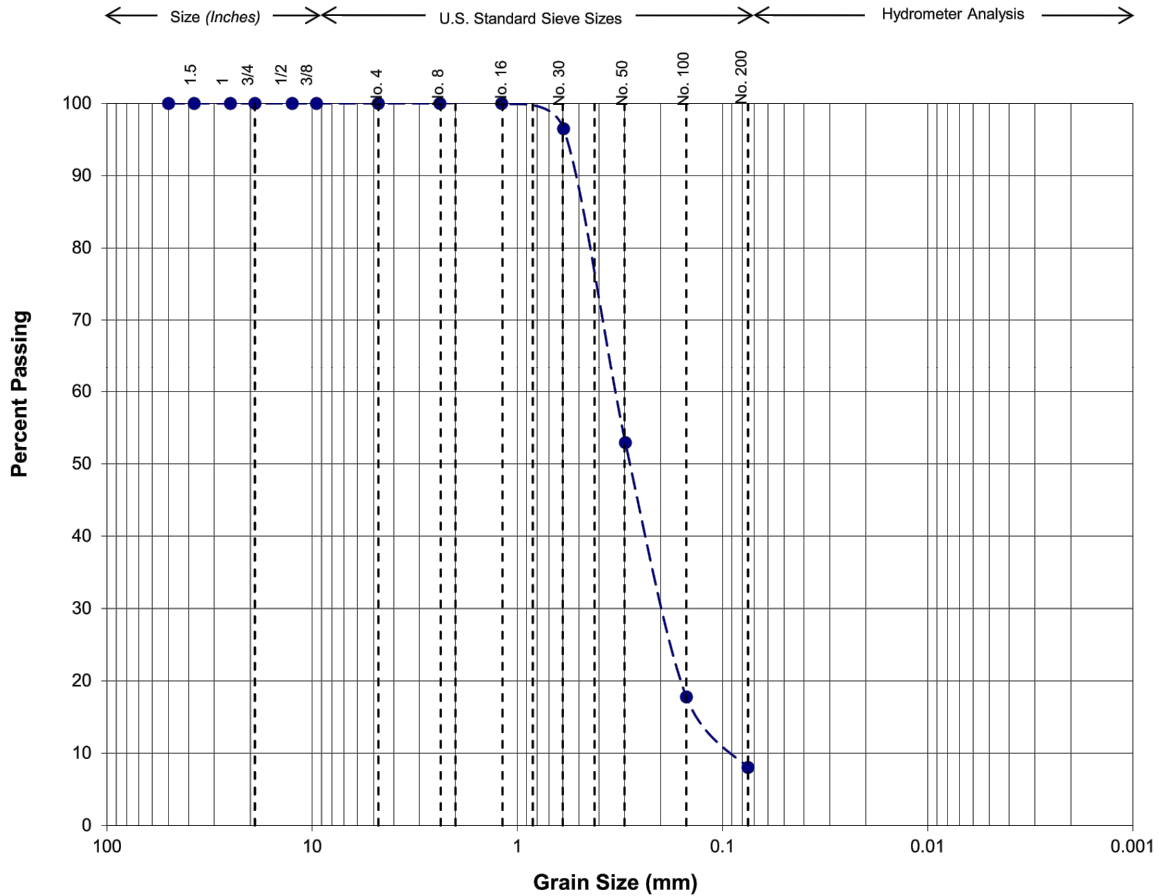
APPENDIX: D.11

Sample Location: B-7  
 Depth (ft): 7.5  
 USCS Soil Type: SP-SM  
 Passing No. 200 (%): 8

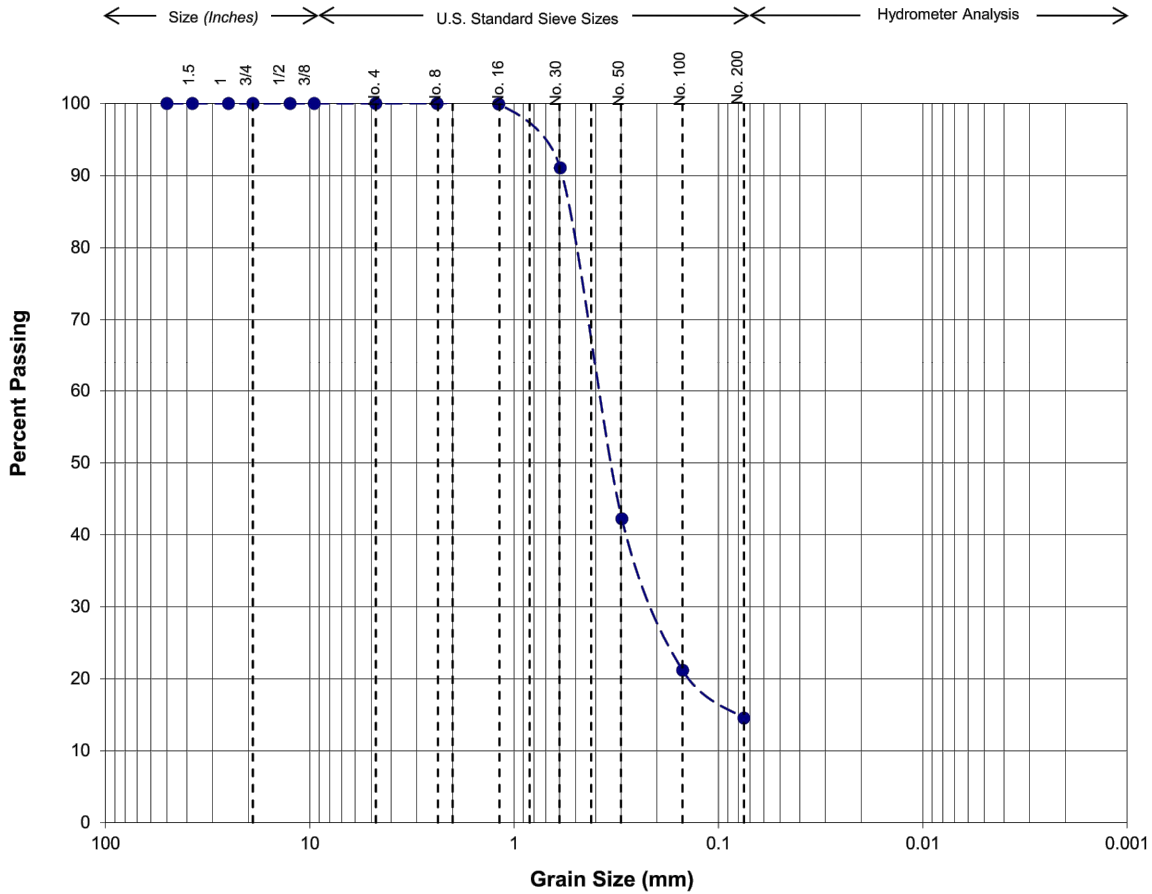
APPENDIX: D.12

Sample Location: B-7  
 Depth (ft): 10  
 USCS Soil Type: SM  
 Passing No. 200 (%): 15

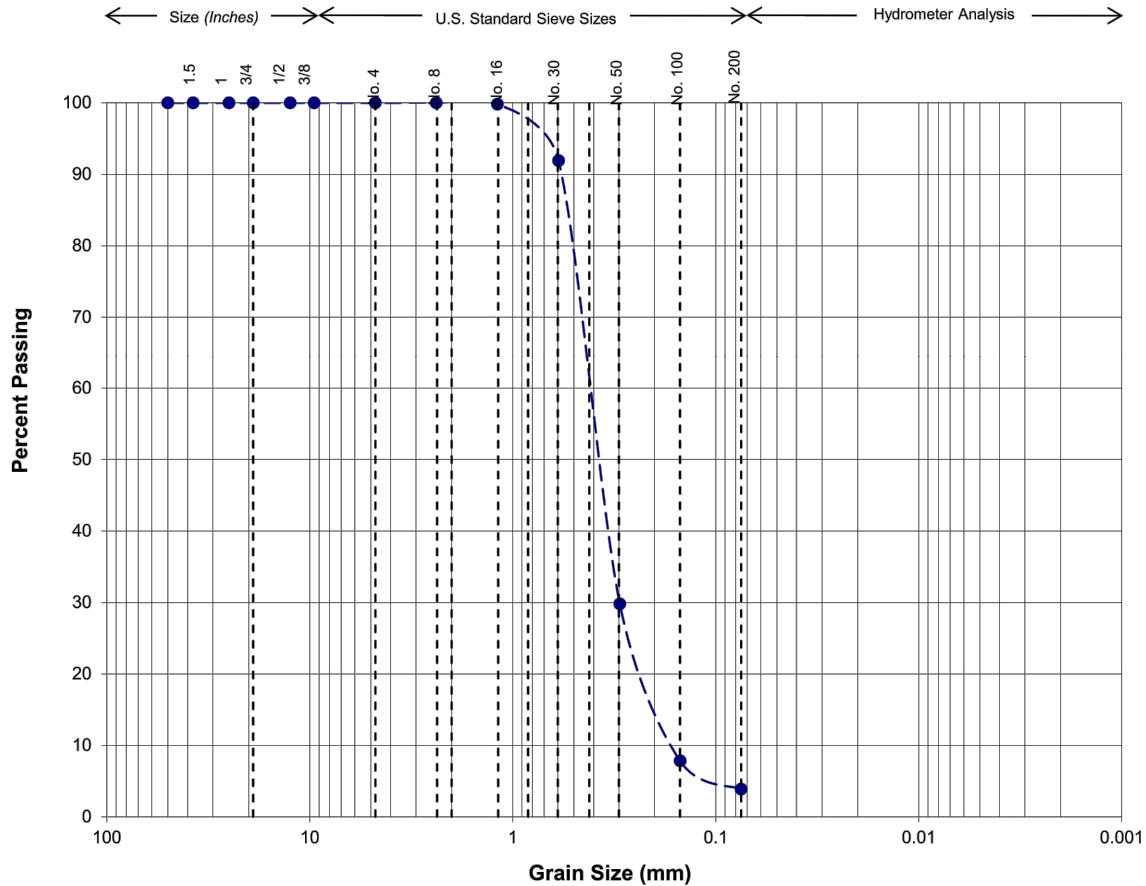
APPENDIX: D.13

Sample Location: B-7  
 Depth (ft): 35  
 USCS Soil Type: SP  
 Passing No. 200 (%): 4

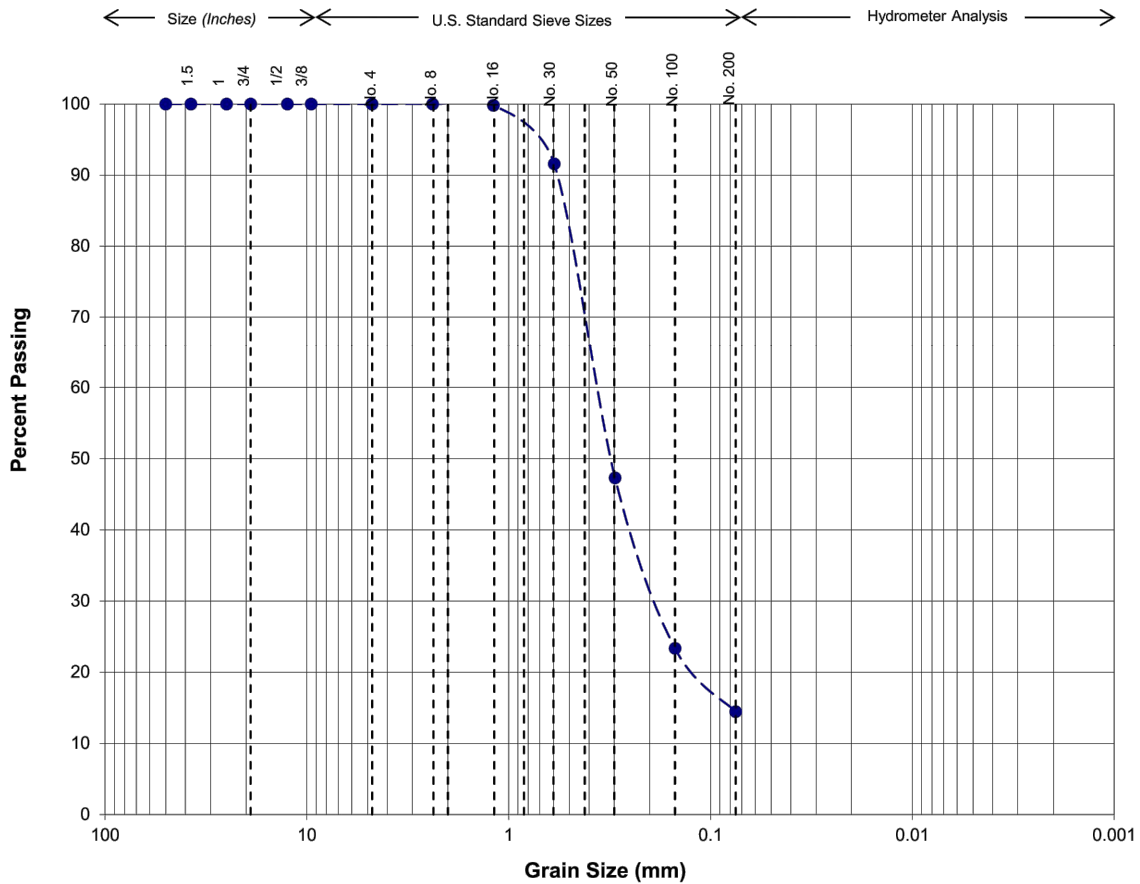
APPENDIX: D.14

Sample Location: B-8  
 Depth (ft): 2.5  
 USCS Soil Type: SP-SM  
 Passing No. 200 (%): 14

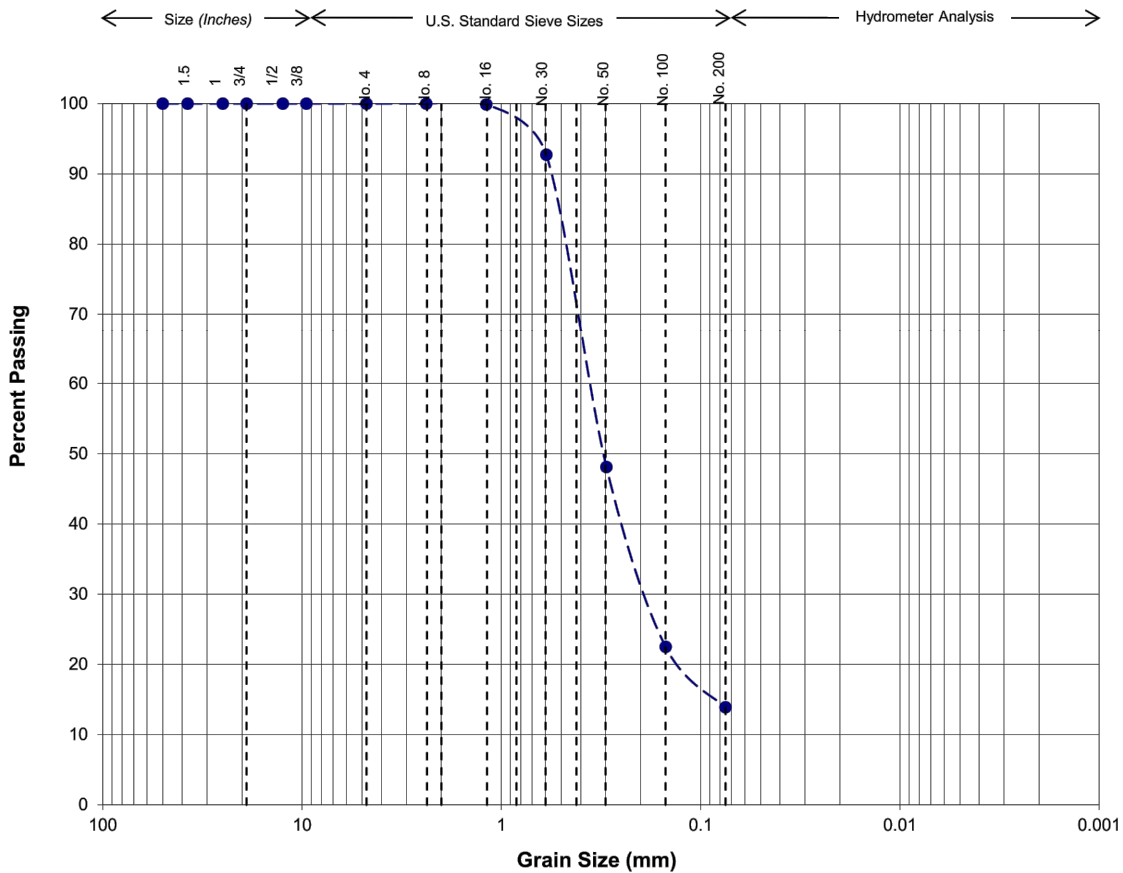
APPENDIX: D.15

Sample Location: B-8

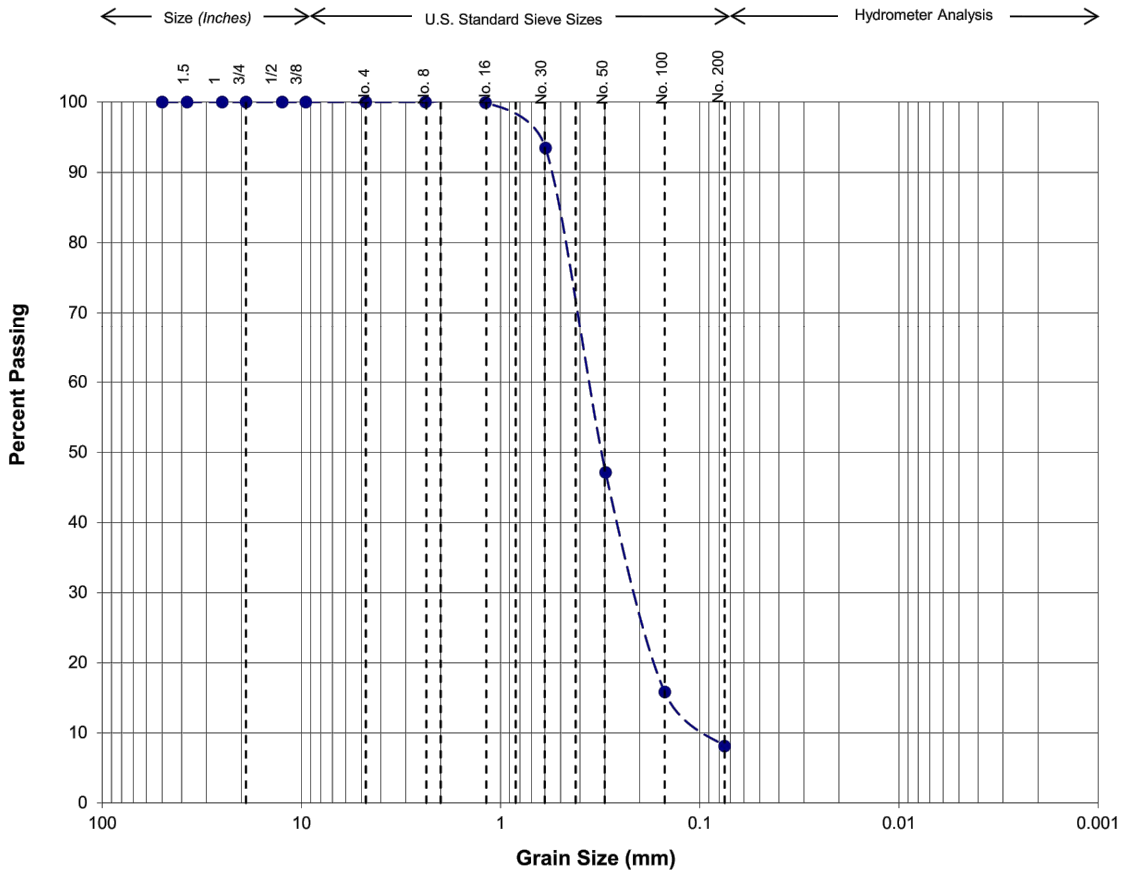
APPENDIX: D.16

Sample Location: B-8  
 Depth (ft): 15  
 USCS Soil Type: SP-SM  
 Passing No. 200 (%): 8

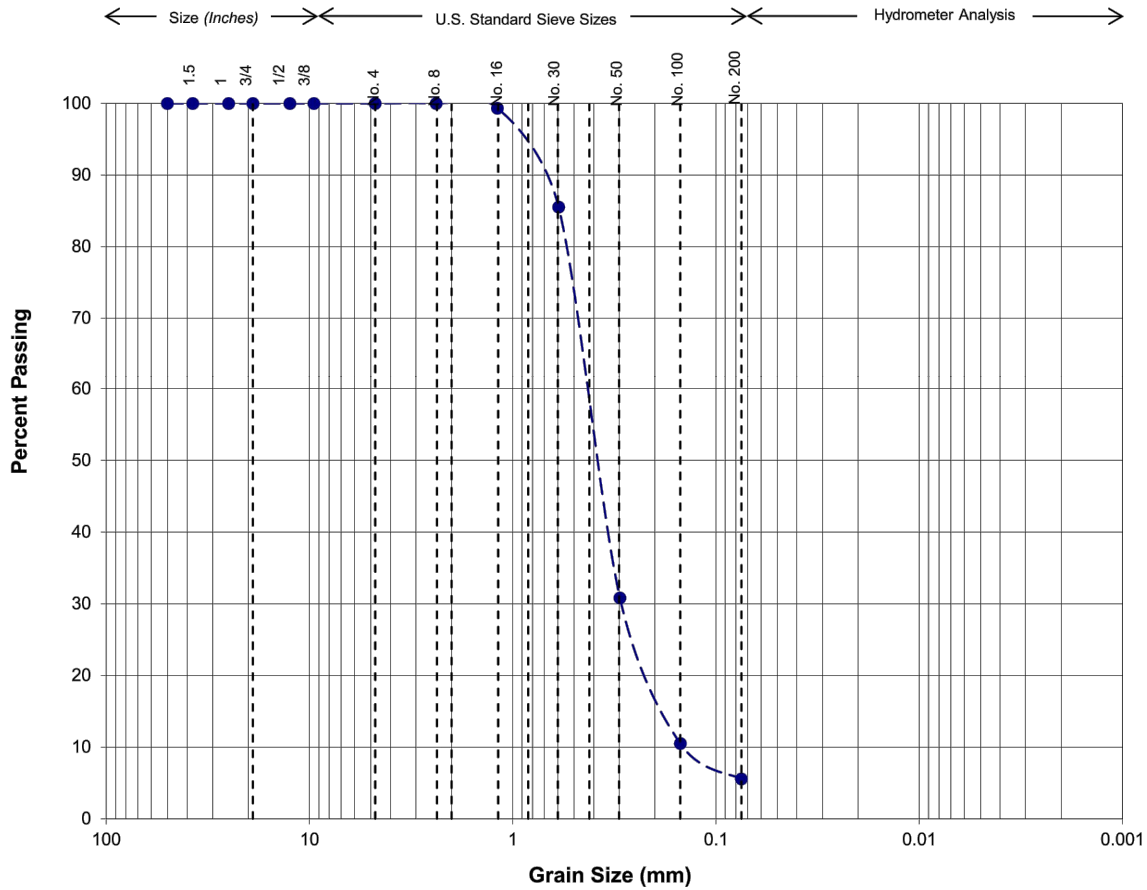
APPENDIX: D.17

Sample Location: B-8  
 Depth (ft): 25  
 USCS Soil Type: SP-SM  
 Passing No. 200 (%): 6

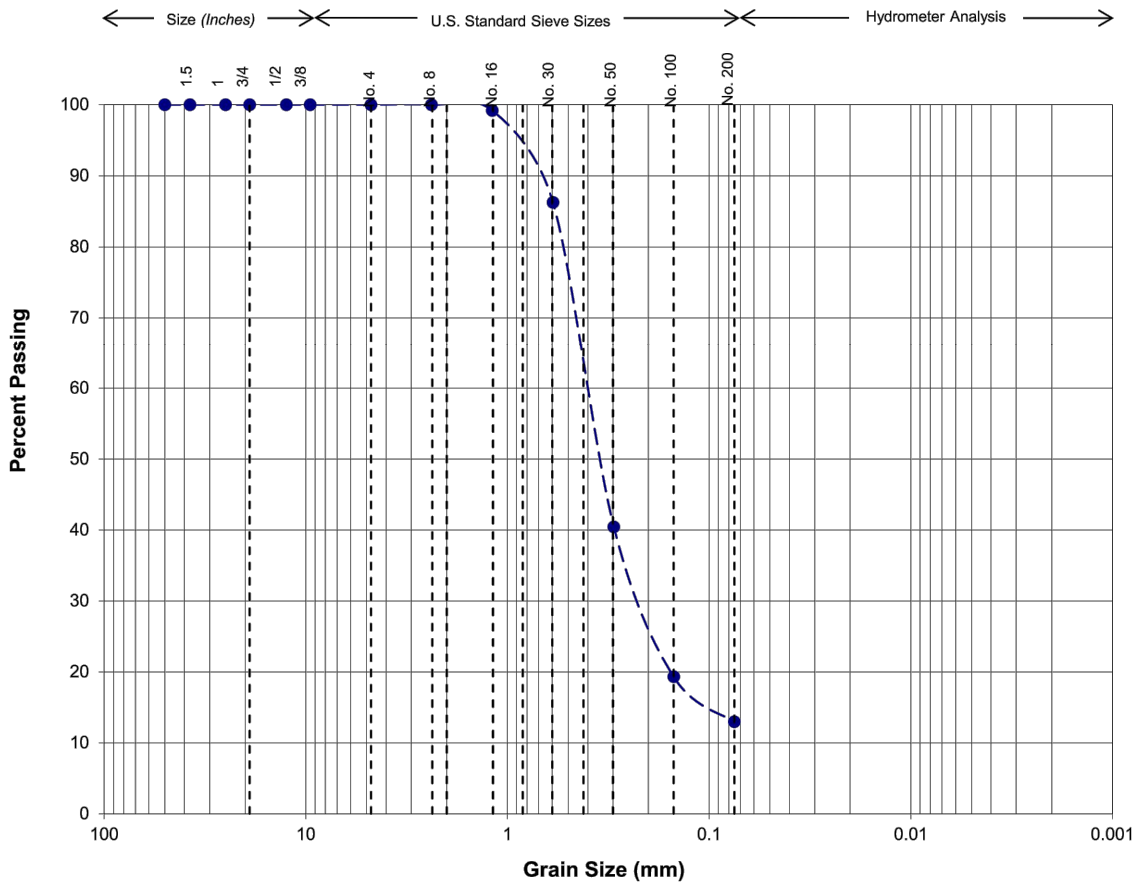
APPENDIX: D.18

Sample Location: B-8  
 Depth (ft): 45  
 USCS Soil Type: SP-SM  
 Passing No. 200 (%): 13
