# Update to the Revised Report Geotechnical Investigation

## Leucadia Mixed-Use 1900-1950 North Coast Highway, Encinitas, California

NOVA Project 2019189  
April 13, 2021

Subject: Update to the Revised Report  
Geotechnical Investigation  
Leucadia Mixed-Use  
1950 North Coast Highway, Encinitas, California

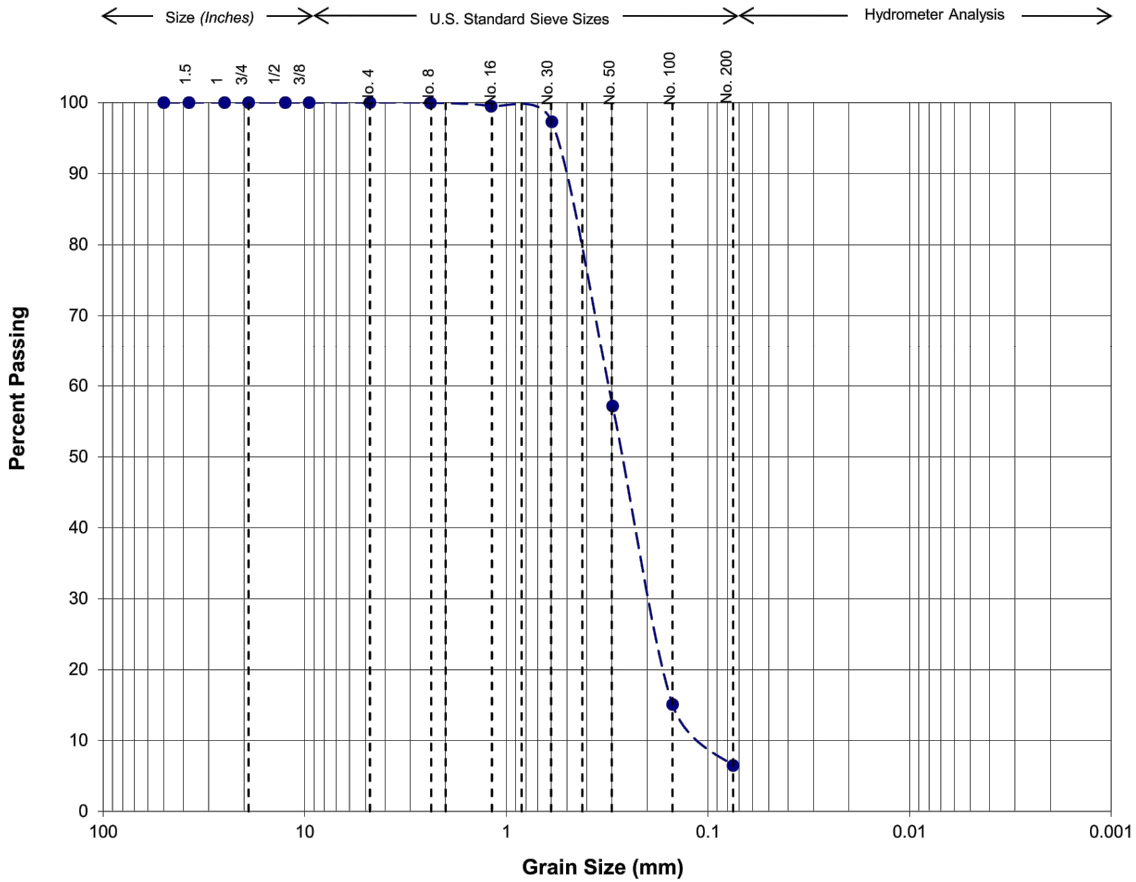
APPENDIX: D.19

Sample Location: B-8  
 Depth (ft): 50  
 USCS Soil Type: SP-SM  
 Passing No. 200 (%): 6

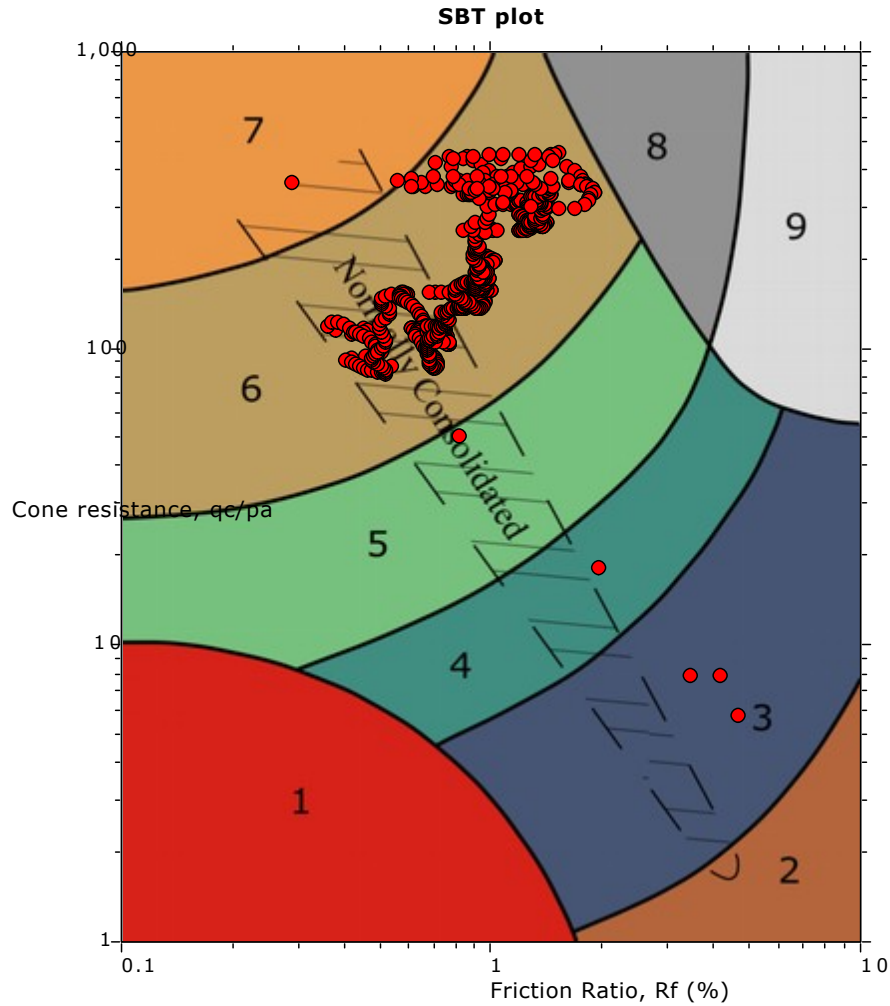
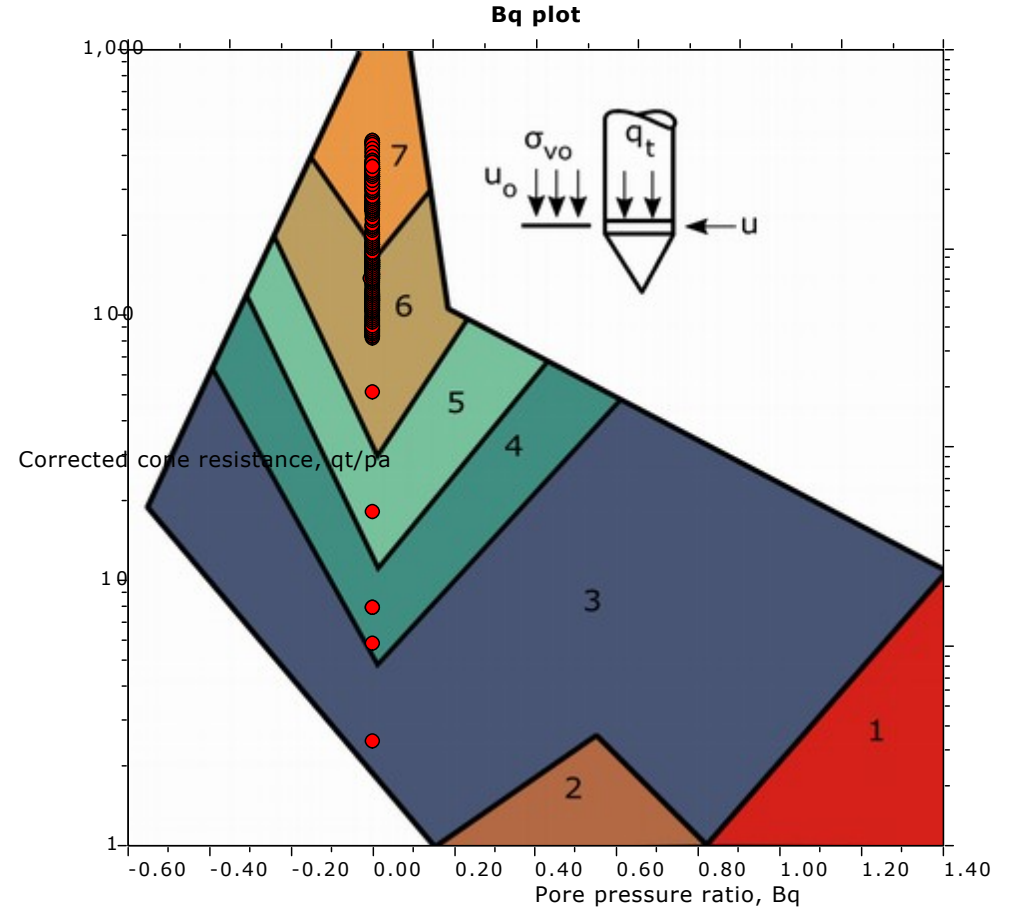
**SBT - Bq plots**

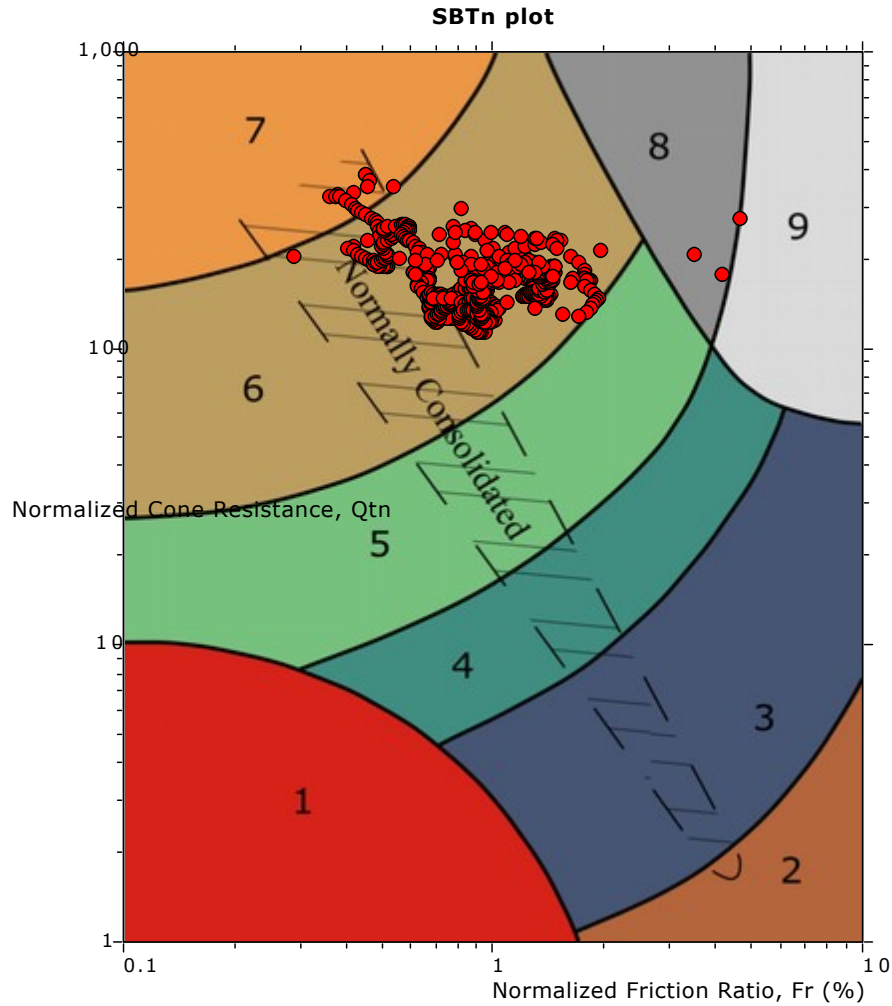
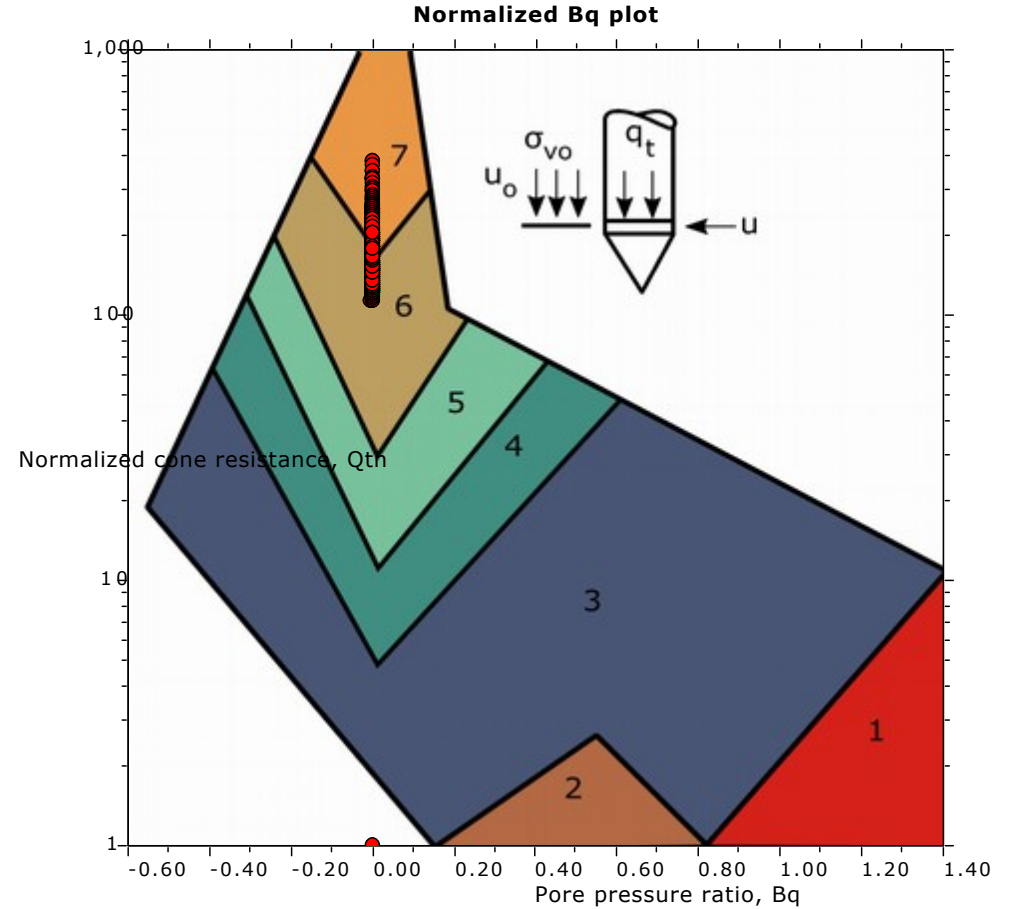
**SBT - Bq plots (normalized)**

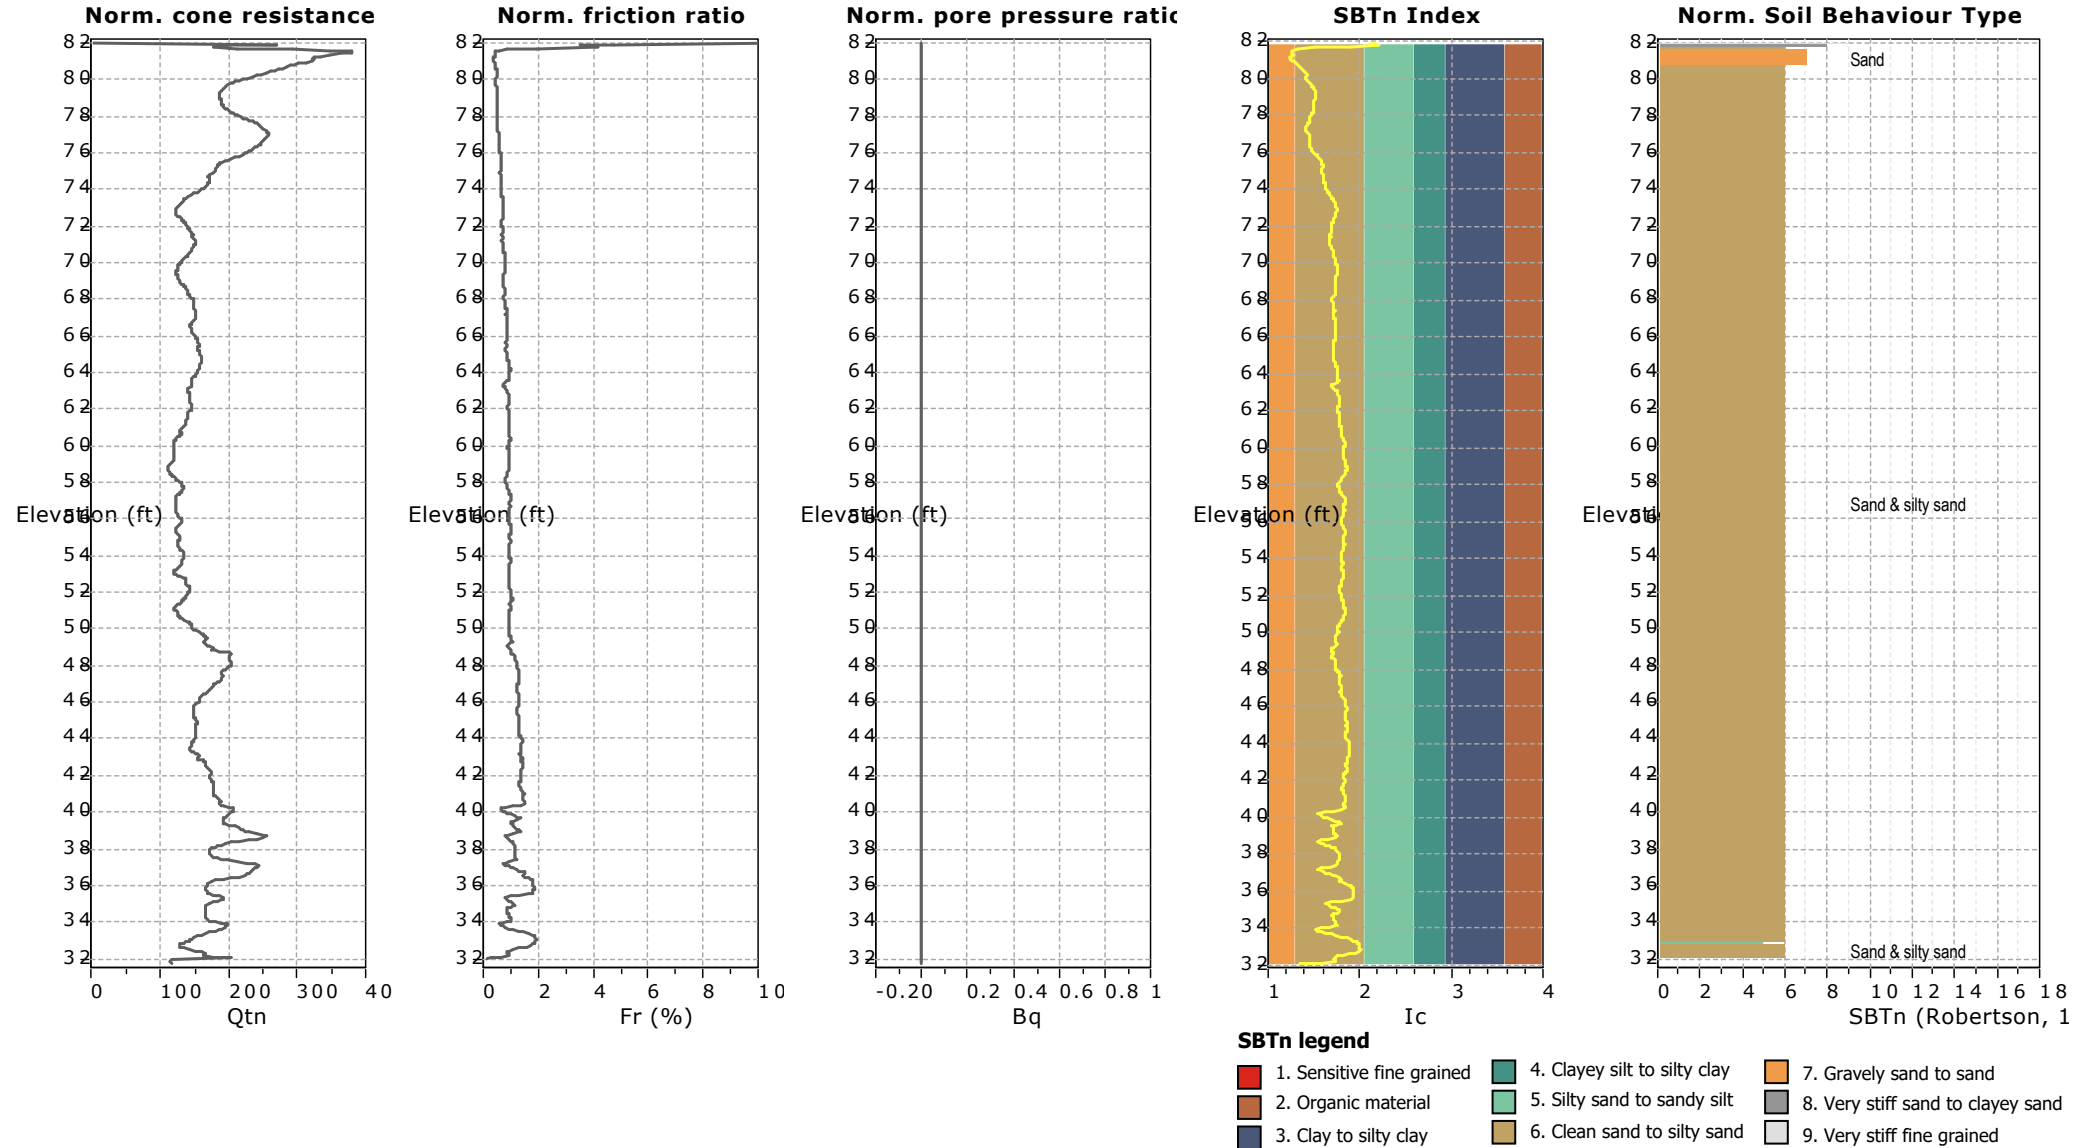
**Updated SBTn plots**

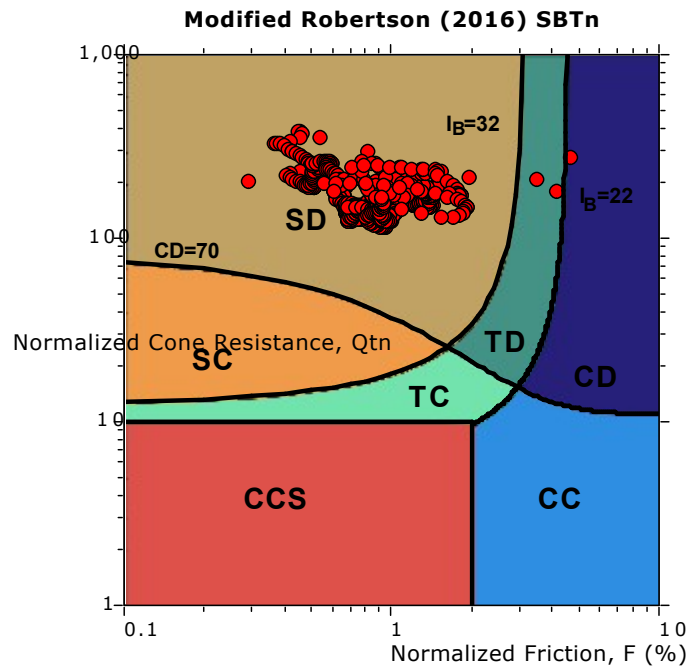
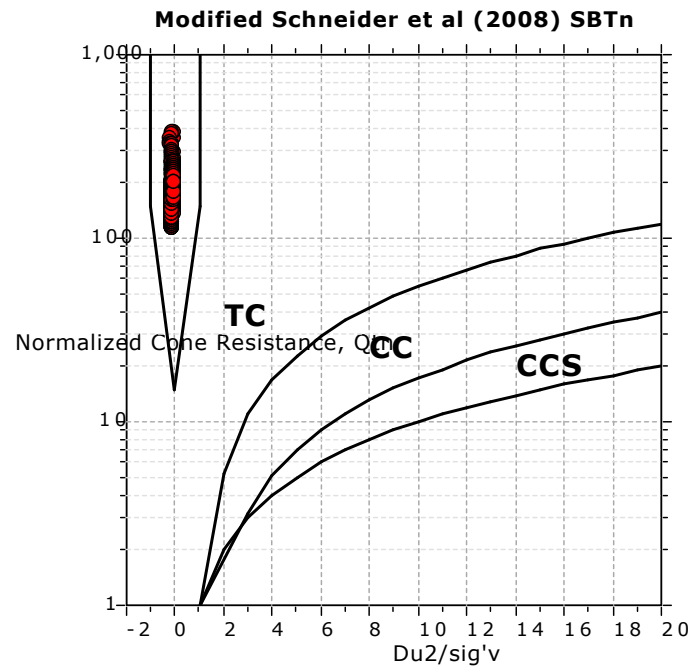
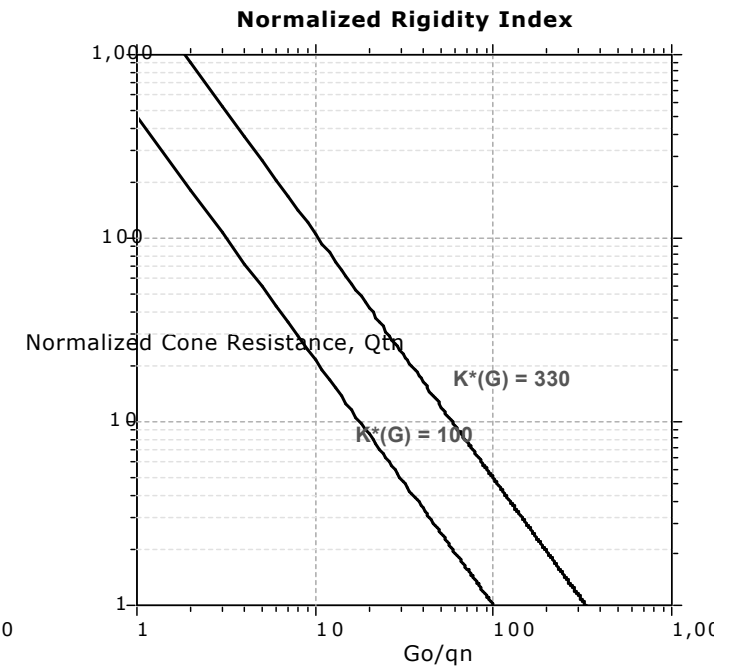
- CCS: Clay-like - Contractive - Sensitive
- CC: Clay-like - Contractive
- CD: Clay-like - Dilative
- TC: Transitional - Contractive
- TD: Transitional - Dilative
- SC: Sand-like - Contractive
- SD: Sand-like - Dilative

$K^*(G) > 330$ : Soils with significant microstructure (e.g. age/cementation)

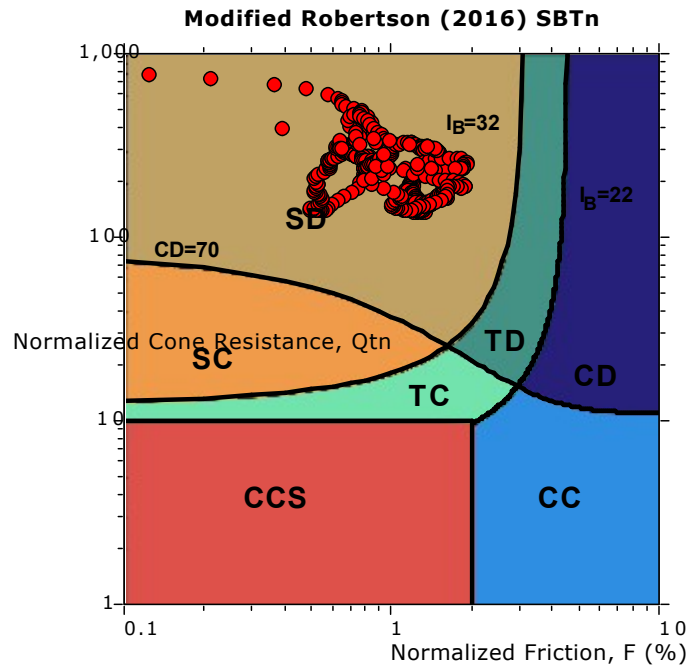
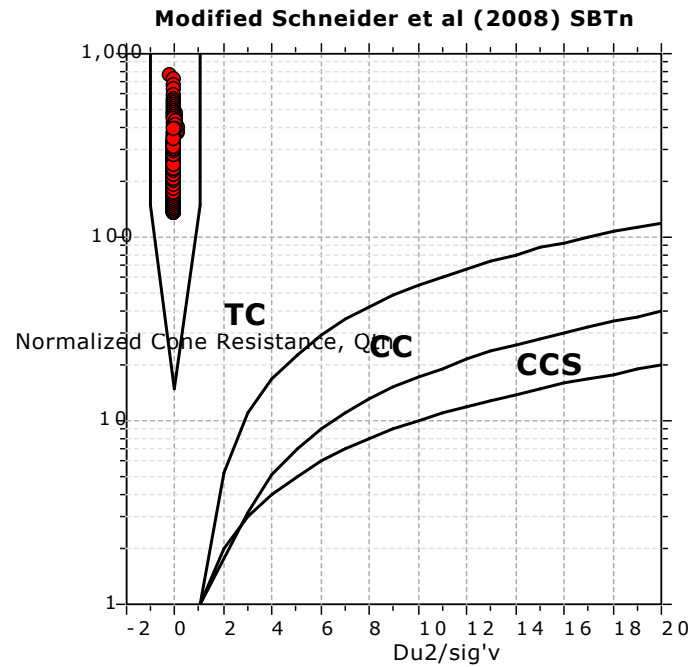
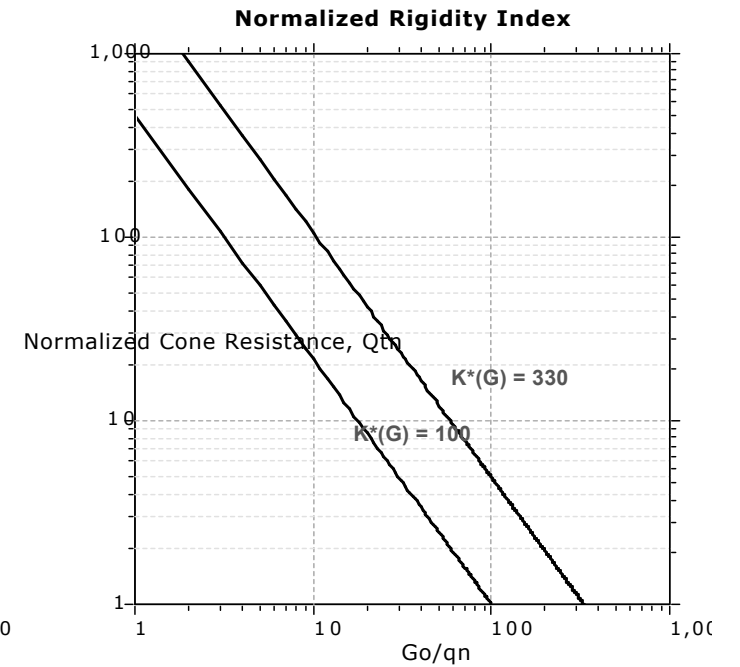
**Updated SBTn plots**

- CCS: Clay-like - Contractive - Sensitive
- CC: Clay-like - Contractive
- CD: Clay-like - Dilative
- TC: Transitional - Contractive
- TD: Transitional - Dilative
- SC: Sand-like - Contractive
- SD: Sand-like - Dilative

$K^*(G) > 330$ : Soils with significant microstructure (e.g. age/cementation)

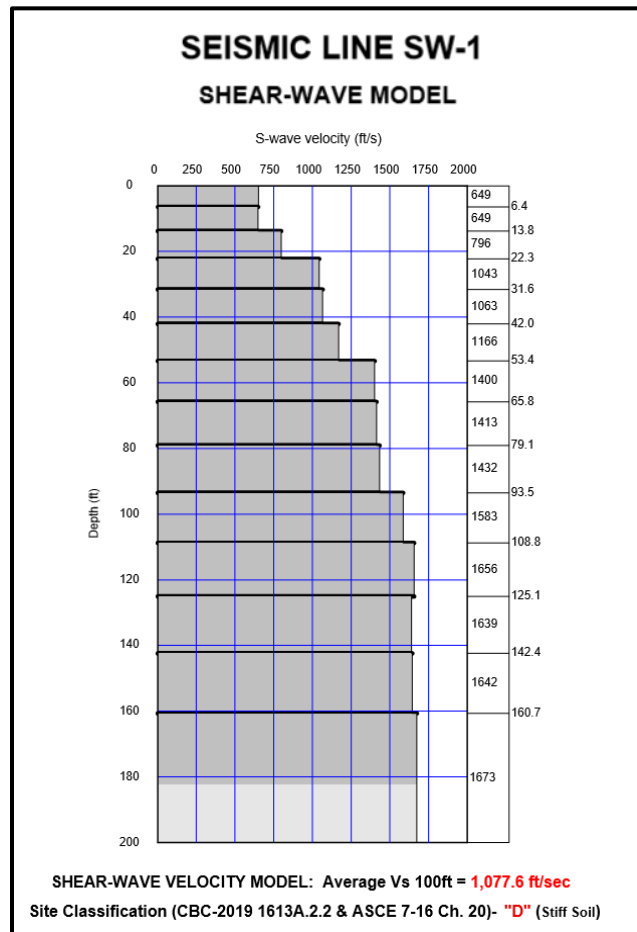
The measured shear wave velocities were found to average 1,077.6 feet/second within the soils/bedrock of the upper 100 feet of the site. Results of this analysis are shown in Figure 1. Using Table 20.3-1 from ASCE 7-16, the site bedrock is determined to be Site Class D.

**Figure 1. Shear Wave Velocities for the Subject Site**

A seismic shear wave survey of the subject site was completed on March 7, 2020. The objective of this survey was to determine the site class based on shear wave velocities of the upper 30 meters (~100 feet) of the underlying soils, referred to as either  $V_{s30}$  or  $V_{100}$ .

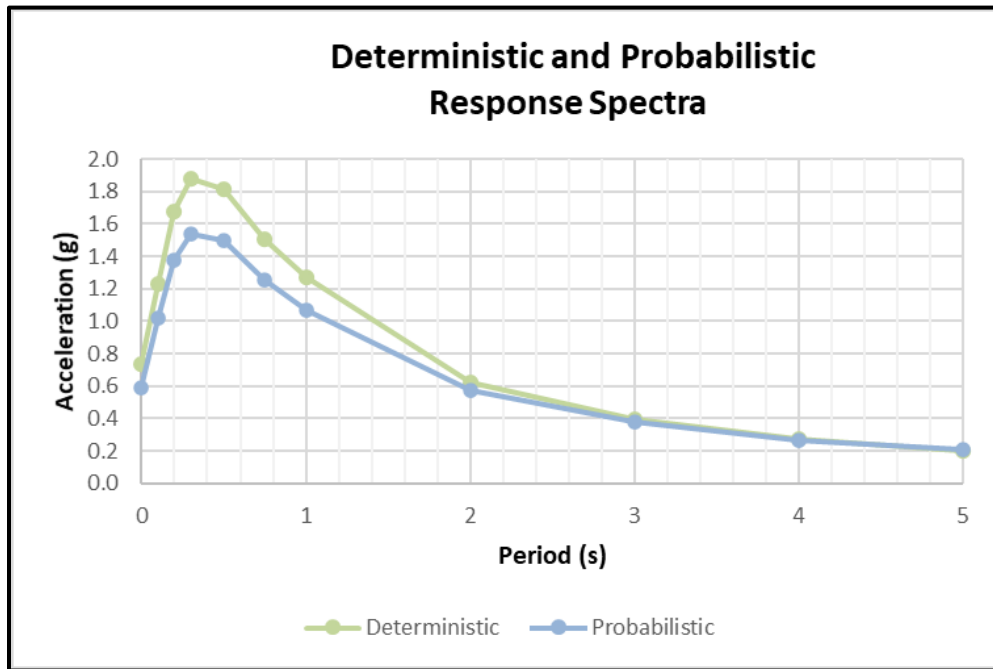
Figure 2 (following page) provides the probabilistic site response based on the method described above.

Figure 2. Probabilistic and Deterministic Seismic Accelerations

The values for the deterministic accelerations are shown in Table 2. Figure 2 depicts the Deterministic and Probabilistic curves graphically. Per Section 21.2.3, the  $MCE_R$  is taken as the lesser of the spectral response accelerations from the PSHA and the DSHA; and therefore, the PSHA accelerations control for this site-specific analysis.

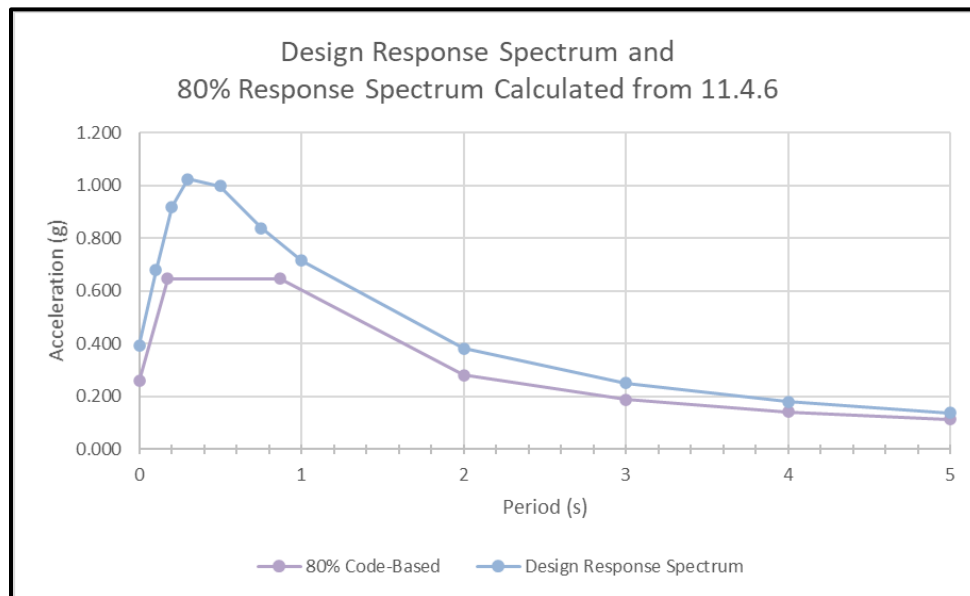
Figure 3 presents the design response spectrum and the 80% code-based design response spectrum, which confirms site-specific design accelerations exceed the 80% design response at all periods.

**Figure 3. Design Response Spectrum and 80% Code- Based Design Response Spectrum**

Per ASCE 7-16 Section 21.3, the spectral response calculated above, shall not be less than 80% of those determined in accordance with Section 11.4.6, where  $F_a$  is determined by Table 11.4-1, and  $F_v = 2.5$  (based on Site Class D and  $S_1 > 0.2$ ).
