**SUBJECT: Geotechnical Services for Master Plan Update and CUP Amendment
Scripps Mercy Hospital
4077 Fifth Avenue
San Diego, California**

**GEOTECHNICAL SERVICES FOR
MASTER PLAN UPDATE AND CUP AMENDMENT
SCRIPPS MERCY HOSPITAL
4077 FIFTH AVENUE
SAN DIEGO, CALIFORNIA
KLEINFELDER PROJECT NO. 20210563.001A**

**JULY 22, 2020
REVISED MARCH 1, 2022**

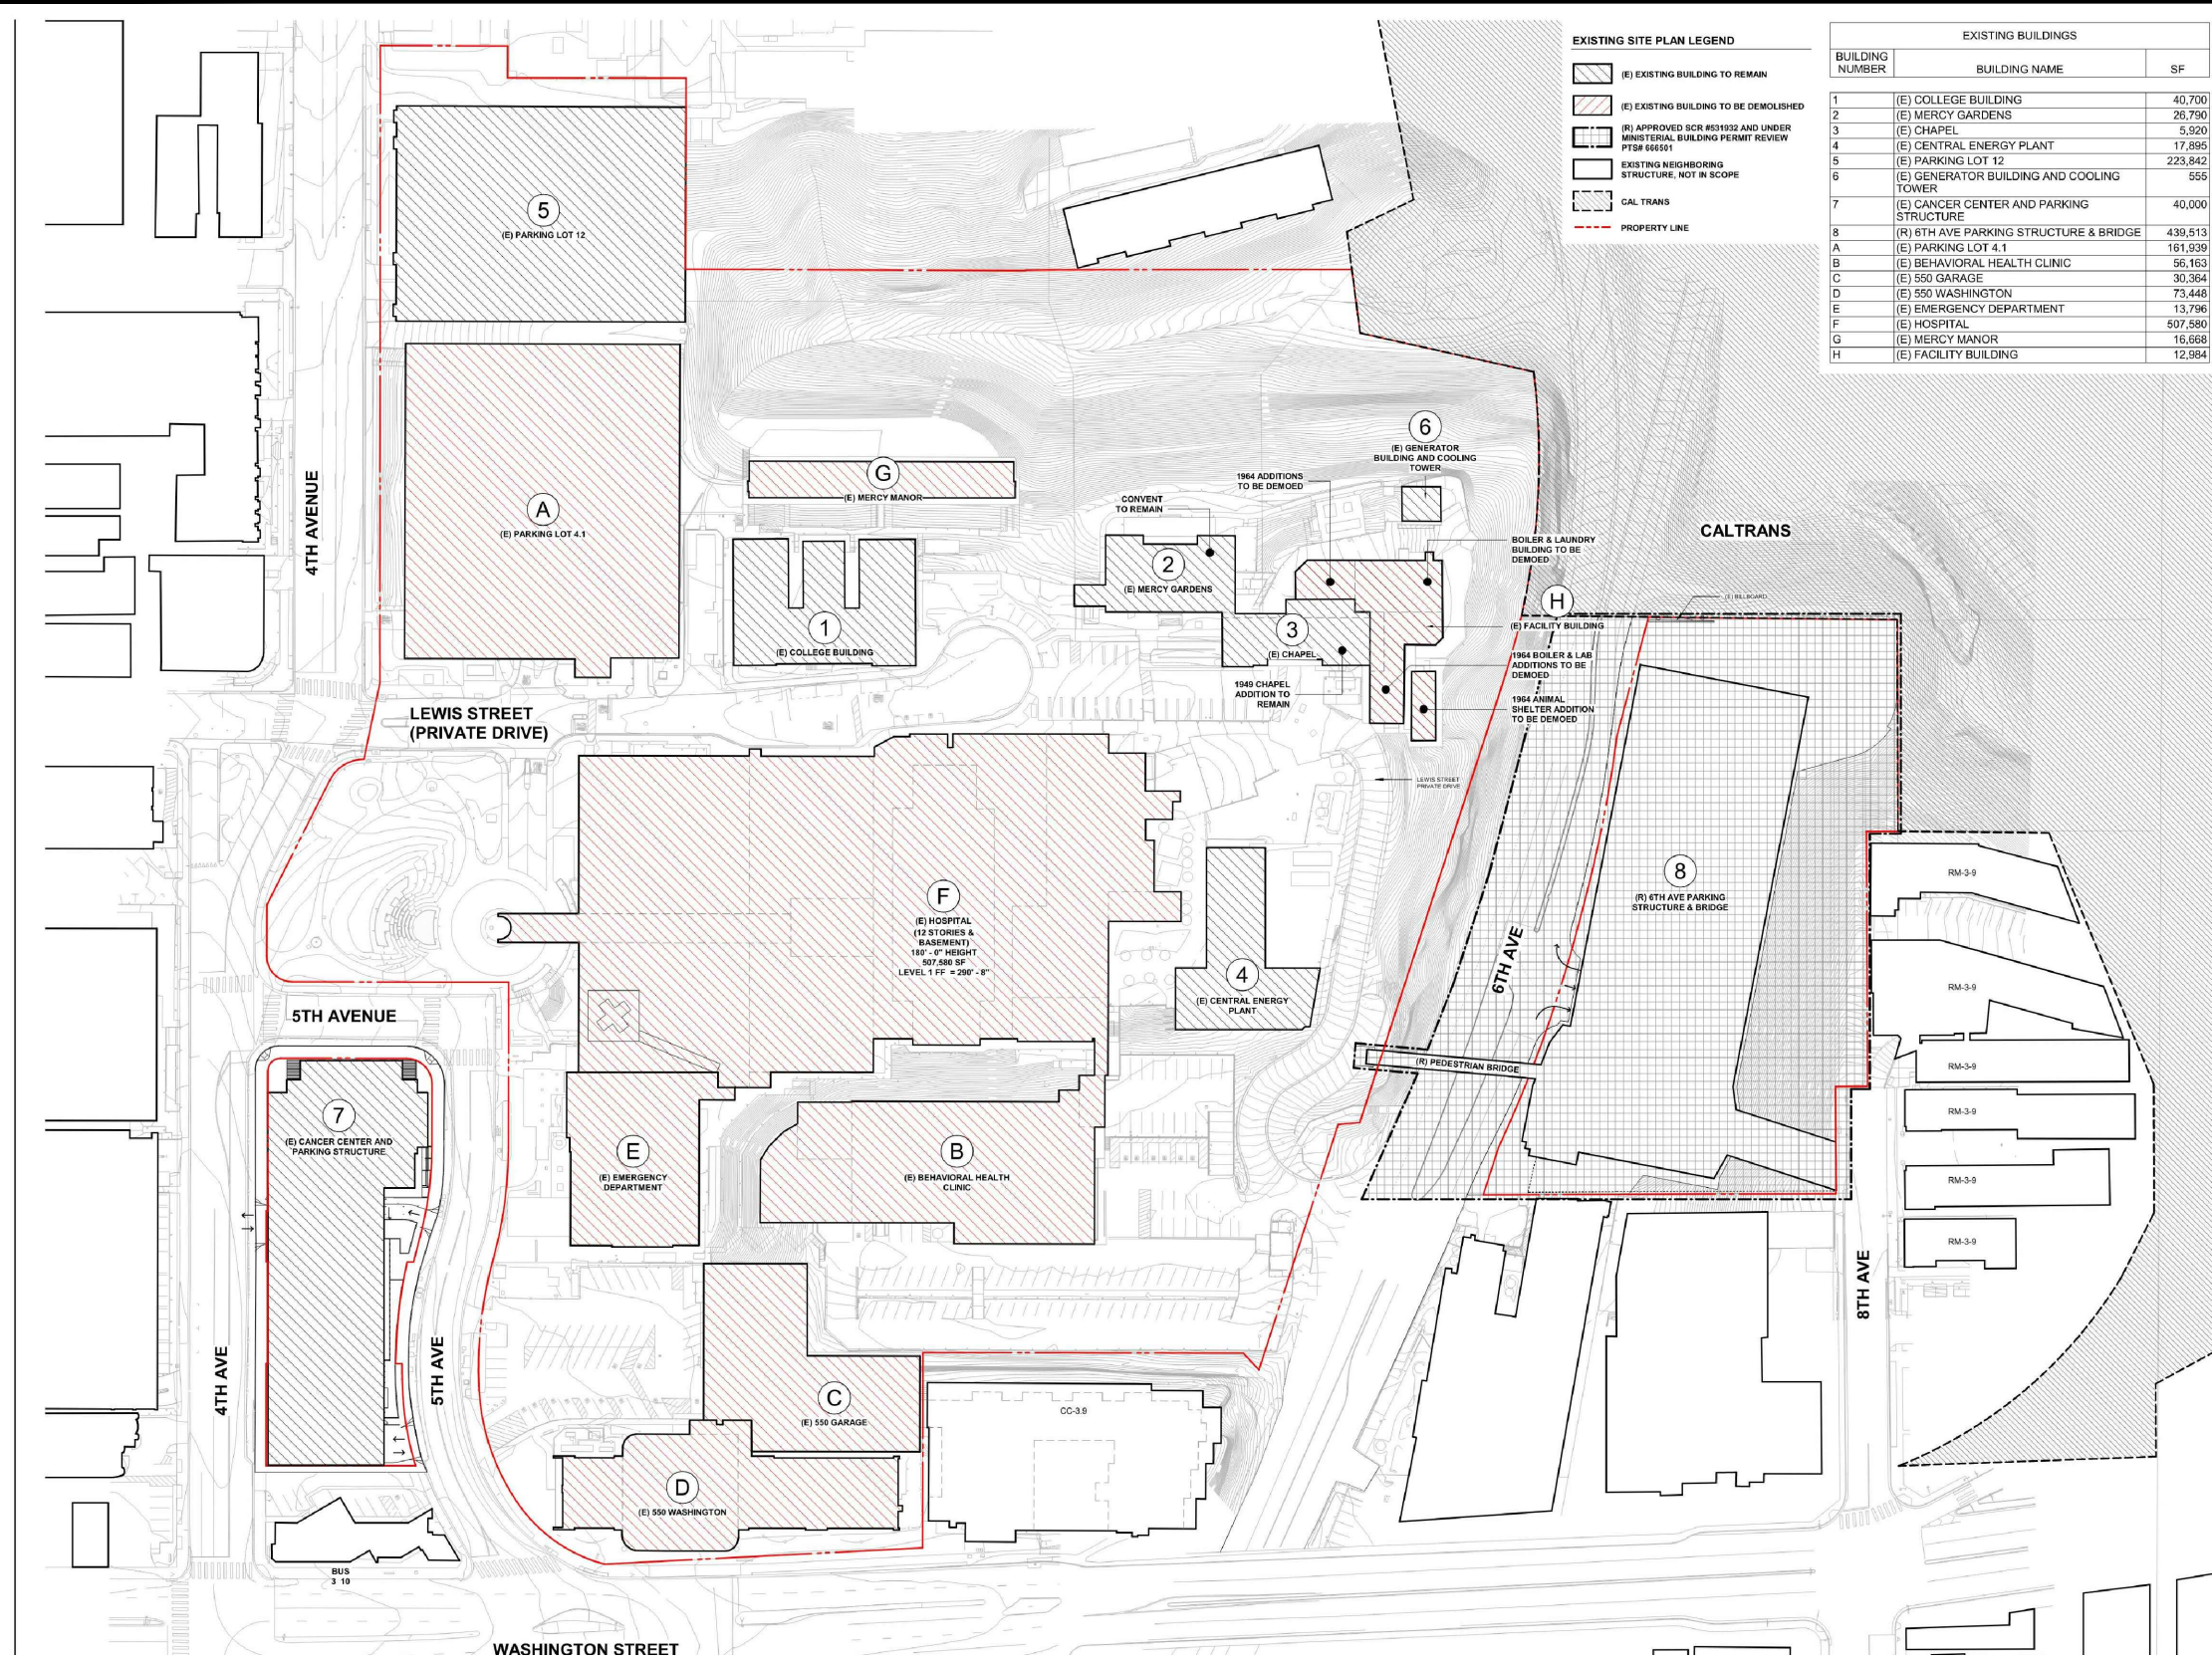
FIGURE
2

BASEMAP SOURCE:
 PDF ENTITLED: EXISTING SITE PLAN, CUP-03, BY
 CO ARCHITECTS, DATED 3/4/2022.

The locations of the existing buildings and their proposed status is shown on Figure 2, Existing Campus Site Conditions. The locations of the proposed projects are shown on Figure 3, Proposed Campus Improvements and Geologic Map. Based on our understanding of the proposed improvements, proposed grades within the new construction areas will have little change to existing elevations to facilitate surface drainage and create building pads; however, the buildings will have variable depths of excavation for subterranean levels. The general campus site conditions are summarized in the following Site Condition section of this report, with more detailed information on each site presented later in this report within the Project Description section.

The 21-acre Scripps Mercy Hospital campus is generally located north of Washington Street, south of Montecito Way, west of 6th Avenue and east of 4th Avenue, as shown on the Vicinity Map, Figure 1. As shown on Sheet CUP-03, Existing Site Plan, the hospital campus is fully developed with numerous buildings, parking lots and access roads. The majority of the campus is situated on a relatively flat lying mesa with surface elevations on the order of +290 to +295 feet above mean sea level (MSL). The south-central portion of the campus was developed within an east-west trending drainage feature which was partially infilled and has surface elevations on the order of 235 to 240 feet MSL. Another roughly east-west trending drainage feature is located along the northern property boundary with slopes descending approximately 100 feet from existing buildings at an approximate inclination of 1.5:1 (horizontal:vertical). The canyon slopes and bottom are generally vegetated with grass, brush and trees. An east-facing cut slope descends to the 6th Avenue access to SR 163. The campus is sparsely landscaped and has generally been graded to provide sufficient surface drainage.

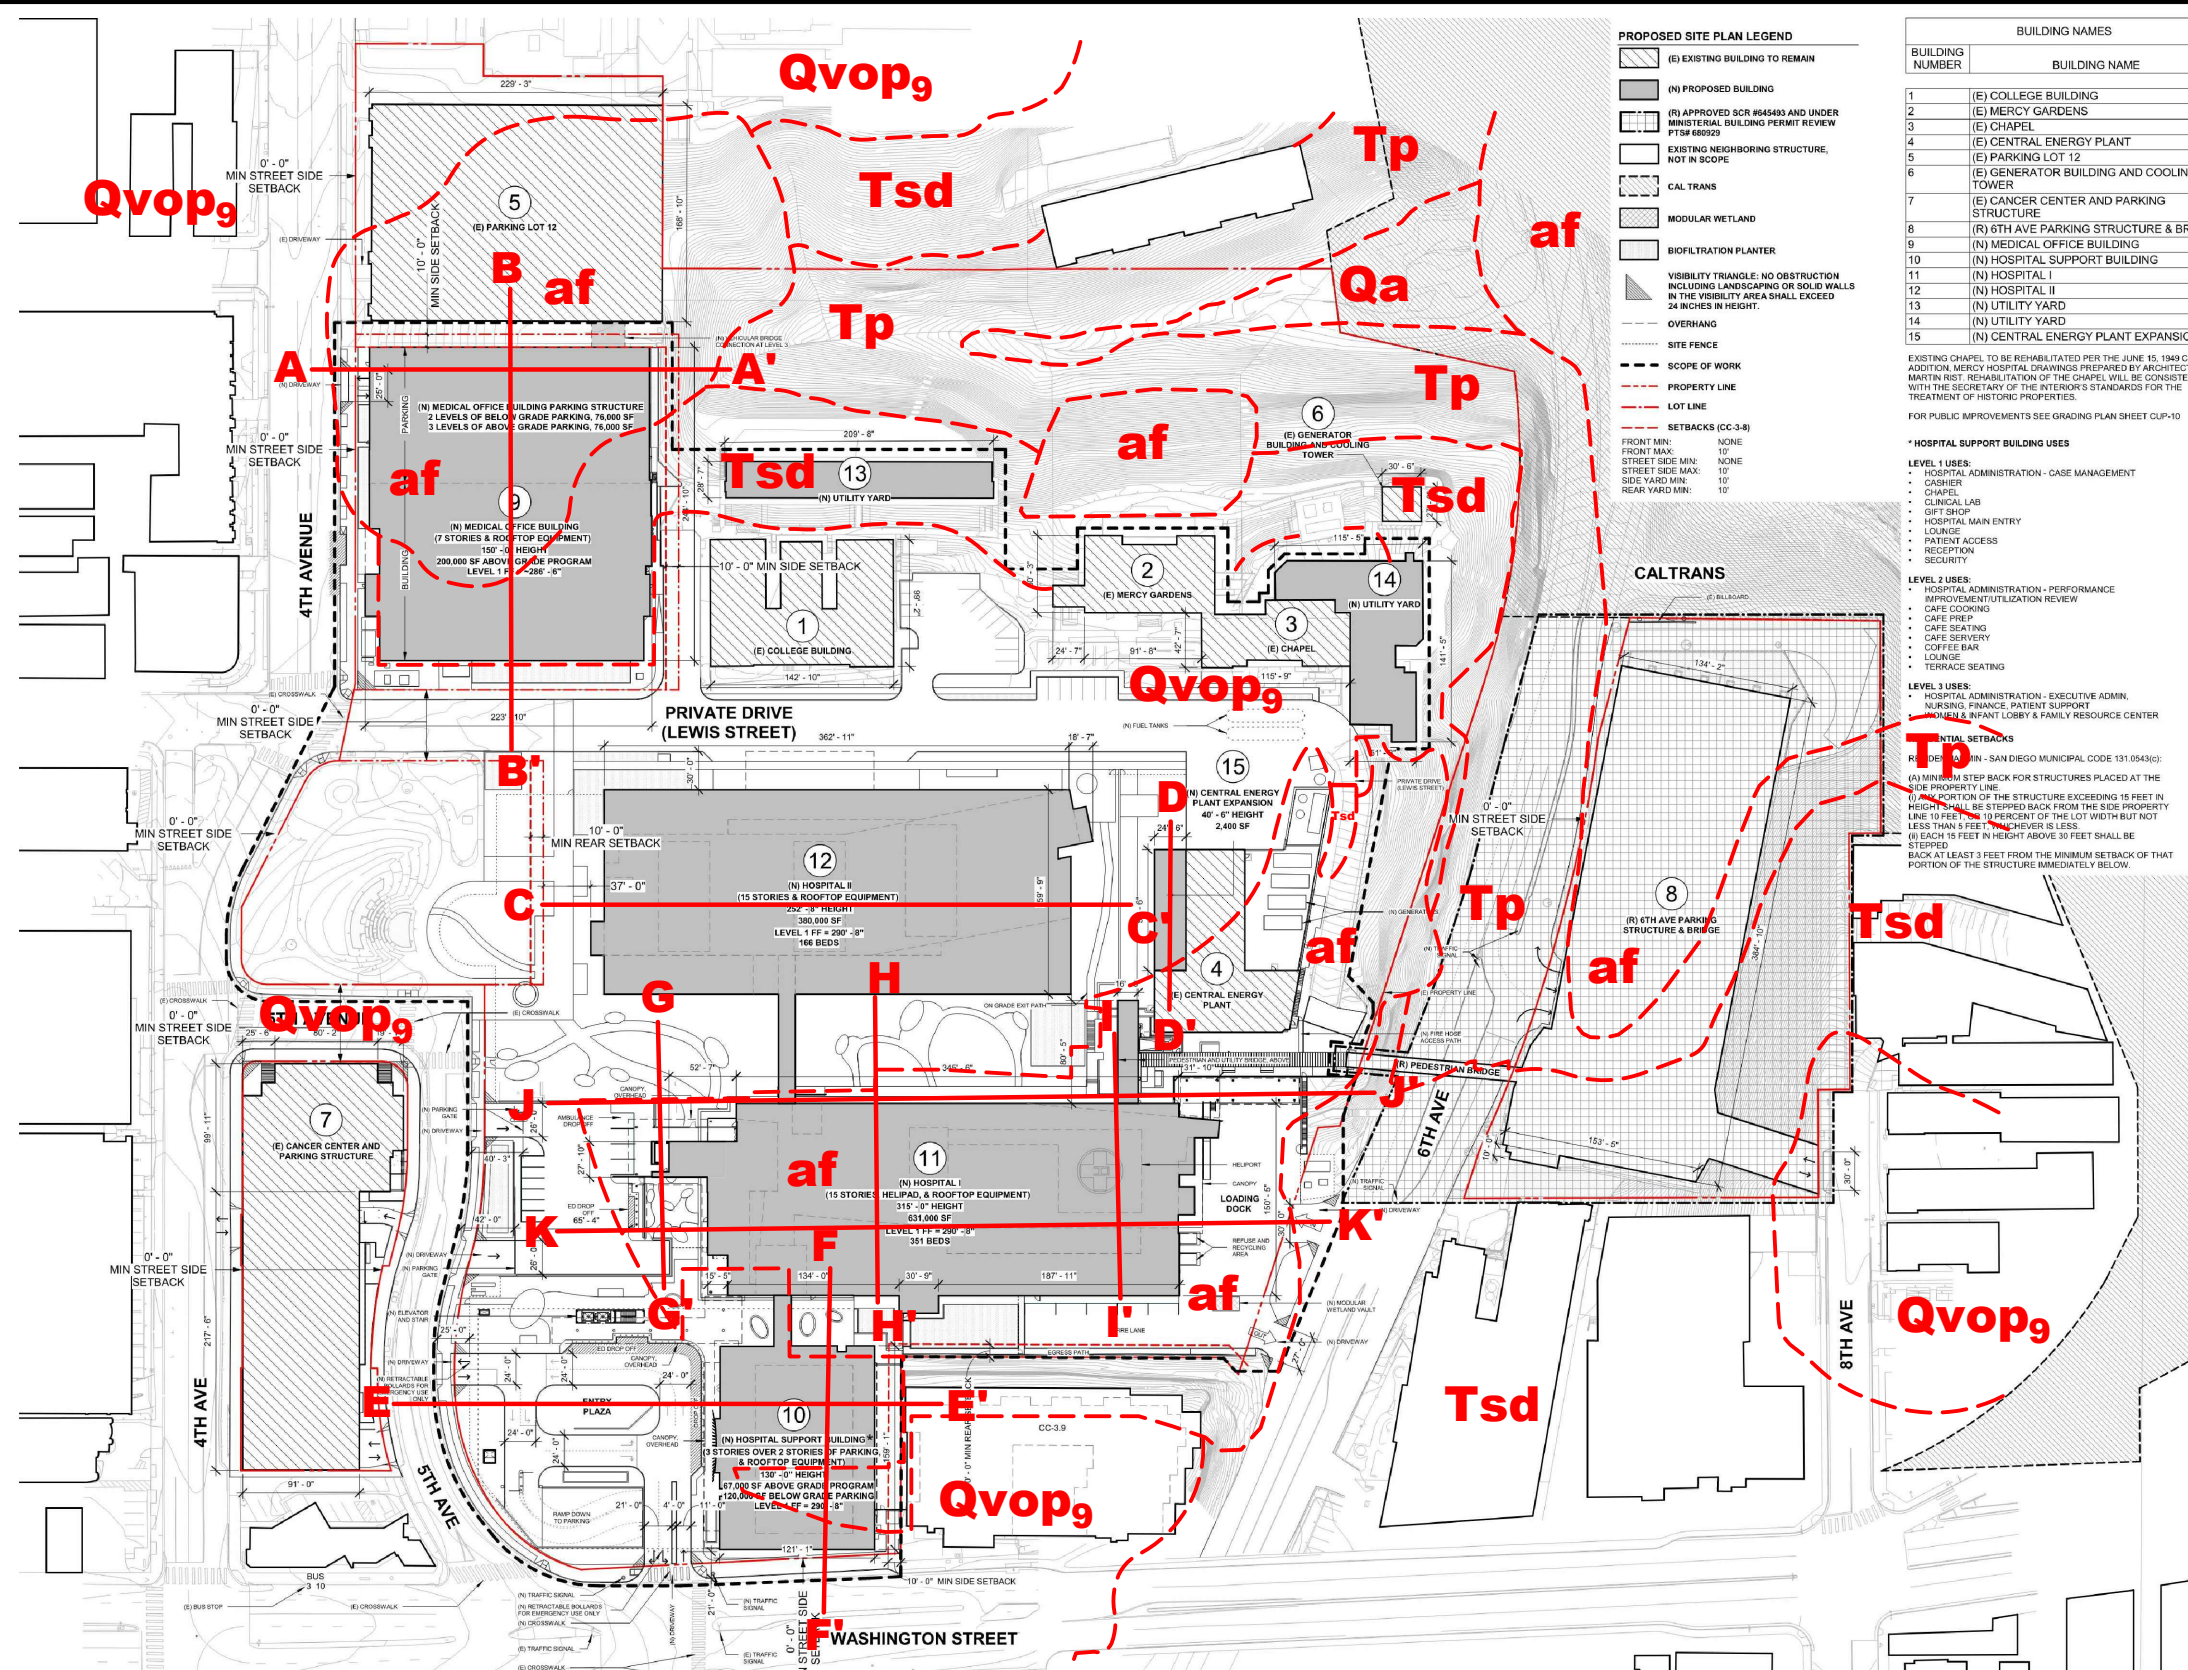
PROPOSED CAMPUS IMPROVEMENTS AND GEOLOGIC MAP

BASEMAP SOURCE:
 PDF FILE ENTITLED: PROPOSED SITE PLAN,
 CUP-04, BY CO ARCHITECTS, DATED 3/4/2022.

The locations of the proposed project sites are shown on Figure 3 along with the geologic contacts. Geologic cross sections for each building are based on available information and presented on Figures 6a through 6i.

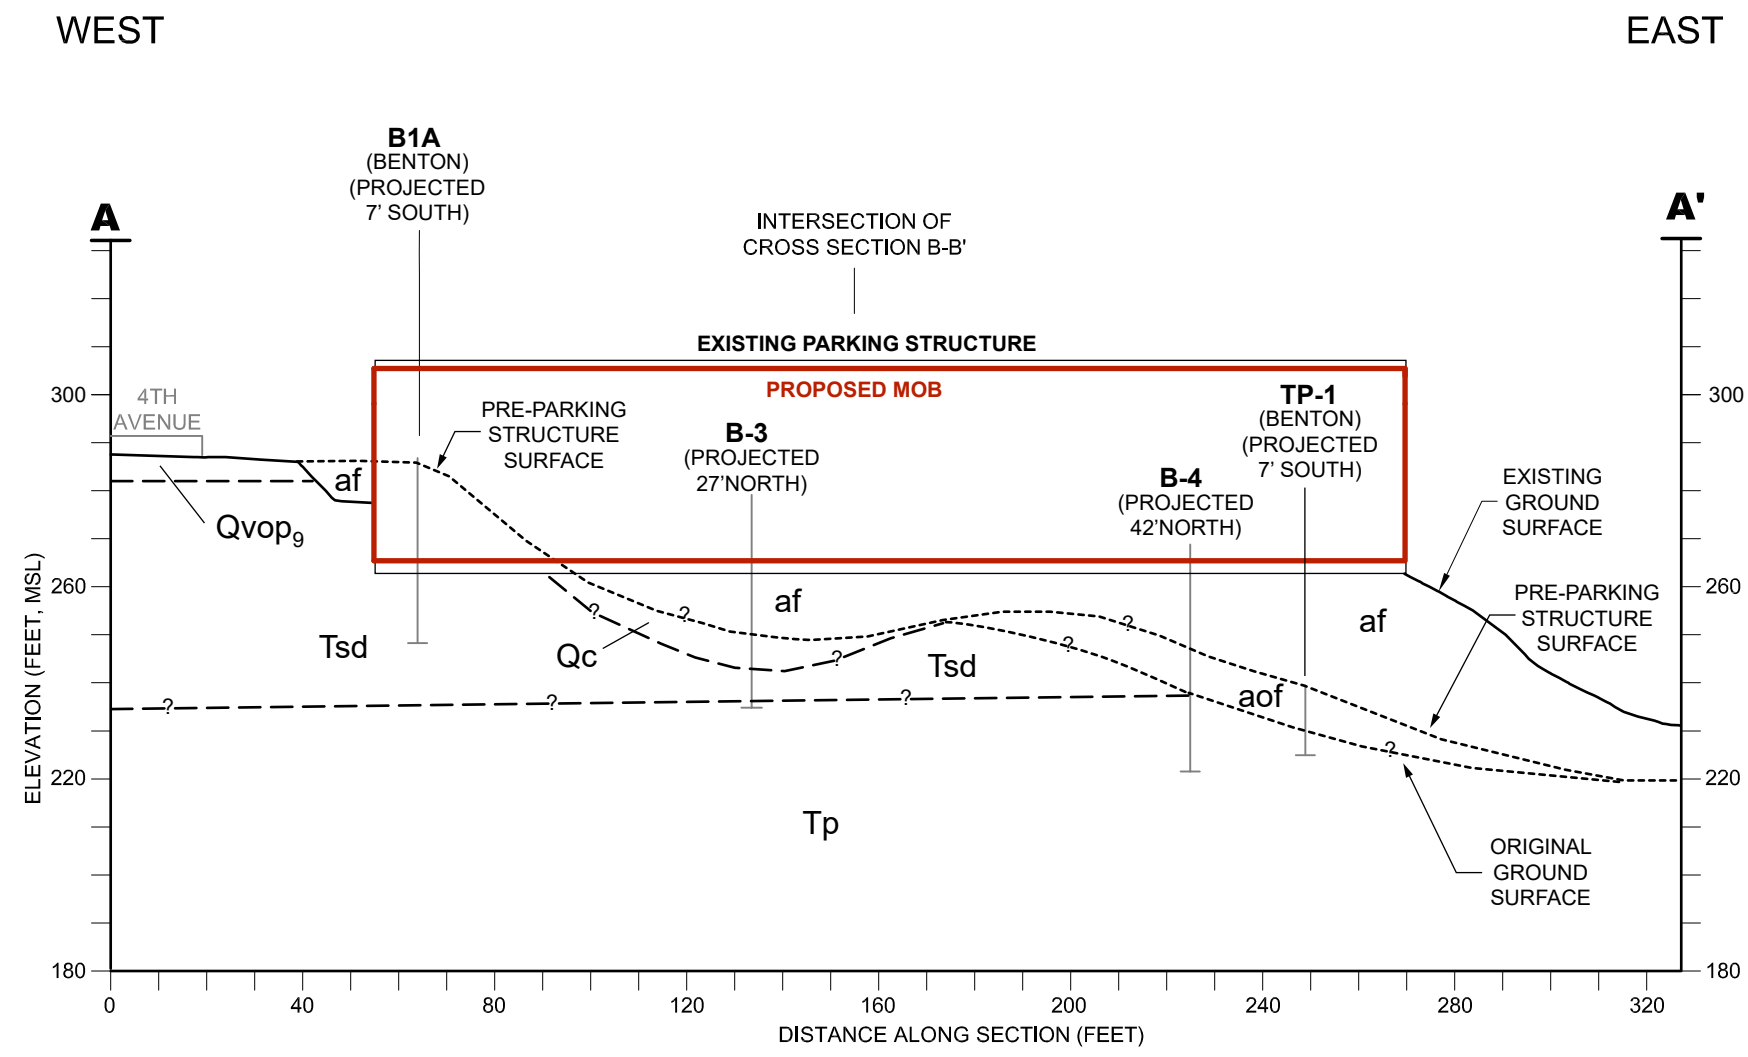
| | PROJECT NO. 20210563 | GEOLOGIC CROSS SECTION A-A' PROPOSED MOB | FIGURE 6A |

| af | ARTIFICIAL FILL | --- | GEOLOGIC CONTACT |

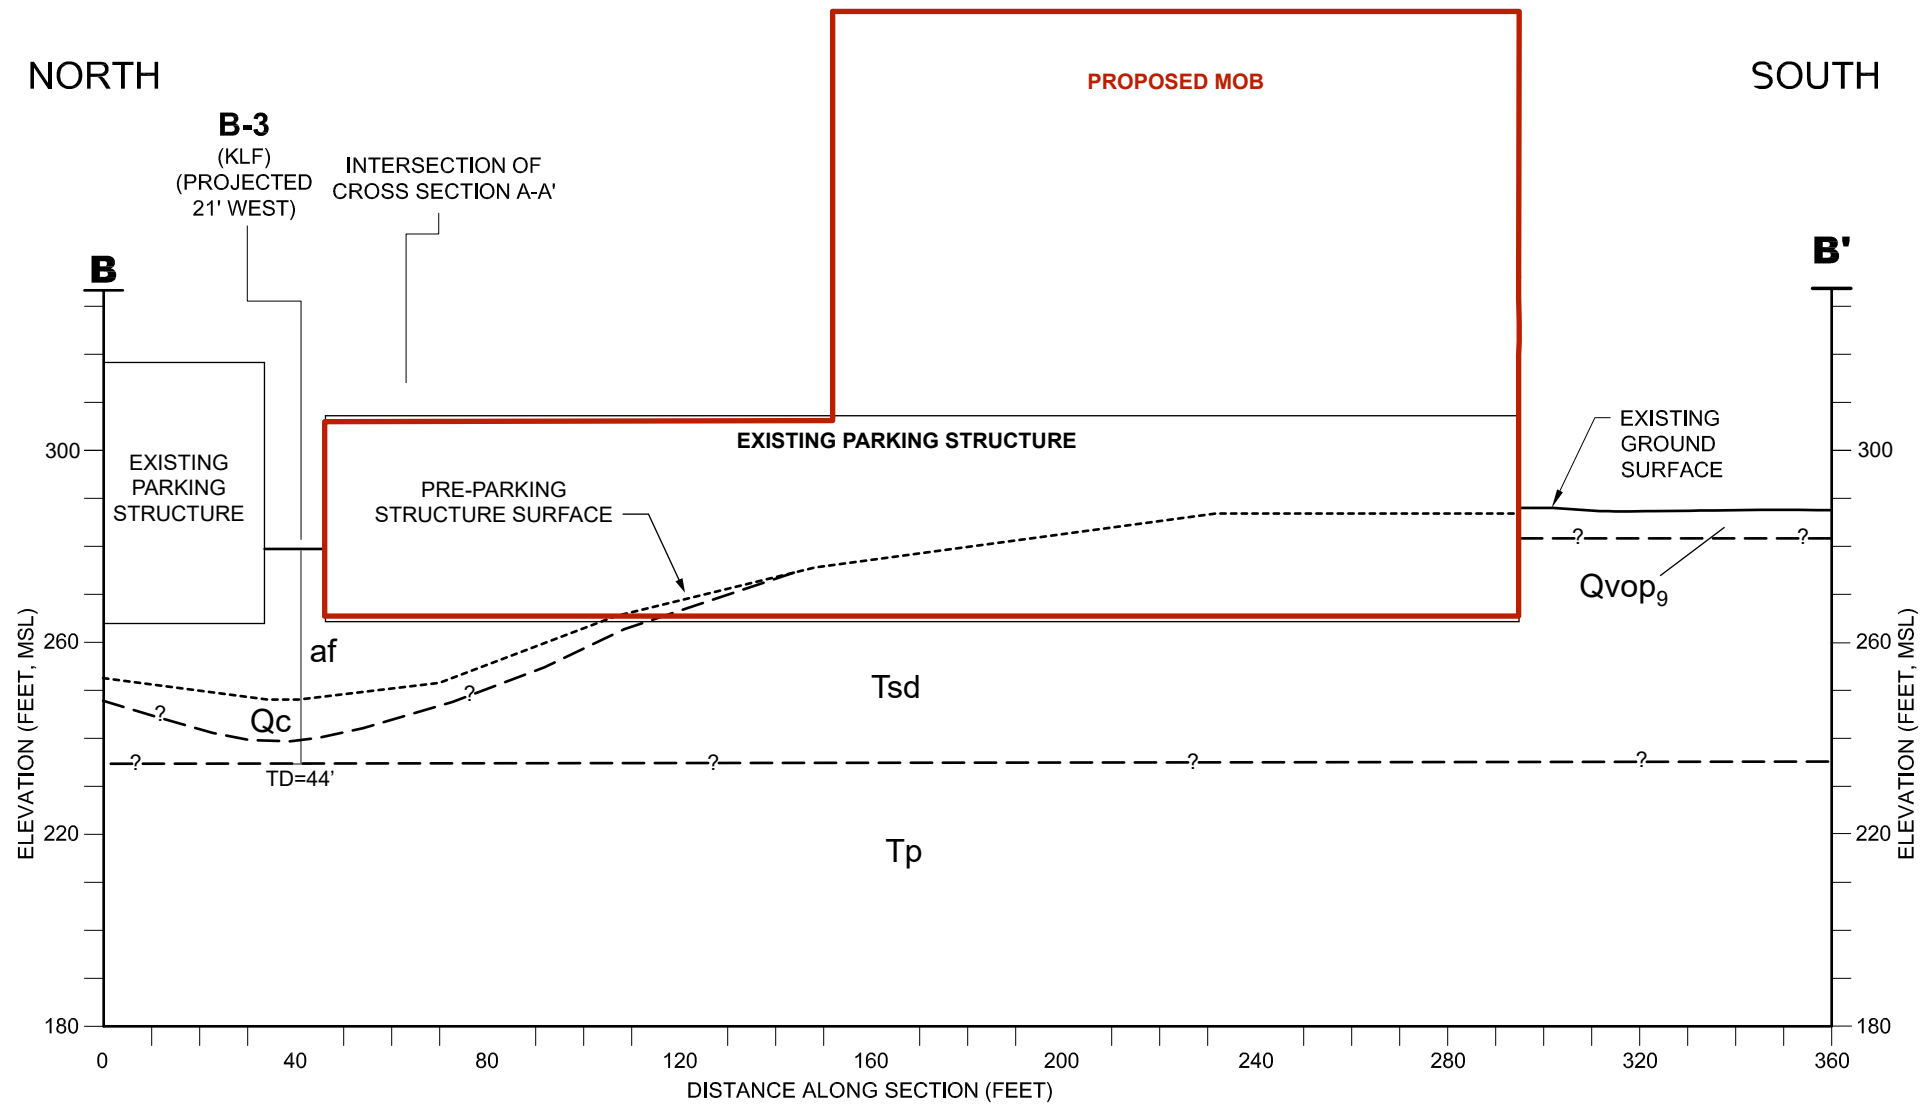
| | PROJECT NO. | 20210563 | GEOLOGIC CROSS SECTION B-B' PROPOSED MOB | FIGURE 6B |

| af | ARTIFICIAL FILL | --- | GEOLOGIC CONTACT |

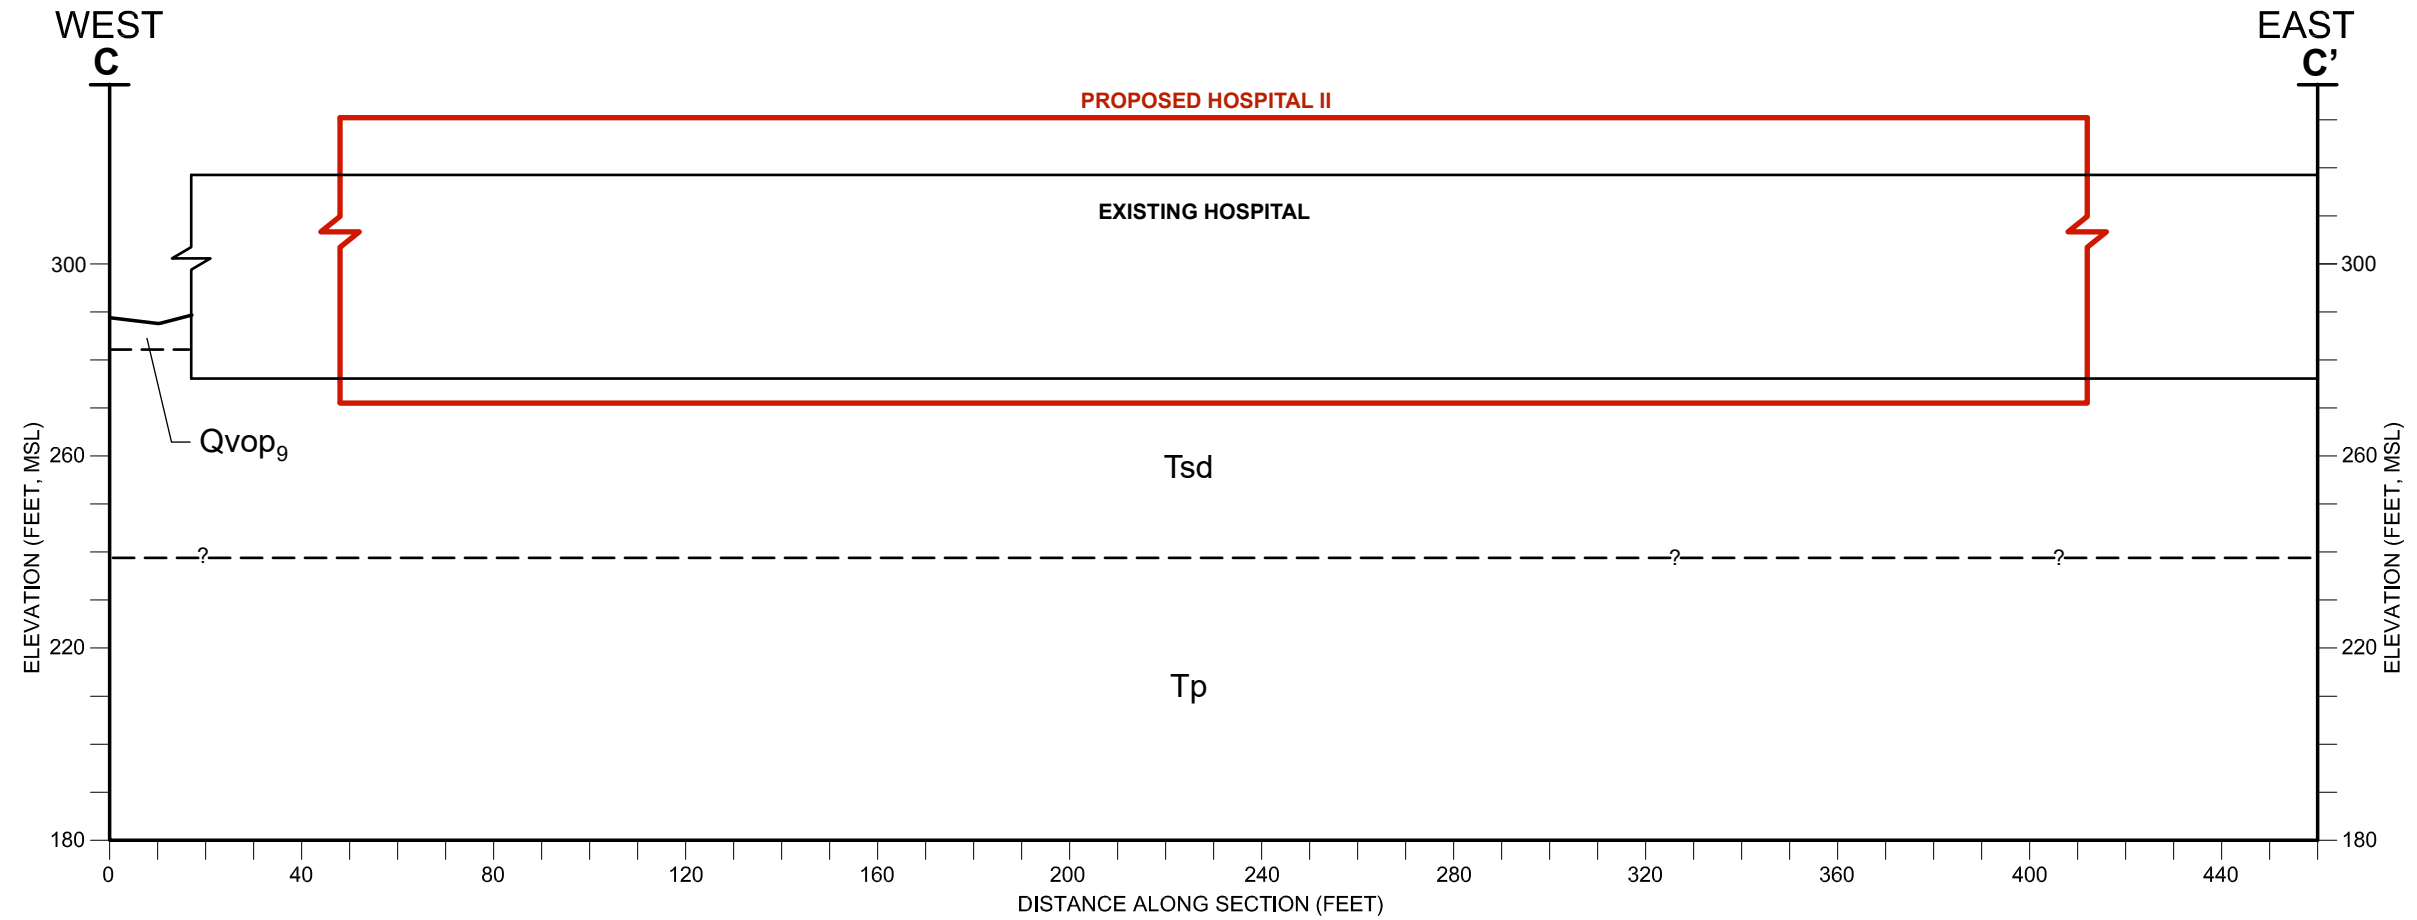
FIGURE
6C

- Qvop₉ VERY OLD PARALIC DEPOSITS
- Tsd SAN DIEGO FORMATION
- Tp POMERADO CONGLOMERATE
- GEOLOGIC CONTACT

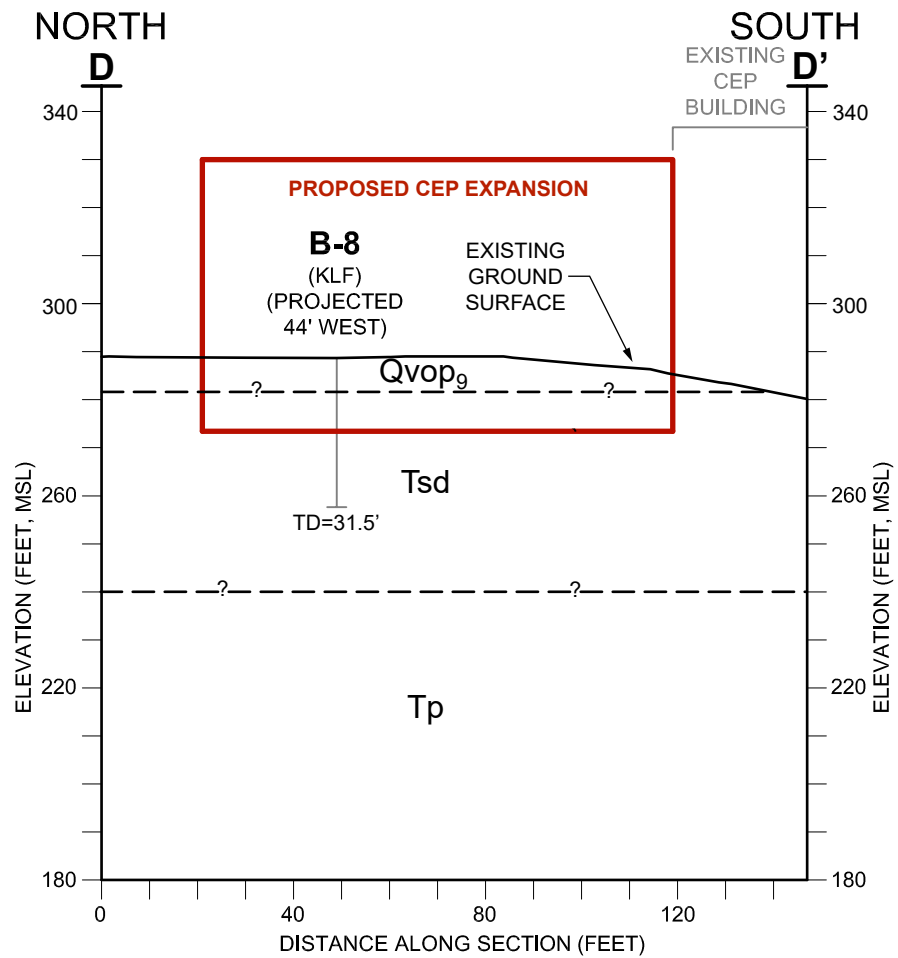
| | PROJECT NO. 20210563 | GEOLOGIC CROSS-SECTION D-D' PROPOSED CEP EXPANSION | FIGURE 6D |

- Qvop₉ VERY OLD PARALIC DEPOSITS
- Tsd SAN DIEGO FORMATION
- Tp POMERADO CONGLOMERATE
- GEOLOGIC CONTACT
- B-2**
(PROJECTED 5' EAST)
APPROXIMATE LOCATION OF BORING, SHOWING ID, PROJECTION AND TOTAL DEPTH
TD = 26.5'

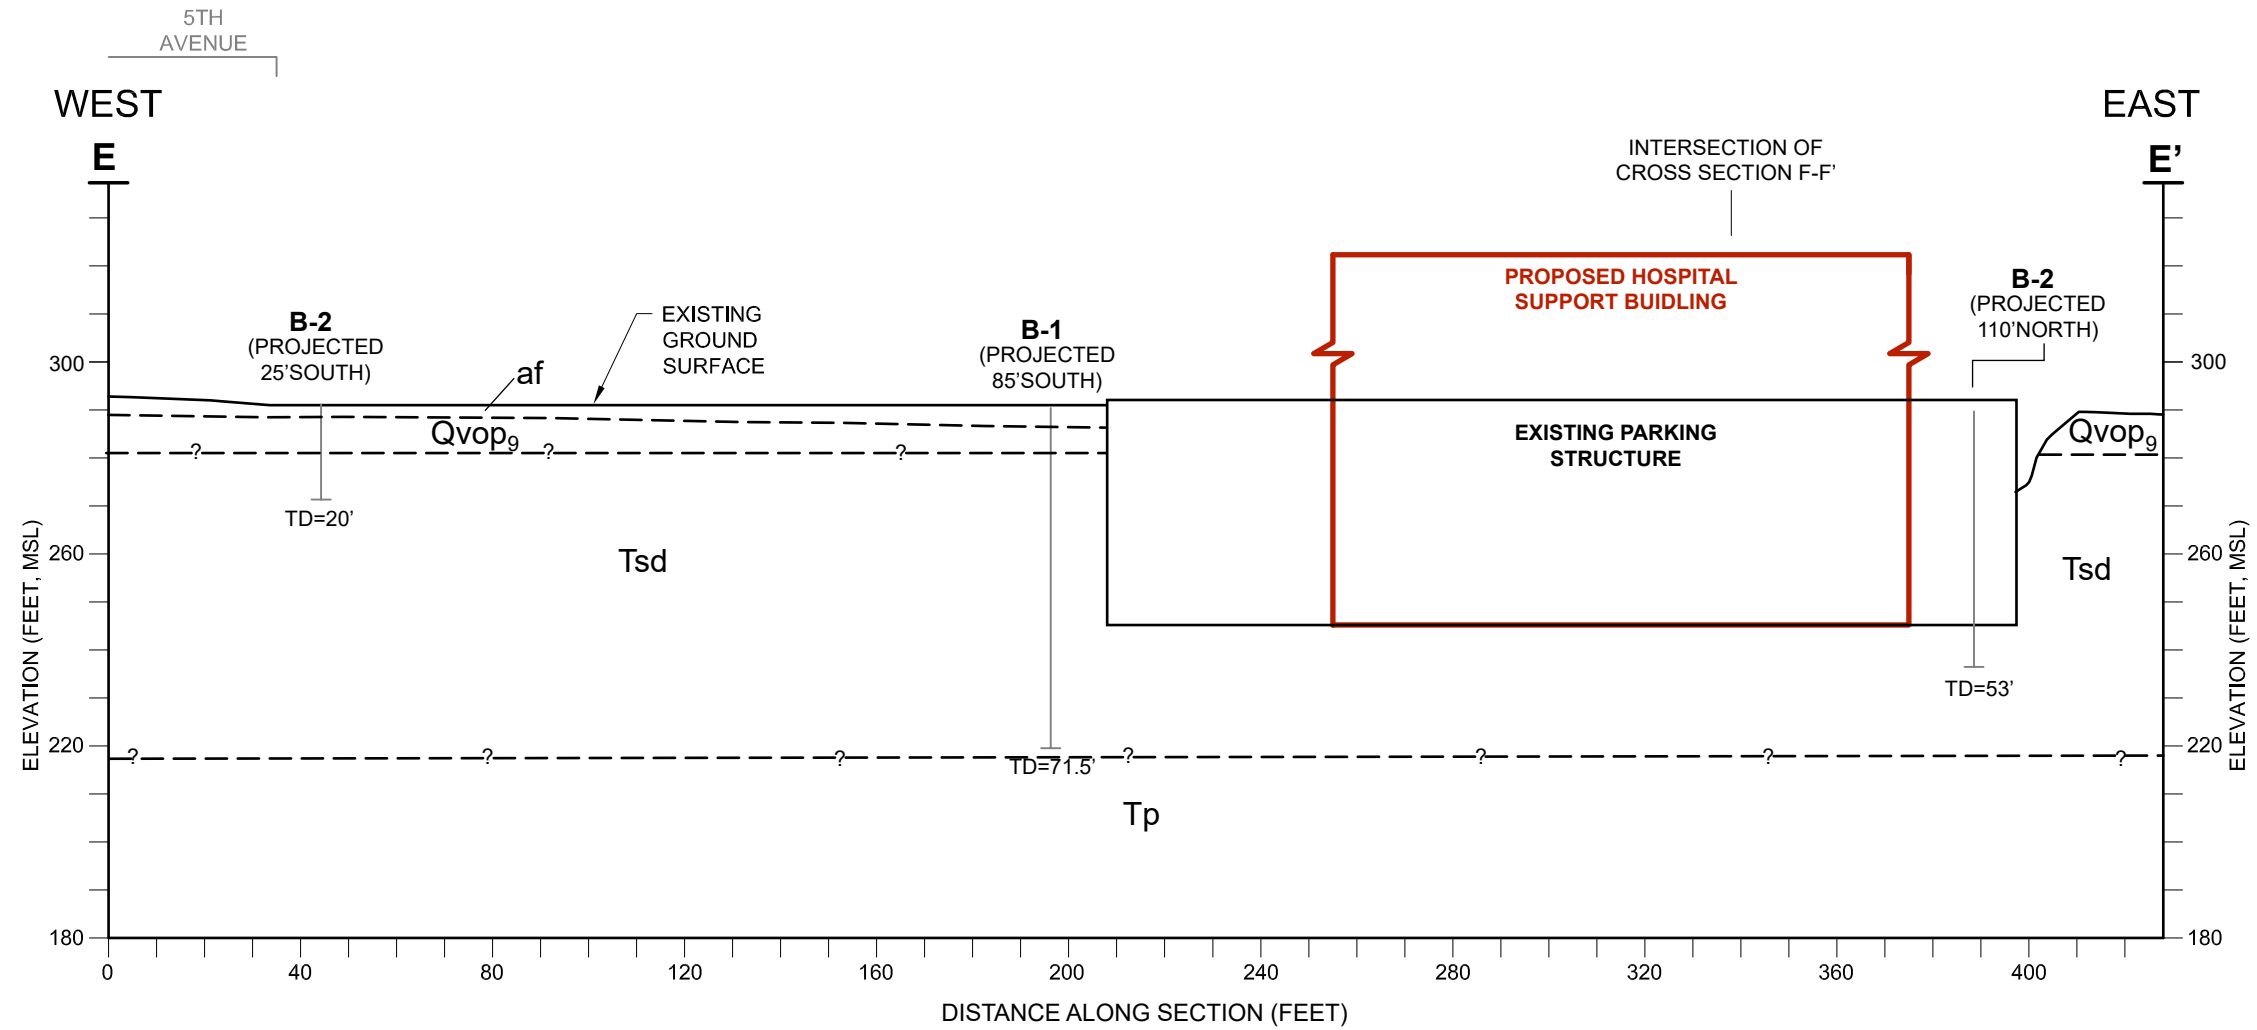
FIGURE
6E

| af | ARTIFICIAL FILL | --- | GEOLOGIC CONTACT |

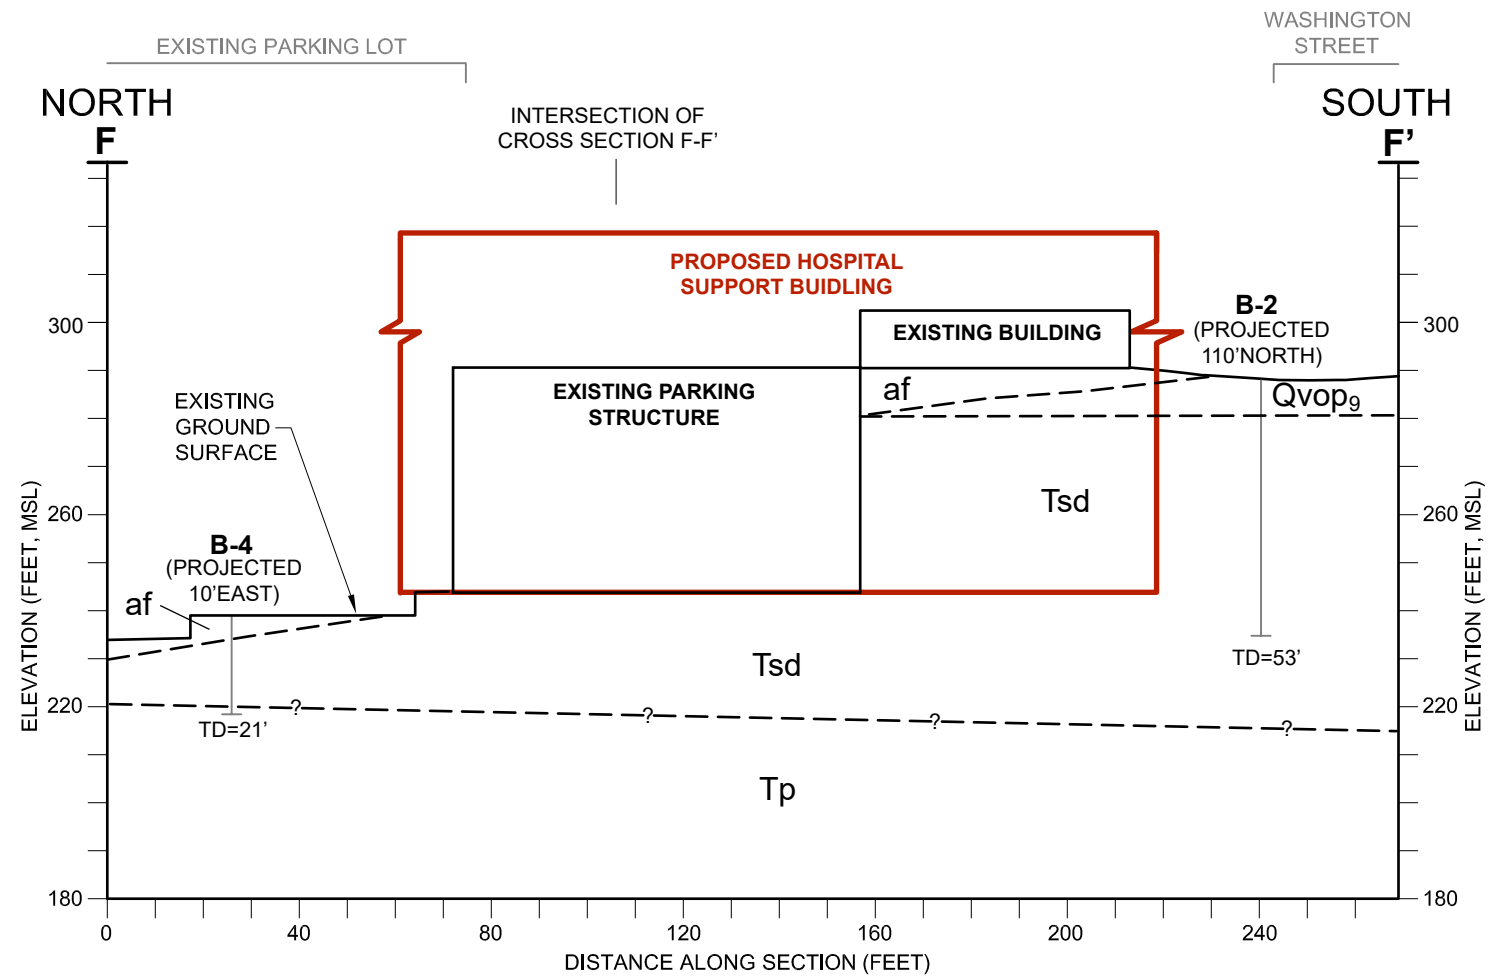
FIGURE
6F

- af ARTIFICIAL FILL
- Qvop₉ VERY OLD PARALIC DEPOSITS
- Tsd SAN DIEGO FORMATION
- Tp POMERADO CONGLOMERATE
- GEOLOGIC CONTACT
- B-2**
(PROJECTED 5' EAST)
APPROXIMATE LOCATION OF BORING, SHOWING ID, PROJECTION AND TOTAL DEPTH
TD = 26.5'

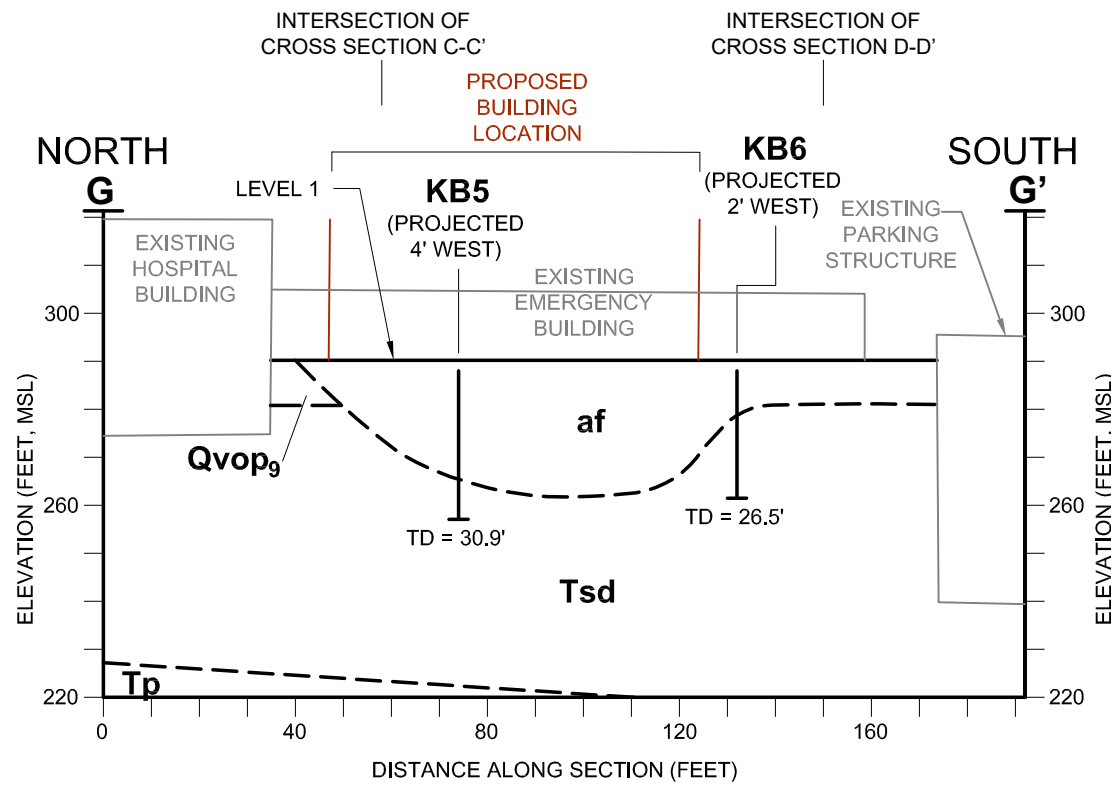
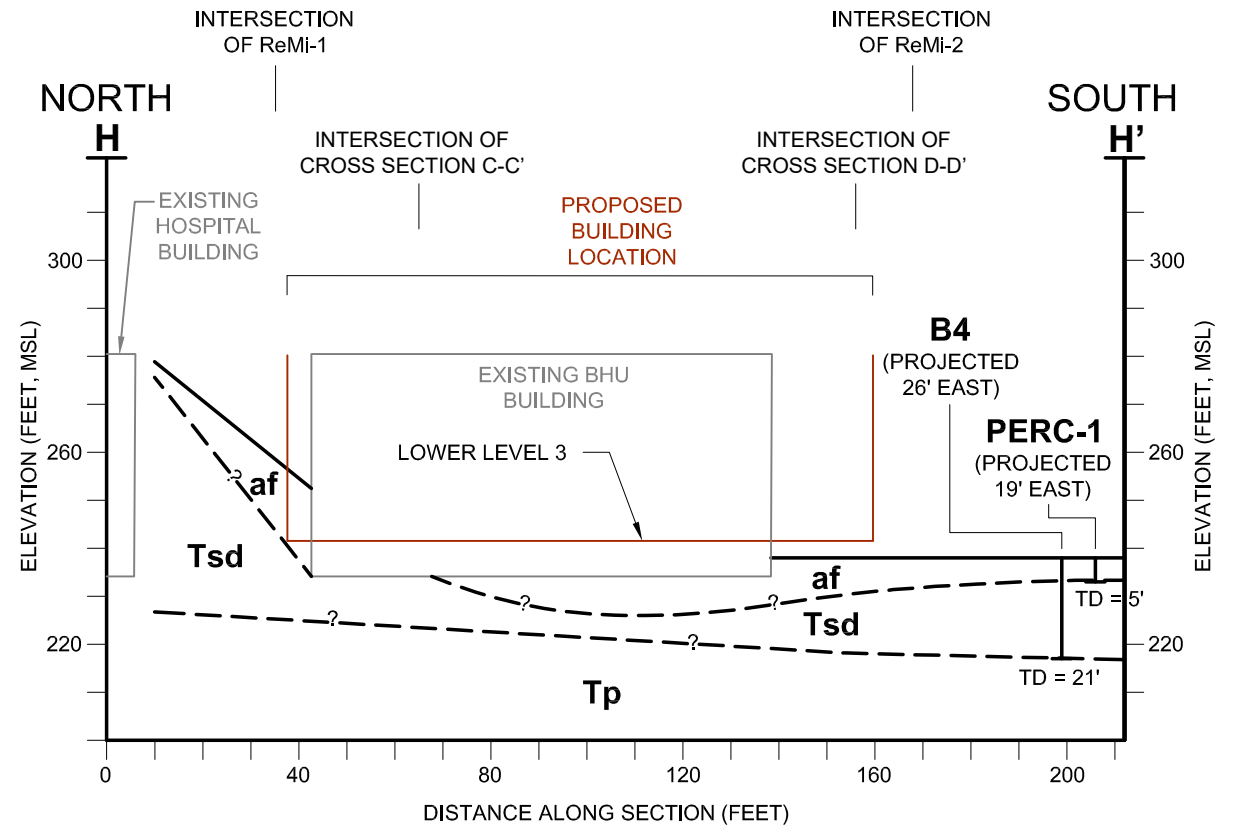
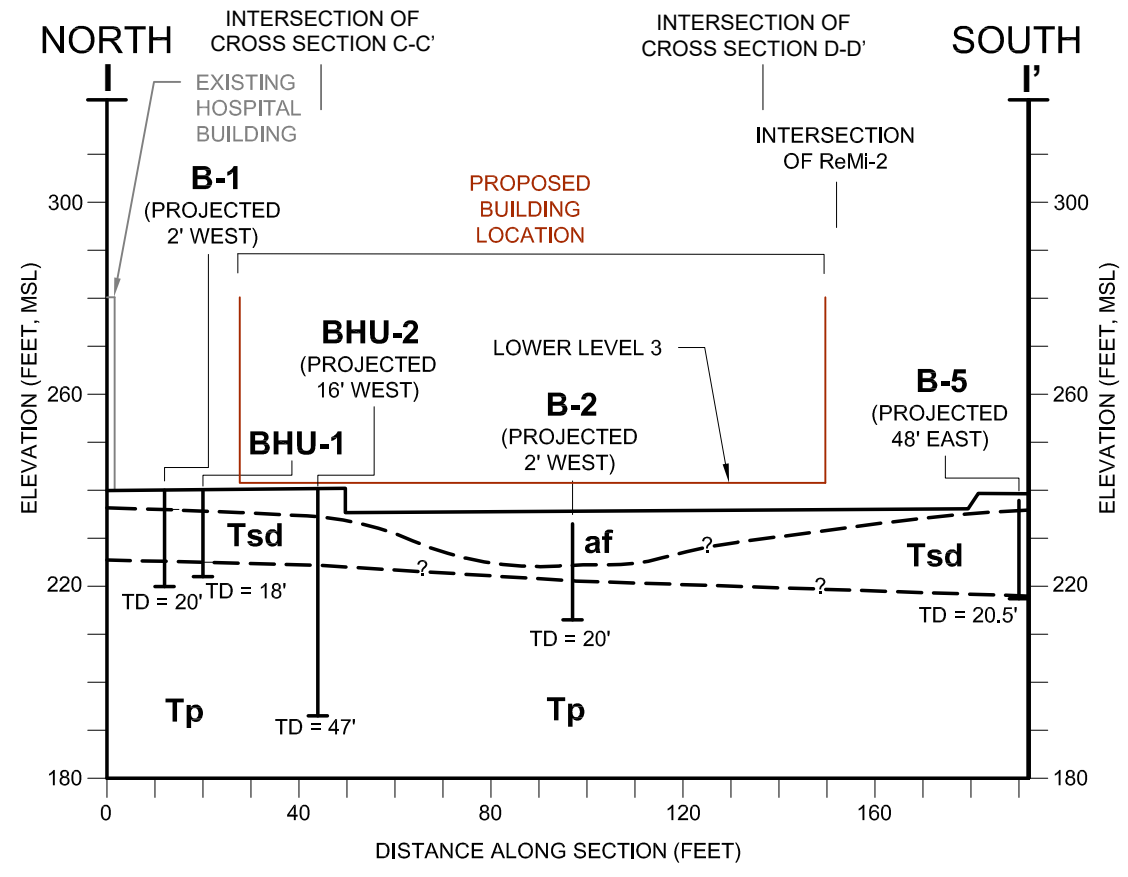
FIGURE
6G

| af | ARTIFICIAL FILL | B-2 (PROJECTED 5' EAST) | APPROXIMATE LOCATION OF BORING, SHOWING ID, PROJECTION AND TOTAL DEPTH |
