Geotechnical Evaluation

January 28, 2021
Client Number 5100
Report Number 10728

**Geotechnical Engineering Study
Proposed Conejo Community Center and Public Park Improvements
1175 Hendrix Avenue
Thousand Oaks, California**

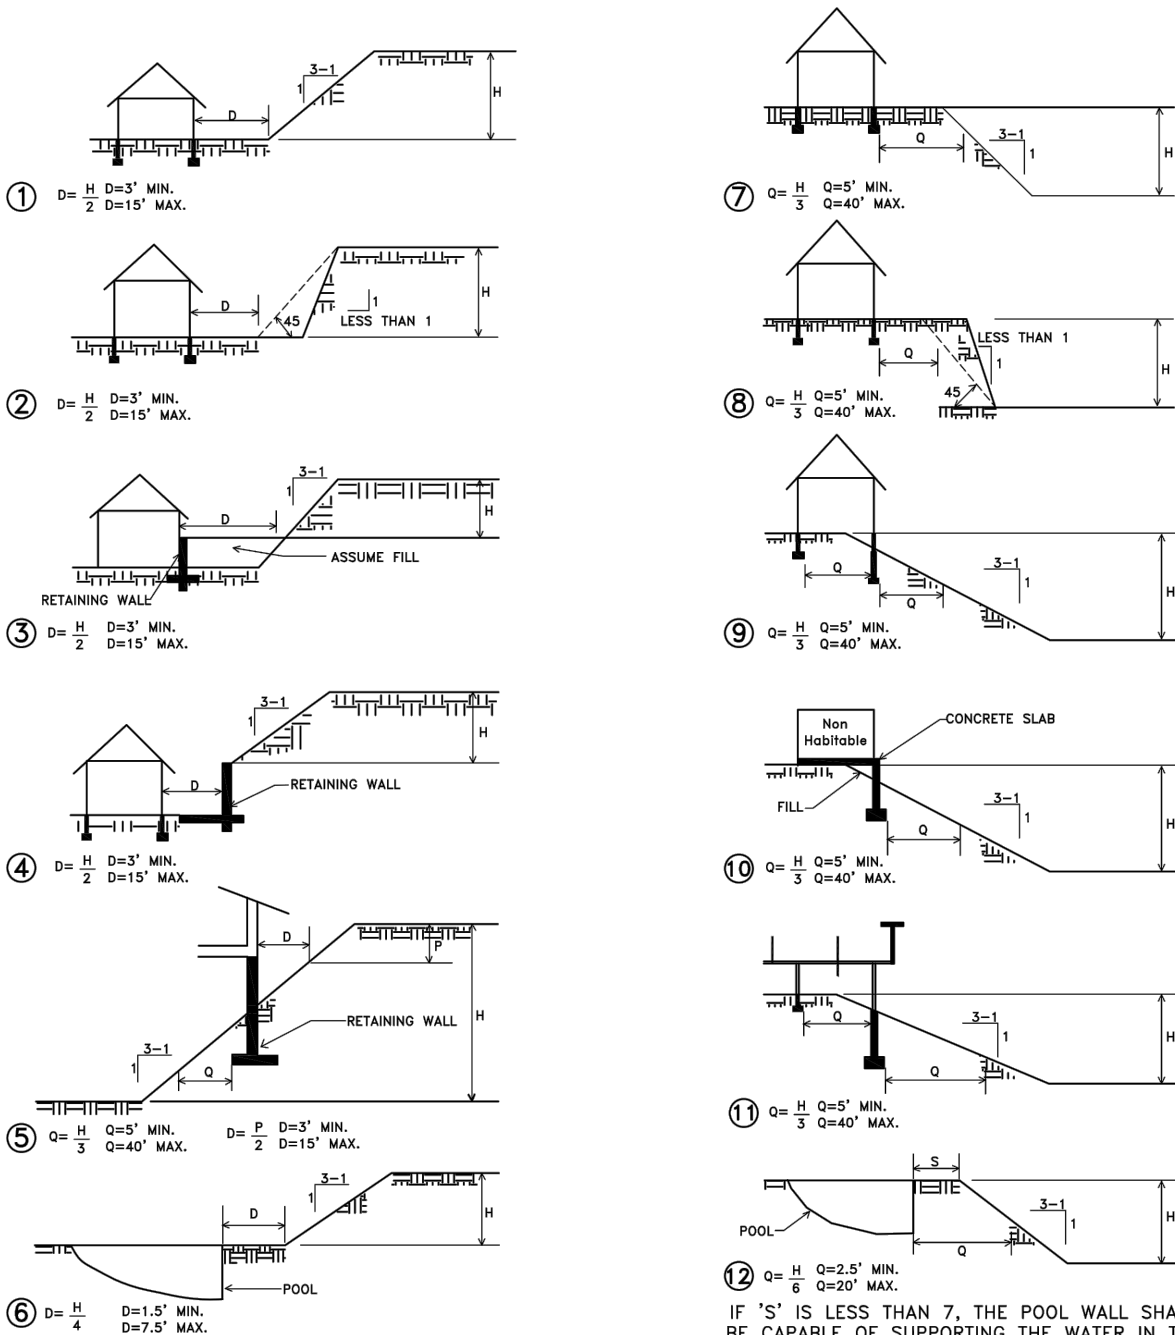
FIGURE 7

FOUNDATIONS ON OR ADJACENT TO SLOPES:

THE PLACEMENT OF BUILDING AND STRUCTURES ON OR ADJACENT TO SLOPES STEEPER THAN 3 HORIZONTAL TO 1 VERTICAL SHALL BE IN ACCORDANCE WITH THE FOLLOWING ILLUSTRATIONS. THE PROVISIONS ARE INTENDED TO PROVIDE PROTECTION FOR THE BUILDING FROM SLOPE DRAINAGE, EROSION AND MUDFLOW, LOOSE SLOPE DEBRIS, SHALLOW SLOPE FAILURES, AND FOUNDATION MOVEMENT.

EXAMPLES OF SLOPE SETBACKS

When located next to a descending 3(H):1(V) slope or steeper, the base of footings for buildings should be a minimum of 5 feet or one-third ($\frac{1}{3}$) the slope height from the face of slope, whichever is greater, but need *not* exceed 40 feet from the face of slope. *Examples of Slope Setbacks* are included in Figure 7.

These embedment depths are below the lowest adjacent, final grade. Where located adjacent to utility trenches, footings shall extend below a one-to-one plane projected upward from the inside bottom of the trench. When located next to a descending 3(H):1(V) slope or steeper, the base of footings for buildings should be a minimum of 5 feet or one-third the slope height from the face of slope, whichever is greater, but need *not* exceed 40 feet from the face of slope. *Examples of Slope Setbacks* are included in Figure 7.

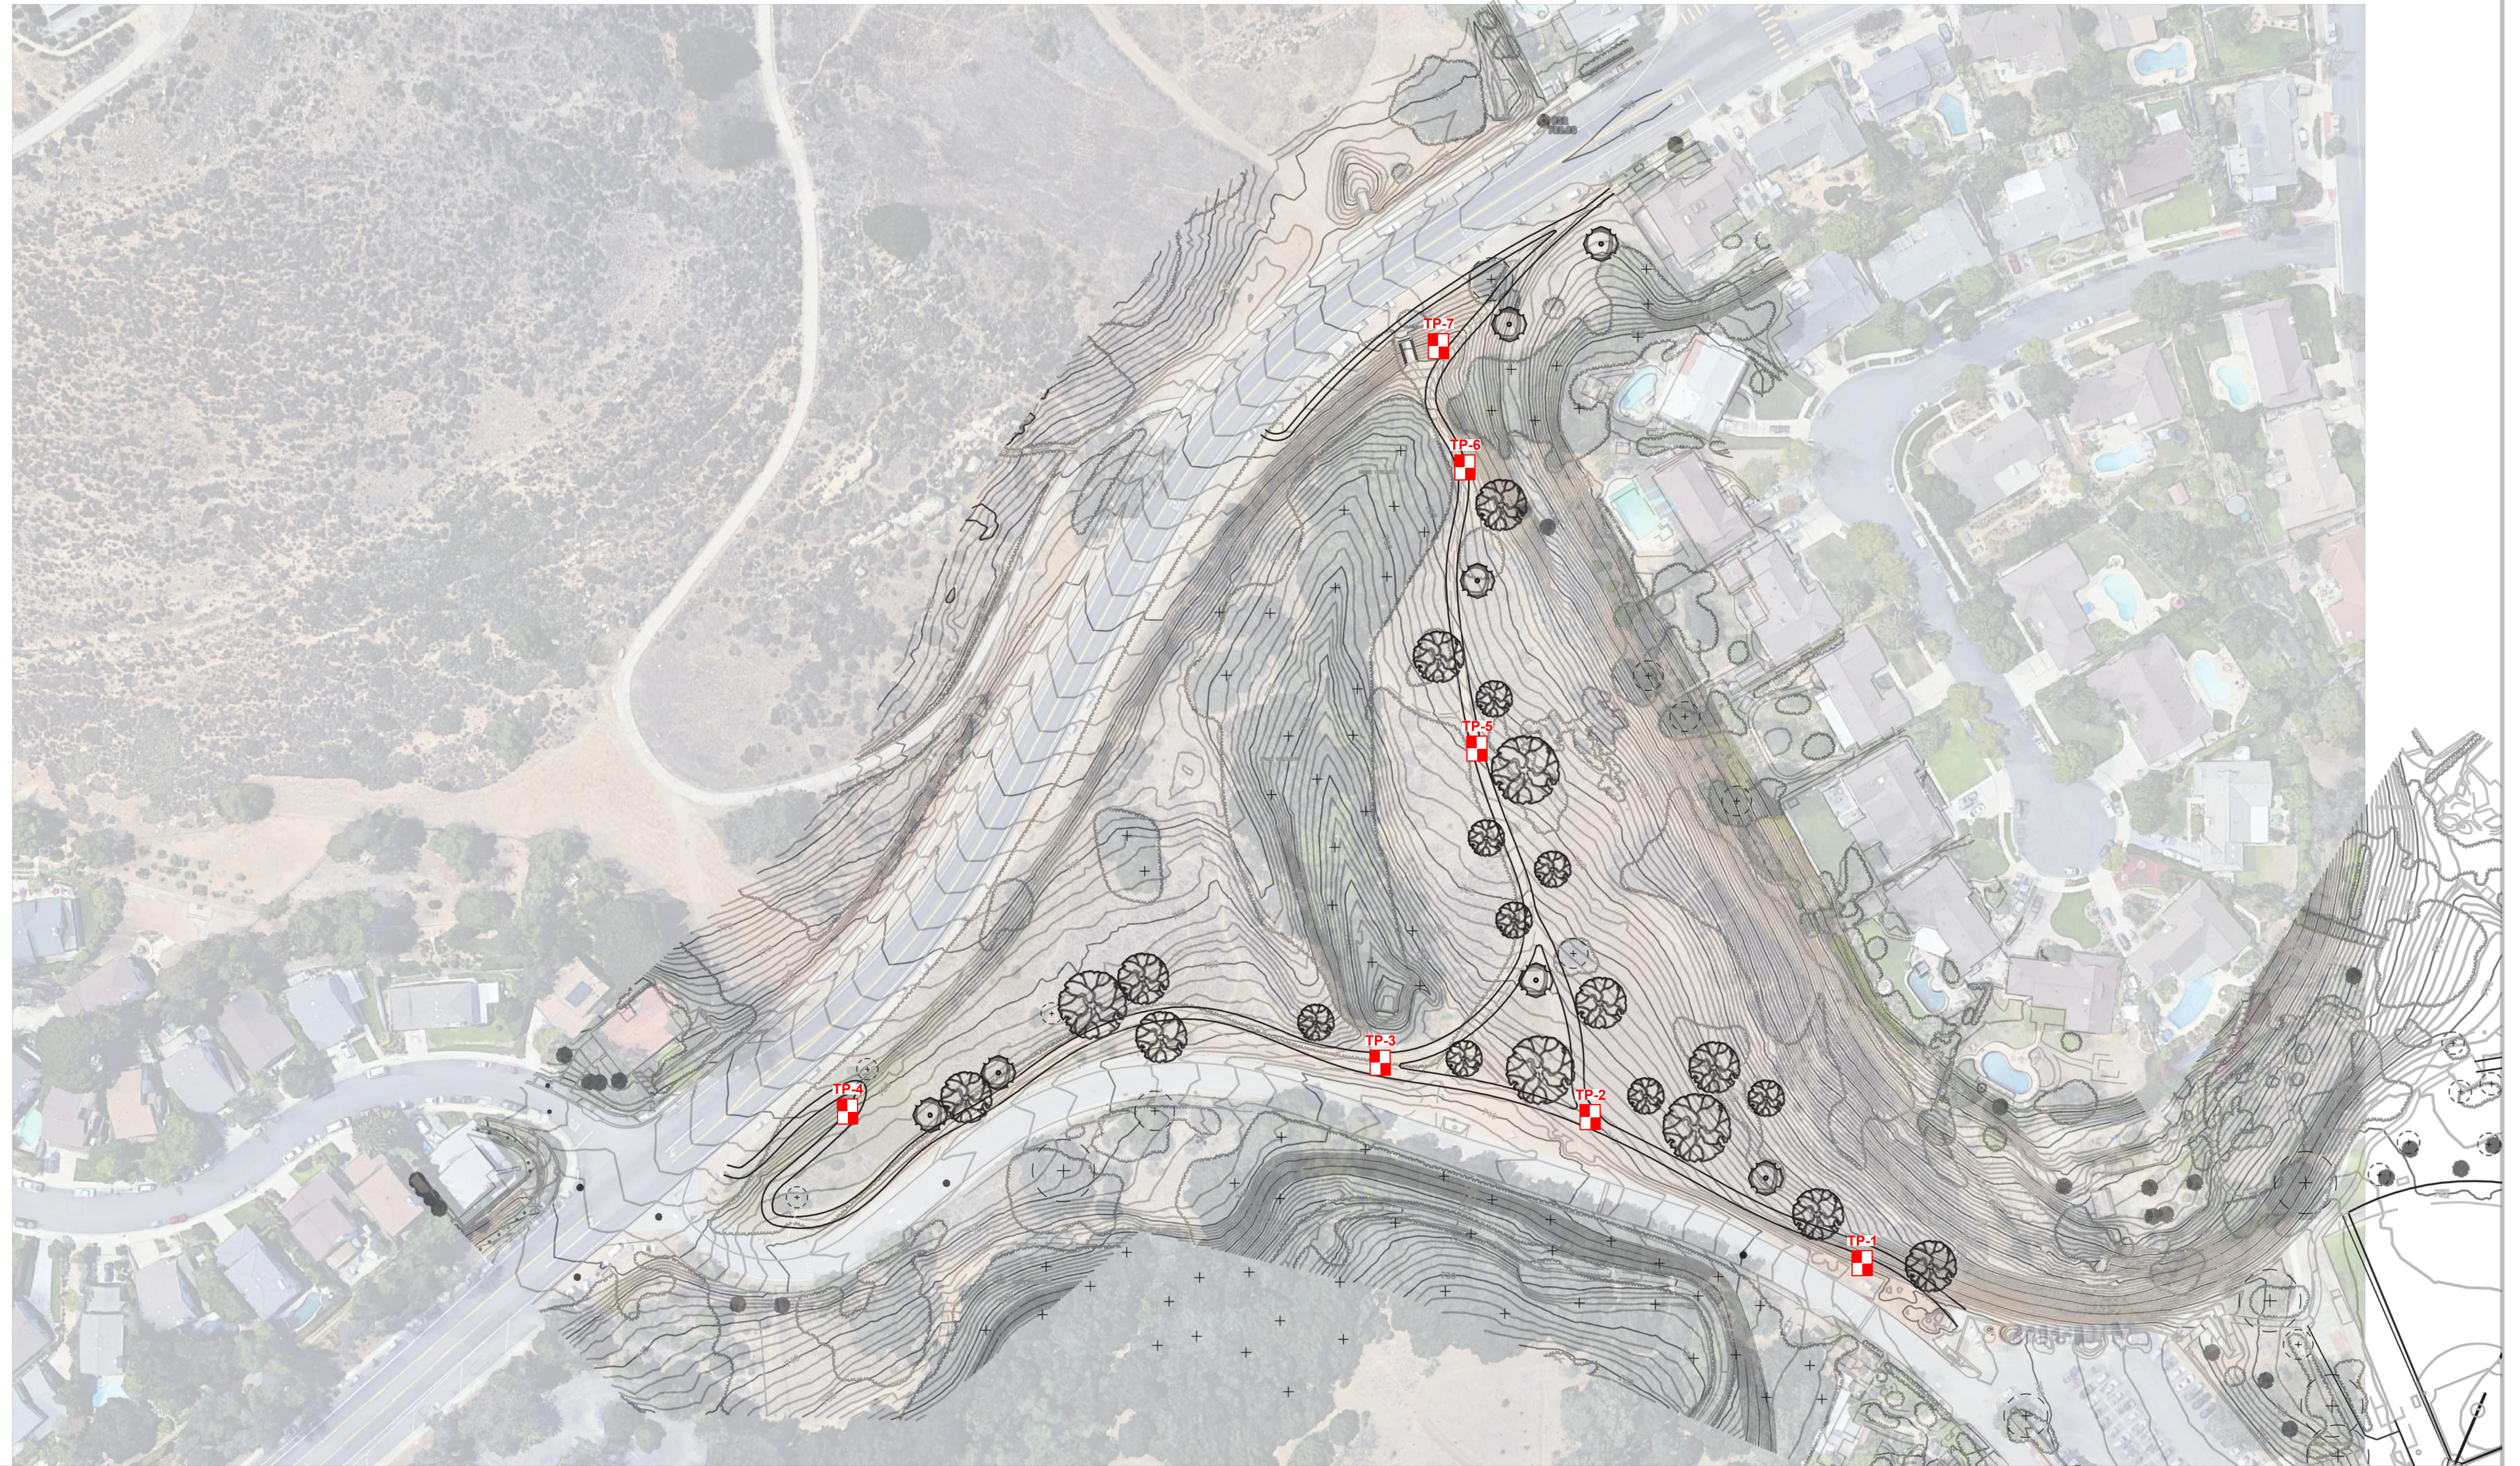
Client No.	5100	PLATE 2
Report No.	10728	
Date	1/28/2021	
Drawing No.	10728cn5100

CONEJO COMMUNITY PARK
L5.0 - TARANTULA HILL TRAIL

At this time, AGS has been provided with a conceptual plan detailing the proposed improvements, as utilized for the base maps for the *Conejo Community Park – Schematic Plan – L1.0 – Main Park* and the *Conejo Community Park – L5.0 – Tarantula Hill Trail* plans included as Plates 1 and 2 of this report. When these plans become finalized, they should be reviewed by AGS prior to submittal to regulatory agencies for approval. A grading plan review report *may* be required by the City to be submitted with the approved grading plans. Additional analysis *may* be required at that time depending on specific details of the proposed grading and improvements, and any corrections deemed necessary will be made known to the Project Civil Engineer. Approval by this office will be indicated by manual signature and stamp once our recommendations have been incorporated into the design or shown as notes on the plan.
