ENGINEERING GEOLOGY INVESTIGATION UPDATE

September 18, 2020
SL10982-3

Old Creek Road
APNs: 046-031-033 &
046-131-043
Cayucos area, San
Luis Obispo County,
California

1.0 INTRODUCTION

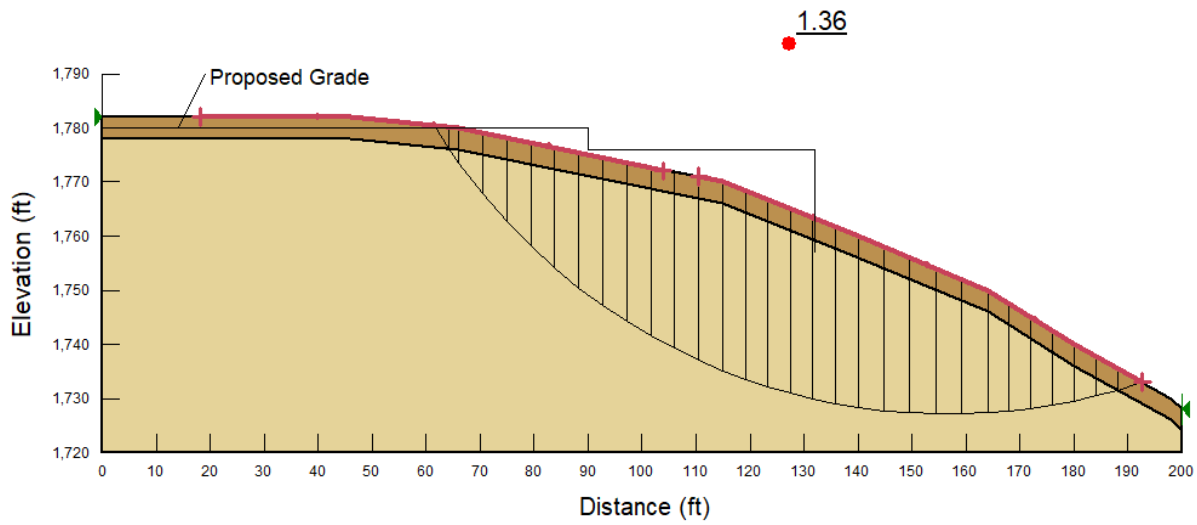
Figure 10: Profile B-B - ADU Natural Slope (seismic)

The critical seismic factor of safety value is presented in Table 3. The potential critical slip surface for pseudo-static conditions is presented on Figure 8, 10 and 12.

Profile	Static Factor of Safety	Seismic Factor of Safety
A-A (Main House)	2.60	1.68
B-B (ADU)	1.94	1.36
C-C (Septic)	1.58	1.11

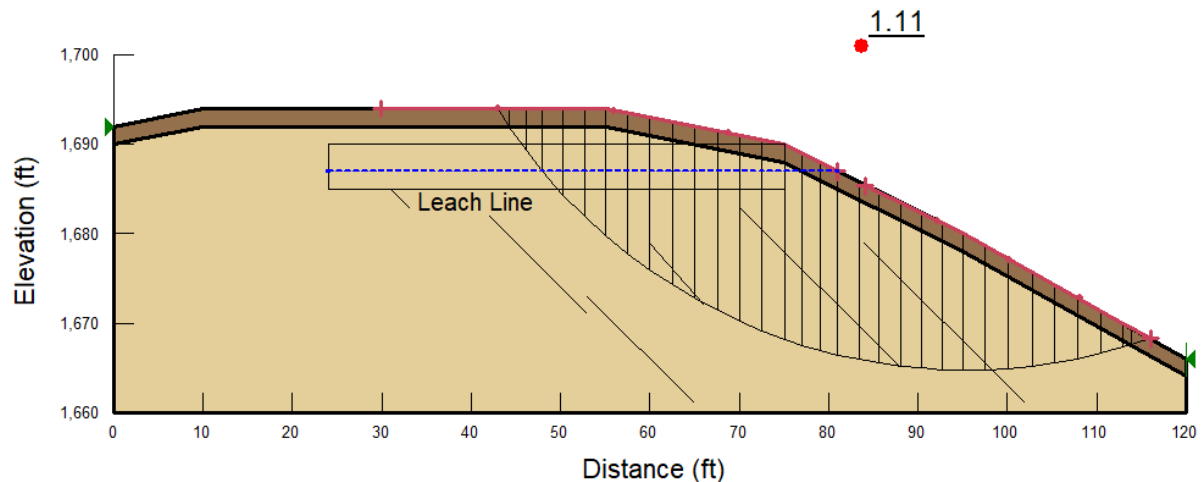
Figure 12: Profile C-C - Septic Natural Slope (seismic)

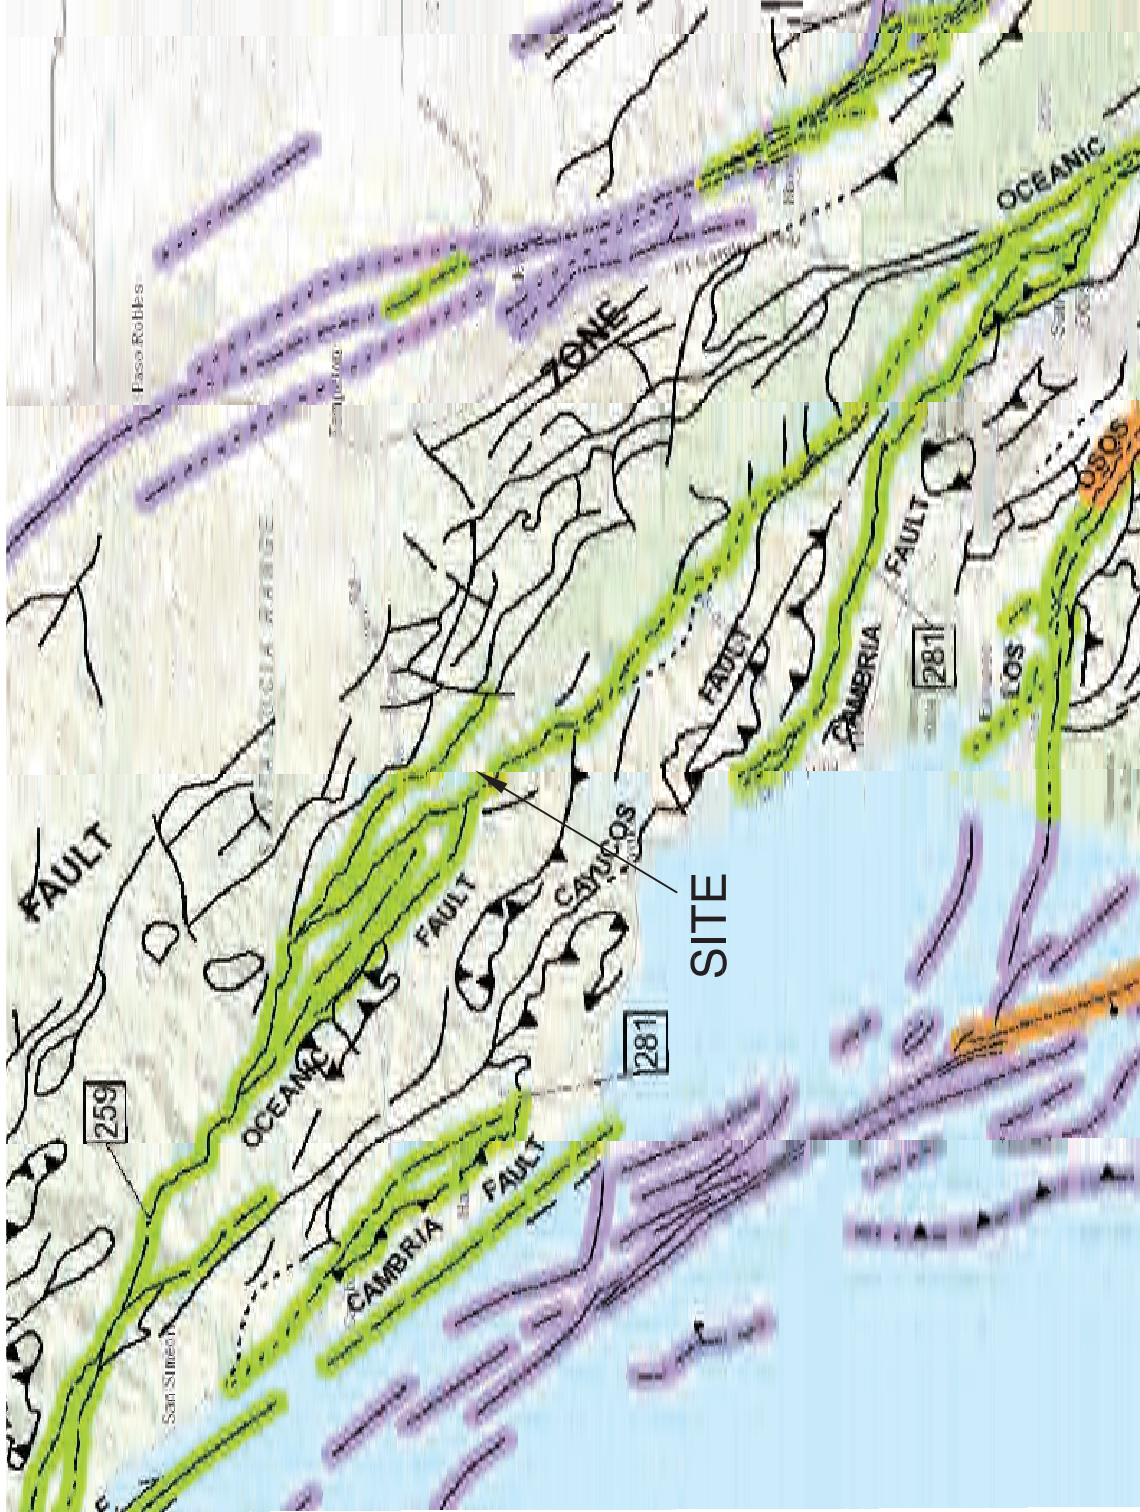
PLATE
3
PROJECT
SL10982-3

REGIONAL FAULT MAP
(JENNINGS, 2010)
OLD CREEK ROAD, APN'S: 046-031-033 & -043, CAYUCOS AREA
SAN LUIS OBISPO COUNTY, CALIFORNIA

The closest known active portion of a Holocene age fault is an active portion of the Hosgri Fault that is located approximately 14.0 miles southwest of the Site (Jennings, 2010). Plate 3 is a Regional Fault Map for the area. The San Andreas fault is the most likely active fault to produce ground shaking at the Site although it is not expected to generate the highest ground accelerations because of its distance from the Site.

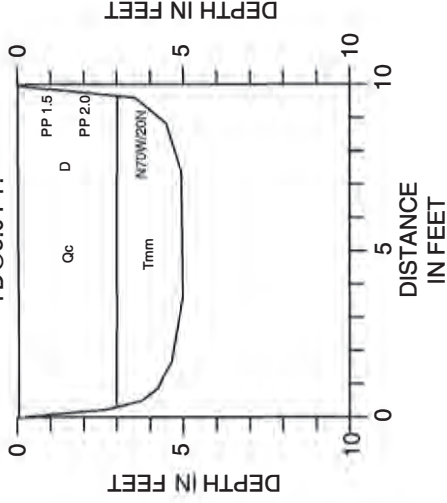
T-4 (EQUIPMENT BUILDING)
TD@5.0 FT.

Oc- dark brown sandy SILT (MH), dry to slightly moist
Tmm- white SILTSTONE, severely weathered to moderately weathered, highly fractured Monterey Formation
