**TOYOTA OF WALNUT CREEK DEVELOPMENT
WALNUT CREEK, CALIFORNIA**

GEOLOGIC HAZARDS ASSESSMENT REPORT

ENGEO Incorporated

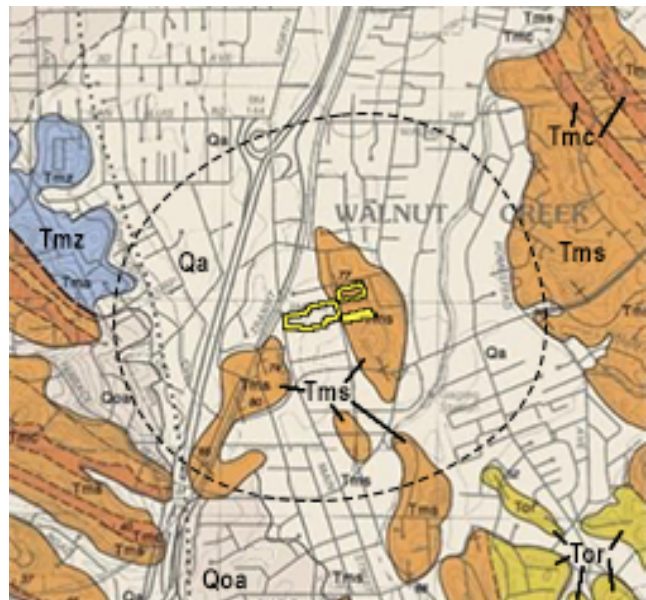
According to the part of the geologic map of Dibblee and Minch (2005) shown here, the surface of the project site (yellow outlines at center) consists of Holocene alluvium (Qa) and Miocene Monterey Formation sandstone (Tms), while the half-mile search area (dashed black outline) also includes Pleistocene alluvium (Qoa), Monterey shale (Tms), and the Paleocene Martinez Formation (Tmz). Other geologic units just outside the search area are the Pliocene Orinda Formation (Tor) and the Paleocene Martinez Formation (Tmz). All of the units are sedimentary in origin and, with the exception of the Holocene deposits (which are too young), have the potential to yield significant paleontological resources.

Key to Adjacent Map
