INLAND FOUNDATION ENGINEERING, INC.
Consulting Geotechnical Engineers and Geologists
www.inlandfoundation.com

February 27, 2020
Revised: March 4, 2020
Project No. R351-011

Re: Geotechnical Investigation, Geologic Hazards Evaluation, and Infiltration Testing
RCCD Ben Clark Training Center
Phase I: Education Center
16791 Davis Avenue, Riverside, California

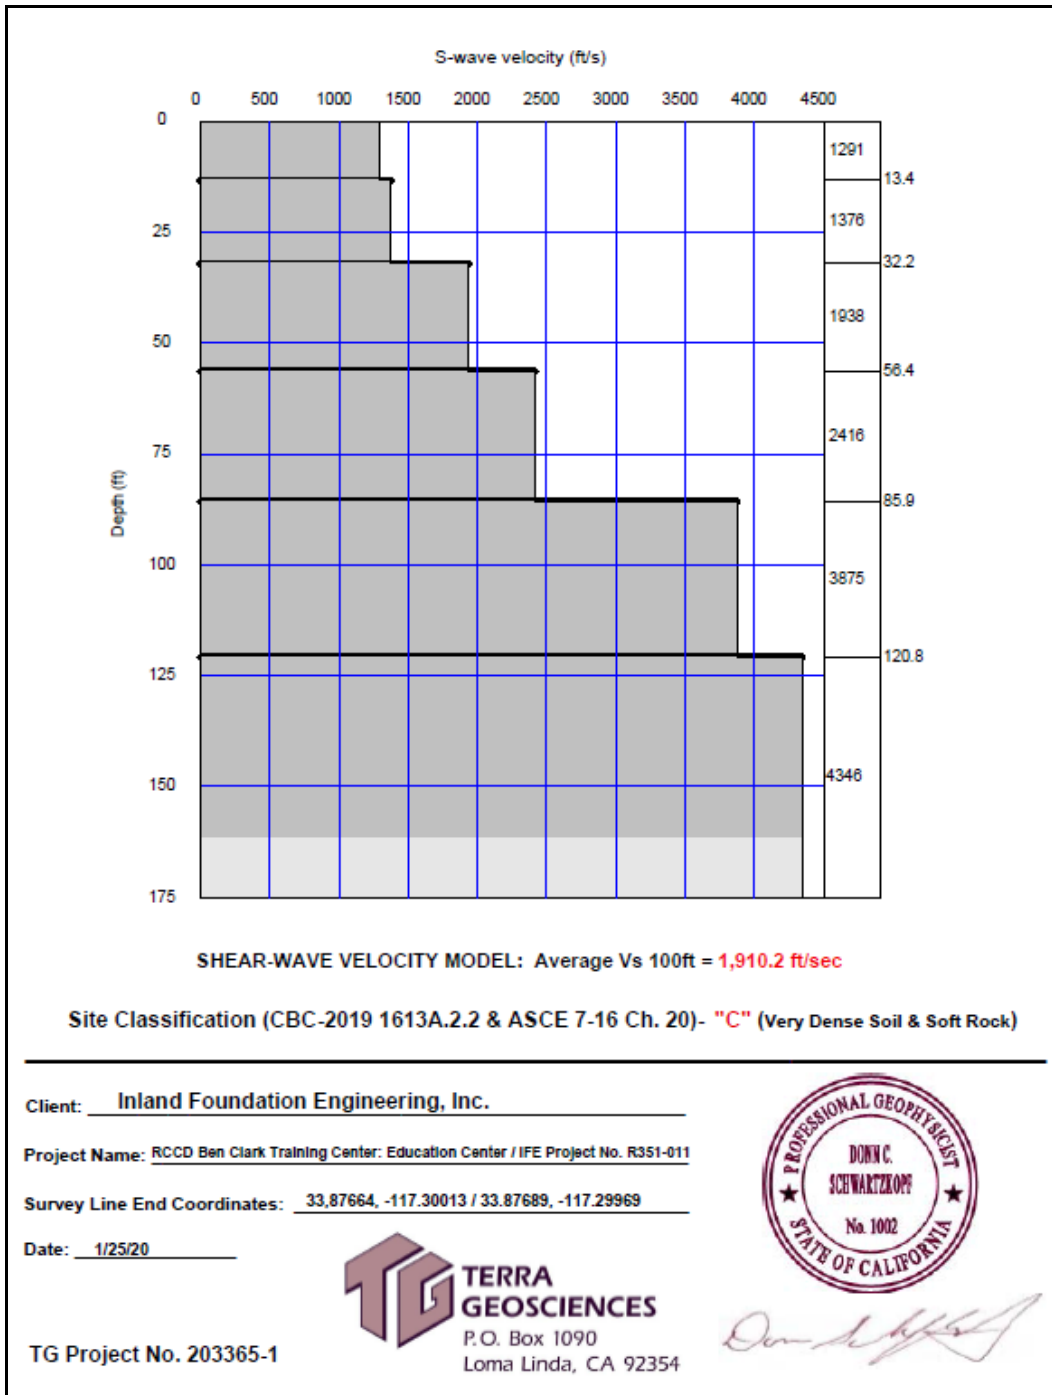
Seismic Parameters: The site coordinates (WGS 84) are 33.8768°N / -117.3000°W. The site is underlain by weathered granitic bedrock with less than approximately four feet of soil mantling the bedrock. A geophysical seismic shear-wave survey was conducted for this study by our subconsultant, Terra Geosciences, for the purposes of evaluating the Site Classification for this project. The results of the shear-wave survey indicate a shear wave velocity of 1,910 feet per second, corresponding to a Site Class C. Figure 8 below is the graphical representation of the shear-wave survey conducted for this site.

FIGURE 8: Shear Wave Velocity Model
