**PRELIMINARY GEOTECHNICAL
INVESTIGATION AND PERCOLATION
TESTING**

**TTM 37731, TTM 37732, AND TTM 37733
COLE AVENUE, BARTON STREET,
AND OBSIDIAN DRIVE
RIVERSIDE, CALIFORNIA**

**LURIN LAND, LLC
RANCHO CUCAMONGA, CALIFORNIA**

**MAY 28, 2019
PROJECT NO. T2864-22-01**

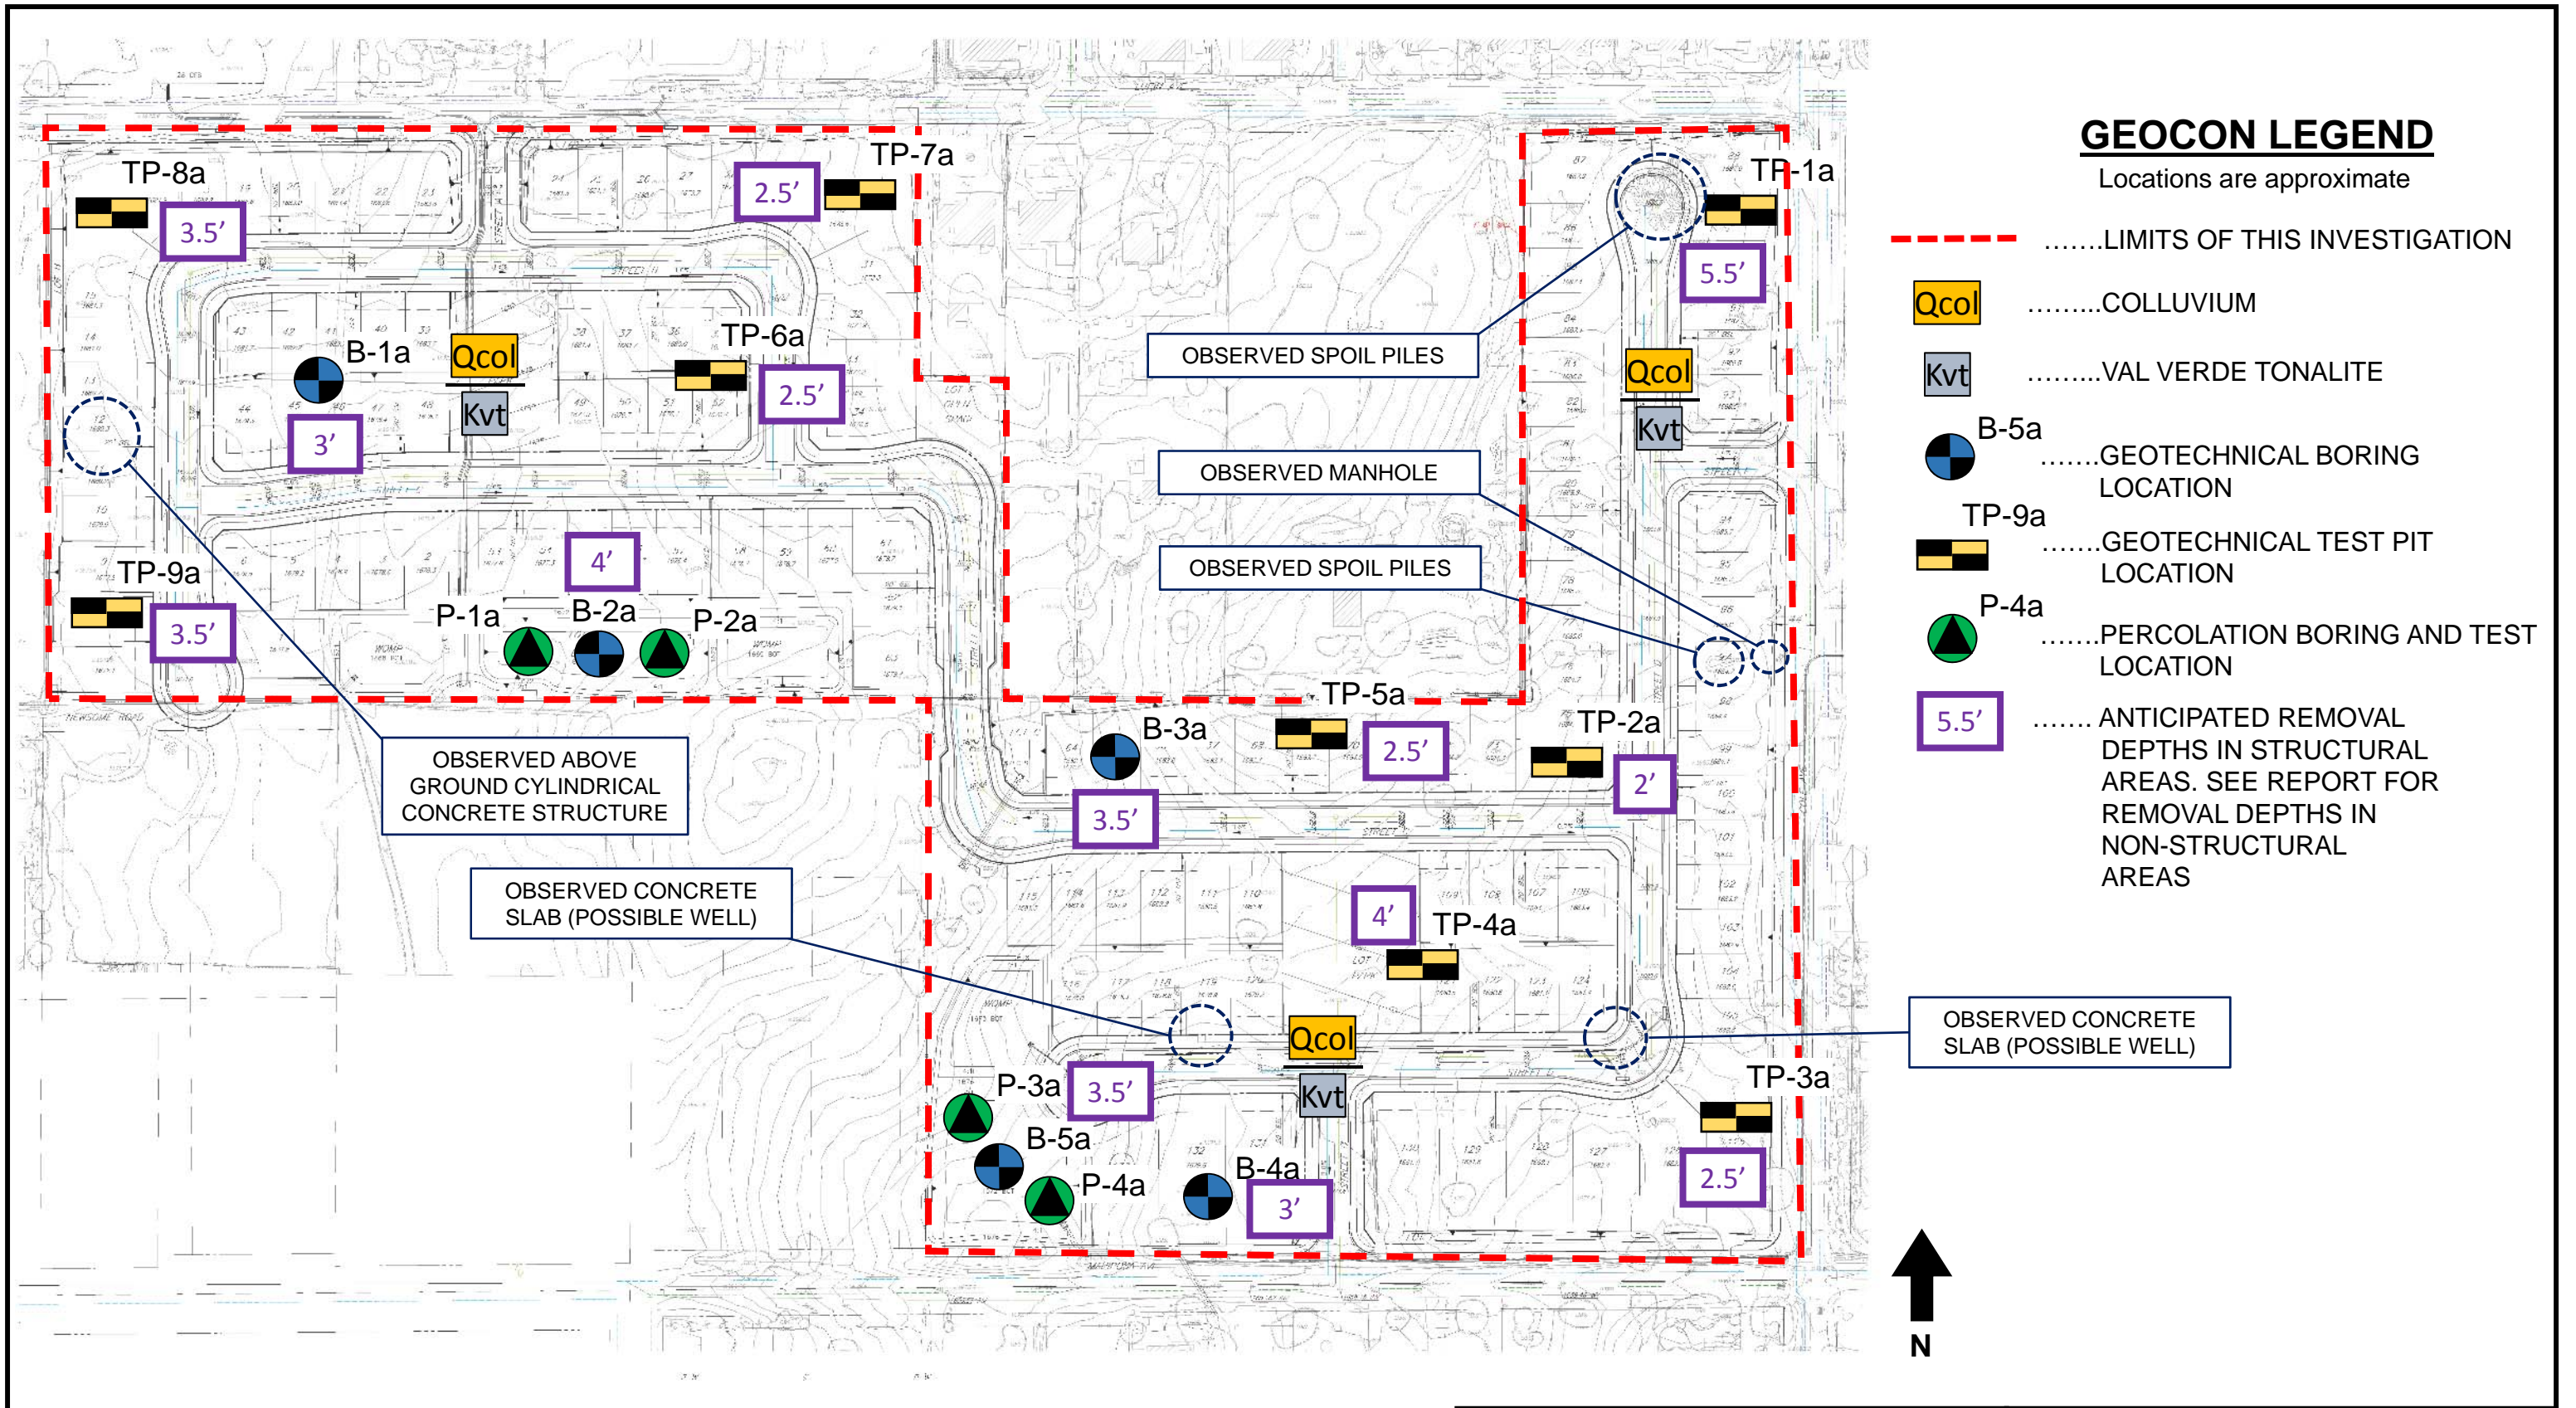
| ATS | MAY 2019 | PROJECT NO. T2864-22-01 FIG. 2a |

-LIMITS OF THIS INVESTIGATION
-GEOLOGIC CONTACT
-UNDOCUMENTED FILL
-COLLUVIUM
-VAL VERDE TONALITE
-GEO TECHNICAL BORING LOCATION
- TP-6cGEO TECHNICAL TEST PIT LOCATION
- P-2cPERCOLATION BORING AND TEST LOCATION
- ANTICIPATED REMOVAL DEPTHS IN STRUCTURAL AREAS. SEE REPORT FOR REMOVAL DEPTHS IN NON-STRUCTURAL AREAS

- Figure 1, Vicinity Map
- Figure 2a, Geologic Map – TTM 37731
- Figure 2b, Geologic Map – TTM 37732
- Figure 2c, Geologic Map – TTM 37733
- Figure 3, Wall/Column Footing Detail
- Figure 4, Typical Retaining Wall Drain Detail
