UPDATE REPORT GEOTECHNICAL INVESTIGATION

Proposed Two-Story Expansion and Renovation
Rancho Springs Medical Center Renovation
25500 Medical Center Drive, Murrieta, California

NOVA Project No. 3019061
December 16, 2019

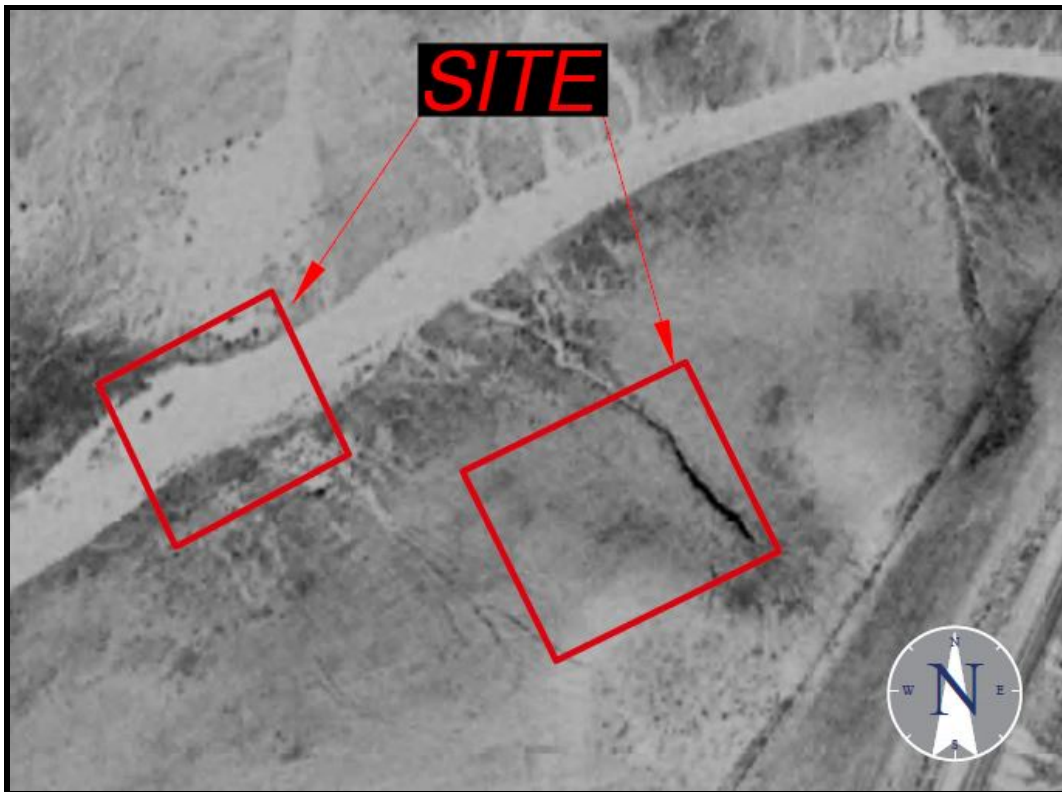
Figure 2-2. 1978 Historical Aerial Photograph of the Site Area

NOVA reviewed historic aerial photography and topographic mapping dating to 1938 as a basis for understanding historical uses of the site. This review indicates that prior to development of Rancho Springs Hospital, the site area had minimal development. It appears that a historic drainage channel transected the campus as indicated in Figure 2-2. This drainage channel has been since graded out during the development of the hospital.

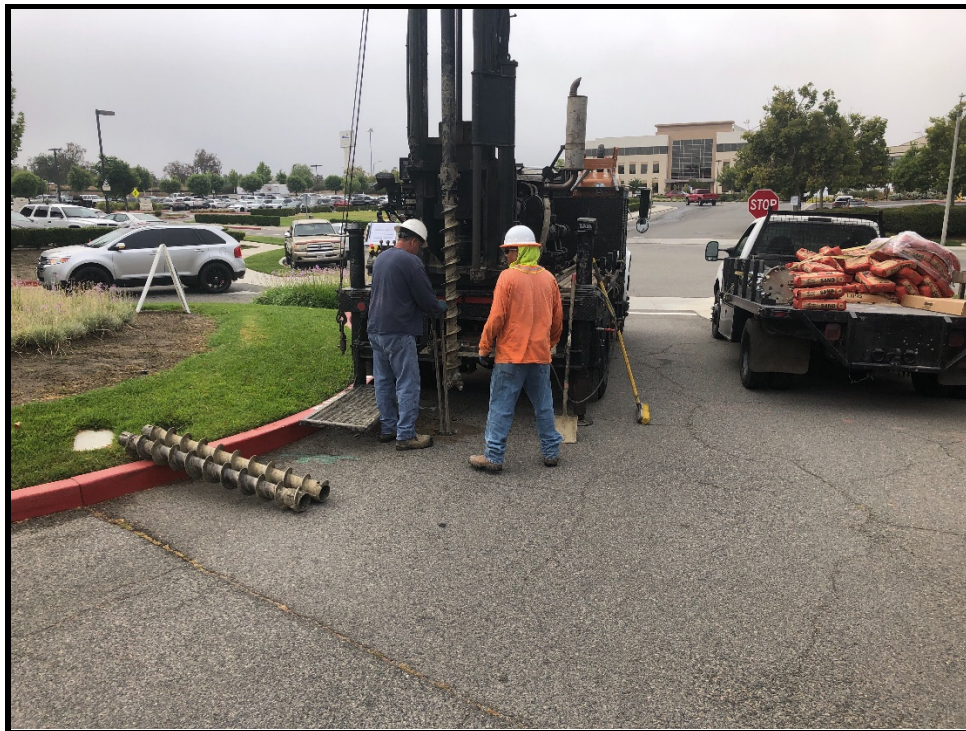
The geotechnical borings were advanced with a truck-mounted drill rig utilizing hollow stem drilling equipment. The borings were drilled at locations determined in the field by a NOVA geologist, then completed under the geologist’s surveillance. Figure 3-2 below presents a photograph of the drilling operation.

Figure 3-2. Drilling Geotechnical Test Boring B-1

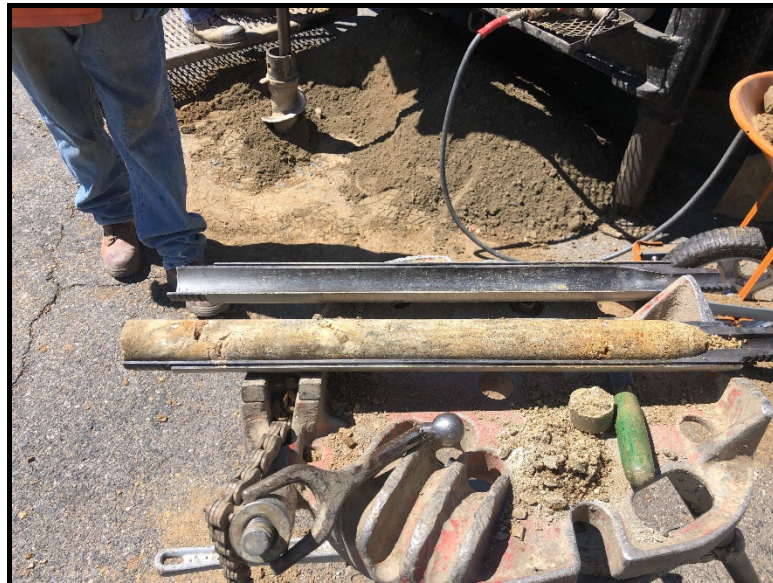
Figure 3-3. Sample from B-7 at 30' bgs

1. The Modified California sampler ('ring sampler', after ASTM D3550) was driven using a 140-pound hammer falling for 30 inches with a total penetration of 18 inches, recording blow counts for each 6 inches of penetration.
2. The Standard Penetration Test sampler ('SPT', after ASTM D1586) was driven in the same manner as the ring sampler, recording blow counts in the same fashion. SPT blow counts for the final 12-inches of penetration comprise the SPT 'N' value, an index of soil consistency.
3. Bulk samples were recovered from the subsurface soils, providing composite samples for index testing.

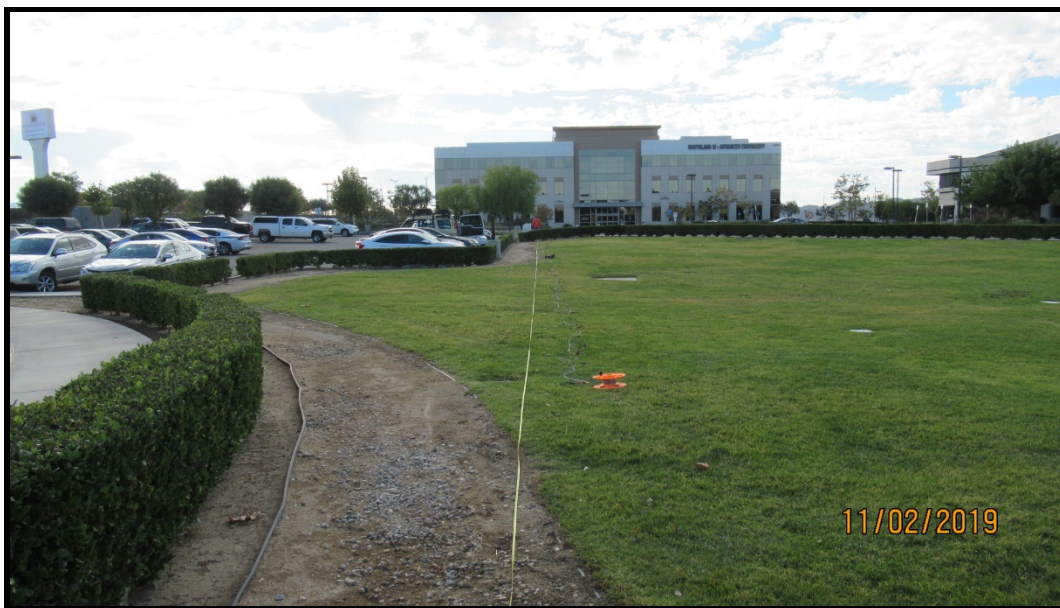
Figure 3-4. Seismic Survey Line, View towards the South.

A seismic shear wave survey was performed on November 2, 2019 by a Professional Geophysicist (PGP). The purpose of the survey was to assess the one-dimensional average shear-wave velocity of the underlying site soils to a minimum depth of 100 feet bgs in order to classify the site in accordance with ASCE 7-16 Table 20.3-1. Multi-channel analysis of surface waves (MASW) and microtremor array measurement (MAM) methods were used for the analysis. Combining results of both methods maximizes the depth and resolution of the data.

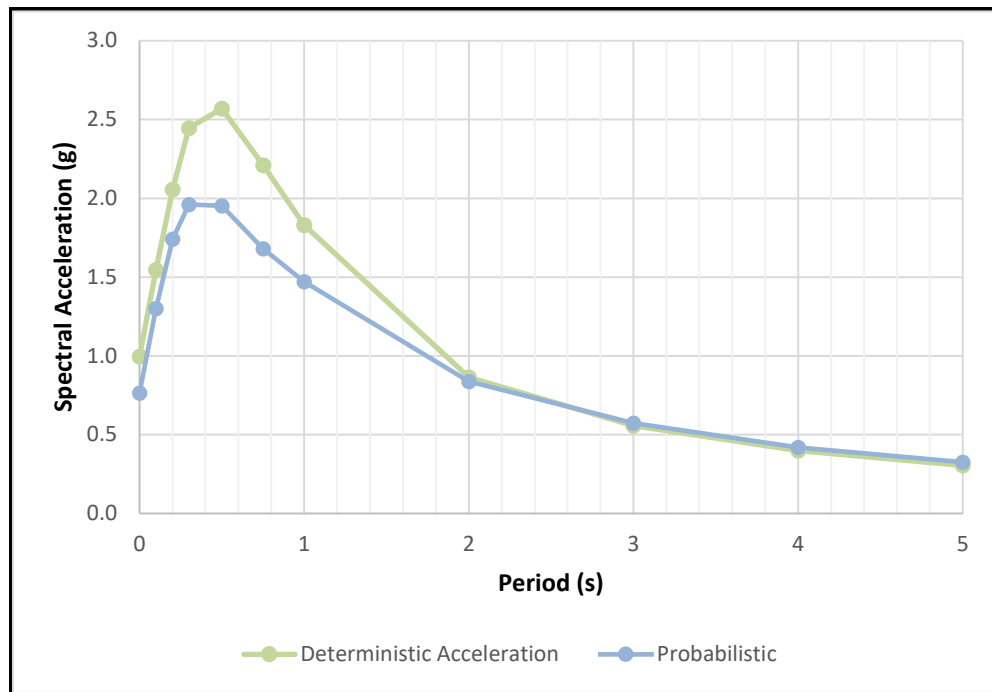
Figure 6-2. Probabilistic and Deterministic Seismic Accelerations

Figure 6-2 provides the probabilistic site response based on the method described above.

The values for the deterministic accelerations are shown in Table 6-2. Figure 6-2 depicts the Deterministic and Probabilistic curves graphically. Per Section 21.2.3, the MCE_R is taken as the lesser of the spectral response accelerations from the PSHA and the DSHA; and therefore, the PSHA accelerations control for this site specific analysis.

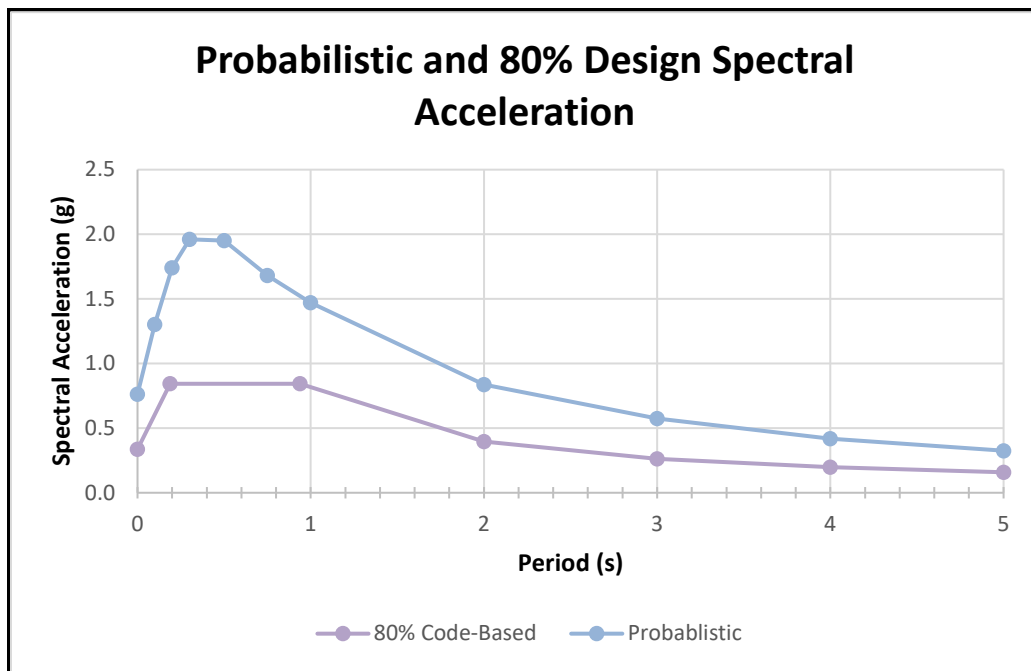
Figure 6-3. Probabilistic Spectral Accelerations and 80% Design Spectral Accelerations

Per ASCE 7-16 Section 21.3, the spectral response calculated above, shall not be less than 80% of those determined in accordance with Section 11.4.6. Figure 6-3 presents the 80% design response spectrum and the results of the controlling PSHA curves, which confirms site-specific accelerations exceed the 80% design response at all periods.
