Feasibility Level Geotechnical Evaluation

East Whisman
450 Clyde Avenue
Mountain View, California

April 3, 2020 | Project No. 403253010

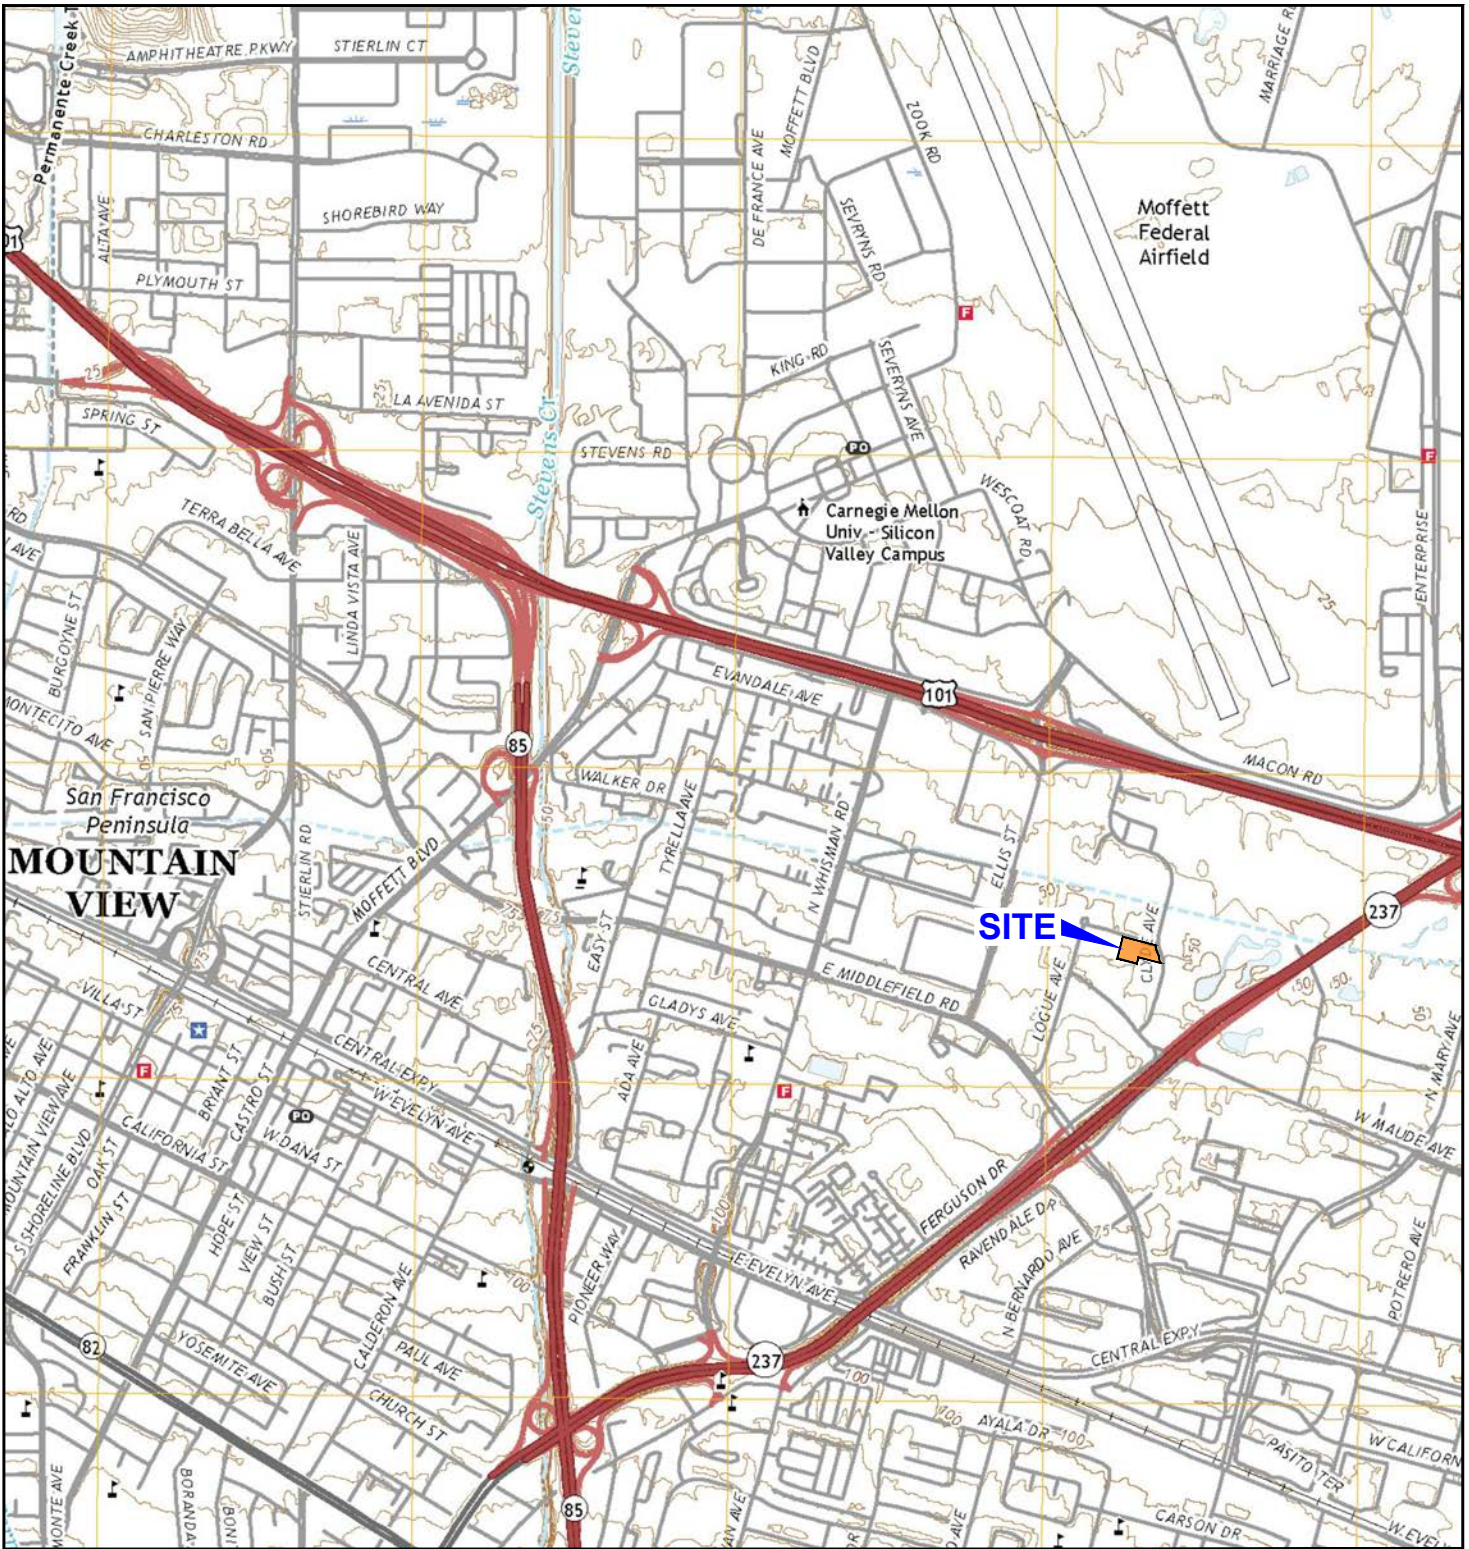
FIGURE 1

NOTE: DIMENSIONS, DIRECTIONS, AND LOCATIONS ARE APPROXIMATE | REFERENCE: USGS, 2018

In accordance with your request, we have performed a feasibility level geotechnical evaluation for the 450 Clyde Avenue property in Mountain View, California (Figure 1) as part of the East Whisman project. The purpose of our geotechnical evaluation was to assess the subsurface conditions and geologic hazards at the site, and to provide preliminary conclusions and recommendations for planning purposes for the sites described in Section 4 of this report.

The subject property is located at 450 Clyde Avenue in Mountain View, California (Figure 1). The site is currently occupied by a one-story commercial building, paved parking areas, and landscaped areas. The property is bounded to the north, west, and south by commercial properties and to the east by Clyde Avenue. The site is relatively flat with elevations that range from about 50 to 53 feet above mean sea level (Google Earth, 2019).

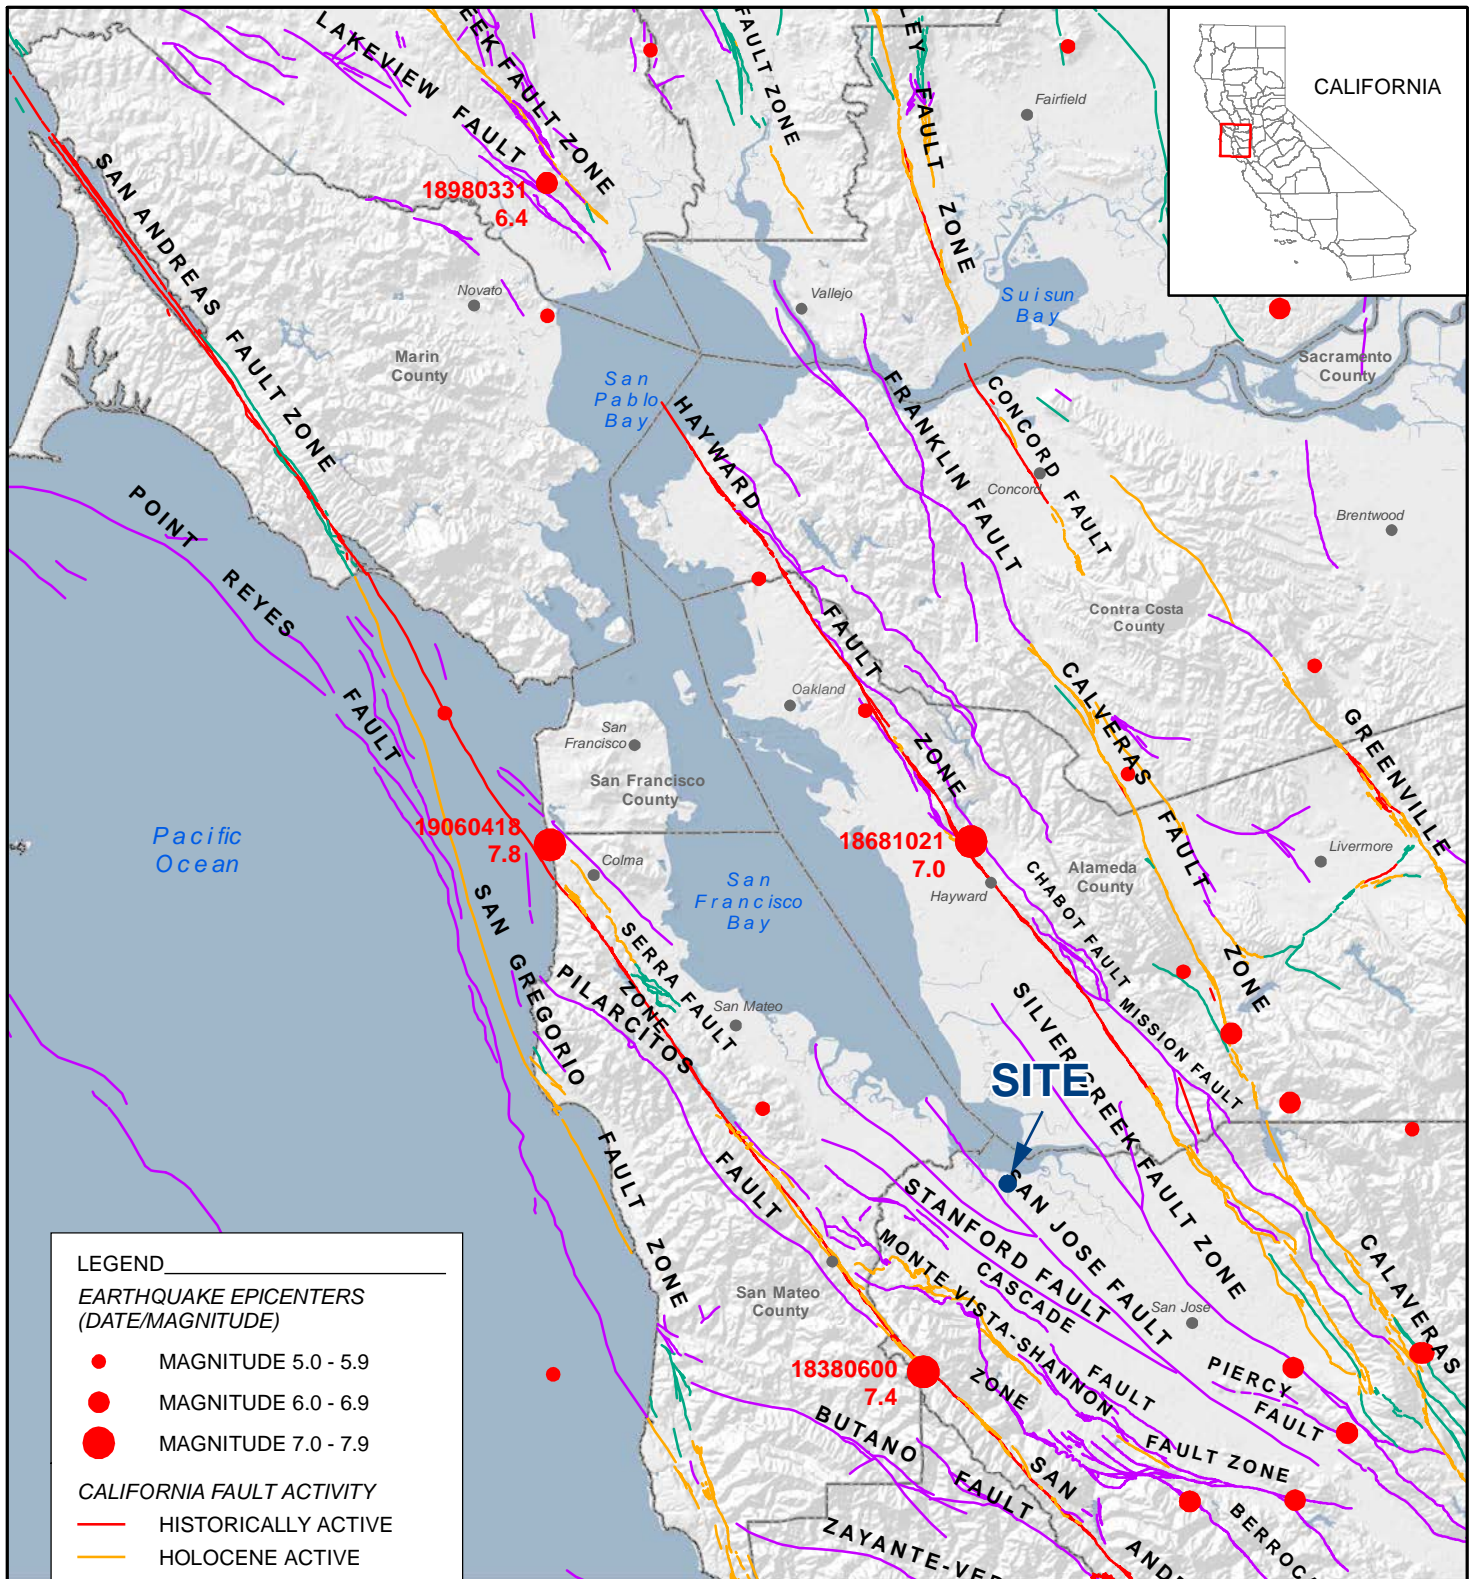
FAULT LOCATIONS AND EARTHQUAKE EPICENTERS

**EARTHQUAKE EPICENTERS
(DATE/MAGNITUDE)**

The site is located in a seismically active region. Figure 3 presents the location of the site relative to the epicenters of historic earthquakes with magnitudes of 5.5 or more from 1800 to 2000. Records of historic ground effects related to seismic activity (e.g. liquefaction, sand boils, lateral spreading, ground cracking) compiled by Knudsen et al. (2000), indicate that no ground effects related to historic seismic activity have been reported for the site.

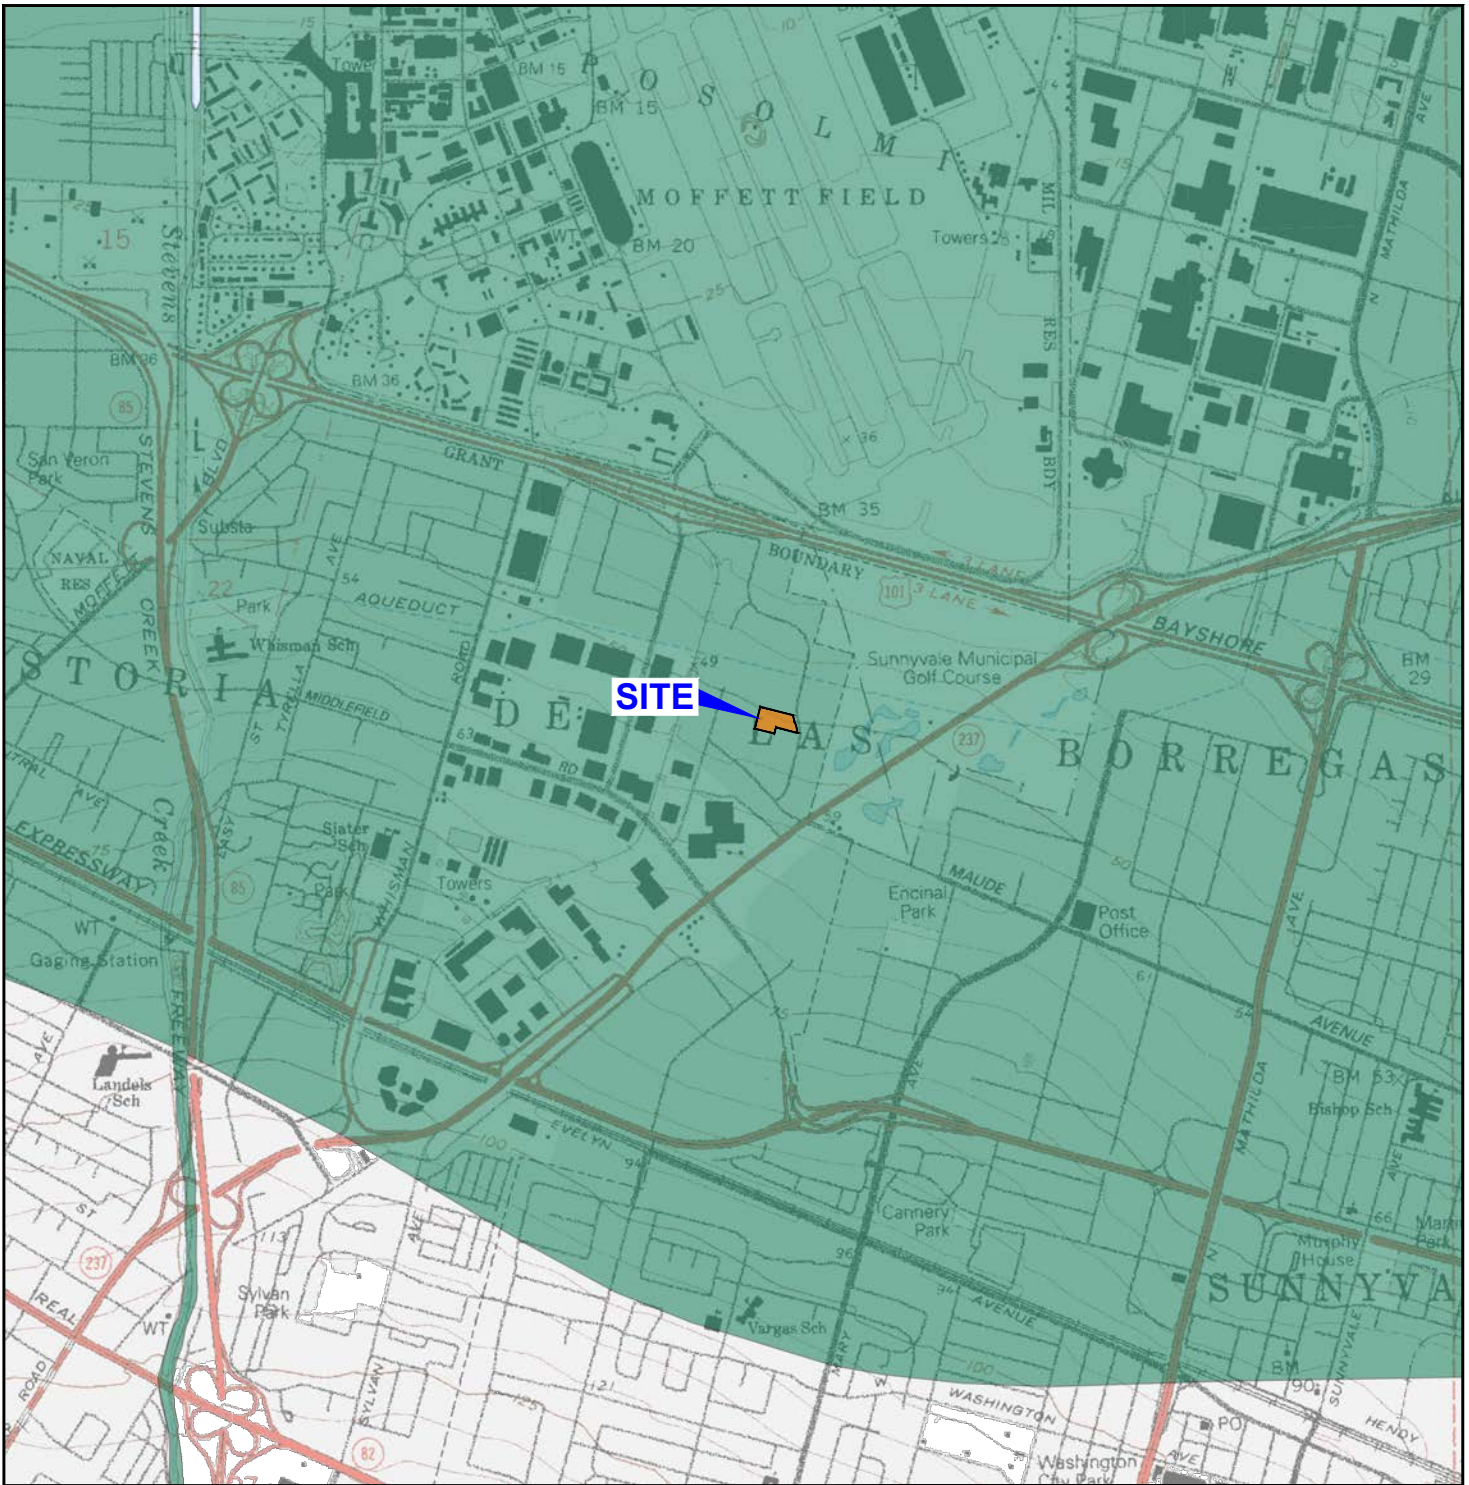
LIQUEFACTION:
 Areas where historic occurrence of liquefaction, or local geological, geotechnical and groundwater conditions indicate a potential for permanent ground displacements such that mitigation as defined in Public Resources Code Section 2693(c) would be required.

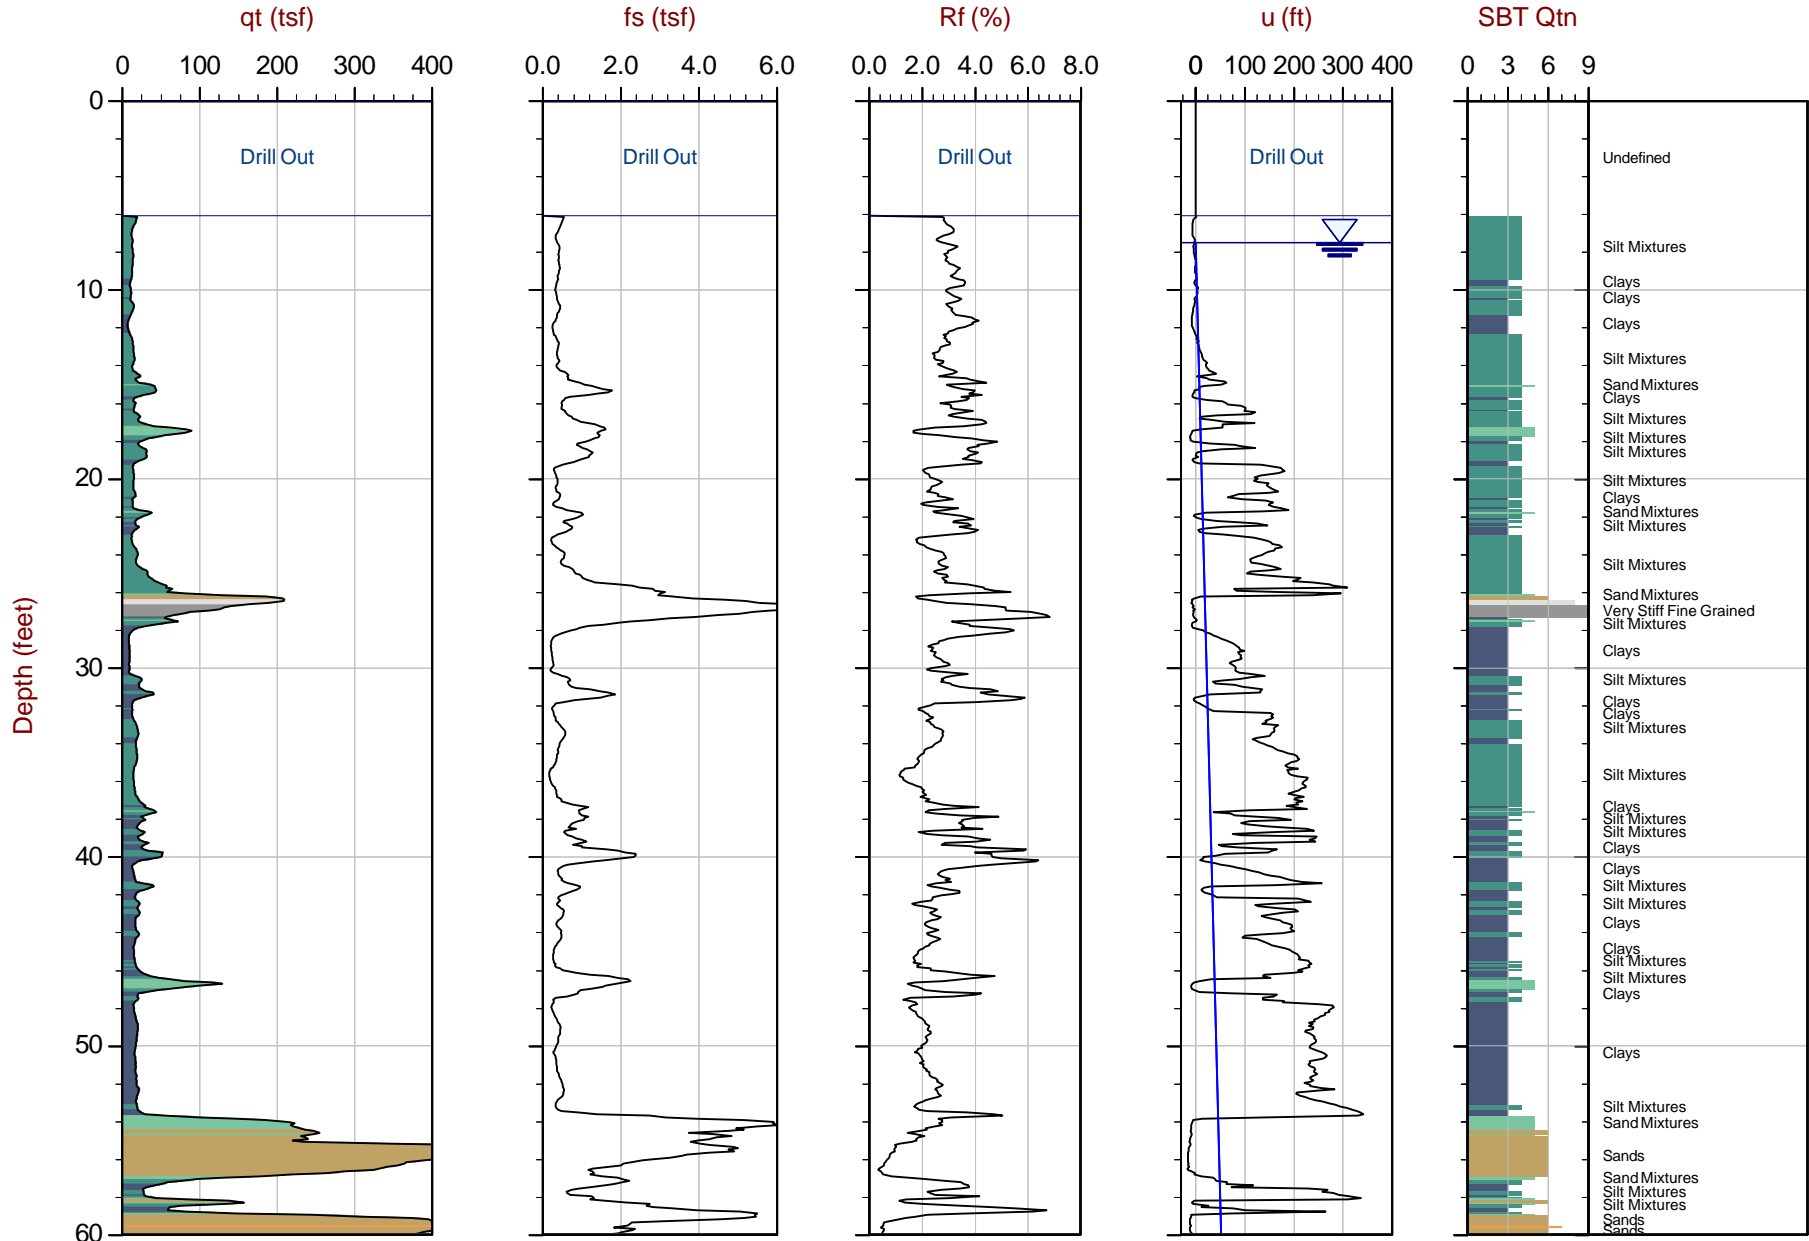
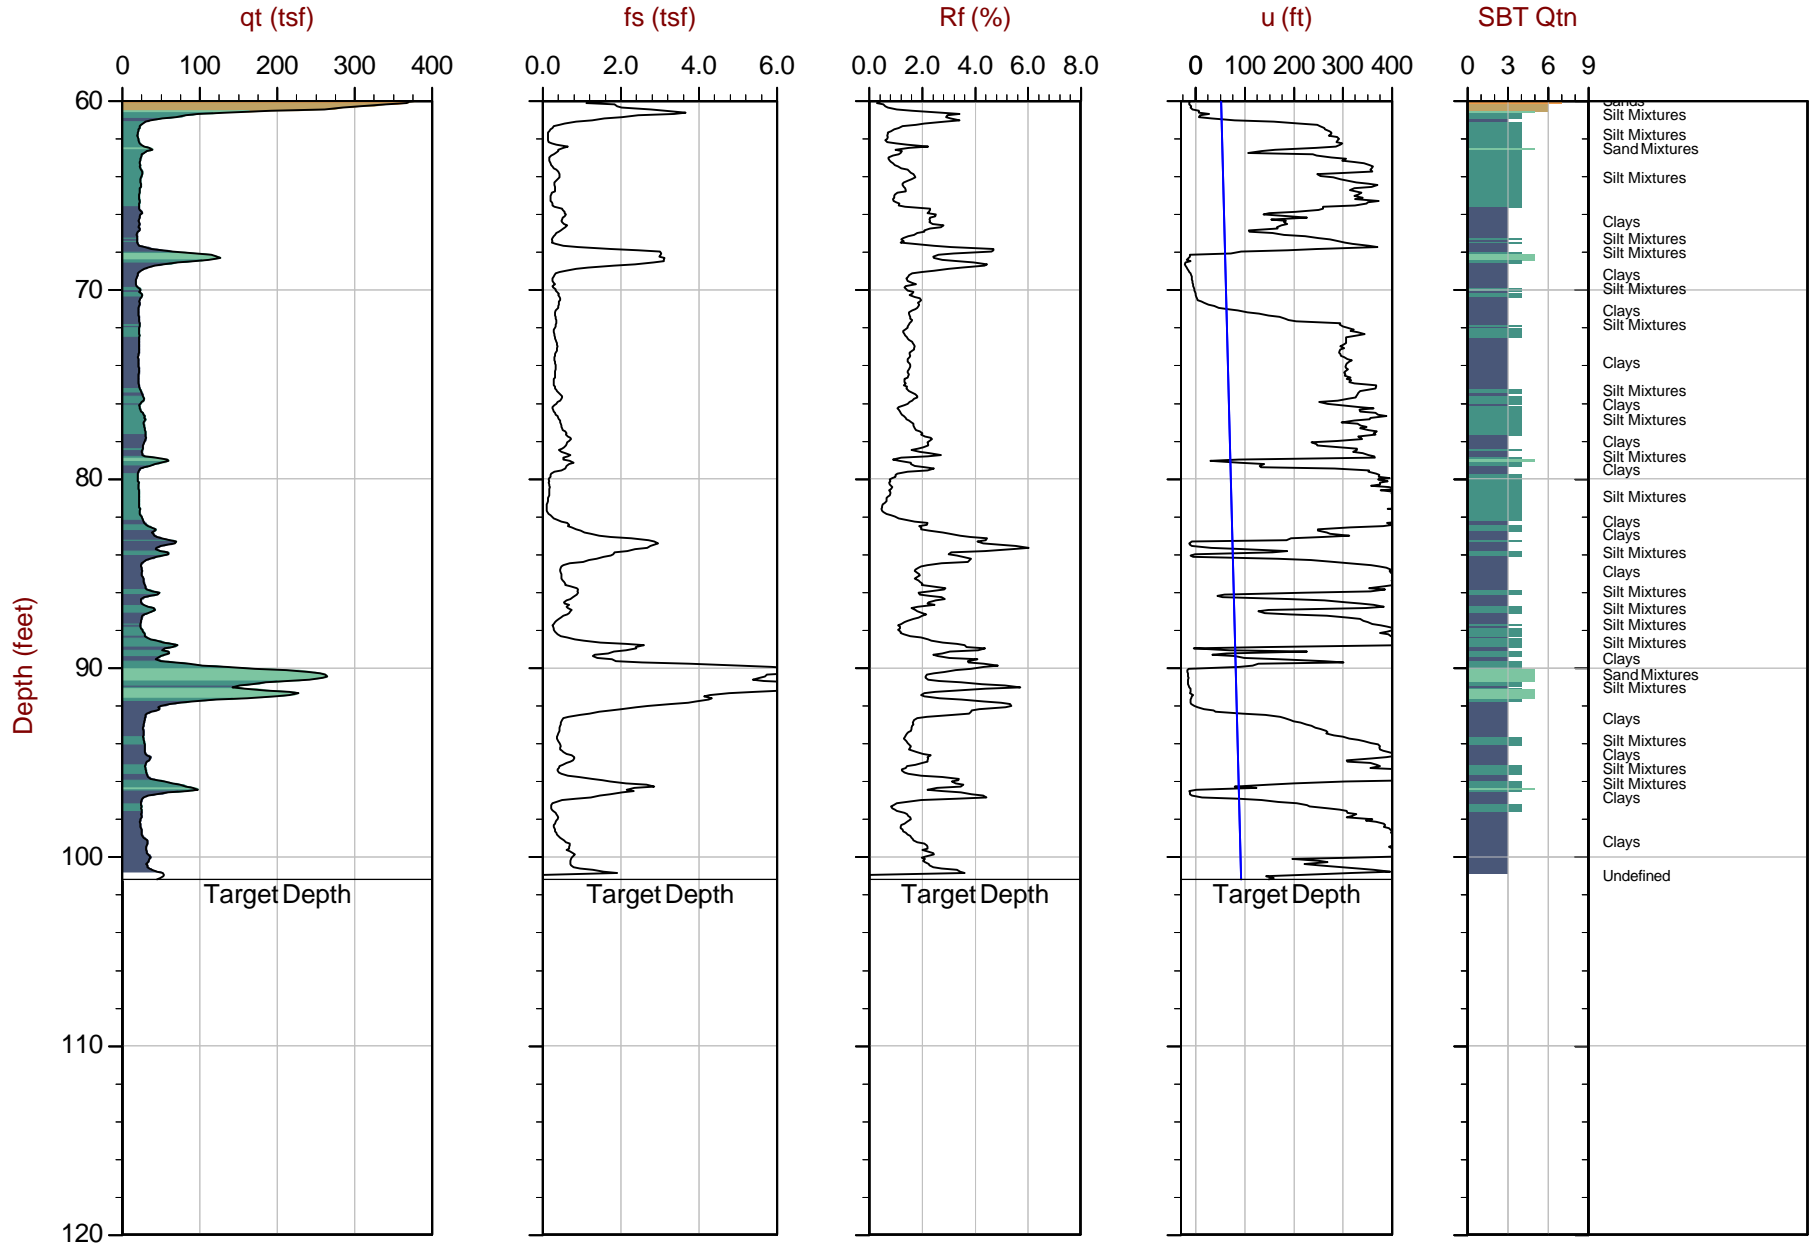
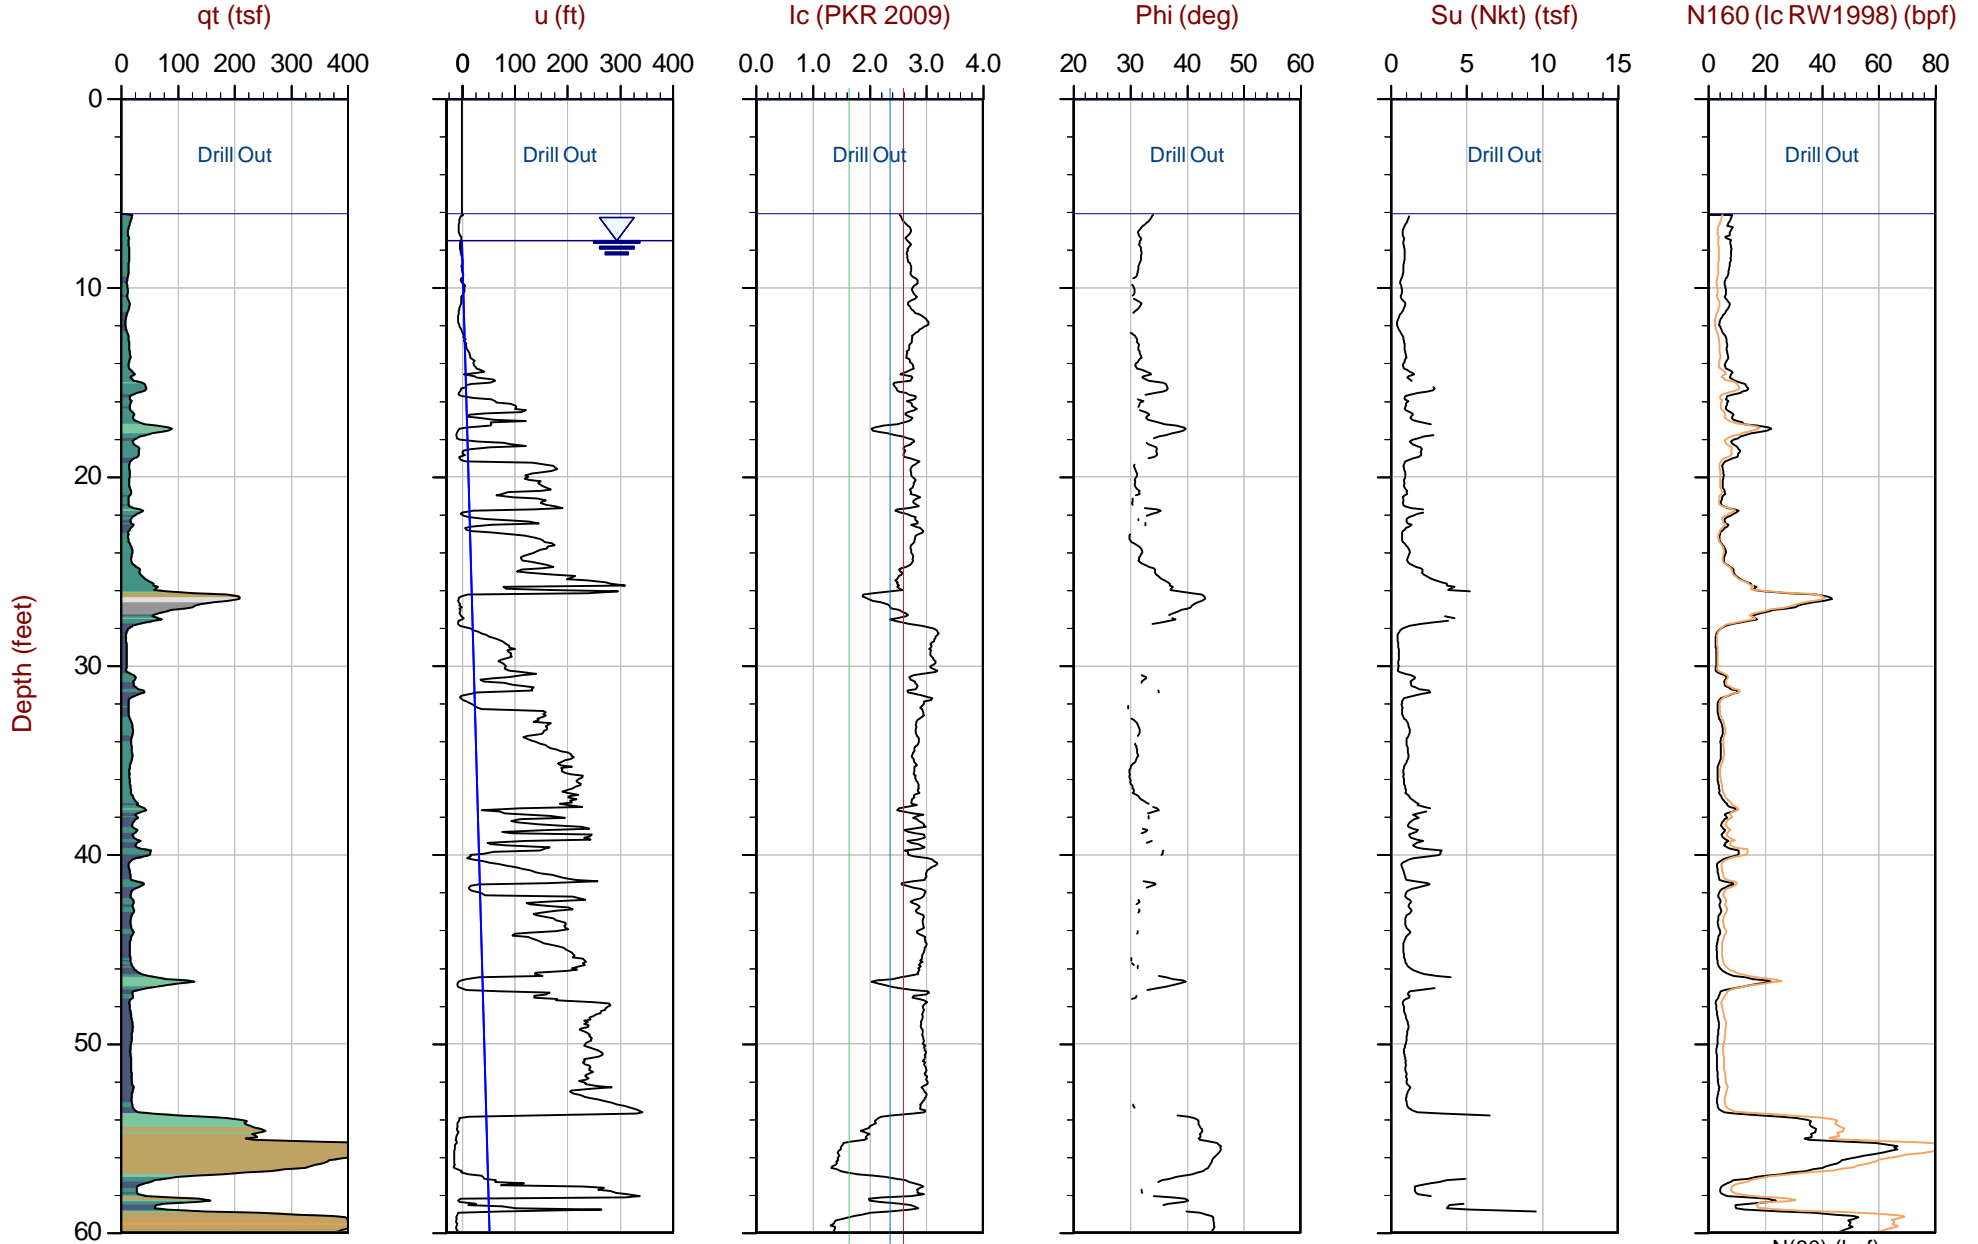
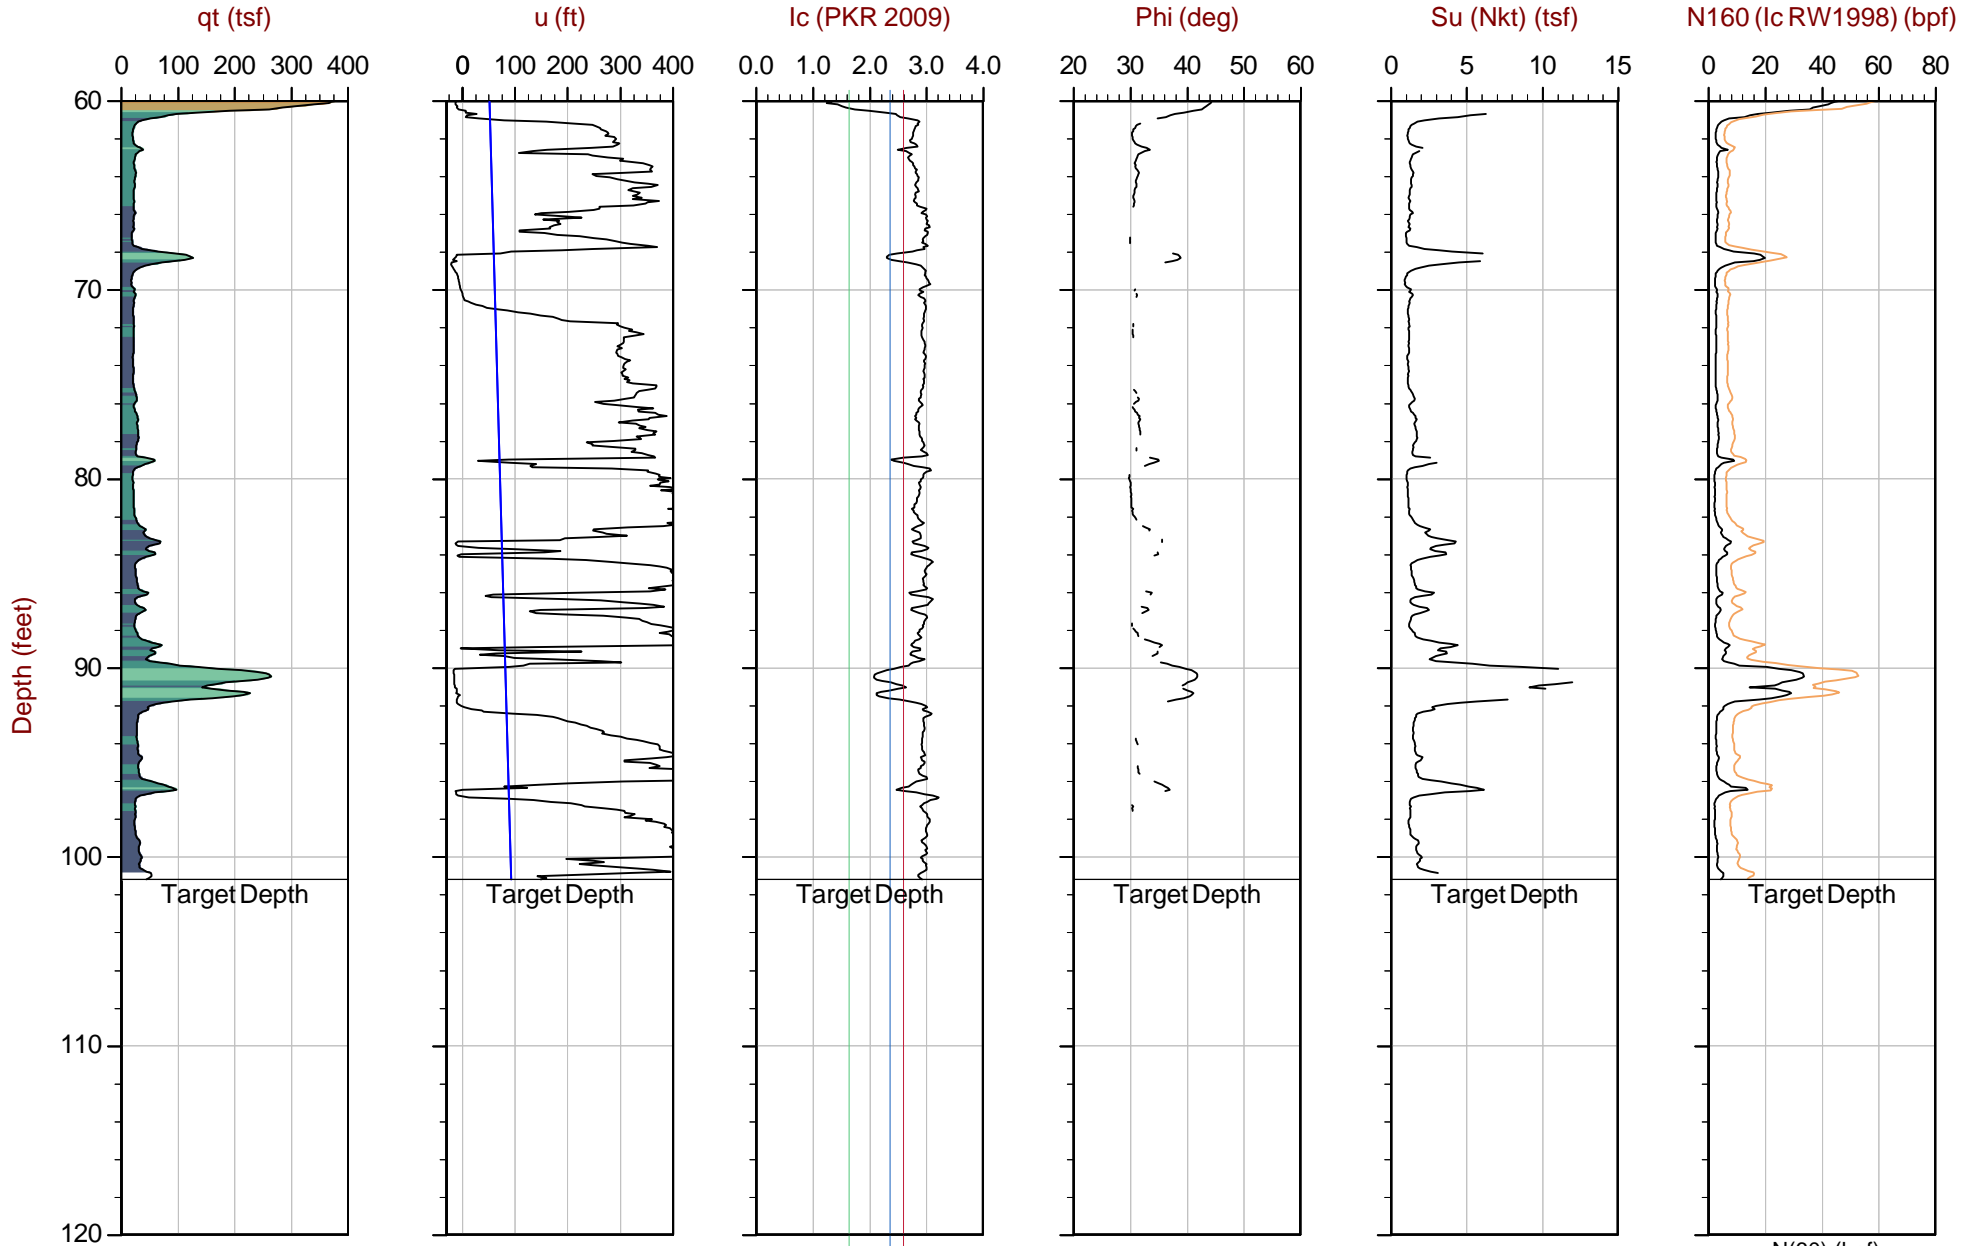
Sounding: CPT-06
Cone: 446:T1500F15U500

Max Depth: 30.850 m / 101.21 ft
 Depth Inc: 0.025 m / 0.082 ft
 Avg Int: Every Point

● Equilibrium Pore Pressure (Ueq)
 ● Assumed Ueq
 ◀ Dissipation, Ueq achieved
 ◀ Dissipation, Ueq not achieved
 — Hydrostatic Line

Job No: 19-56150
Date: 2019-09-25 08:22
Site: East Whisman

A penetrometer with a conical tip having an apex angle of 60 degrees and a cone base area of 15 square centimeters was hydraulically pushed through the soil using the reaction mass of a 30-ton rig at a constant rate of about 20 millimeters per second in accordance with ASTM D 5778. The penetrometer was instrumented to measure, by electronic methods, the water pressure acting on a transducer near the cone tip, the force on the conical point required to penetrate the soil, and the force on a friction sleeve behind the cone tip as the penetrometer was advanced. Penetration and pore water pressure data (P_w) was collected and recorded electronically at intervals of approximately 1 inch. Cone resistance (Q_t) was calculated by dividing the measured force of penetration by the cone base area. Friction sleeve resistance (F_s) was calculated by dividing the measured force on the friction sleeve by the surface area of the sleeve. The friction ratio (R_f) was calculated as the ratio of the tip resistance to the sleeve friction (Q_t/F_s). A graph of the computed values of cone resistance (Q_t), friction ratio (F_s/Q_t), and pore water pressure (U) are presented on the logs in the following pages. The tip resistance and friction ratio were used to classify the soil type encountered using the method by Robertson and Campanella (1986). Equivalent SPT blowcounts at a 60 percent energy ratio with overburden correction ($N_{1(60)}$ values) were calculated from the tip resistance and friction ratio. A graph of the equivalent $N_{1(60)}$ values and the encountered soil types are also presented on the logs in the following pages.

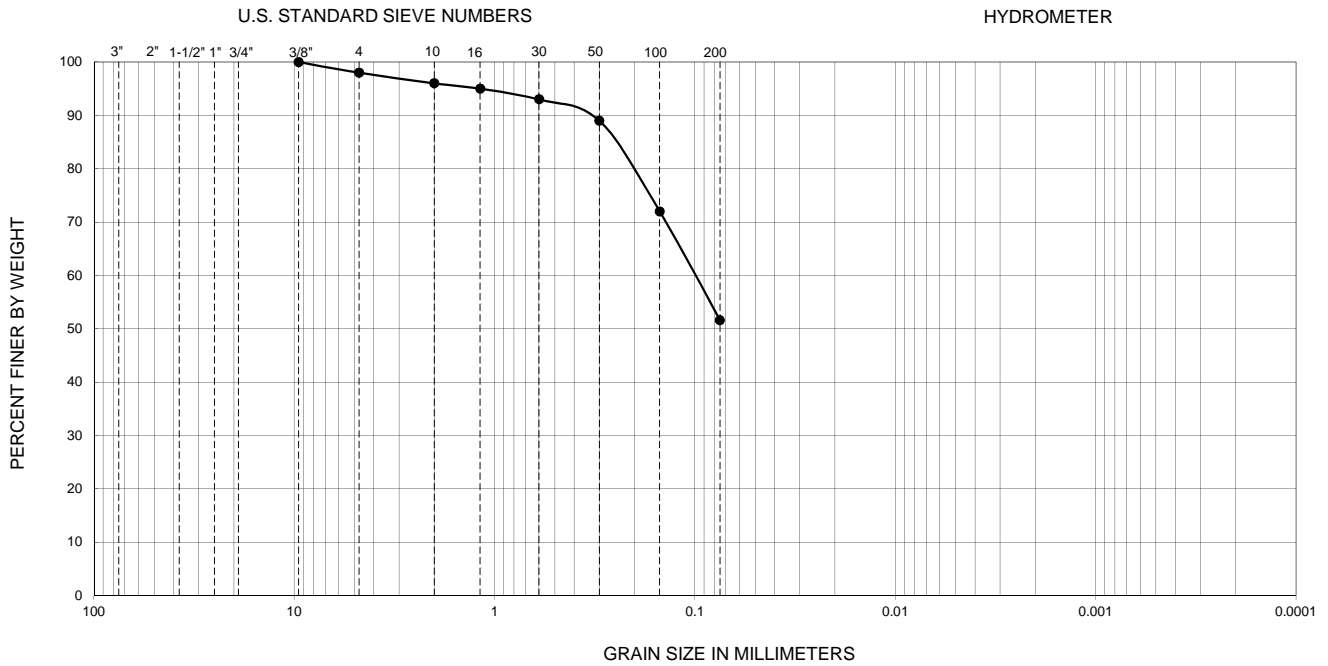
GRADATION TEST RESULTS

Symbol	Sample Location	Depth (ft)	Liquid Limit	Plastic Limit	Plasticity Index	D ₁₀	D ₃₀	D ₆₀	C _u	C _c	Passing No. 200 (percent)	USCS
●	B-2	21.0-21.5	--	--	NP	--	--	--	--	--	52	ML

PERFORMED IN ACCORDANCE WITH ASTM D 422 / D6913

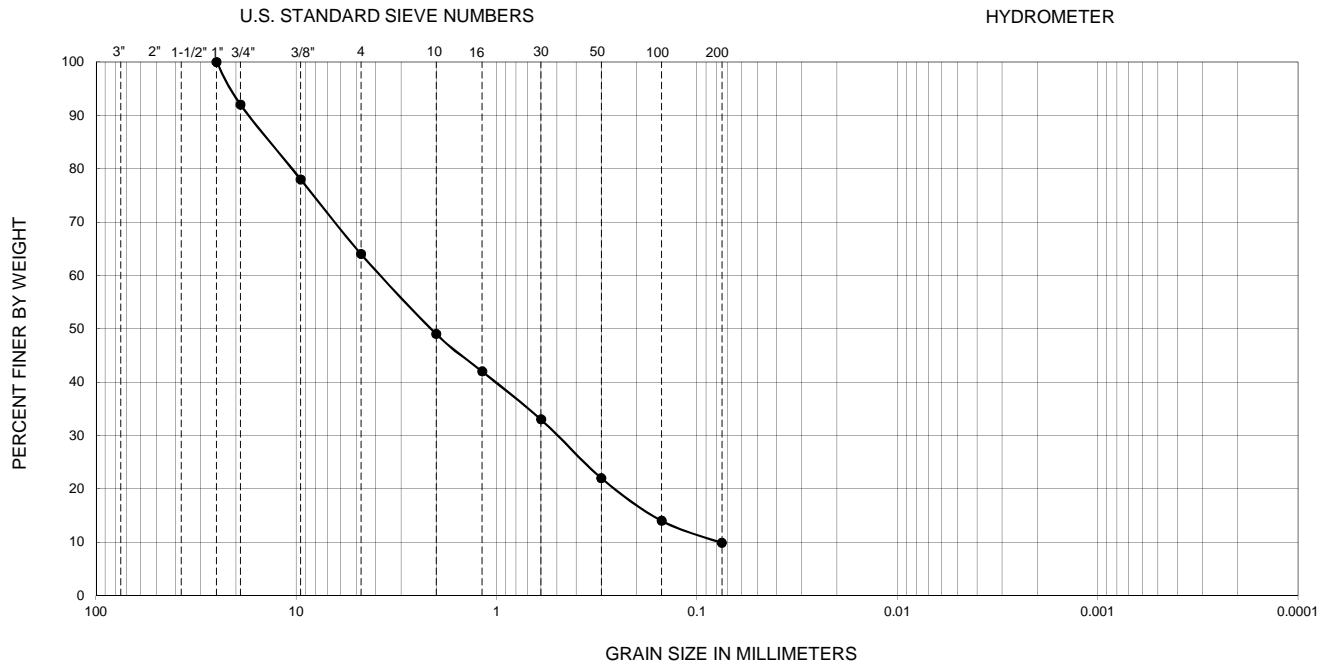
GRADATION TEST RESULTS

Symbol	Sample Location	Depth (ft)	Liquid Limit	Plastic Limit	Plasticity Index	D ₁₀	D ₃₀	D ₆₀	C _u	C _c	Passing No. 200 (percent)	USCS
●	B-2	25.0-26.5	--	--	--	0.08	0.50	3.80	50.7	0.9	10	SP-SC

PERFORMED IN ACCORDANCE WITH ASTM D 422 / D6913

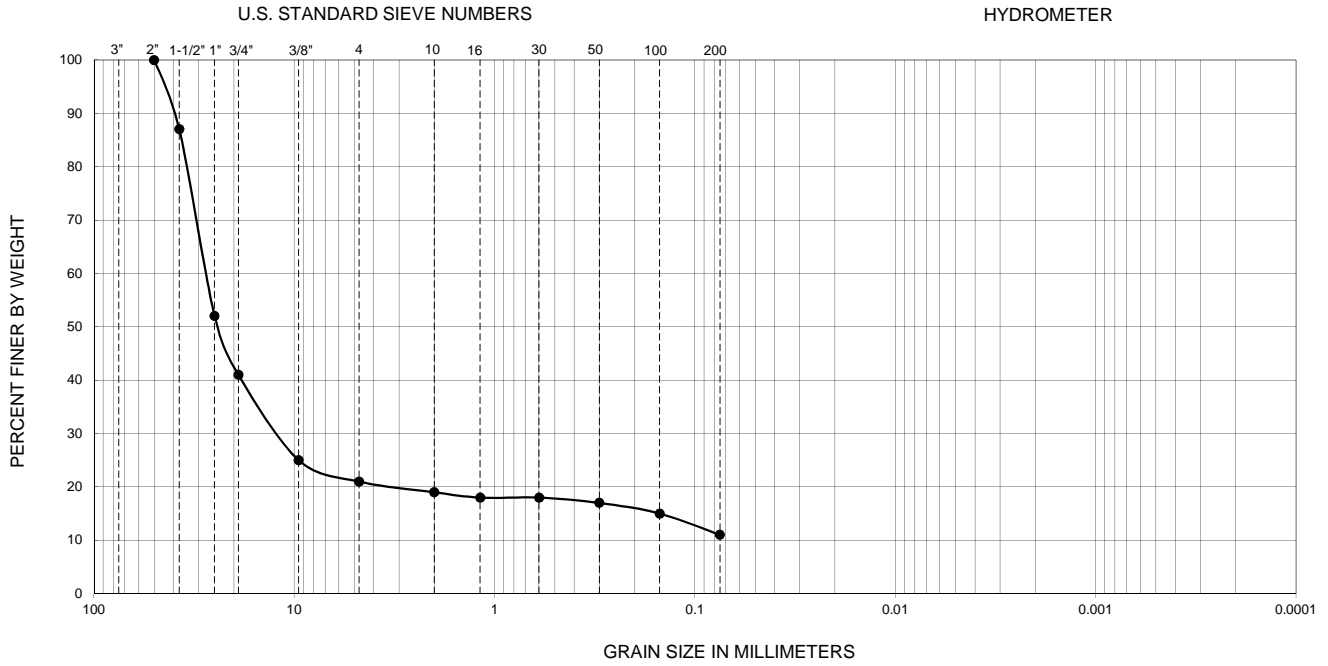
Symbol	Sample Location	Depth (ft)	Liquid Limit	Plastic Limit	Plasticity Index	D ₁₀	D ₃₀	D ₆₀	C _u	C _c	Passing No. 200 (percent)	USCS
●	B-2	31.0-31.5	--	--	--	0.075	12.5	27.9	372.0	74.7	11	GP-GM

PERFORMED IN ACCORDANCE WITH ASTM D 422 / D6913

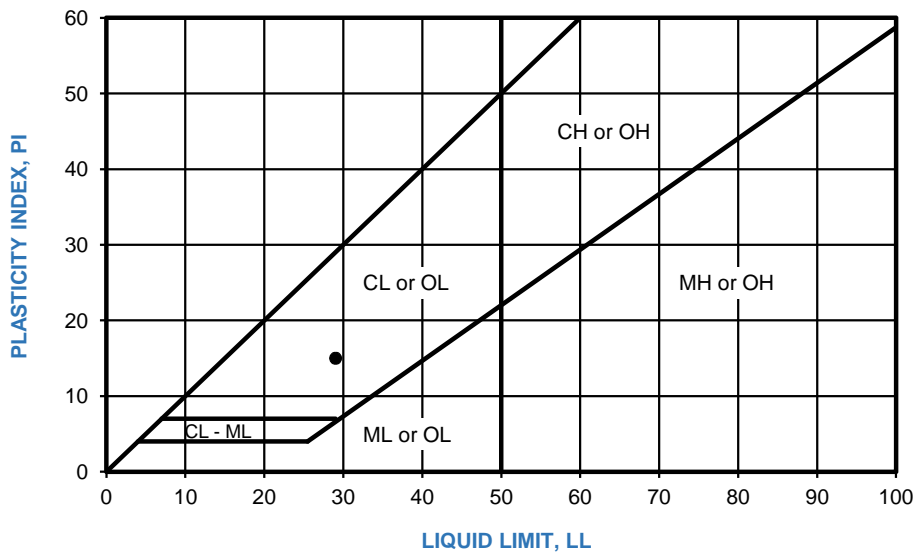
FIGURE C-4

SYMBOL	LOCATION	DEPTH (ft)	LIQUID LIMIT	PLASTIC LIMIT	PLASTICITY INDEX	USCS CLASSIFICATION (Fraction Finer Than No. 40 Sieve)	USCS
●	B-2	10.0-11.5	29	14	15	CL	CL
■	B-2	21.0-21.5	--	--	NP	ML	ML

NP - INDICATES NON-PLASTIC

PERFORMED IN ACCORDANCE WITH ASTM D 4318

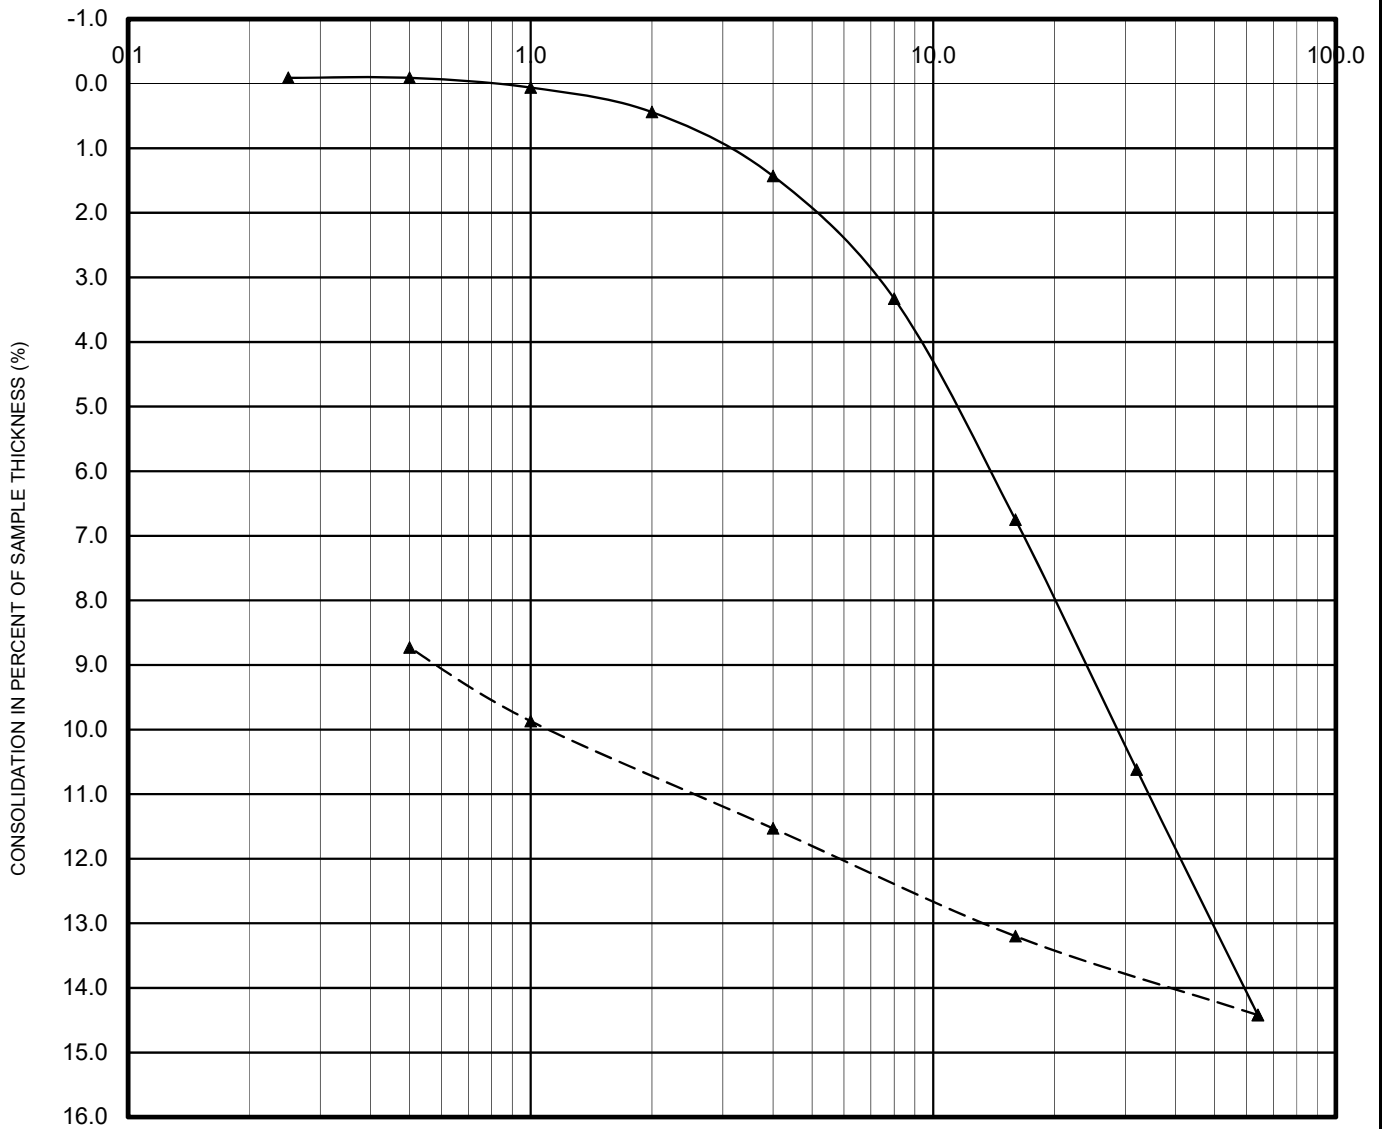
STRESS IN KIPS PER SQUARE FOOT

—▲— Loading After Inundation
-▲- Rebound Cycle

Sample Location
Depth (ft)
Soil Type
