Feasibility Level Geotechnical Evaluation

East Whisman
450 Clyde Avenue
Mountain View, California

April 3, 2020 | Project No. 403253010

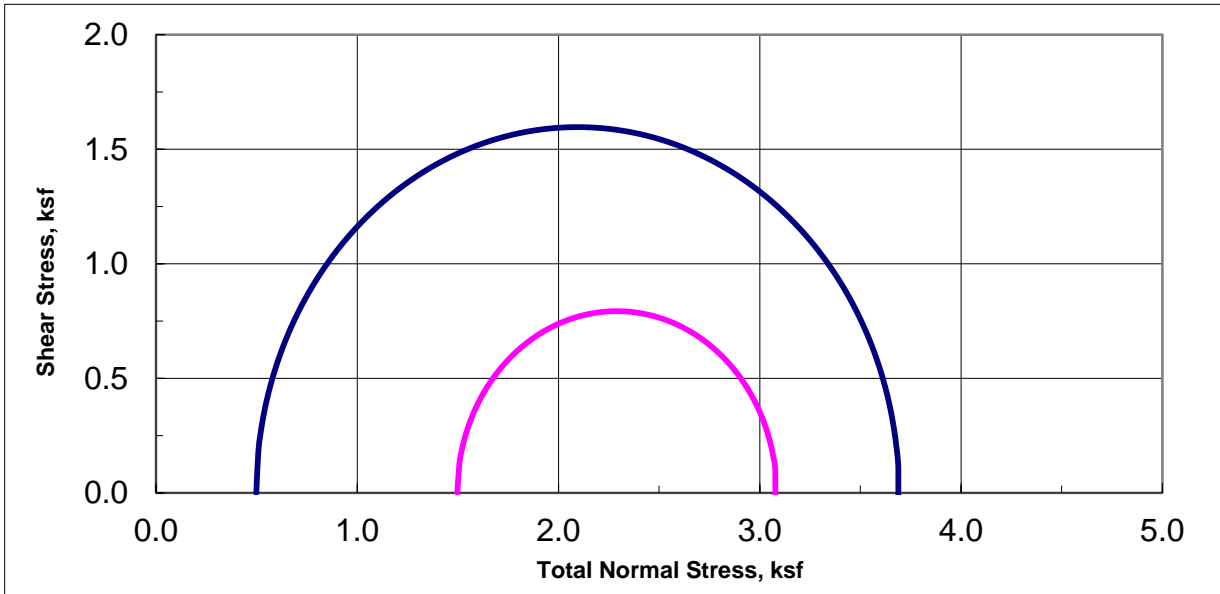
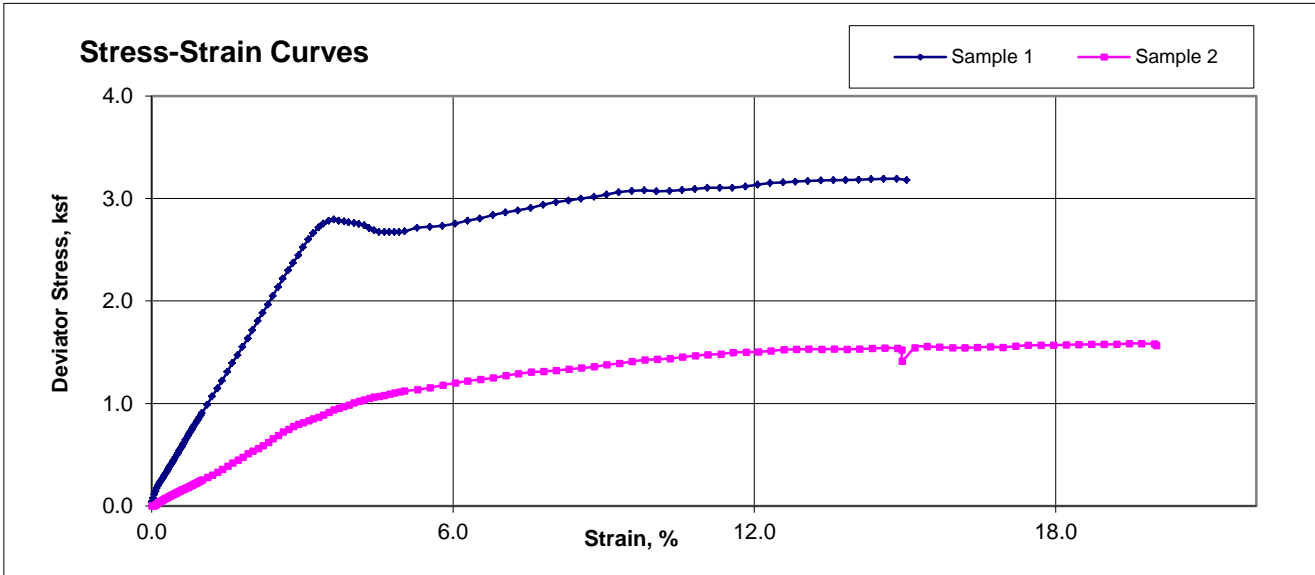
SYMBOL	DESCRIPTION	SOIL TYPE	SAMPLE LOCATION	SAMPLE DEPTH (ft.)	MOISTURE CONTENT w , (%)	DRY DENSITY γ_d , (pcf)	CELL PRESSURE (ksf)	UNDRAINED SHEAR STRENGTH (ksf)
◆	Dark Gray Sandy Lean CLAY	CL	B-2	3.0-4.0	21.3	94.8	0.50	1.60
●	Brown Lean CLAY	CL	B-2	15.0-17.0	24.4	99.7	1.50	0.80

PERFORMED IN ACCORDANCE WITH ASTM D 2850
 STRAIN RATE: 1.0%/MIN

Triaxial compression tests were performed on selected relatively undisturbed samples in accordance with ASTM D 2850. The test results are shown on Figure C-8.

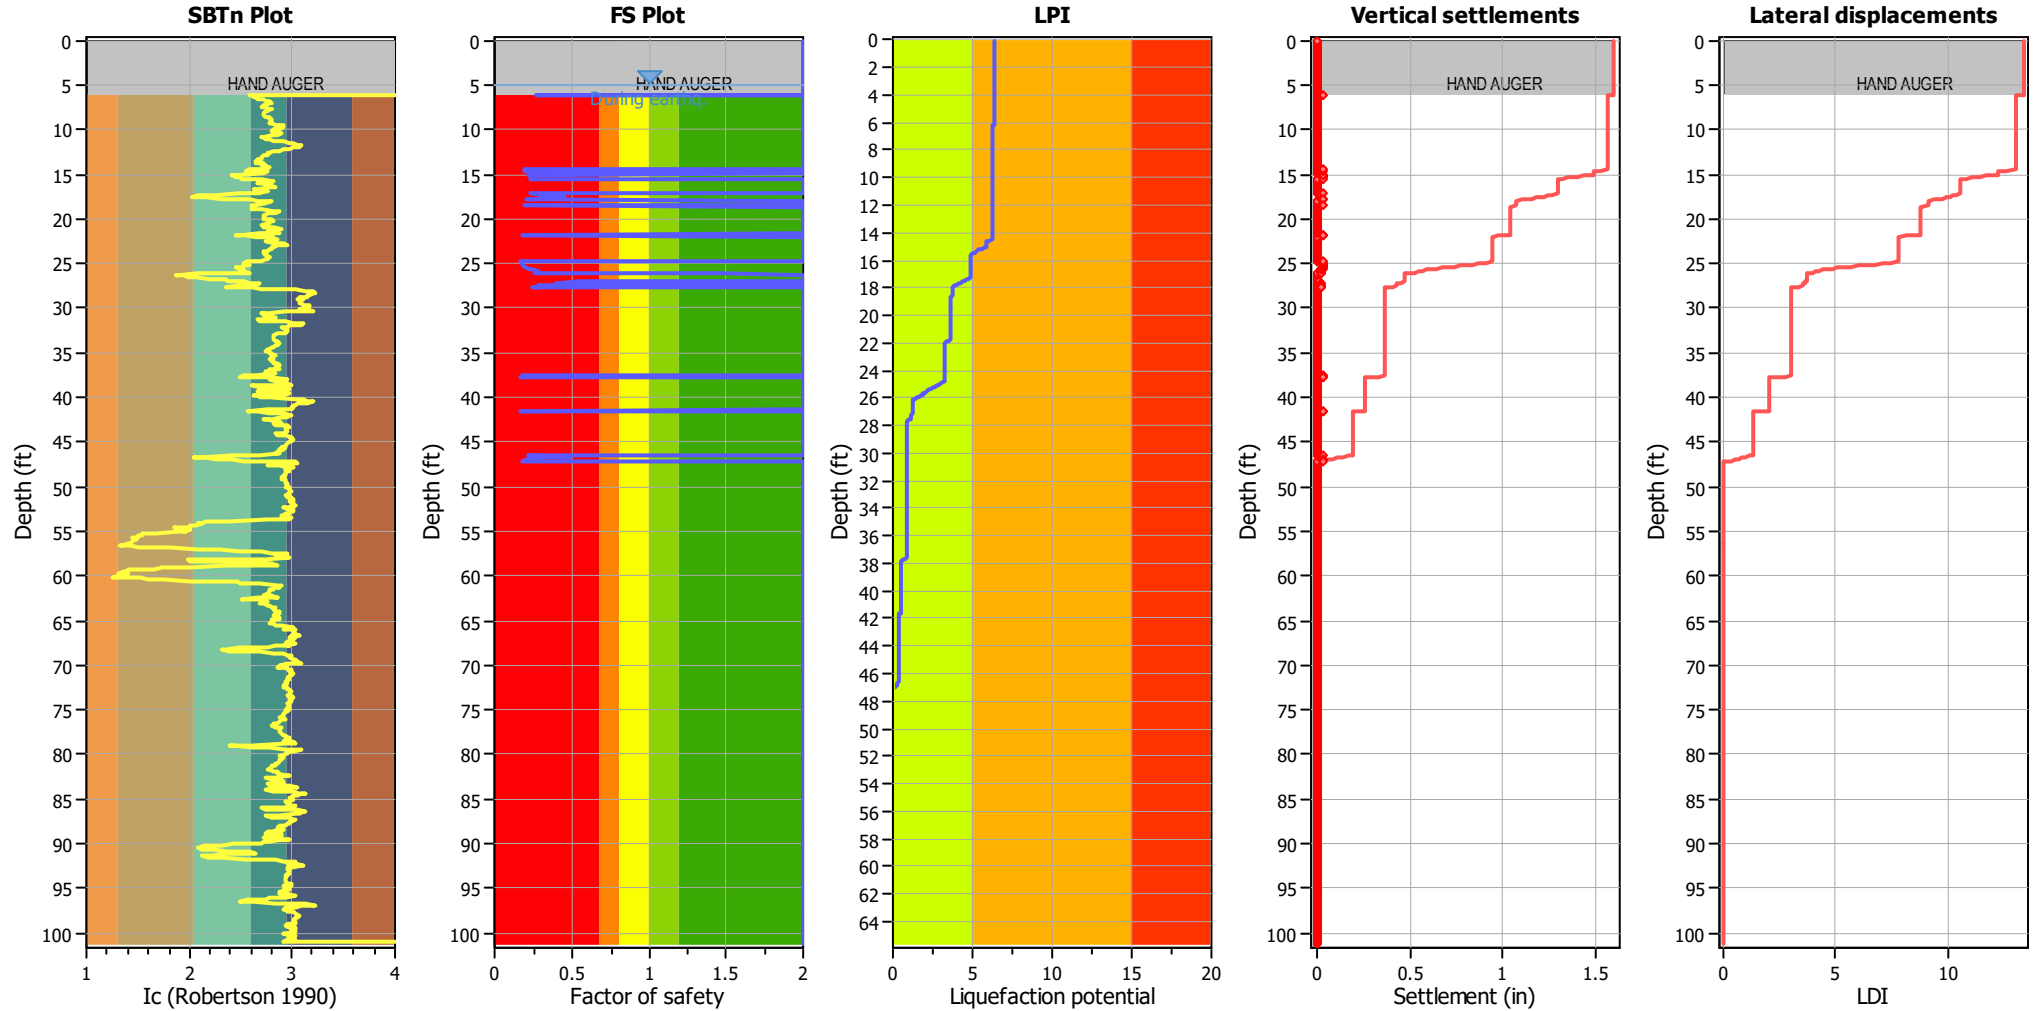
CPT: CPT-6
 Total depth: 101.21 ft

Analysis method:	B&I (2014)	G.W.T. (in-situ):	7.30 ft	Use fill:	No	Clay like behavior	
Fines correction method:	B&I (2014)	G.W.T. (earthq.):	5.00 ft	Fill height:	N/A	applied:	.
Points to test:	Based on Ic value	Average results interval:	1	Fill weight:	N/A	Limit depth applied:	Yes
Earthquake magnitude M_w :	7.30	Ic cut-off value:	2.60	Trans. detect. applied:	No	Limit depth:	50.00 ft
Peak ground acceleration:	0.72	Unit weight calculation:	Based on SBT	K_σ applied:	Yes	MSF method:	Method based
