Geologic Impact Analysis  
Santa Rosa Fire Station 5  
1400 Fountaingrove Parkway  
Santa Rosa, California

Ross Drulis Cusenbery Architecture, Inc.  
18294 Sonoma Highway | Sonoma, California 95476

December 14, 2020 | Project No. 403891001

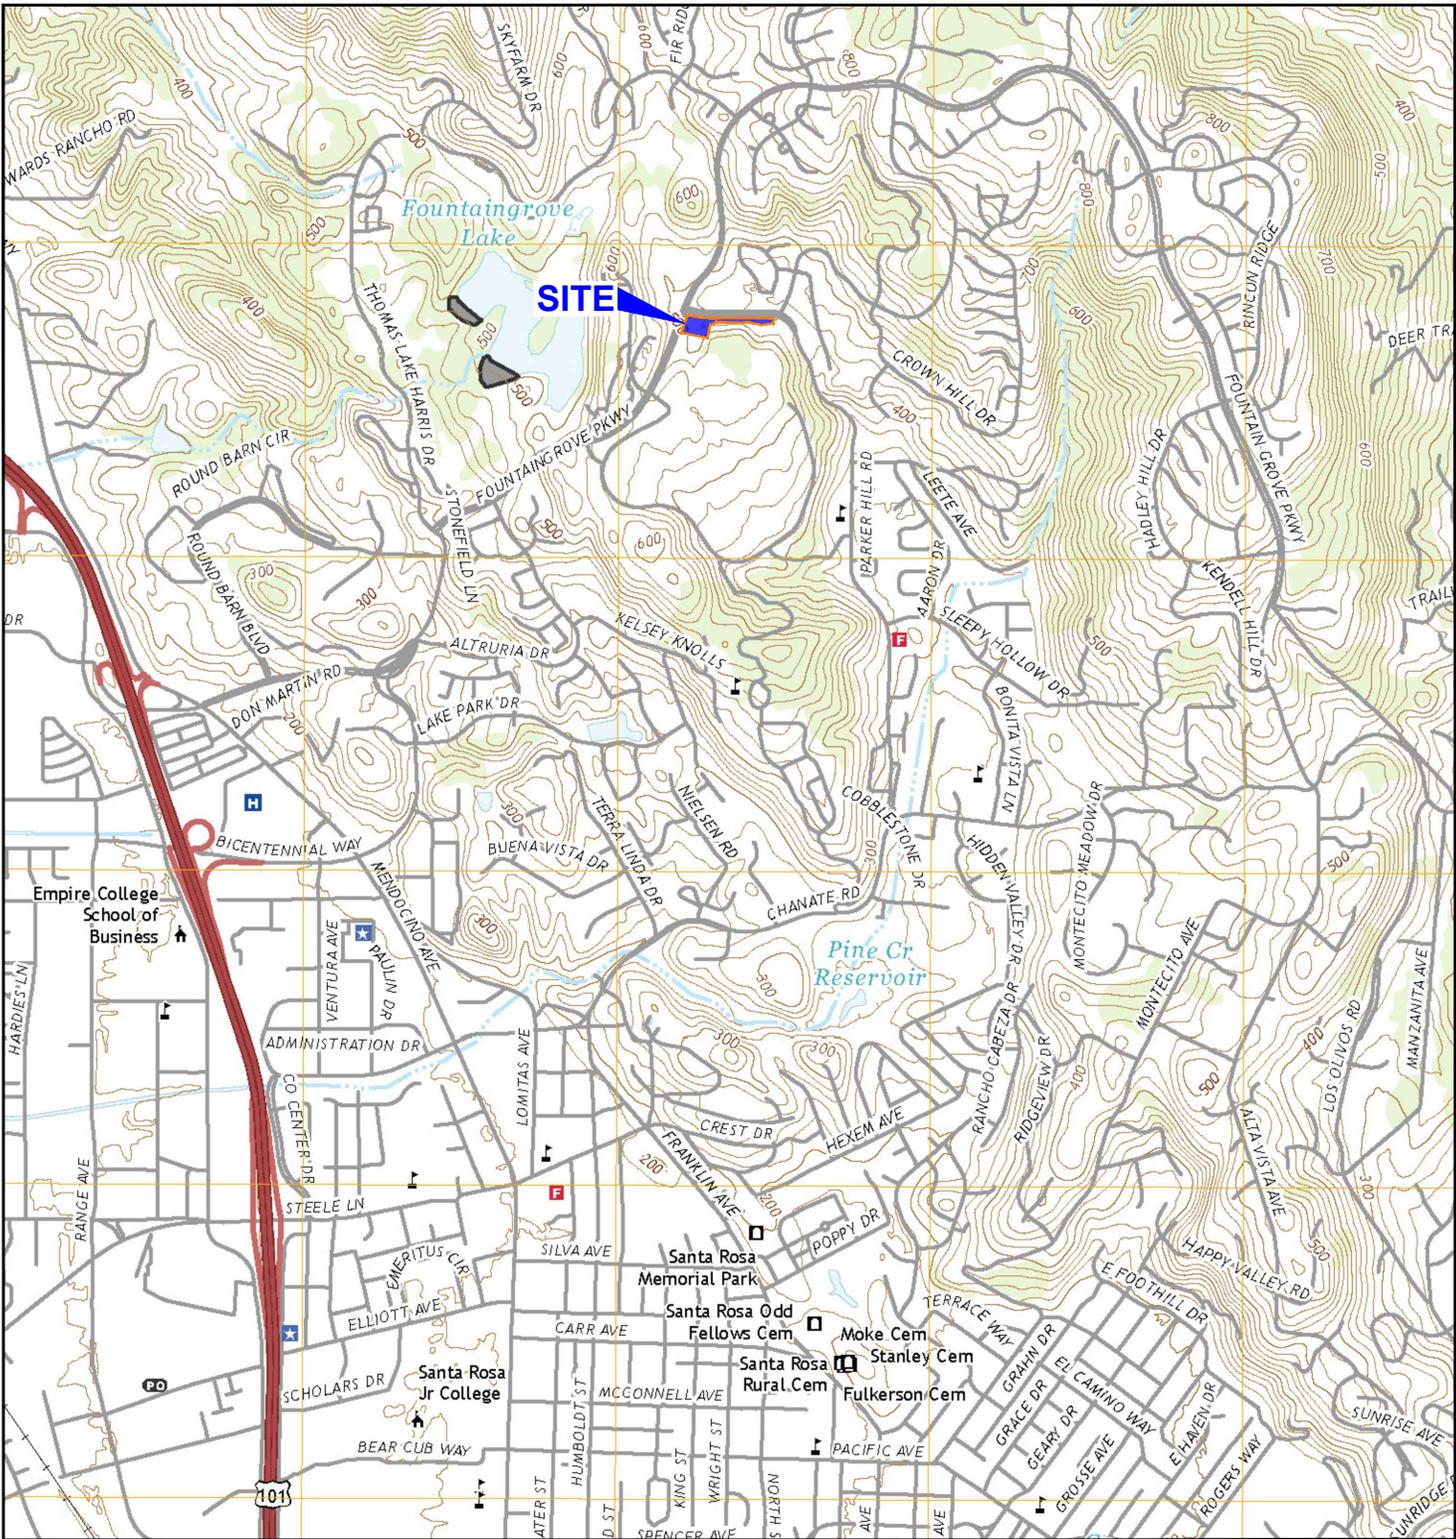
**FIGURE 1**

NOTE: DIMENSIONS, DIRECTIONS, AND LOCATIONS ARE APPROXIMATE | REFERENCE: USGS, 2018

In accordance with your authorization, we have performed a Geologic and Geotechnical Impact Analysis for the proposed Permanent Fire Station 5 Rebuild project located at 1400 Fountaingrove Parkway, at the southeast corner of intersection of Fountaingrove Parkway and Stagecoach Road in Santa Rosa, California (Figures 1 and 2). The purpose of this study was to evaluate the geologic and soil conditions at the project site based on available information, and to assess potential project impacts related to geology and soil.

The subject property is located in a hillside neighborhood and encompasses approximately 2 acres of undeveloped land (Figures 1 and 2). Access to the site is provided by a gravel paved road that is located about 100 feet south of the intersection of Fountaingrove Parkway and Stagecoach Road. Parts of the site were impacted by the 2017 Tubbs Fire that burned several trees on the site that have since been cut down and removed. Vegetation at the site includes patches of light grasses and weeds and scattered shrubs and trees that were not impacted by the fire.

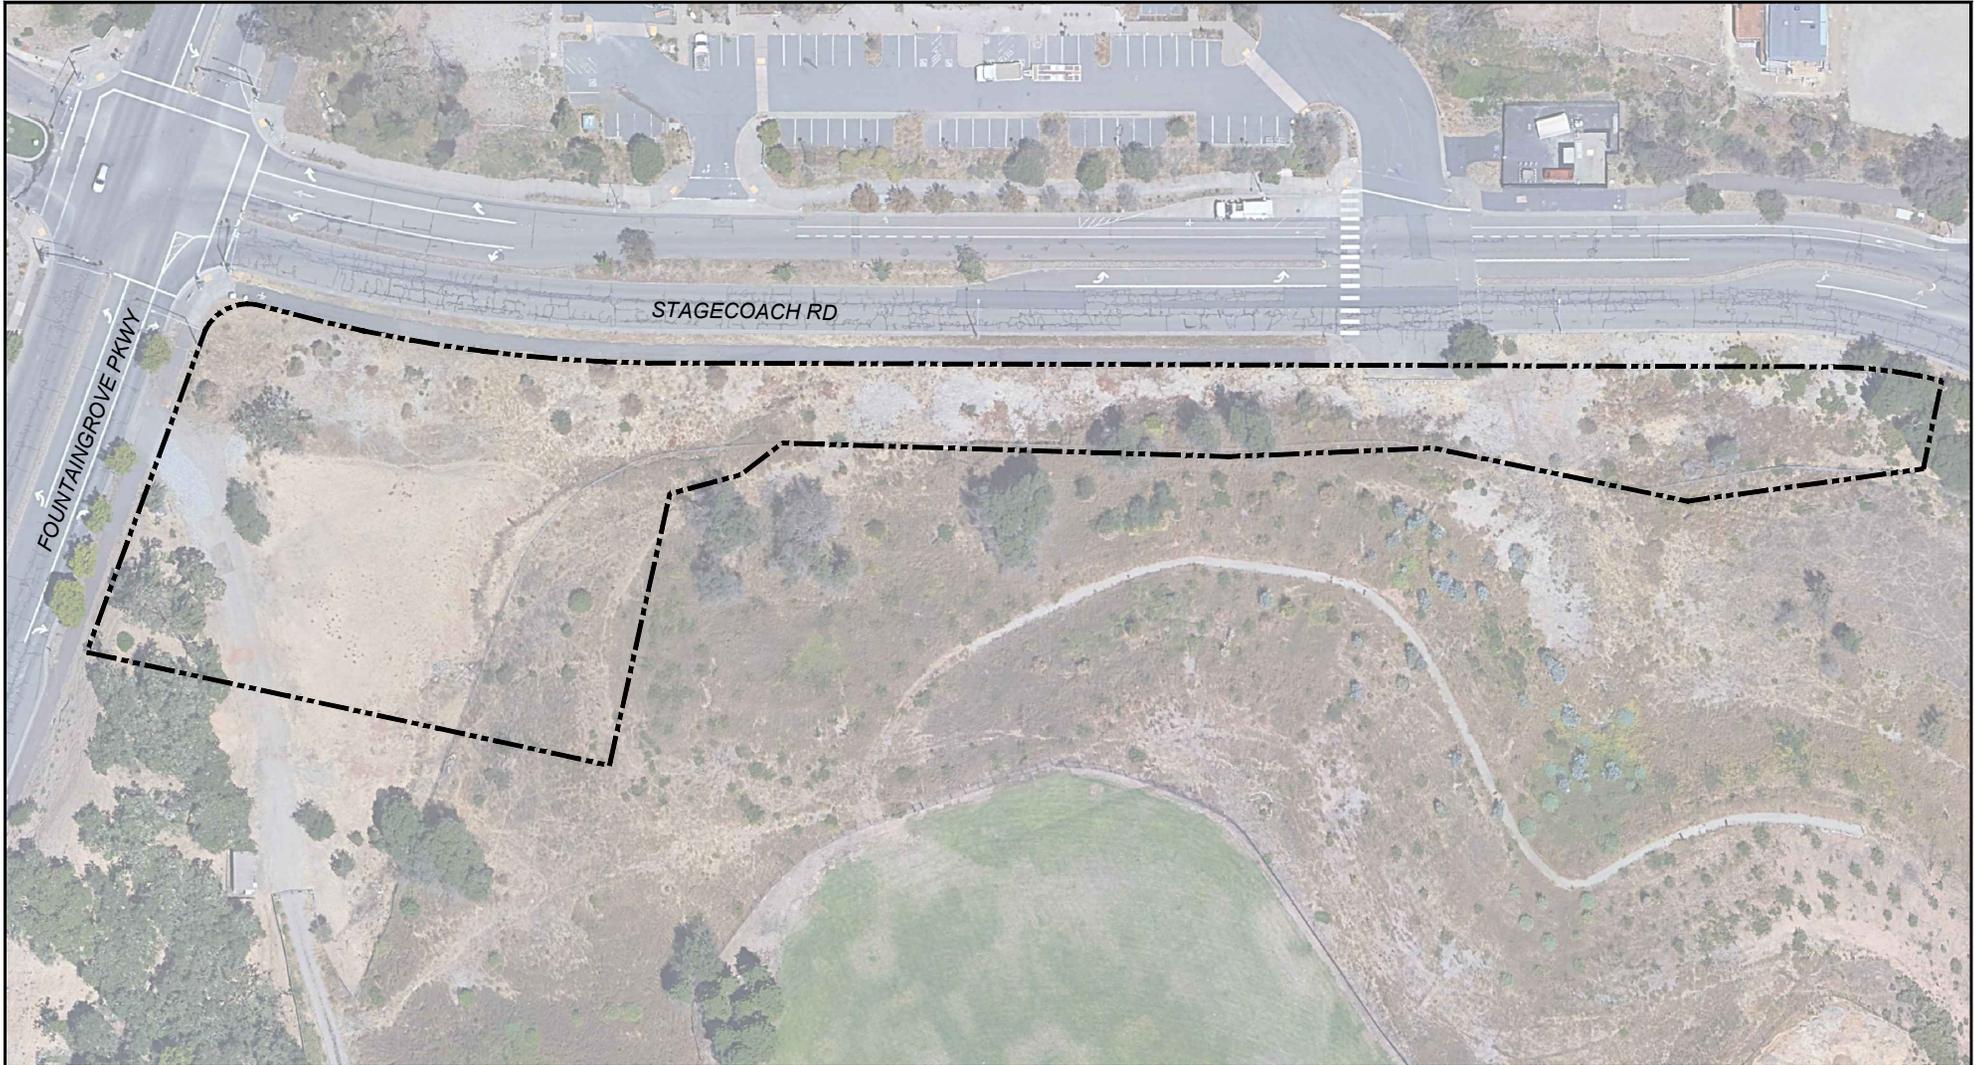
**FIGURE 2**

**LEGEND**  
- - - - - SITE BOUNDARY

NOTE: DIMENSIONS, DIRECTIONS, AND LOCATIONS ARE APPROXIMATE | REFERENCE: GOOGLE EARTH, 2020

The project site has an irregular shape and includes a rectangular-shaped area at its western end adjacent to Fountaingrove Parkway and a narrow strip, or panhandle, that runs parallel to Stagecoach Road (Figures 2 and 3). The proposed fire station will be located in the rectangular area at the west end of the site, which includes a large pad area that has a surface gradient of about 10% and drains to the northeast into a small creek.

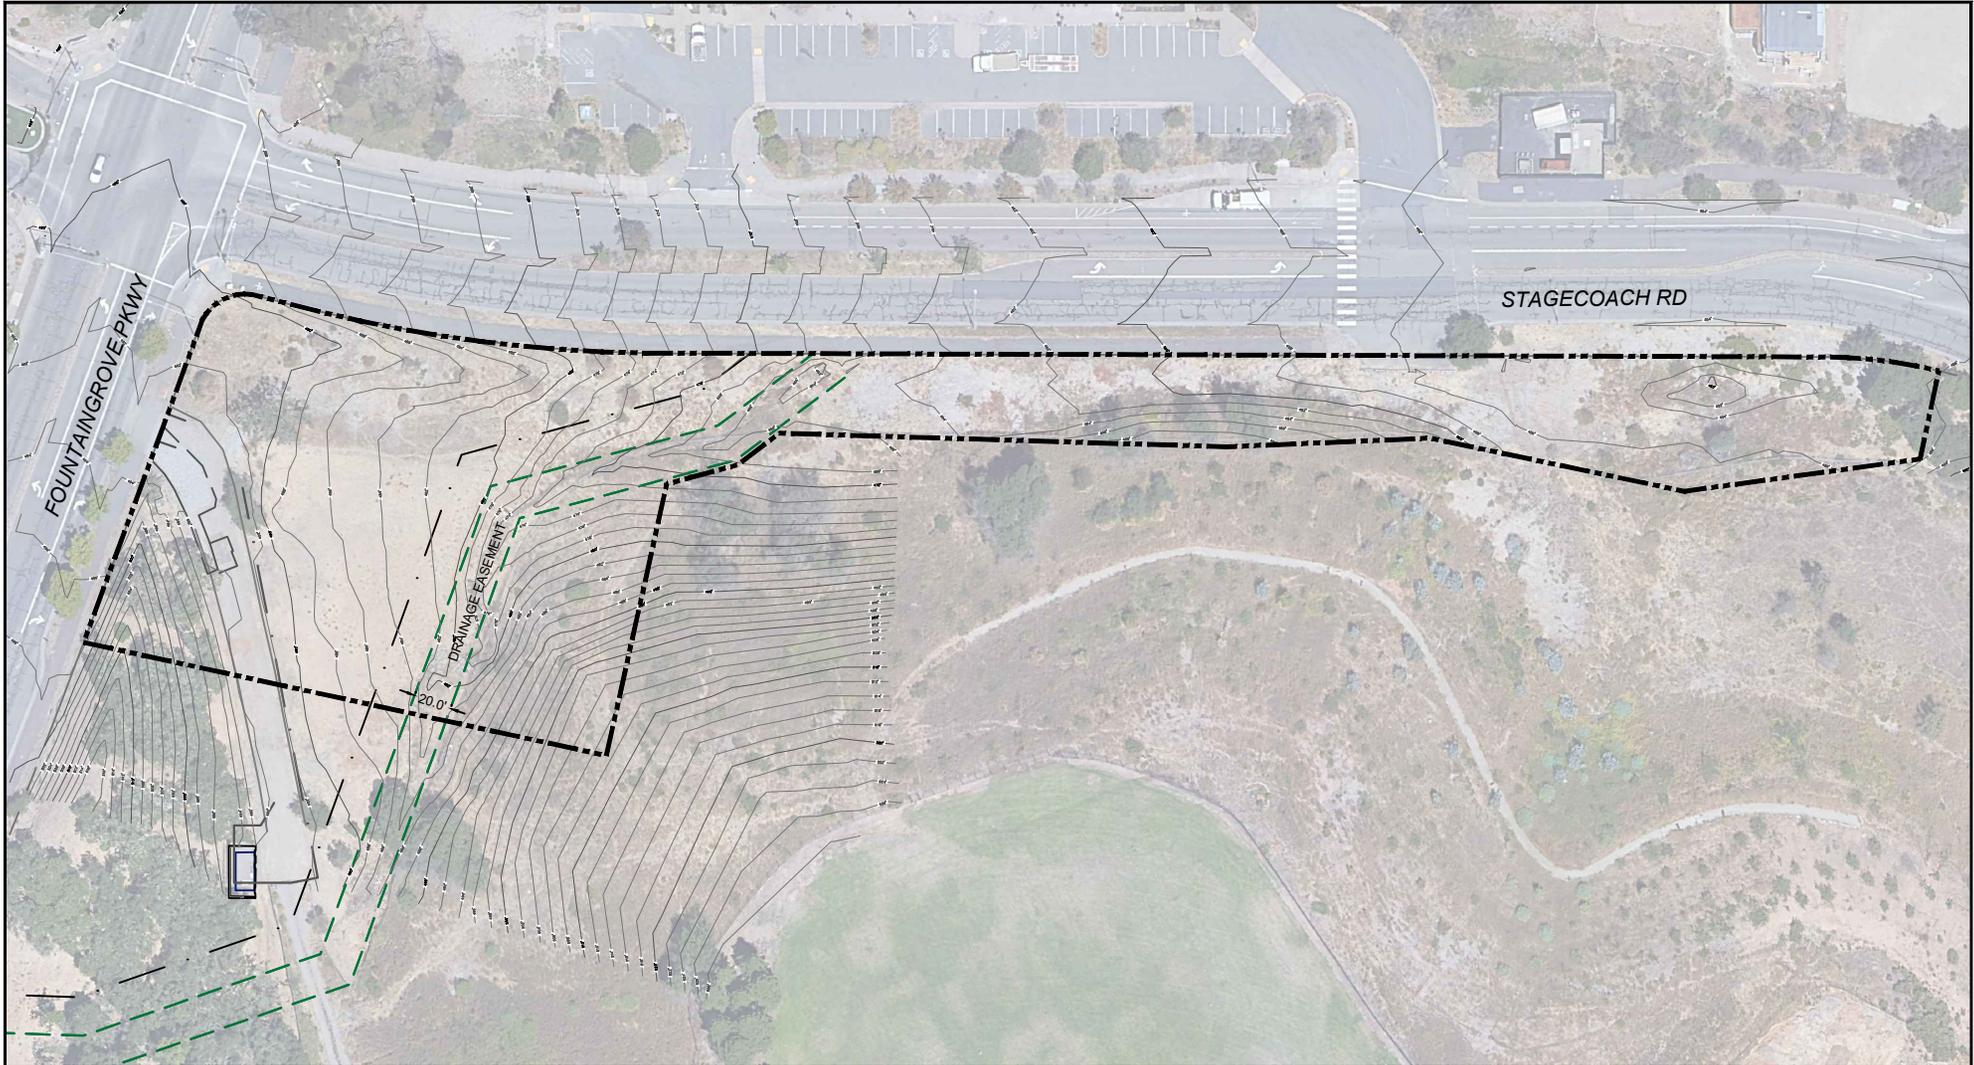
**FIGURE 3**

**LEGEND**  
 - - - - - SITE BOUNDARY

NOTE: DIMENSIONS, DIRECTIONS, AND LOCATIONS ARE APPROXIMATE | REFERENCES: RossDrulisCusenbery, 2020; GOOGLE EARTH, 2020

The proposed fire station project consists of an approximately 9,000- to 11,000-square-foot, one- or two-story essential structure with three drive through apparatus bays along with paved driveways, an above-ground fuel storage tank and an emergency generator pad (RDC, 2020). Conceptual plans for the project indicate that development of the site will require cut and fill grading and may require construction of retaining walls and excavation along the adjoining slopes (Figure 3).

Topographic features at the site include the large pad area, ascending slopes along the eastern, southwestern, and southern site boundaries, and a small creek channel that runs along the base of the eastern slope (Figure 3). The top of the eastern slope lies at an elevation of about 530 feet above mean sea level (MSL) and descends to an elevation of about 470 feet above MSL with an overall height of about 60 feet. The overall horizontal to vertical ratios of the slope vary from about 3:1 to 4:1 (H:V), with localized lower portions of the slope at about 2:1 (H:V). A smaller slope with a height of about 16 feet is located in the southwest corner of the project site along Fountaingrove Parkway. The creek channel that runs along the eastern side of the pad area flows to the northeast into a storm water inlet structure on the south side of Stagecoach Road. The creek channel currently conveys surface drainage from the pad area and adjoining hillsides along with drainage off of Fountaingrove Parkway via a 36-inch diameter CMP culvert that flows into the head of the channel, which is located south of the site. Within the site boundaries, the creek consists of a one- to two-foot deep, unlined, open channel that exposes surficial soil overlying bedrock. The current conceptual plans include the creek channel within a drainage easement that connects to the existing inlet structure at Stagecoach Road (RDC, 2020).

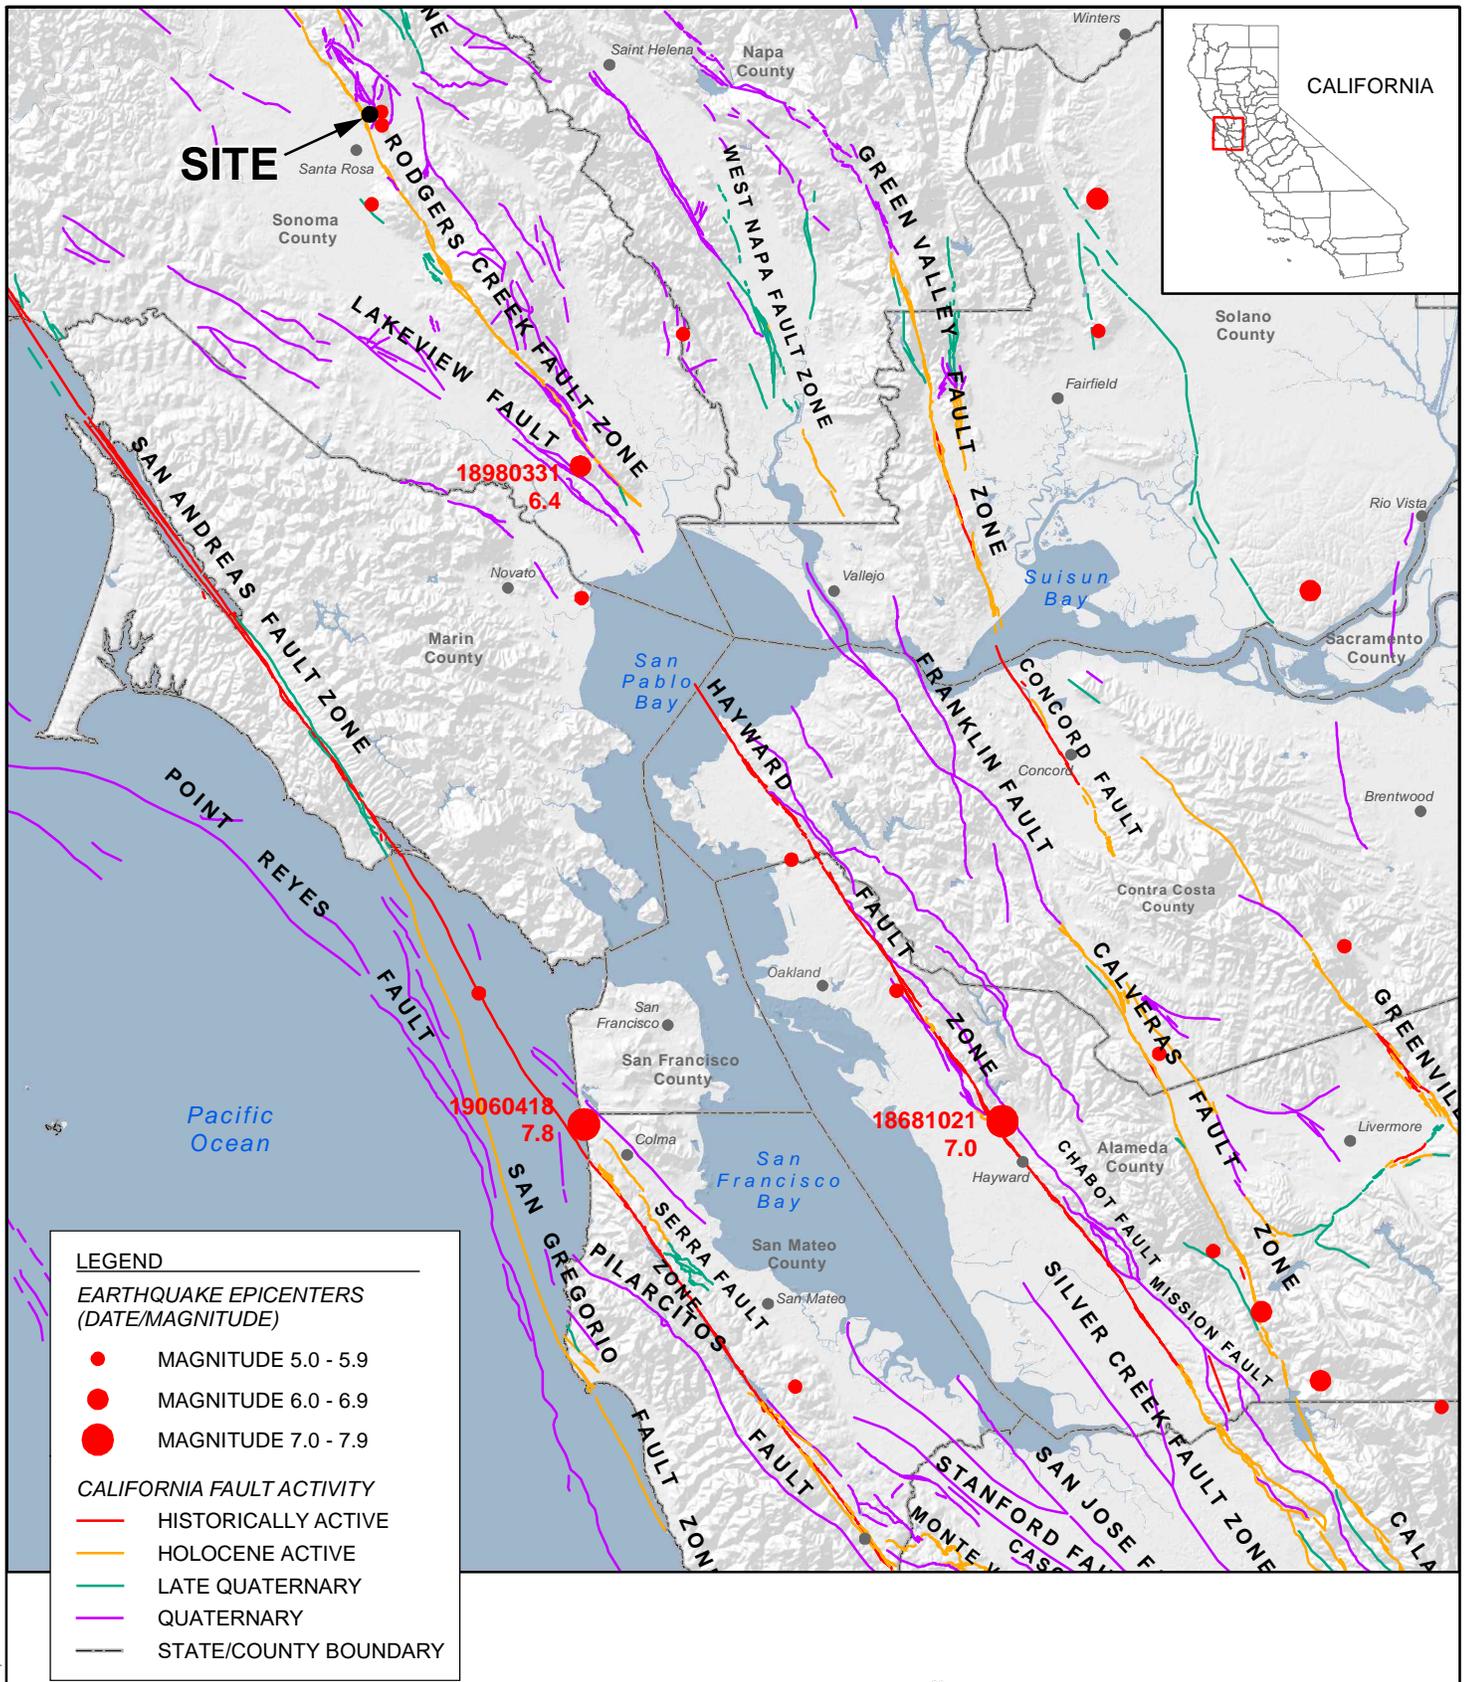
**FIGURE 4**

**FAULT LOCATIONS AND EARTHQUAKE EPICENTERS**

The site is located in a seismically active region. Figure 4 presents the location of the site relative to the epicenters of historic earthquakes with magnitudes of 5.5 or more from 1800 to 2000. Earthquakes of historical significance to the site are summarized in Table 1 including earthquakes within 10 kilometers (km) of the site exceeding a magnitude of 5.5, earthquakes exceeding magnitude 6 within 50 km of the site, and earthquakes exceeding magnitude 7 within 100 kilometers (km) of the site since 1900. Two earthquakes exceeding magnitude 5.5 have occurred within 10 km of the site since 1900. These two earthquakes, of magnitude 5.6 and 5.7, occurred on October 1, 1969 along the Rodgers Creek fault, in the eastern part of Santa Rosa, causing wide spread damage to many of the older structures in Santa Rosa (Cloud et al., 1970; USGS, 2019). The epicenters of these earthquakes were located about 2.6 km and 3.8 km south of the project site. The magnitude 5.6 earthquake occurred with the City of Santa Rosa and is shown on Figure 6.

The site is not located within an Alquist-Priolo Earthquake Fault Zone established by the State Geologist (CDMG, 1983; CGS, 2018), or fault rupture hazard zones established by the City of Santa Rosa (2009) and the County of Sonoma (2017). These zones delineate regions of potential ground surface rupture adjacent to active faults. The regional fault map presented as Figure 4 indicates that several faults are located near the site (Jennings and Bryant, 2010). The closest active fault to the site is the Rodgers Creek fault, which is within approximately ½ mile of the site to the southwest.

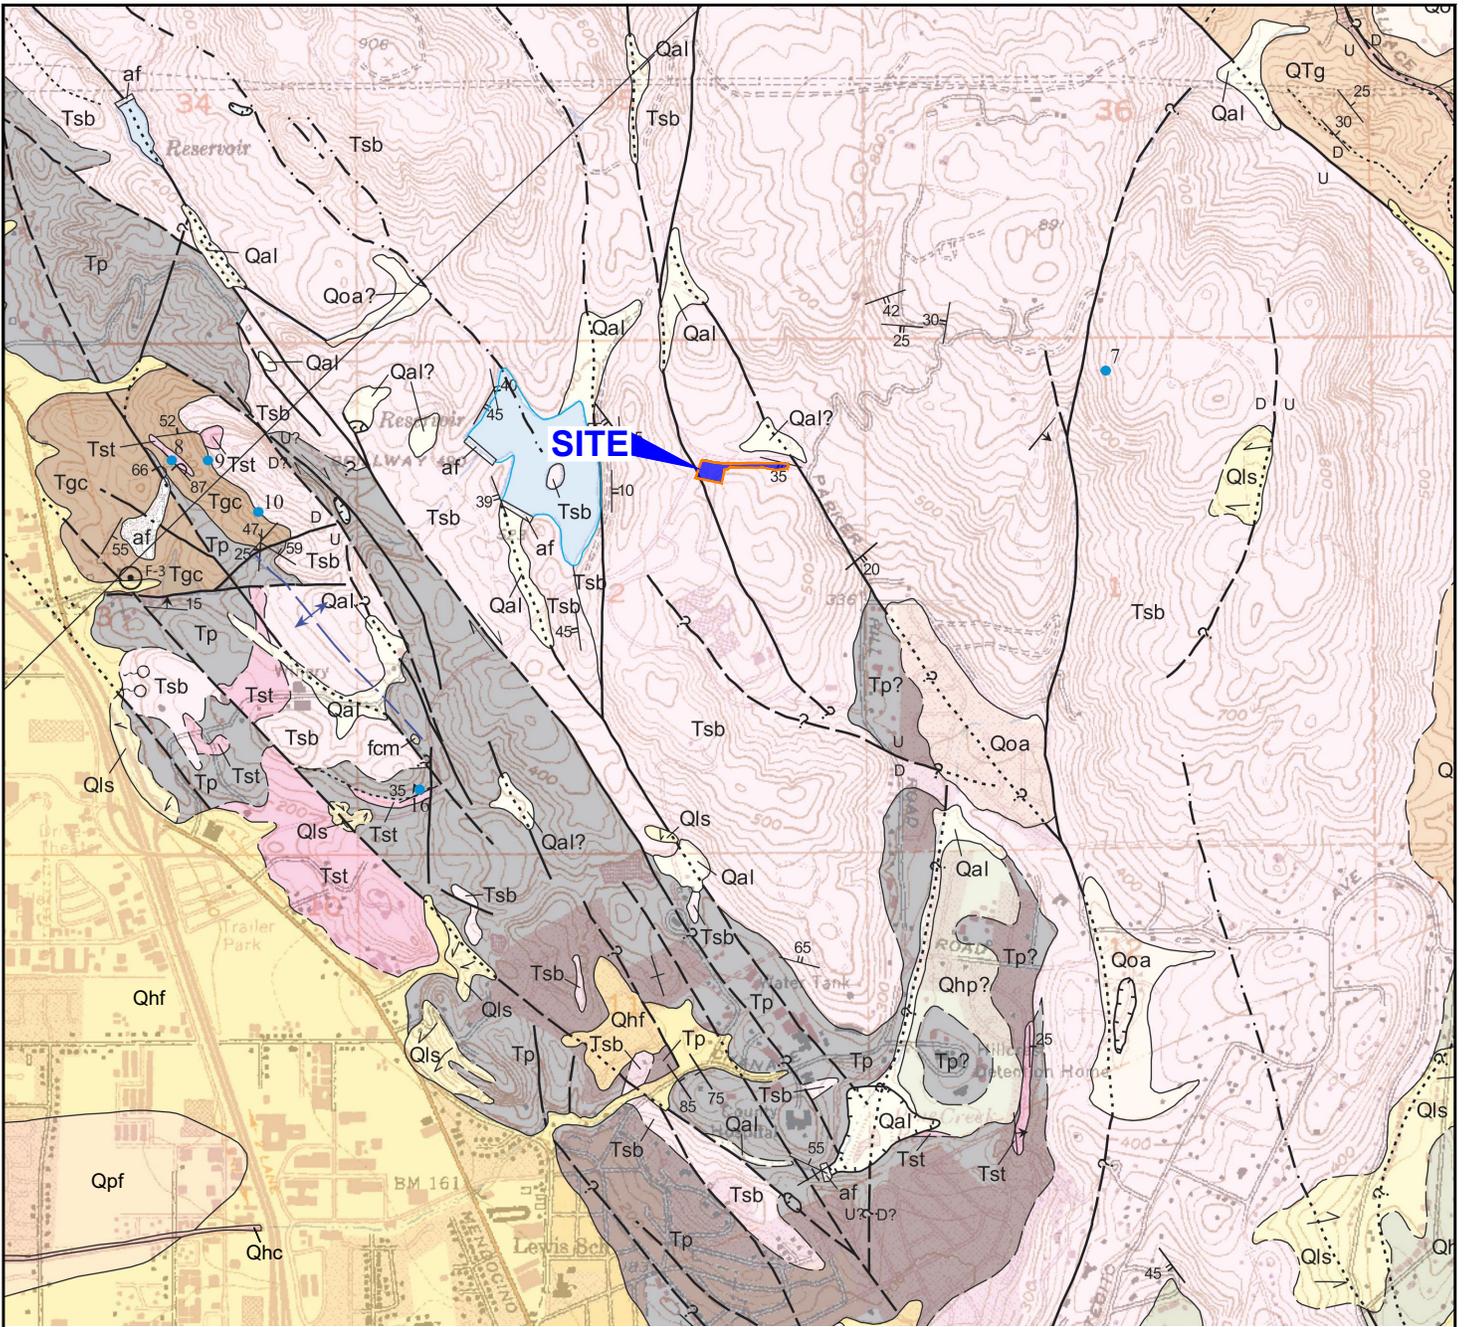
<b>af</b> ARTIFICIAL FILL (HOLOCENE)	<b>Qhp</b> ALLUVIAL DEPOSITS, UNDIVIDED (HOLOCENE & PLEISTOCENE)	<b>QTg</b> FLUVIAL & LACUSTRINE DEPOSITS (PLEISTOCENE & PLEIOCENE)	<b>Tsb</b> ANDESITE, BASALTIC ANDESITE, & BASALT (PLIOCENE & MIOCENE)
<b>Qhc</b> CHANNELS (HOLOCENE)	<b>Qhpf</b> ALLUVIAL FAN & TERRACE DEPOSITS (HOLOCENE & PLEISTOCENE)	<b>Tgc</b> CLOVERLEAF RANCH GRAVEL (PLIOCENE)	▲▲▲▲ THRUST FAULT
<b>Qhf</b> ALLUVIAL FAN DEPOSITS (HOLOCENE)	<b>Qls</b> LANDSLIDE DEPOSITS (HOLOCENE & PLEISTOCENE)	<b>Tp</b> PETALUMA FORMATION (PLIOCENE & MIOCENE)	----- FAULT
<b>Qal</b> ALLUVIAL DEPOSITS (HOLOCENE/PLEISTOCENE)	<b>Qoa</b> OLDER ALLUVIUM, UNDIVIDED (PLEISTOCENE)	<b>Tst</b> RHYOLITIC TO DACITIC & MINOR ANDESITIC TUFF (PLIOCENE & MIOCENE)	- - - - - GEOLOGIC CONTACT
			┆┆┆┆ STRIKE AND DIP OF BEDDING

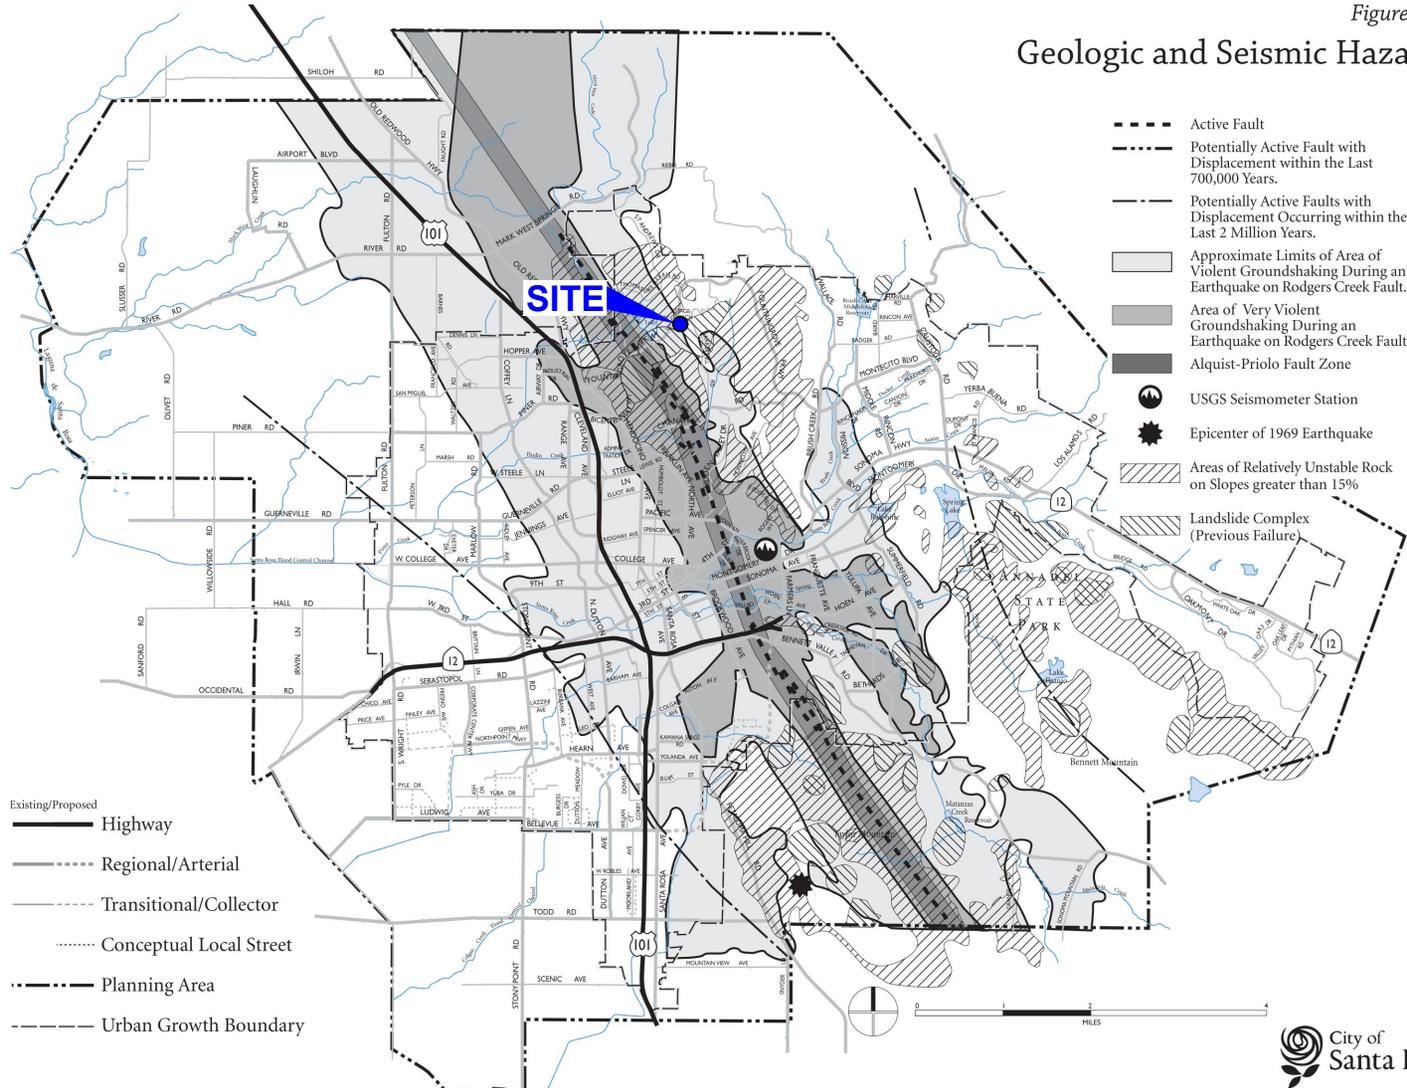
Figure 12-3

# Geologic and Seismic Hazards

- Active Fault
- - - Potentially Active Fault with Displacement within the Last 700,000 Years.
- - - Potentially Active Faults with Displacement Occurring within the Last 2 Million Years.
- Approximate Limits of Area of Violent Groundshaking During an Earthquake on Rodgers Creek Fault.
- Area of Very Violent Groundshaking During an Earthquake on Rodgers Creek Fault
- Alquist-Priolo Fault Zone
- USGS Seismometer Station
- ★ Epicenter of 1969 Earthquake
- ▨ Areas of Relatively Unstable Rock on Slopes greater than 15%
- ▨ Landslide Complex (Previous Failure)

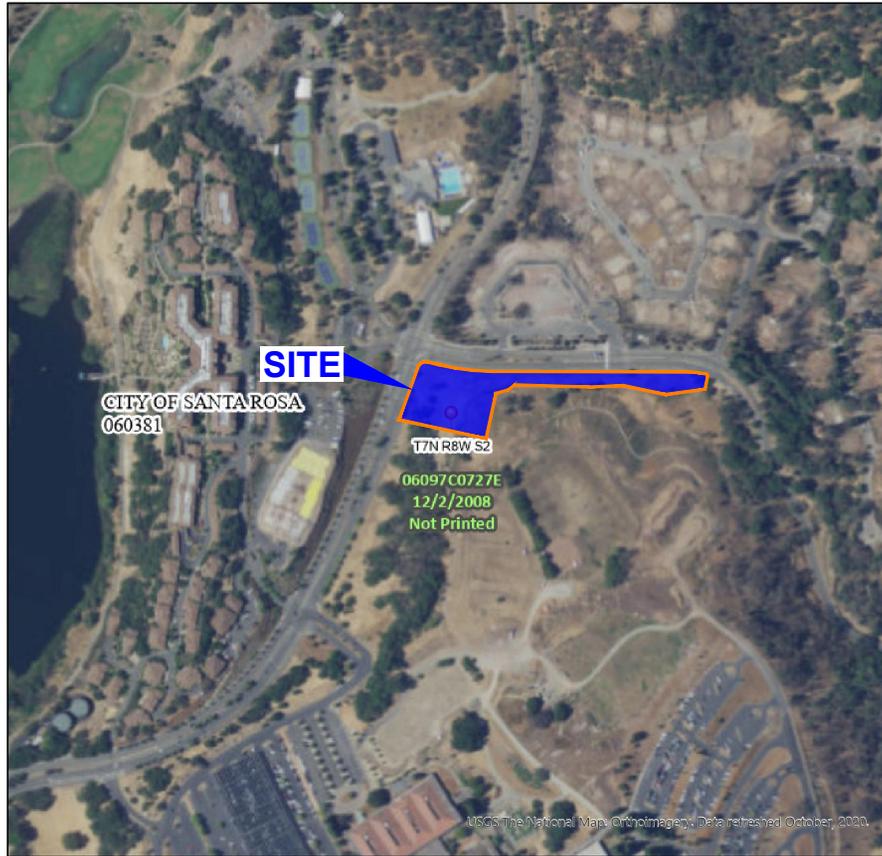
**FEMA FLOOD MAP**  
 SANTA ROSA FIRE STATION 5  
 1400 FOUNTAINGROVE PARKWAY  
 SANTA ROSA, CALIFORNIA  
 403891001 | 12/20

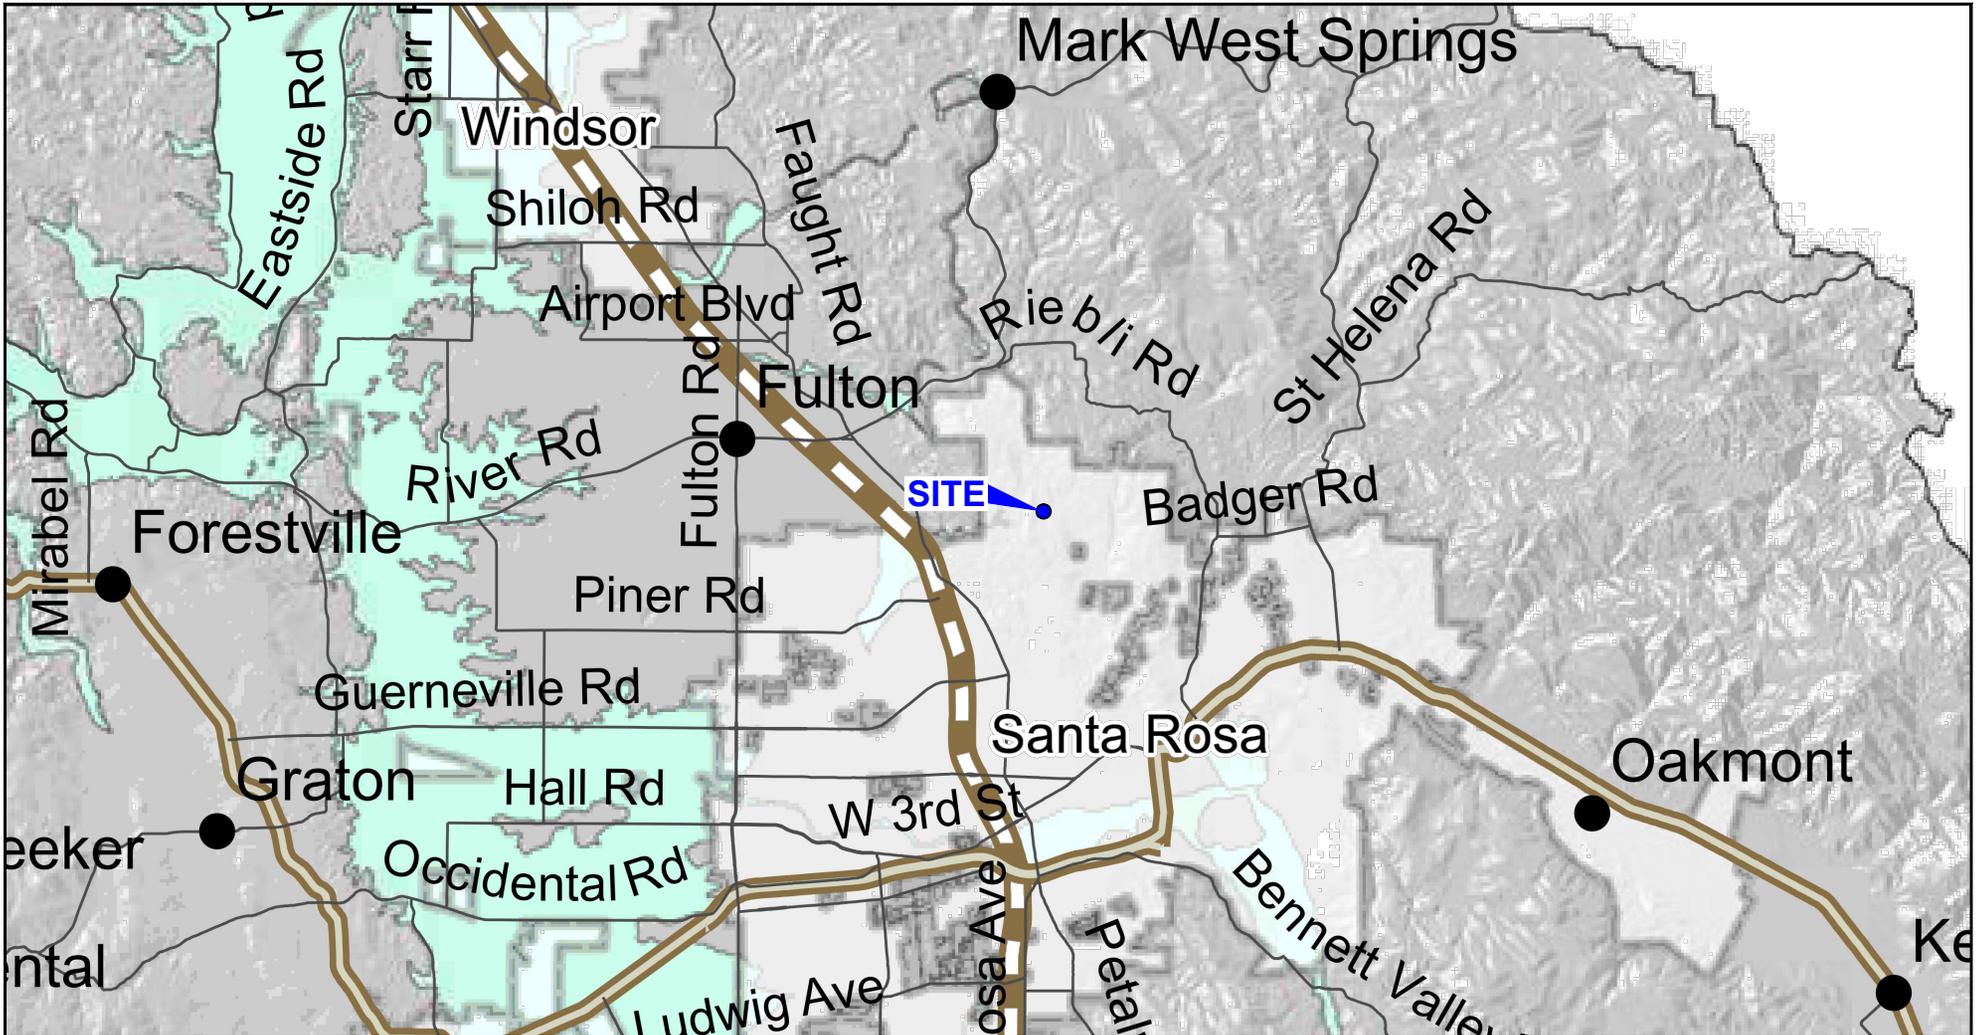
**DAM FAILURE INUNDATION**

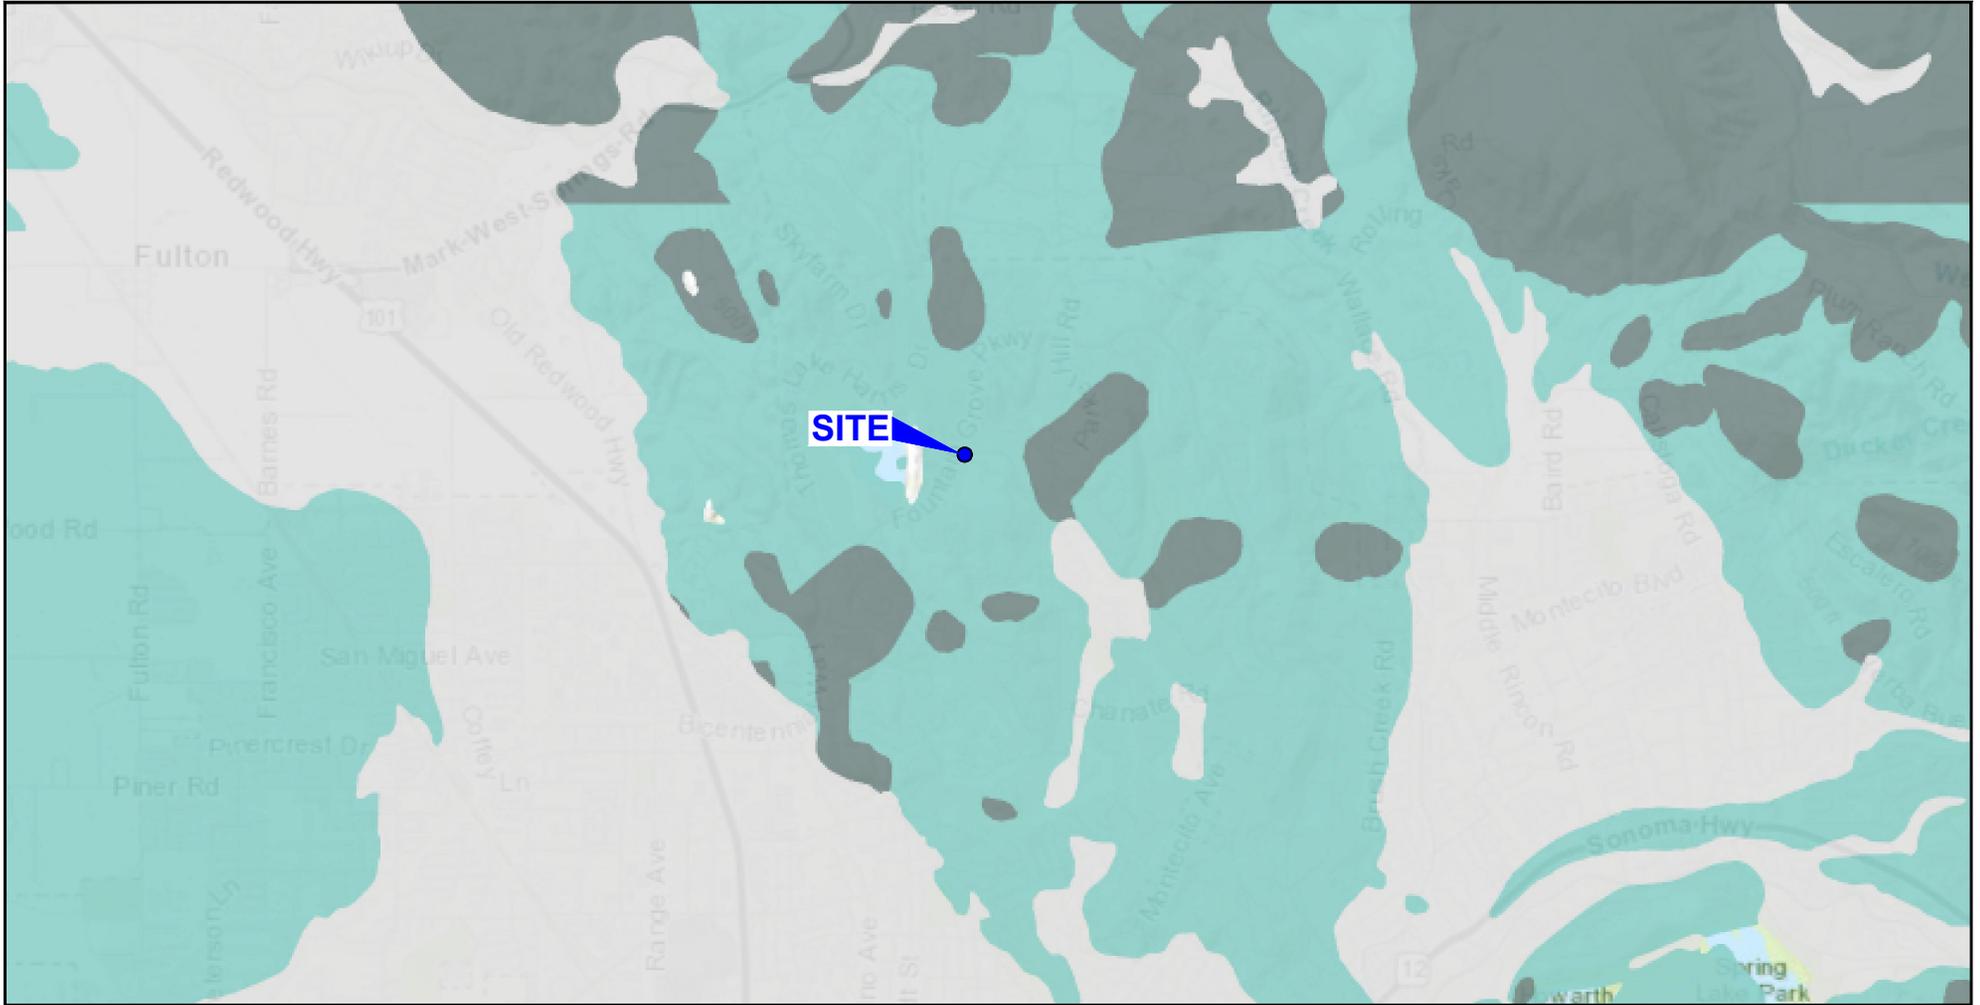
**FIGURE 10**

LANDSLIDE HAZARD (RAINFALL INDUCED):

Regional mapping of landslides and earth flows in Sonoma County by the USGS (Wentworth et al., 1997) is presented on the Association of Bay Area Governments interactive hazard viewer map web site and is included as Figure 10. The regional mapping indicates that the site is located in an area where few landslides are present or likely to occur. The California Geological Survey (Wills et al., 2011) has also prepared regional maps depicting the susceptibility of hillside areas to deep-seated landslides. This map indicates that the slope along the eastern and southern boundaries of the site has a high susceptibility to deep-seated landslides.
