Victorville Wellness Center
Victorville, California

Geotechnical Investigation Report

Prepared For: City of Victorville
Prepared By: Merrell Johnson

**Re: Geotechnical Investigation Report 0| Victorville Wellness Center |
Victorville, California | M.J. Project No. 2102.041.500**

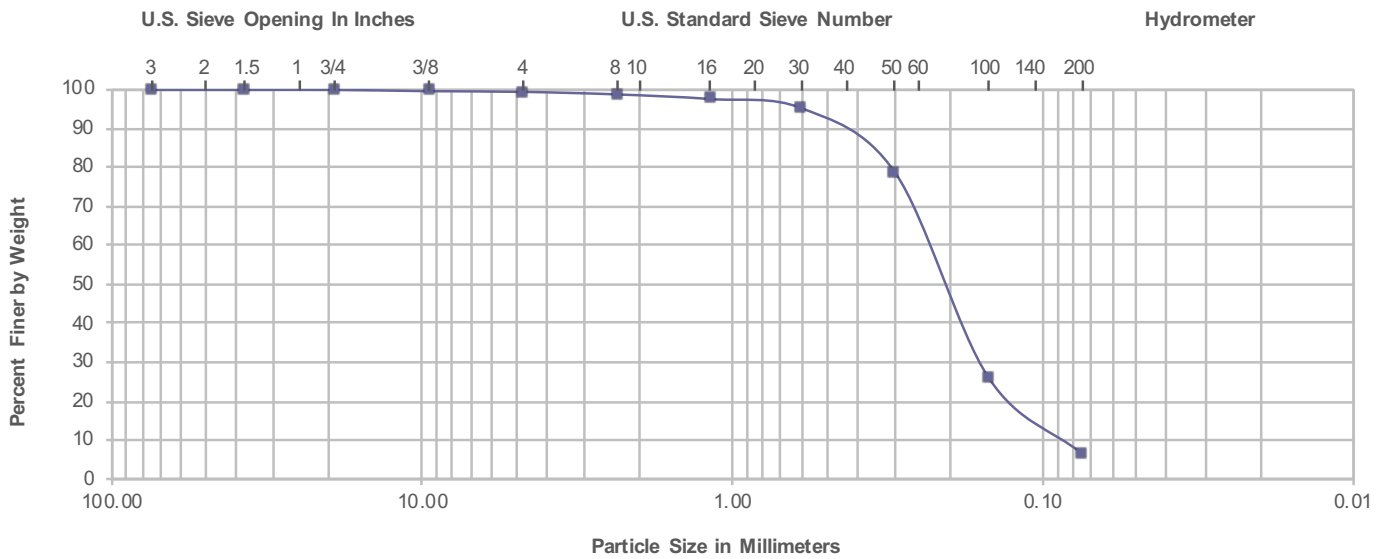
Sample ID: CRG11052013 Gravel (%): 0.5% Sand (%): 93.0% Fines (%): 6.5%

Classification, ASTM D2487: (SP-SM) Poorly graded sand with silt
 Sample Origin: Boring Eight at 0' to 5'
 Laboratory Remarks:

C _u	C _c	Moisture	D ₁₀₀	D ₆₀	D ₃₀	D ₁₀	LL	PL	PI	SG	FM	Other
3	1	1.7%	9.500	0.240	0.170	0.090	ND	ND	ND	ND	ND	-

Method / Procedure Used: D422
 Size of Initial Dry Mass (g): 504.2
 Determination of Dry Mass: D2216
 Particles; Shape, Hardness: ND
 Dispersion Device/Period: Manual/12 hr
 Type & Amount of Agent: Defloc. & 1.0
 Comments:

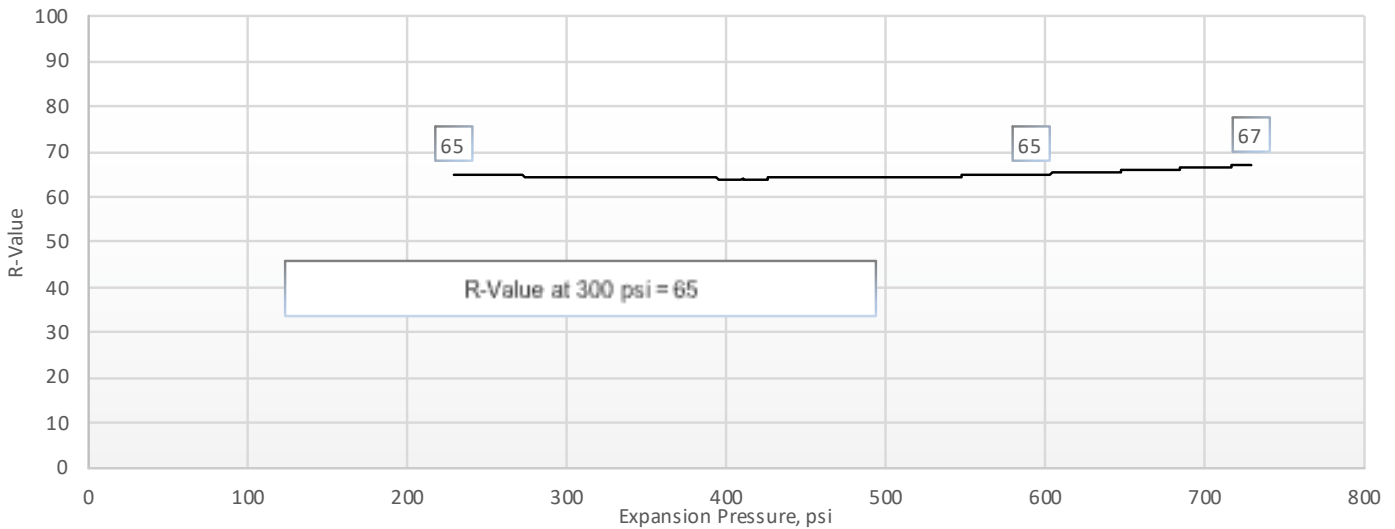
R-Value & Expansion VS. Exudation

Brigette Number:	1	2	3
Moisture Content (%):	11.3	12.9	14.9
Dry Density (pcf):	108.3	109.8	108.0
Exudation Pressure (psi):	729	591	229
Expansion Pressure (psf):	0	0	0
R-Value:	67	65	65

The laboratory program consisted of in-place moisture content and dry density determinations, a maximum density/optimum moisture content test, sieve analyses, an R-(Resistance-) value test, and a corrosivity assessment. The tests were performed in accordance with ASTM and California Test procedures. The results of the laboratory tests are summarized in Appendix C.
