Geotechnical Assessment

October 19, 2020
Revised May 20, 2021
File No. 22039

Subject: Preliminary Geotechnical Assessment
Proposed Office Building
2045 Violet Street, Los Angeles, California

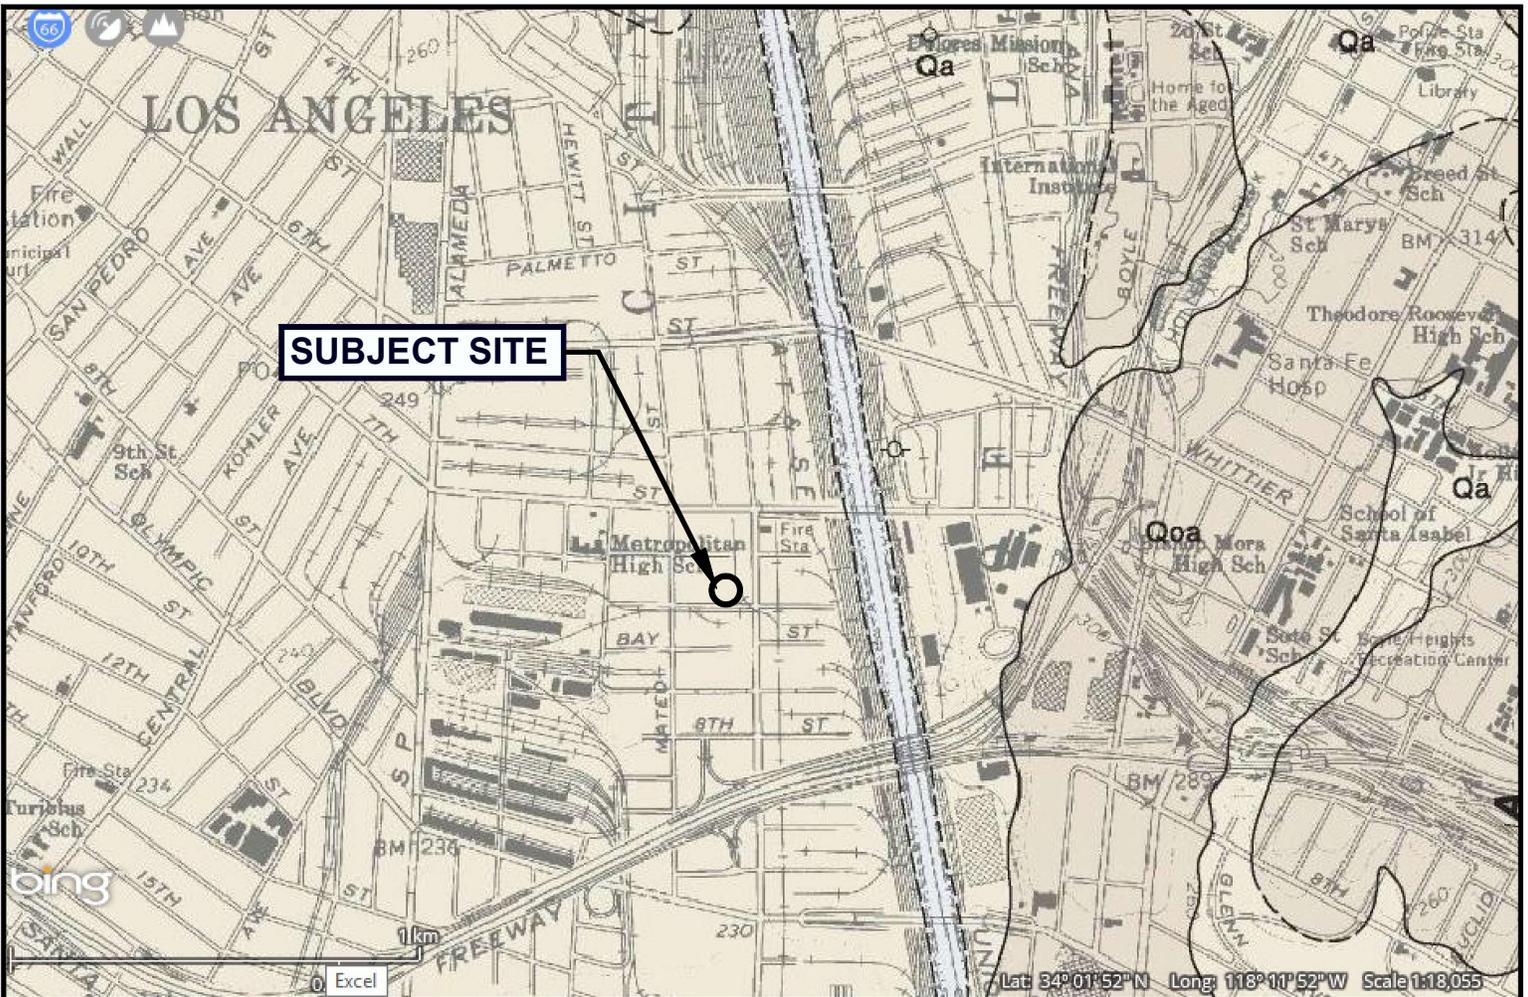
Qa: Surficial Sediments - Alluvium: unconsolidated floodplain deposits of silt, sand and gravel
 Qoa: Older Surficial Sediments - remnants of older weakly consolidated alluvial deposits of gravel, sand and silt

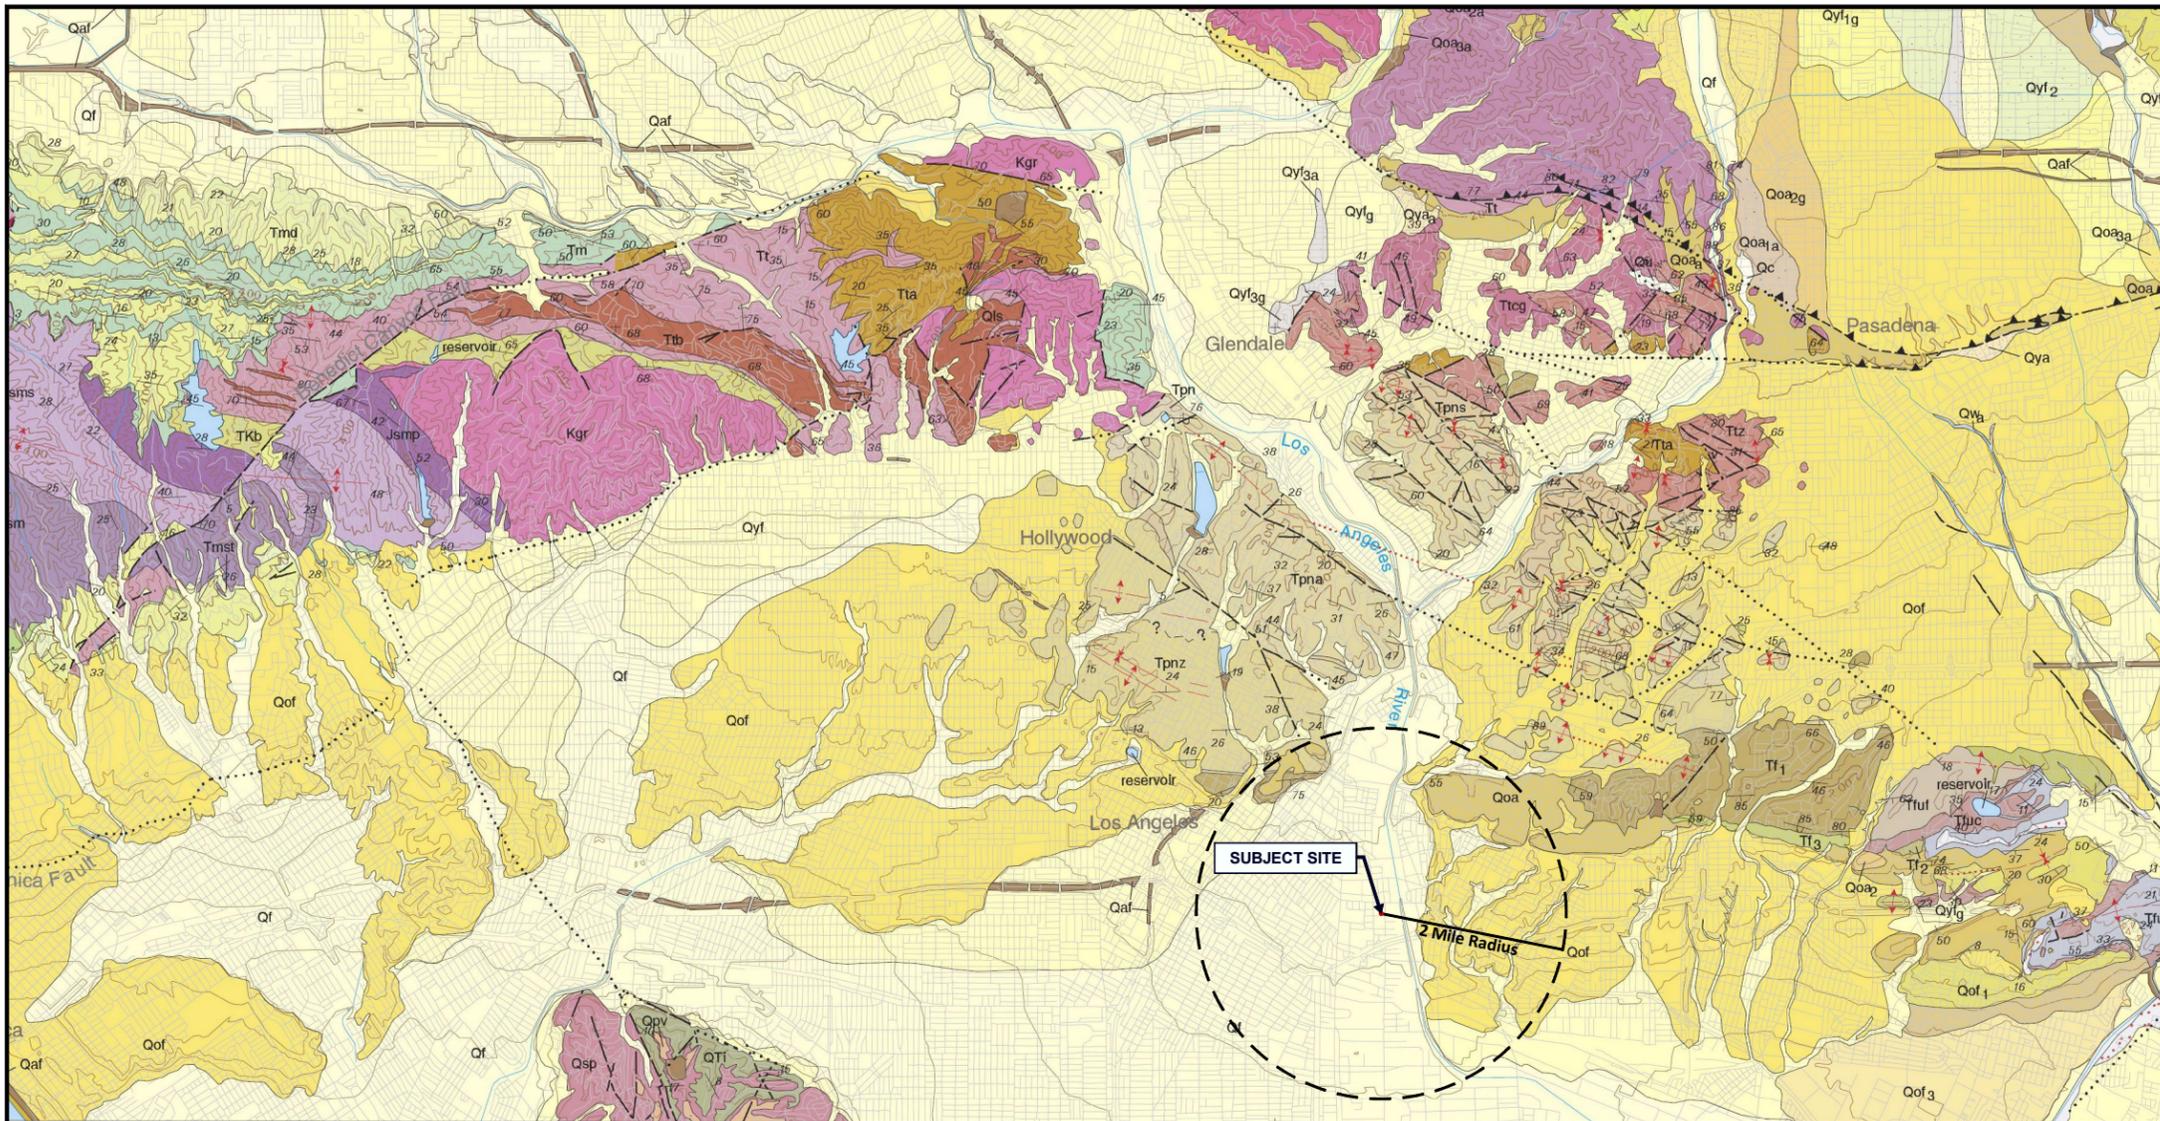
- Qaf: Artificial Fill
- Qf: Alluvial-Fan Deposits
- Qof: Old Alluvial-Fan Deposits
- Qoa: Old Alluvium
- Tf: Fernando Formation

REFERENCE: U.S. DEPARTMENT OF THE INTERIOR, U.S. GEOLOGICAL SURVEY, PRELIMINARY GEOLOGIC MAP OF THE LOS ANGELES 30' X 60' QUADRANGLE, SOUTHERN CALIFORNIA, VERSION 1.0, 2005, COMPILED BY ROBERT F. YERKES AND RUSSELL H. CAMPBELL.

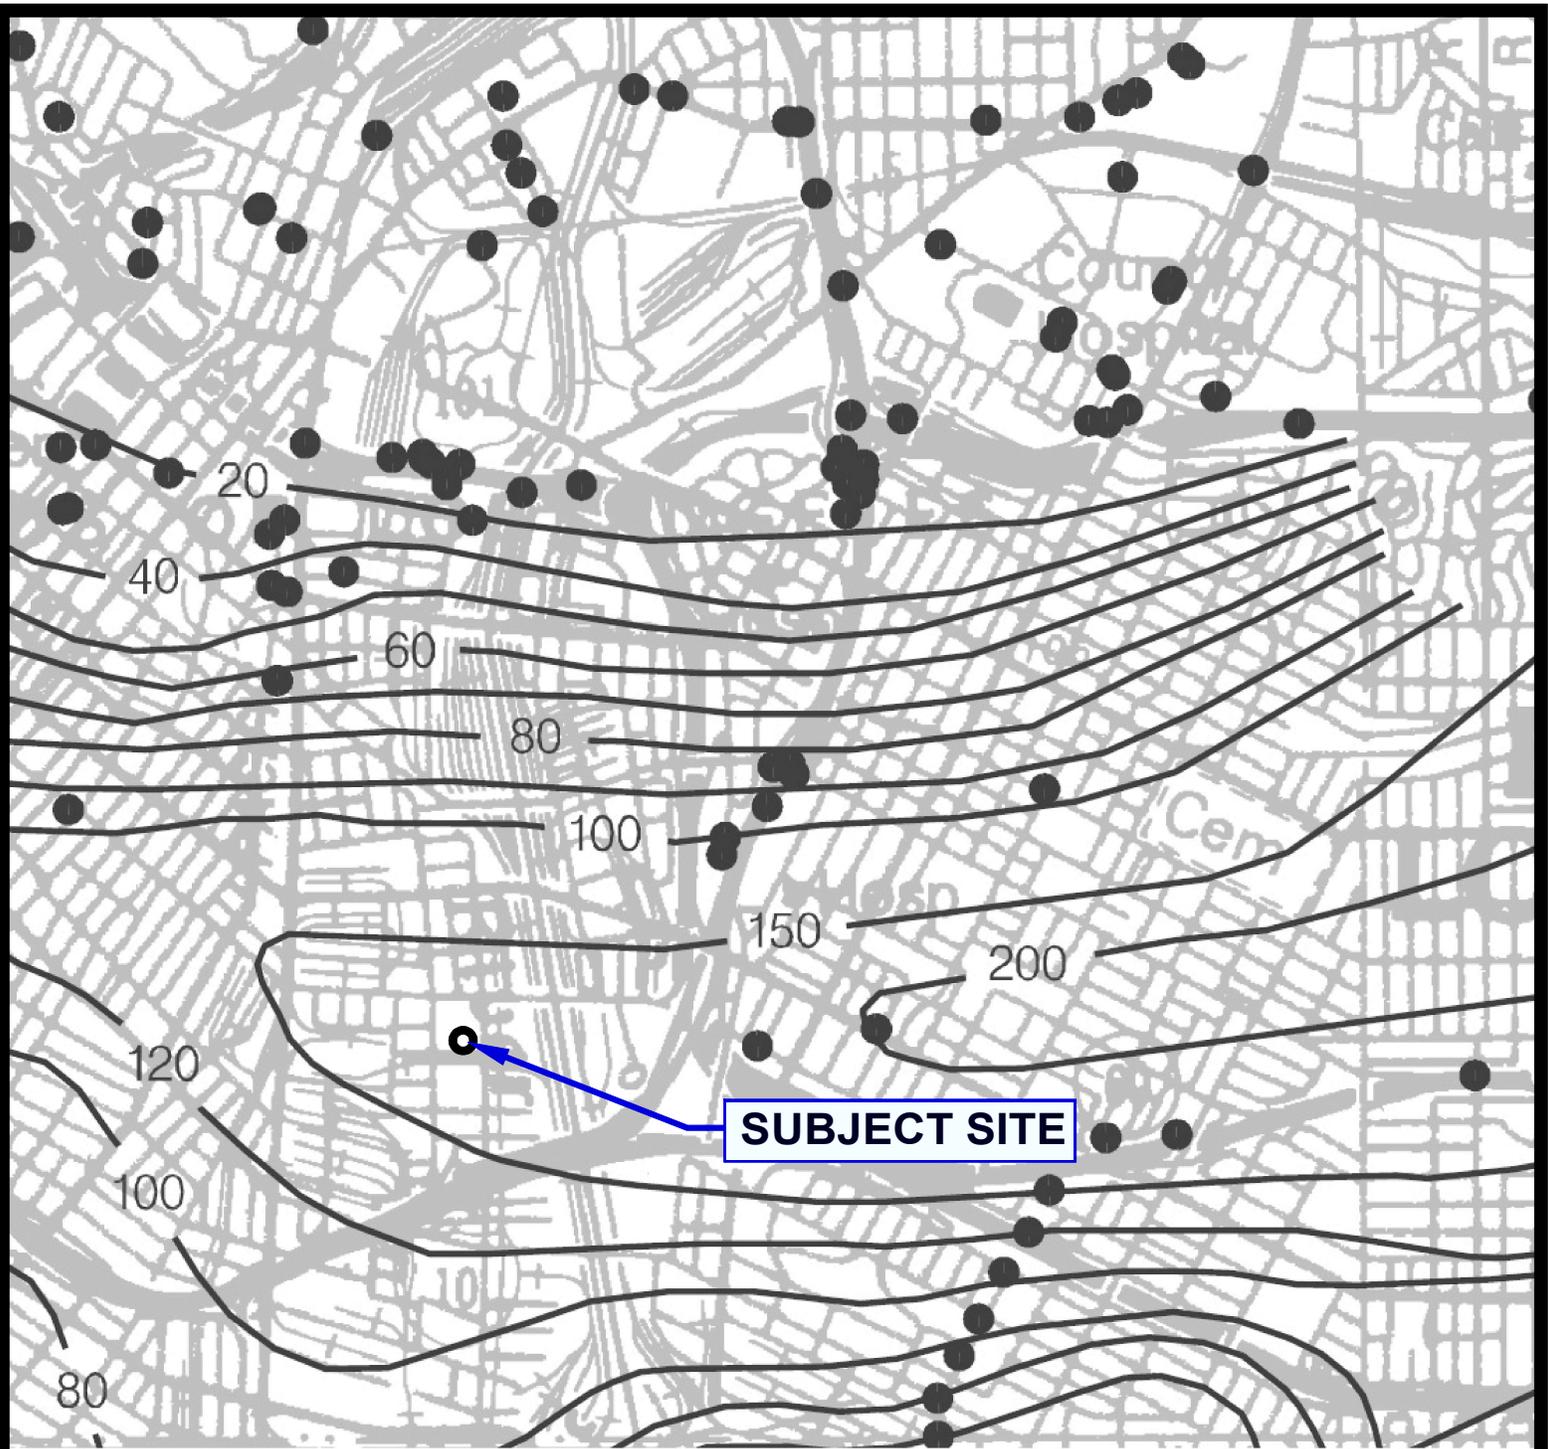
20 Depth to groundwater in feet

Review of the Seismic Hazard Zone Report (SHZR) for the Los Angeles 7½-Minute Quadrangle, (CDMG, 1998, Revised 2006), indicates that the historically highest groundwater level in the vicinity of the site is estimated at 160 feet below ground surface. A copy of the Historically Highest Groundwater Levels Map is included in the Appendix of this report.

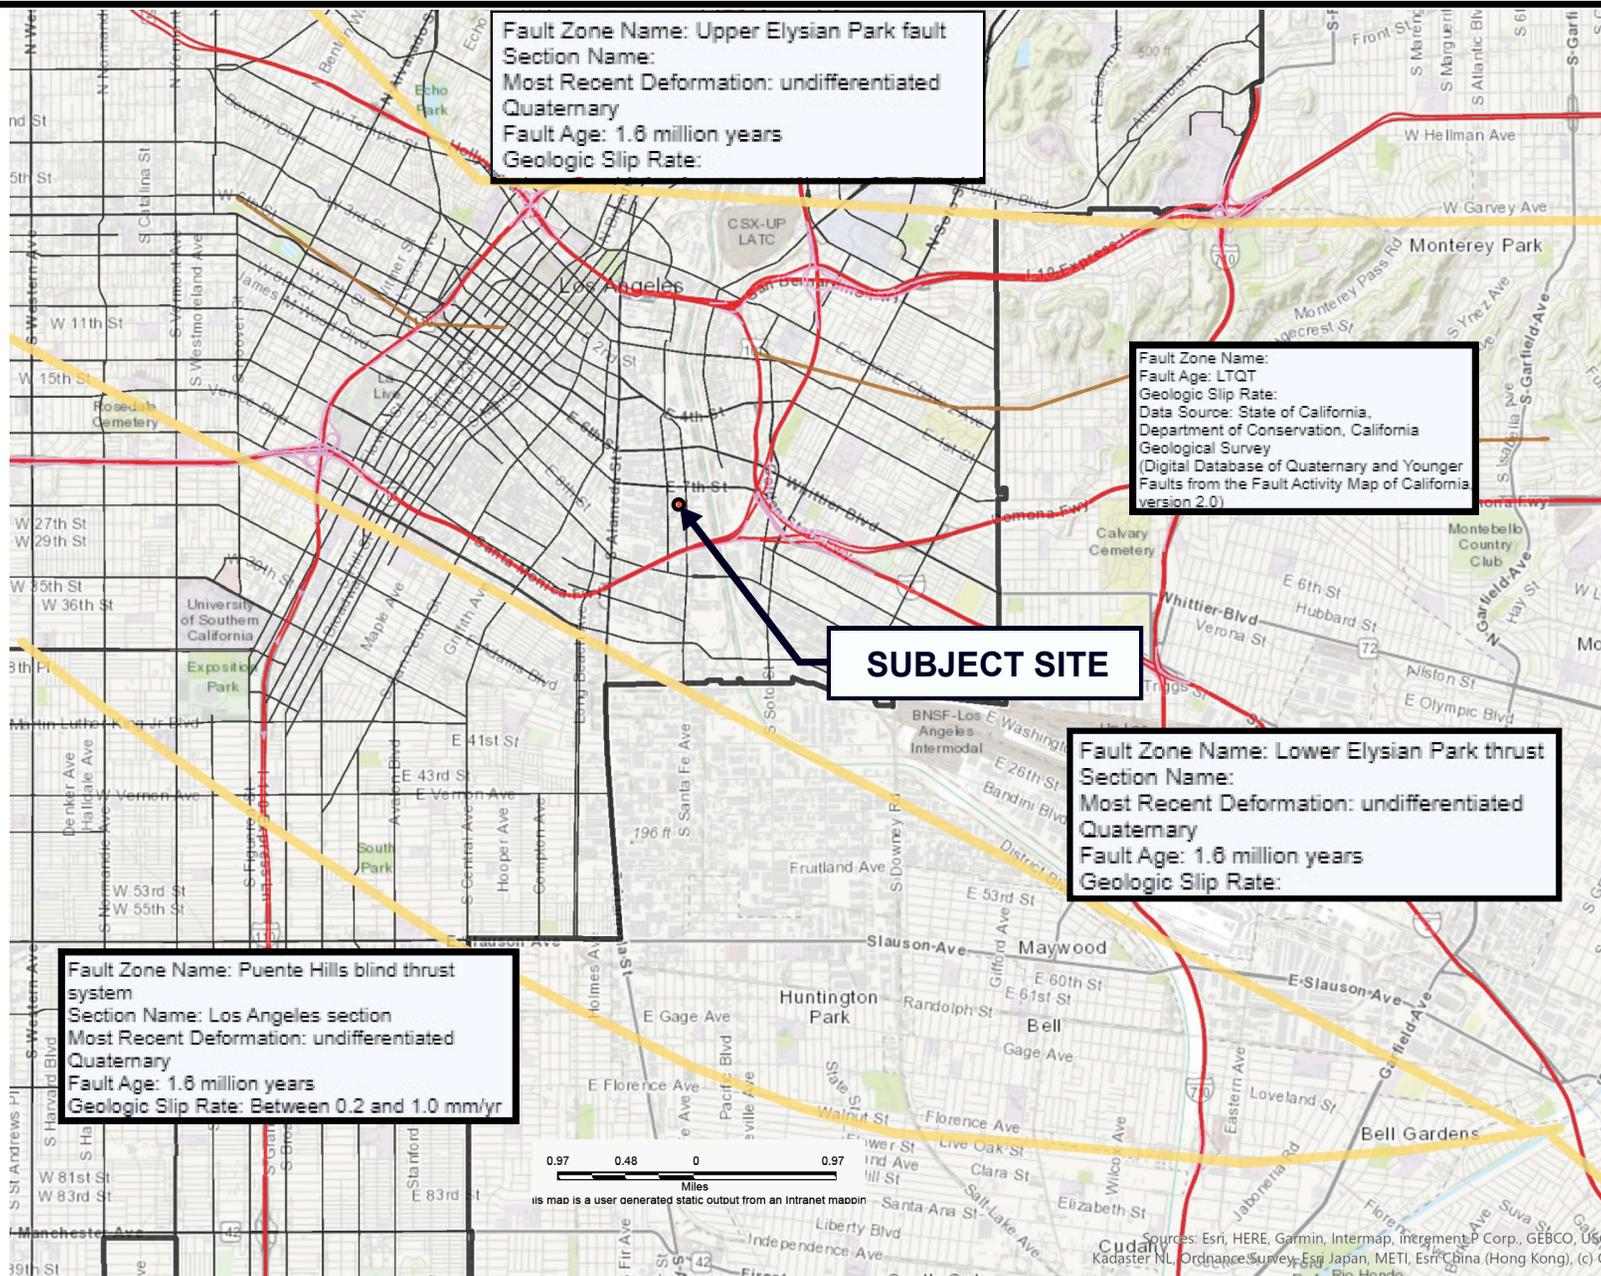
LOCAL FAULT MAP

REFERENCE: FAULT ACTIVITY MAP OF CALIFORNIA (2010), NAVIGATE L.A. NAVIGATE L.A., CITY OF LOS ANGELES

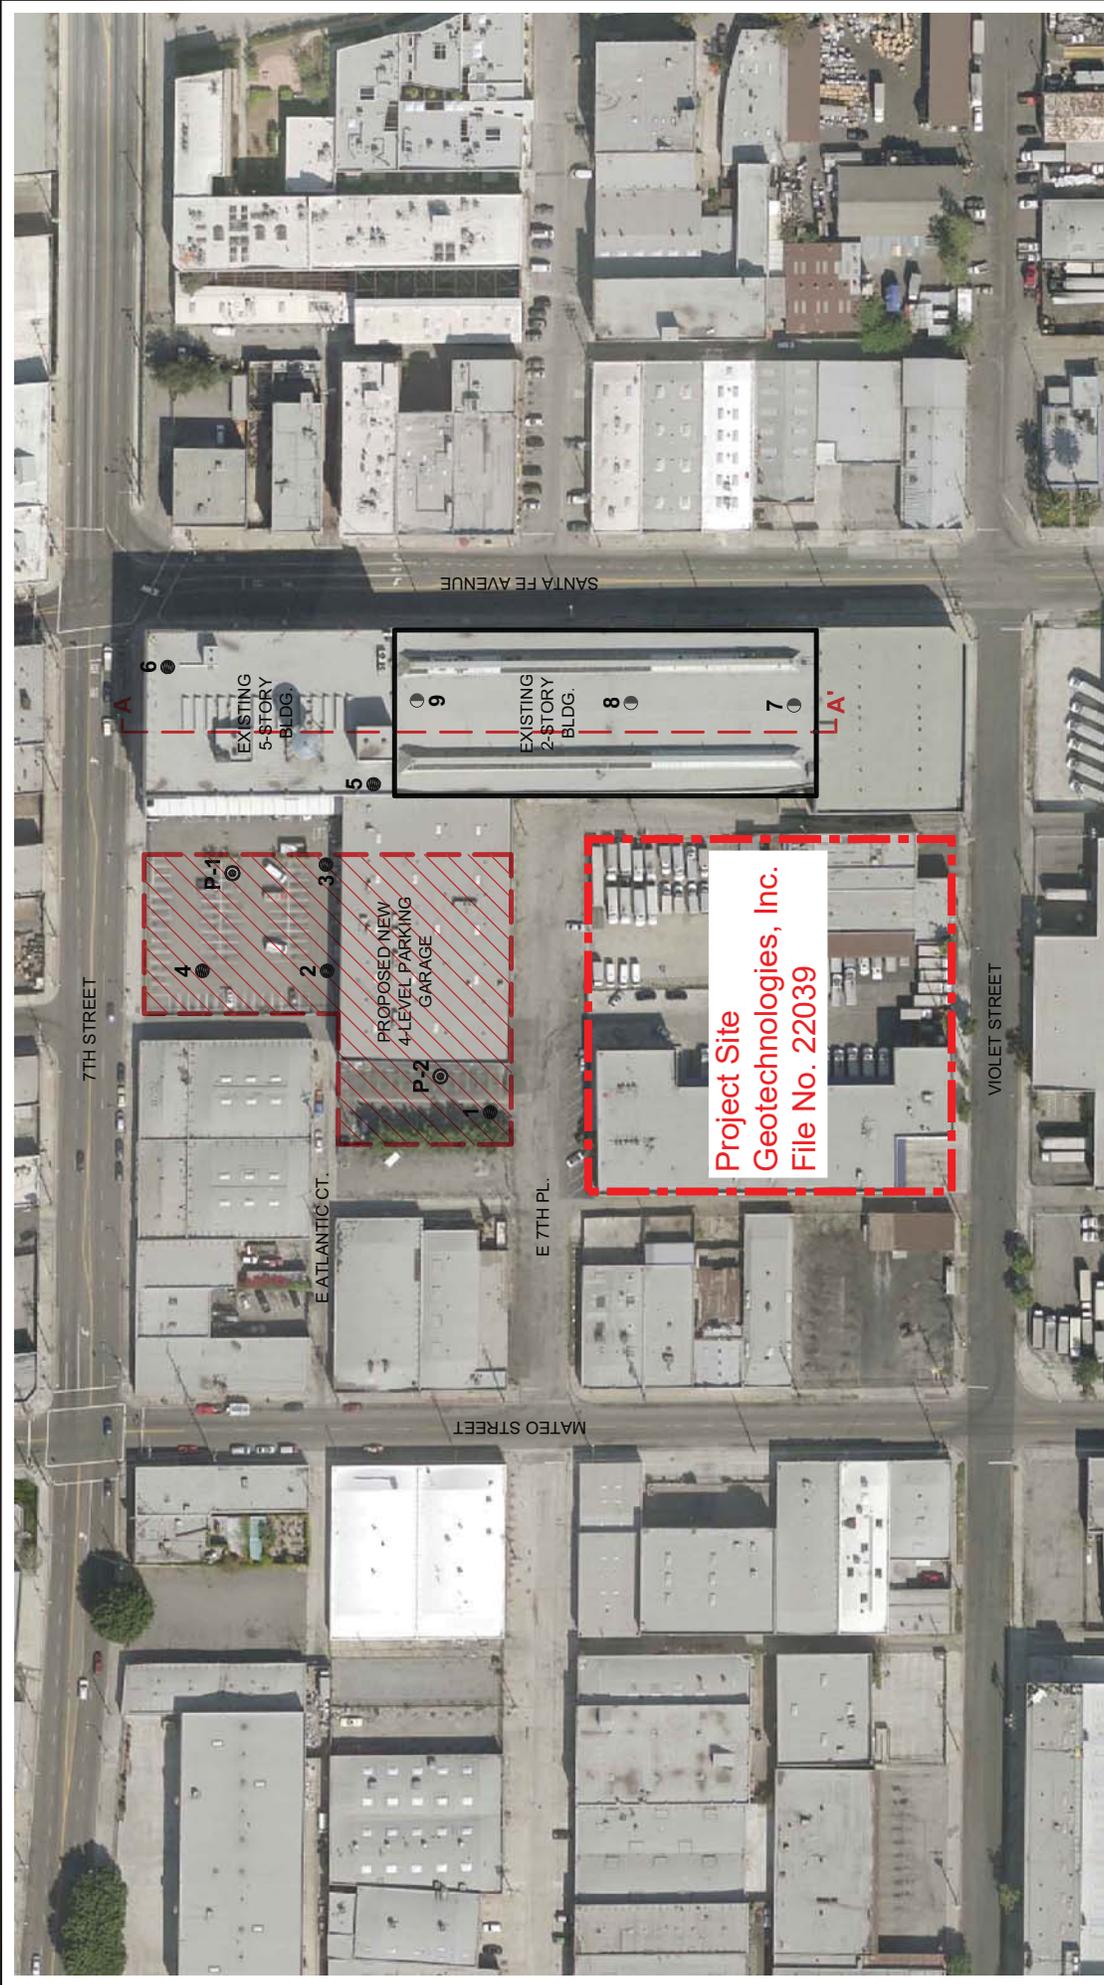
PLOT PLAN

Proposed Ford Plant Redevelopment
2030 East 7th Street
Los Angeles, California
