**PRELIMINARY  
GEOTECHNICAL EVALUATION  
FOR THE  
BARLOW CAPITAL INVESTMENTS LLC,  
CUSTOM RESIDENCE  
LOCATED AT  
8561 EL PASEO GRANDE  
LA JOLLA, CALIFORNIA 92037**

**REVISED December 3, 2020**

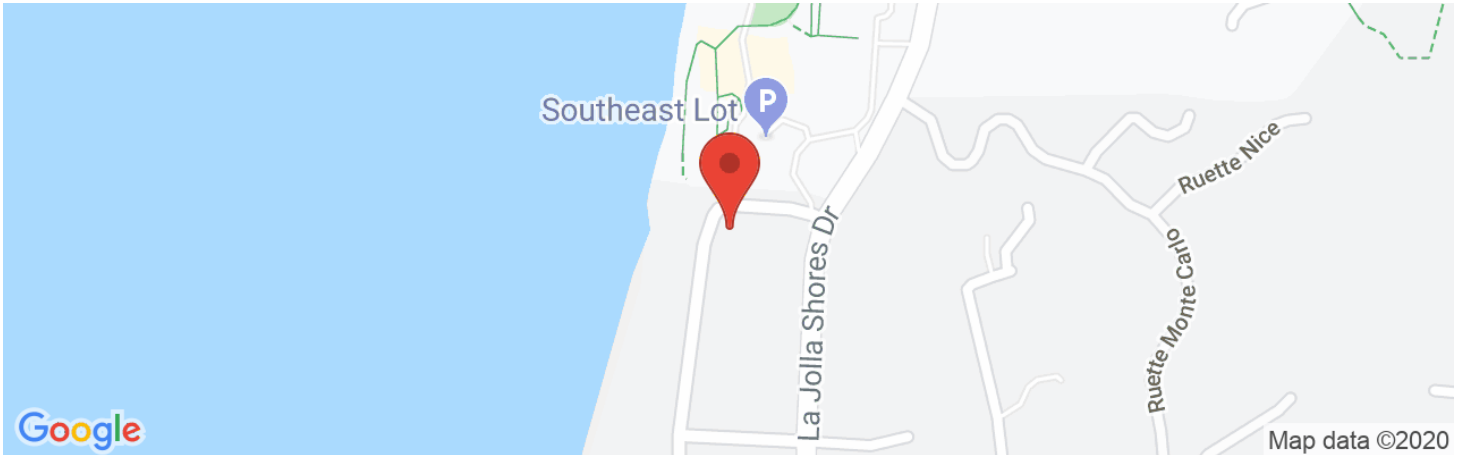
<b>Date</b>	2/4/2020, 2:27:46 PM
<b>Design Code Reference Document</b>	ASCE7-10
<b>Risk Category</b>	II
<b>Site Class</b>	D - Stiff Soil

Type	Value	Description
$S_S$	1.286	$MCE_R$ ground motion. (for 0.2 second period)
$S_1$	0.499	$MCE_R$ ground motion. (for 1.0s period)
$S_{MS}$	1.286	Site-modified spectral acceleration value
$S_{M1}$	0.749	Site-modified spectral acceleration value
$S_{DS}$	0.858	Numeric seismic design value at 0.2 second SA
$S_{D1}$	0.499	Numeric seismic design value at 1.0 second SA

Type	Value	Description
SDC	D	Seismic design category
$F_a$	1	Site amplification factor at 0.2 second
$F_v$	1.501	Site amplification factor at 1.0 second
PGA	0.581	$MCE_G$ peak ground acceleration
$F_{PGA}$	1	Site amplification factor at PGA
$PGA_M$	0.581	Site modified peak ground acceleration
$T_L$	8	Long-period transition period in seconds
$SsRT$	1.286	Probabilistic risk-targeted ground motion. (0.2 second)
$SsUH$	1.534	Factored uniform-hazard (2% probability of exceedance in 50 years) spectral acceleration
$SsD$	2.434	Factored deterministic acceleration value. (0.2 second)
$S1RT$	0.499	Probabilistic risk-targeted ground motion. (1.0 second)
$S1UH$	0.571	Factored uniform-hazard (2% probability of exceedance in 50 years) spectral acceleration.
$S1D$	1.058	Factored deterministic acceleration value. (1.0 second)
$PGAd$	0.937	Factored deterministic acceleration value. (Peak Ground Acceleration)
$C_{RS}$	0.839	Mapped value of the risk coefficient at short periods

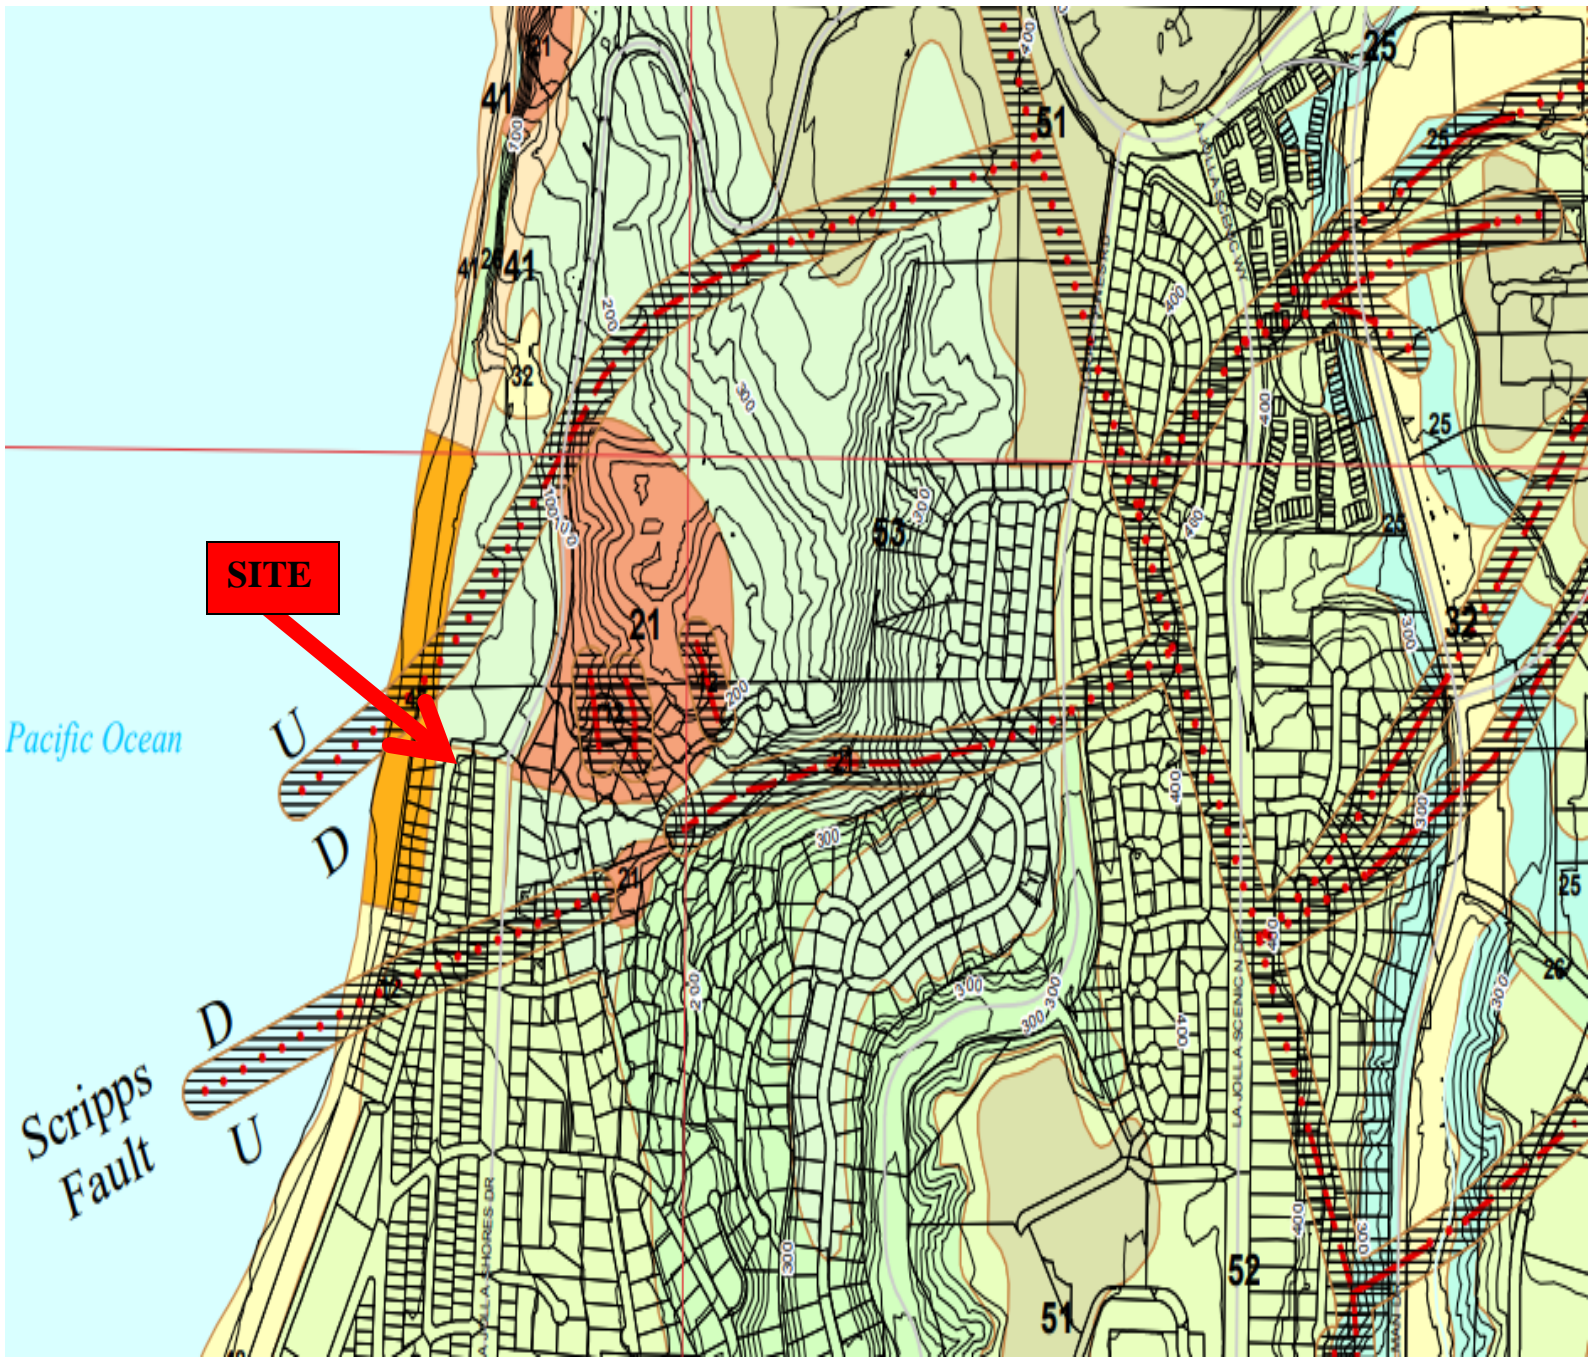
Partial Blow-Up Excerpt from the City of San Diego SEISMIC SAFETY STUDY Geologic Hazards and Faults

GRID TILE: 30

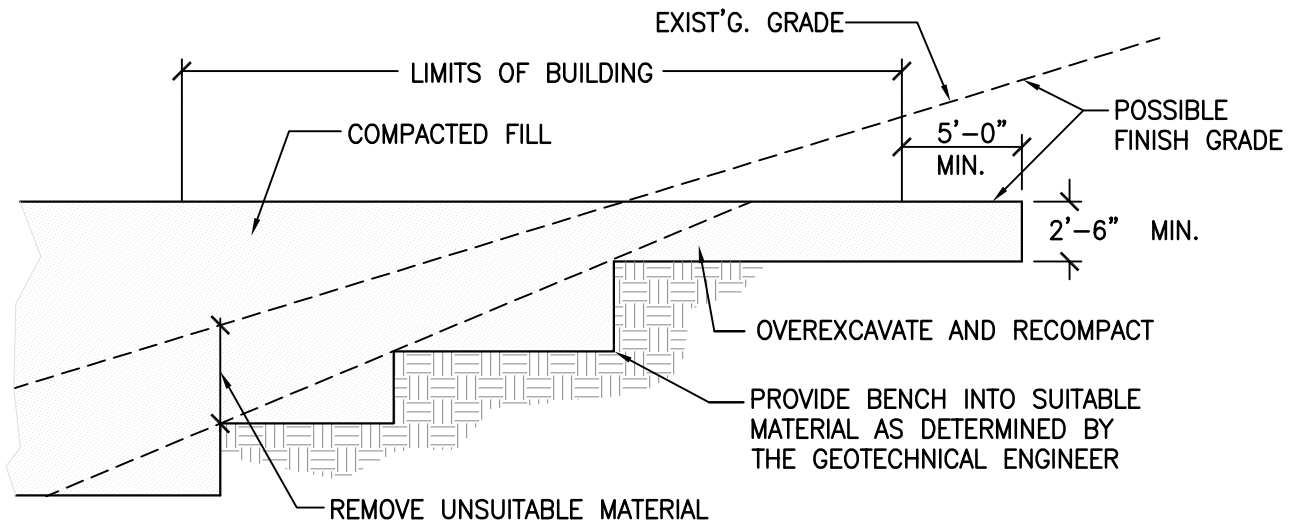
### CUT-FILL LOT

REMOVALS, KEYWAY DEPTH/WIDTH, AND SUBDRAIN RECOMMENDATIONS MAY BE MODIFIED BY THE GEOTECHNICAL ENGINEER BASED ON FIELD CONDITIONS.

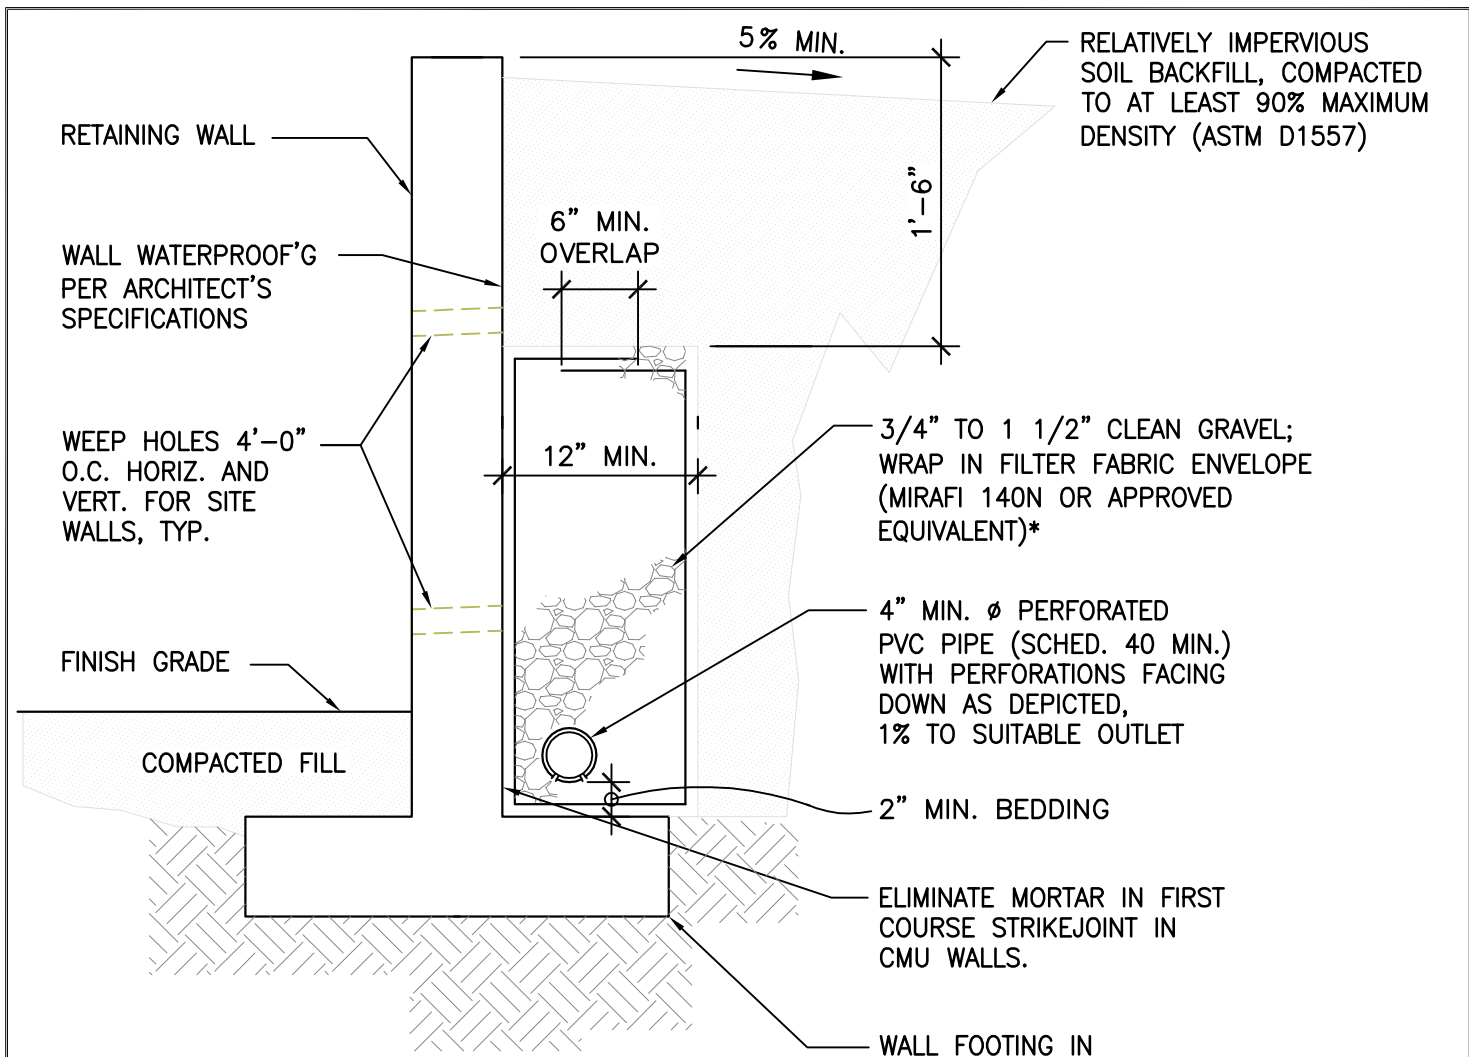
**SPECIFICATIONS FOR CALTRANS CLASS 2 PERMEABLE MATERIAL**

U.S. STANDARD SIEVE SIZE	% PASSING
1"	100
3/4"	90-100
3/8"	40-100
No. 4	25-40
No. 8	18-33
No. 30	5-15
No. 50	0-7
No. 200	0-3

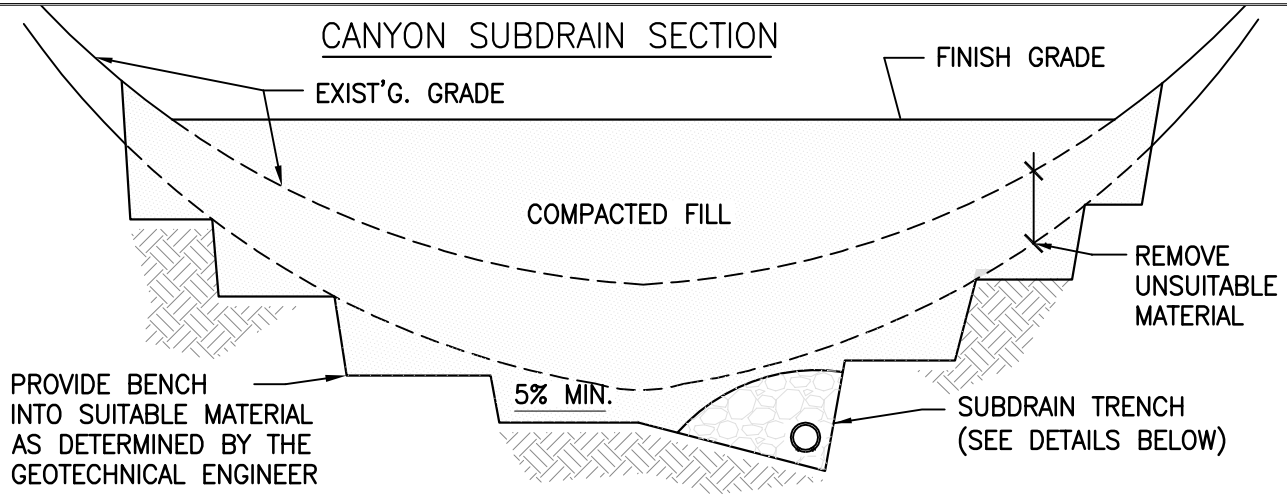
### CANYON SUBDRAIN SECTION

\*IF CALTRANS CLASS 2 PERMEABLE MATERIAL (SEE SPECIFICATIONS, FIGURE D-6) IS USED IN PLACE OF 3/4" TO 1 1/2" GRAVEL, FILTER FABRIC IS NOT REQUIRED. CALTRANS CLASS 2 PERMEABLE MATERIAL MUST BE COMPACTED TO AT LEAST 90% MAX. DENSITY (ASTM D1557).

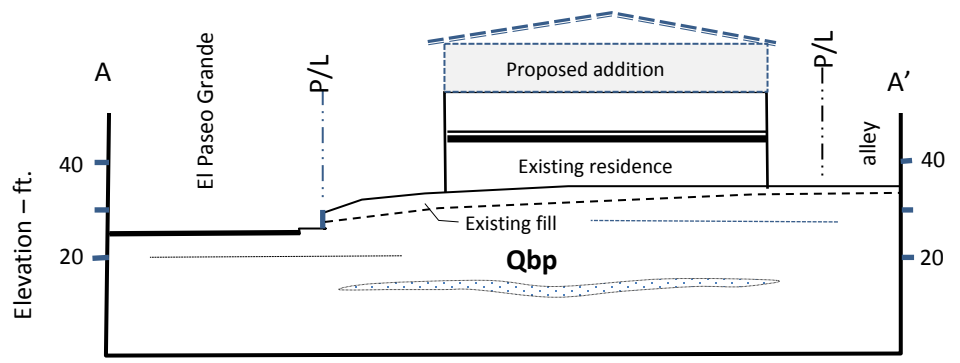
**GEOLOGIC SECTION A-A'**  
**8561 EL PASEO GRANDE, LA JOLLA, CALIFORNIA**

**Qbp:** Bay Point Formation (Old paralic deposits)

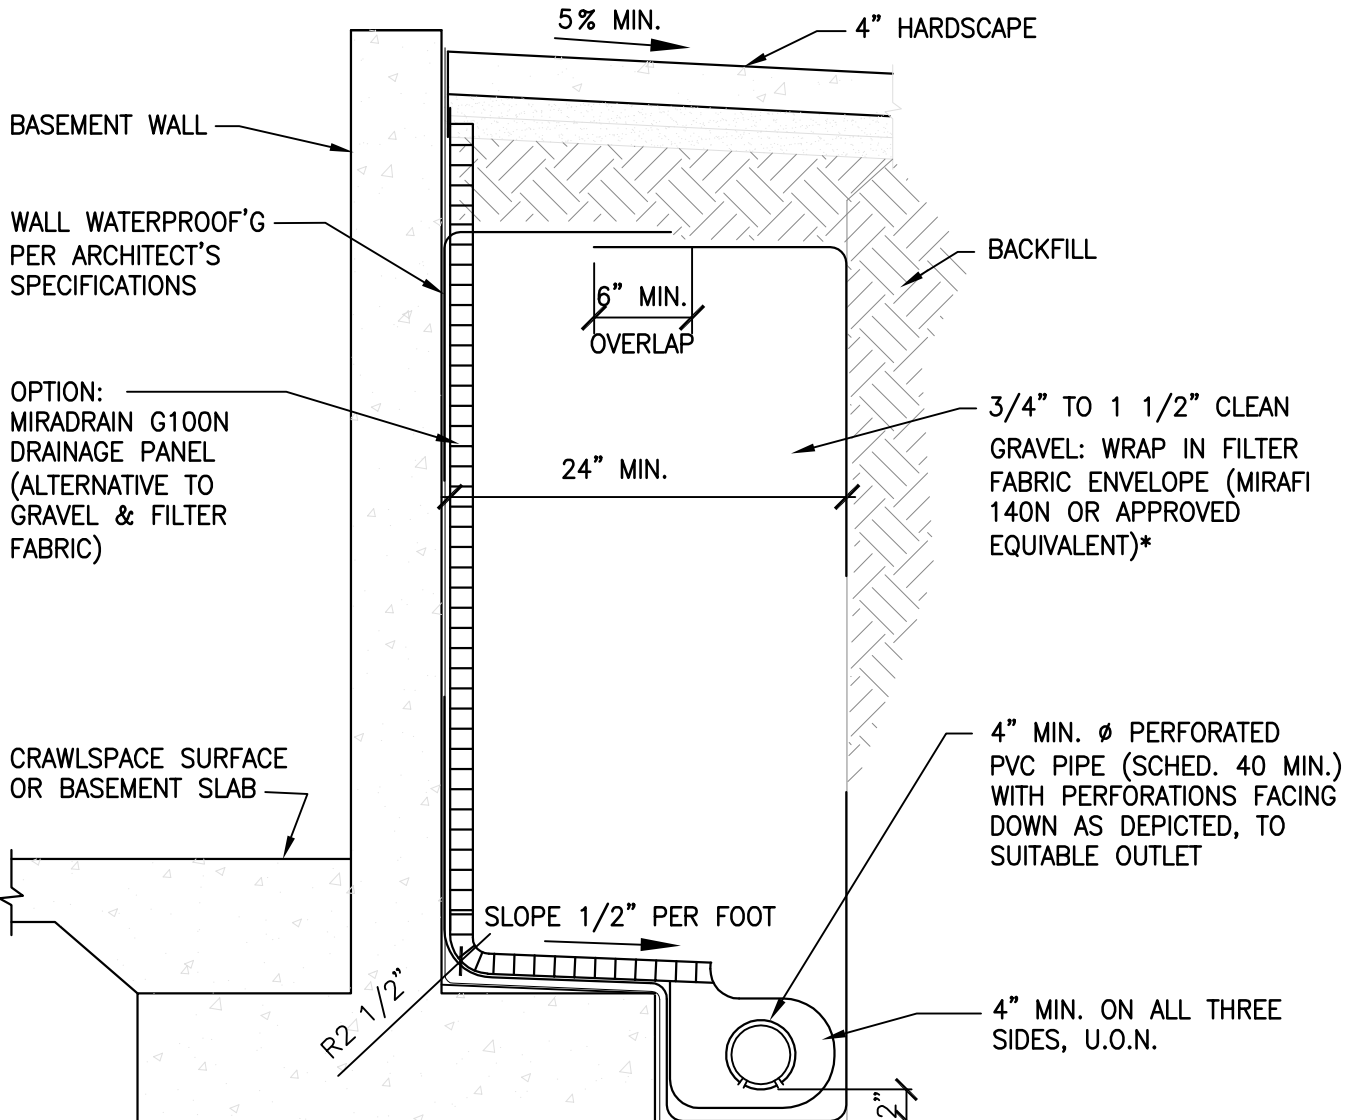
SPECIFICATIONS FOR CALTRANS CLASS 2 PERMEABLE MATERIAL

U.S. STD. SIEVE SIZE	% PASSING
1"	100
3/4"	90-100
3/8"	40-100
No. 4	25-40
No. 8	18-33
No. 30	5-15
No. 50	0-7
No. 200	0-3
