Geotechnical Feasibility Study

Collier Avenue Project
(APN 389-220-003 through APN 389-220-006)

Project Number: 4626GS

February 1, 2021

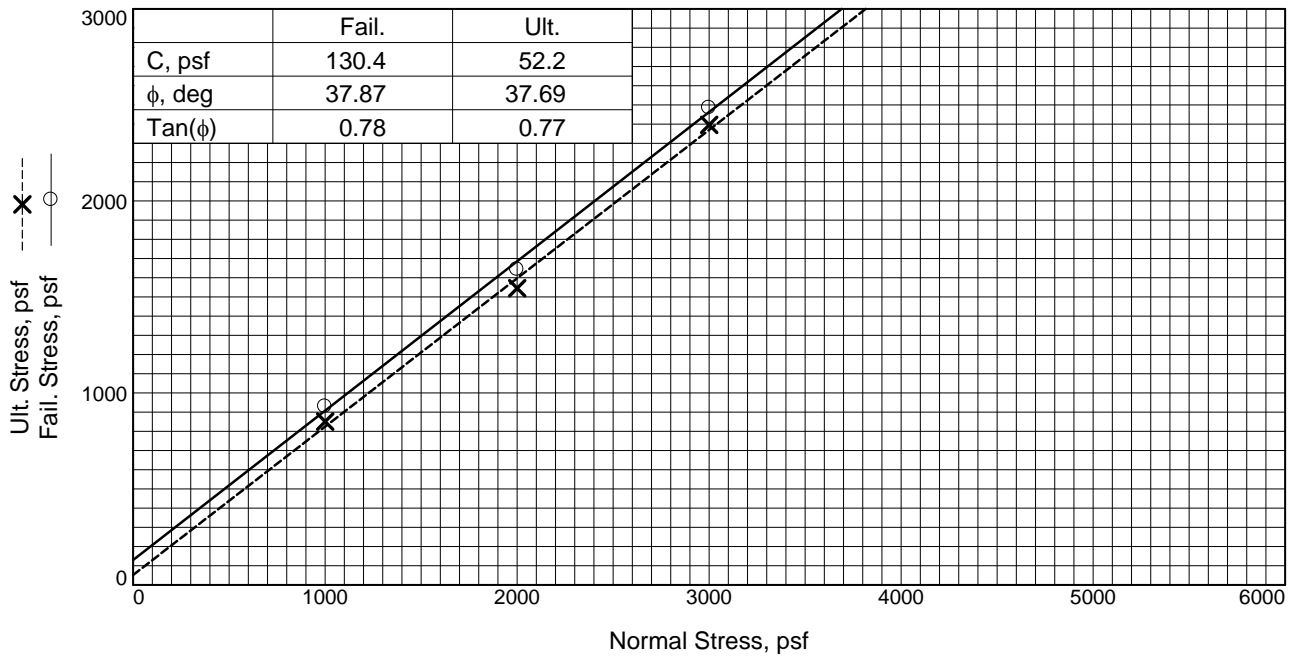
Sample No.	1	2	3	
Initial	Water Content, %	8.5	8.5	8.5
	Dry Density, pcf	118.9	118.9	118.9
	Saturation, %	52.9	52.9	52.9
	Void Ratio	0.4438	0.4438	0.4438
	Diameter, in.	2.416	2.416	2.416
	Height, in.	1.000	1.000	1.000
At Test	Water Content, %	14.5	13.9	13.4
	Dry Density, pcf	118.9	118.9	118.9
	Saturation, %	90.0	86.4	83.0
	Void Ratio	0.4438	0.4438	0.4438
	Diameter, in.	2.416	2.416	2.416
	Height, in.	1.000	1.000	1.000
Normal Stress, psf	1000.0	2000.0	3000.0	
Fail. Stress, psf	929.2	1643.3	2484.5	
Displacement, in.	0.090	0.180	0.170	
Ult. Stress, psf	851.0	1545.4	2396.4	
Displacement, in.	0.130	0.220	0.220	
Strain rate, in./min.	0.100	0.100	0.100

Sample Type: BULK
Description: Silty fine sand, light brown (5YR 6/4)

Direct shear tests were performed on select samples of near-surface earth material in general accordance with ASTM D 3080 procedures. The shear machine is of the constant strain type. The shear machine is designed to receive a 1.0-inch high, 2.42-inch diameter ring sample. Specimens from the sample were sheared at various pressures normal to the face of the specimens. The specimens were tested in a submerged condition. The maximum shear stresses were plotted versus the normal confining stresses to determine the shear strength (cohesion and angle of internal friction).

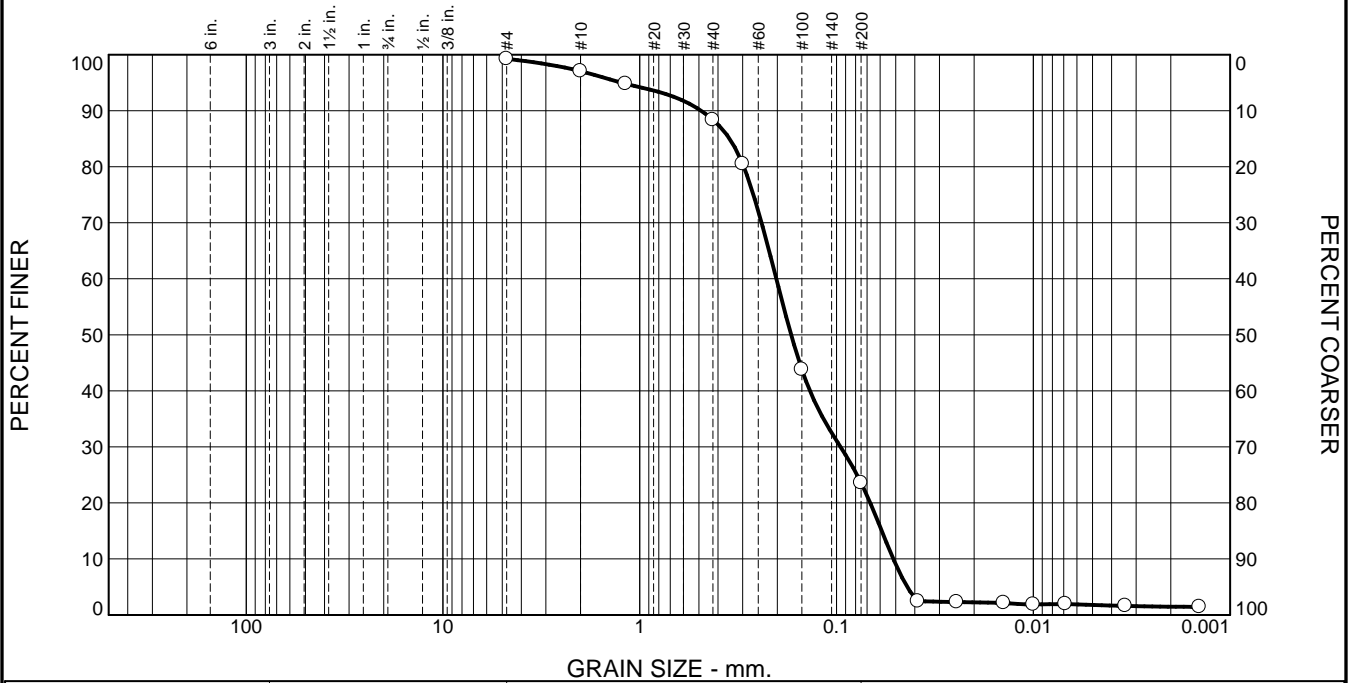
Particle Size Distribution Report

% +3"	% Gravel		% Sand			% Fines	
	Coarse	Fine	Coarse	Medium	Fine	Silt	Clay
			2.2	8.7	64.8	21.8	1.8

TEST RESULTS			
Opening Size	Percent Finer	Spec.* (Percent)	Pass? (X=Fail)
#4	99.3		
#10	97.1		
#16	94.8		
#40	88.4		
#50	80.5		
#100	43.8		
#200	23.6		
0.0386 mm.	2.5		
0.0245 mm.	2.3		
0.0141 mm.	2.2		
0.0100 mm.	1.9		
0.0069 mm.	1.9		
0.0034 mm.	1.6		
0.0014 mm.	1.5

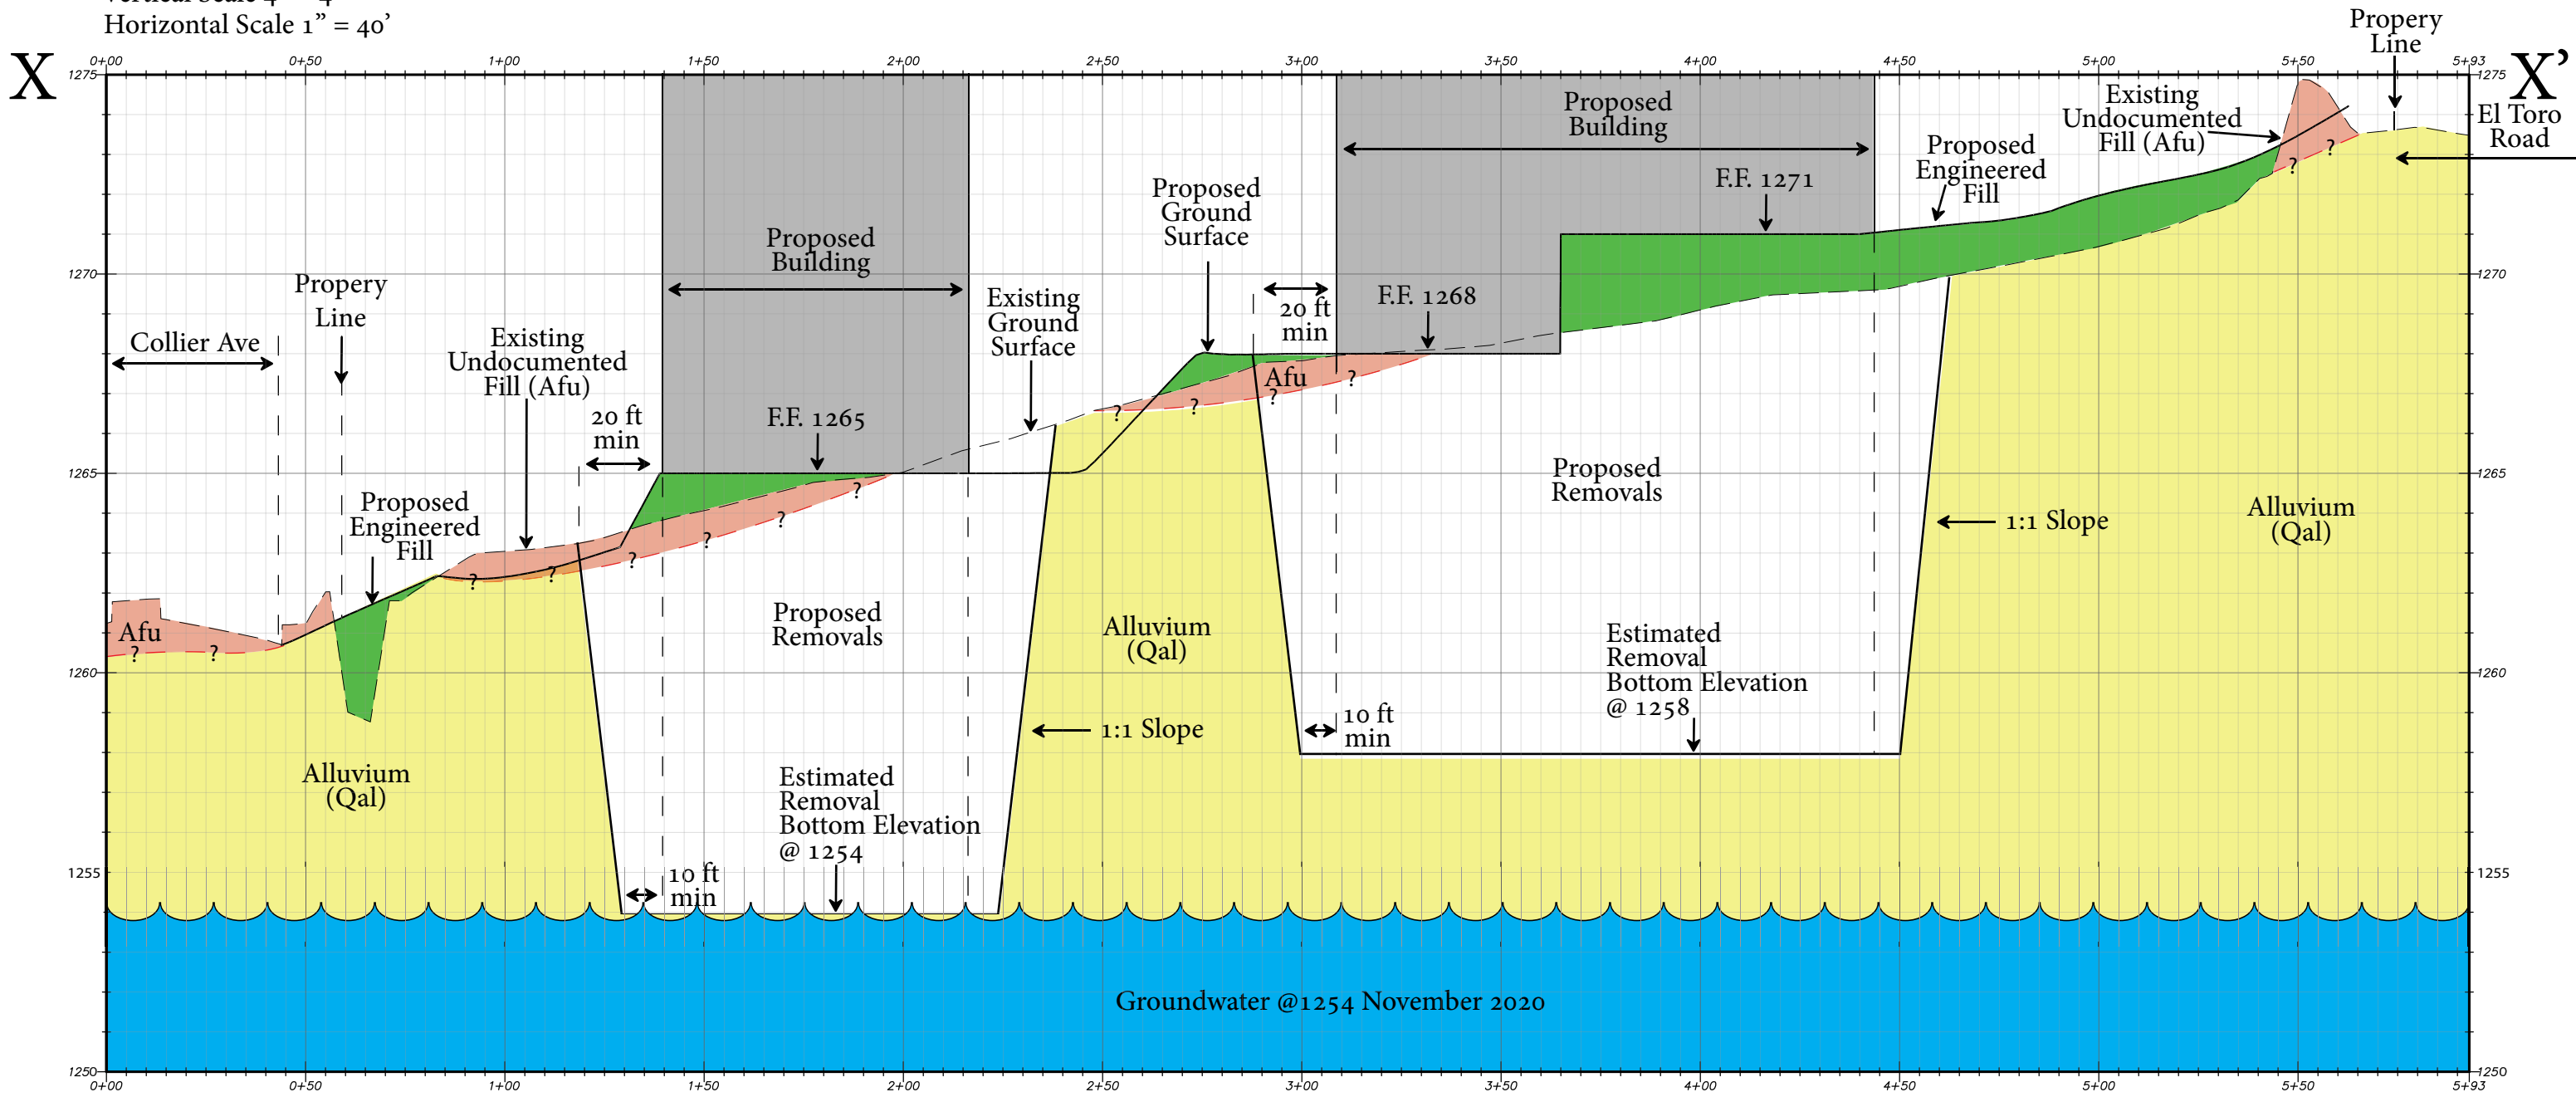
APPENDIX 7 - PLATE 2 - GEOTECHNICAL CROSS SECTION X-X'

Vertical Exageration 10:1
 Vertical Scale 4" = 4'
 Horizontal Scale 1" = 40'

Note: Base map from I.E.Surveying & Engineering Inc, Precise Grading Plan, APN 389-220-003 through 389-220-004, Saddleback Industrial plan dated Dec. 8, 2020

6. **Alluvial Removals in Structure Areas:** In order to address both static settlement of loose, compressible, and/or porous alluvium, and dynamic settlement due to the effects of liquefaction, alluvial removals beneath the proposed structures should be made to a minimum depth of 10 feet below the existing ground surface in proposed fill areas and 10 feet below pad grade in proposed cut areas so that a minimum of 10 feet of engineered fill exists beneath the structure, unless competent bedrock is reached at a shallower depth. The removal bottoms should extend laterally beyond the structure perimeter a distance equal to the removal depth, with a minimum of 10 feet, so that a 1:1 plane may be projected from the structure perimeter to the bottom outside edge of the removal. Deeper removals may be necessary based upon exposed conditions during grading. Groundwater may be reached during the recommended alluvial removals. The soils that have been removed should be cleared of vegetation and man-made debris and may then be stockpiled for re-use as engineered fill. For reference, a representative cross section, X-X', showing proposed alluvial removals in structure areas is included as Plate 2. Note that there is vertical exaggeration in the cross section in order to show the removals in more detail.
