VOLUME II: APPENDICES TO THE ENVIRONMENTAL IMPACT REPORT**PART 1**

**Cultural
Resources
Assessment
Report**

CULTURAL RESOURCES ASSESSMENT REPORT FOR THE MELBA ROAD AND ISLAND VIEW LANE RESIDENTIAL PROJECT, CITY OF ENCINITAS, SAN DIEGO COUNTY, CALIFORNIA

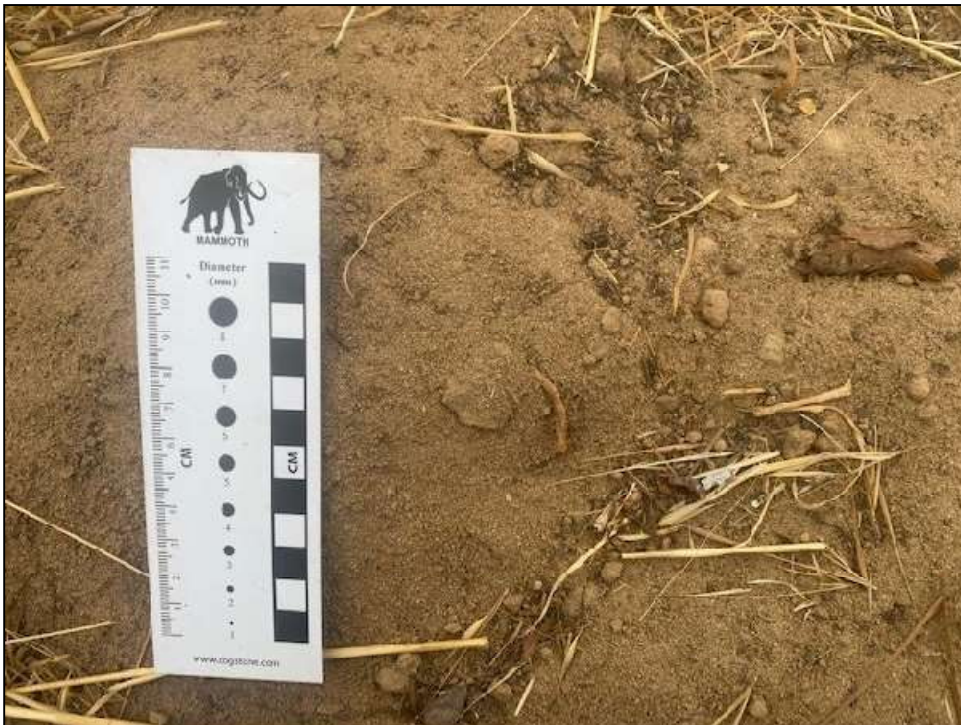
Figure 6. Silty sand sediments close-up

On July 1, 2021, Cogstone Archaeologist Sandy Duarte surveyed the Project area. The area was highly disturbed due to the residential properties. Some areas were not accessible due to dense overgrowth of plants and bushes, especially within areas that were used as nurseries. The intensive cultural resources pedestrian survey consisted of 1-3 meter wide transects. Ground visibility within the Project area was generally poor (approximately 3-5 percent) due to the developed properties, landscape, and hardscape (Figure 5). Much of the area was covered in dry tall grass, weeds, pine trees, palm trees, eucalyptus trees, and decorative plants. Where visible, surficial sediments primarily consisted of yellowish-brown sandy silts (Figure 6). Much of the larger pebble to cobble sized gravel observed is most likely the result of importing decorative, road, and roof gravels into the area. Modern refuse was also observed.

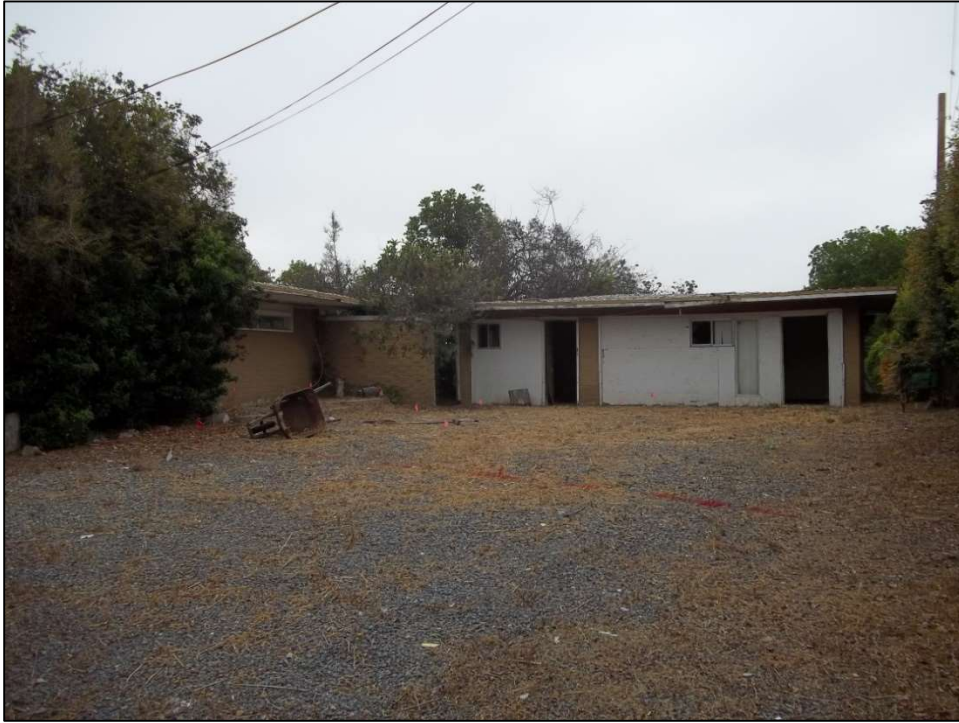
Figure 7. Partial site overview of 1190 Island View Lane, facing east

Much of the building’s exterior is covered by dense vegetation. The east elevation of the building shows a substantial degree of damage including a partial roof collapse, missing doors, deteriorating wood board cladding, etc. (Figure 7).

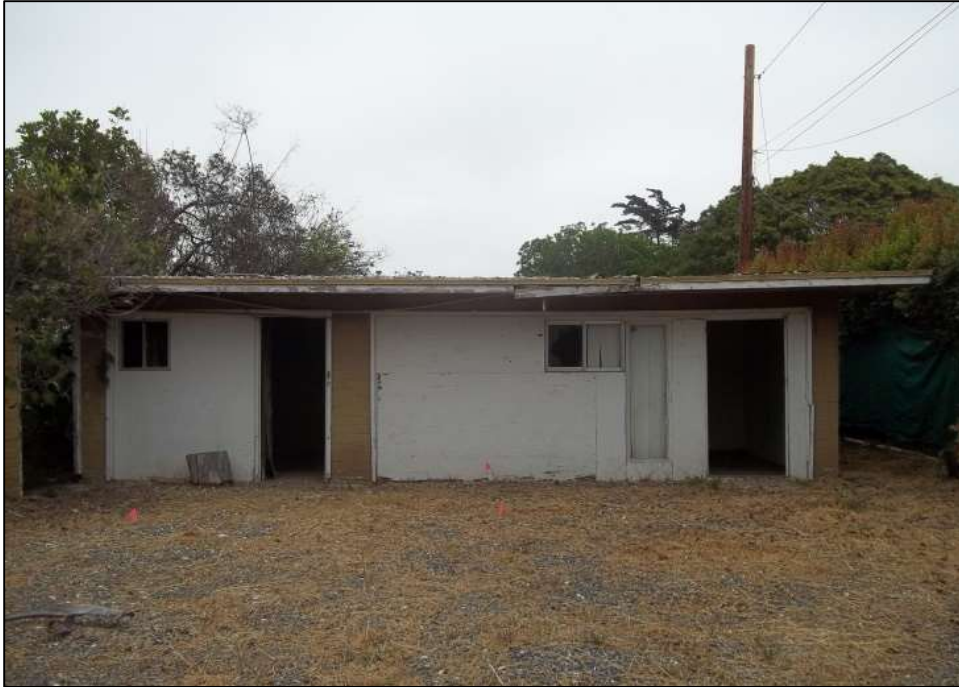
Figure 8. 1190 Island View Lane, large ancillary building, west facade, facing east

This one-story ancillary building has a square footprint and a flat roof with wide overhanging eaves. From what can be seen from ground level, it appears the roof is gravel similar to the adjacent residential building. This building is in poor condition due to substantial deterioration of materials. The County Assessor's records indicate this building was originally constructed for use as a garage but was later converted to a multi-roomed ancillary building. The original sections of the building are recognizable by the Stretcher Bond brick course. Areas later filled in at the west façade (assumed at the time the garage was converted from its original use) are evident from the use of large plywood sheets and the installation of two one-by-one, aluminum framed sliding windows, a large single-pane fixed window, and two pedestrian door frames. A small concrete room addition (year of addition is not known) is at the northern end of the east elevation. A section of roof at the back of this building (east elevation) has collapsed. An additional two pedestrian door frames and a one-by-one sliding window with an aluminum frame are at the east elevation (Figure 8).

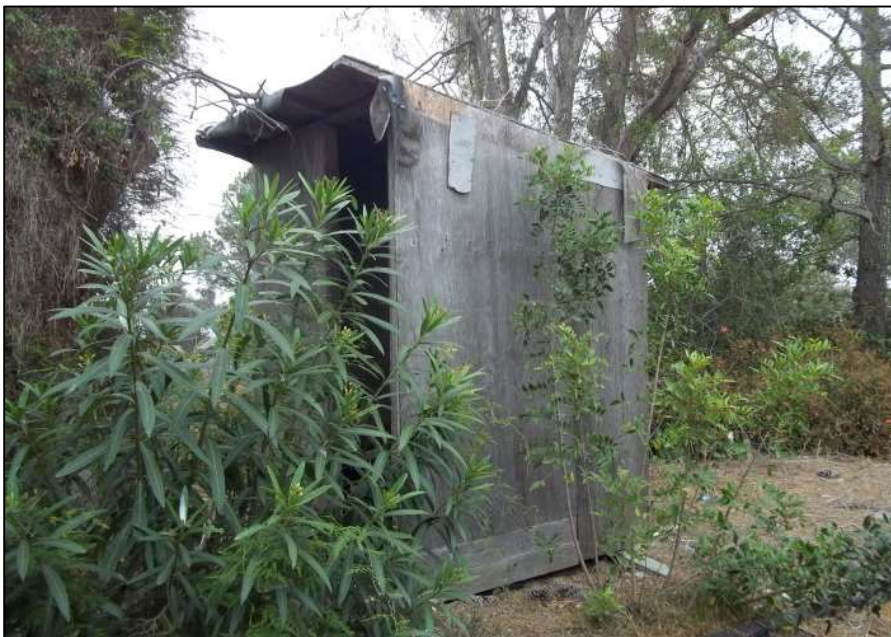
Figure 9. 1190 Island View Lane, shed, south façade (left) and east elevation (right), facing west

The shed is located approximately 20-30 feet from the west façade of the main residence. It is small with a sloped shed roof and is clad with wood boards (possibly plywood). The roof is covered in large sheets of asphalt which show substantial deterioration. A narrow wood framed entrance (no door present) is located at the building’s south façade (Figure 9).

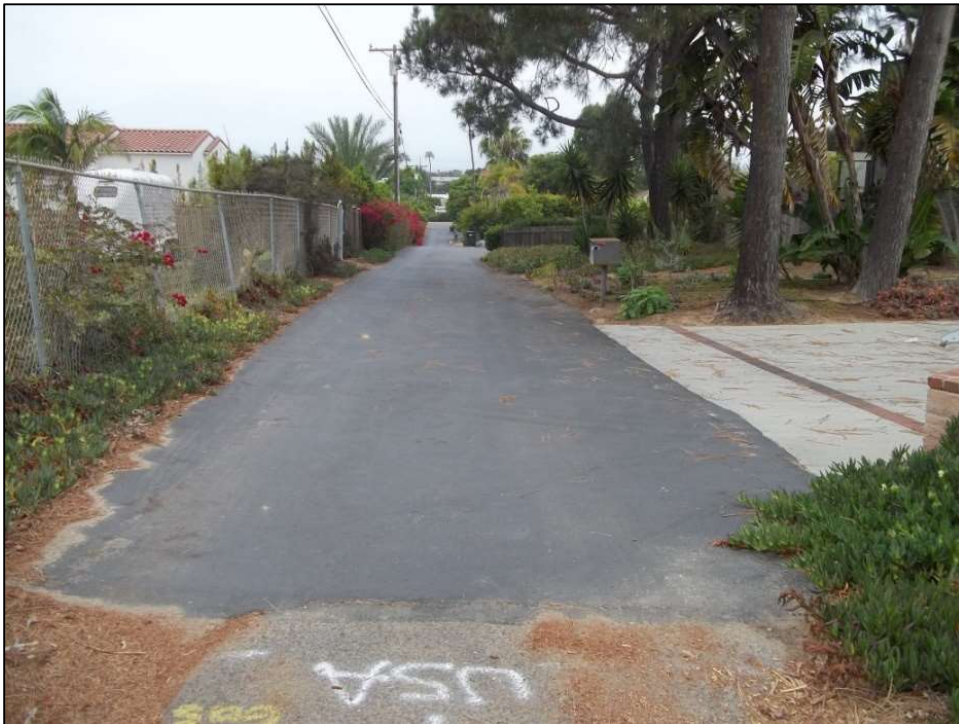
Figure 10. Island View Lane, facing west

This paved, single lane, residential road first appears in a 1947 USDA aerial photograph (NETROnline 1947). It was originally used as a private access road from Balour Drive to the single-family residence at 1190 Island View Lane (per the San Diego County Assessor, the original address of 1190 Island View Lane was 795 Balour Drive). On December 30, 1947, a right of easement was granted to the San Diego Gas and Electric Company for the right to place and maintain “poles and wires.” In 1953, a right of way for public road access was granted to the County of San Diego (First American Title 2021). Sometime between 1967 and ca. 1978, the parcels immediately north of Island View Lane were developed and easement of the road was granted to these residences which connect to their own respective driveways. It is assumed based on aerials from 1967, 1978 and 1980 that Island View Lane was first paved sometime in the 1970s. On average, Island View Lane is 10-12 feet wide, paved with asphalt, and is in good condition (Figure 10).

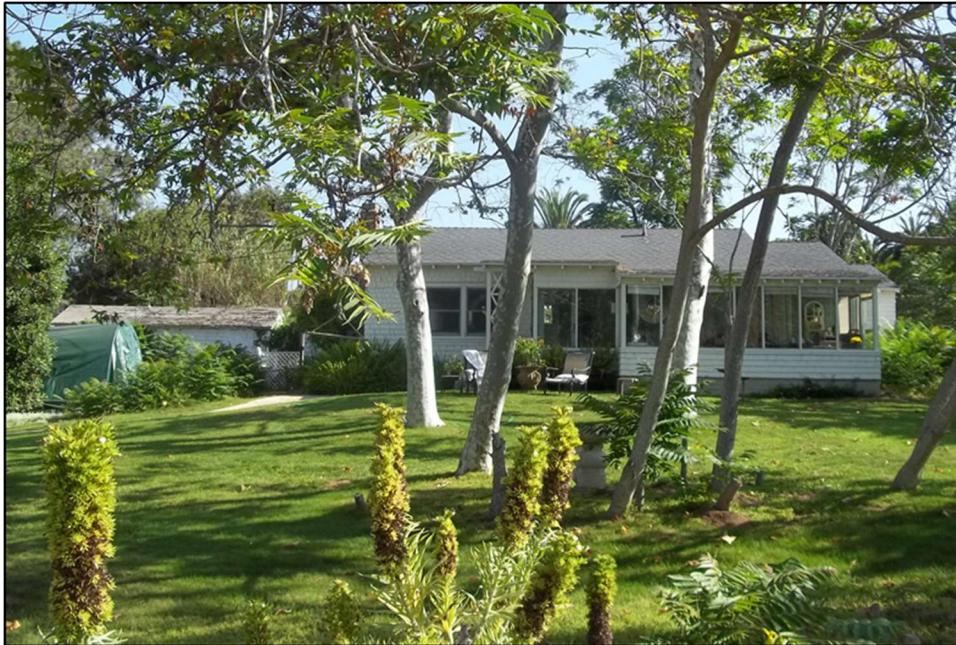
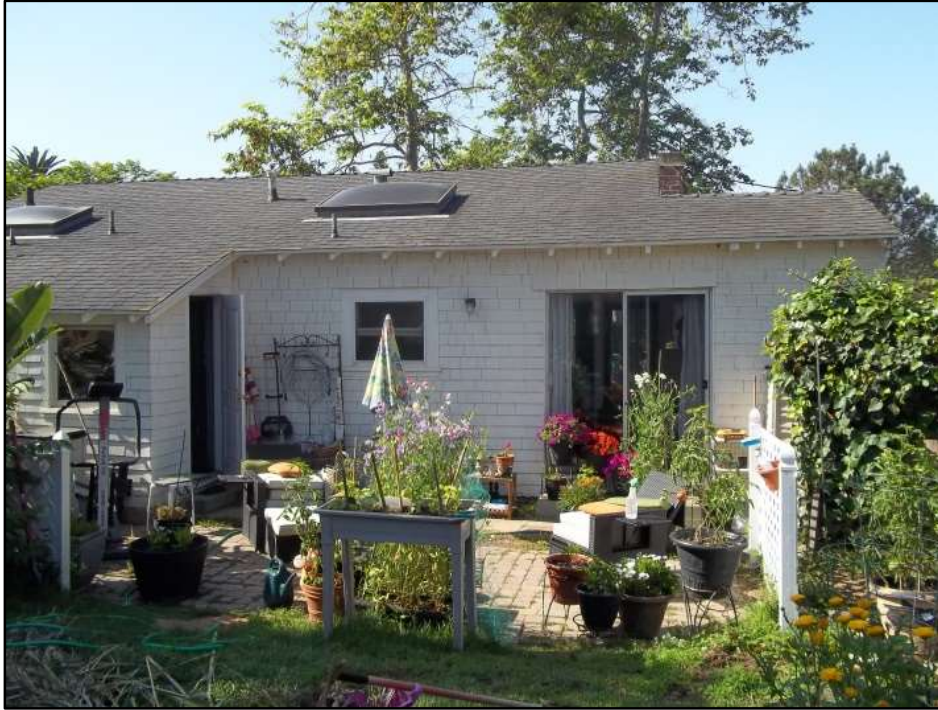
This one-story single-family residence was constructed ca. 1938 and is set on a raised concrete foundation approximately 1-2 feet above ground level. The building’s footprint is irregular but does follow a general rectangular shape. The roof is comprised of multi-leveled gabled roofs with slight to moderate exposed overhanging eaves and is clad with composition shingles. Two skylights (added ca. 1975) are located on the north side of the center of the roof. The exterior of

the building is clad with a coursed wood shingle pattern. The main entrance is located at the south façade which is accessible by an elevated porch (approximately 2 feet above ground level). A sunroom (or solarium) is located at the eastern half of the south façade. It consists of multiple fixed, large, single-pane glass windows and is covered by a low-pitched shed roof. A red brick chimney, organized in a running bond, is located at the west elevation. Windows at this elevation are one-over-one single-hung windows with wood sashes.

Windows at the east elevation are identical to the west elevation as they are one-over-one single-hung windows with wood sashes. Fenestration at the north elevation includes two doors: one aluminum framed glass sliding door and one two-paneled wood door; both do not appear to be historic in age. Three crank-out casement windows are located near the middle of the elevation. Additional windows include one large rectangular, one-over-one, wood sash, single hung window and one smaller rectangular, one-over-one, single hung window (Figures 11 and 12).

Figure 11. 1220 Melba Road, south façade, facing north

Figure 12. 1220 Melba Road, north façade, facing south

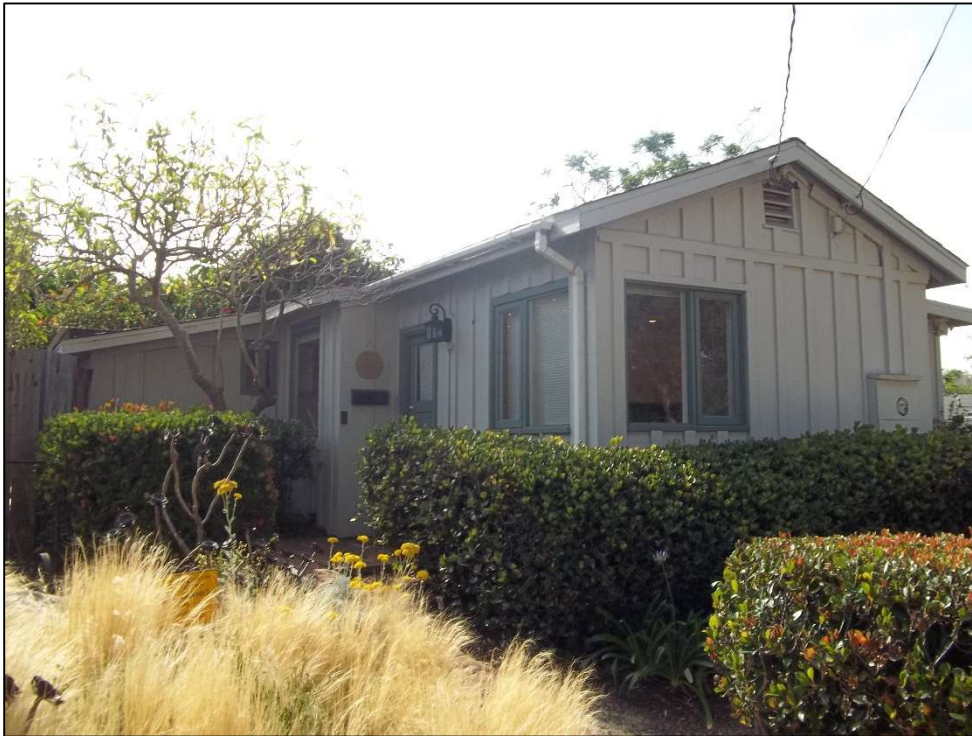
Figure 13. 1230 Melba Road, residence, north façade (left) and west elevation (right), facing southeast

This small, one-story, single-family residence is in overall good condition. The building has an irregular footprint with a normal pitched open gabled roof (clad in composition shingles) intersected by a low-pitched shed roof (roofing material not known) at the south elevation and a flat roofed porch overhang (covered with corrugated metal sheeting) at the east elevation. The building addition at the southern elevation is set on a concrete block foundation, approximately 1-2 feet ground level. The exterior is clad in wood board and batten siding. The main entrance is located at the north façade and consists of a panel and glass wood door. Windows are wood framed and appear to be original to the building. Two wood framed corner windows (two panes each; one fixed, one casement) are located at the junction of the west elevation and the north façade. Fenestration at the north elevation includes a small wood framed casement window, an

aluminum framed sliding window, an aluminum framed sliding door, a five-glass paned door, and one vinyl framed window (not historic in age; Figure 13).

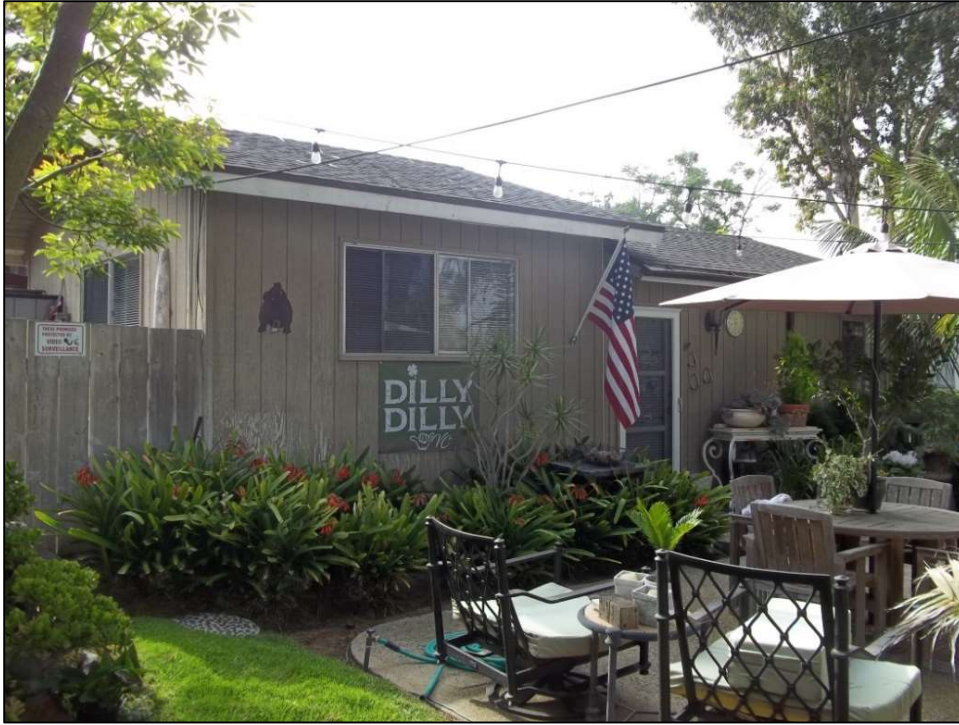
Figure 14. 1230A Melba Road, west façade, facing southeast

This one-story single-family residence has a rectangular footprint and a normal pitched roof. The building is set on a concrete foundation and elevated less than a foot above ground level. The roof is clad with composition shingles and has a moderate eave overhang. The exterior of the building is clad in vertical wood siding (weatherboard) and the condition of the material does not appear historic in age (possibly added within the last 10-15 years). The main entrance is located at the west façade and consists of a three-paneled glass/wood door; while the doorknob and lock hardware are not historic in age, the door itself does appear historic. The windows on all elevations are one-by-one sliding windows with aluminum frames, six large and two small. A secondary pedestrian door with a small upper and lower louvered vent is found at the east elevation and allows access to and from the backyard (Figure 14).

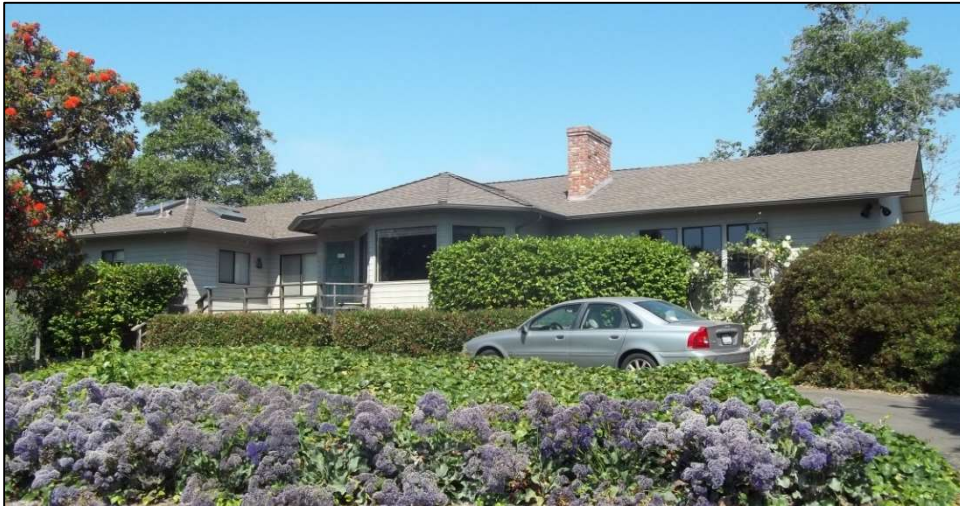
Figure 15. 1240 Melba Road, Main House, southeast façade, facing northwest

center of the southeast façade (added ca. 1967) (NETROnline 1967). The residence is set atop a brick foundation which raises the building approximately 2 feet above ground level. The roof is clad in composition shingles with a red brick chimney located near the center of the body of the building. The exterior of the building is clad in horizontal wood siding (weatherboard), which does not appear historic in age and was possibly added within the last 20 years. The main entrance to the main house is an eight-paneled wood door located at the southeast façade, under the eaves of the multi-faceted hip roof. A sliding glass door and a one-by-one sliding window are at the southern corner of the southeast façade. The southeast elevation consists of multiple one-by-one sliding windows and one large fixed bay window. At the northeast elevation, there are two large roll-up garage doors and a louvered gabled vent (Figure 15).

The northwest elevation consists of multiple one-by-one sliding windows and one-over-one single hung windows (all with vinyl frames). There are also four sliding glass doors; two of these sliding doors are situated on the building projection located at the southern end of the northwest elevation. A large porch overhang supported by three posts is attached to this projection. At the southwest elevation are two large one-by-one sliding windows and one sliding glass door.

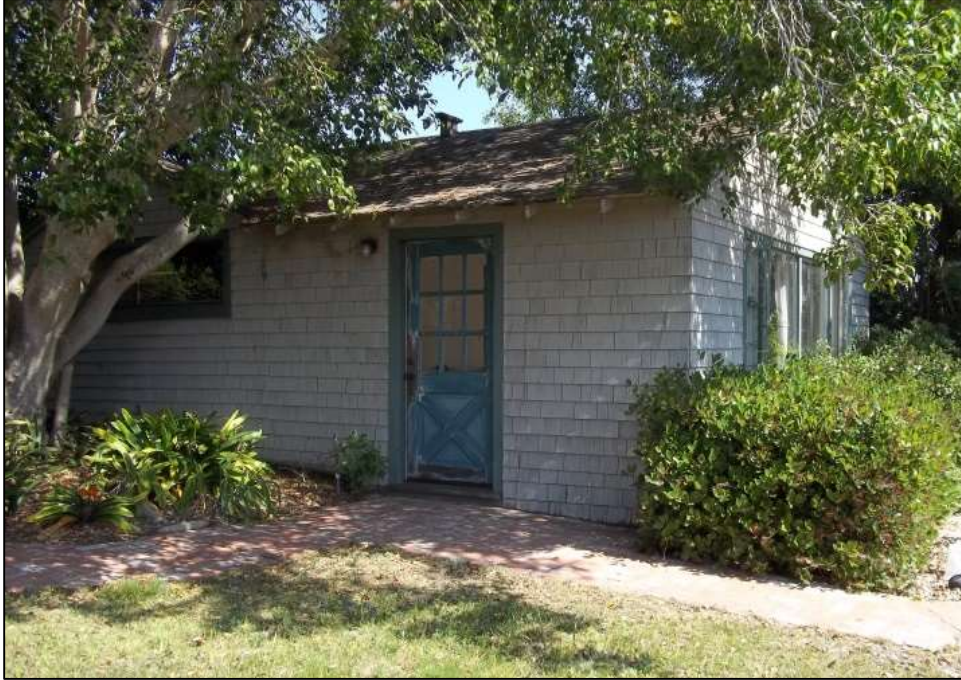
Figure 14. 1240 Melba Road, guest house, south façade

The single-story guest house has a rectangular footprint and has no particular architectural style. The roof is a composition clad intersecting gabled roof with wide exposed eaves. The exterior of the building is clad in square butt shingles. There is one pedestrian door (wood, nine glass panels over one wood cross panel) located at the south façade. At the west end of the south façade is a one-by-one aluminum framed, sliding window. At the east elevation is a large four paneled picture window (wood framed) with the two narrow rectangular windows swinging out. A gabled louvered vent is located at the east elevation (Figure 16).

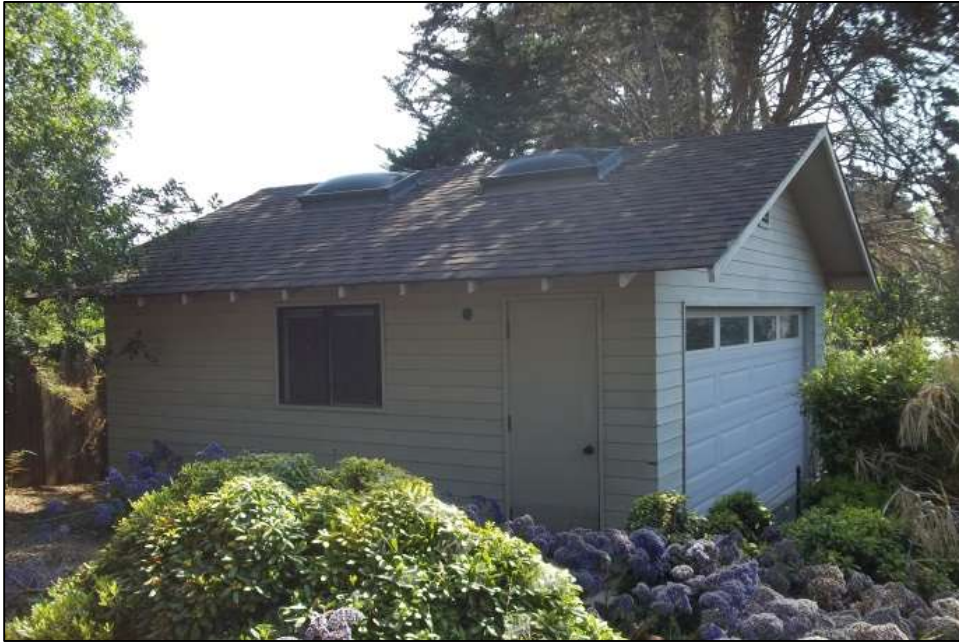
Figure 15. 1240 Melba Road, detached garage, west elevation (left) and south façade (right), facing northeast

The single-story detached garage has no particular style but has wide overhanging exposed eaves as commonly seen with Ranch style. The building's footprint is rectangular and the exterior is clad in horizontal wood weatherboard panels. The normal pitched gabled roof is clad with composition shingles (Figure 17).

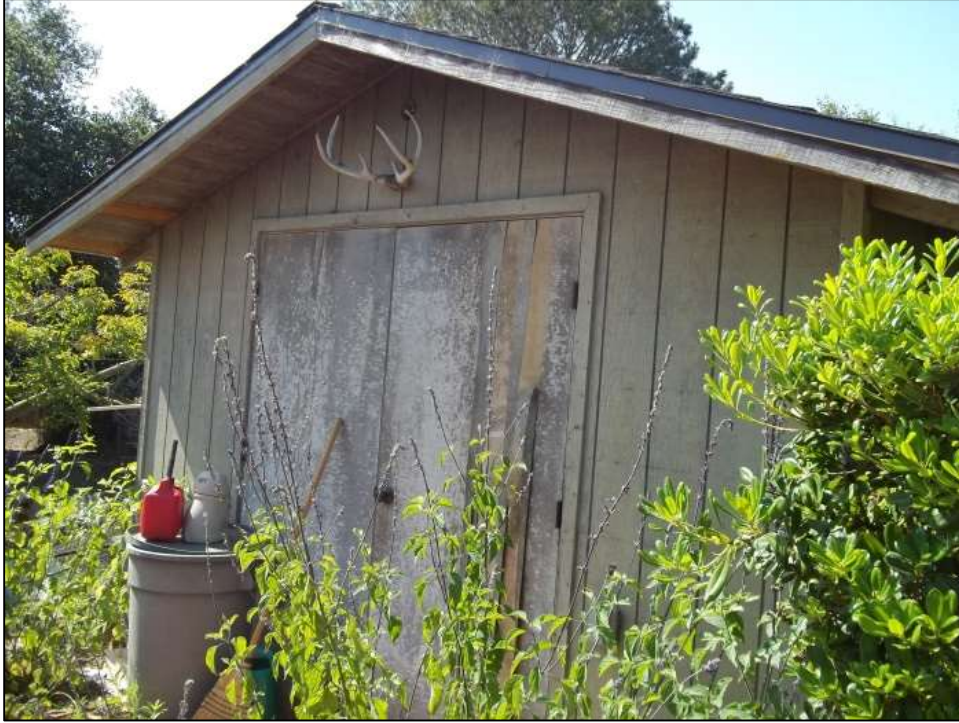
Figure 16. 1240 Melba Road , shed, north façade

This small shed is one story with a rectangular footprint. The normal pitched gabled roof is clad with composition shingles and has a wide eave overhang with exposed rafters. An approximately 4-5 foot overhang at the east elevation, supported by three wood posts, creates a shelter that is currently used for storage of building materials. The exterior of the building is clad in vertical weatherboard which shows notable deterioration; however, despite the deterioration of materials it is uncertain if it is historic in age or was added at a later date. The only entrance to the shed is located at the north façade; the flush wood doors show substantial fading and peeling of materials (Figure 18).

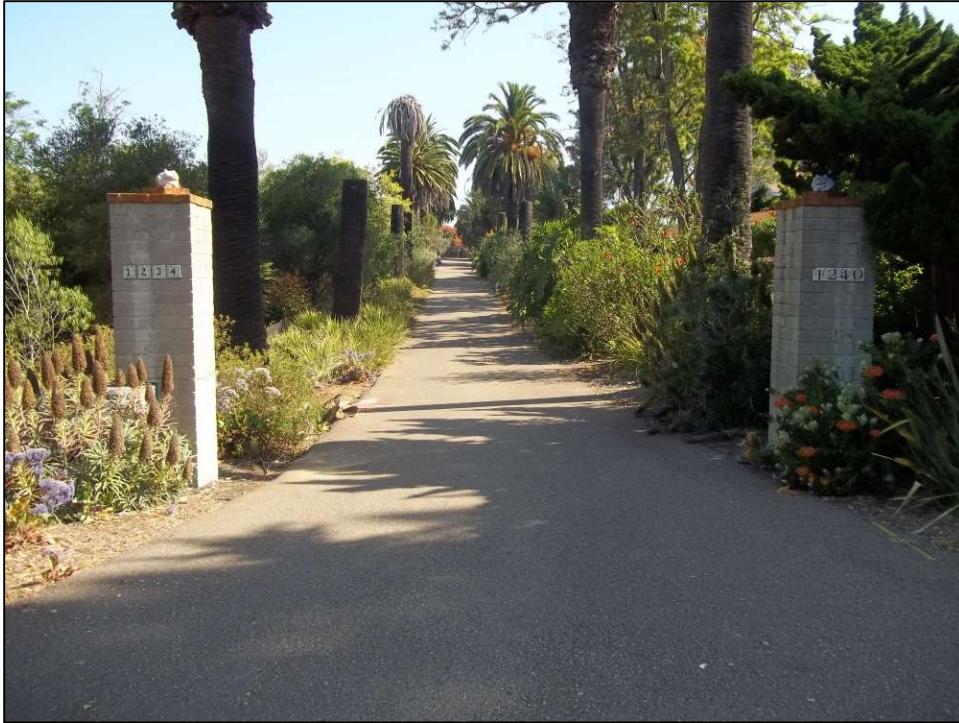
Figure 17. Driveway/ Boulevard of 1234 and 1240 Melba Road, facing north

This driveway begins at Melba Road and leads directly to the residence at 1240 Melba Road with a round-about at the northernmost portion. It is not known when the round-about was added due to the presence of tall trees, however it is first partially visible in the late 1980s (NETROnline 1987). Both the west and east sides of the driveway are lined by over a dozen 50+ year old palm trees giving it the aesthetic of a boulevard. Many of the palm tree crowns have been removed leaving behind the bole (Figure 19).

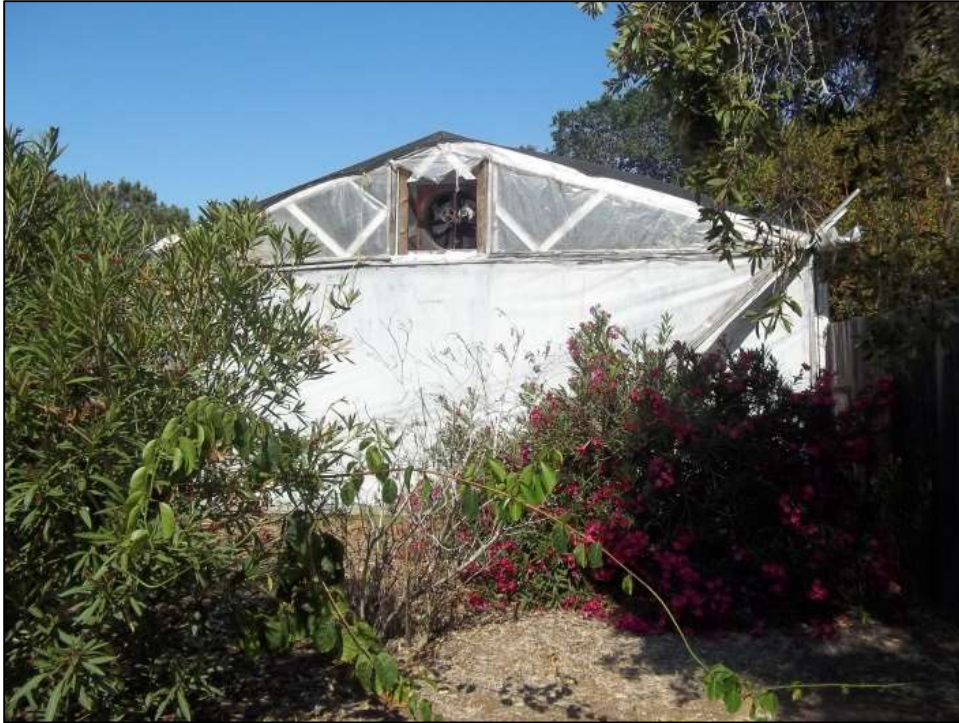
Figure 18. 1234 Melba Ave., Greenhouse, west elevation, facing east

The large greenhouse has a rectangular footprint and is still in use. The building is wood framed with exposed wood trusses. The normal pitched gabled roof and sides of the building are covered in a combination of large plastic sheets, bird netting, and sheets of plywood. There is one pedestrian door at the east elevation, however, it is inaccessible as it is covered by plastic sheeting. The primary entrance to the large greenhouse is at the south elevation through an intentional gap in the plastic sheeting which aligns with a concrete paved walkway, allowing easy access to and from the building. A long metal rail hangs over this entrance which was possibly used as a track for a sliding door (Figure 20).

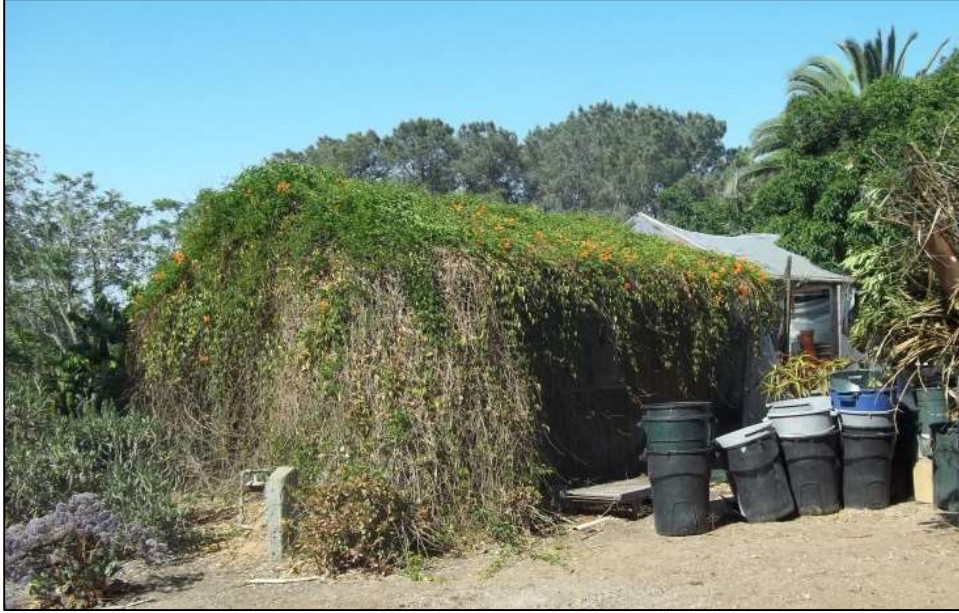
Figure 19. 1234 Melba Ave., administration building, east elevation (left) and north elevation (right), facing southwest

The majority of this small single-story building is largely covered with vines; only a portion of the north elevation and east façade are visible. The roof has a low pitch with a wide eave overhang at the west elevation. A single flush pedestrian door is present at the west façade. The exterior of the building is clad in vertical clapboard. Single aluminum framed, two-paneled sliding windows are located at the north elevation, east elevation, and south elevation (Figure 21).

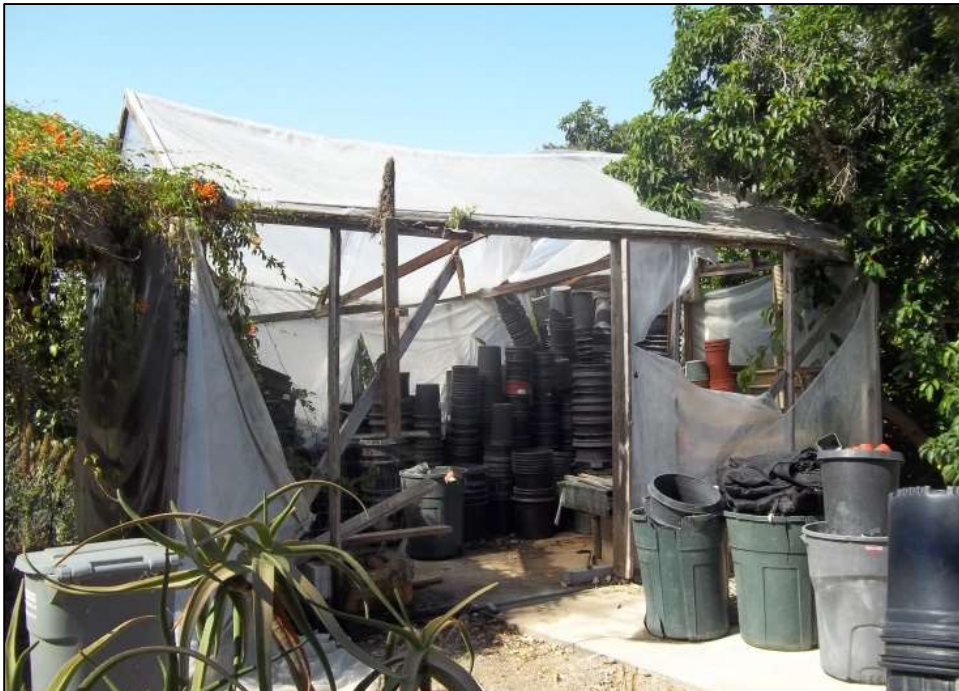
Figure 20. 1234 Melba Ave., administration building (left) and north façade of greenhouse (right), facing south

The small greenhouse is adjacent to the west façade of the administration building. The greenhouse is a simple wood frame with the roof and much of the exterior of the structure covered with plastic sheeting. The roof is a normal pitch with no overhang (Figure 22).

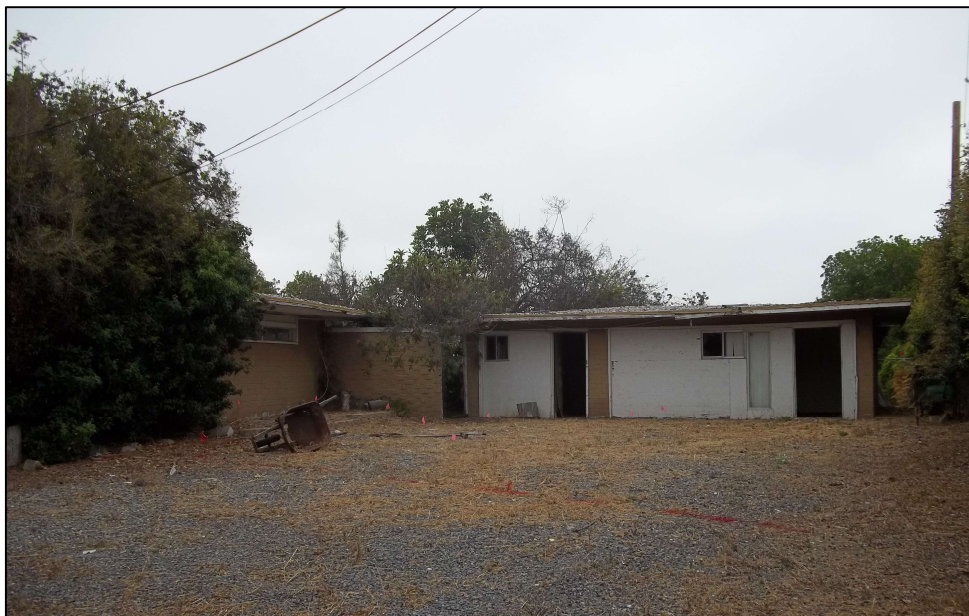
P5b. Description of Photo:
Site overview, facing east

This property consists of a single-family residence and two ancillary buildings (all are in poor condition). The residence has an irregular footprint but is largely rectangular. The roof consists of three low pitched telescoping hipped gable roofs covered in gravel. The roof has a wide eave overhang except for the northernmost segment of the building (added ca. 1947-1953) where there is no eave overhang due to severe deterioration of materials. Most of the exterior of the building is comprised of brick organized in a Stretcher Bond course. Fenestration is an eclectic collection of fixed, sliding, picture, ribbon, and multi-paneled windows in addition to glass, flush, and multi-paneled pedestrian doors (See Continuation Sheet; P5b Photos Cont.). The main entrance is located near the middle of the west façade and is identified by a large glass pedestrian door flanked on both sides by large, fixed single-pane windows with wooden frames and sills. The ca. 1947-1953 addition at the northern end of the residence is composed of wood board, chicken wire, and stucco (this section is heavily deteriorated). There are two chimneys associated with this residence, one is covered in a heavy plastic tarp and located at the center of the building, the other is at the northern addition; the red brick is set in a Stretcher Bond. (See Continuation Sheet)

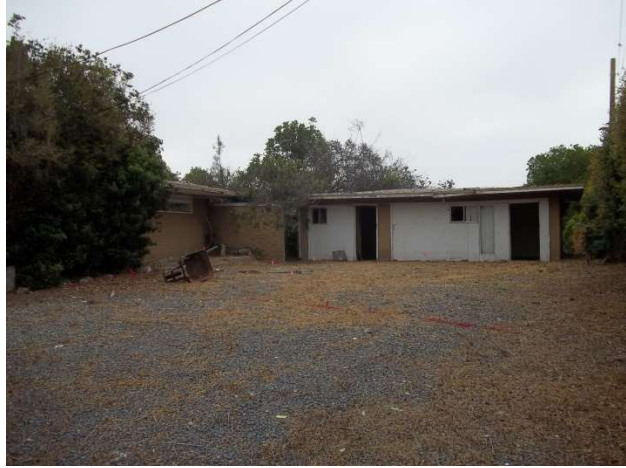
3. Main building (left) and ancillary building (right)

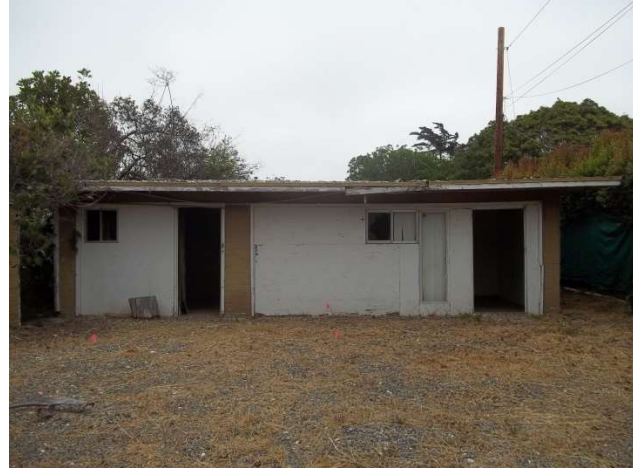
4. Ancillary building, west façade, facing east

This one-story ancillary building has a square footprint and a flat roof with wide overhanging eaves. From what can be seen of the roof from ground level, it appears the roof is covered in gravel such as the adjacent residential building. This building is in poor condition due to substantial deterioration of materials. The county assessor's records indicate this building was originally constructed for use as a garage but was later converted to a multi-roomed ancillary building. The original sections of the building are recognizable by the Stretcher Bond brick course. Areas later filled in at the west façade (assumed at the time the garage was converted from its original use) are evident from the use of large plywood sheets and the installation of two one-by-one, aluminum framed sliding windows, a large single-pane fixed window, and two pedestrian door frames. A small concrete room addition (year of addition is not known) is at the northern end of the east elevation. A section of roof at the back of this building (east elevation) has collapsed. An additional two pedestrian door frames and one one-by-one sliding window with an aluminum frame are at the east elevation.

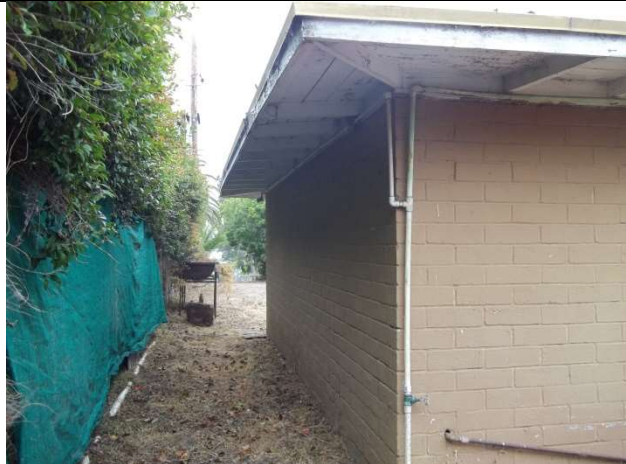
5. Ancillary building, south elevation (left) and east elevation (right)

Much of the building's exterior is covered by dense vegetation. The east elevation of the building shows a substantial degree of damage as seen with a partial roof collapse, missing doors, deteriorating wood board cladding, etc.

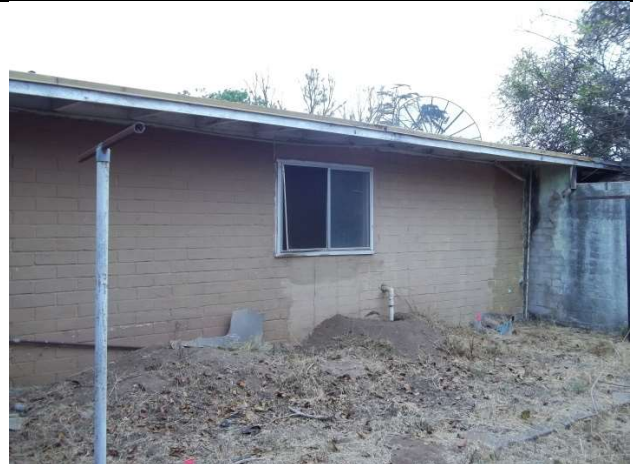
6. Ancillary building, east elevation

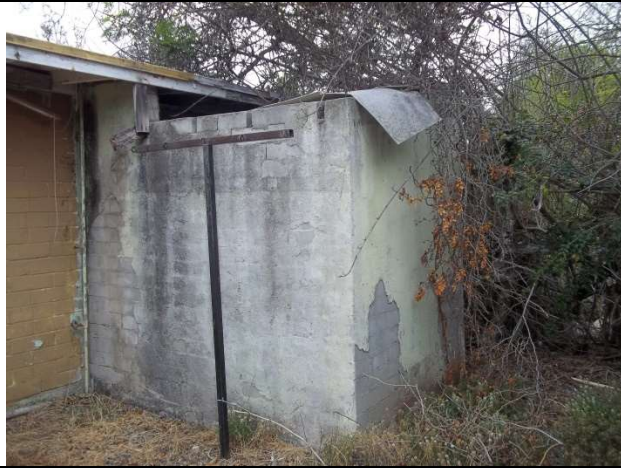
7. Ancillary building, east elevation

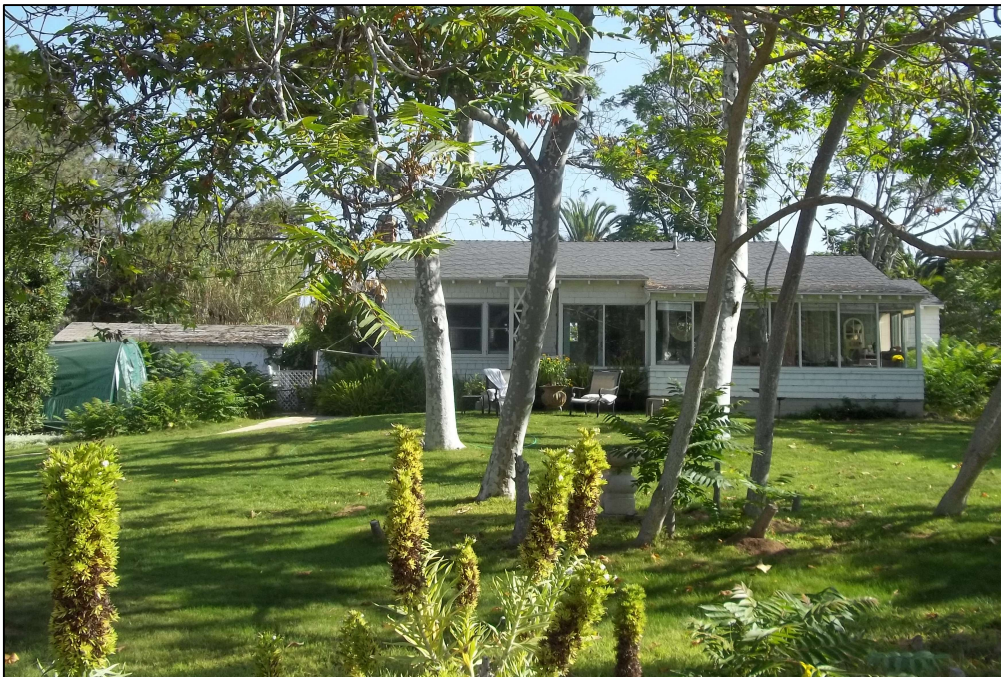
P5b. Description of Photo:

South façade, facing north

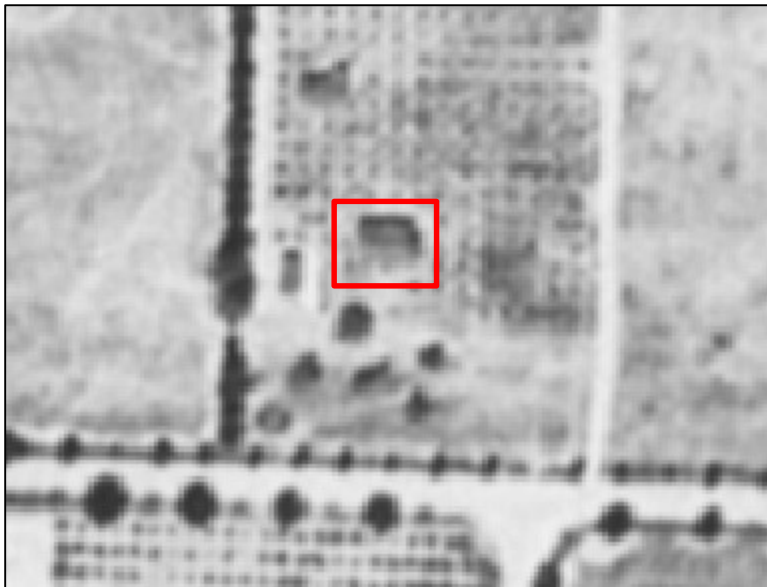
1939 USDA Aerial Photograph of 1220 Melba Road (red: residence; FrameFinder 1939)

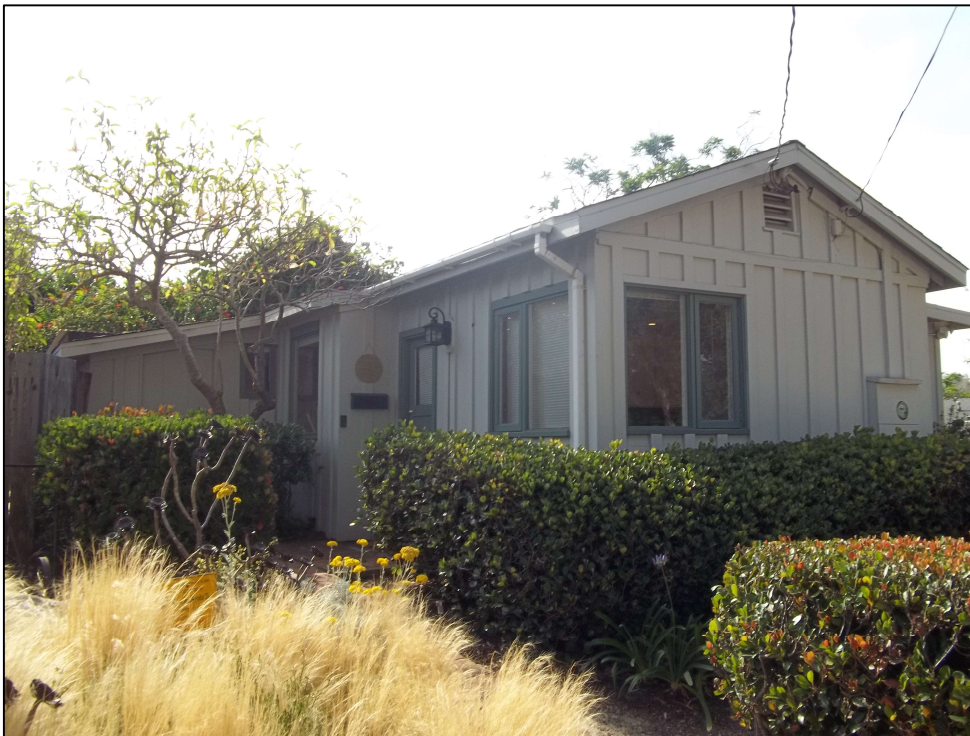
This small, one-story, single-family residence is in overall good condition. The building has an irregular footprint with a normal pitched open gabled roof (clad in composition shingles) intersected by a low pitched shed roof (roofing material not known) at the south elevation, and a flat roofed porch overhang (covered with corrugated metal sheeting) at the east elevation. The building addition at the southern elevation is set on a concrete block foundation, approximately 1-2 feet above ground level. The exterior is clad in wood board and batten siding. The main entrance is located at the north façade and consists of a panel and glass wood door. Windows are wood framed and appear to be original to the building. Two wood framed corner windows (two panes each; one fixed, one casement) are located at the junction of the west elevation and the north façade. (See Continuation Sheet)

P5b. Description of Photo:
Residence, north façade (left) and west elevation (right)

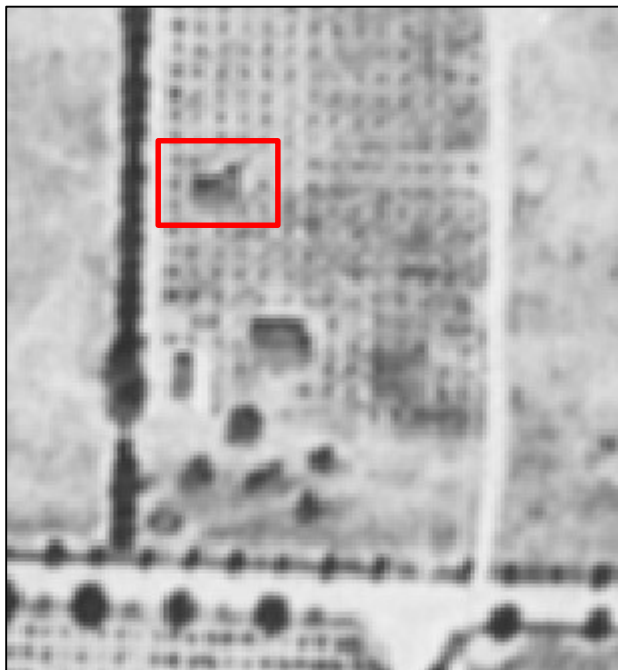
1939, residence at what is now 1230 Melba Road (Frame Finder 1939)

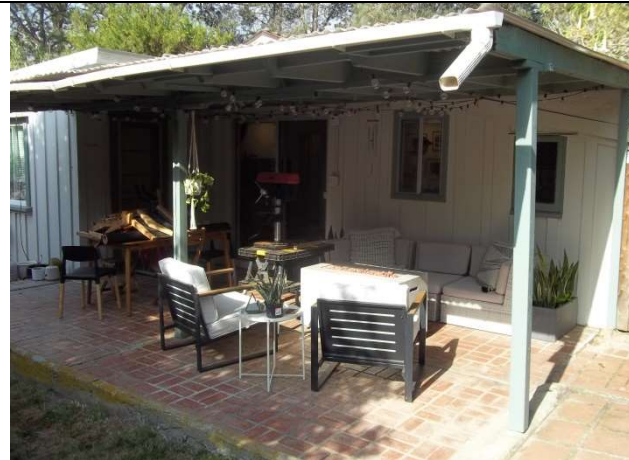
4. Residence, east elevation with porch overhang

Integrity: This residence appears to maintain its integrity of Location and Association. With the construction of the building addition at the south elevation and the porch overhang at the east elevation there has been a notable impact to the building's integrity of Design, Materials, Feeling, and Workmanship. However, the addition at the south elevation is over 50 years old and is now considered a historic-aged feature of this building. Due to residential development in the immediate surrounding area, this building has lost some of its integrity of Setting.

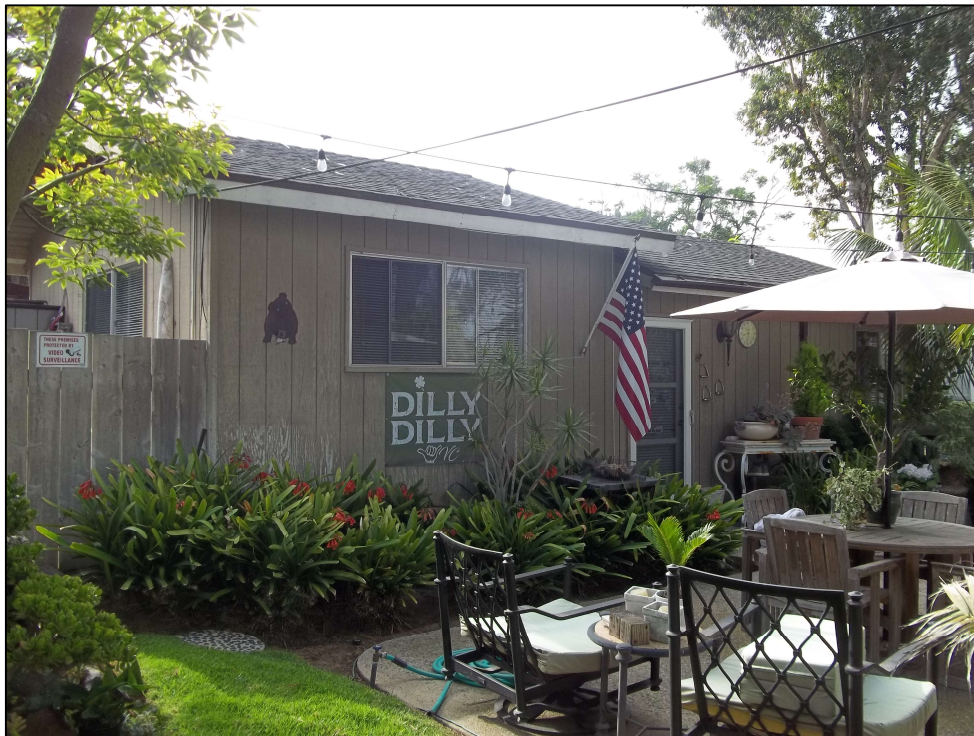
This one-story, single-family residence has a rectangular footprint and a normal pitched roof. The building is set on a concrete foundation and elevated less than a foot above ground level. The roof is clad with composition shingles and has a moderate eave overhang. The exterior of the building is clad in vertical wood siding (weatherboard) and the condition of the material does not appear historic in age (possibly added within the last 10-15 years). The main entrance is located at the west façade and consists of a three paneled glass/wood door; while the doorknob and lock hardware are not historic in age, the door itself does appear historic in age. The six large and two small windows on all elevations are one-by-one sliding windows with aluminum frames. A secondary pedestrian door with a small upper and lower louvered vent is found at the east elevation and allows access to and from the backyard.

P5b. Description of Photo:
West Façade, facing southeast

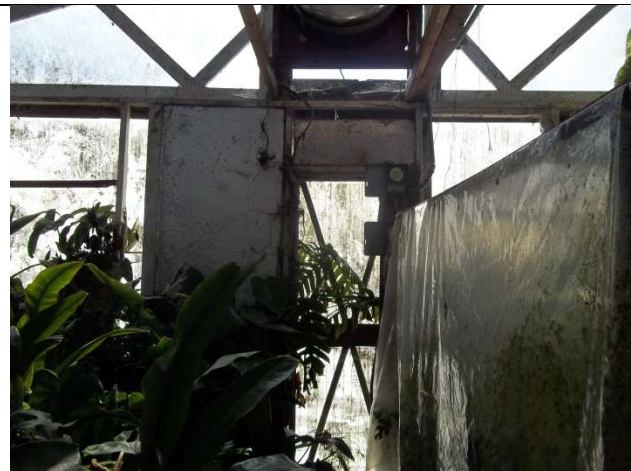
23. Interior, ventilation equipment at east elevation
