VOLUME II: APPENDICES TO THE ENVIRONMENTAL IMPACT REPORT**PART 1**

**Cultural
Resources
Assessment
Report**

CULTURAL RESOURCES ASSESSMENT REPORT FOR THE MELBA ROAD AND ISLAND VIEW LANE RESIDENTIAL PROJECT, CITY OF ENCINITAS, SAN DIEGO COUNTY, CALIFORNIA

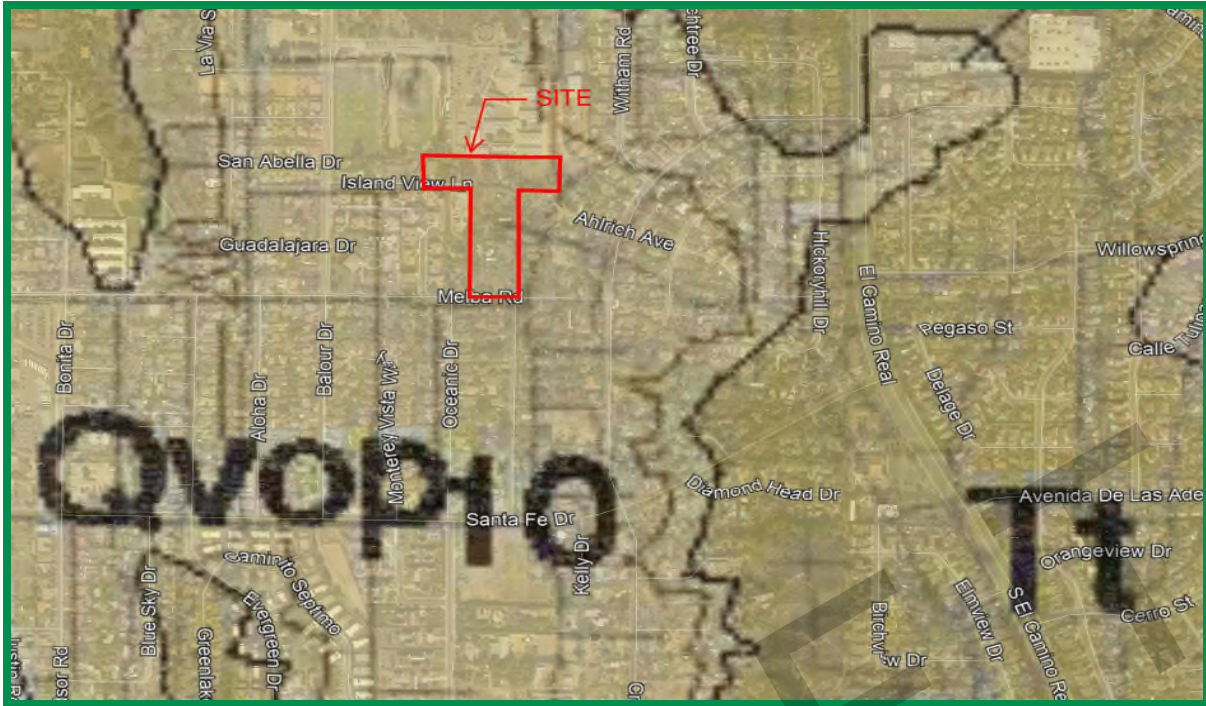
The site is located on the western portion of the coastal plain. Marine sedimentary units make up the geologic sequence encountered on the site and consist of middle to early Pleistocene-age Very Old Paralic Deposits (formerly known as Terrace Deposits). The Very Old Paralic Deposits are shallow marine deposits generally consisting of sand and silty sand units interfingering with layers of silt and clay. This unit may be in excess of 50 feet thick underlain by the Torrey Sandstone. The Regional Geologic Map shows the geologic units in the area of the site.
