Project No. 07516-42-02  
May 10, 2023

Subject: RESPONSE TO CITY OF SAN DIEGO REVIEW COMMENTS  
NAKANO  
SAN DIEGO, CALIFORNIA

<p><b>GEOCON</b>          INCORPORATED</p> <p>GEOTECHNICAL ■ ENVIRONMENTAL ■ MATERIALS          6940 ANDERS DRIVE ■ SAN DIEGO, CALIFORNIA 92121-2974          PHONE 858.558.4900 ■ FAX 858.558.4159</p>	SCALE 1" = 60'	DATE 05 - 10 - 2023	FIGURE 1
	PROJECT NO. 07516 - 42 - 02		SHEET 1 OF 1
	SHEET 1 OF 1

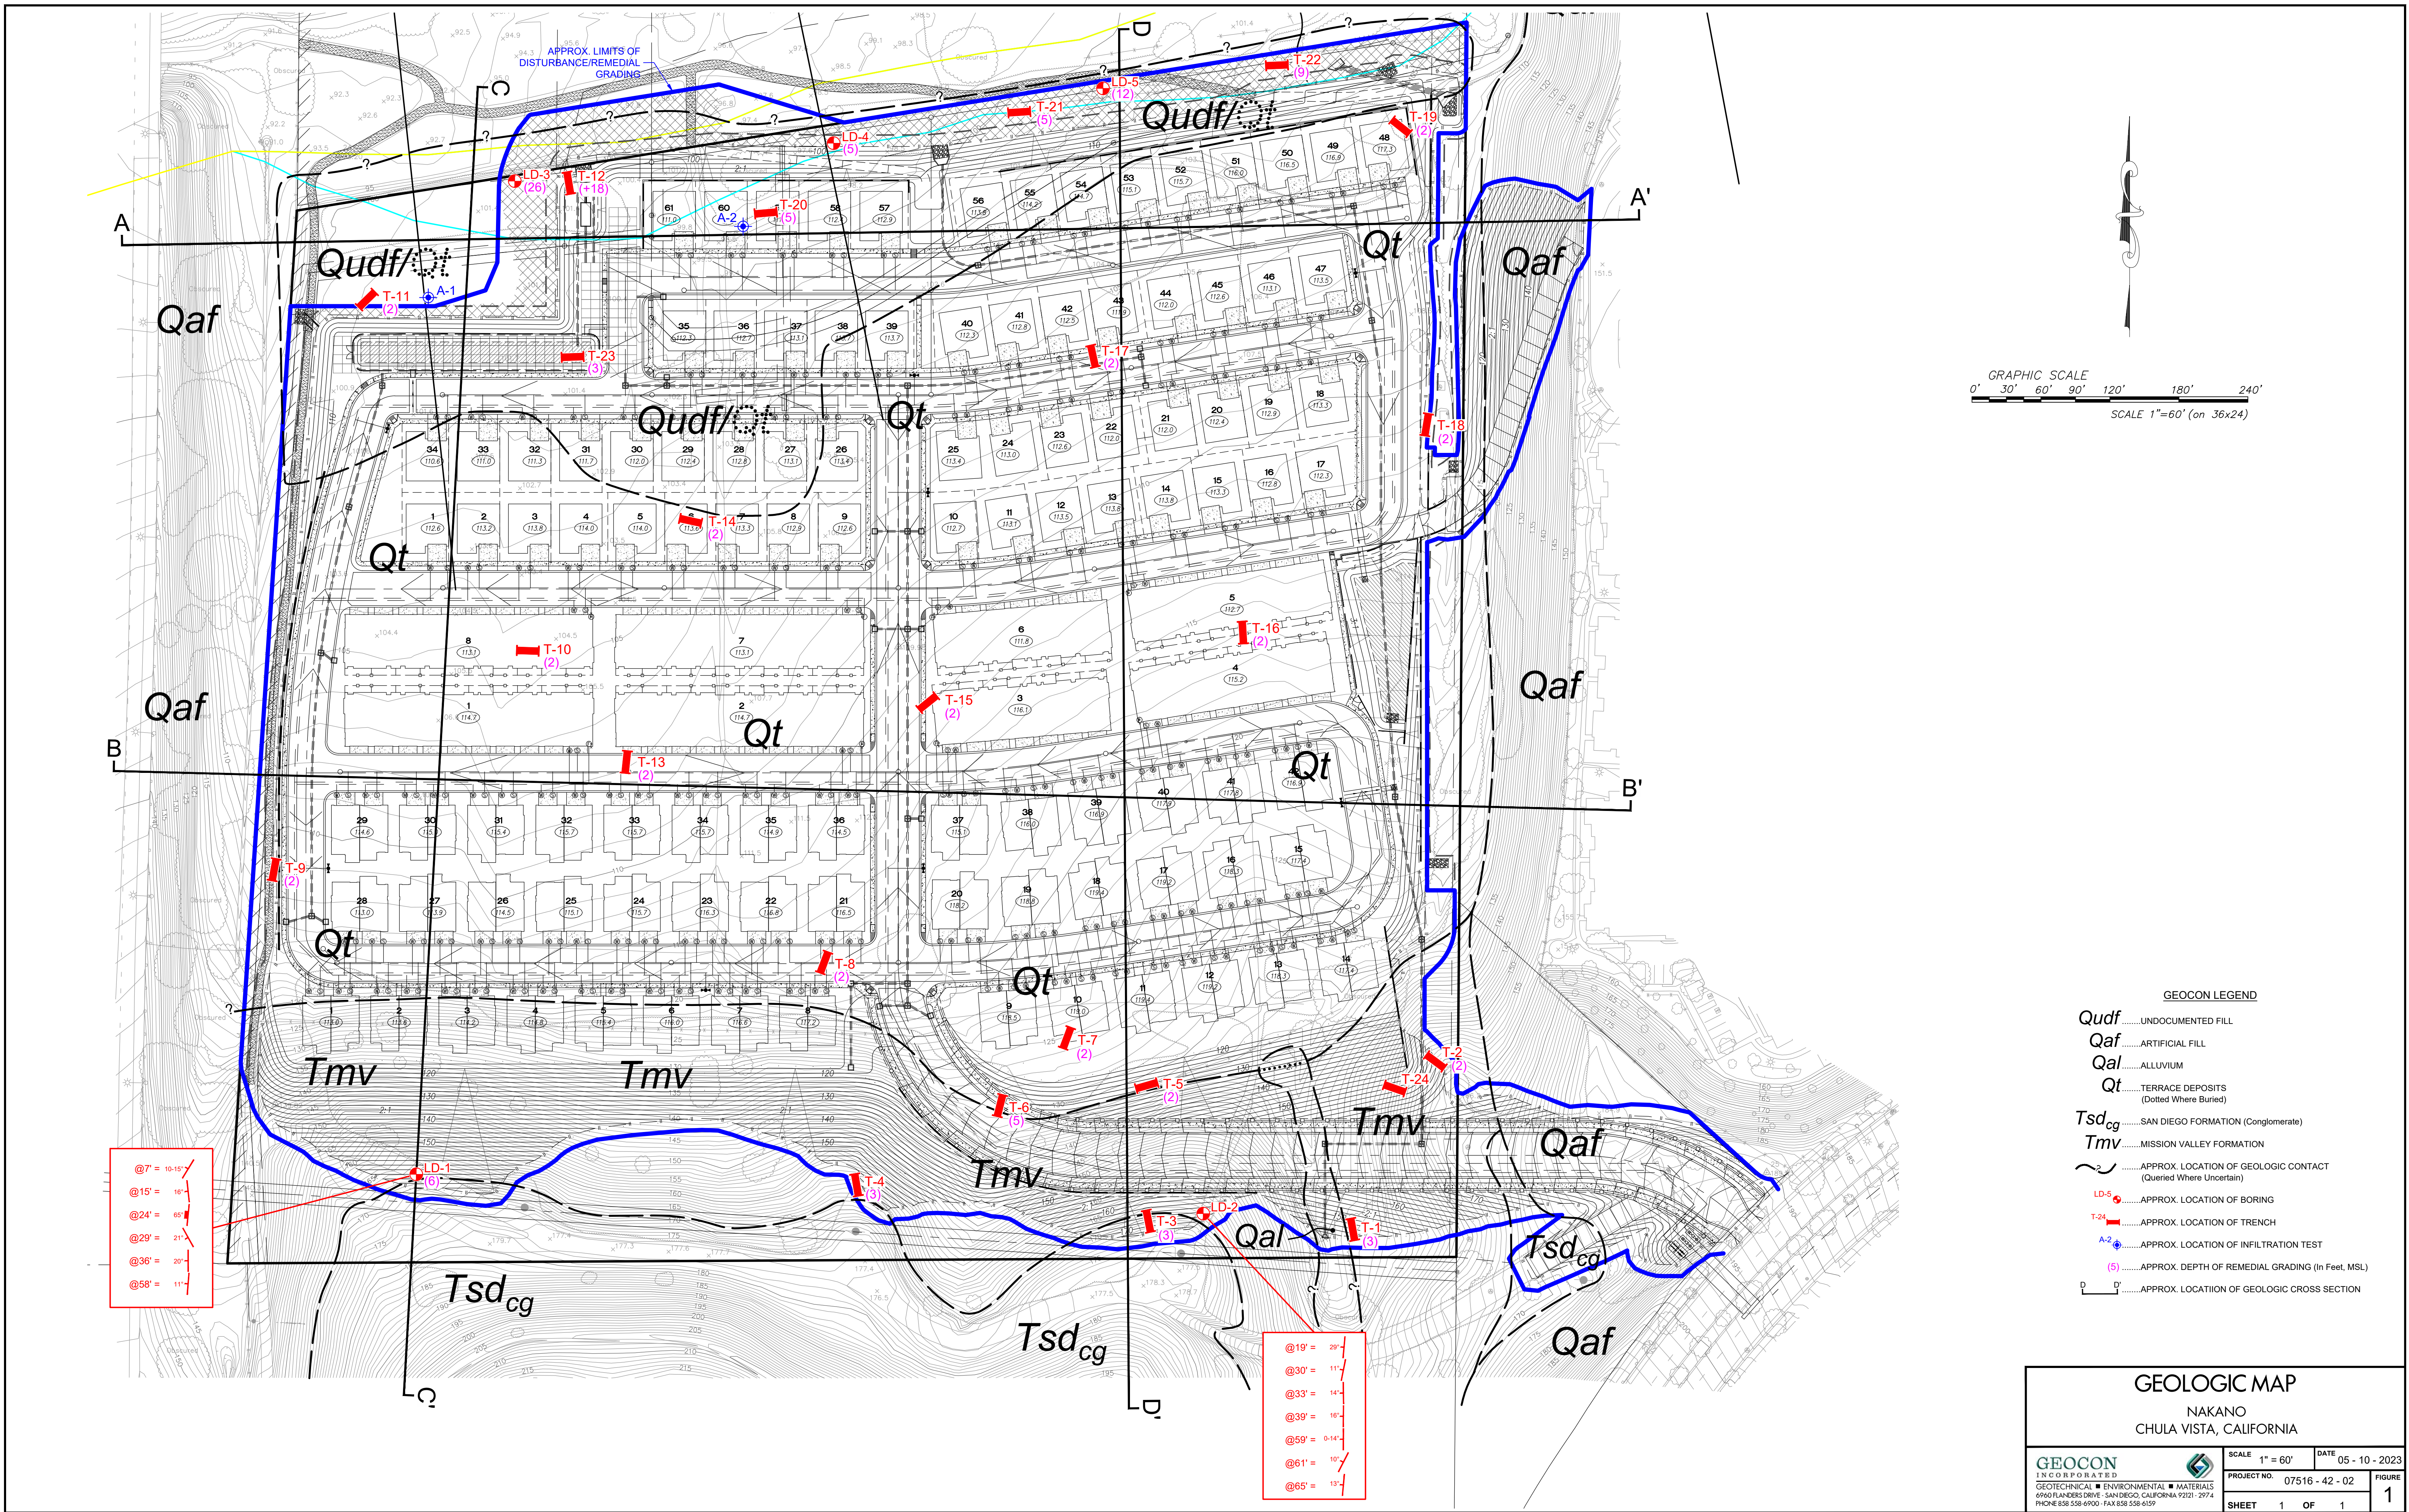
**Response:** Figure 1 is the requested updated geologic map using a CAD file of Reference 4 as the base map. Figure 1 shows the proposed development and the disturbance limits and limits of anticipated remedial grading. Cross sections are provided on Figures 2 and 3.

- GEOCON LEGEND**
- Qudf* ..... UNDOCUMENTED FILL
  - Qaf* ..... ARTIFICIAL FILL
  - Qal* ..... ALLUVIUM
  - Qt* ..... TERRACE DEPOSITS  
(Dotted Where Buried)
  - Tsd<sub>cg</sub>* ..... SAN DIEGO FORMATION (Conglomerate)
  - Tmv* ..... MISSION VALLEY FORMATION
  - ..... APPROX. LOCATION OF GEOLOGIC CONTACT  
(Queried Where Uncertain)
  - LD-5 ..... APPROX. LOCATION OF BORING
  - T-24 ..... APPROX. LOCATION OF TRENCH
  - A-2 ..... APPROX. LOCATION OF INFILTRATION TEST
  - (5) ..... APPROX. DEPTH OF REMEDIAL GRADING (in Feet, MSL)
  - D ..... APPROX. LOCATION OF GEOLOGIC CROSS SECTION

**Response:** To evaluate the potential for liquefaction and groundwater impacting removals, we performed three large-diameter borings on the norther edge of the development at the locations shown on Figure 1 (Borings LD-3 through LD-5). We encountered undocumented fill overlying alluvium and terrace deposits. Seepage was encountered near a depth of 33 feet in boring LD-3. The seepage is below the expected removal bottom and within the underlying terrace deposits. Logs of the borings are appended.
