Project No. 07516-42-02  
February 9, 2022

Subject: ADDENDUM GEOTECHNICAL REPORT AND  
RESPONSE TO CITY OF SAN DIEGO REVIEW COMMENTS  
NAKANO  
SAN DIEGO, CALIFORNIA

We prepared this addendum to provide an updated geologic map and to respond to review comments from the City of San Diego, LDR-Geology department (Reference 1). The updated geologic map and the log from a recent boring and test pit are appended. The review comments and our responses are presented below.

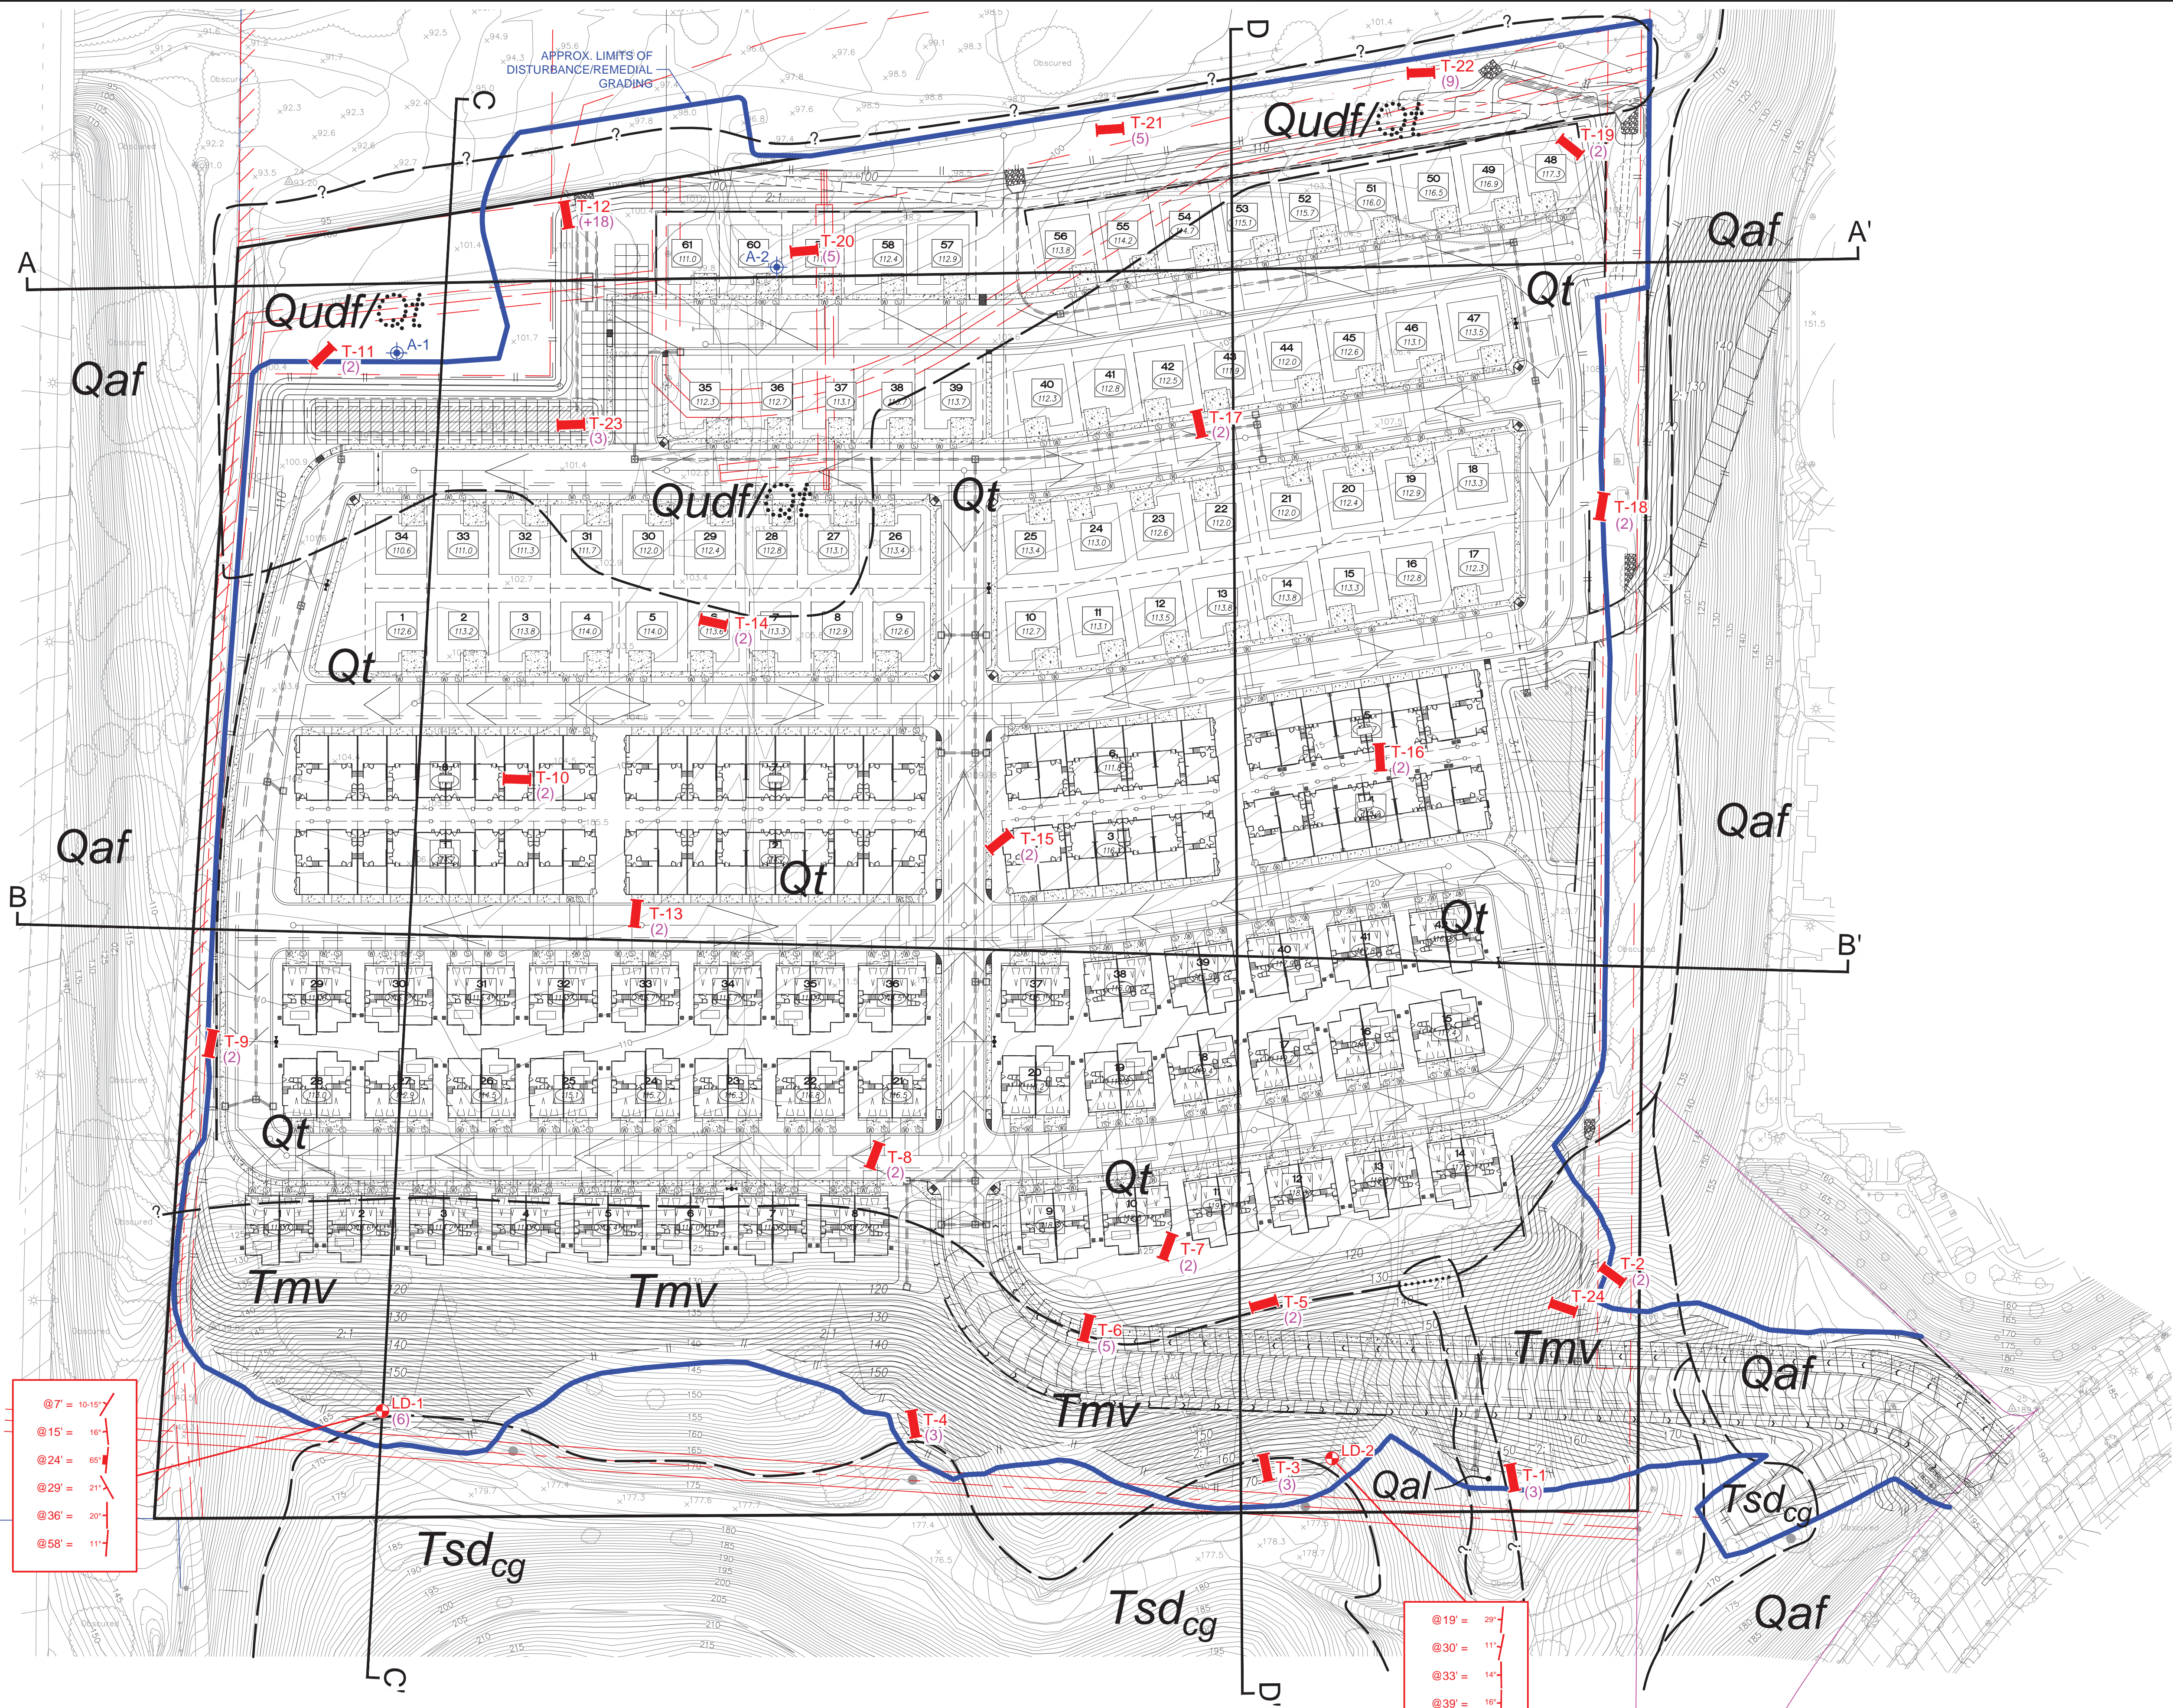
<b>GEOCON</b> INCORPORATED <small>GEOTECHNICAL ■ ENVIRONMENTAL ■ MATERIALS</small> <small>6940 ANDERS DRIVE ■ SAN DIEGO, CALIFORNIA 92121-2974</small> <small>PHONE 858.558.4900 ■ FAX 858.558.4159</small>	SCALE 1" = 60'	DATE 02 - 09 - 2022
	PROJECT NO. 07516 - 42 - 02	FIGURE 1
	SHEET 1 OF 1

- Qudf ..... UNDOCUMENTED FILL
- Qaf ..... ARTIFICIAL FILL
- Qal ..... ALLUVIUM
- Qt ..... TERRACE DEPOSITS  
(Dotted Where Buried)
- Tsd<sub>cg</sub> ..... SAN DIEGO FORMATION (Conglomerate)
- Tmv ..... MISSION VALLEY FORMATION
- ~ ..... APPROX. LOCATION OF GEOLOGIC CONTACT  
(Queried Where Uncertain)
- LD-2 ..... APPROX. LOCATION OF BORING
- T-24 ..... APPROX. LOCATION OF TRENCH
- A-2 ..... APPROX. LOCATION OF INFILTRATION TEST
- (5) ..... APPROX. DEPTH OF REMEDIAL GRADING (in Feet, MSL)
- ..... APPROX. LOCATION OF GEOLOGIC CROSS SECTION

**Response:** The southeast corner of the property is not underlain by a landslide. A second large diameter boring (LD-2) was drilled to a depth of 70 feet at the east end of the proposed cut slope (Figure 1 and appended boring log). The boring bottom elevation is approximately 16 feet below proposed pad grade at toe of slope. Observations made during downhole logging show similar geologic conditions to those observed in LD-1, i.e., a massive to poorly bedded very fine-grained silty sandstone dipping approximately 14 degrees due west. There are no slide planes, bedding plane shears, or other geologic features indicative of landsliding present in LD-1 or LD-2.

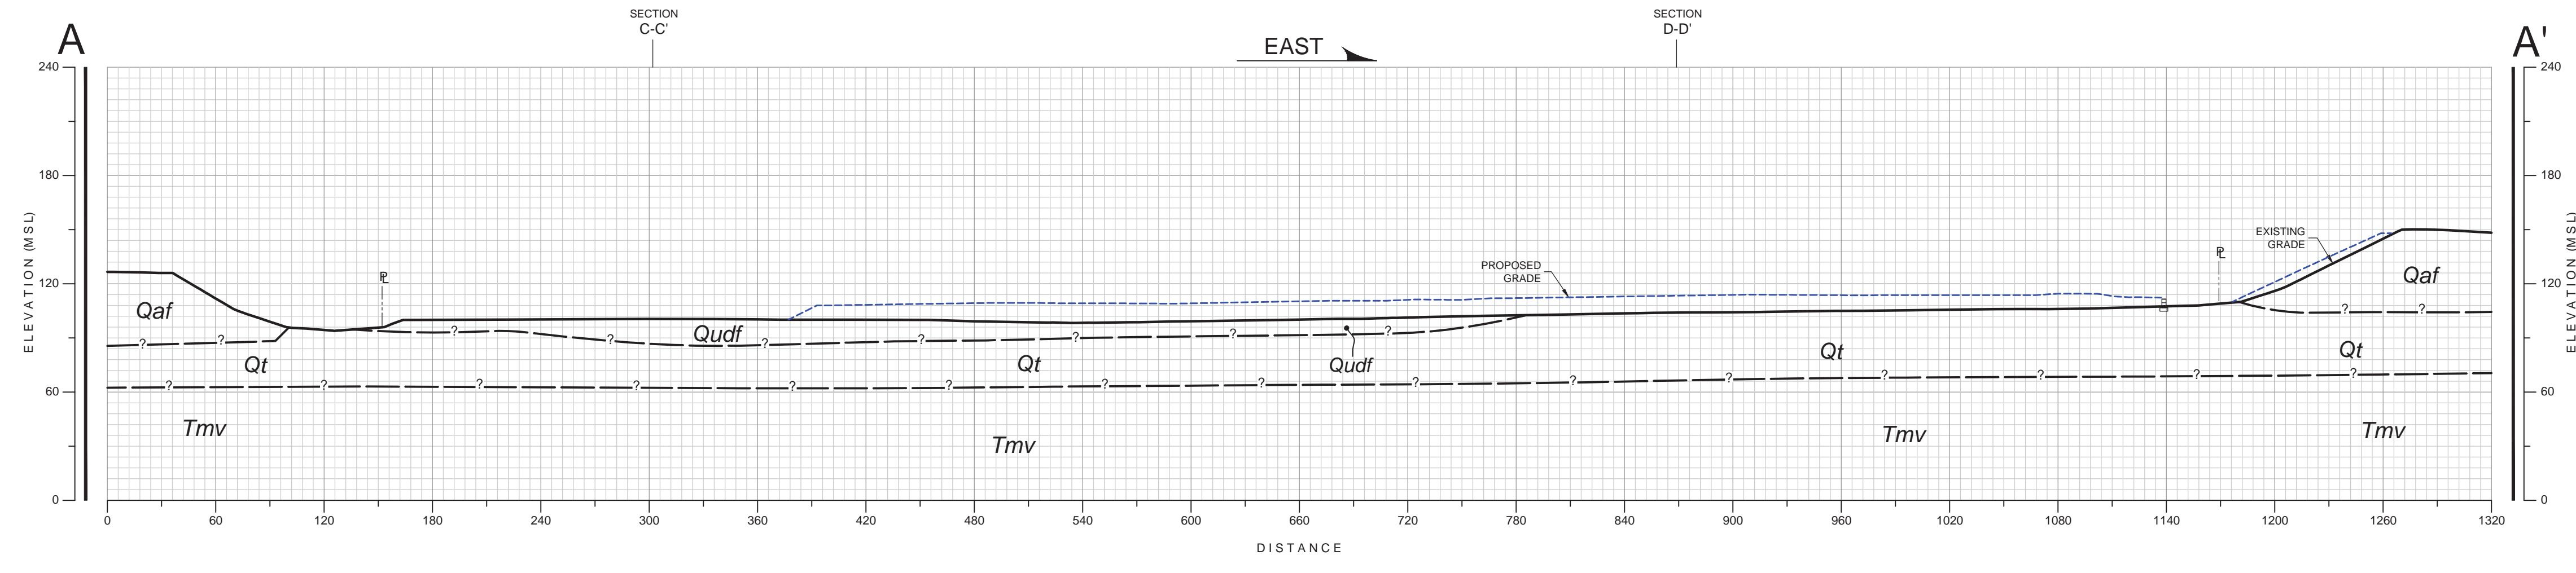
**GEOLOGIC CROSS-SECTION A-A'**  
SCALE: 1" = 60' (Vert. = Horiz.)

- GEOCON LEGEND**
- Qudf* ..... UNDOCUMENTED FILL
  - Qaf* ..... ARTIFICIAL FILL
  - Qt* ..... TERRACE DEPOSITS
  - Tmv* ..... MISSION VALLEY FORMATION
  - ~?~ ..... APPROX. LOCATION OF GEOLOGIC CONTACT  
(Queried Where Uncertain)

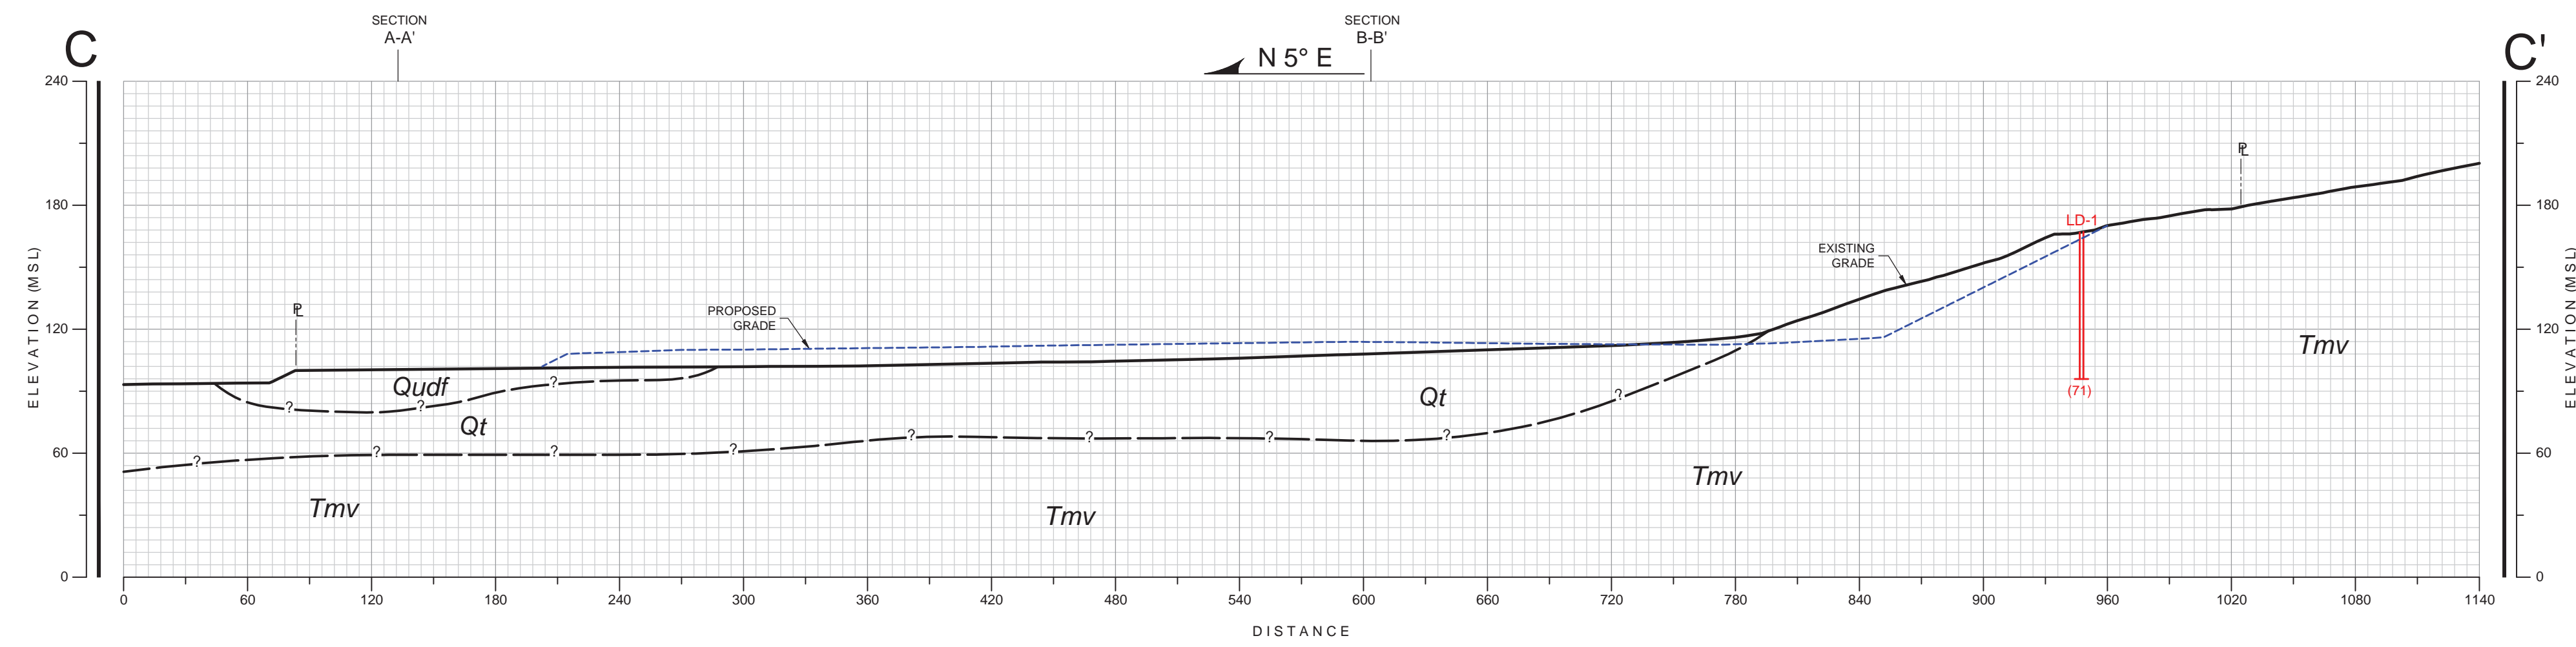
**GEOLOGIC CROSS-SECTION C-C'**  
SCALE: 1" = 60' (Vert. = Horiz.)

- GEOCON LEGEND**
- Qudf*.....UNDOCUMENTED FILL
  - Qaf*.....ARTIFICIAL FILL
  - Qt*.....TERRACE DEPOSITS
  - Tmv*.....MISSION VALLEY FORMATION
  - .....APPROX. LOCATION OF GEOLOGIC CONTACT  
(Queried Where Uncertain)

**Response:** We performed a seismic slope stability analysis for cross sections C-C' and D-D' in accordance with *Recommended Procedures for Implementation of DMG Special Publication 117: Guidelines for Analyzing and Mitigating Landslide Hazards in California*, prepared by the Southern California Earthquake Center (SCEC), dated June 2002.

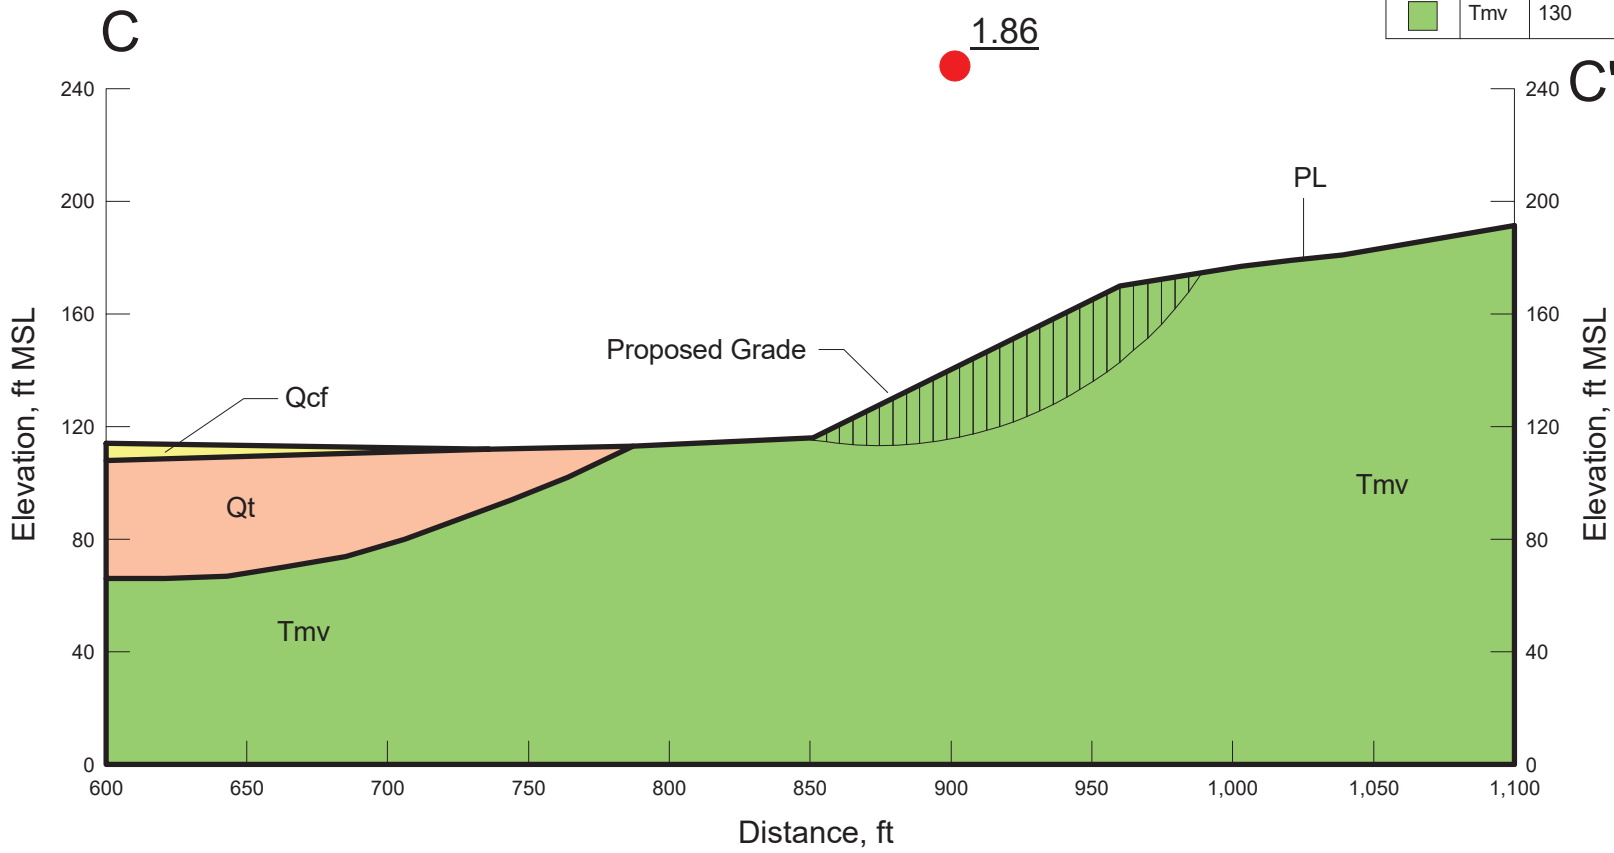
Figure 5

Color	Name	Unit Weight (pcf)	Cohesion' (psf)	Phi' (°)
Yellow	Qcf	125	300	27
Orange	Qt	125	300	27
Green	Tmv	130	675	30

Using the parameters discussed herein, an equivalent site acceleration,  $k_{EQ}$ , of approximately 0.1g was calculated (see Figure 4). Using this  $k_{EQ}$ , we get a factor of safety of 1.86 for Section C-C' (see Figure 5) and 2.2 for Section D-D' (see Figure 6). A slope is considered acceptable by the screening analysis if the calculated factor of safety is greater than 1.0 using  $k_{EQ}$ ; therefore, the slopes pass the screening analysis for seismic slope stability.

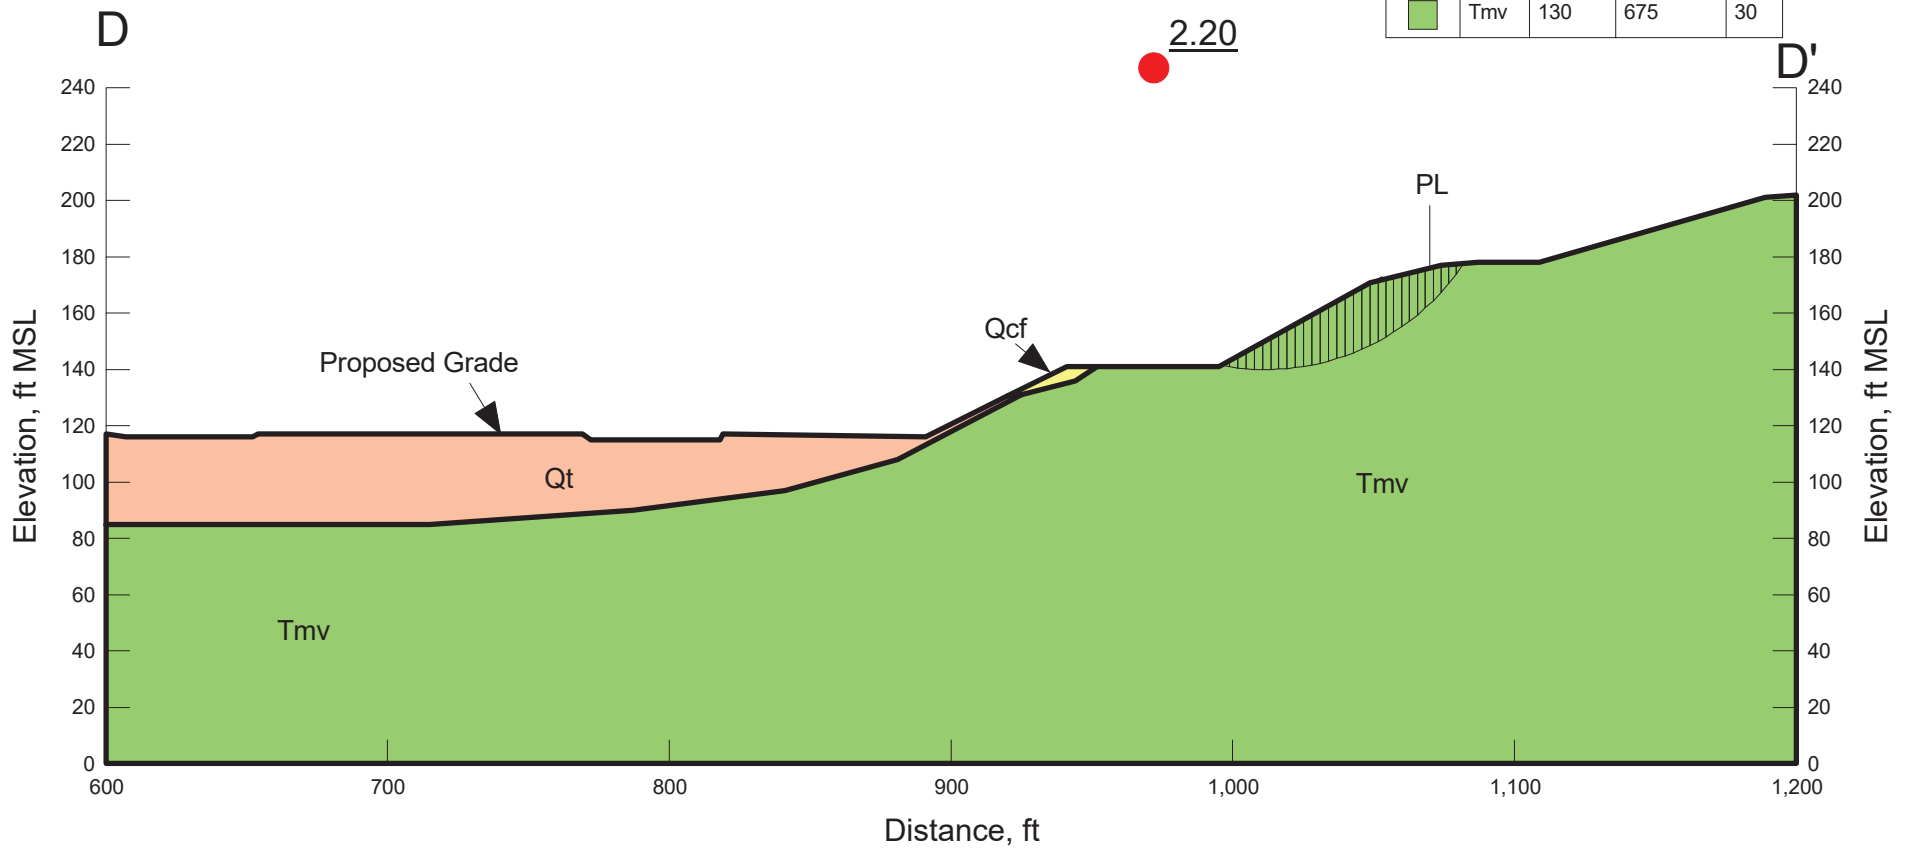
Figure 6

Nakano  
 Project No. 07516-42-02  
 Name: D-D'Proposed Slope\_Seismic.gsz  
 Date: 02/08/2022 Time: 07:02:01 PM  
 Horz Seismic Coef.: 0.1

Color	Name	Unit Weight (pcf)	Cohesion' (psf)	Phi' (°)
Yellow	Qcf	125	300	27
Orange	Qt	125	300	27
Green	Tmv	130	675	30
