Appendix C – Preliminary Geotechnical Investigation

**PRELIMINARY GEOTECHNICAL INVESTIGATION  
PROPOSED MIXED-USE DEVELOPMENT  
WESTLAKE CENTER – BURLINGTON SITE  
99 SOUTHGATE AVENUE  
DALY CITY, CALIFORNIA**

September 16, 2020  
Project No. 20-1906

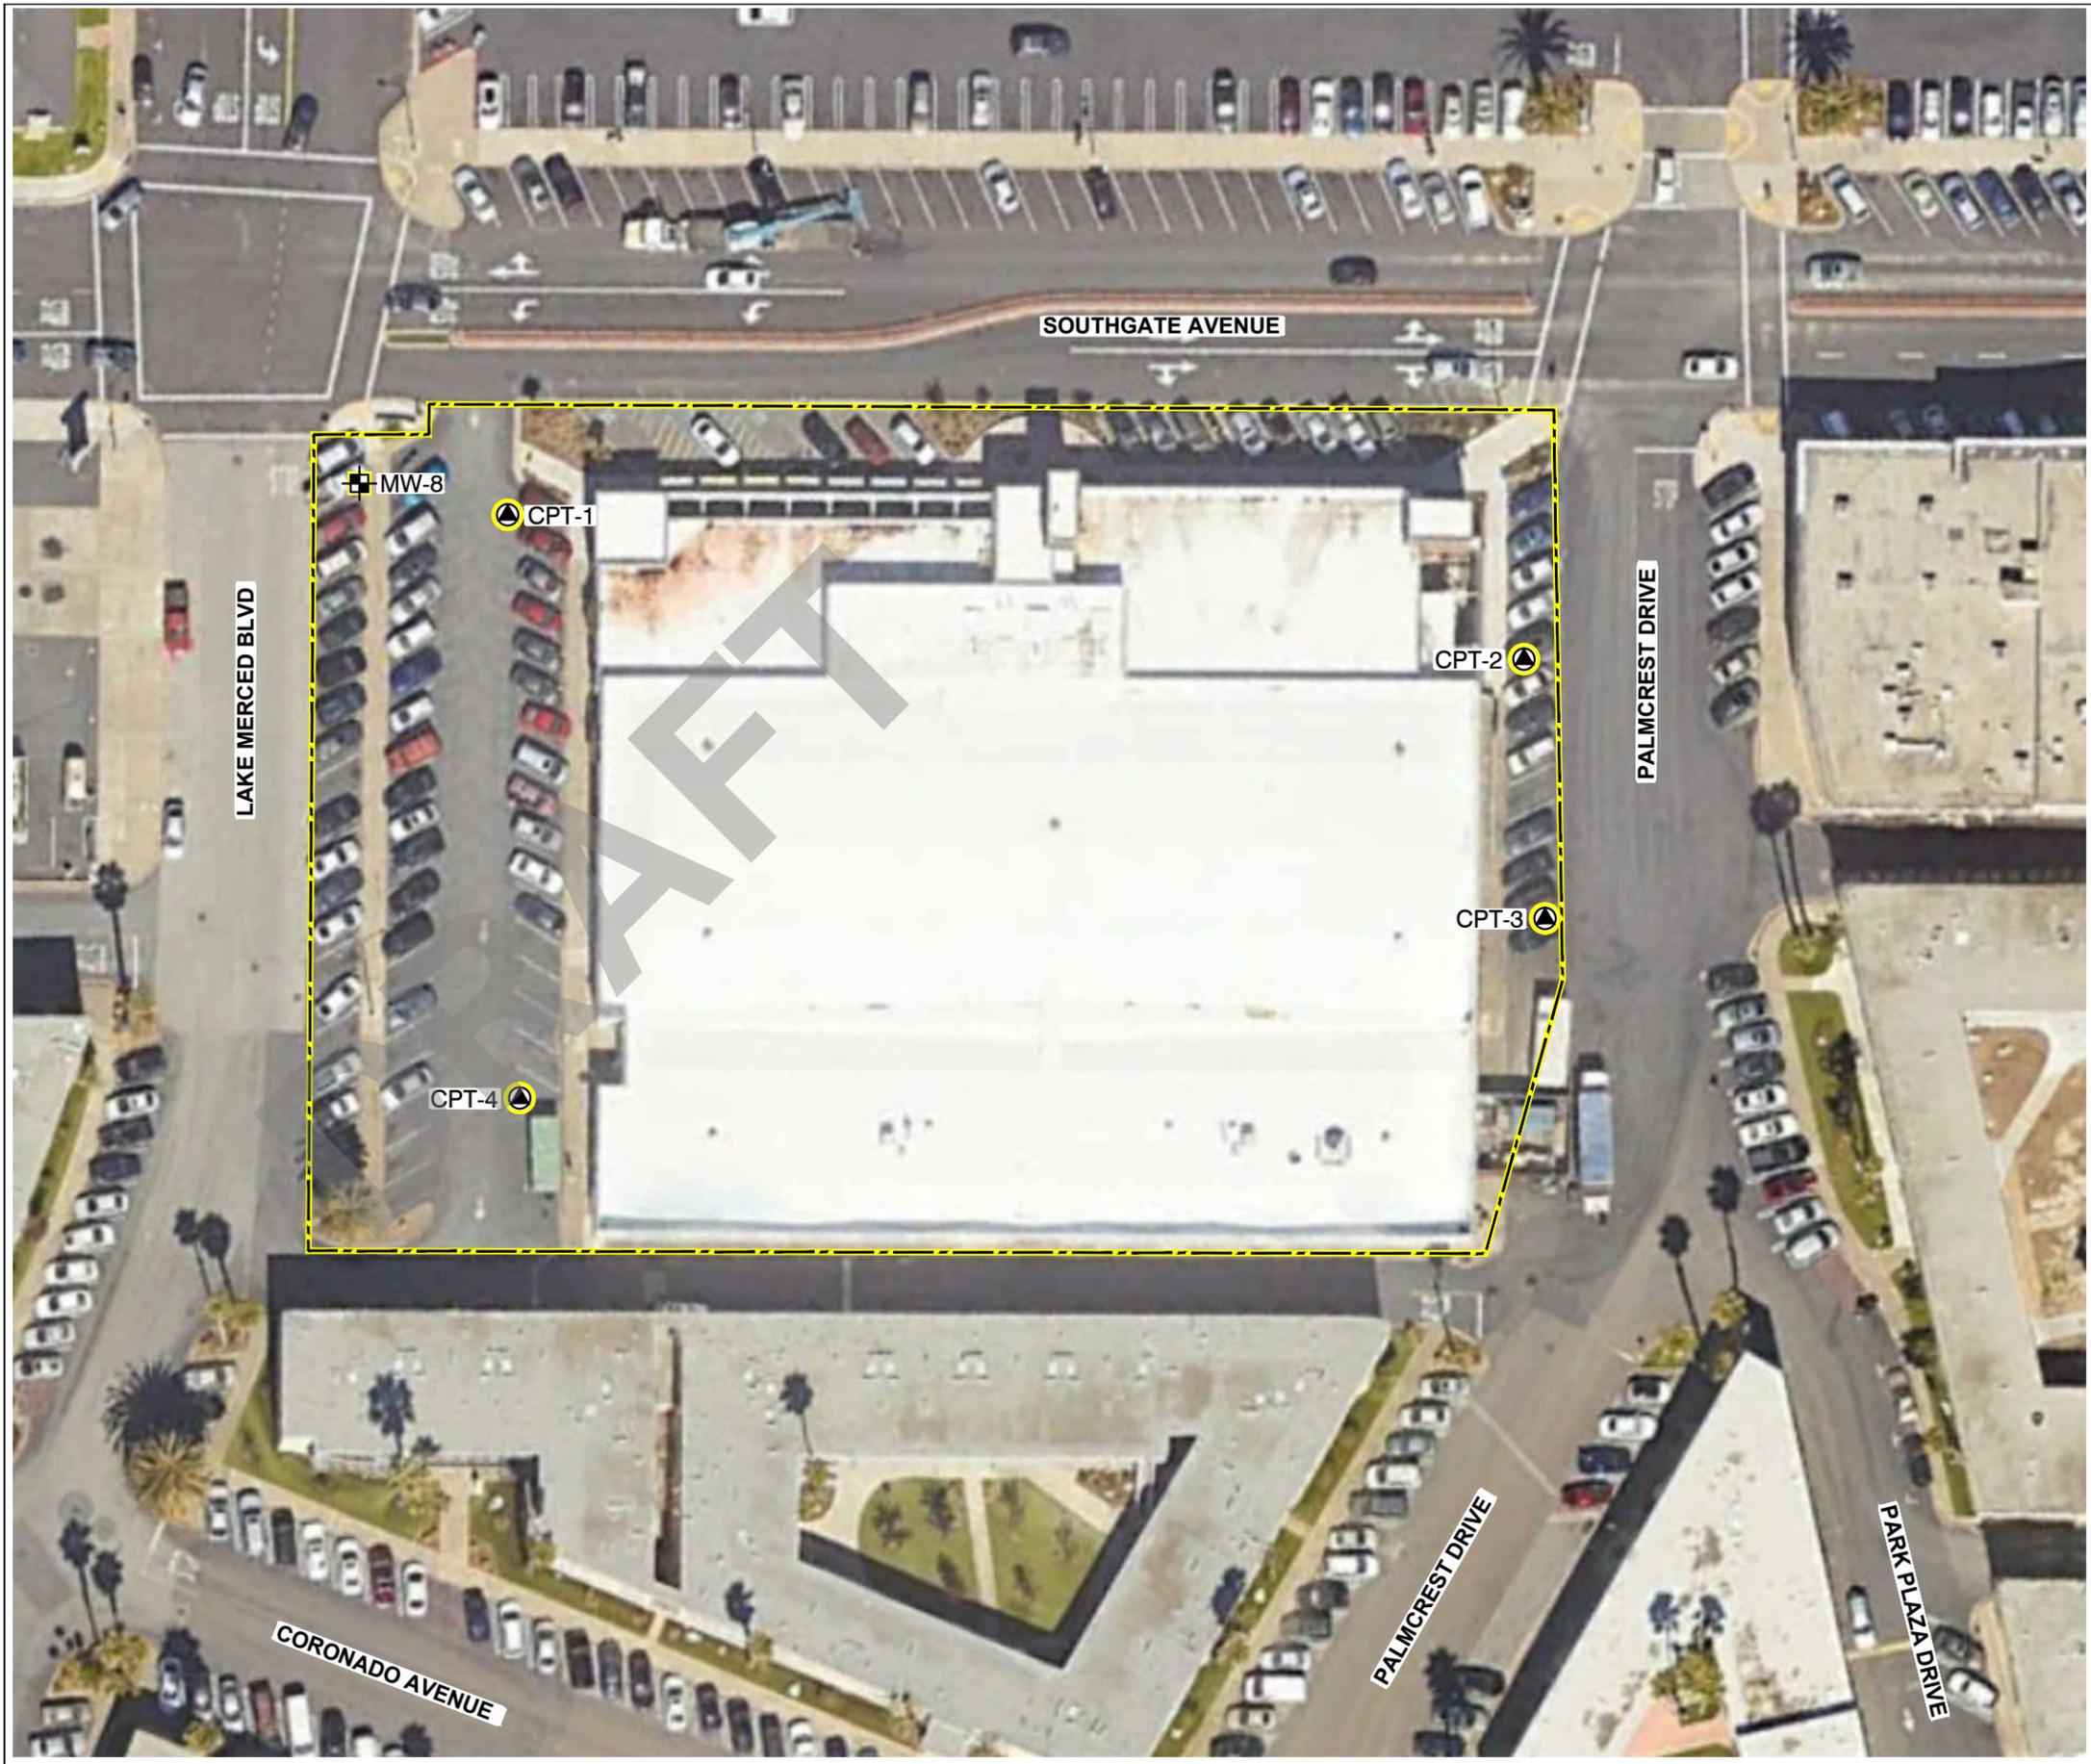
<b>WESTLAKE CENTER</b> <b>99 SOUTHGATE AVENUE</b> Daly City, California		
<b>SITE PLAN</b>		
Date 09/09/20	Project No. 20-1906	Figure 2

- CPT-1

Our field investigation consisted of performing four CPTs, designated as CPT-1 through CPT-4, at the approximate locations shown on the Site Plan, Figure 2. Prior to performing our field investigation, we obtained a drilling permit from the City of Daly City Department of Water and Wastewater Resources and contacted Underground Service Alert (USA) to notify them of our work, as required by law. We also retained Precision Locating LLC, a private utility locator, to check that the CPT locations were clear of buried utilities.
