**REPORT OF PRELIMINARY GEOTECHNICAL
INVESTIGATION**

Davidson Residential Development
811-827 Coast Boulevard South
La Jolla, California

JOB NO. 20-12787
24 September 2020

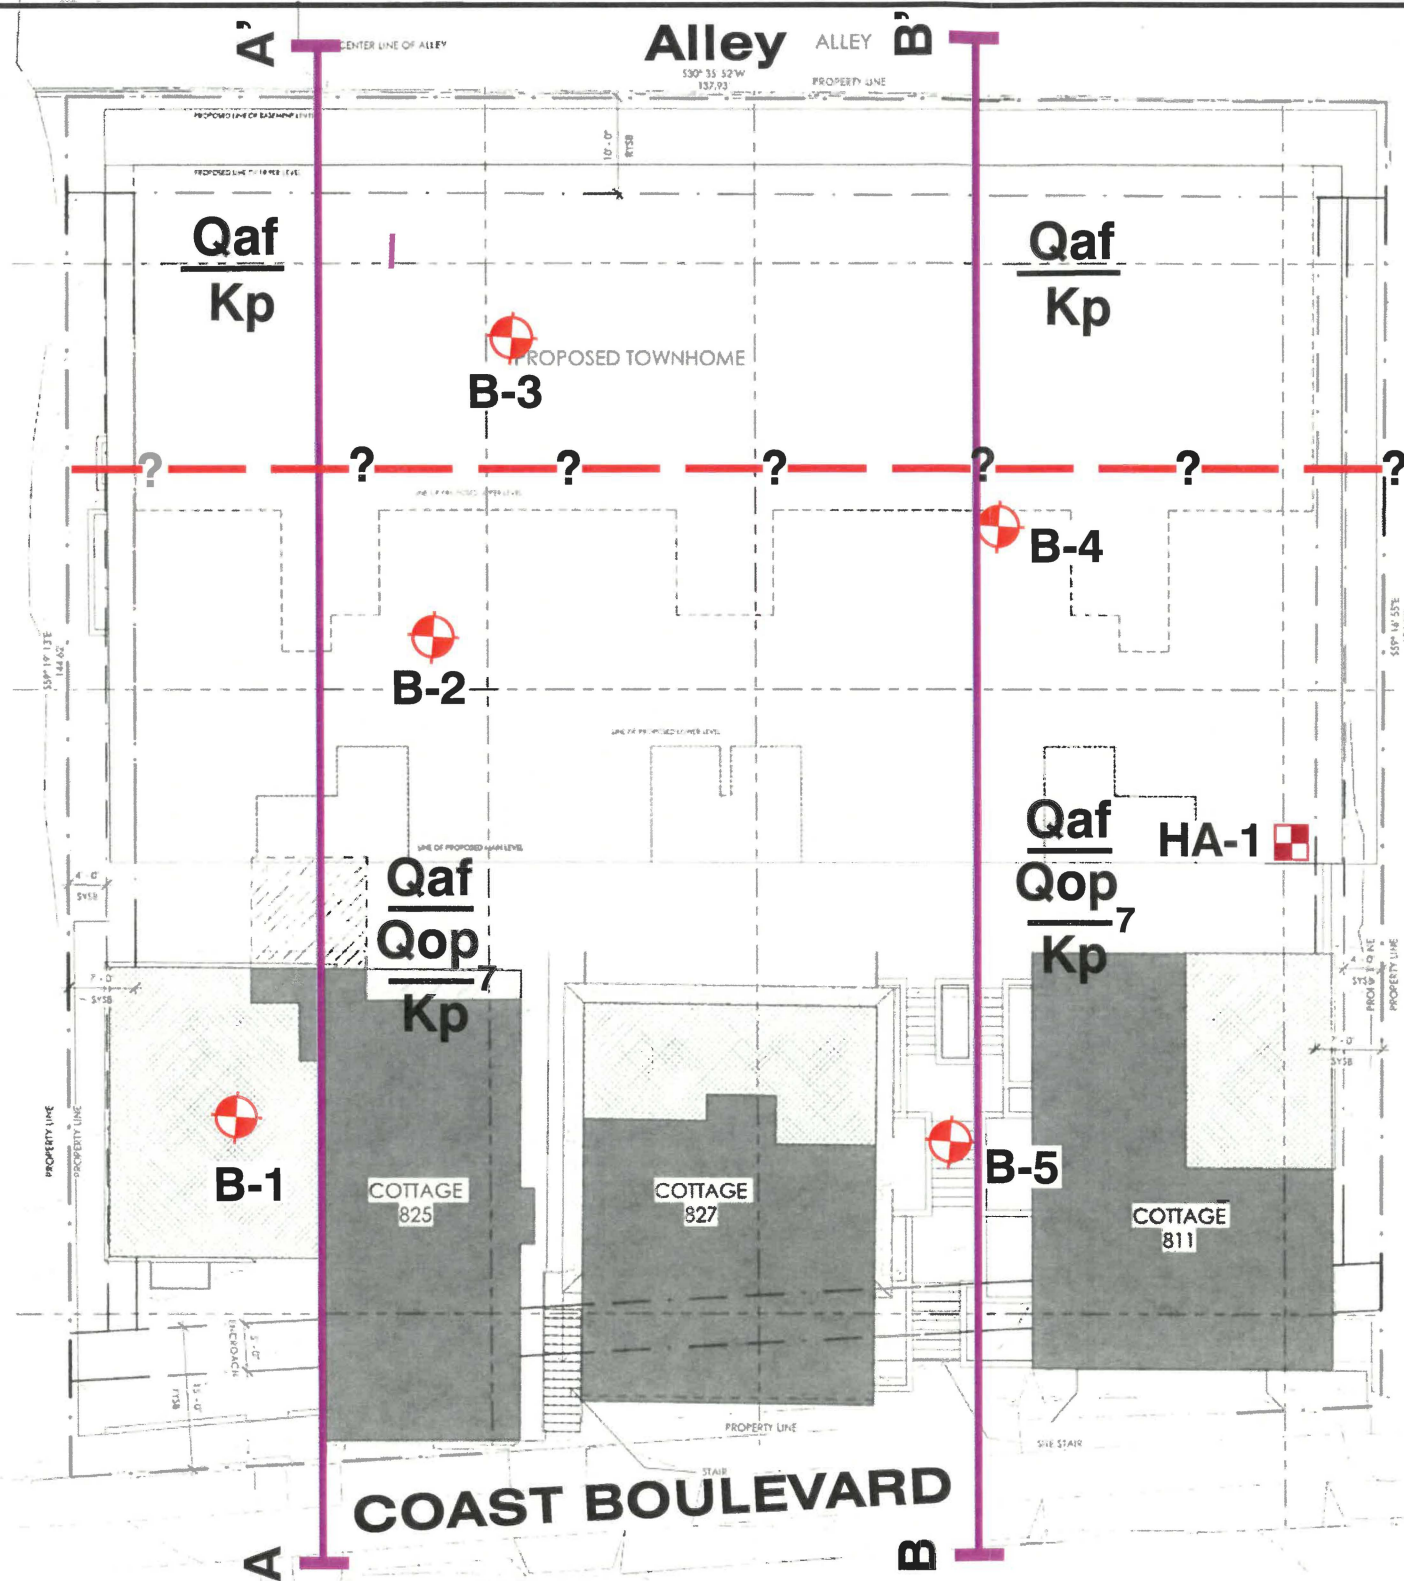
Scale: 1" = 20'
(approximate)

- LEGEND**
- Approximate Location of Exploratory Hand Auger Boring
HA-1
 - Approximate Location of Exploratory Boring
B-5
 - Approximate Location of Cross Section
A A'

- GEOLOGIC LEGEND**
- Qaf** Artificial Fill
 - Qop₇** Old Parallic Deposits (unit 7)
 - Kp** Point Loma Formation
 - Approximate Geologic Contact

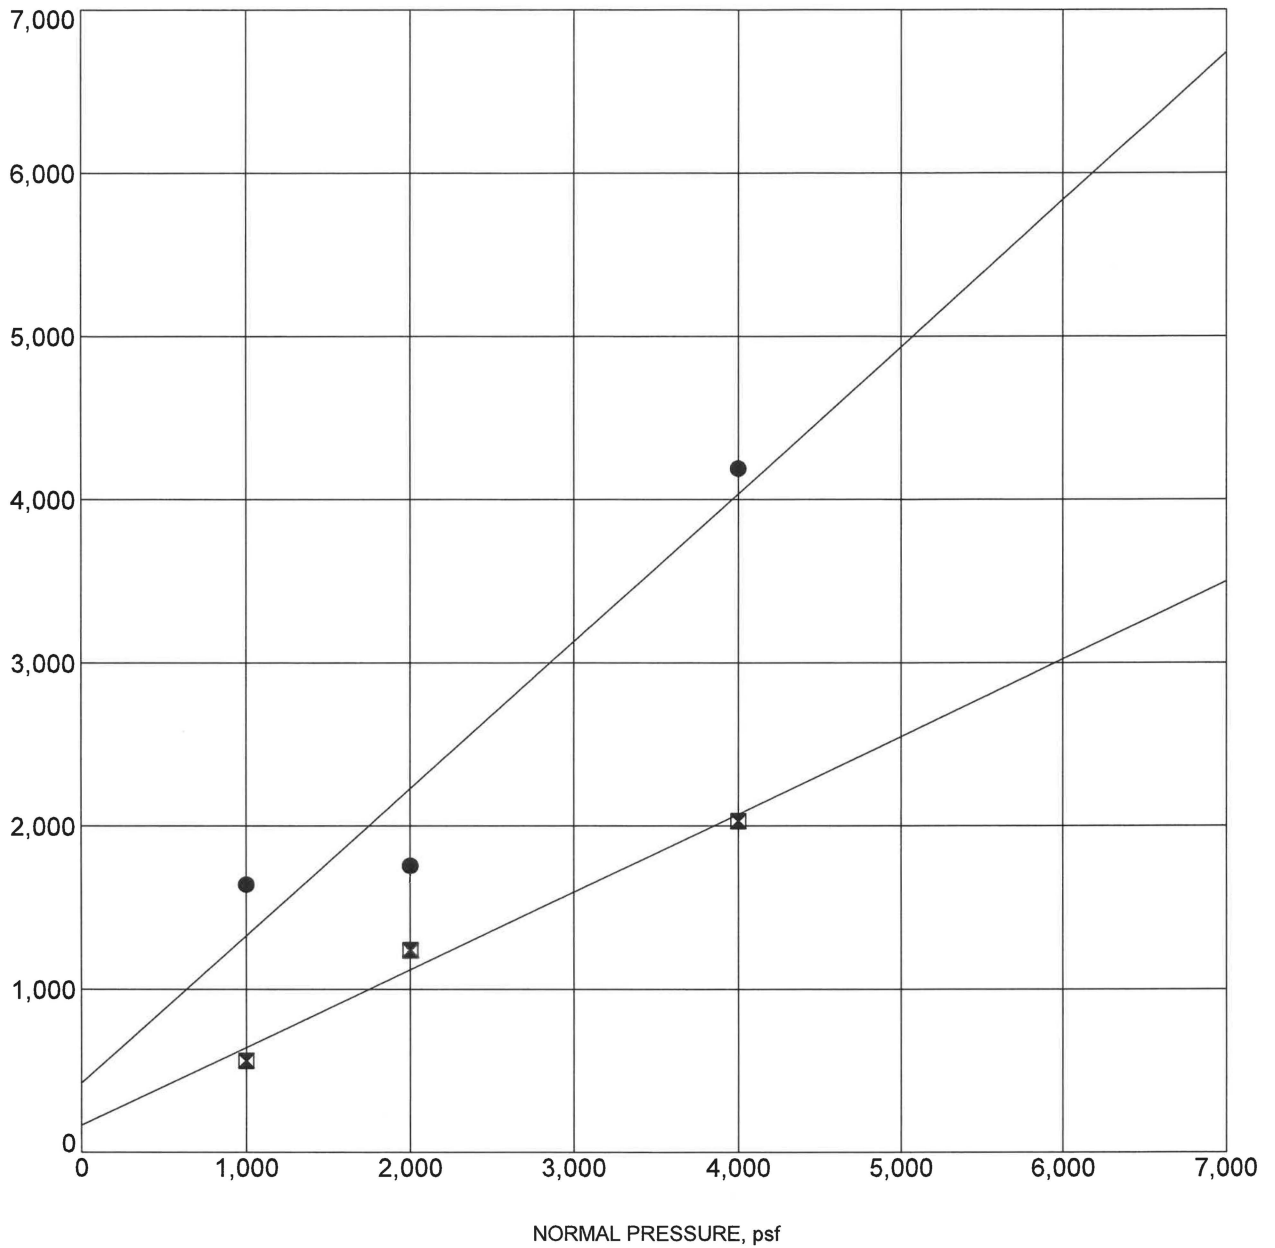
SHEAR STRENGTH, psf

Specimen Identification	Classification	γ_d	MC%	c	ϕ
● B-3 @ 9.0'	SILTY SAND (SM), Light Olive Brown			425	42
⊠ B-4 @ 12.5'	SILTY SAND (SP-SM), Light Olive Brown			166	25

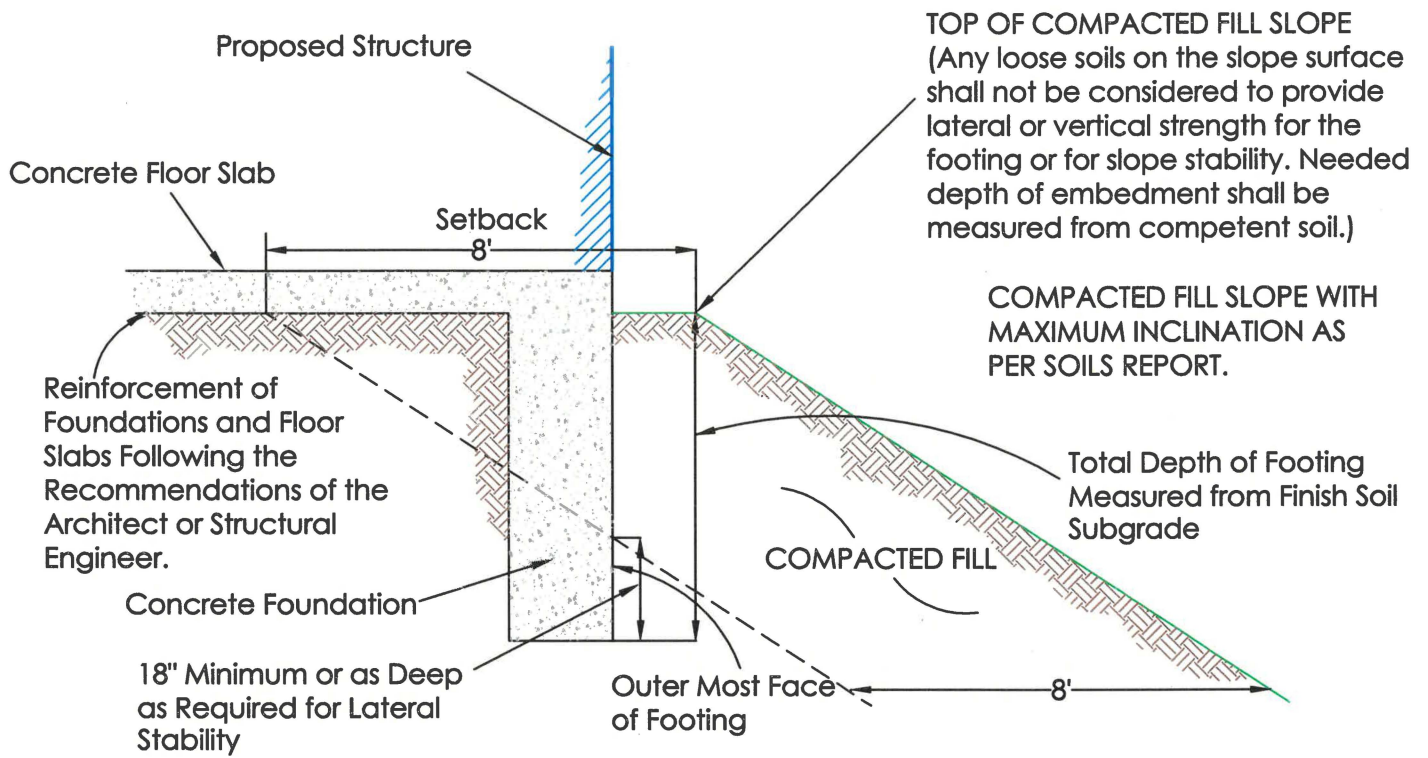
FOUNDATION REQUIREMENTS NEAR SLOPES

TYPICAL SECTION

(Showing Proposed Foundation Located Within 8 Feet of Top of Slope)

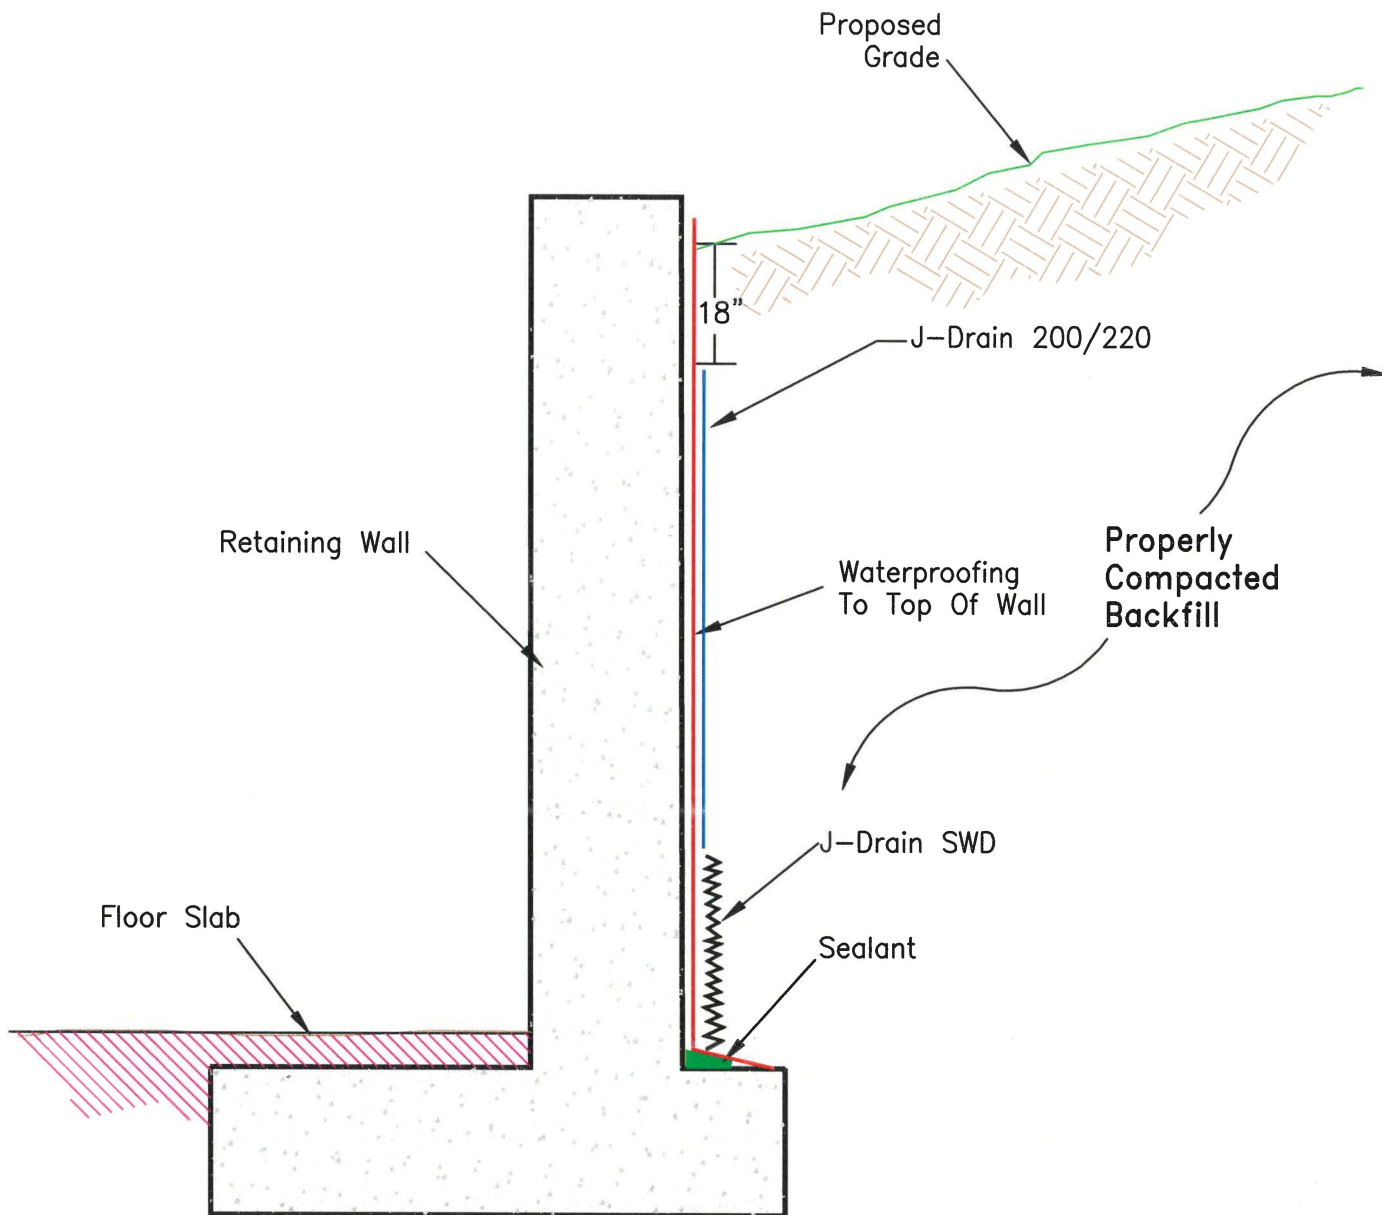
SCHEMATIC RETAINING WALL SUBDRAIN RECOMMENDATIONS

NOTE: As an option to Miradrain 6000, Gravel or Crushed rock 3/4" maximum diameter may be used with a minimum 12" thickness along the interior face of the wall and 2.0 cu.ft./ft. of pipe gravel envelope.

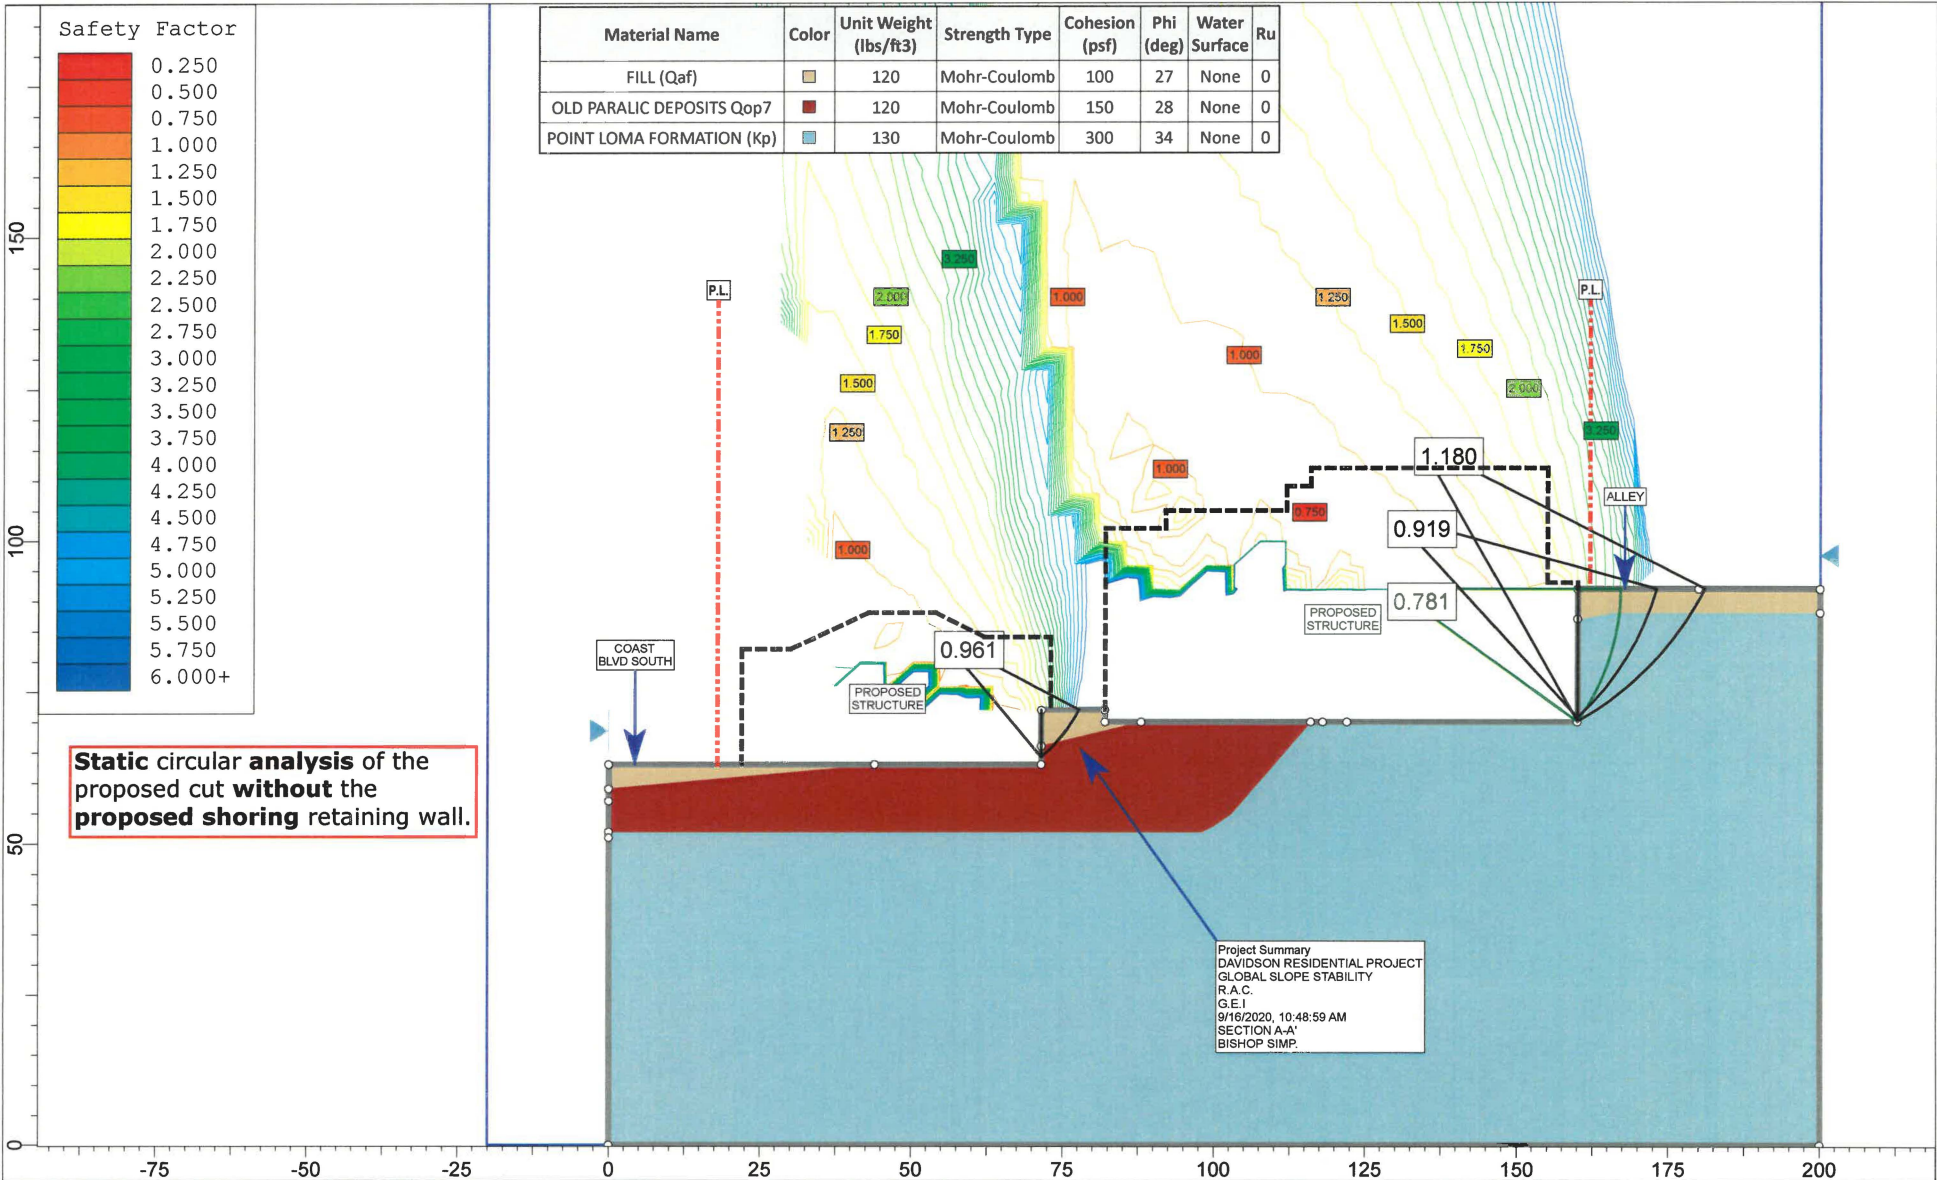
Static circular analysis of the proposed cut without the proposed shoring retaining wall.

Project Summary
 DAVIDSON RESIDENTIAL PROJECT
 GLOBAL SLOPE STABILITY
 R.A.C.
 G.E.I
 9/16/2020, 10:48:59 AM
 SECTION A-A'
 BISHOP SIMP.

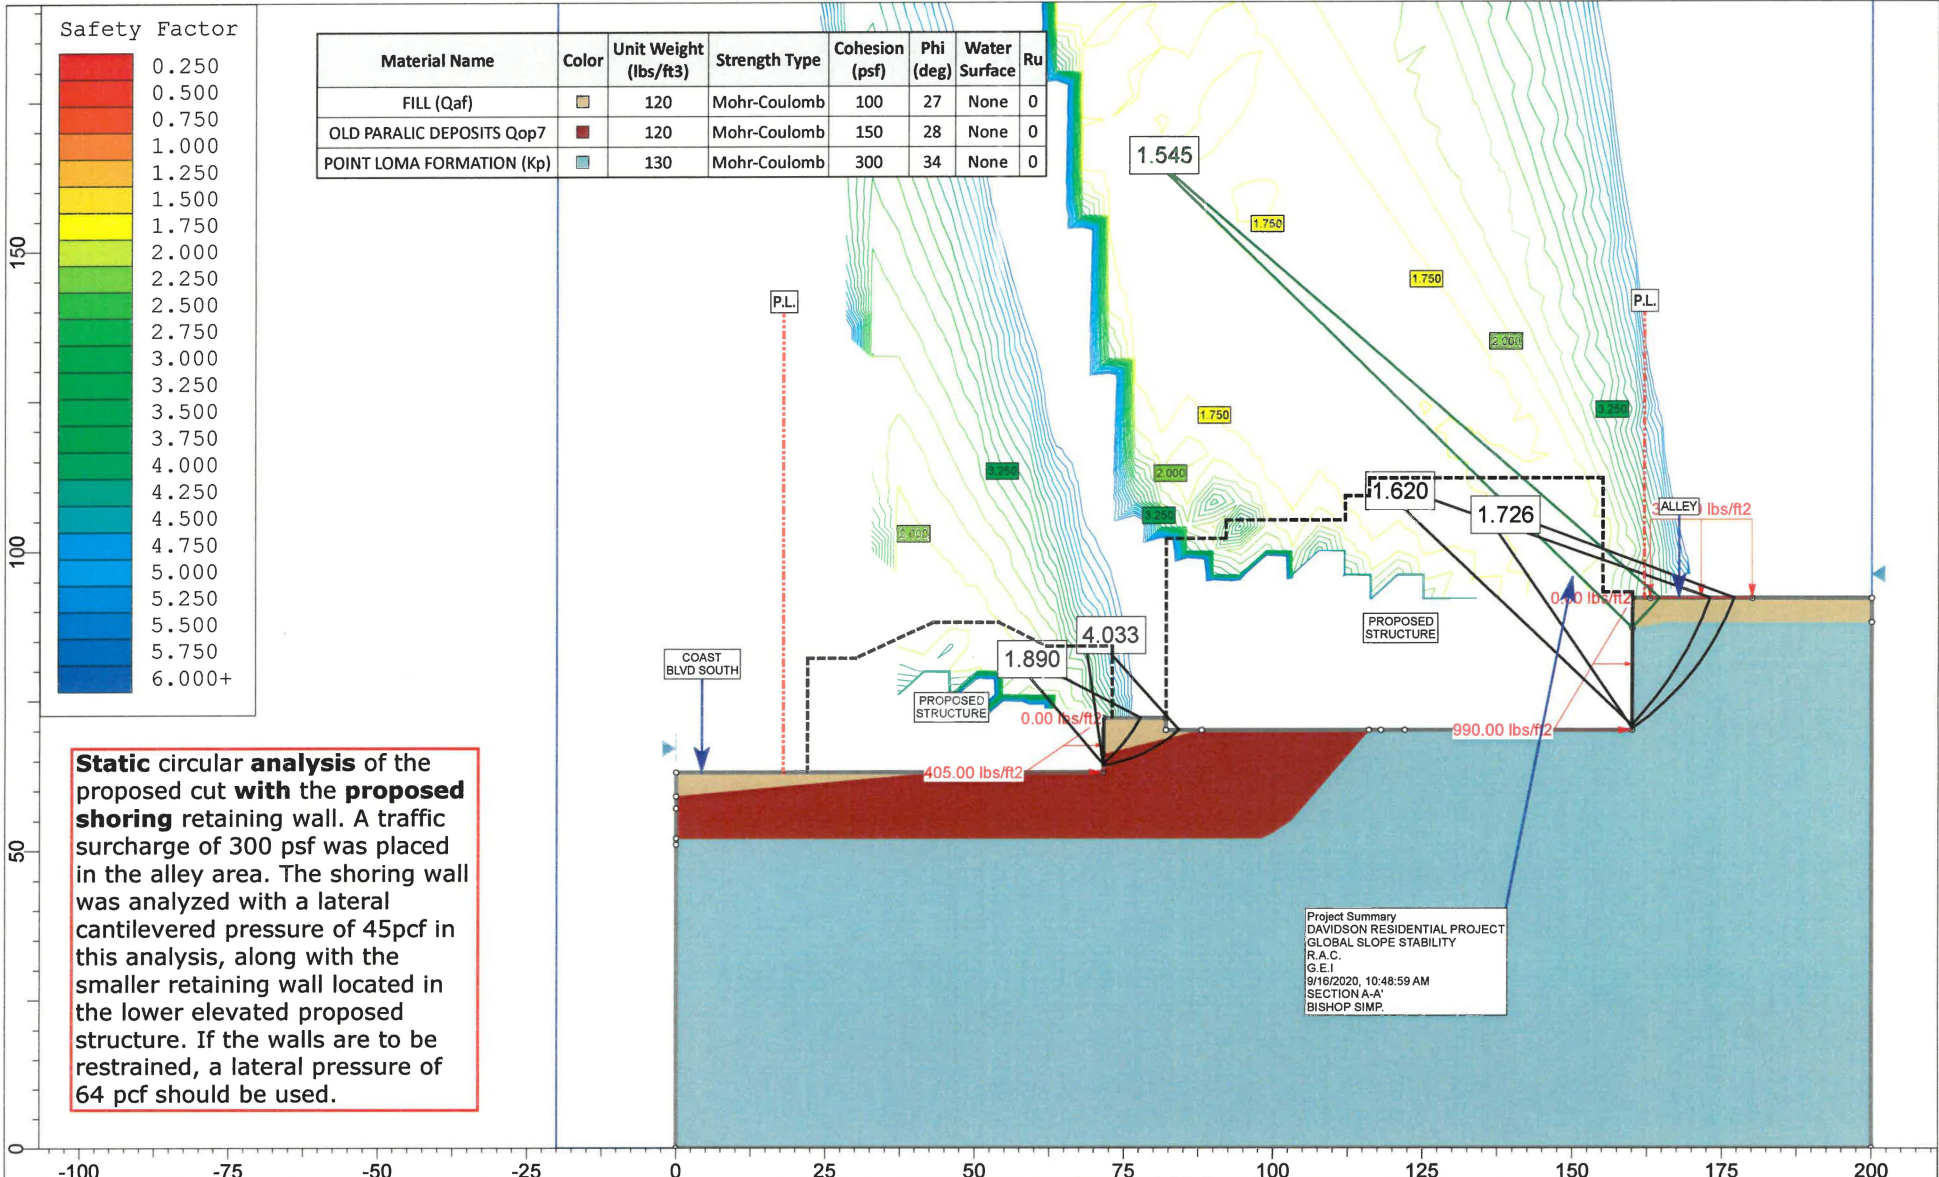
Static circular analysis of the proposed cut **with the proposed shoring** retaining wall. A traffic surcharge of 300 psf was placed in the alley area. The shoring wall was analyzed with a lateral cantilevered pressure of 45pcf in this analysis, along with the smaller retaining wall located in the lower elevated proposed structure. If the walls are to be restrained, a lateral pressure of 64 pcf should be used.

Project Summary
 DAVIDSON RESIDENTIAL PROJECT
 GLOBAL SLOPE STABILITY
 R.A.C.
 G.E.I.
 9/16/2020, 10:48:59 AM
 SECTION A-A'
 BISHOP SIMP.

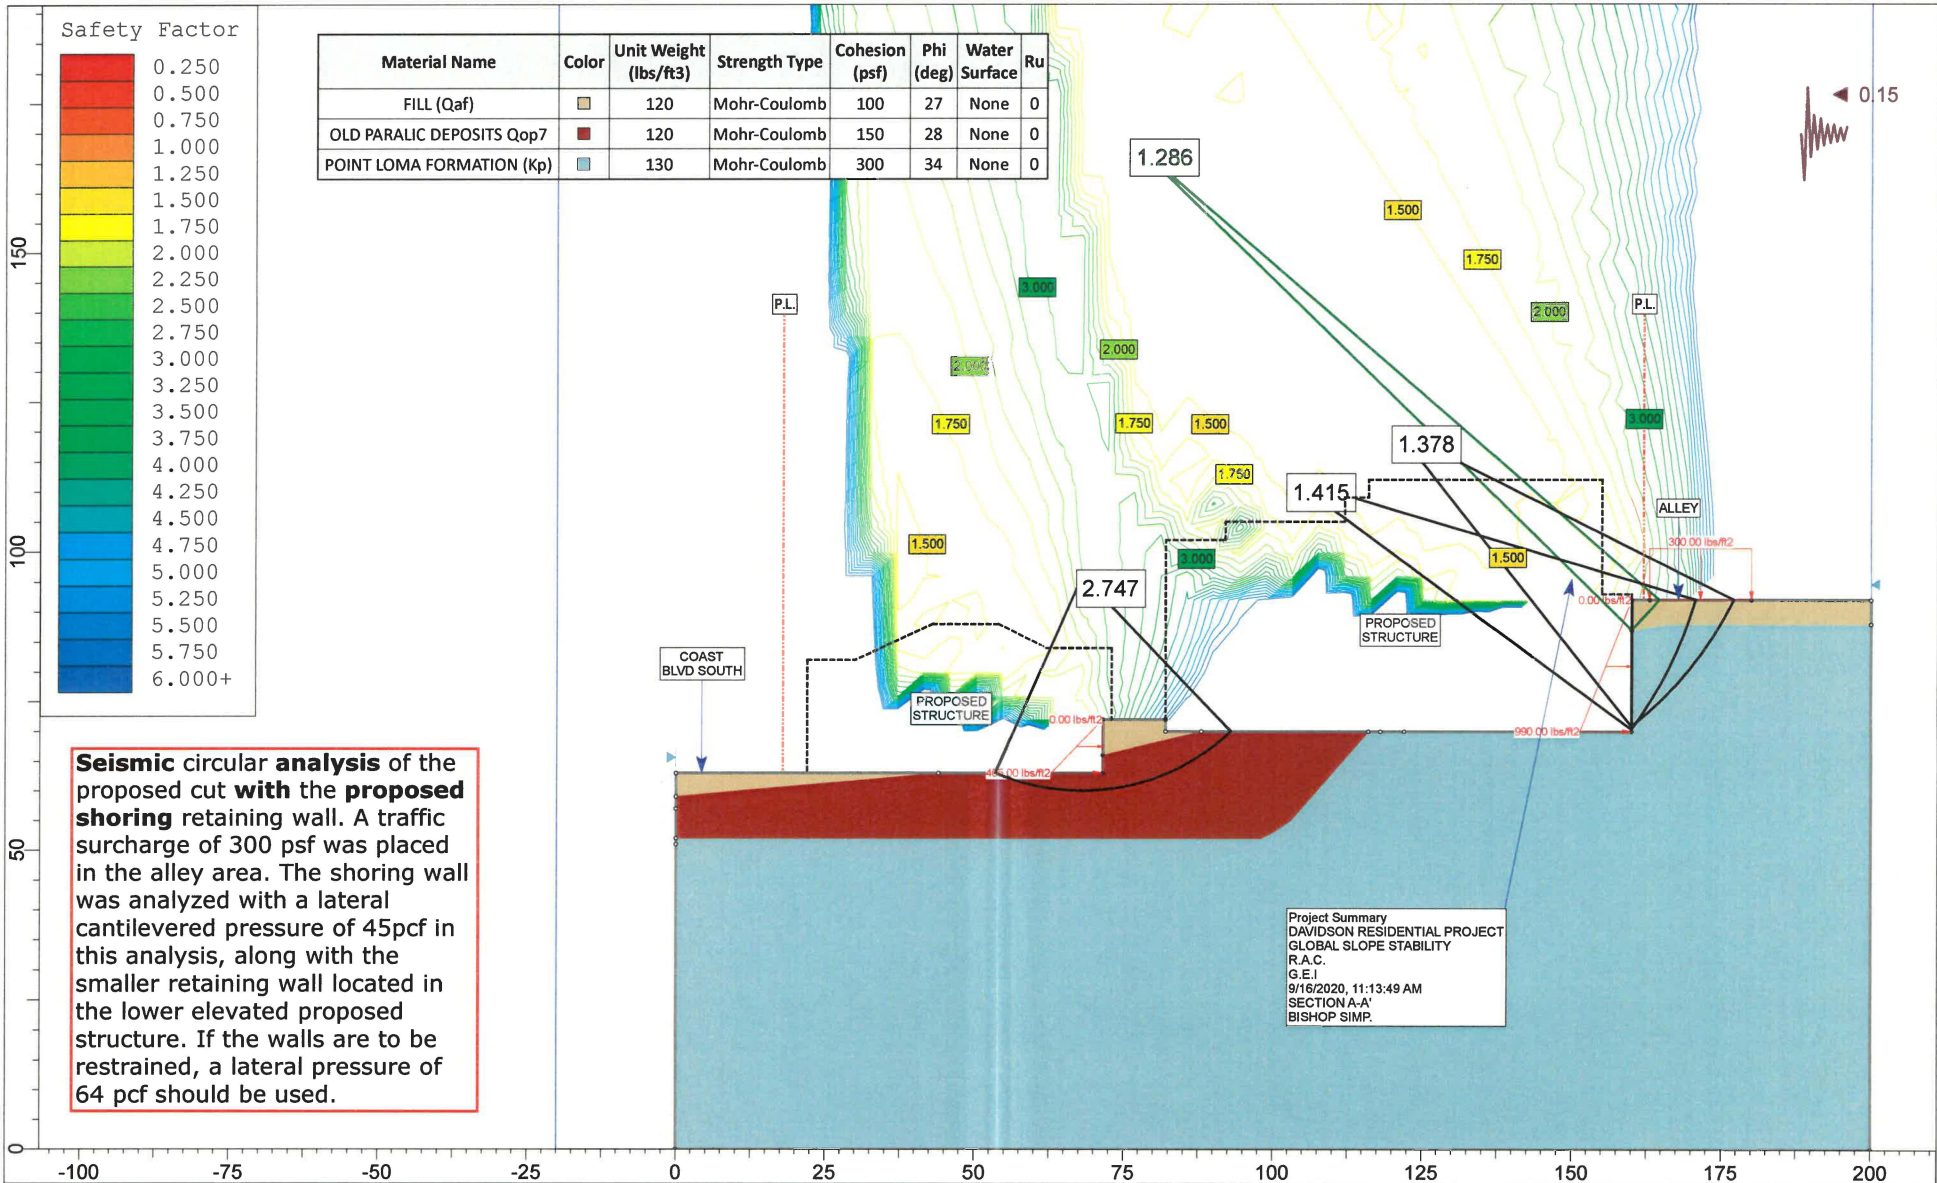
Geotechnical Exploration, Inc.	Project		DAVIDSON RESIDENTIAL PROJECT		SECTION A-A'	
	Analysis Description		GLOBAL SLOPE STABILITY			
	Drawn By	R.A.C.	Scale	1:370	Company	G.E.I.
	Date	9/16/2020, 11:13:49 AM	File Name	JOB NO. 20-12787_S(A)_02w_0.15gSHAKE.slim

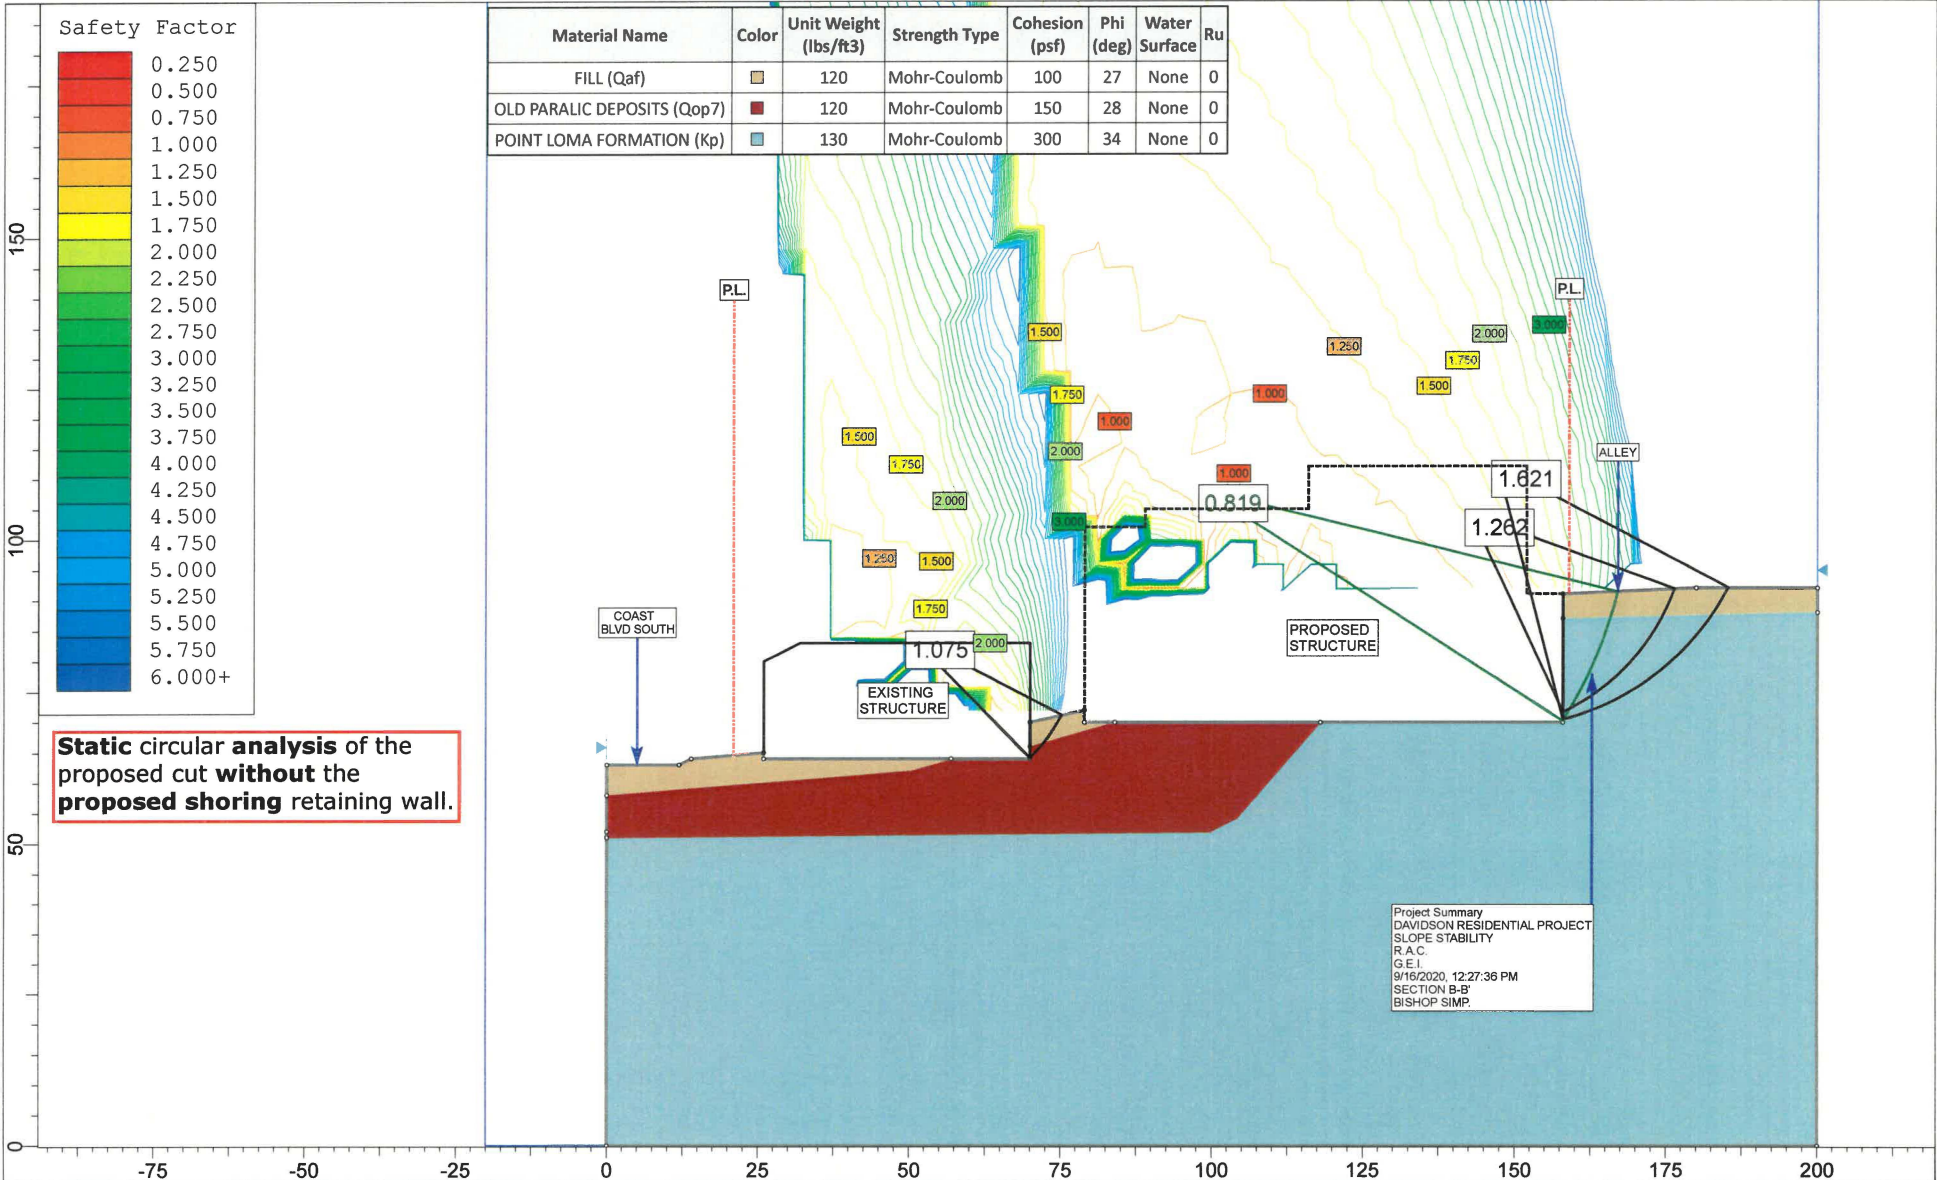
Project		DAVIDSON RESIDENTIAL PROJECT		SECTION B-B'	
Analysis Description		SLOPE STABILITY			
Drawn By	R.A.C.	Scale	1:365	Company	G.E.I.
Date	9/16/2020, 12:27:36 PM	File Name	JOB NO. 20-12787_S(B)_01.slim

Material Name	Color	Unit Weight (lbs/ft ³)	Strength Type	Cohesion (psf)	Phi (deg)	Water Surface	Ru
FILL (Qaf)		120	Mohr-Coulomb	100	27	None	0
OLD PARALIC DEPOSITS (Qop7)		120	Mohr-Coulomb	150	28	None	0
POINT LOMA FORMATION (Kp)		130	Mohr-Coulomb	300	34	None	0

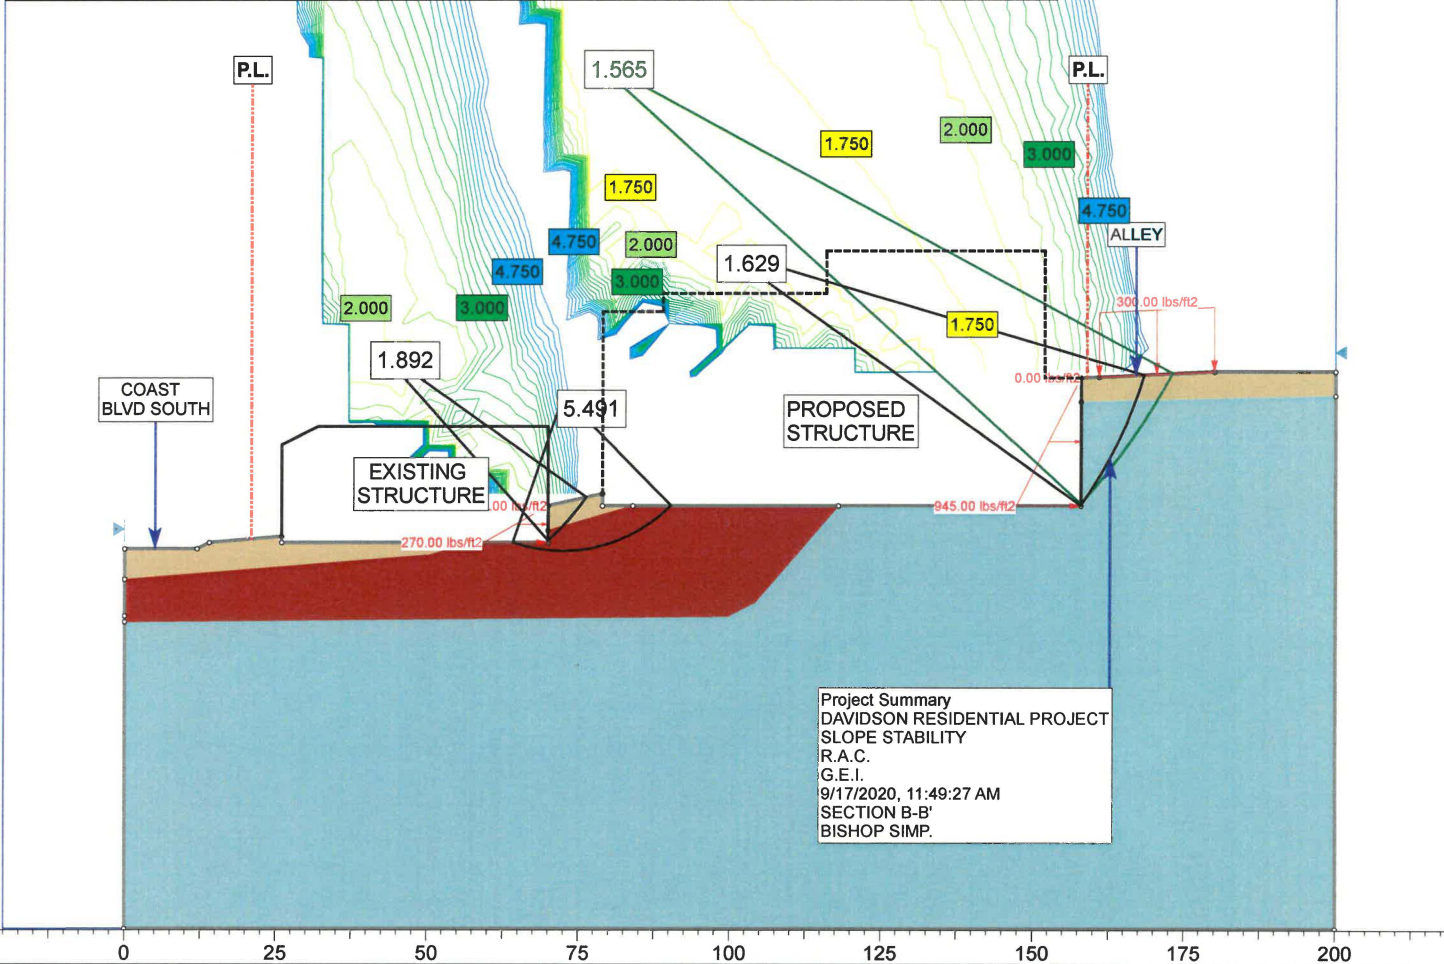
Static circular analysis of the proposed cut with the proposed shoring retaining wall. A traffic surcharge of 300 psf was included in the alley. The proposed shoring wall was analyzed with a lateral cantilevered triangular pressure of 45 pcf in this analysis. A similar load was assumed for the existing structure retaining wall. If the shoring wall is to be restrained, a lateral pressure of 64 pcf should be used.

Project Summary
 DAVIDSON RESIDENTIAL PROJECT
 SLOPE STABILITY
 R.A.C.
 G.E.I.
 9/17/2020, 11:49:27 AM
 SECTION B-B'
 BISHOP SIMP.

Material Name	Color	Unit Weight (lbs/ft3)	Strength Type	Cohesion (psf)	Phi (deg)	Water Surface	Ru
FILL (Qaf)	Light Brown	120	Mohr-Coulomb	100	27	None	0
OLD PARALIC DEPOSITS (Qop7)	Dark Red	120	Mohr-Coulomb	150	28	None	0
POINT LOMA FORMATION (Kp)	Light Blue	130	Mohr-Coulomb	300	34	None	0

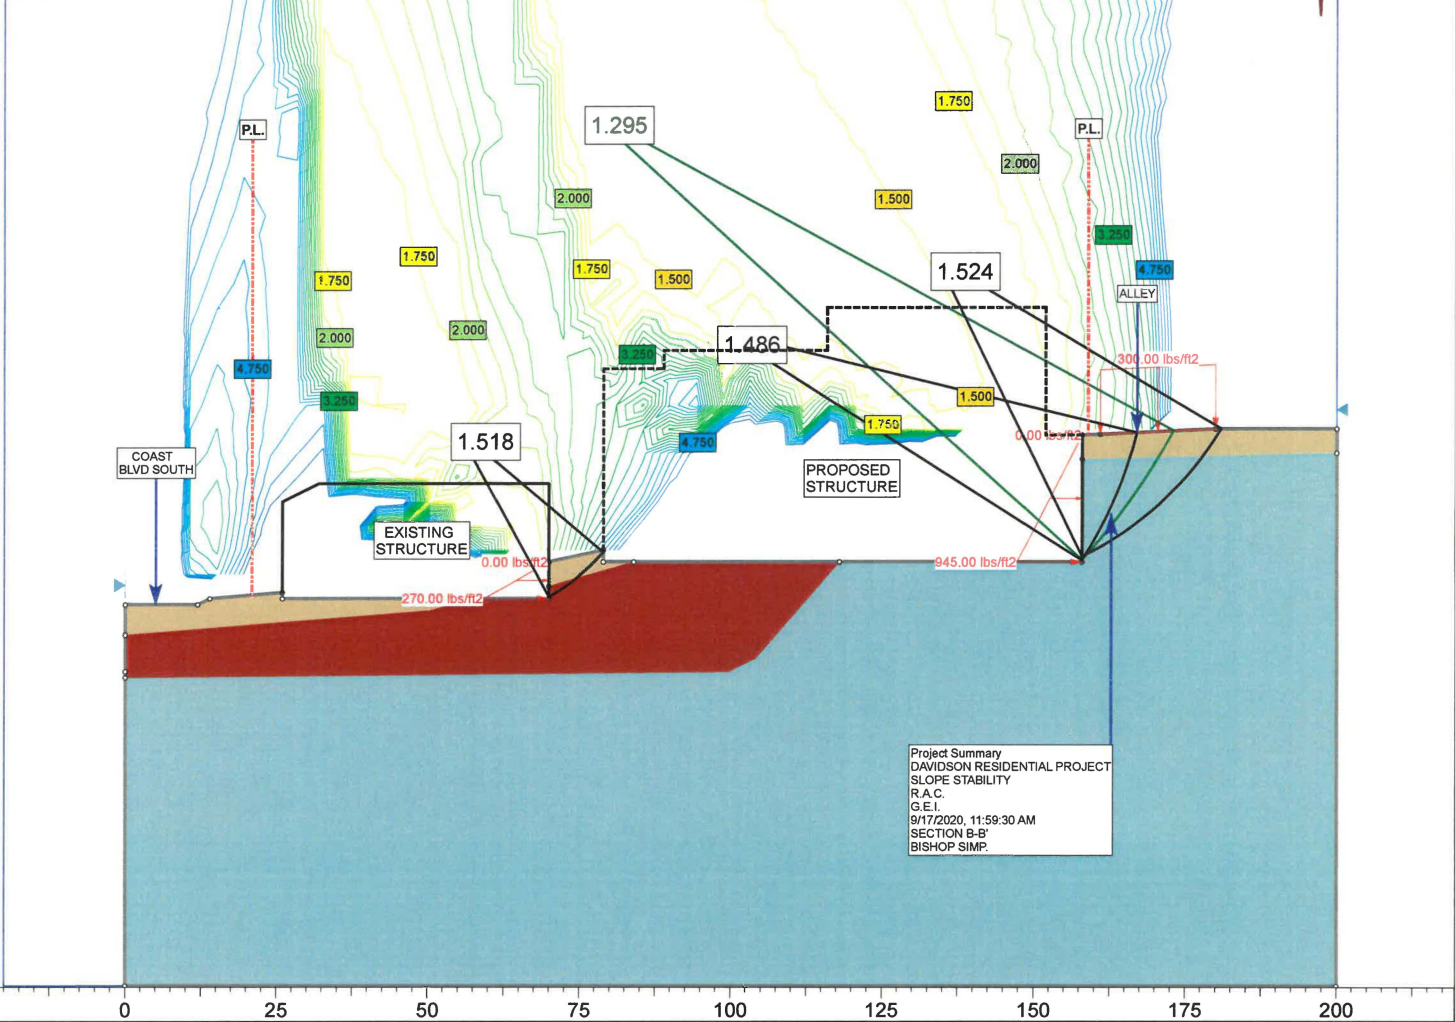
Seismic circular analysis of the proposed cut **with the proposed shoring** retaining wall. A traffic surcharge of 300 psf was included in the alley. The proposed shoring wall was analyzed with a lateral cantilevered triangular pressure of 45 pcf in this analysis. A similar load was assumed for the existing structure retaining wall. If the shoring wall is to be restrained, a lateral pressure of 64 pcf should be used.

Project Summary
 DAVIDSON RESIDENTIAL PROJECT
 SLOPE STABILITY
 R.A.C.
 G.E.I.
 9/17/2020, 11:59:30 AM
 SECTION B-B'
 BISHOP SIMP.

Project		DAVIDSON RESIDENTIAL PROJECT		SECTION B-B'	
Analysis Description					
SLOPE STABILITY					
Drawn By	R.A.C.	Scale	1:365	Company	G.E.I.
Date	9/17/2020, 11:59:30 AM		File Name	JOB NO. 20-12787_S(B)_02w_0.15gSHAKE.slim
