**REPORT OF PRELIMINARY GEOTECHNICAL  
INVESTIGATION**

Davidson Residential Development  
811-827 Coast Boulevard South  
La Jolla, California

**JOB NO. 20-12787**  
24 September 2020

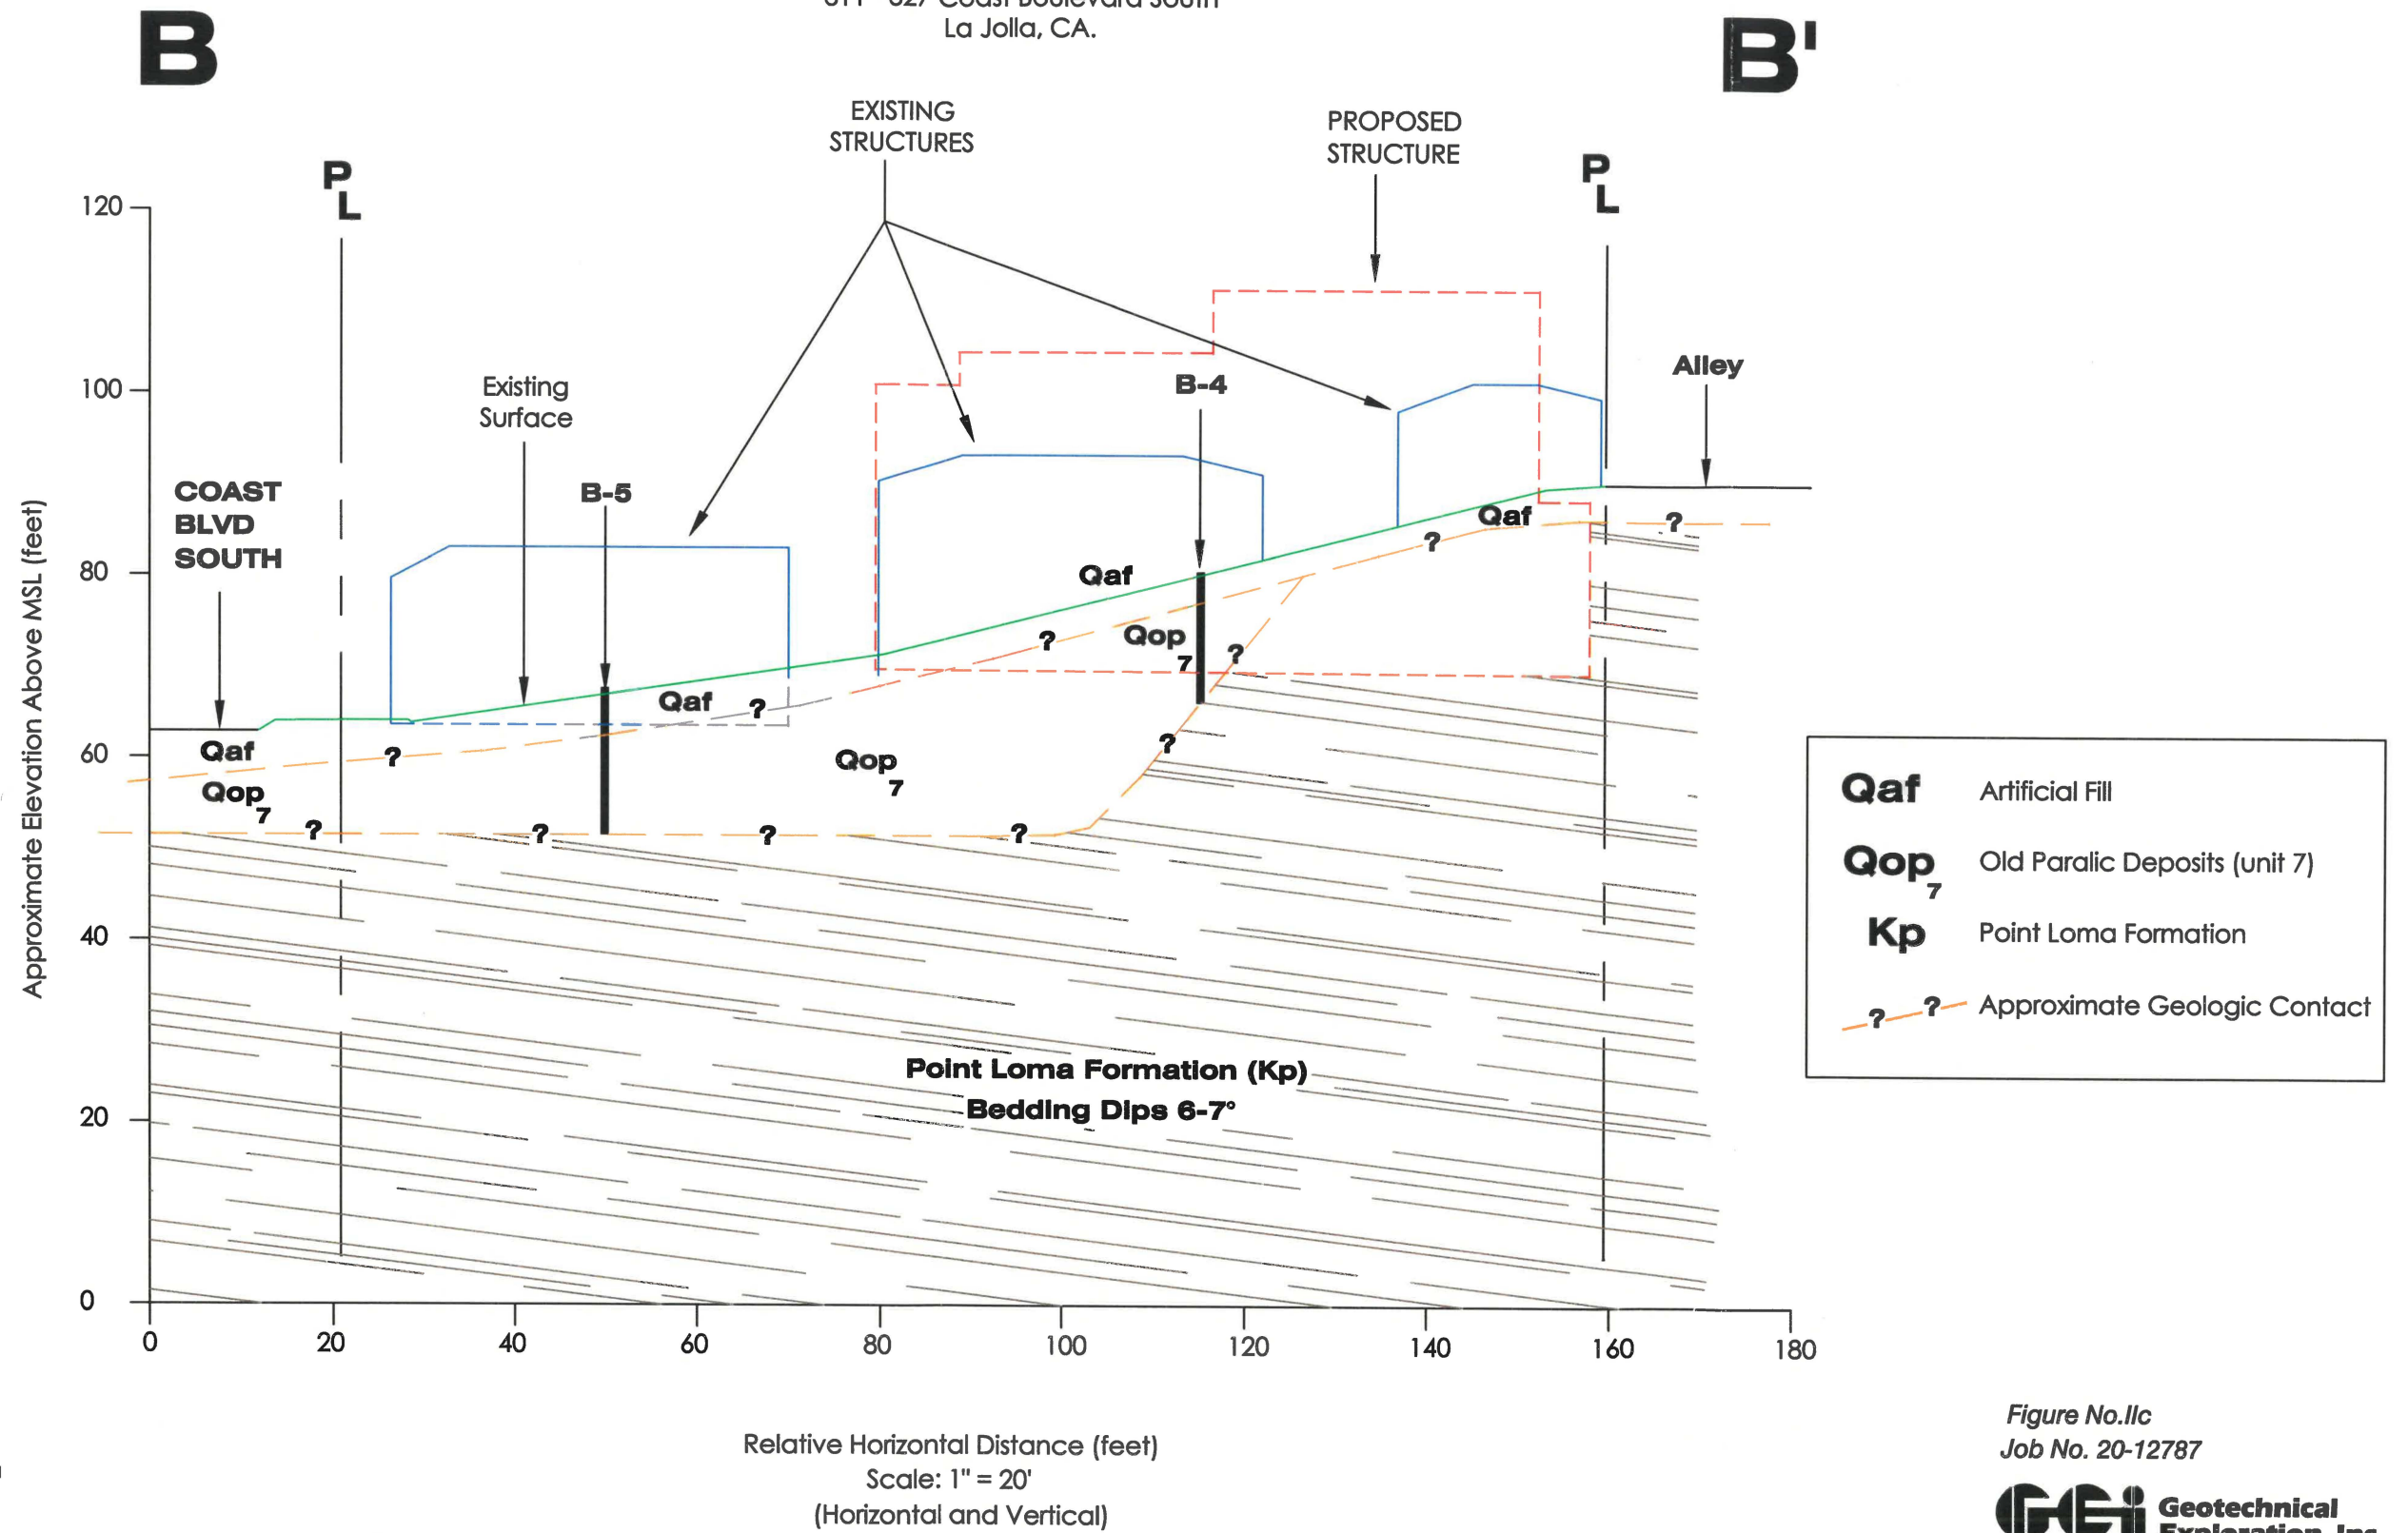
# CROSS SECTION B-B'

NOTE: This Cross Section is not to be used for legal purposes. Locations and dimensions are approximate. Actual property dimensions and locations of utilities may be obtained from the Approved Building Plans or the "As-Built" Grading Plans.

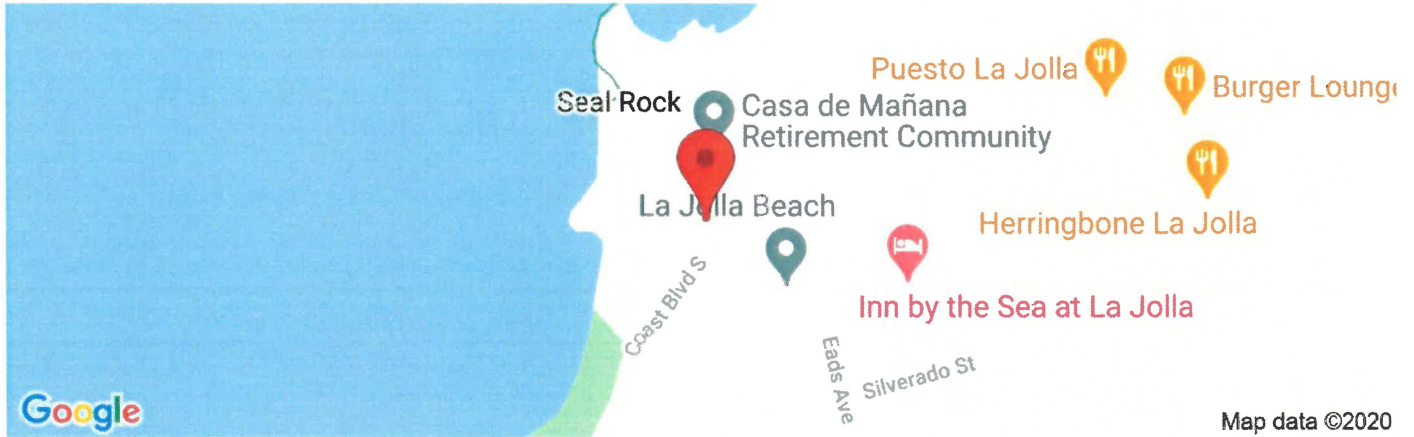
<b>Date</b>	9/22/2020, 11:37:24 AM
<b>Design Code Reference Document</b>	ASCE7-16
<b>Risk Category</b>	II
<b>Site Class</b>	D - Stiff Soil

Type	Value	Description
$S_S$	1.345	$MCE_R$ ground motion. (for 0.2 second period)
$S_1$	0.472	$MCE_R$ ground motion. (for 1.0s period)
$S_{MS}$	1.345	Site-modified spectral acceleration value
$S_{M1}$	null -See Section 11.4.8 <b>0.864</b>	Site-modified spectral acceleration value
$S_{DS}$	0.897	Numeric seismic design value at 0.2 second SA
$S_{D1}$	null -See Section 11.4.8 <b>0.575</b>	Numeric seismic design value at 1.0 second SA

Type	Value	Description
SDC	null -See Section 11.4.8 <b>D</b>	Seismic design category
$F_a$	1	Site amplification factor at 0.2 second
$F_v$	null -See Section 11.4.8 <b>1.83</b>	Site amplification factor at 1.0 second
PGA	0.611	$MCE_G$ peak ground acceleration
$F_{PGA}$	1.1	Site amplification factor at PGA
$PGA_M$	0.673	Site modified peak ground acceleration
$T_L$	8	Long-period transition period in seconds
SsRT	1.345	Probabilistic risk-targeted ground motion. (0.2 second)
SsUH	1.547	Factored uniform-hazard (2% probability of exceedance in 50 years) spectral acceleration
SsD	2.125	Factored deterministic acceleration value. (0.2 second)
S1RT	0.472	Probabilistic risk-targeted ground motion. (1.0 second)
S1UH	0.531	Factored uniform-hazard (2% probability of exceedance in 50 years) spectral acceleration.
S1D	0.746	Factored deterministic acceleration value. (1.0 second)
PGA <sub>d</sub>	0.88	Factored deterministic acceleration value. (Peak Ground Acceleration)
