**REPORT OF PRELIMINARY GEOTECHNICAL
INVESTIGATION**

Lot 31, Rancho del Sol
APN 305-060-18-00
San Diego, California

JOB NO. 19-12420

16 October 2019

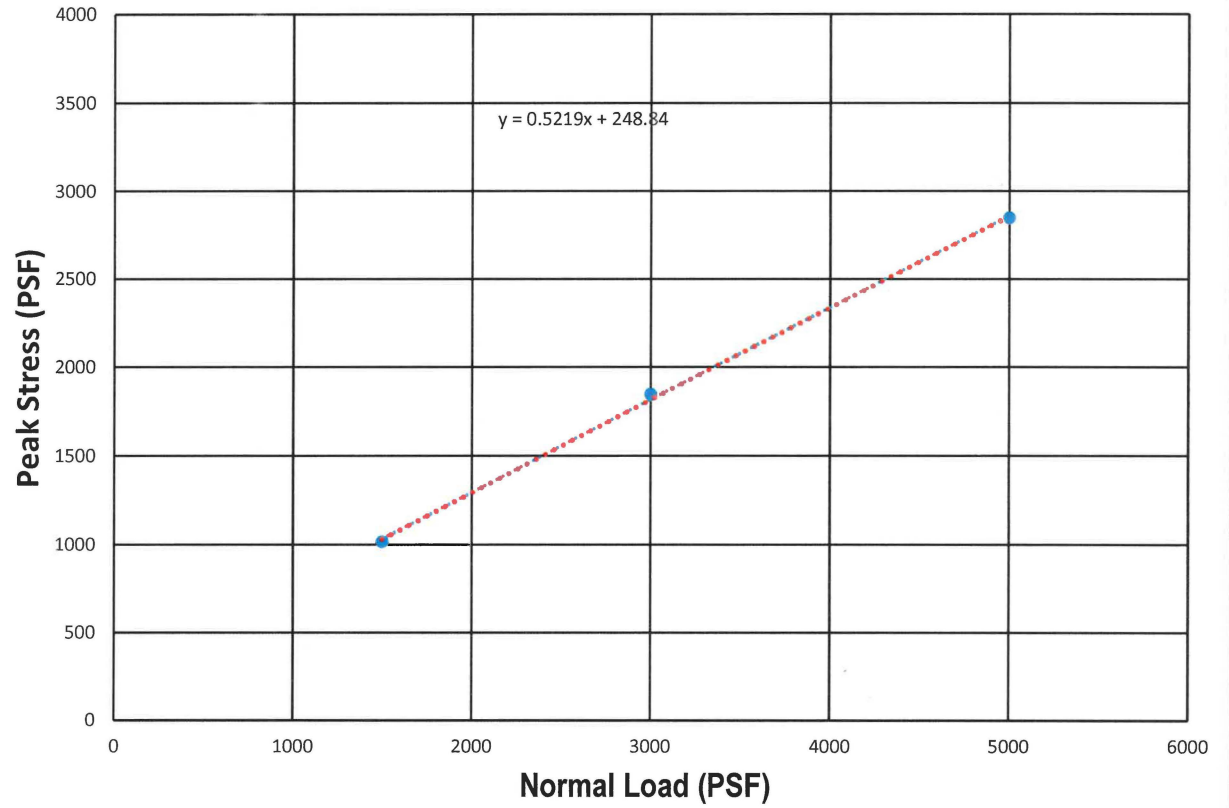
Test Method: Remolded to 90% of Maximum Dry Density - Saturated

Normal Load (PSF)	Peak Stress (PSF)
1500	1015
3000	1844
5000	2846
Phi Angle (Degrees)	27.6
Cohesion (PSF)	249

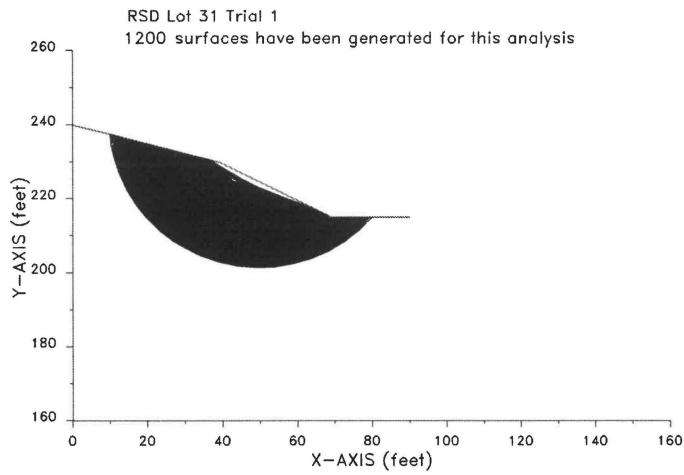
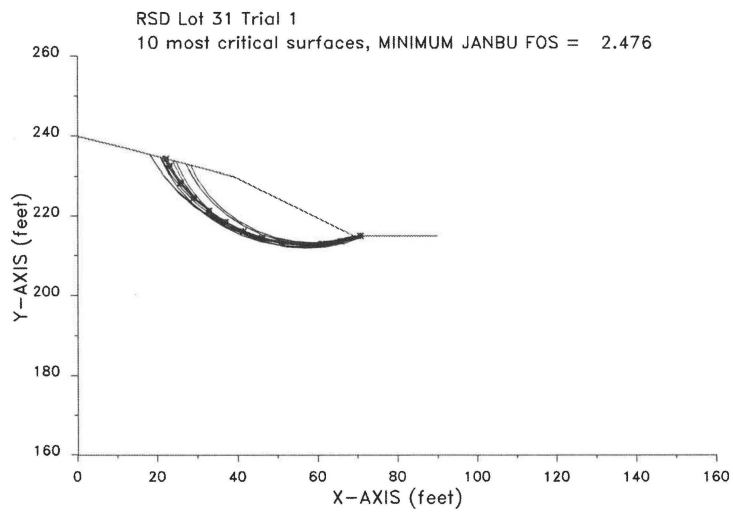
SECTION A-A'

LOT31R1 9-24-19 12:04

Soil Unit No.	Unit Weight Moist (pcf)	Weight Sat. (pcf)	Cohesion Intercept (psf)	Friction Angle (deg)	Pore Pressure Parameter Ru
1	115.0	125.0	250.0	27.50	.

A critical failure surface searching method, using a random technique for generating CIRCULAR surfaces has been specified. 1200 trial surfaces will be generated and analyzed. 40 Surfaces initiate from each of 30 points equally spaced along the ground surface between x = 65.0 ft and x = 80.0 ft

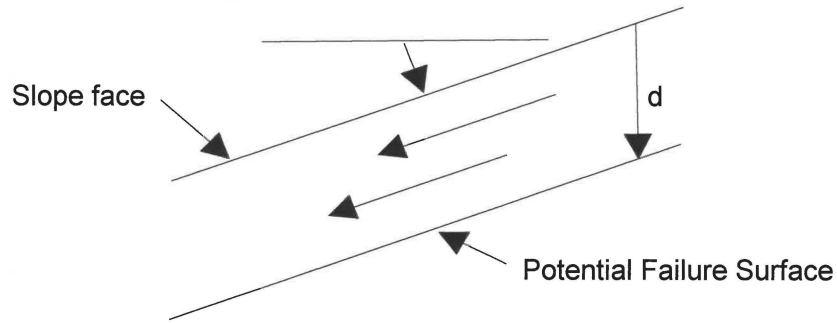
SURFICIAL STABILITY CALCULATIONS FOR PROPOSED CUT AND FILL SLOPES

slope
ratio
2 to 1

phi(deg)= 27.5
c(psf)= 250
gamma Sat(pcf)= 125
gamma Buoy(pcf)= 62.6
slope angle(deg)= 26.6
depth= 5
FS= 1.52
