**REPORT OF PRELIMINARY GEOTECHNICAL  
INVESTIGATION**

Lot 31, Rancho del Sol  
APN 305-060-18-00  
San Diego, California

**JOB NO. 19-12420**

16 October 2019

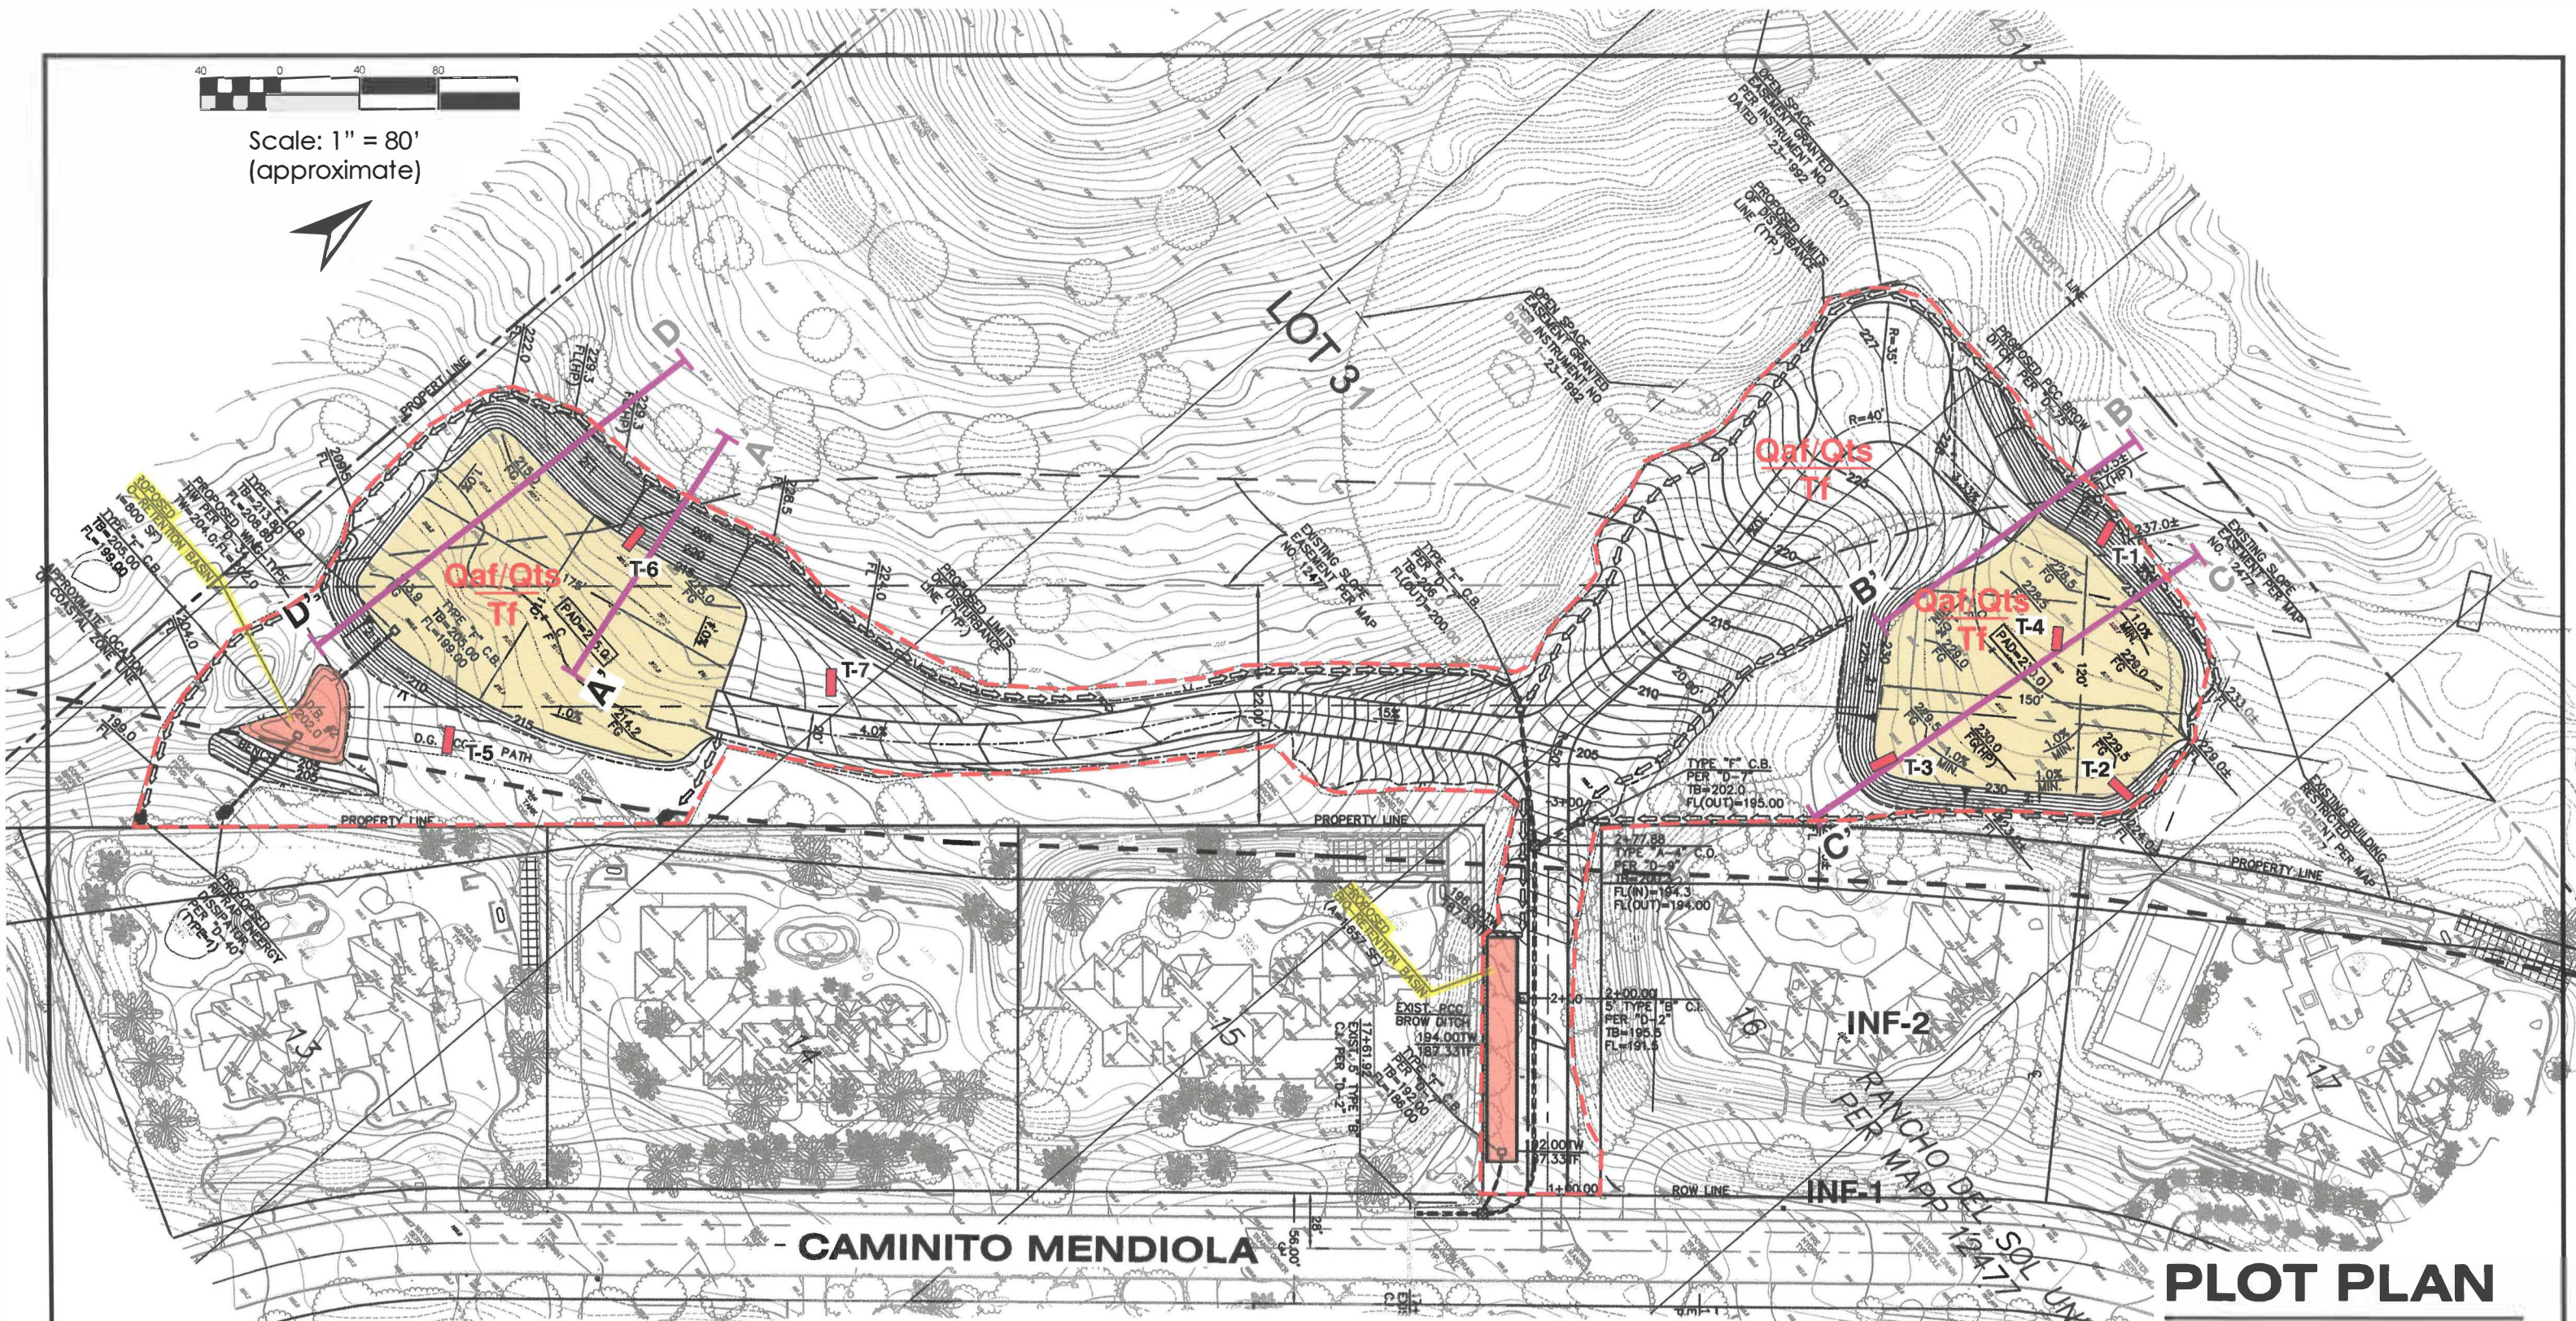
NOTE: This Plot Plan is not to be used for legal purposes. Locations and dimensions are approximate. Actual property dimensions and locations of utilities may be obtained from the Approved Building Plans or the "As-Built" Grading Plans.

REFERENCE: This PLOT PLAN was prepared from an existing PRELIMINARY GRADING PLAN by FARRINGTON ENGINEERING CONSULTANTS, INC. dated 6-20-19 and from on-site field reconnaissance performed by GEI.

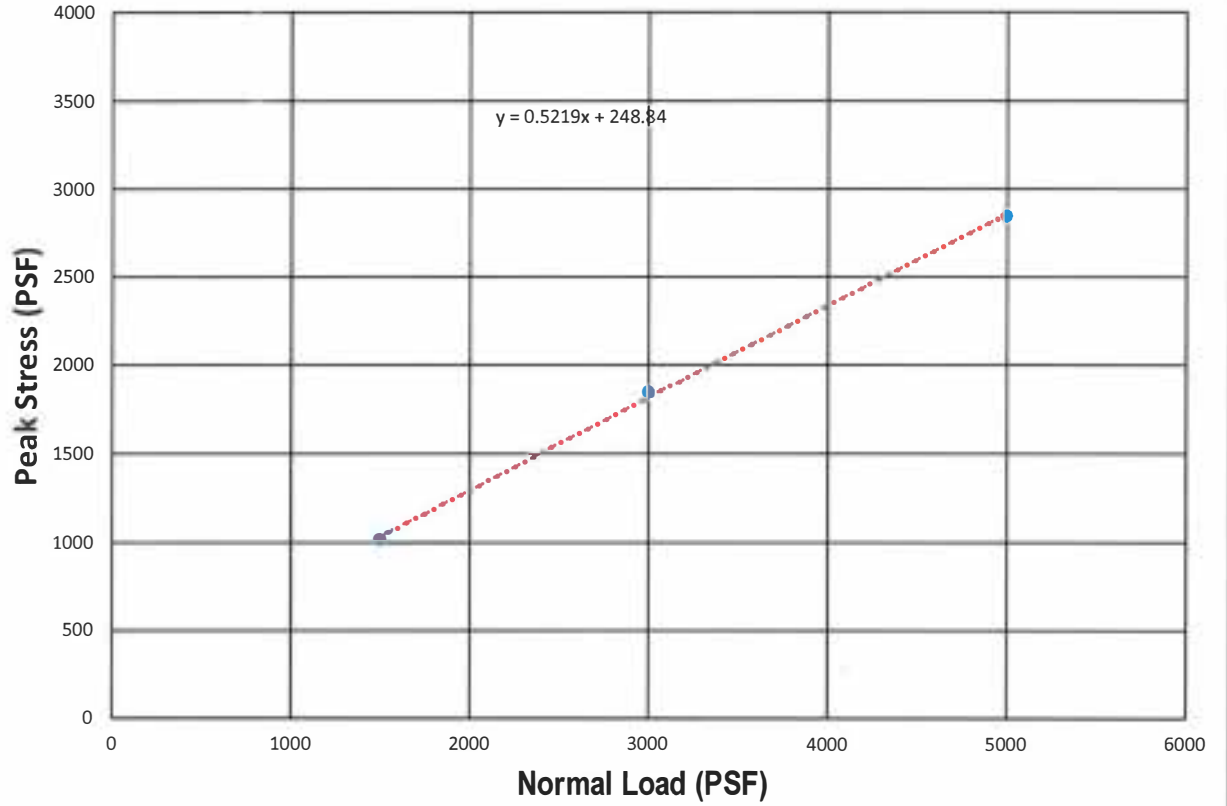
**Test Method:** Remolded to 90% of Maximum Dry Density - Saturated

Normal Load (PSF)	Peak Stress (PSF)
1500	1015
3000	1844
5000	2846
<b>Phi Angle (Degrees)</b>	27.6
<b>Cohesion (PSF)</b>	249

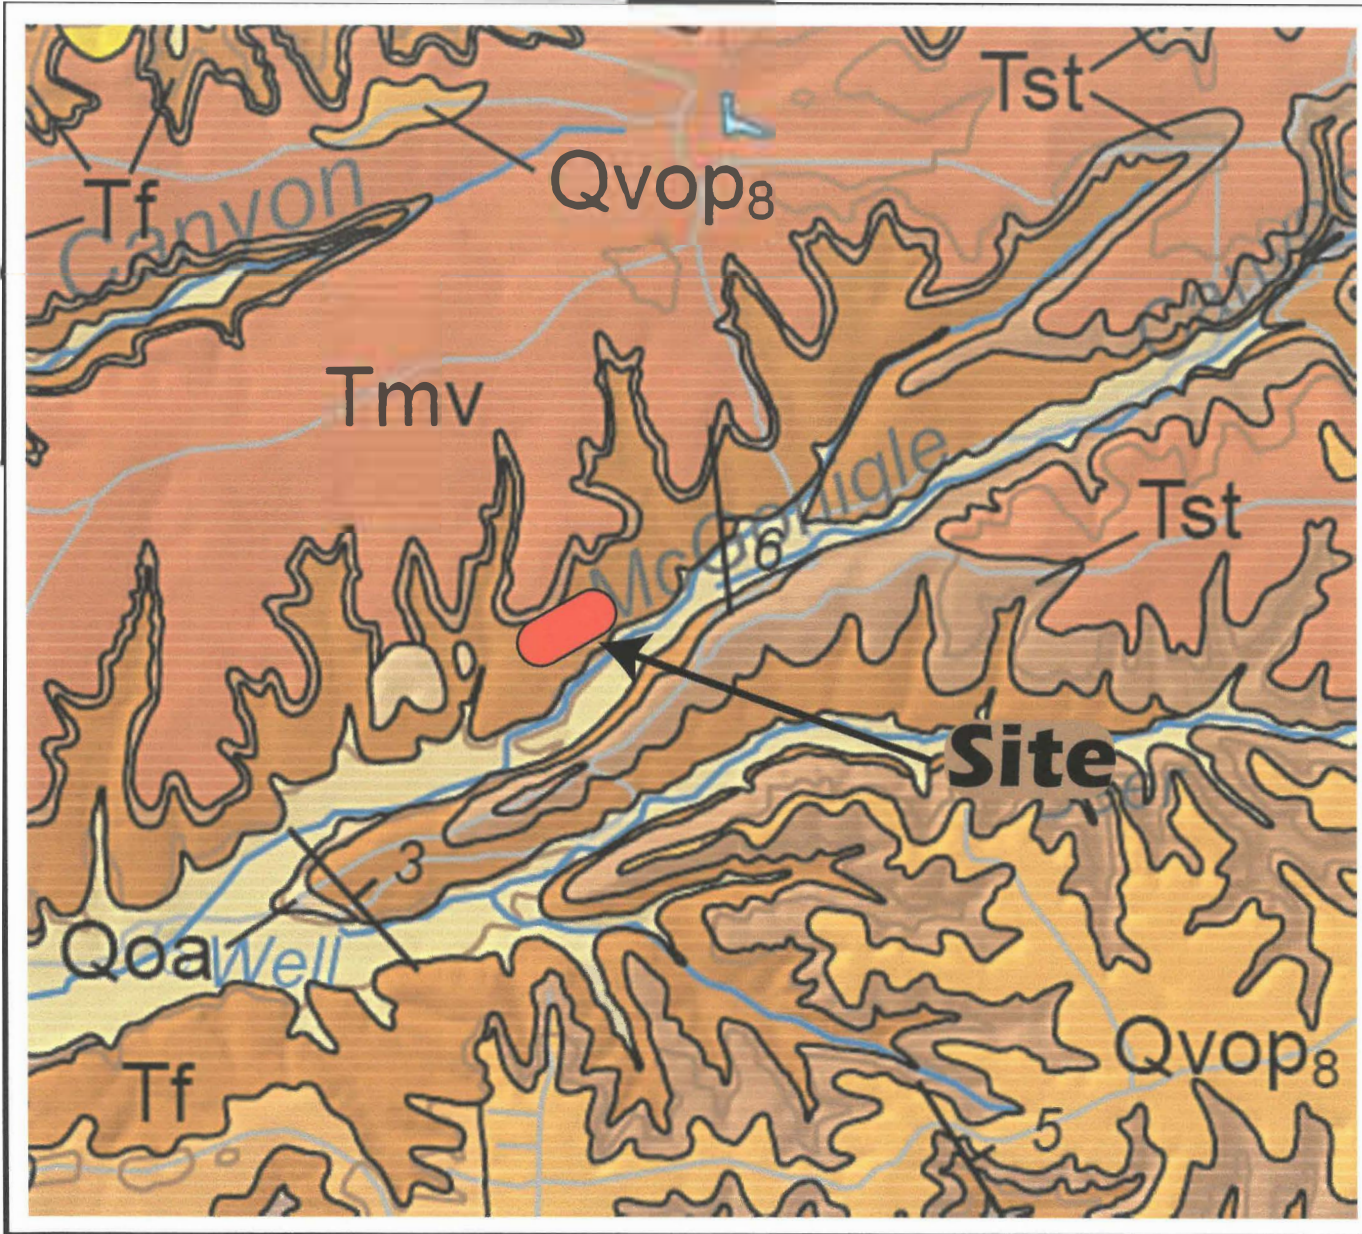
EXCERPT FROM GEOLOGIC MAP OF THE SAN DIEGO 30' x 60' QUADRANGLE, CALIFORNIA

By  
Michael P. Kennedy<sup>1</sup> and Siang S. Tan<sup>1</sup>  
2008

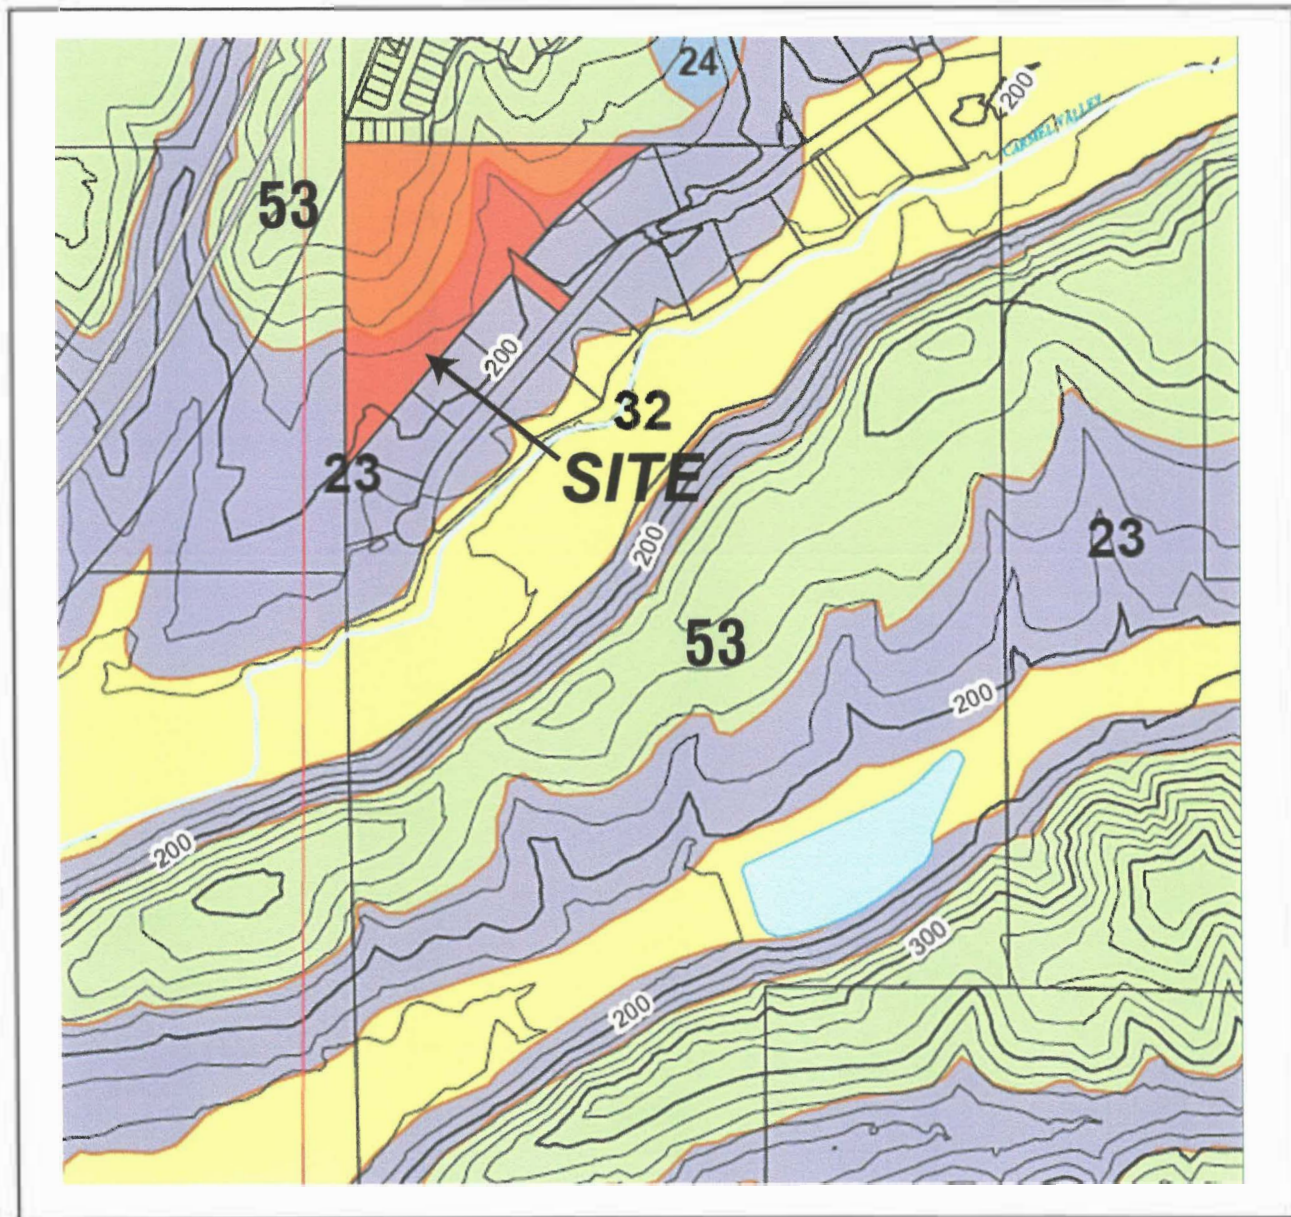
**Geologic Hazards Map Excerpt  
from City of San Diego  
Geologic Hazards and Fault Map  
Sheet 39**

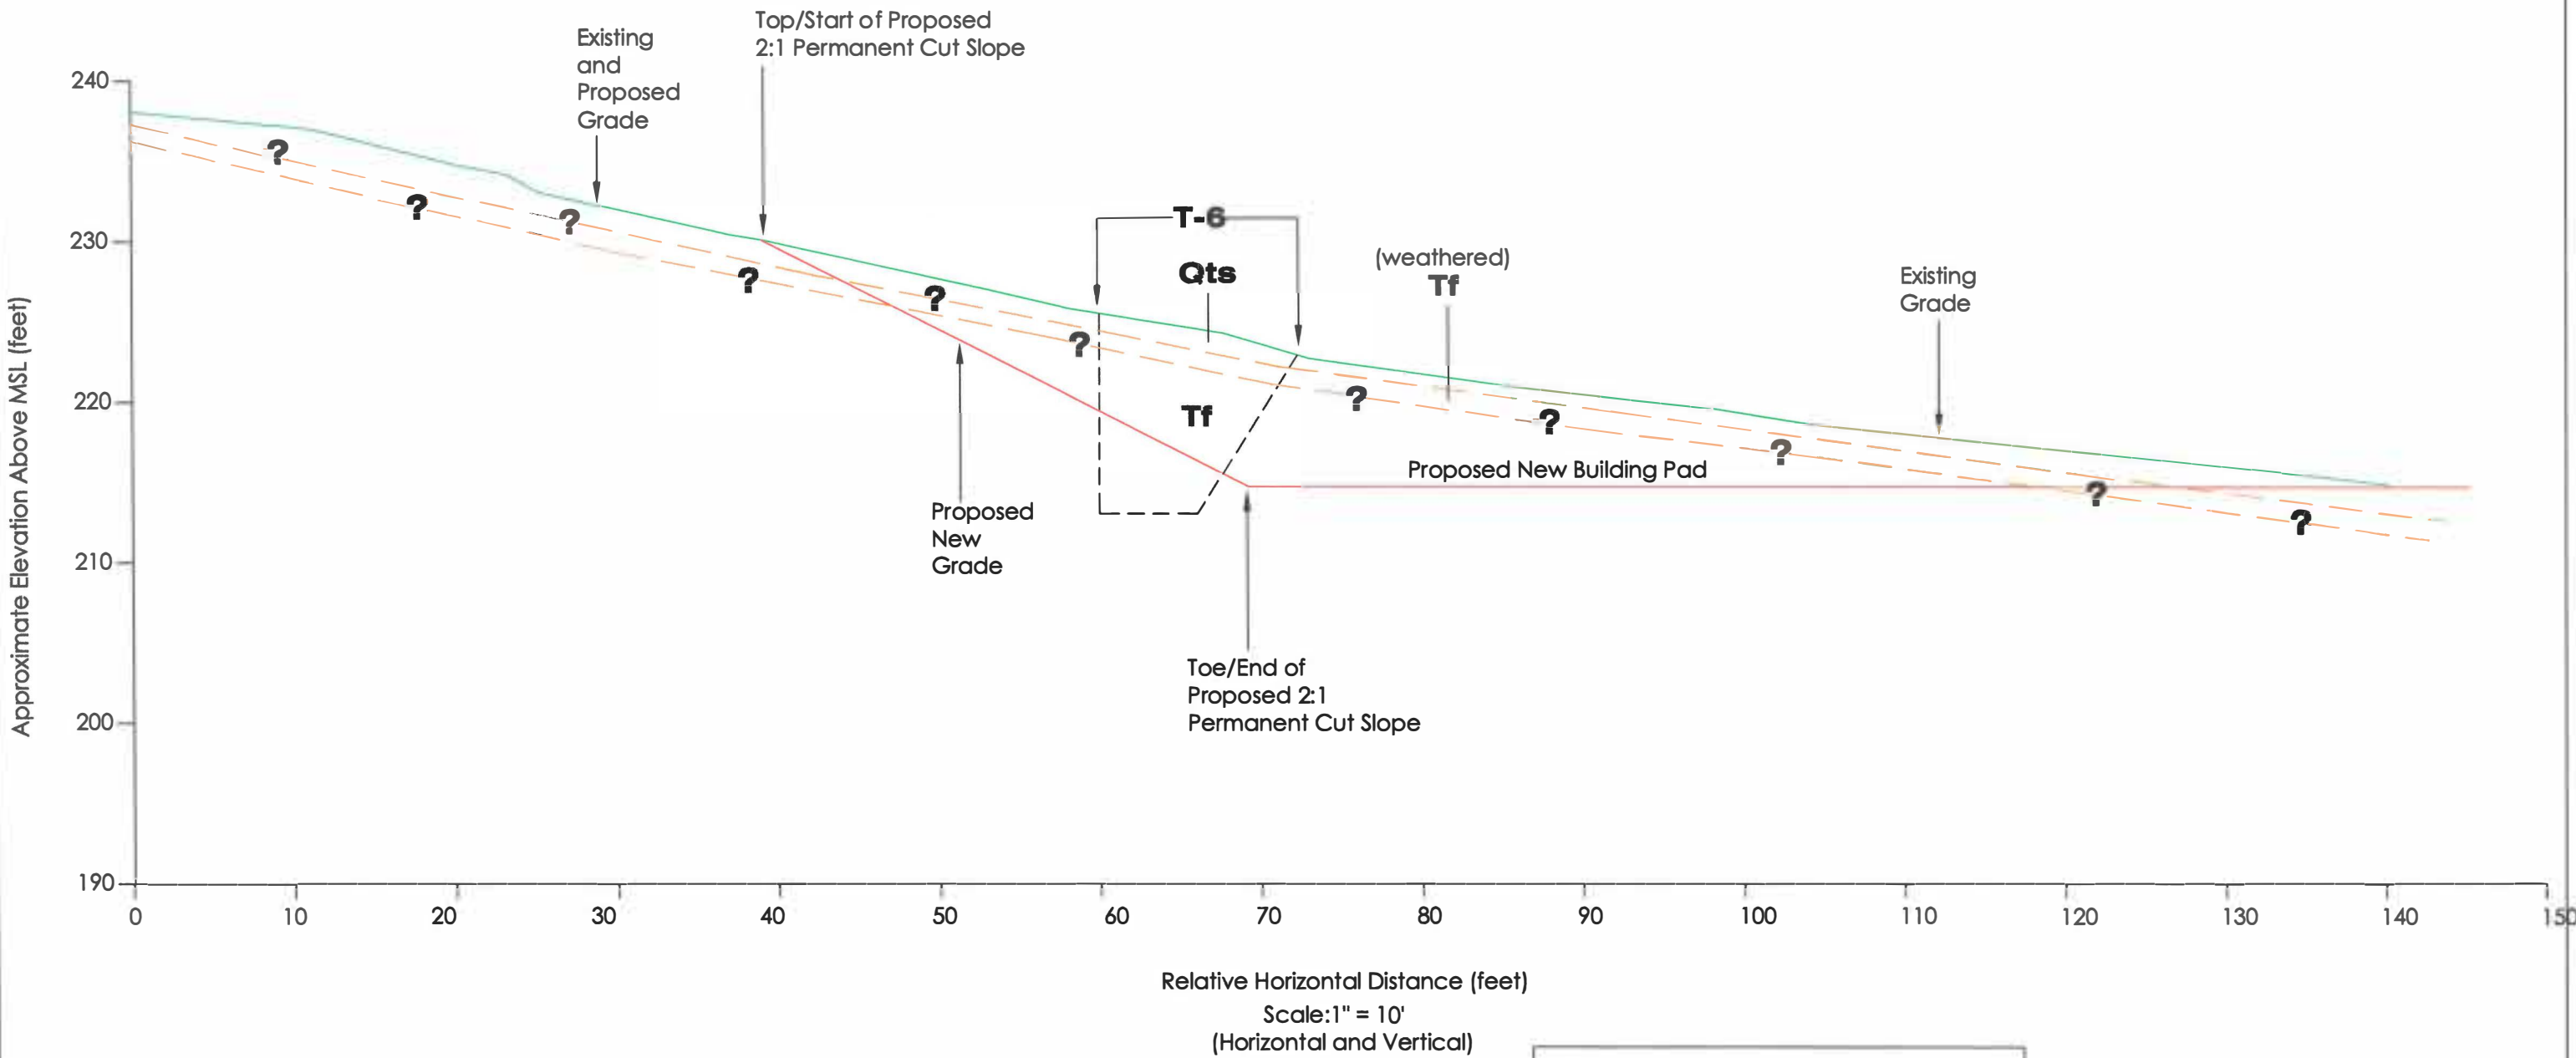
**A**

**A'**

<b>Qtz</b>	Topsoil ( 1 Foot )
<b>Tf</b>	Weathered Friars Formation ( 1 Foot )
<b>Tf</b>	Friars Formation
	Approximate Geologic Contact

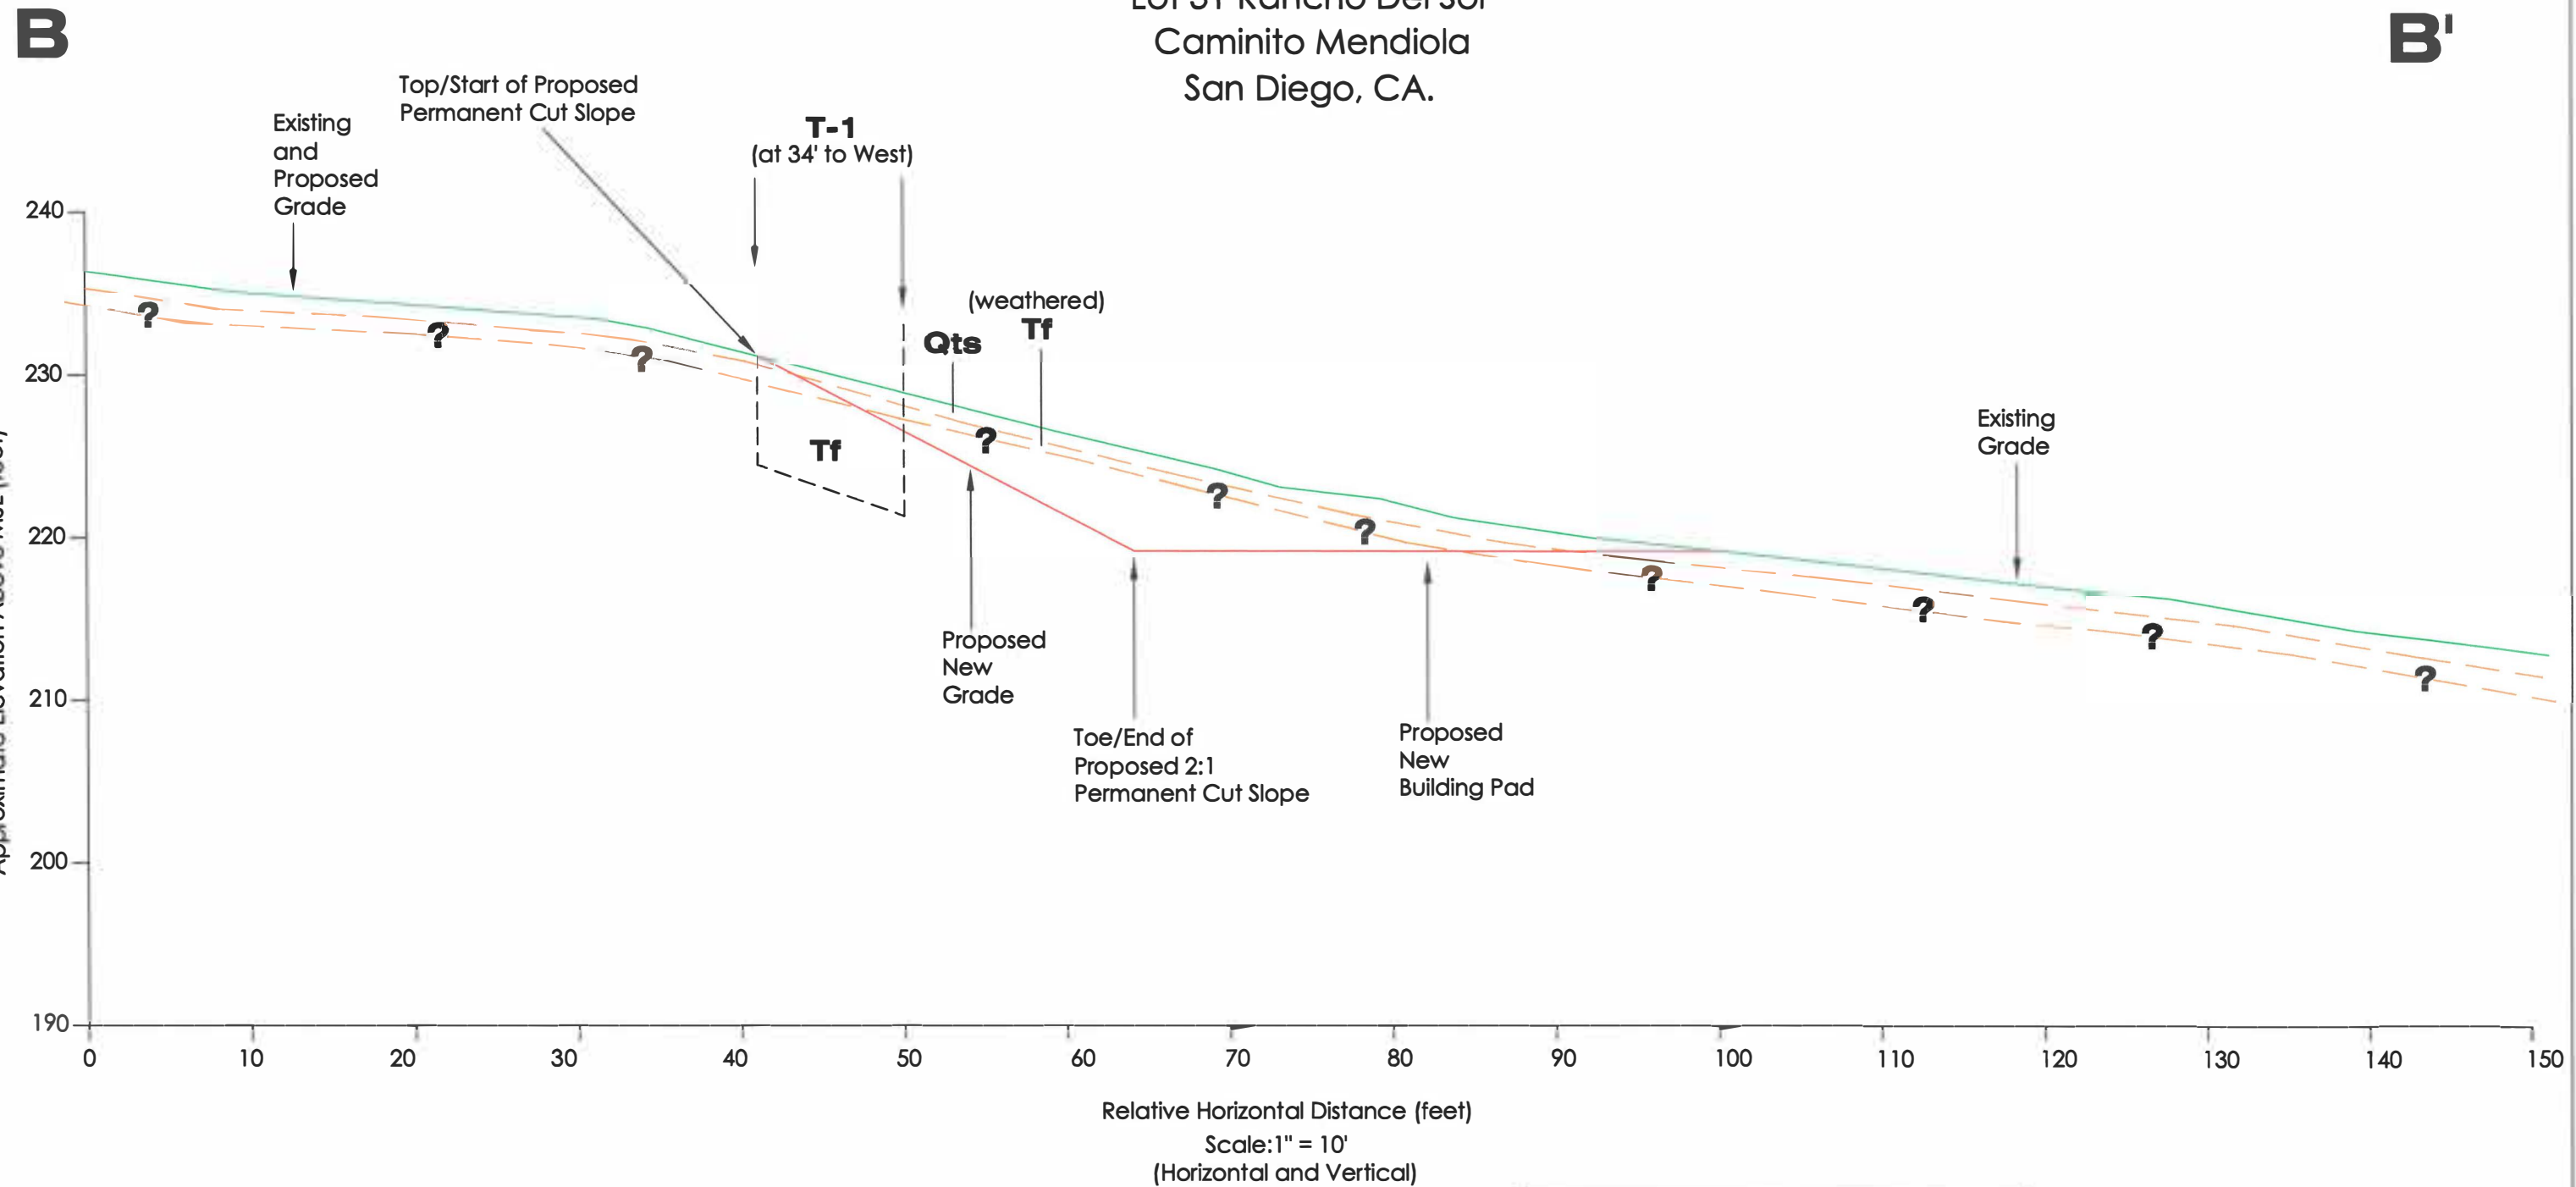
Figure No. VIIb  
Job No. 19-12420

# GEOLOGIC CROSS SECTION B-B'

<b>Qaf/Qts</b>	Fill/Topsoil ( 1 Foot )
<b>Tf</b>	Weathered Friars Formation ( 1 Foot )
<b>Tf</b>	Friars Formation
	Approximate Geologic Contact

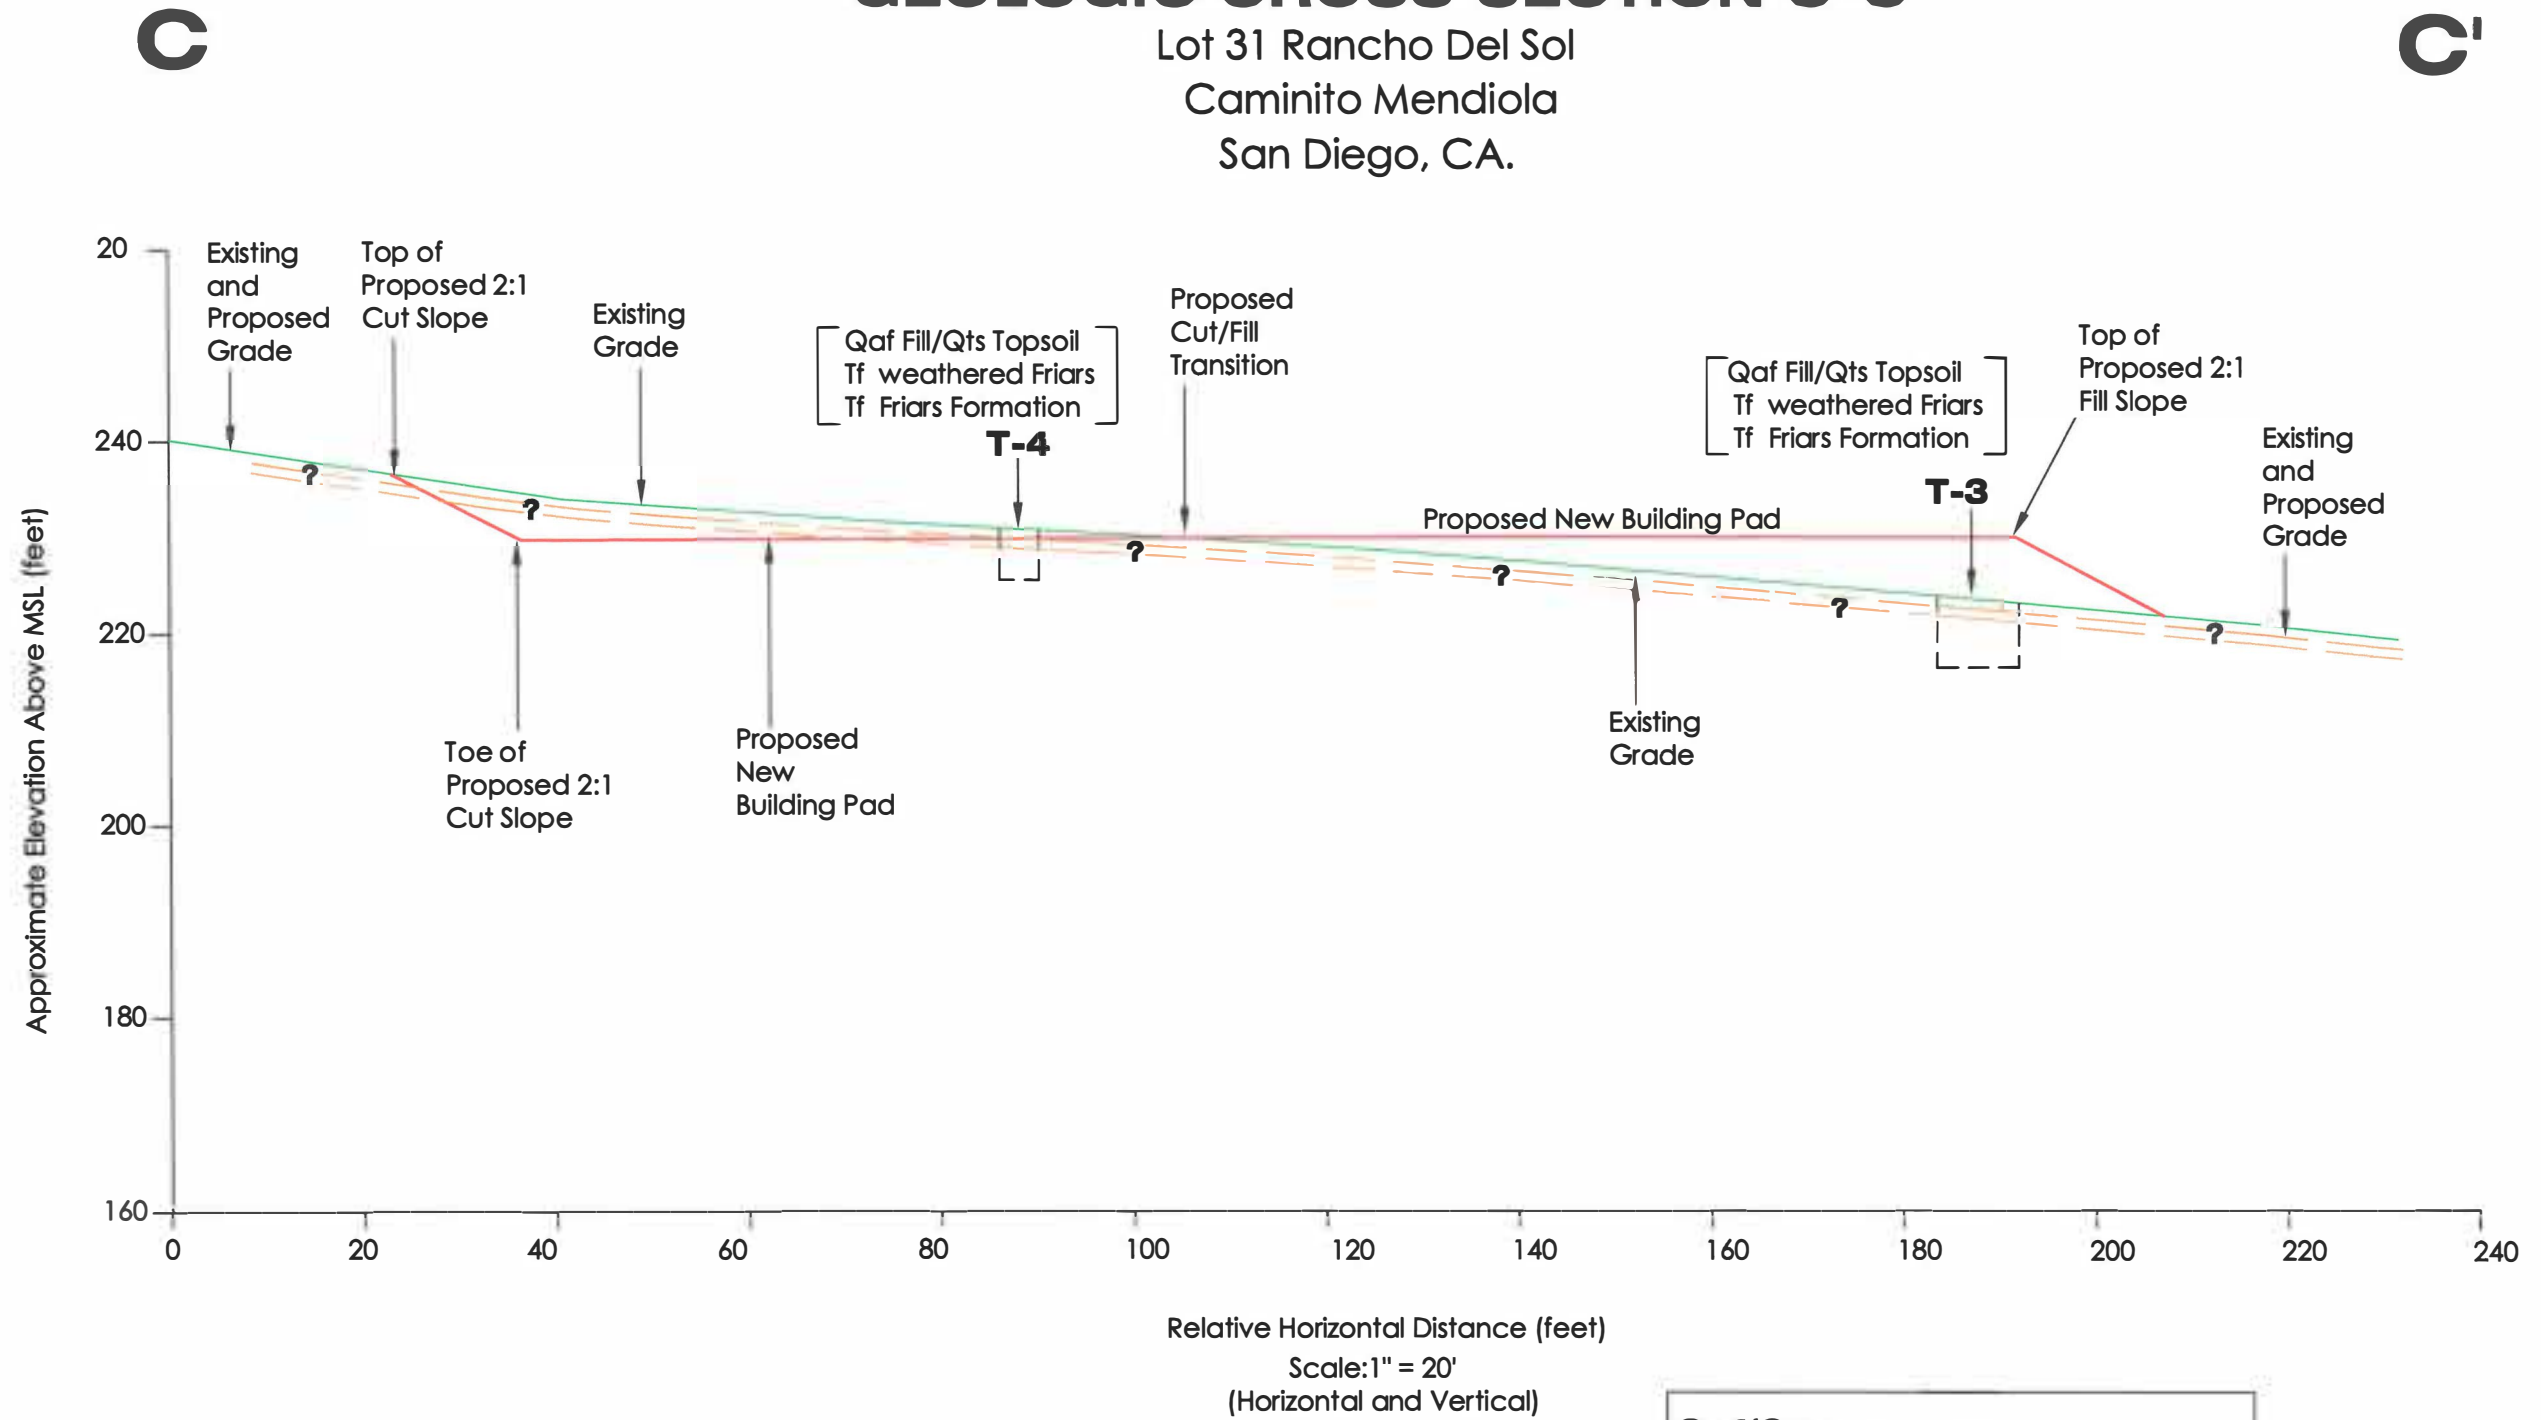
# GEOLOGIC CROSS SECTION C-C'

<b>Qaf/Qts</b>	Fill/Topsoil ( 1 Foot )
<b>Tf</b>	Weathered Friars Formation ( 1 Foot )
<b>Tf</b>	Friars Formation
	Approximate Geologic Contact

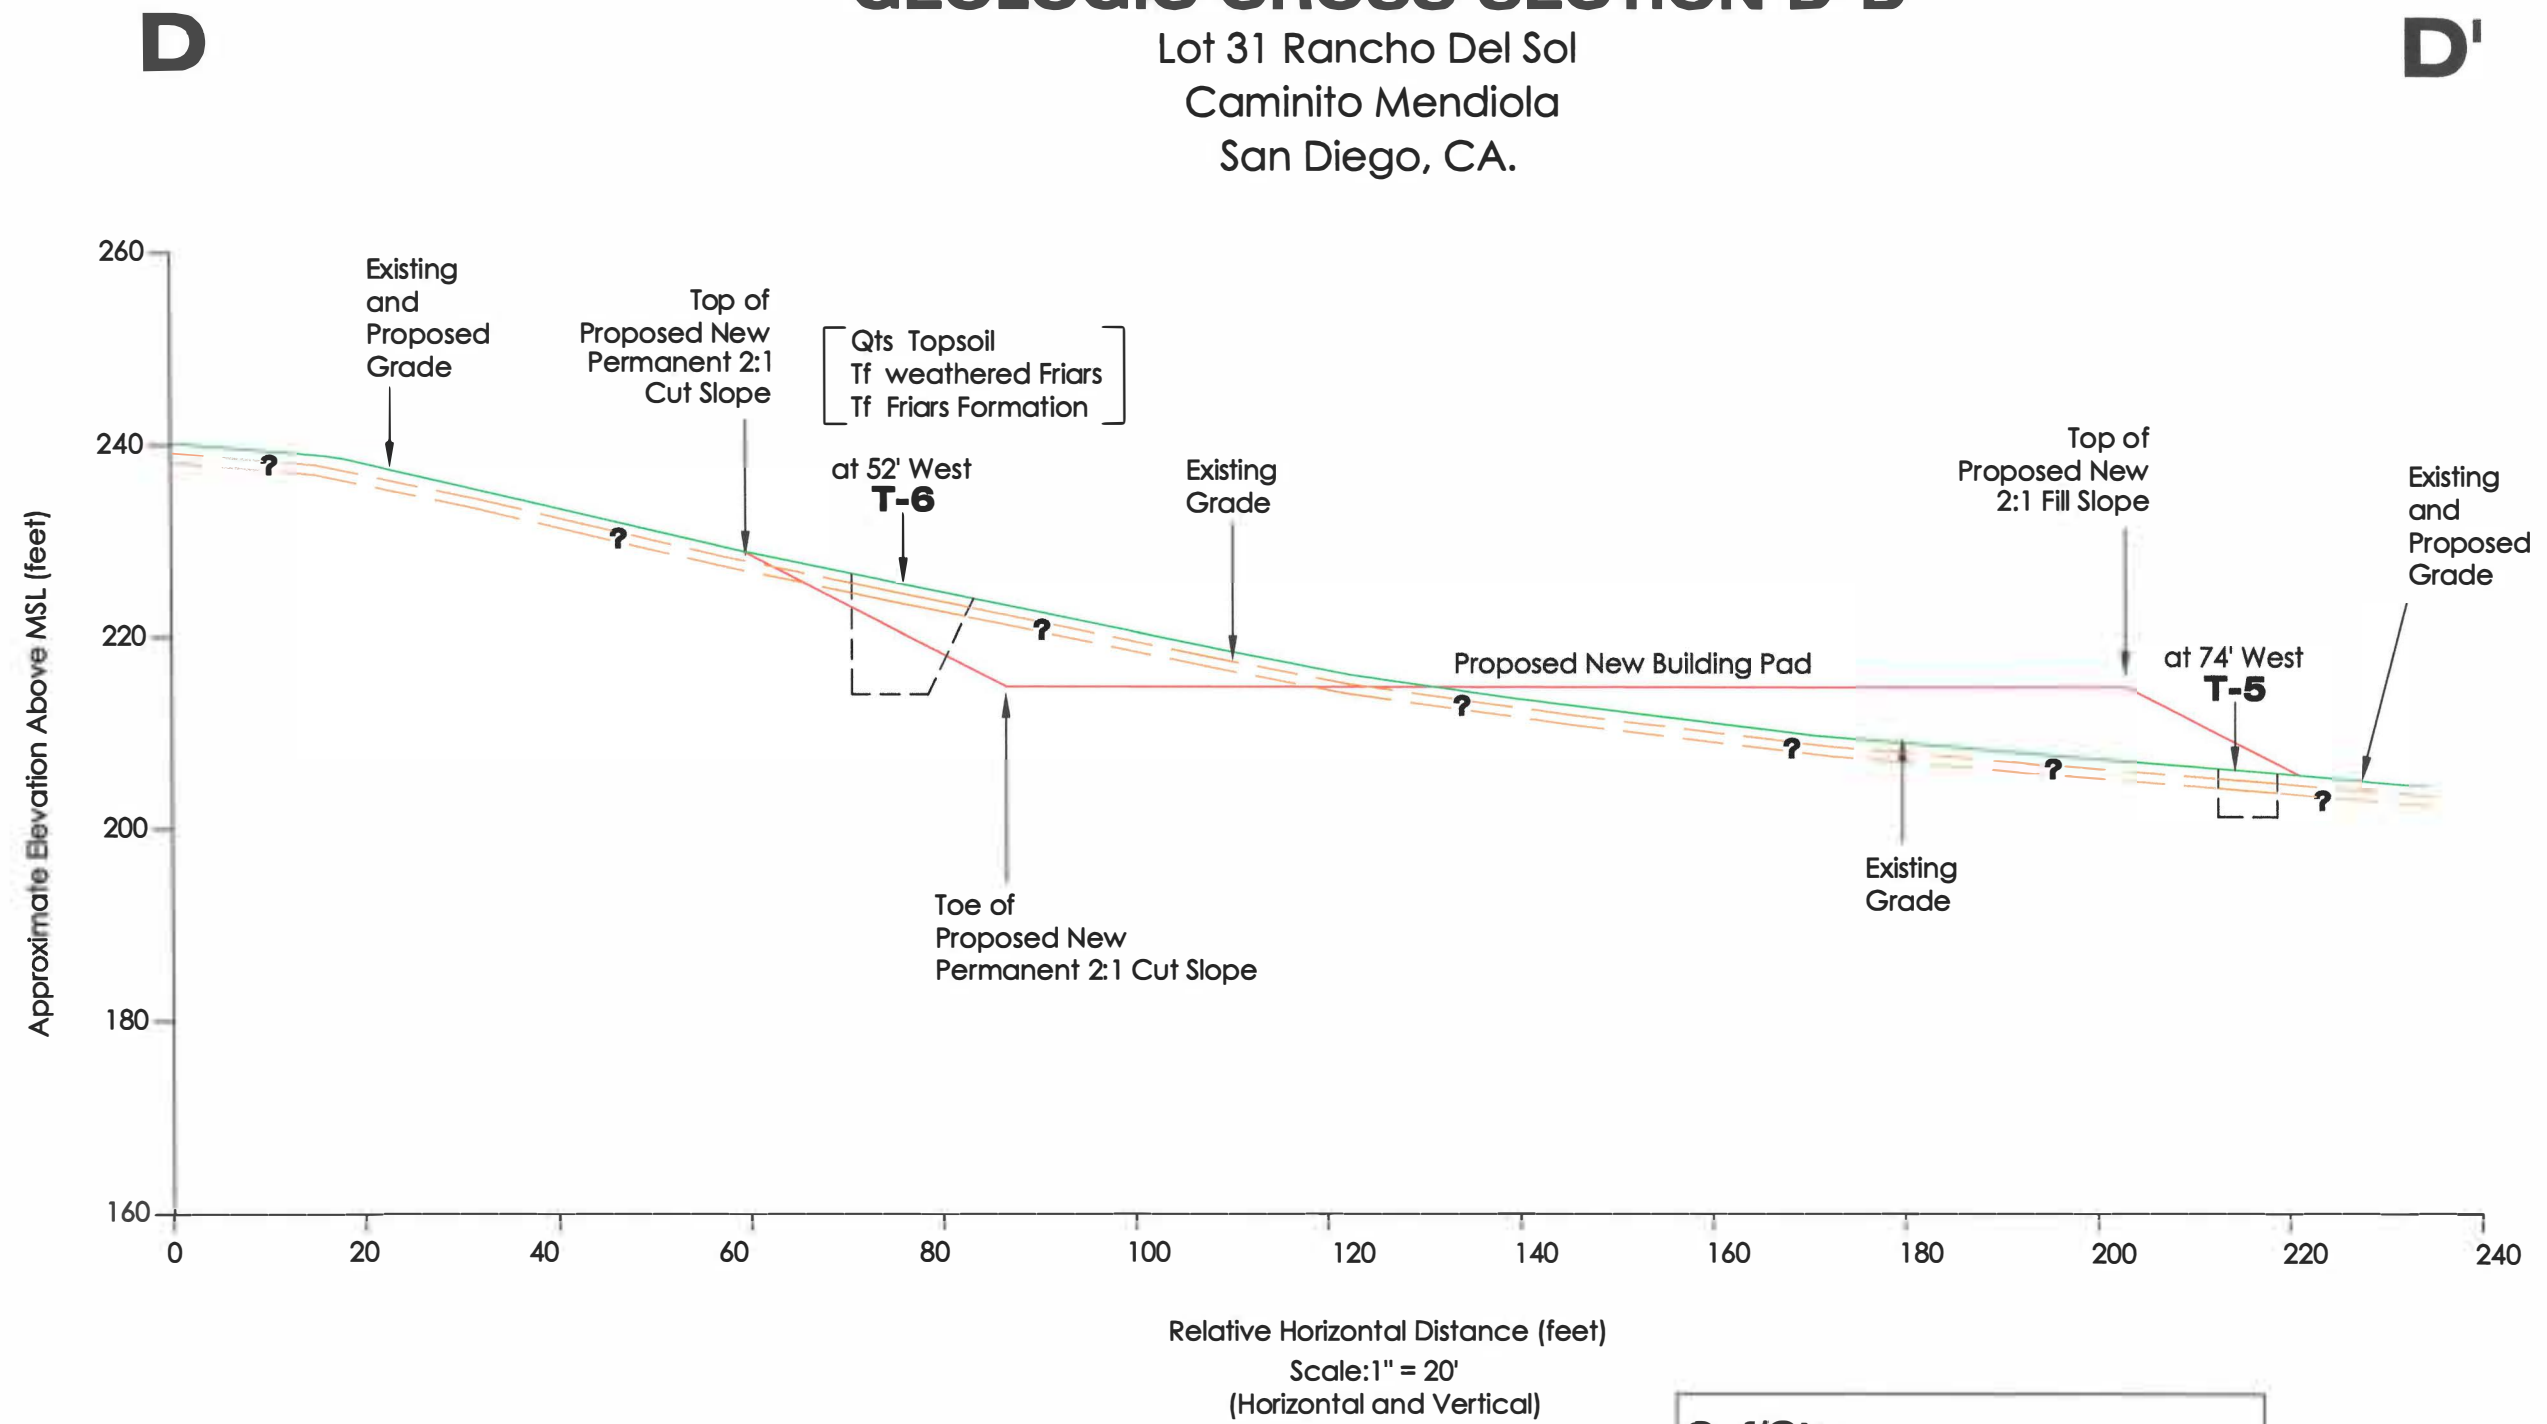
Figure No. VIId  
Job No. 19-12420

# GEOLOGIC CROSS SECTION D-D'

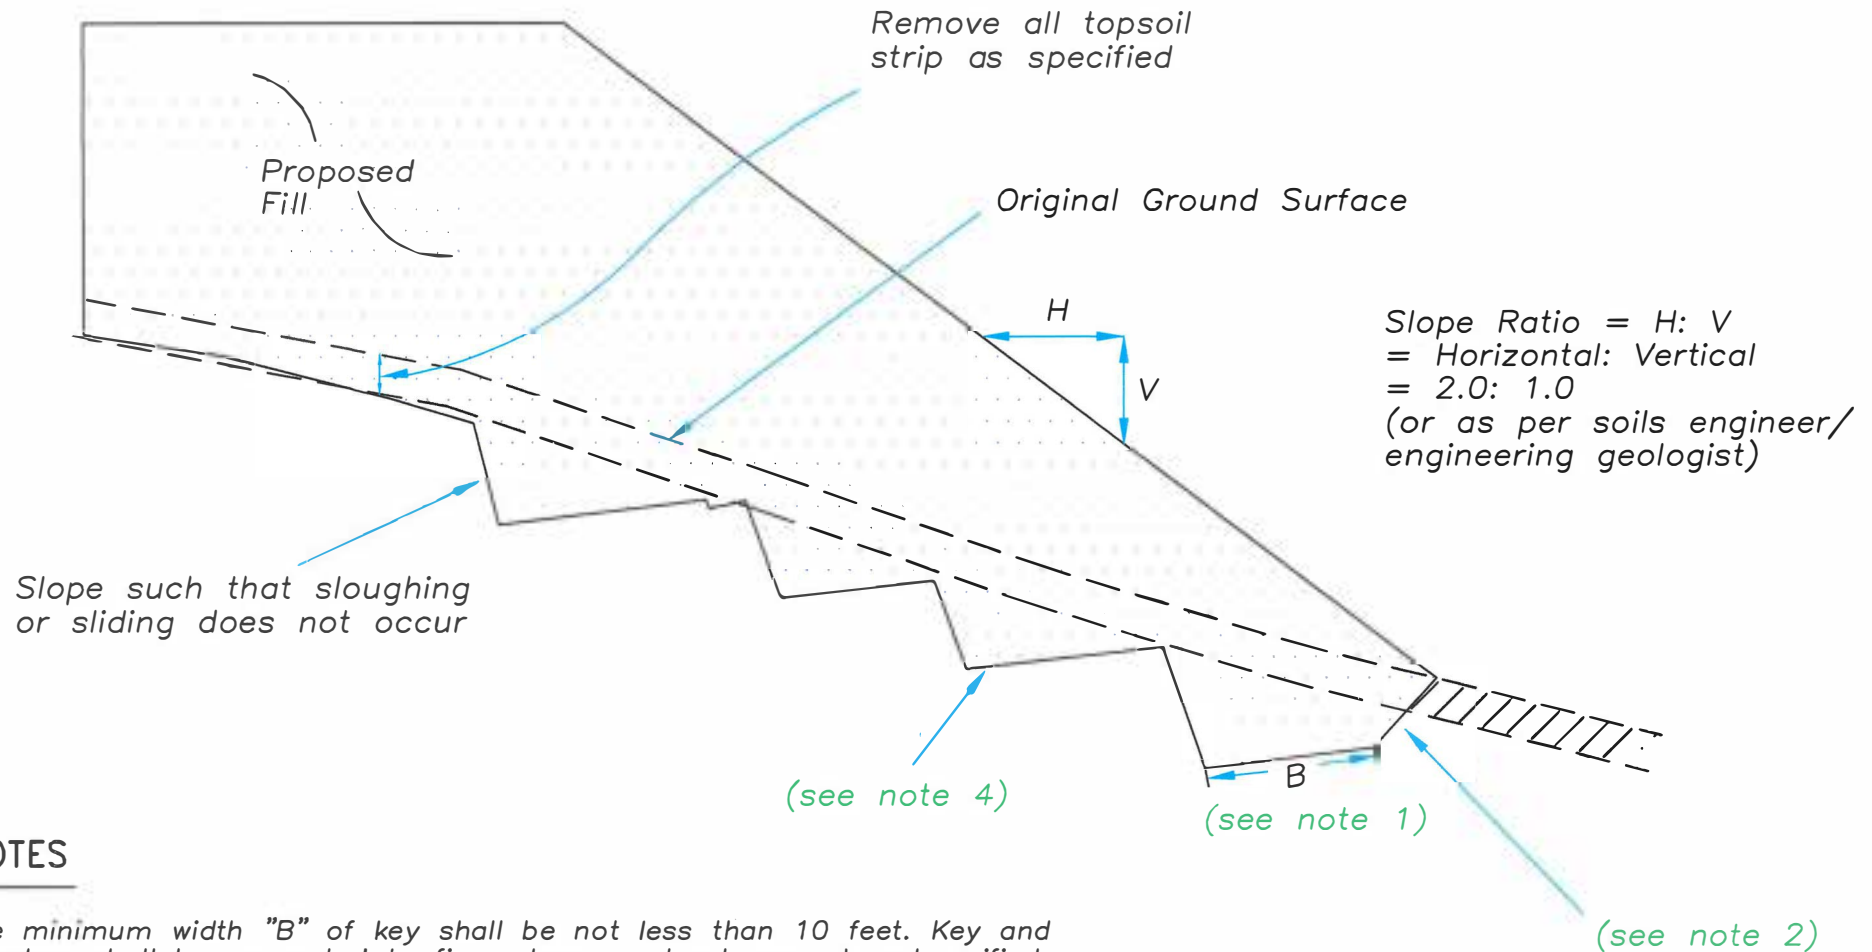
# BENCH AND KEY REQUIREMENTS

1. The minimum width "B" of key shall be not less than 10 feet. Key and benches shall be excavated to firm, dense, natural-ground and verified by a Soils Engineer/Engineering Geologist.
2. The outside edge of bottom key shall be below topsoil or loose surface material: Minimum one foot embedment into dense material (or as per Soils Engineer/Engineering Geologist).
3. Key and benching required where the natural slope is steeper than 5.0 horizontal to 1.0 vertical (5.0:1.0), or as per Soils Engineer/ Engineering Geologist.
4. Minimum 10% fall into slope (or as per Soils Engineer/Engineering Geologist).
5. Compaction test required every two (2) vertical feet from lowest fill area.
