**REPORT OF PRELIMINARY GEOTECHNICAL  
INVESTIGATION**

Lot 31, Rancho del Sol  
APN 305-060-18-00  
San Diego, California

**JOB NO. 19-12420**

16 October 2019

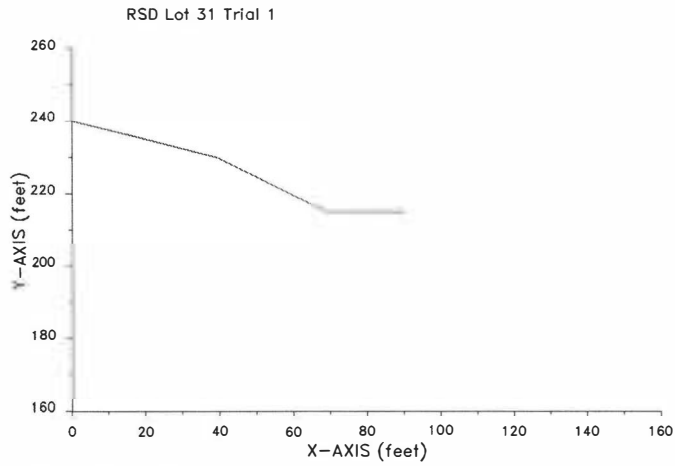
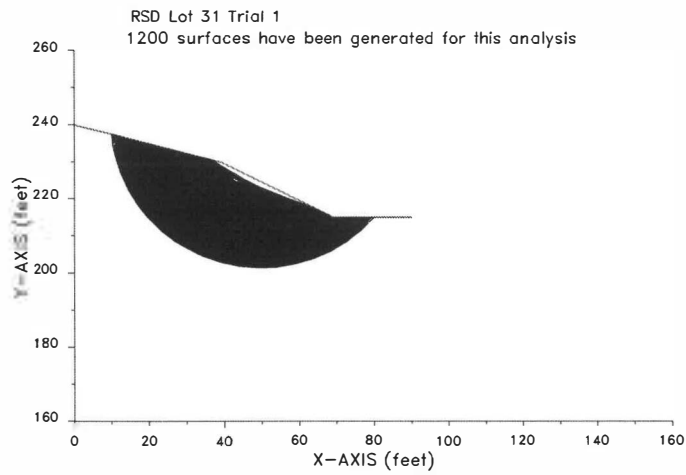
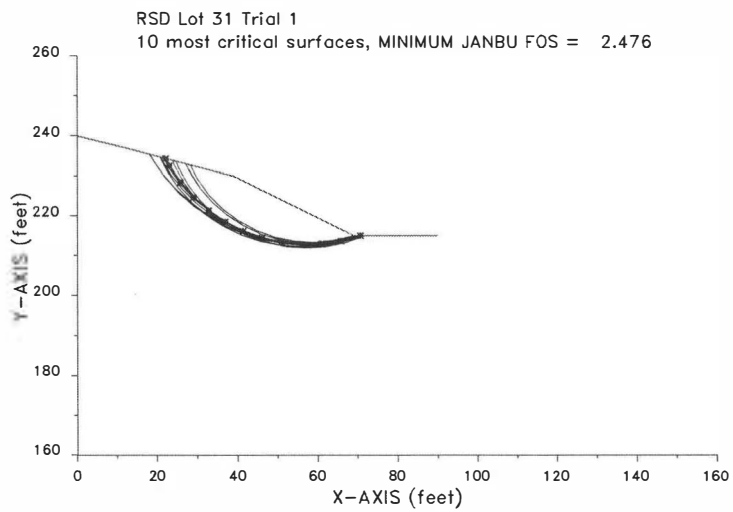
# SECTION A-A'

Soil Unit No.	Unit Weight Moist (pcf)	Weight Sat. (pcf)	Cohesion Intercept (psf)	Friction Angle (deg)	Pore Pressure Parameter Ru
1	115.0	125.0	250.0	27.50

A critical failure surface searching method, using a random technique for generating CIRCULAR surfaces has been specified. 1200 trial surfaces will be generated and analyzed. 40 Surfaces initiate from each of 30 points equally spaced along the ground surface between x = 65.0 ft and x = 80.0 ft

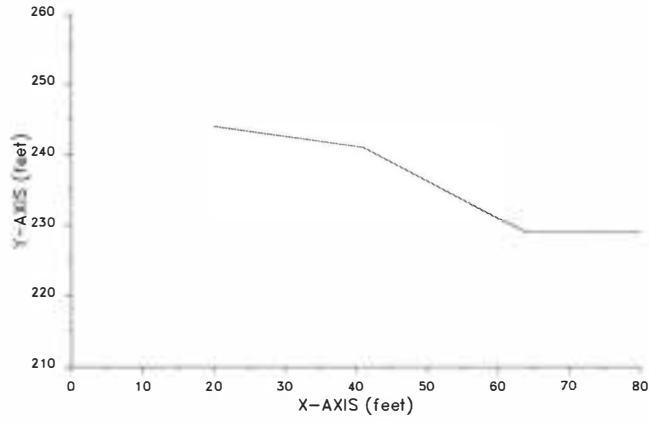
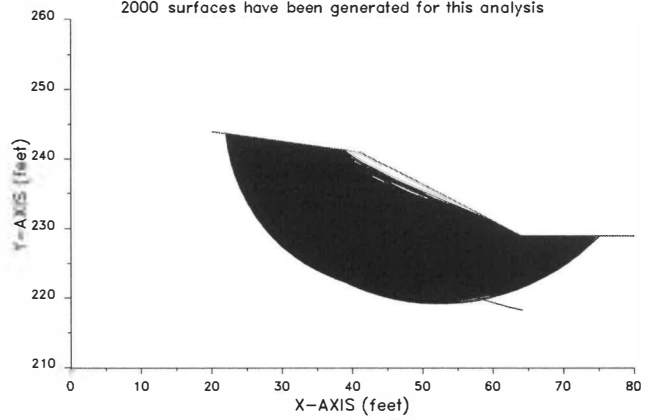
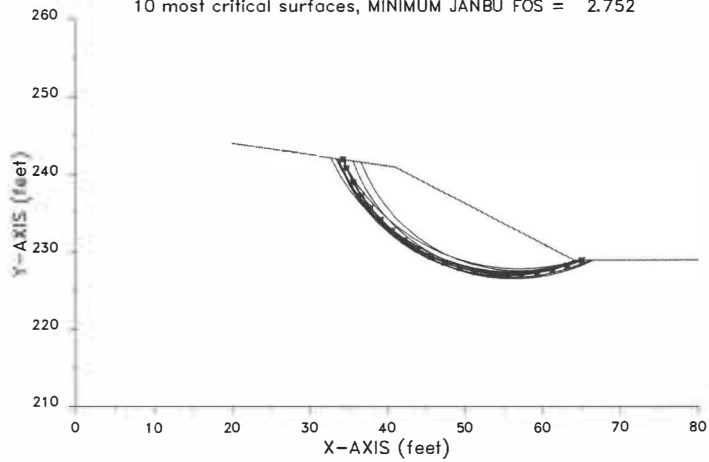
Rancho Del Sol Lot 31 Section B  
2000 surfaces have been generated for this analysis

Rancho Del Sol Lot 31 Section B  
10 most critical surfaces, MINIMUM JANBU FOS = 2.752

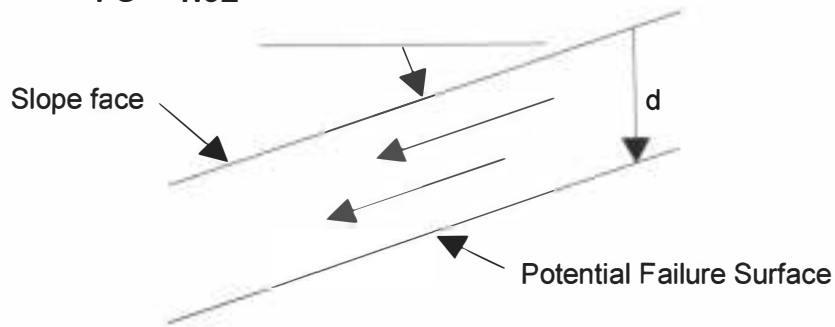
# SURFICIAL STABILITY CALCULATIONS FOR PROPOSED CUT AND FILL SLOPES

slope	slope
<u>ratio</u>	<u>angle</u>
2 to 1	26.6

<u>radians</u>
phi(deg)= 27.5	0.4800
c(psf)= 250	
gamma Sat(pcf)= 125	
gamma Buoy(pcf)= 62.6	
slope angle(deg)= 26.6	0.4643
depth= 5	
<b>FS= 1.52</b>
