**UPDATED  
GEOLOGIC HAZARDS ASSESSMENT  
AND GEOTECHNICAL ENGINEERING STUDY  
MARE ISLAND TECHNOLOGY ACADEMY  
NEW CAMPUS  
1 & 2 POSITIVE PLACE  
VALLEJO, CALIFORNIA**

PROJECT: MARE ISLAND TECHNOLOGY ACADEMY – NEW CAMPUS,  
1 & 2 POSITIVE PLACE  
VALLEJO, CALIFORNIA

SUBJECT: Updated Geologic Hazards Assessment and Geotechnical Engineering Study

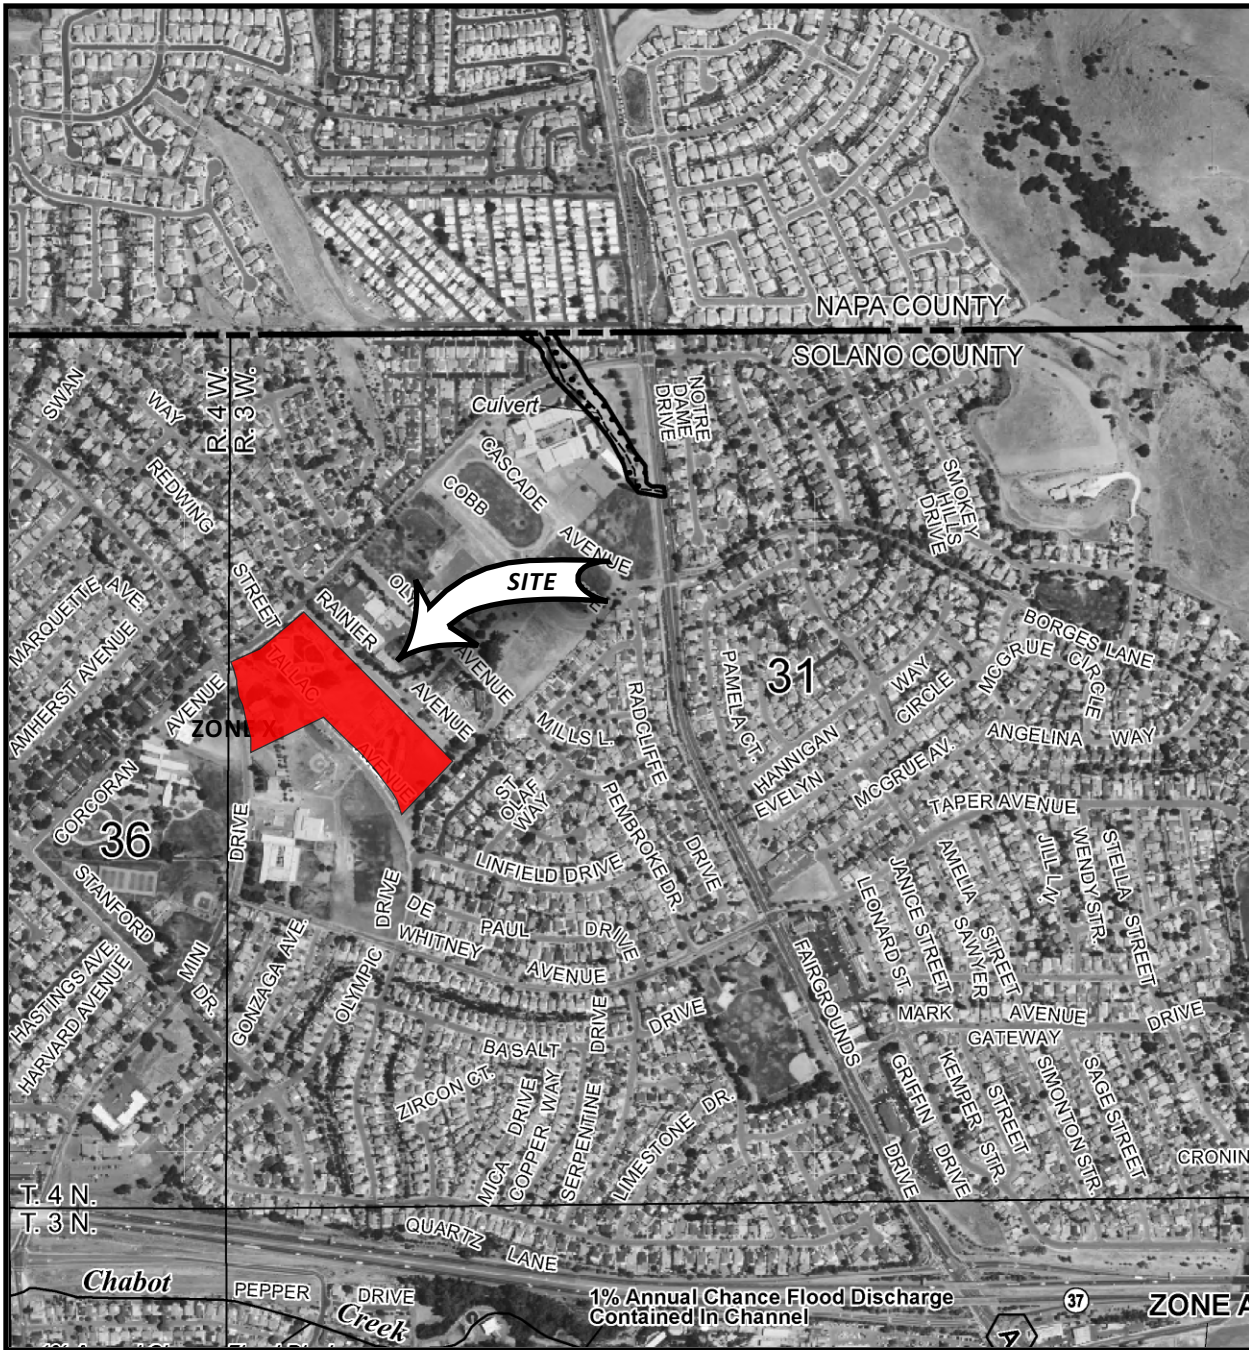
Base: FEMA (2014)

According to Flood Insurance Rate Map, Panel Number 06095C 0440 F, dated June 9, 2014, published by the Federal Emergency Management Agency (FEMA), the site is located within Zone X (stippled). Zone X is defined as: *areas outside the 0.2% annual chance floodplain*. See Figure 10 for details.

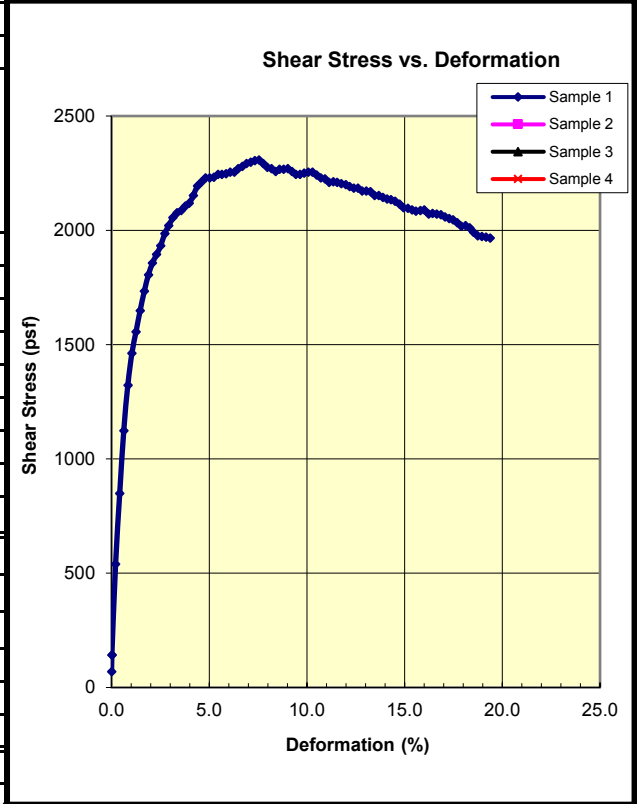
Specimen Data				
	1	2	3	4
Boring:	B10			
Sample:	2			
Depth (ft):	2.0-2.5			
Visual Description:	Yellowish Brown CLAY w/ Sand			
Normal Load (psf)	2500			
Dry Mass of Specimen (g)	131.1			
Initial Height (in)	1.00			
Initial Diameter (in)	2.41			
Initial Void Ratio	0.568			
Initial Moisture (%)	18.3			
Initial Wet Density (pcf)	129.5			
Initial Dry Density (pcf)	109.5			
Initial Saturation (%)	88.6			
$\Delta$ Height Consol (in)	0.0178			
At Test Void Ratio	0.540			
At Test Moisture (%)	19.6			
At Test Wet Density (pcf)	133.3			
At Test Dry Density (pcf)	111.4			
At Test Saturation (%)	99.6			
Strain Rate (%/min)	0.9			
Strengths Picked at	Peak			
Shear Stress (psf)	2308			
$\Delta$ Height (in) at Peak				
Ultimate Stress (psf)

Remarks: \*DS-CU\* A fully undrained condition may not be attained in this test.  $\Delta H$  is not measured during undrained direct shear tests.

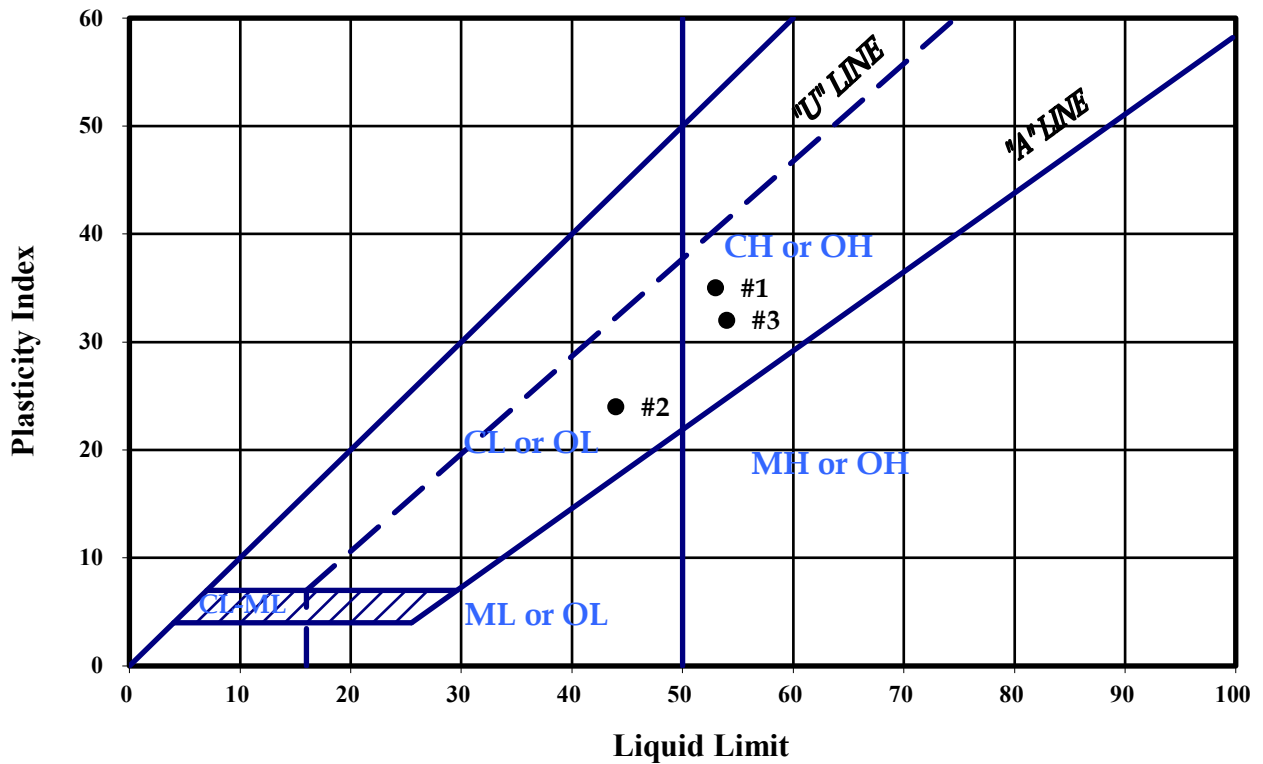
**Plasticity Chart**

Test No.:	1	2	3	4	5
Boring No.:	19-1	Bag B	Bag A		
Sample Depth:	2.5 - 3.0'	0.0 - 2.0'	0.0 - 2.0'		
Liquid Limit:	53	44	54		
Plastic Limit:	18	20	22		
Plasticity Index:	35	24	32
