# Appendix D

Geotechnical Assessments

Subject: Preliminary Geologic Investigation of Proposed  
Residence at #77 Portuguese Bend Road, Rolling  
Hills, California

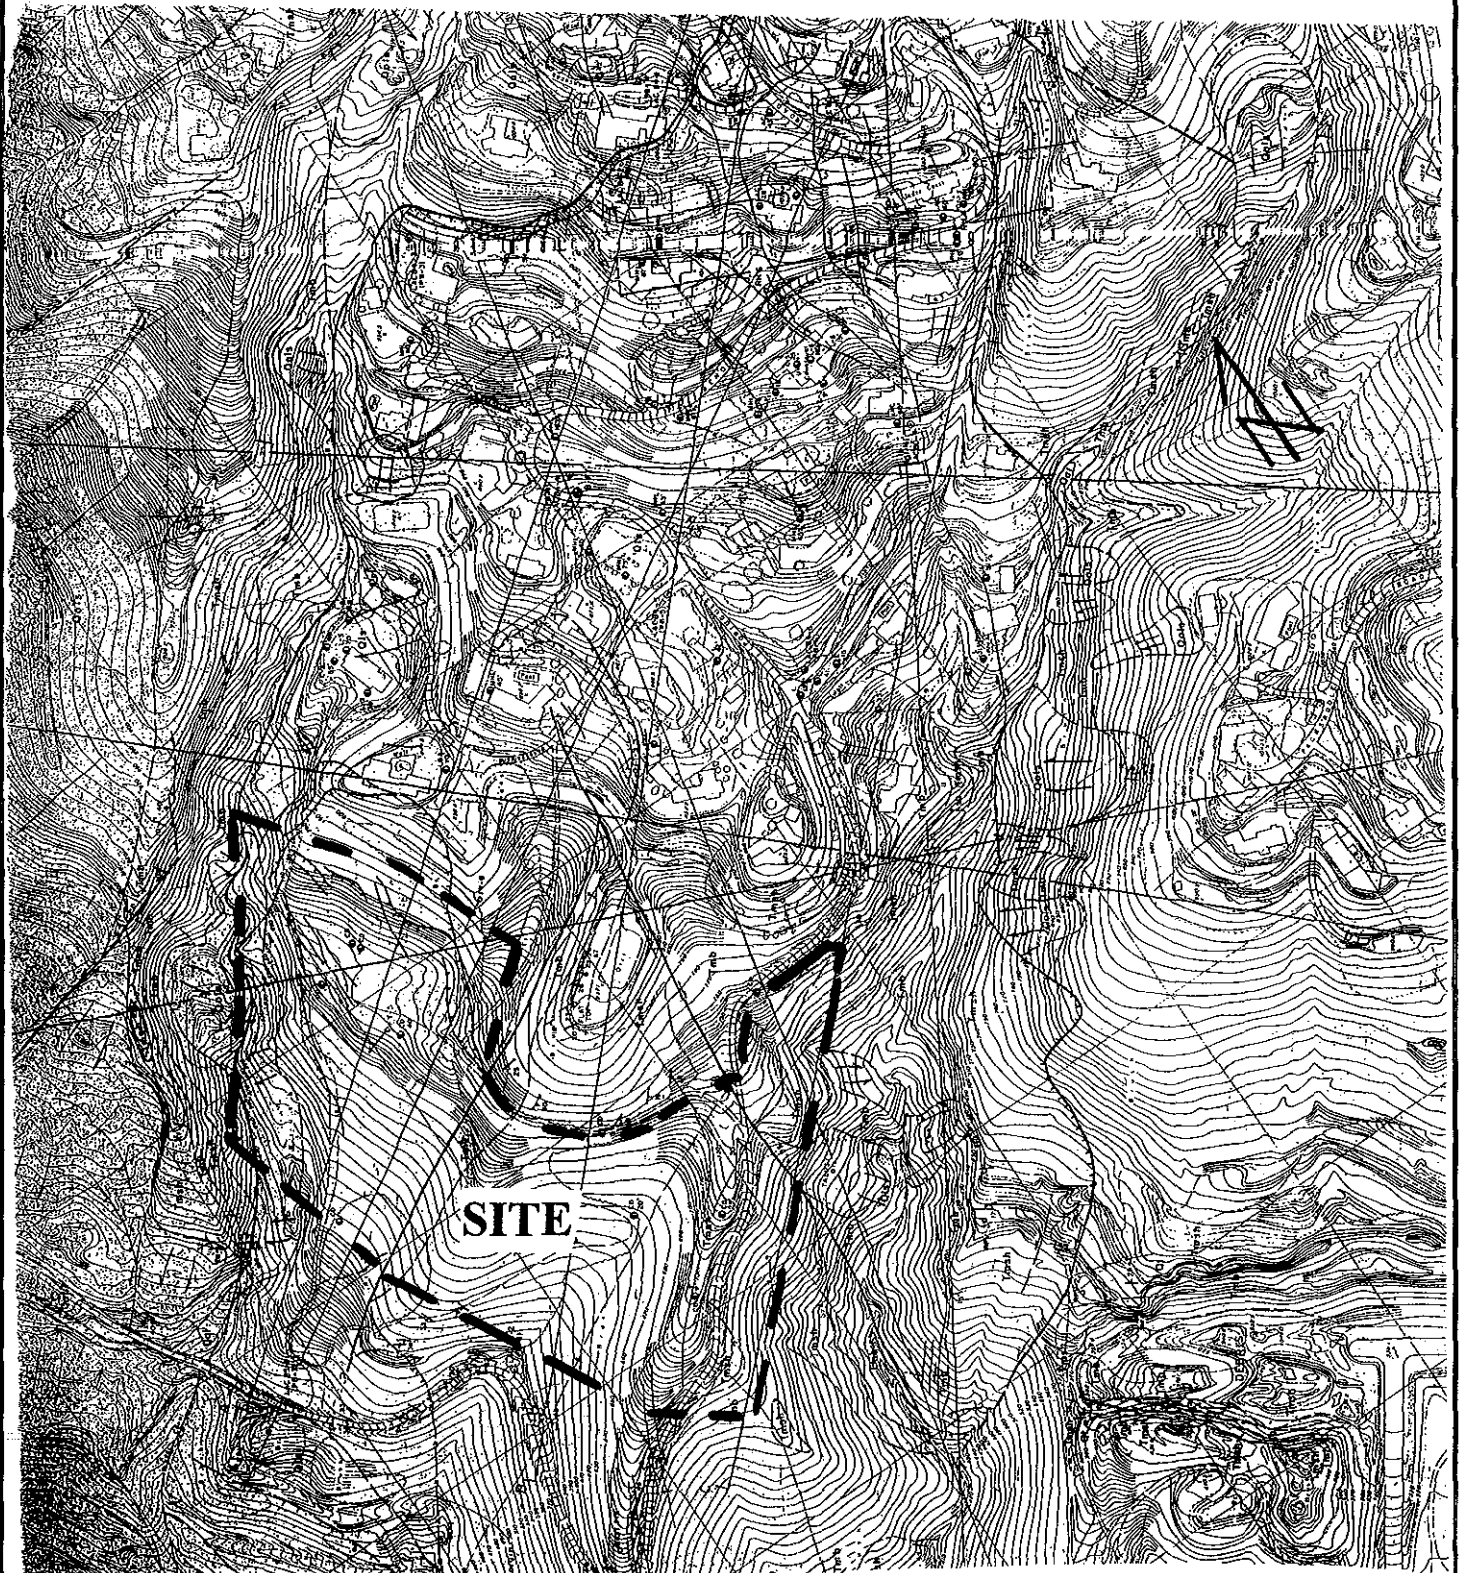
**W.O. 430412      *Figure 3***

Geologic Map of the Flying Triangle Landslide

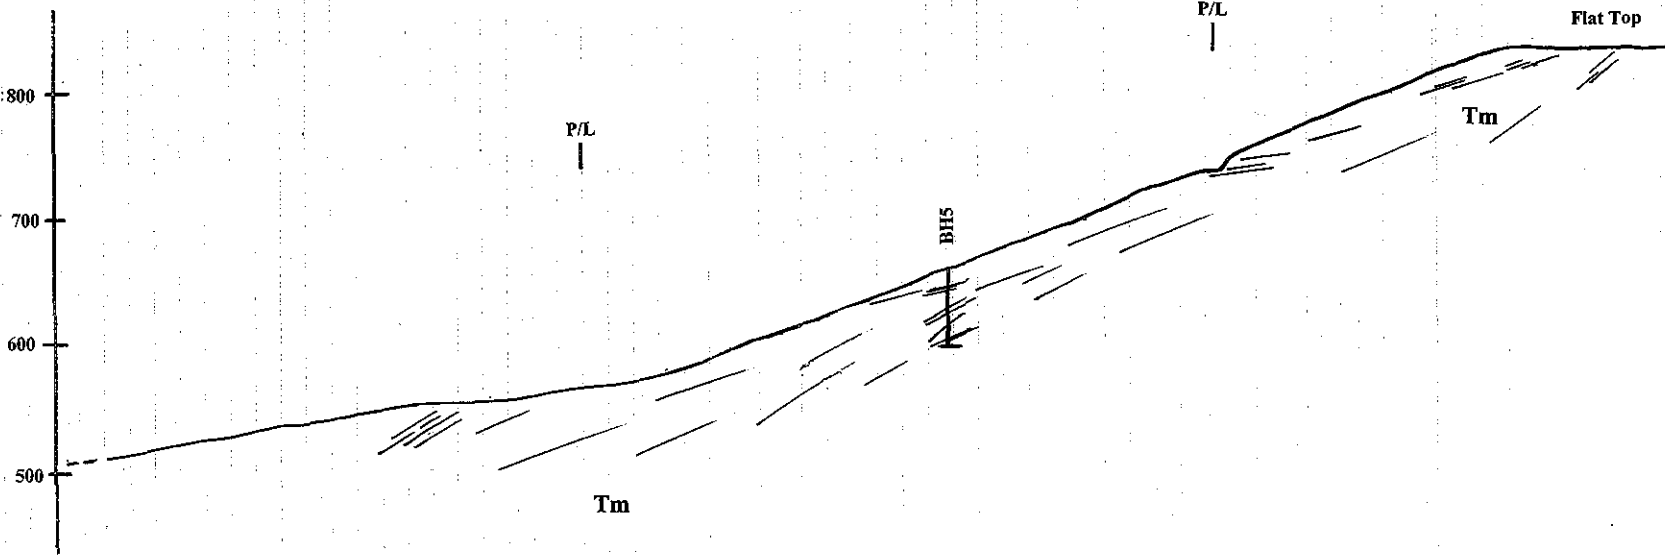
GEOLOGIC SECTION B-B'

Scale 1" ~ 100ft. (H=V)

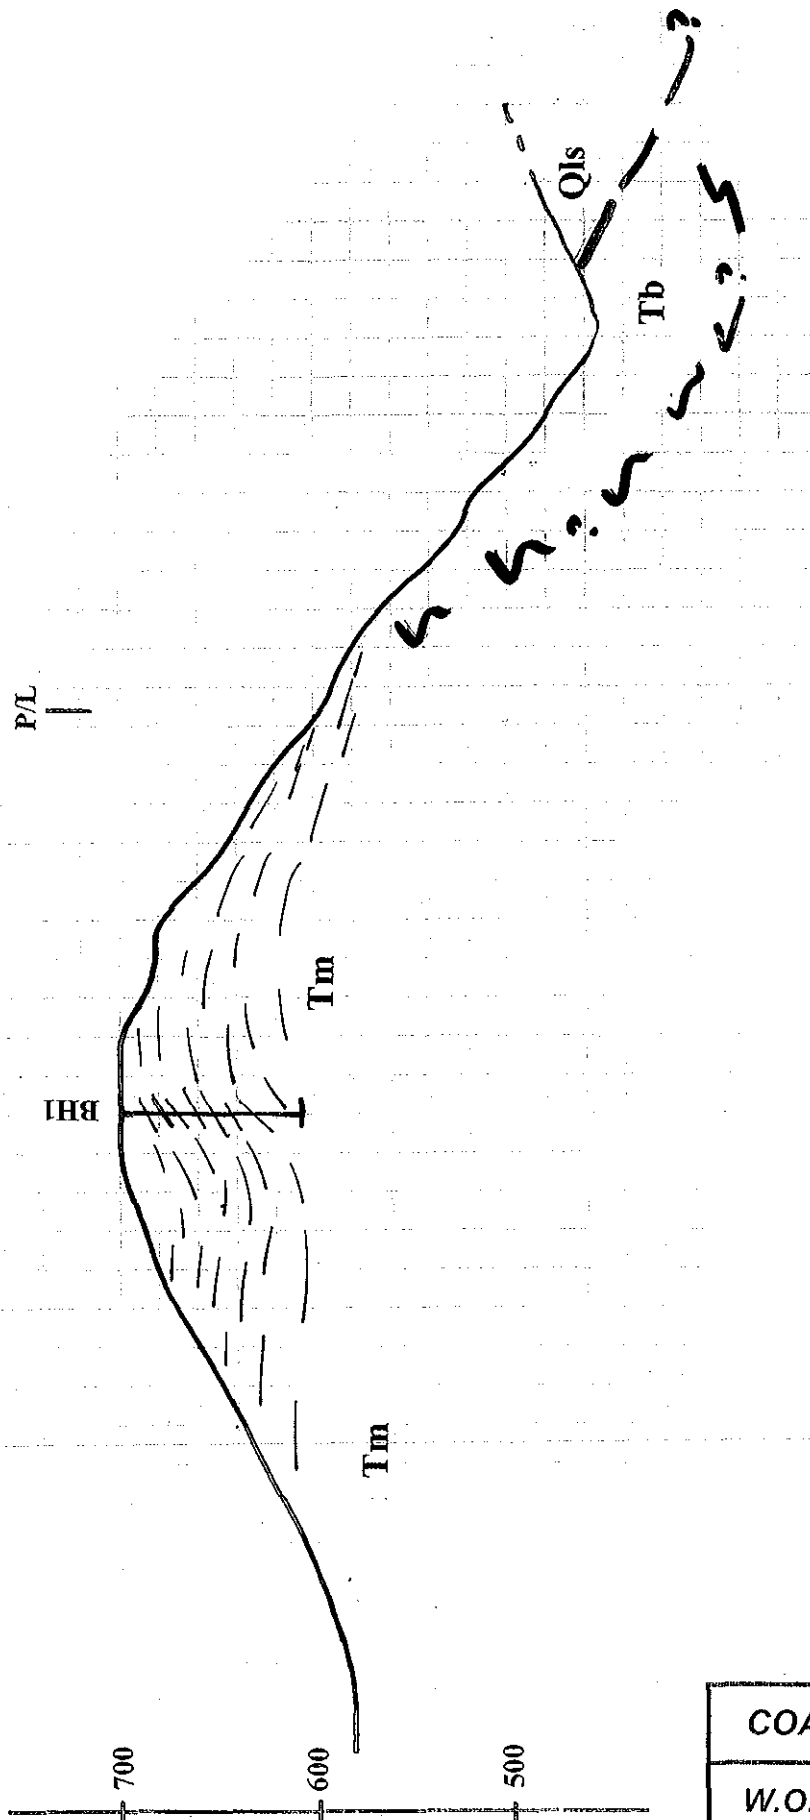
# GEOLOGIC SECTION C-C'

Scale 1" = 100ft. (H=V)

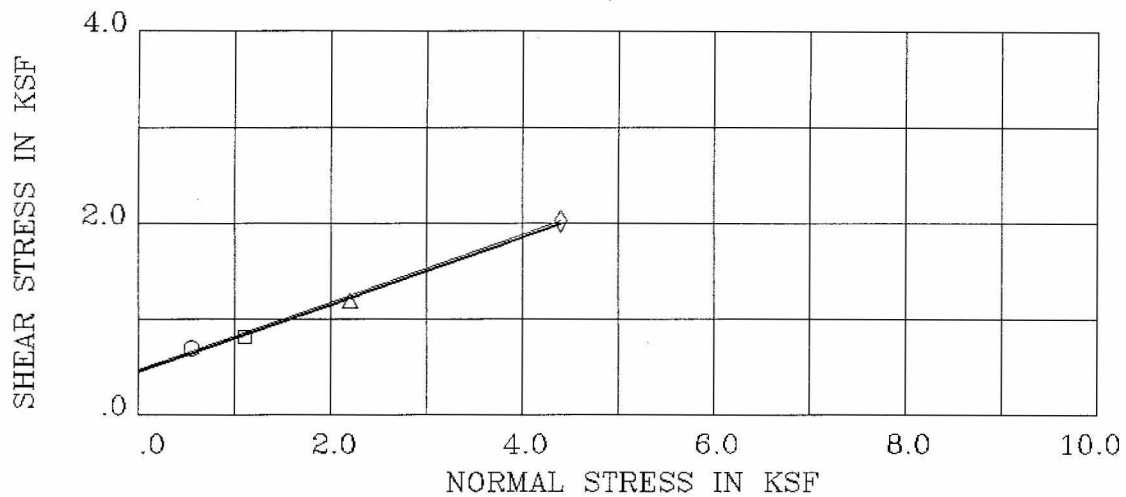
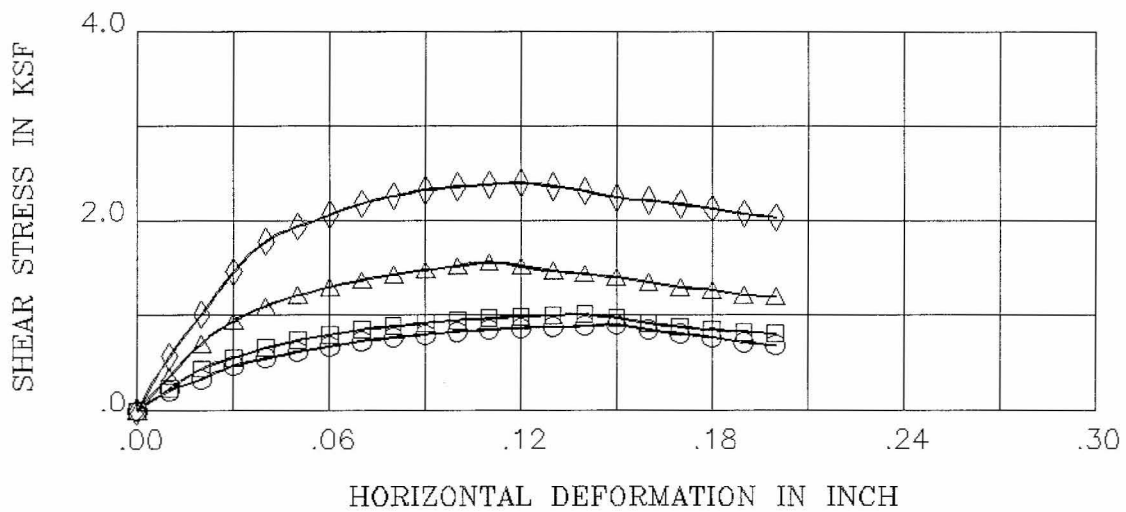
Project 4868-12	Shen - Portuguese Bend Road	
SWN Soiltech Consultants	DIRECT SHEAR TEST	Plate No. C-1

BORING/SAMPLE : B.3/S.1                      DEPTH (ft) : 3  
 DESCRIPTION : Colluvium - sand-silty clay  
 STRENGTH INTERCEPT (C) : .453 KSF  
 FRICTION ANGLE (PHI) : 19.5 DEG                      (RESIDUAL STRENGTH)

SYMBOL	MOISTURE CONTENT (%)	DRY DENSITY (pcf)	VOID RATIO	NORMAL STRESS (ksf)	PEAK SHEAR (ksf)	RESIDUAL SHEAR (ksf)
○	28.9	94.7	.811	.55	.90	.69
□	28.9	94.7	.811	1.10	1.01	.81
△	28.9	94.7	.811	2.20	1.55	1.20
◇	28.9	94.7	.811	4.40	2.39	2.03

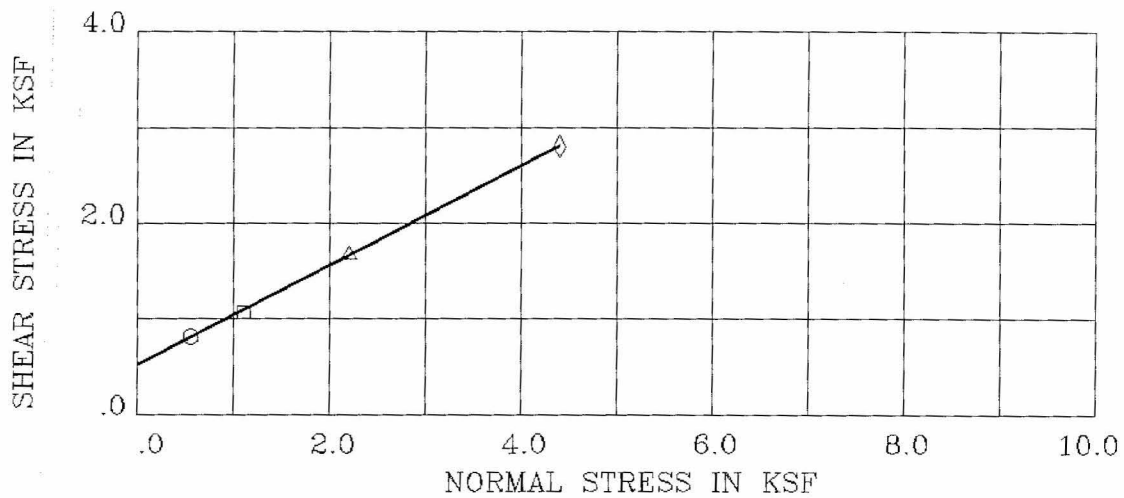
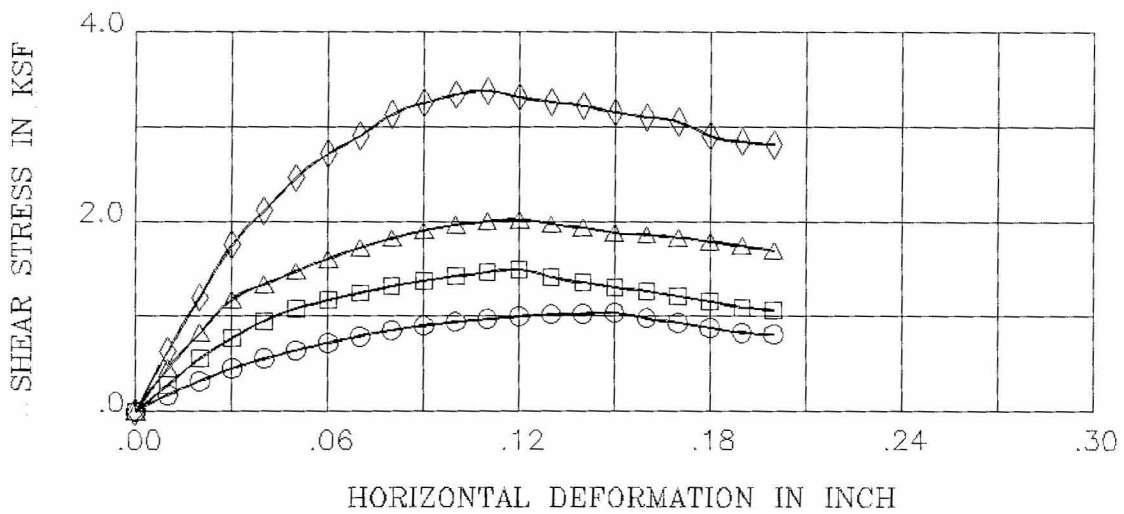
Project 4868-12	Shen - Portuguese Bend Road	
SWN Soiltech Consultants	DIRECT SHEAR TEST	Plate No. C-2

BORING/SAMPLE : B.1/S.1                      DEPTH (ft) : 5  
 DESCRIPTION : Terrace - silty-clayey sand  
 STRENGTH INTERCEPT (C) : .518 KSF  
 FRICTION ANGLE (PHI) : 27.6 DEG                      (RESIDUAL STRENGTH)

SYMBOL	MOISTURE CONTENT (%)	DRY DENSITY (pcf)	VOID RATIO	NORMAL STRESS (ksf)	PEAK SHEAR (ksf)	RESIDUAL SHEAR (ksf)
○	28.6	95.4	.799	.55	1.04	.81
□	28.6	95.4	.799	1.10	1.50	1.07
△	28.6	95.4	.799	2.20	2.02	1.69
◇	28.6	95.4	.799	4.40	3.37	2.81

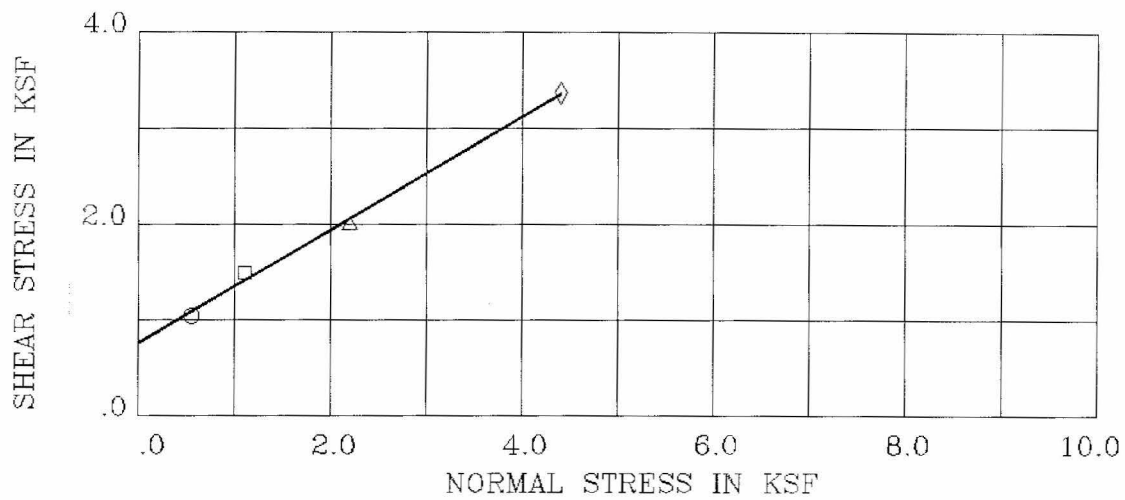
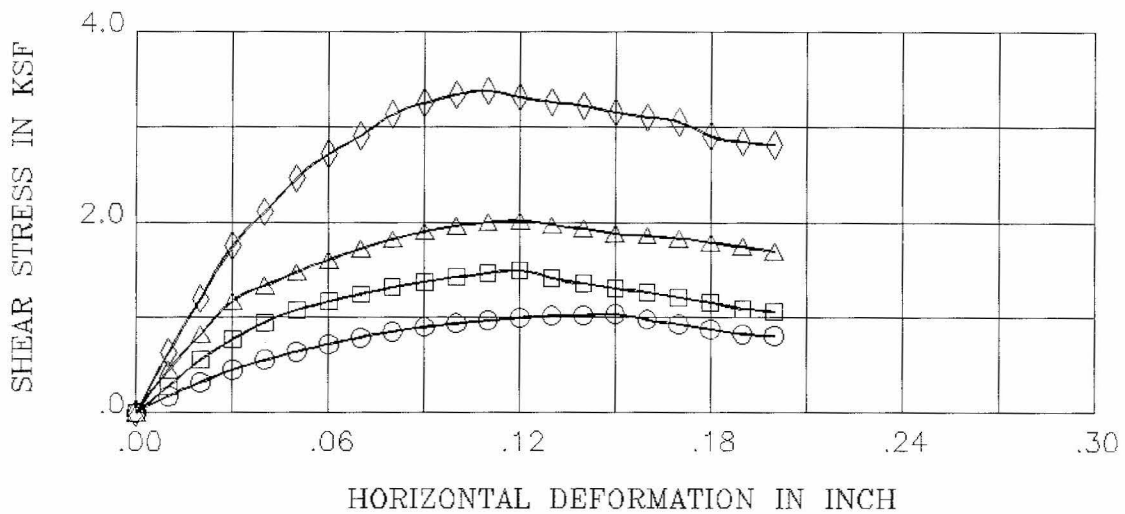
Plate No. C-3

BORING/SAMPLE : B.1/S.1                      DEPTH (ft) : 5  
 DESCRIPTION : Terrace - silty-clayey sand  
 STRENGTH INTERCEPT (C) : .761 KSF  
 FRICTION ANGLE (PHI) : 30.6 DEG                      (PEAK STRENGTH)

SYMBOL	MOISTURE CONTENT (%)	DRY DENSITY (pcf)	VOID RATIO	NORMAL STRESS (ksf)	PEAK SHEAR (ksf)	RESIDUAL SHEAR (ksf)
○	28.6	95.4	.799	.55	1.04	.81
□	28.6	95.4	.799	1.10	1.50	1.07
△	28.6	95.4	.799	2.20	2.02	1.69
◇	28.6	95.4	.799	4.40	3.37	2.81

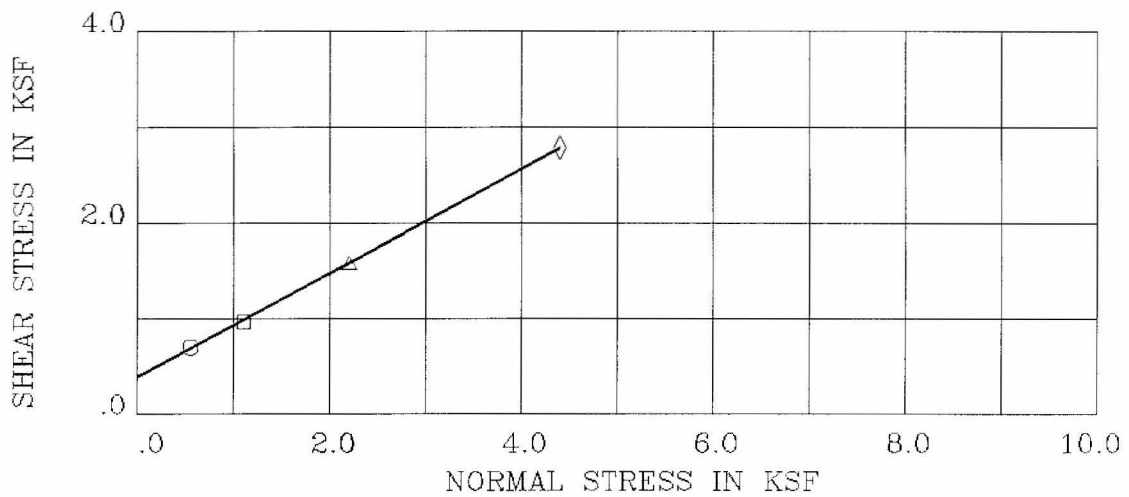
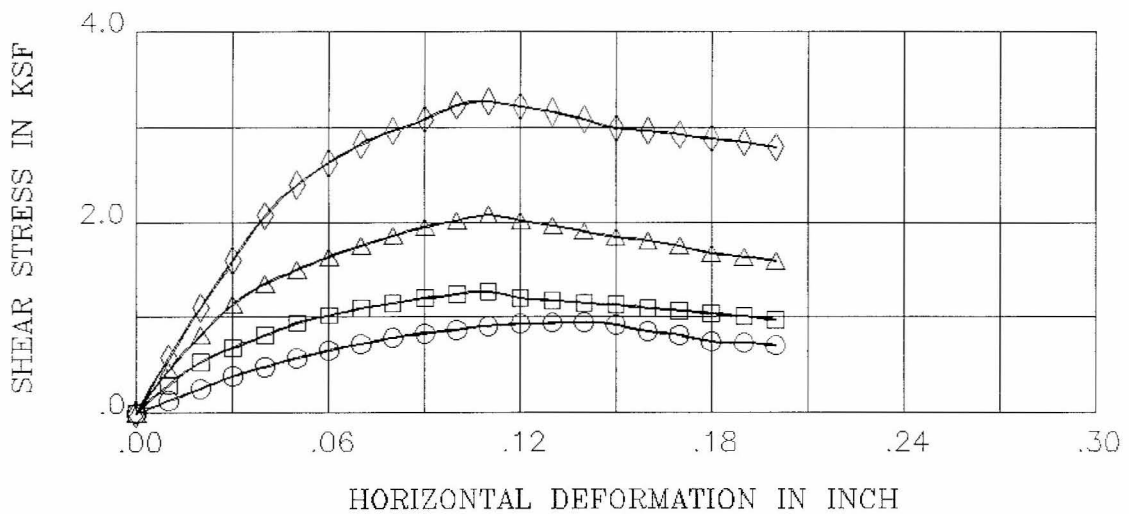
Project 4868-12	Shen - Portuguese Bend Road
SWN Soiltech Consultants	<b>DIRECT SHEAR TEST</b> Plate No. C-4

BORING/SAMPLE : B.1/S.3                      DEPTH (ft) : 20  
 DESCRIPTION : Terrace - silty-clayey sand  
 STRENGTH INTERCEPT (C) : .388      KSF  
 FRICTION ANGLE (PHI) : 28.6      DEG                      (RESIDUAL STRENGTH)

SYMBOL	MOISTURE CONTENT (%)	DRY DENSITY (pcf)	VOID RATIO	NORMAL STRESS (ksf)	PEAK SHEAR (ksf)	RESIDUAL SHEAR (ksf)
○	29.2	93.7	.831	.55	.95	.70
□	29.2	93.7	.831	1.10	1.27	.97
△	29.2	93.7	.831	2.20	2.08	1.59
◇	29.2	93.7	.831	4.40	3.27	2.79

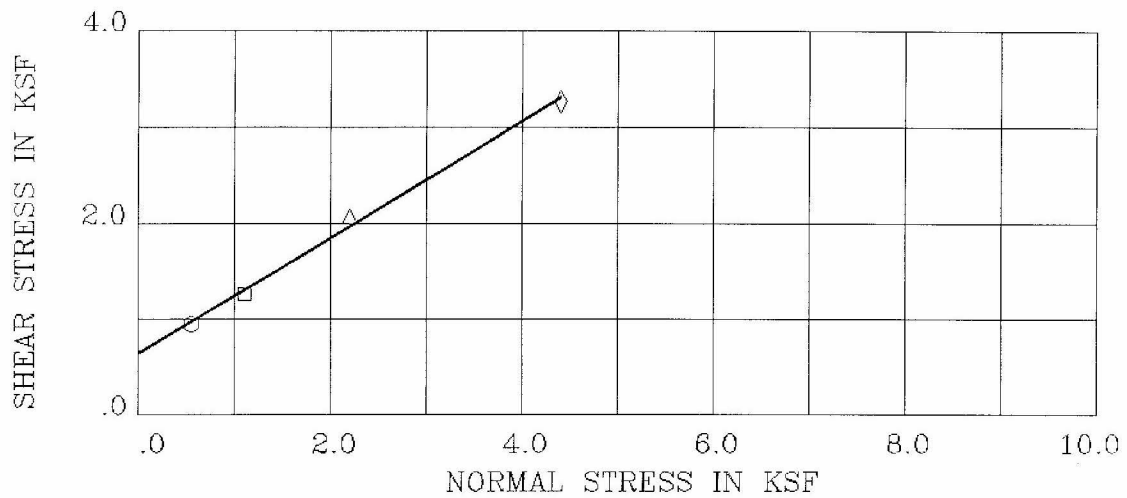
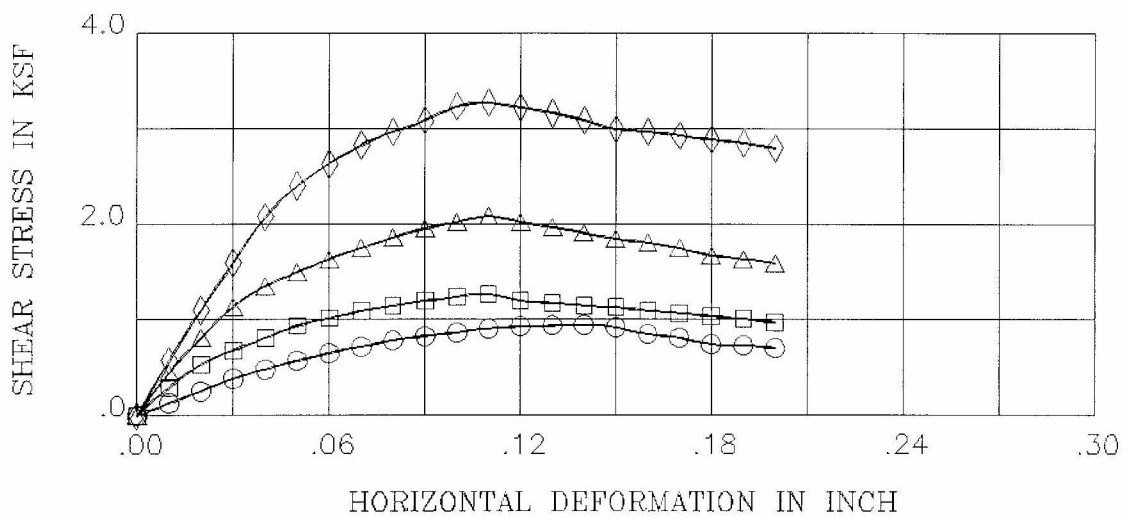
Project 4868-12	Shen - Portuguese Bend Road
SWN Soiltech Consultants	<b>DIRECT SHEAR TEST</b> Plate No. C-5

BORING/SAMPLE : B.1/S.3                      DEPTH (ft) : 20  
 DESCRIPTION : Terrace - silty-clayey sand  
 STRENGTH INTERCEPT (C) : .642 KSF  
 FRICTION ANGLE (PHI) : 31.2 DEG                      (PEAK STRENGTH)

SYMBOL	MOISTURE CONTENT (%)	DRY DENSITY (pcf)	VOID RATIO	NORMAL STRESS (ksf)	PEAK SHEAR (ksf)	RESIDUAL SHEAR (ksf)
○	29.2	93.7	.831	.55	.95	.70
□	29.2	93.7	.831	1.10	1.27	.97
△	29.2	93.7	.831	2.20	2.08	1.59
◇	29.2	93.7	.831	4.40	3.27	2.79

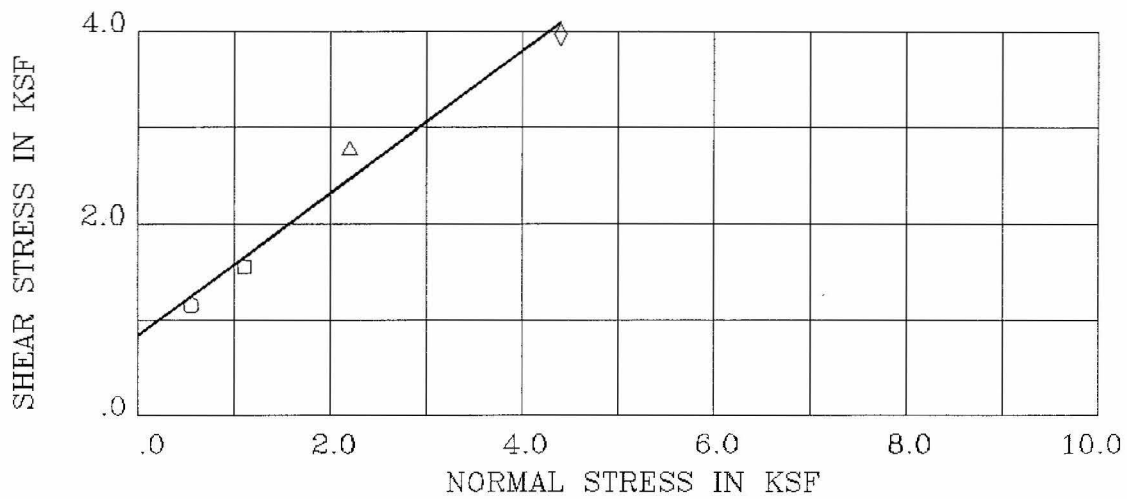
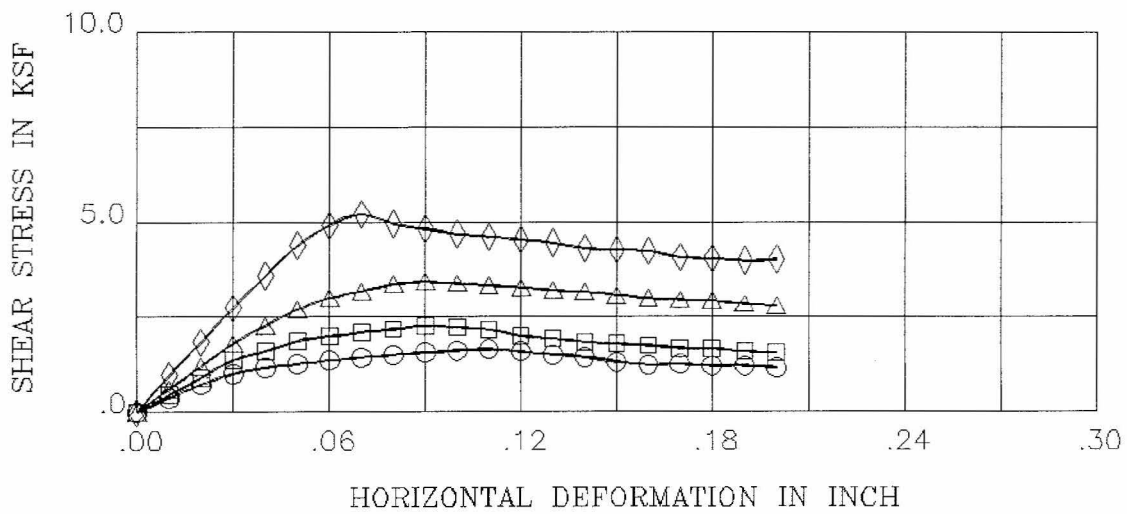
Project 4868-12	Shen - Portuguese Bend Road	
SWN Soiltech Consultants	DIRECT SHEAR TEST	Plate No. C-6

BORING/SAMPLE : B.1/S.8                      DEPTH (ft) : 75  
 DESCRIPTION : Bedrock - siltstone  
 STRENGTH INTERCEPT (C) : .849      KSF  
 FRICTION ANGLE (PHI) : 36.4      DEG                      (RESIDUAL STRENGTH)

SYMBOL	MOISTURE CONTENT (%)	DRY DENSITY (pcf)	VOID RATIO	NORMAL STRESS (ksf)	PEAK SHEAR (ksf)	RESIDUAL SHEAR (ksf)
○	40.6	80.3	1.138	.55	1.65	1.16
□	40.6	80.3	1.138	1.10	2.27	1.56
△	40.6	80.3	1.138	2.20	3.42	2.79
◇	40.6	80.3	1.138	4.40	5.20	3.98

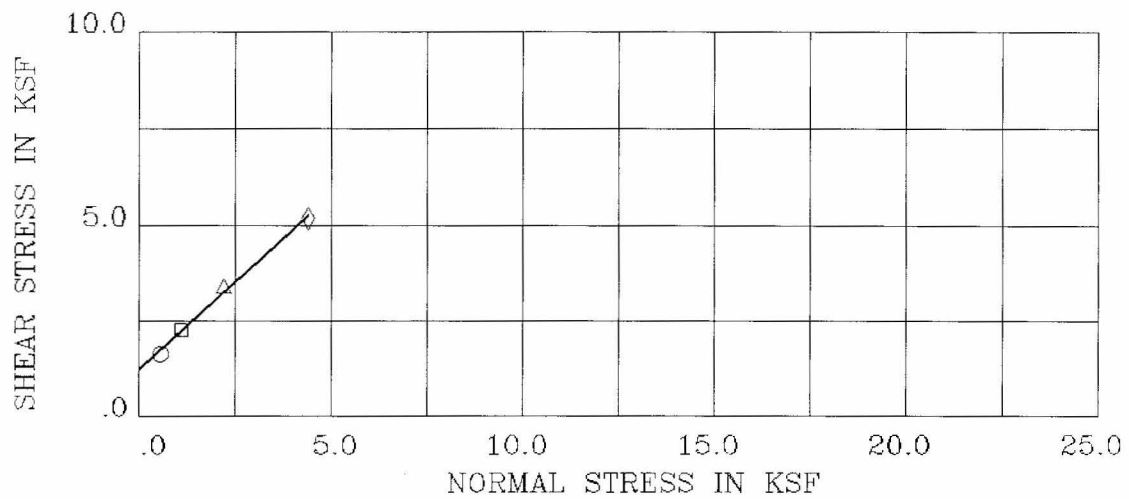
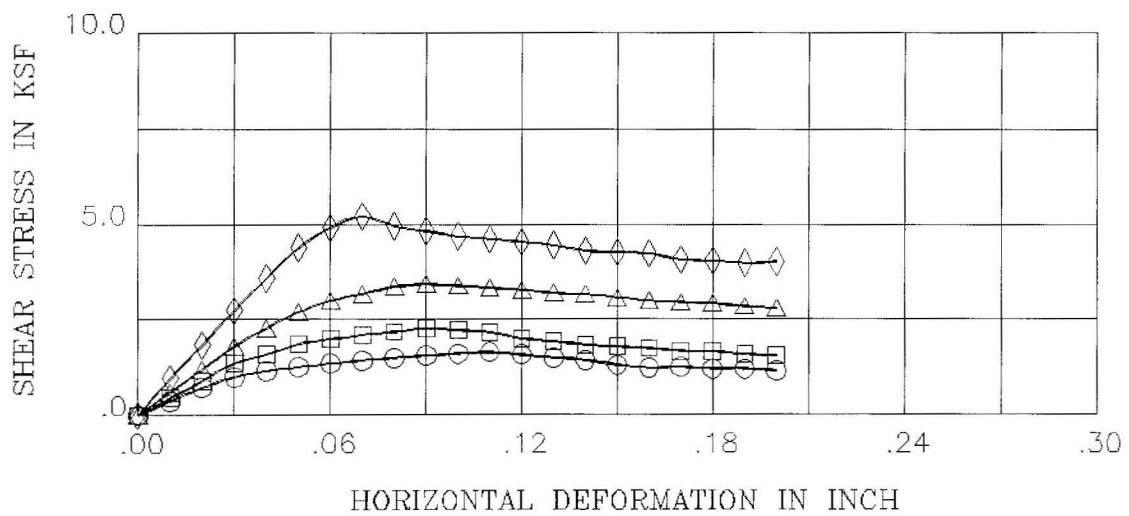
Project 4868-12	Shen - Portuguese Bend Road	
SWN Soiltech Consultants	DIRECT SHEAR TEST	Plate No. C-7

BORING/SAMPLE : B.1/S.8                      DEPTH (ft) : 75  
 DESCRIPTION : Bedrock - siltstone  
 STRENGTH INTERCEPT (C) : 1.250      KSF  
 FRICTION ANGLE (PHI) : 42.5      DEG                      (PEAK STRENGTH)

SYMBOL	MOISTURE CONTENT (%)	DRY DENSITY (pcf)	VOID RATIO	NORMAL STRESS (ksf)	PEAK SHEAR (ksf)	RESIDUAL SHEAR (ksf)
○	40.6	80.3	1.138	.55	1.65	1.16
□	40.6	80.3	1.138	1.10	2.27	1.56
△	40.6	80.3	1.138	2.20	3.42	2.79
◇	40.6	80.3	1.138	4.40	5.20	3.98

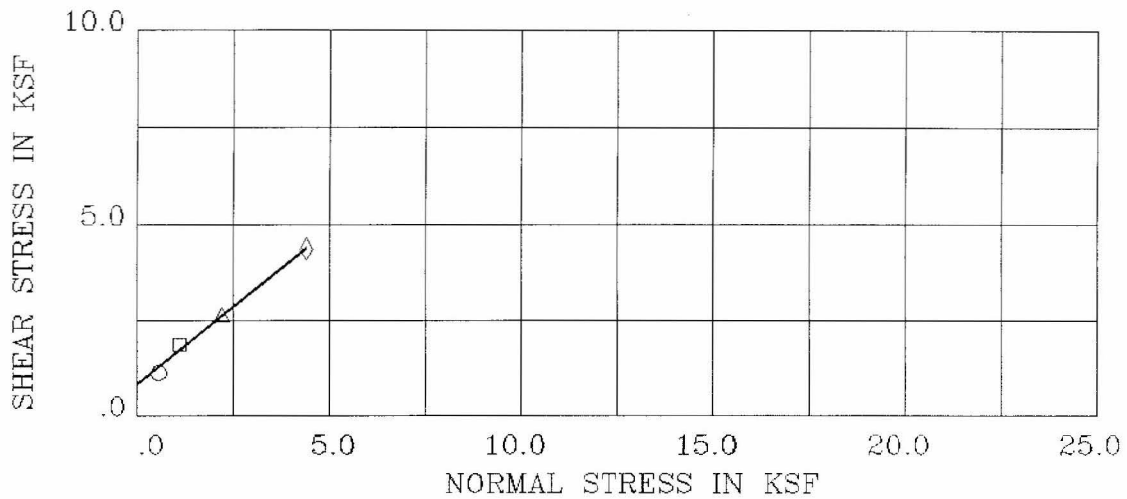
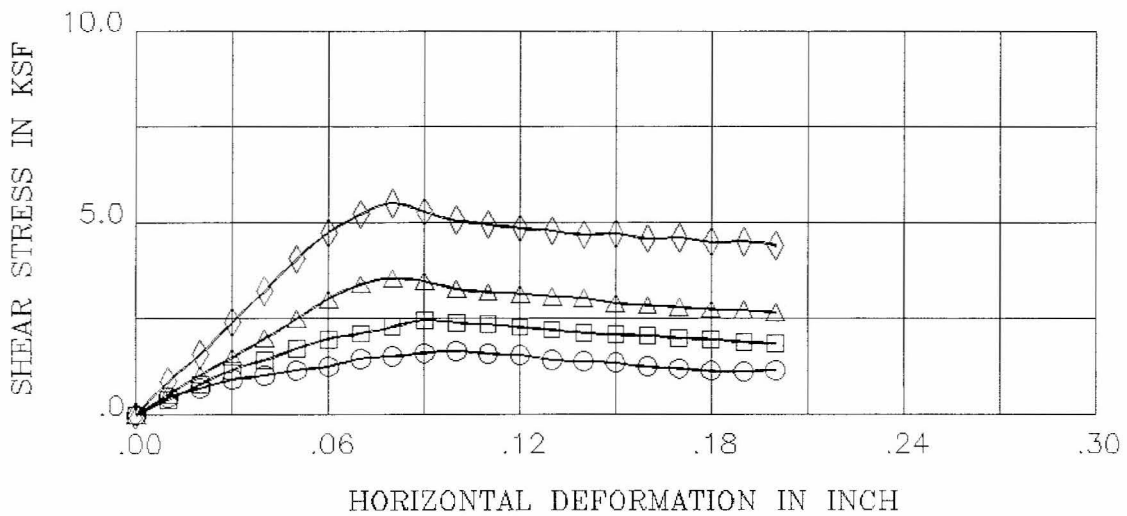
Project 4868-12	Shen - Portuguese Bend Road	
SWN Soiltech Consultants	DIRECT SHEAR TEST	Plate No. C-8

BORING/SAMPLE : B.4/S.4                      DEPTH (ft) : 21  
 DESCRIPTION : Bedrock - siltstone  
 STRENGTH INTERCEPT (C) : .830      KSF                      (RESIDUAL STRENGTH)  
 FRICTION ANGLE (PHI) : 39.2      DEG

SYMBOL	MOISTURE CONTENT (%)	DRY DENSITY (pcf)	VOID RATIO	NORMAL STRESS (ksf)	PEAK SHEAR (ksf)	RESIDUAL SHEAR (ksf)
○	26.6	97.3	.763	.55	1.67	1.13
□	26.6	97.3	.763	1.10	2.46	1.87
△	26.6	97.3	.763	2.20	3.54	2.66
◇	26.6	97.3	.763	4.40	5.49	4.38

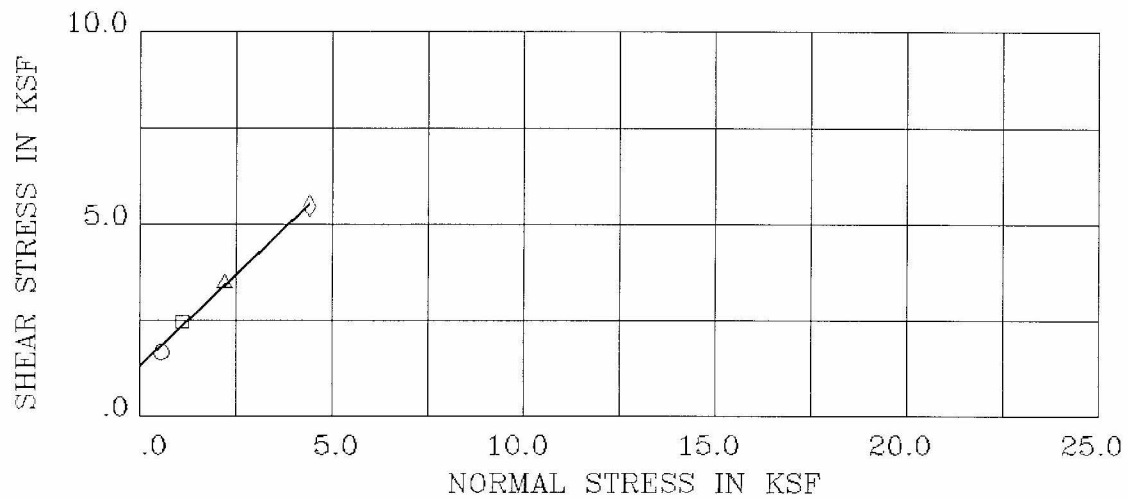
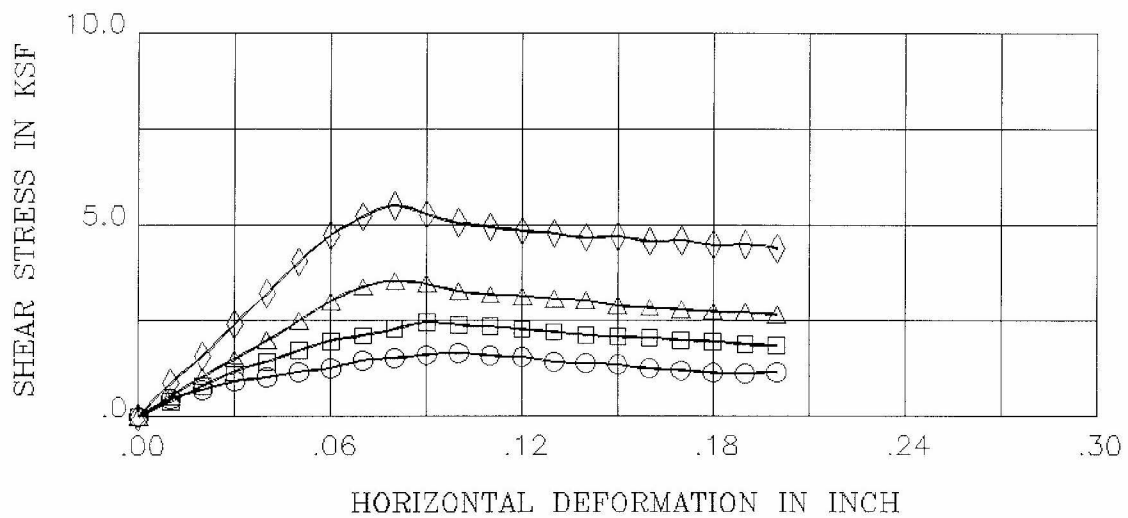
Project 4868-12	Shen - Portuguese Bend Road	
SWN Soiltech Consultants	DIRECT SHEAR TEST	Plate No. C-9

BORING/SAMPLE : B.4/S.4                      DEPTH (ft) : 21  
 DESCRIPTION : Bedrock - siltstone  
 STRENGTH INTERCEPT (C) : 1.295      KSF  
 FRICTION ANGLE (PHI) : 44.1      DEG                      (PEAK STRENGTH)

SYMBOL	MOISTURE CONTENT (%)	DRY DENSITY (pcf)	VOID RATIO	NORMAL STRESS (ksf)	PEAK SHEAR (ksf)	RESIDUAL SHEAR (ksf)
○	26.6	97.3	.763	.55	1.67	1.13
□	26.6	97.3	.763	1.10	2.46	1.87
△	26.6	97.3	.763	2.20	3.54	2.66
◇	26.6	97.3	.763	4.40	5.49	4.38

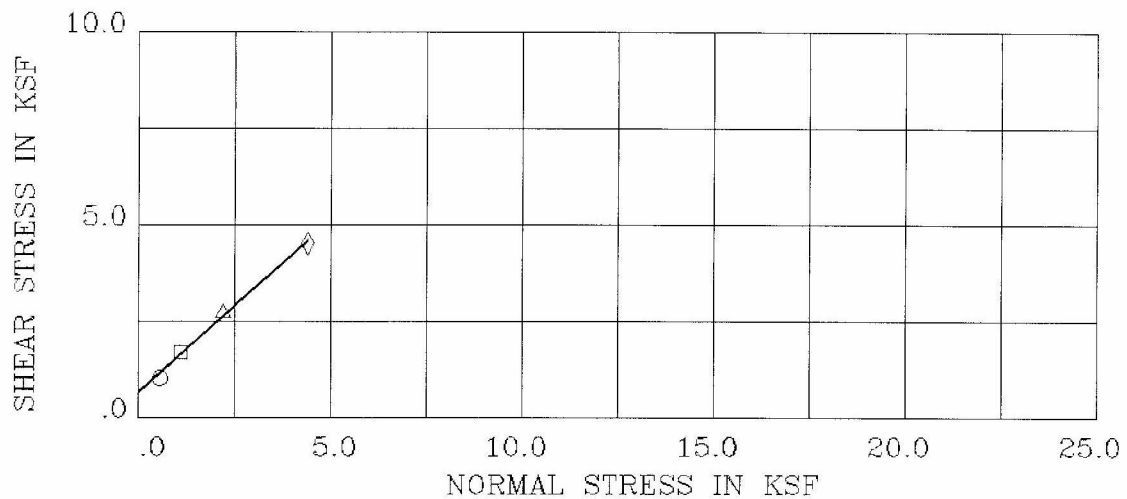
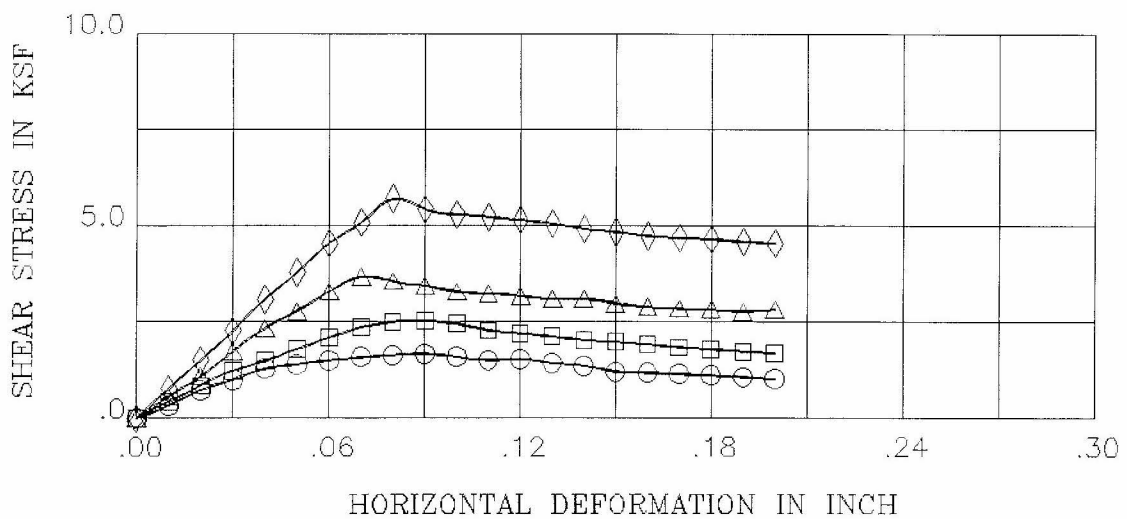
Project 4868-12	Shen - Portuguese Bend Road	
SWN Soiltech Consultants	DIRECT SHEAR TEST	Plate No. C-10

BORING/SAMPLE : B.2/S.7                      DEPTH (ft) : 50  
 DESCRIPTION : Bedrock - basalt  
 STRENGTH INTERCEPT (C) : .666      KSF  
 FRICTION ANGLE (PHI) : 41.8      DEG                      (RESIDUAL STRENGTH)

SYMBOL	MOISTURE CONTENT (%)	DRY DENSITY (pcf)	VOID RATIO	NORMAL STRESS (ksf)	PEAK SHEAR (ksf)	RESIDUAL SHEAR (ksf)
○	23.4	103.2	.663	.55	1.68	1.03
□	23.4	103.2	.663	1.10	2.54	1.70
△	23.4	103.2	.663	2.20	3.68	2.78
◇	23.4	103.2	.663	4.40	5.68	4.53

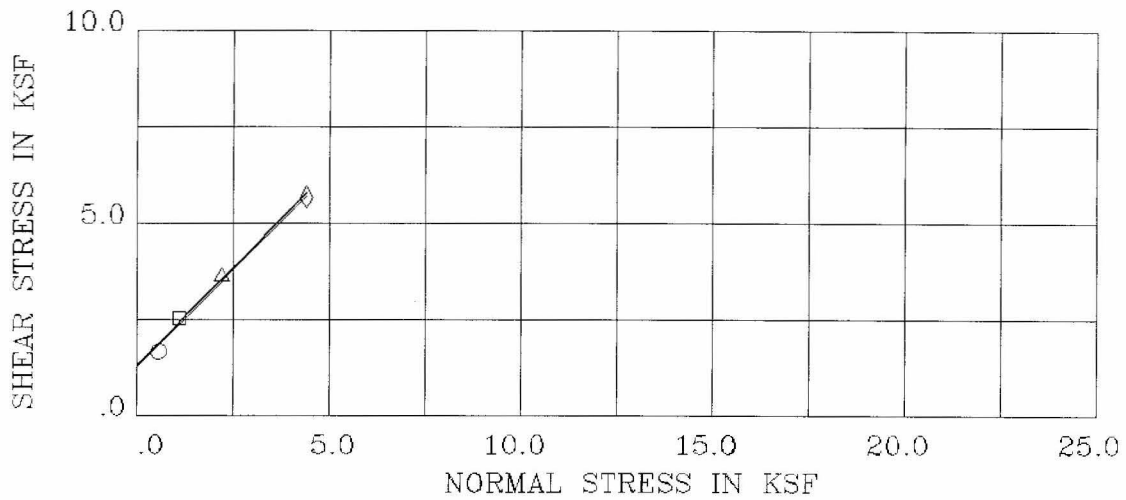
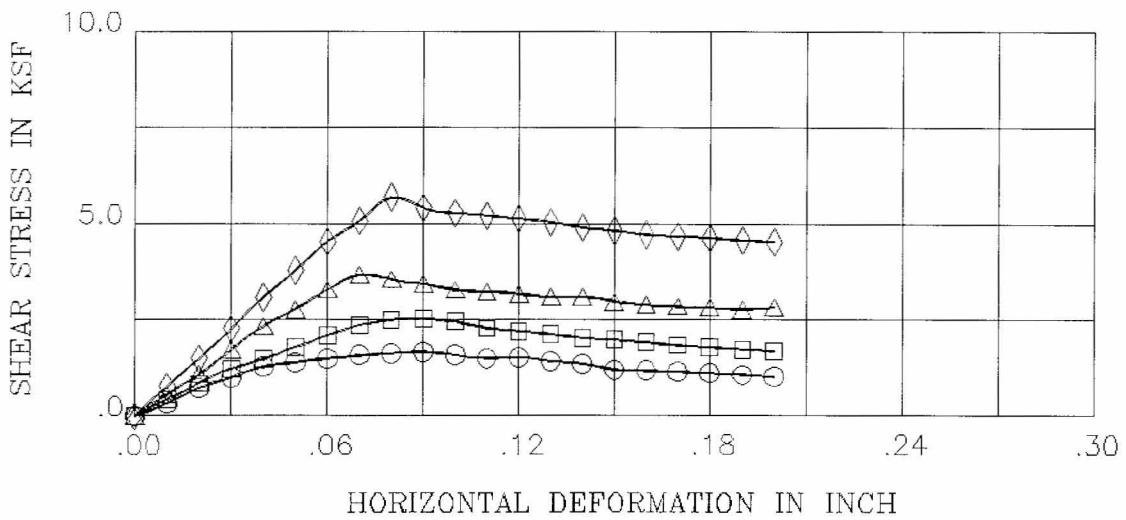
Project 4868-12	Shen - Portuguese Bend Road	
SWN Soiltech Consultants	DIRECT SHEAR TEST	Plate No. C-11

BORING/SAMPLE : B.2/S.7                      DEPTH (ft) : 50  
 DESCRIPTION : Bedrock - basalt  
 STRENGTH INTERCEPT (C) : 1.307      KSF                      (PEAK STRENGTH)  
 FRICTION ANGLE (PHI) : 45.3              DEG

SYMBOL	MOISTURE CONTENT (%)	DRY DENSITY (pcf)	VOID RATIO	NORMAL STRESS (ksf)	PEAK SHEAR (ksf)	RESIDUAL SHEAR (ksf)
O	23.4	103.2	.663	.55	1.68	1.03
□	23.4	103.2	.663	1.10	2.54	1.70
△	23.4	103.2	.663	2.20	3.68	2.78
◇	23.4	103.2	.663	4.40	5.68	4.53

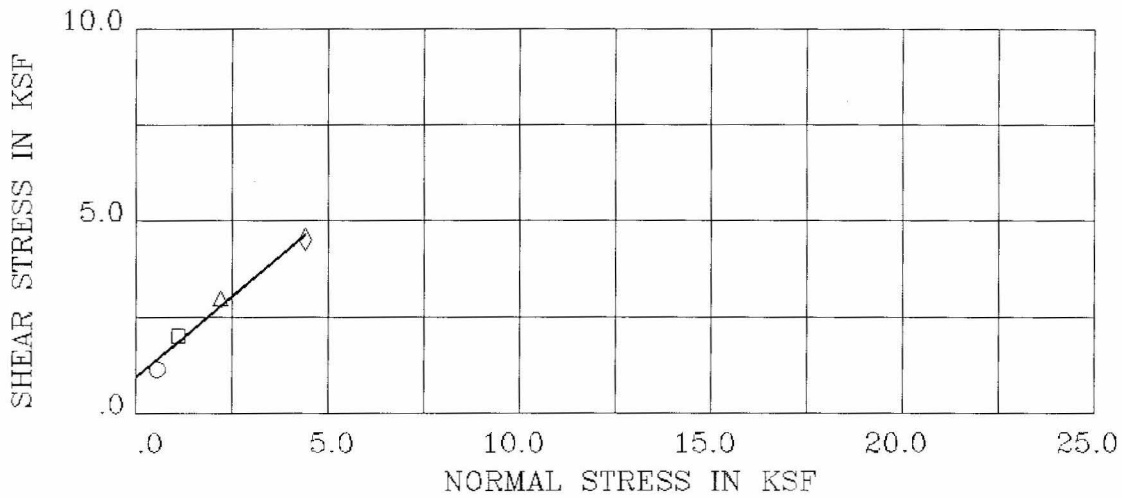
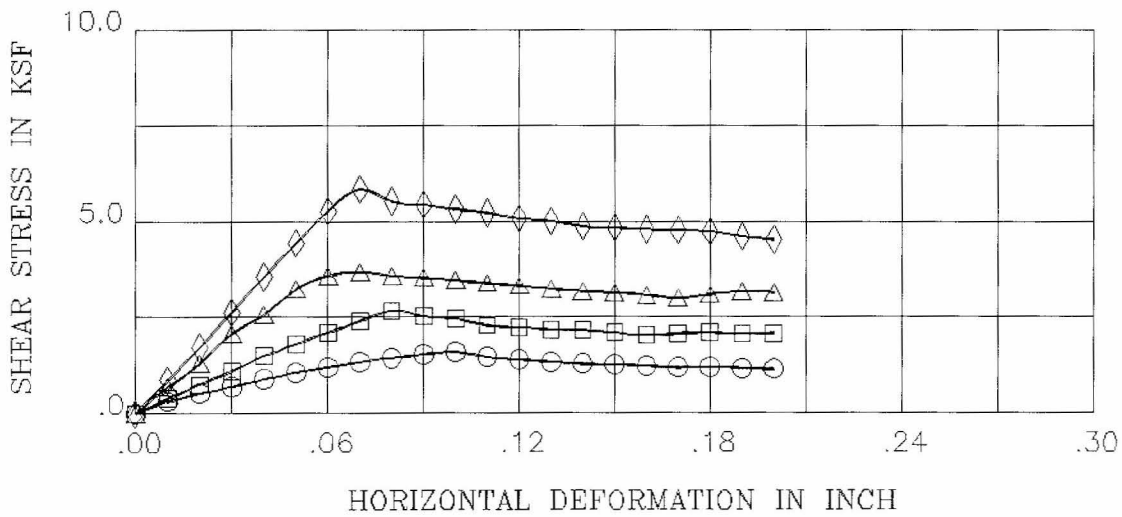
Project 4868-12	Shen - Portuguese Bend Road	
SWN Soiltech Consultants	DIRECT SHEAR TEST	Plate No. C-12

BORING/SAMPLE : B.3/S.10      DEPTH (ft) : 95  
 DESCRIPTION : Bedrock - basalt  
 STRENGTH INTERCEPT (C) : .937      KSF  
 FRICTION ANGLE (PHI) : 40.0      DEG      (RESIDUAL STRENGTH)

SYMBOL	MOISTURE CONTENT (%)	DRY DENSITY (pcf)	VOID RATIO	NORMAL STRESS (ksf)	PEAK SHEAR (ksf)	RESIDUAL SHEAR (ksf)
○	19.4	110.8	.549	.55	1.59	1.15
□	19.4	110.8	.549	1.10	2.66	2.02
△	19.4	110.8	.549	2.20	3.68	2.99
◇	19.4	110.8	.549	4.40	5.83	4.52

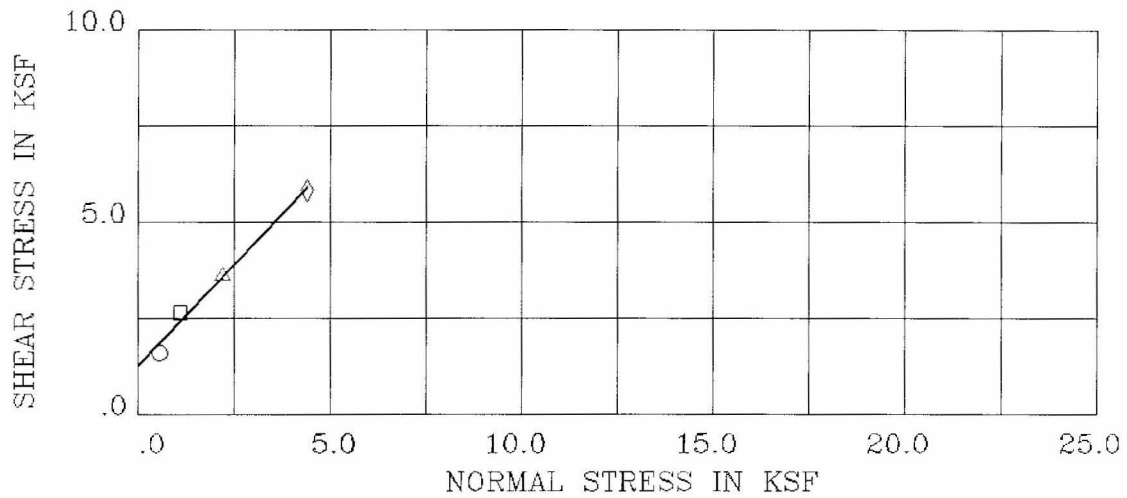
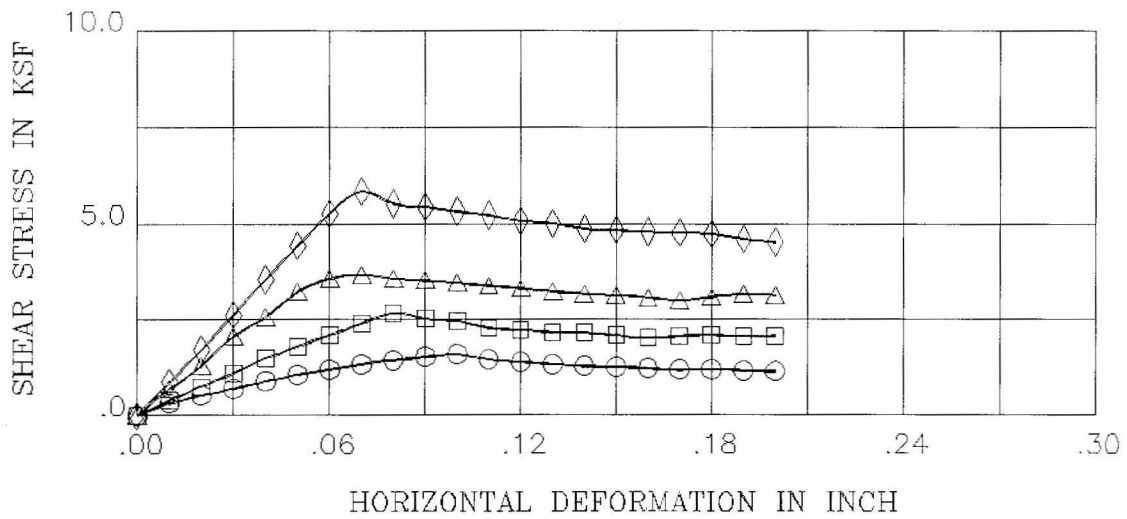
Project 4868-12	Shen - Portuguese Bend Road
SWN Soiltech Consultants	<b>DIRECT SHEAR TEST</b> Plate No. C-13

BORING/SAMPLE : B.3/S.10      DEPTH (ft) : 95  
 DESCRIPTION : Bedrock - basalt  
 STRENGTH INTERCEPT (C) : 1.269      KSF      (PEAK STRENGTH)  
 FRICTION ANGLE (PHI) : 46.5      DEG

SYMBOL	MOISTURE CONTENT (%)	DRY DENSITY (pcf)	VOID RATIO	NORMAL STRESS (ksf)	PEAK SHEAR (ksf)	RESIDUAL SHEAR (ksf)
○	19.4	110.8	.549	.55	1.59	1.15
□	19.4	110.8	.549	1.10	2.66	2.02
△	19.4	110.8	.549	2.20	3.68	2.99
◇	19.4	110.8	.549	4.40	5.83	4.52

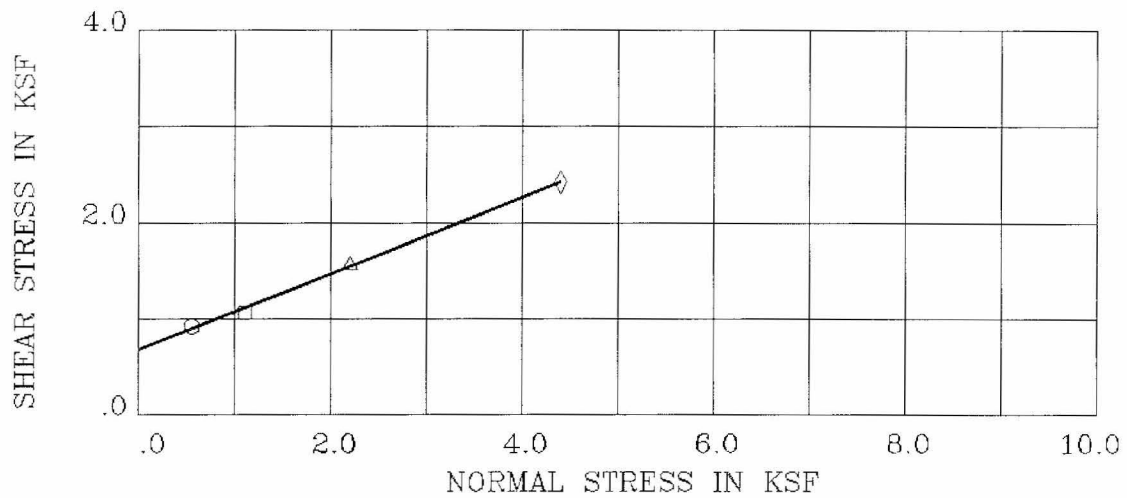
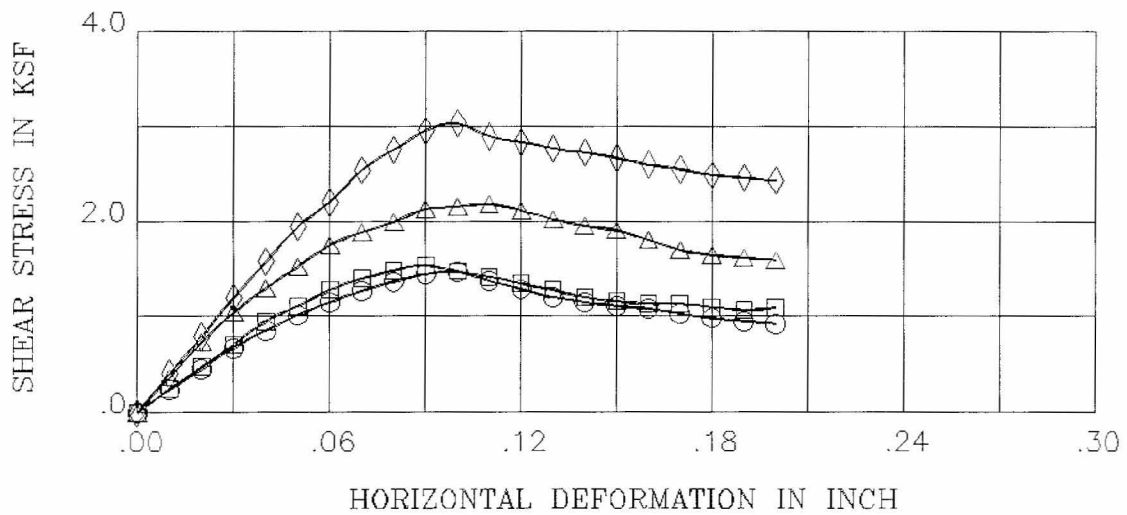
Project 4868-12	Shen - Portuguese Bend Road	
SWN Soiltech Consultants	DIRECT SHEAR TEST	Plate No. C-14

BORING/SAMPLE : B.4/S.1                      DEPTH (ft) : 5  
 DESCRIPTION : Bedrock - clay  
 STRENGTH INTERCEPT (C) : .680      KSF  
 FRICTION ANGLE (PHI) : 21.7      DEG                      (RESIDUAL STRENGTH)

SYMBOL	MOISTURE CONTENT (%)	DRY DENSITY (pcf)	VOID RATIO	NORMAL STRESS (ksf)	PEAK SHEAR (ksf)	RESIDUAL SHEAR (ksf)
○	42.3	78.4	1.190	.55	1.47	.92
□	42.3	78.4	1.190	1.10	1.53	1.07
△	42.3	78.4	1.190	2.20	2.18	1.59
◇	42.3	78.4	1.190	4.40	3.03	2.42
