# Appendix D

Geotechnical Assessments

Subject: Preliminary Geologic Investigation of Proposed  
Residence at #77 Portuguese Bend Road, Rolling  
Hills, California

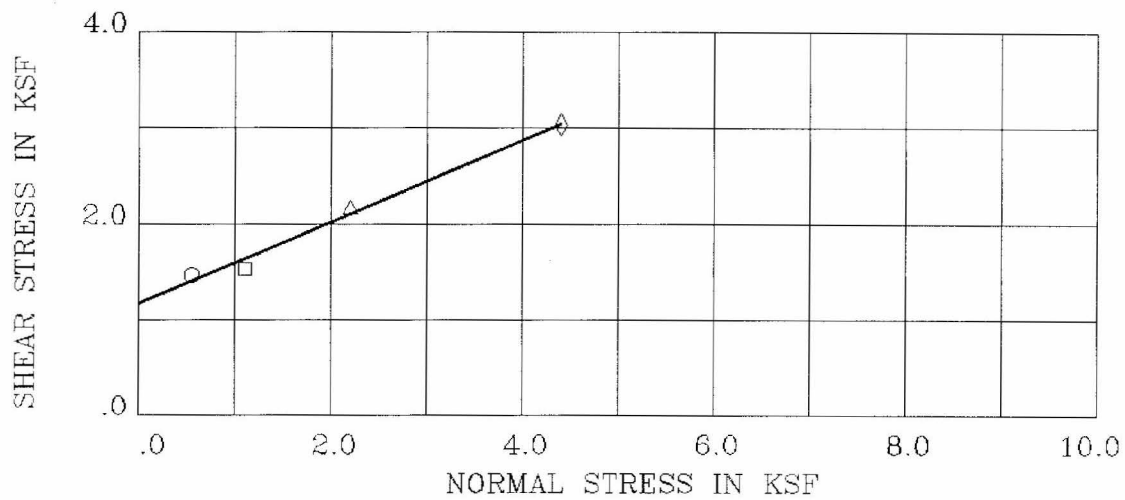
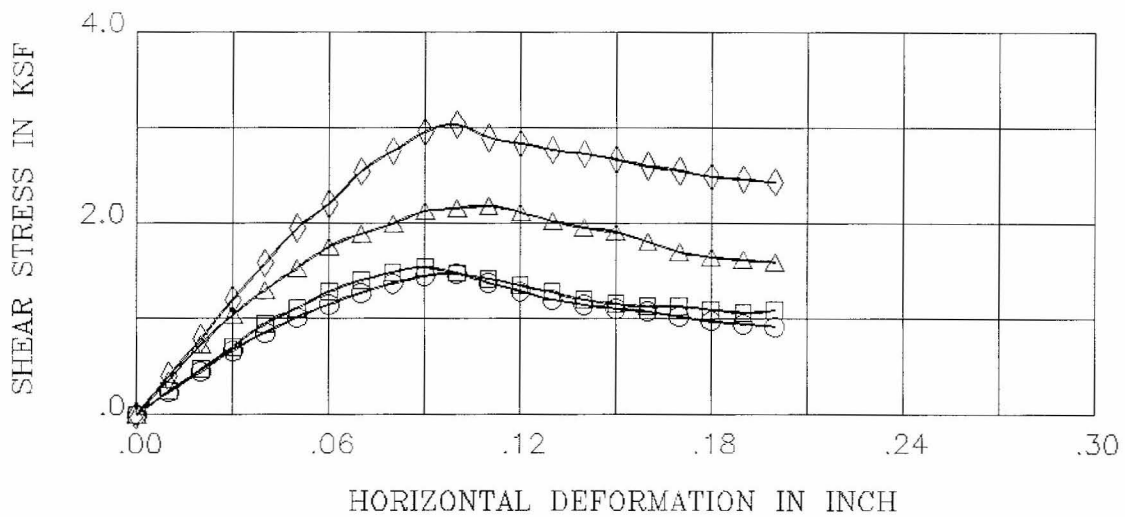
Project 4868-12	Shen - Portuguese Bend Road
SWN Soiltech Consultants	<b>DIRECT SHEAR TEST</b> Plate No. C-15

BORING/SAMPLE : B.4/S.1                      DEPTH (ft) : 5  
 DESCRIPTION : Bedrock - clay  
 STRENGTH INTERCEPT (C) : 1.179      KSF  
 FRICTION ANGLE (PHI) : 23.0      DEG                      (PEAK STRENGTH)

SYMBOL	MOISTURE CONTENT (%)	DRY DENSITY (pcf)	VOID RATIO	NORMAL STRESS (ksf)	PEAK SHEAR (ksf)	RESIDUAL SHEAR (ksf)
○	42.3	78.4	1.190	.55	1.47	.92
□	42.3	78.4	1.190	1.10	1.53	1.07
△	42.3	78.4	1.190	2.20	2.18	1.59
◇	42.3	78.4	1.190	4.40	3.03	2.42

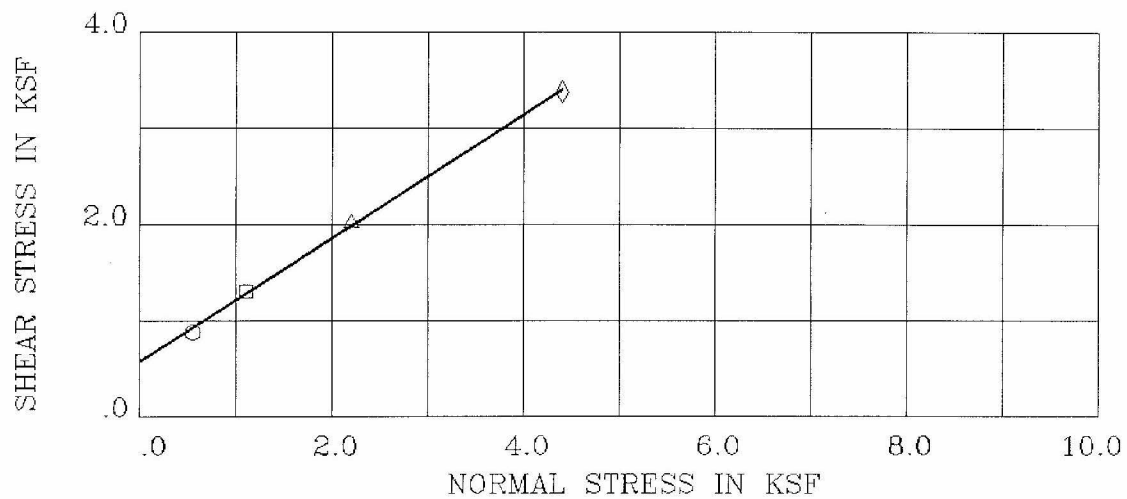
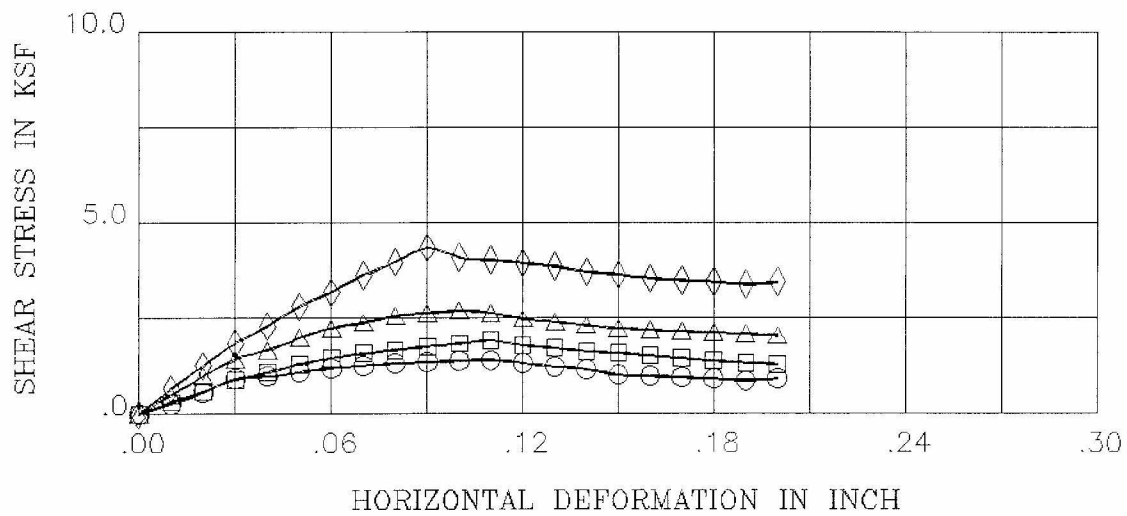
BORING/SAMPLE : B.3/S.5                      DEPTH (ft) : 32  
 DESCRIPTION : Slide Debris - siltstone  
 STRENGTH INTERCEPT (C) : .576 KSF  
 FRICTION ANGLE (PHI) : 32.8 DEG                      (RESIDUAL STRENGTH)

SYMBOL	MOISTURE CONTENT (%)	DRY DENSITY (pcf)	VOID RATIO	NORMAL STRESS (ksf)	PEAK SHEAR (ksf)	RESIDUAL SHEAR (ksf)
○	31.8	90.0	.907	.55	1.42	.88
□	31.8	90.0	.907	1.10	1.92	1.31
△	31.8	90.0	.907	2.20	2.69	2.05
◇	31.8	90.0	.907	4.40	4.32	3.38

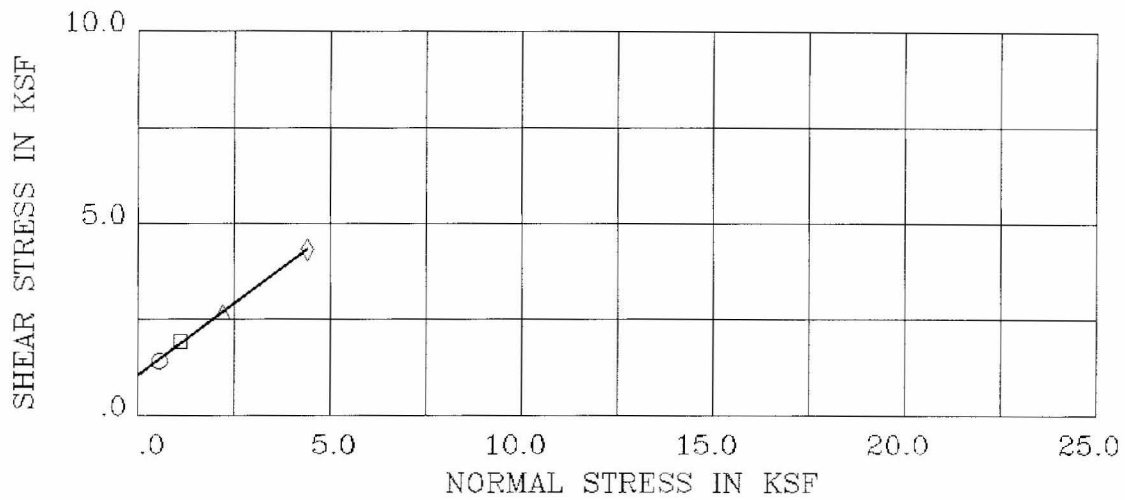
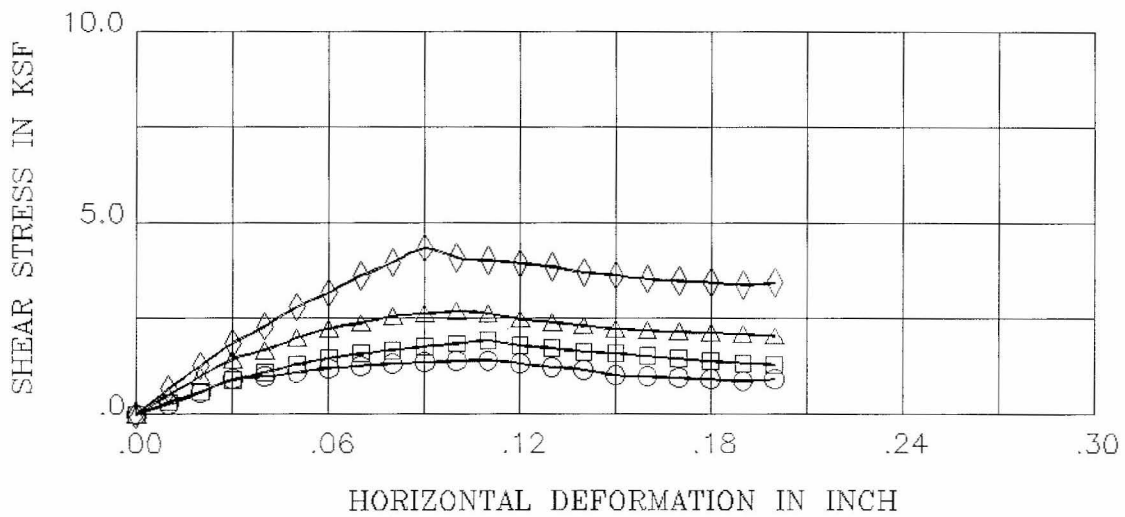
Project 4868-12	Shen - Portuguese Bend Road	
SWN Soiltech Consultants	DIRECT SHEAR TEST	Plate No. C-17

BORING/SAMPLE : B.3/S.5                      DEPTH (ft) : 32  
 DESCRIPTION : Slide Debris - siltstone  
 STRENGTH INTERCEPT (C) : 1.050 KSF  
 FRICTION ANGLE (PHI) : 36.7 DEG                      (PEAK STRENGTH)

SYMBOL	MOISTURE CONTENT (%)	DRY DENSITY (pcf)	VOID RATIO	NORMAL STRESS (ksf)	PEAK SHEAR (ksf)	RESIDUAL SHEAR (ksf)
○	31.8	90.0	.907	.55	1.42	.88
□	31.8	90.0	.907	1.10	1.92	1.31
△	31.8	90.0	.907	2.20	2.69	2.05
◇	31.8	90.0	.907	4.40	4.32	3.38

Remark : Undisturbed samples, soaked

The shear strength parameters adopted in the analyses are based on direct shear tests on representative undisturbed samples of the terrace deposits and bedrock under soaked conditions. The residual shear strengths of the samples of the terrace deposits and bedrock have been used in the static loading conditions, while the peak shear strengths have been used in the seismic loading conditions. It is our professional opinion that the peak shear strengths of the terrace deposits and bedrock are likely to be available during an earthquake.

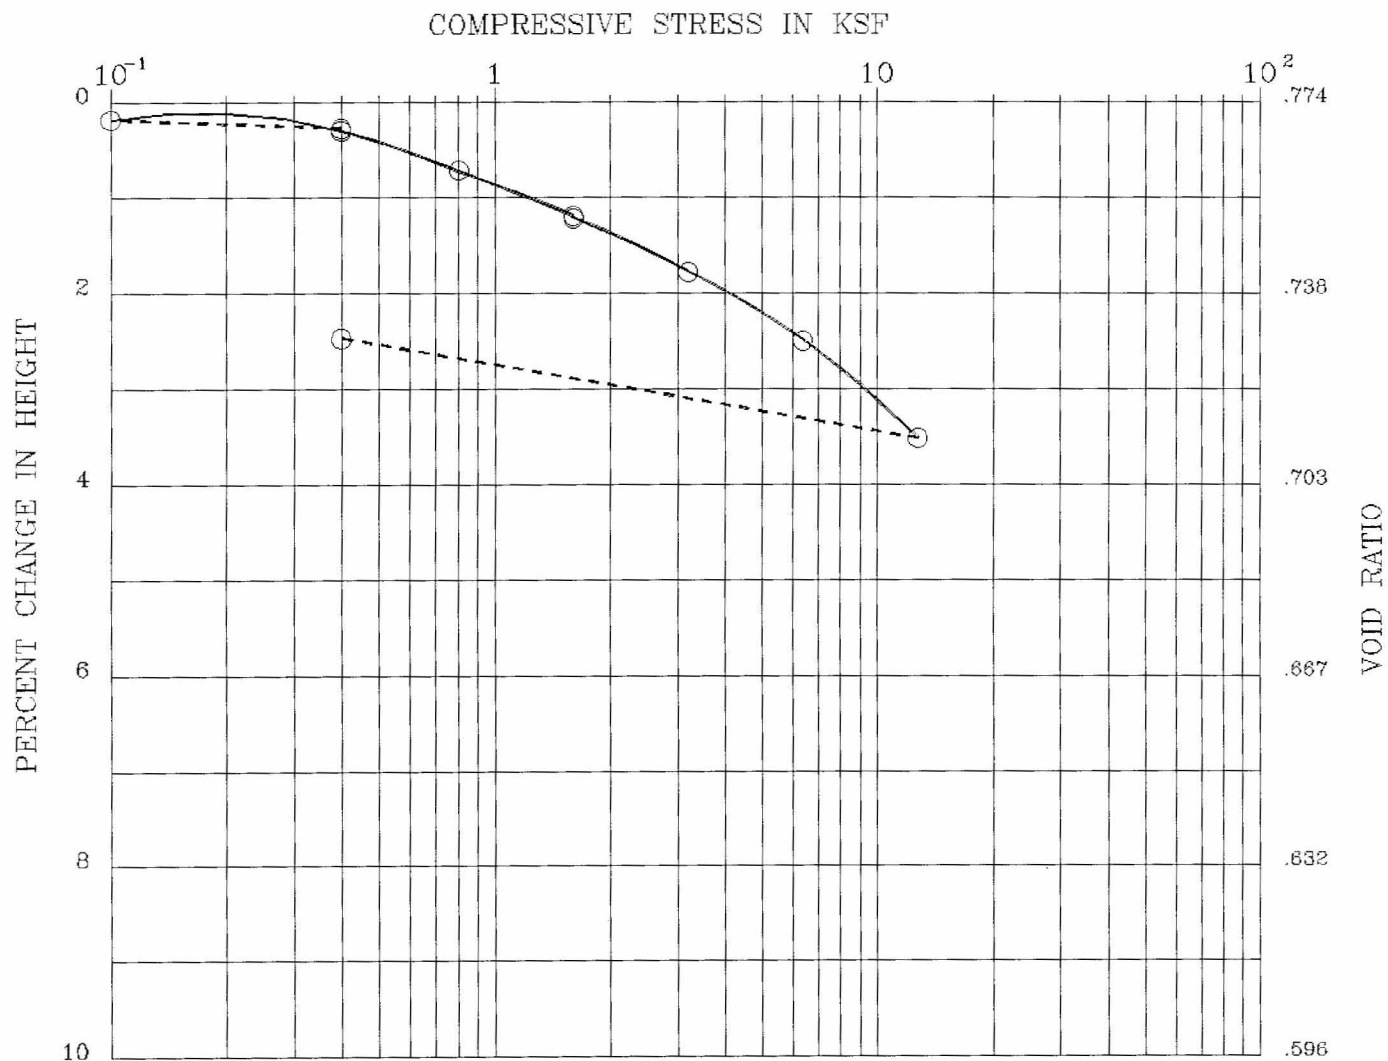
Project 4868-12	Shen - Portuguese Bend Road	
SWN Soiltech Consultants	CONSOLIDATION TEST	Plate No. D-1

BORING : B.1/S.1                      DESCRIPTION : Terrace - silty-clayey sand  
 DEPTH (ft) : 5                              LIQUID LIMIT :  
 SPEC. GRAVITY : 2.71                      PLASTIC LIMIT :

MOISTURE CONTENT (%)	DRY DENSITY (pcf)	PERCENT SATURATION	VOID RATIO
INITIAL	17.6	95.4	62	.774
FINAL	27.2	97.3	100	.738

Remark : Undisturbed sample, water added at 1.60 ksf

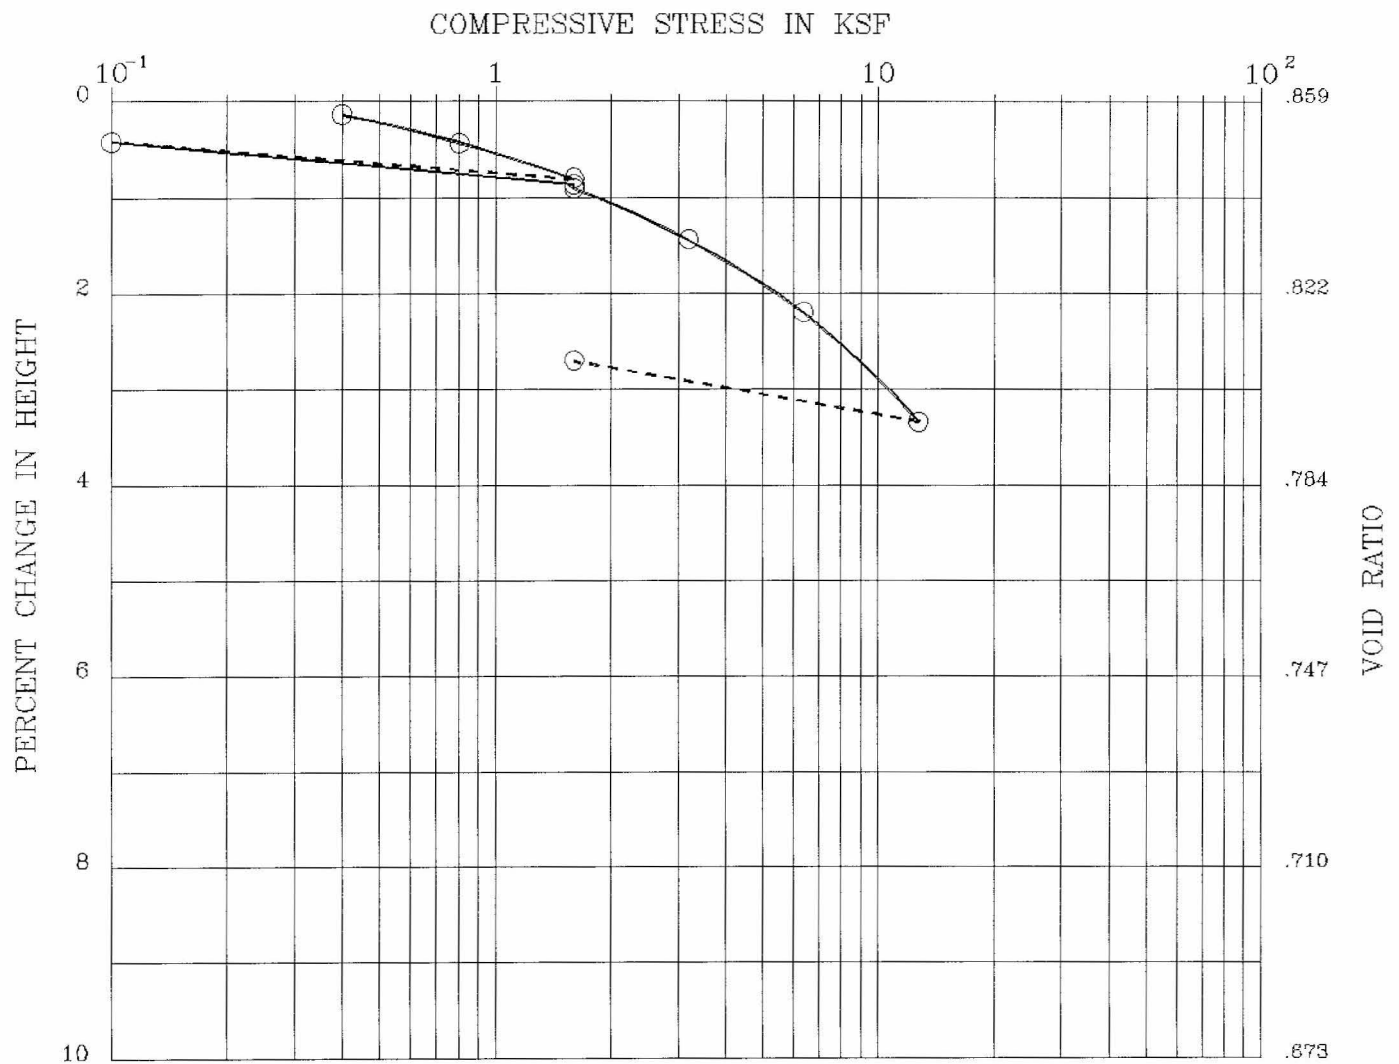
Project 4868-12	Shen - Portuguese Bend Road	
SWN Soiltech Consultants	CONSOLIDATION TEST	Plate No. D-2

BORING : B.1/S.2                      DESCRIPTION : Terrace - silty-clayey sand  
 DEPTH (ft) : 15                        LIQUID LIMIT :  
 SPEC. GRAVITY : 2.71                    PLASTIC LIMIT :

<u>MOISTURE CONTENT (%)</u>	<u>DRY DENSITY (pcf)</u>	<u>PERCENT SATURATION</u>	<u>VOID RATIO</u>
INITIAL	24.5	91.2	78	.859
FINAL	29.5	94.0	100	.803

Remark : Undisturbed sample, water added at 1.60 ksf

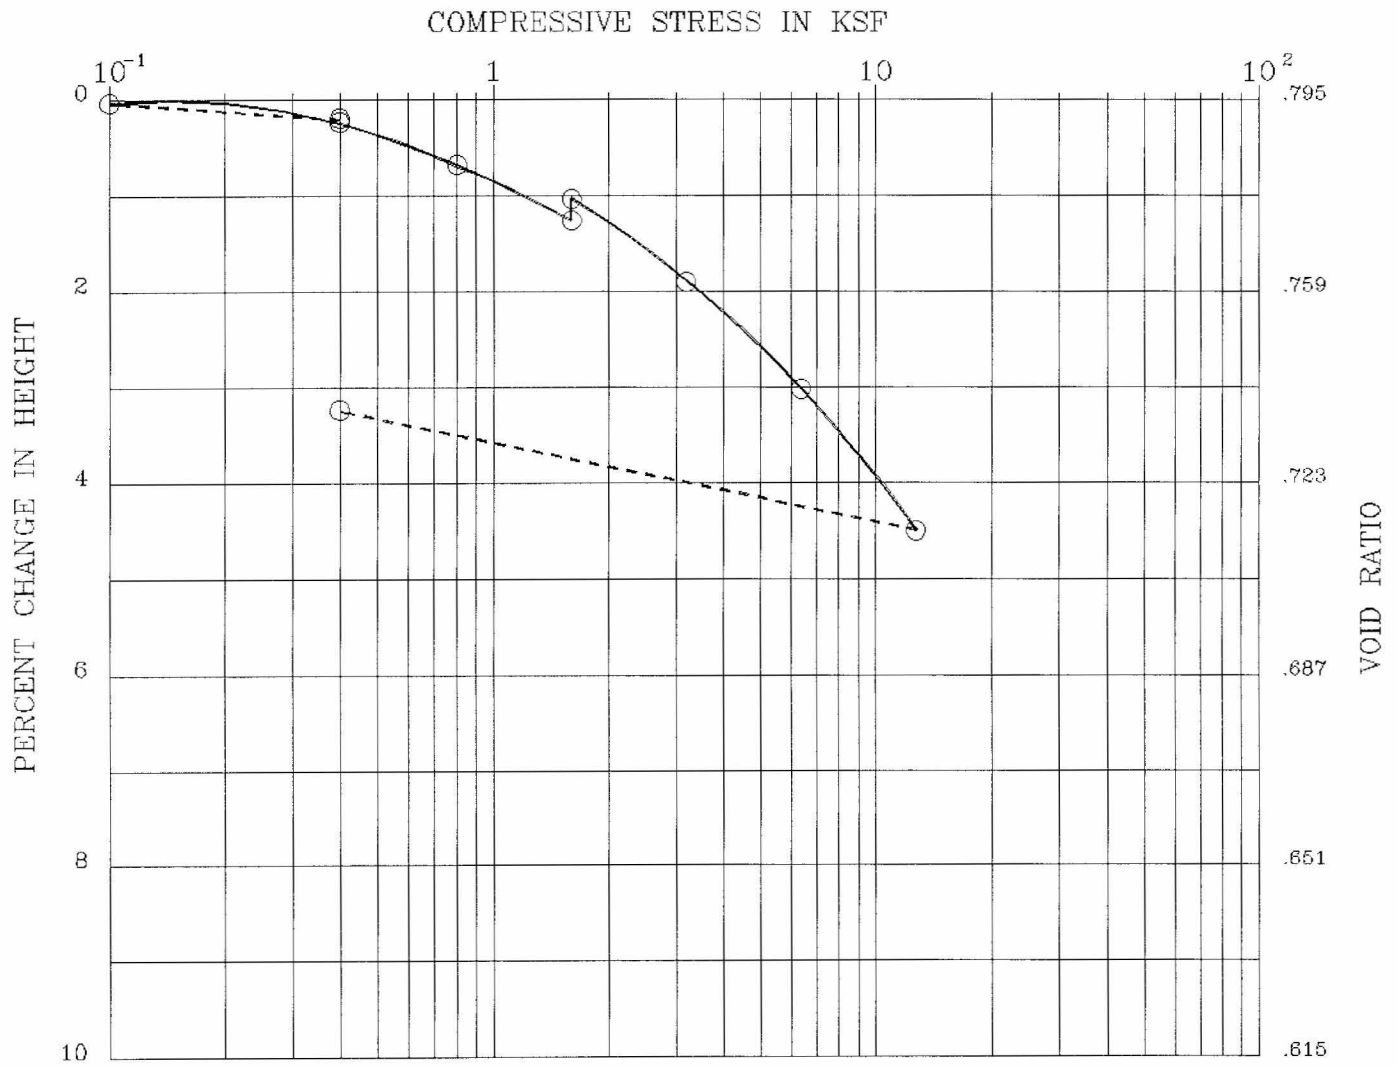
Plate No. D-3

BORING : B.3/S.1                      DESCRIPTION : Colluvium - sandy-silty clay  
 DEPTH (ft) : 3                              LIQUID LIMIT :  
 SPEC. GRAVITY : 2.72                      PLASTIC LIMIT :

MOISTURE CONTENT (%)	DRY DENSITY (pcf)	PERCENT SATURATION	VOID RATIO
INITIAL	15.9	94.7	55	.795
FINAL	26.5	98.7	100	.723

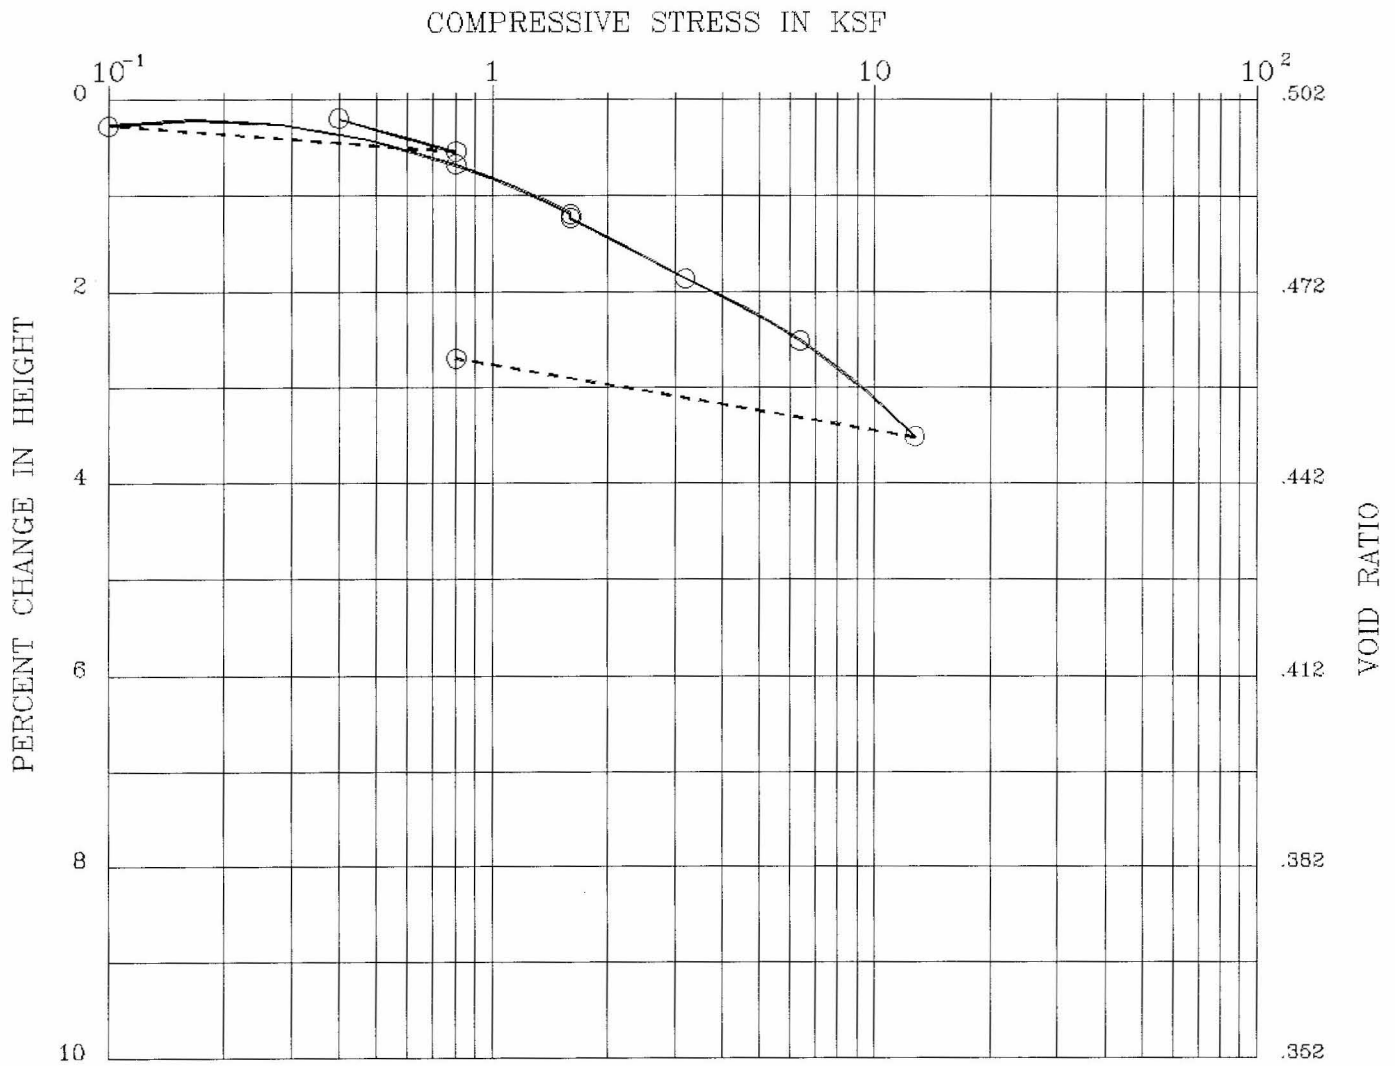
Project 4868-12	Shen - Portuguese Bend Road	
SWN Soiltech Consultants	CONSOLIDATION TEST	Plate No. D-4

BORING	: B.3/S.2	DESCRIPTION	: Slide debris - basalt
DEPTH (ft)	: 9	LIQUID LIMIT	:
SPEC. GRAVITY	: 2.73	PLASTIC LIMIT	:

MOISTURE CONTENT (%)	DRY DENSITY (pcf)	PERCENT SATURATION	VOID RATIO
INITIAL	14.6	113.6	80	.502
FINAL	16.7	117.1	100	.457

Remark : Undisturbed sample, water added at 1.60 ksf

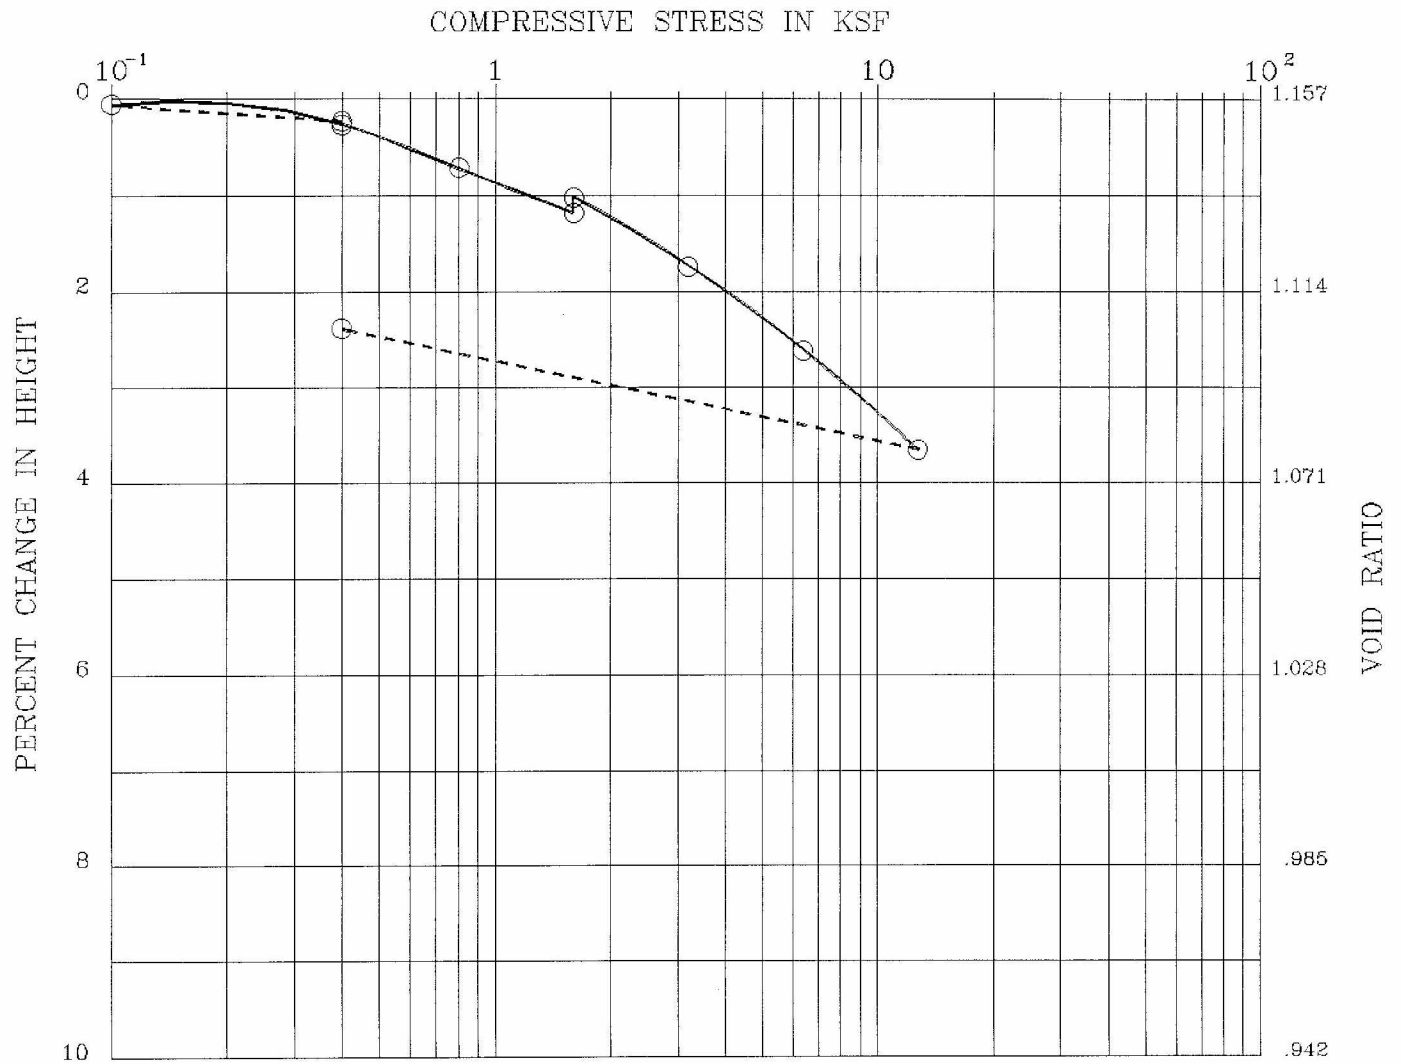
BORING : B.4/S.1                      DESCRIPTION : Bedrock - clay  
 DEPTH (ft) : 5                              LIQUID LIMIT :  
 SPEC. GRAVITY : 2.71                      PLASTIC LIMIT :

MOISTURE CONTENT (%)	DRY DENSITY (pcf)	PERCENT SATURATION	VOID RATIO
INITIAL	27.2	78.4	64	1.157
FINAL	40.3	80.8	100	1.093

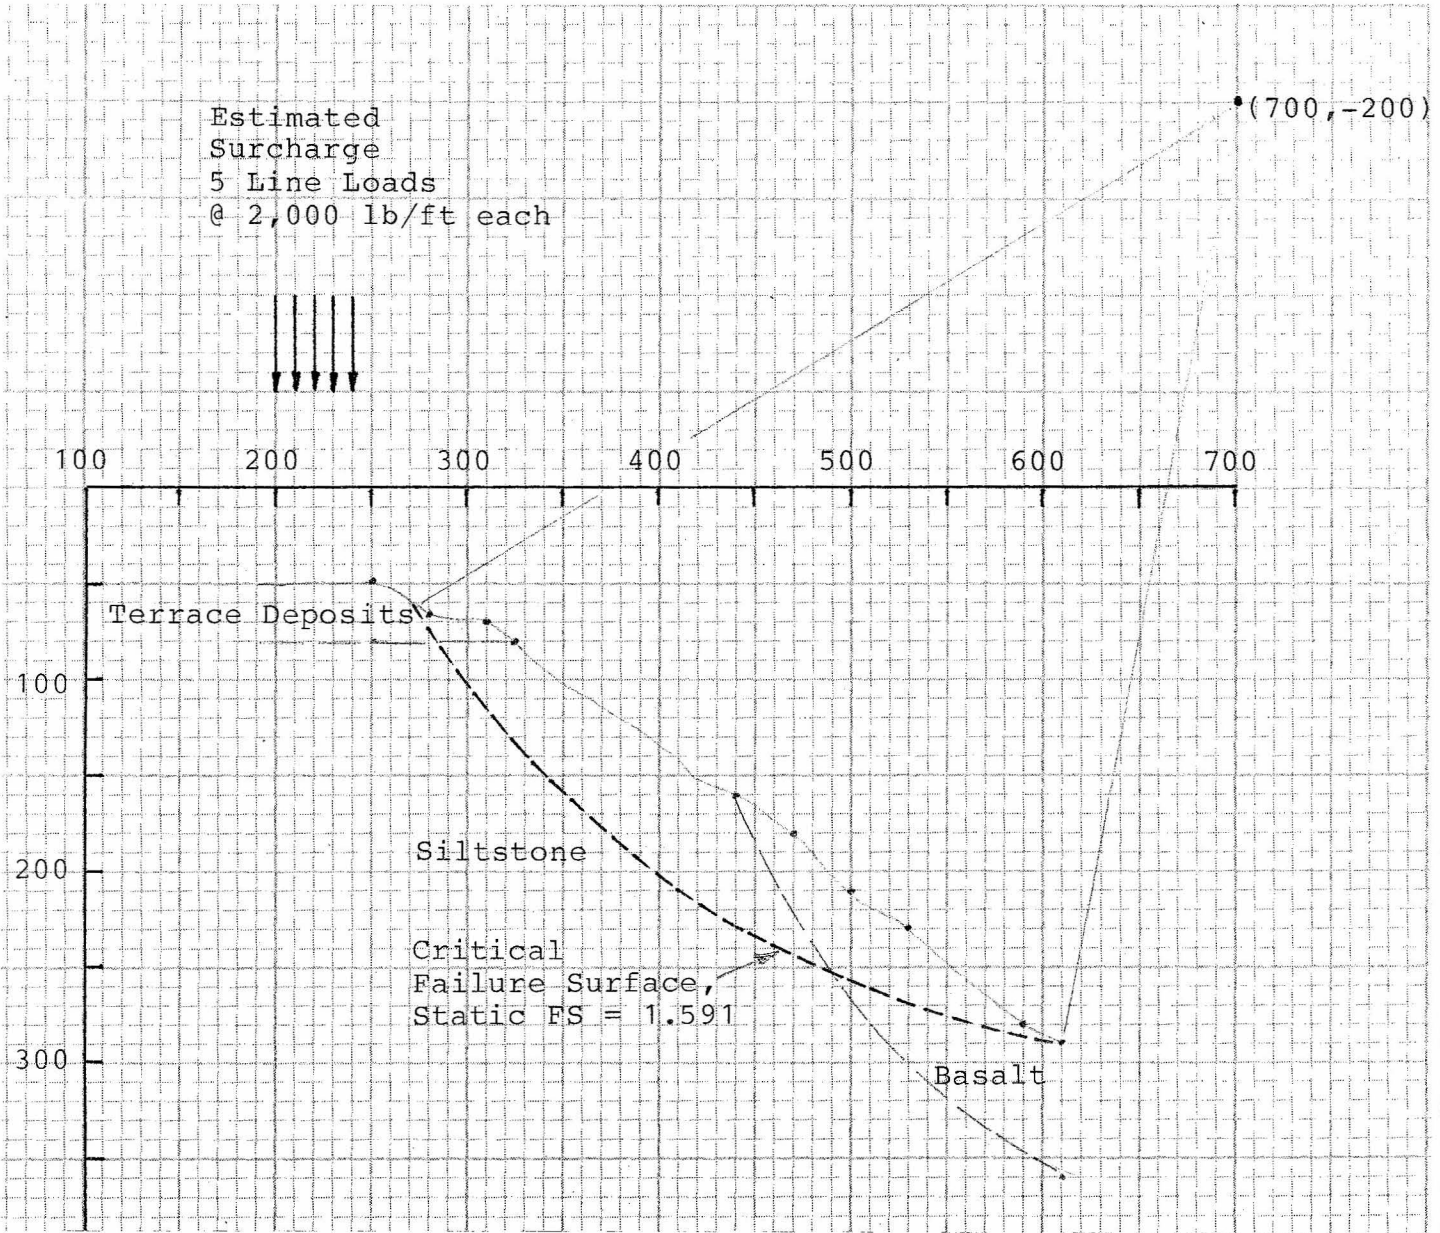
## Section C-C'

Scale: 1" = 100'

Stability of the existing slope below the area of the proposed residence, as shown along Section C-C' of the Coast Geotechnical report, has been analyzed by Bishop's Simplified Method. Searches have been made to determine the most critical failure surfaces.

Both static and seismic loading conditions have been considered. In the seismic analysis, the seismic force is represented by a pseudostatic horizontal inertial force equal to 0.15 times the total weight of the potential sliding mass acting out of the slope.

Calculations are included on Plates IV-1 through IV-6. Factors-of-safety in excess of 1.50 and 1.10 have been obtained for static and seismic loading conditions, respectively.

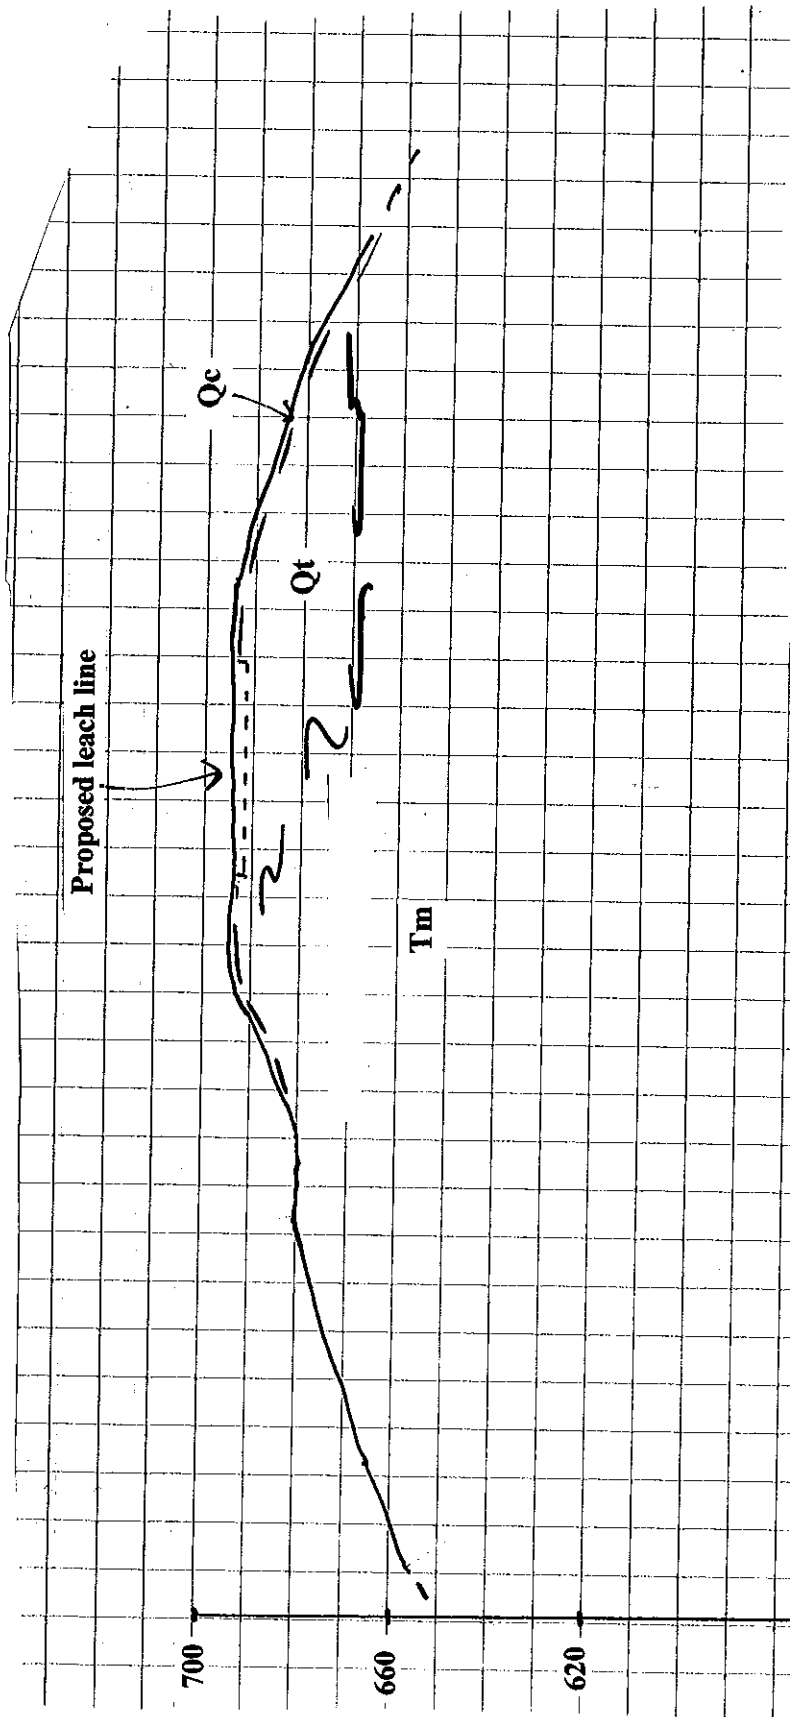
# GEOLOGIC CROSS SECTION

Scale 1" ~ 40ft (H=V)

- h. The dimensions of the proposed septic tank and leach field are shown on Figure 2.1. Section A-A', Figure 3, is a geologic cross-section that indicates typical leach field construction. Typical leach trench construction is depicted on Figure 6.

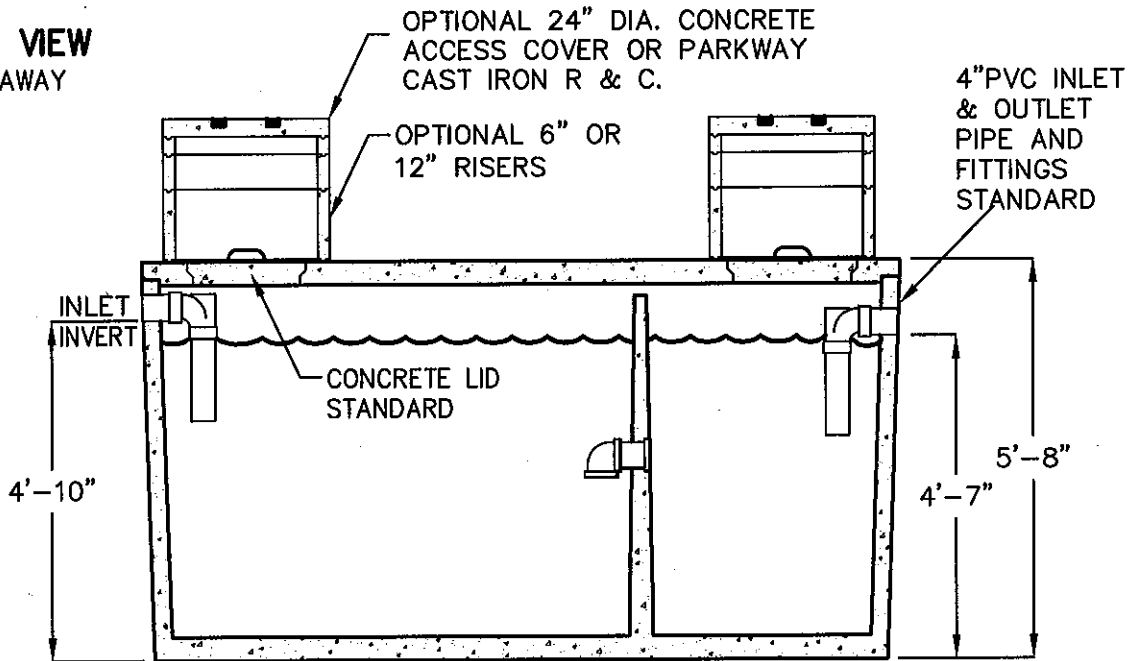
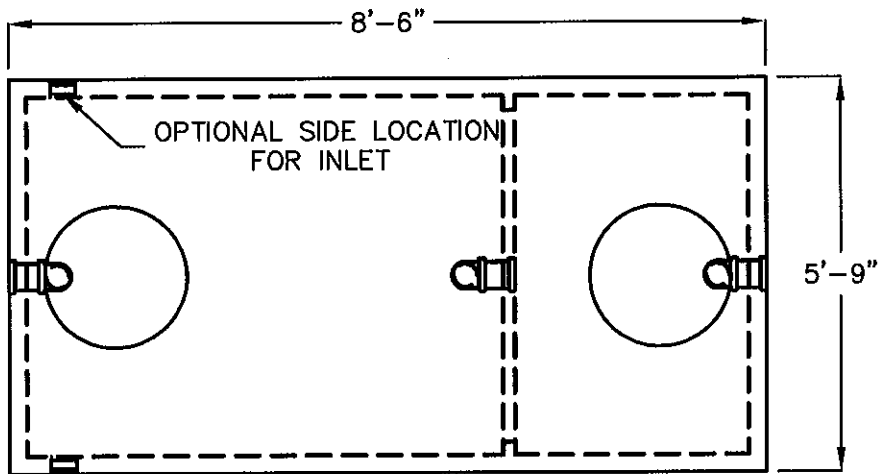
Figure 5

**SIDE VIEW  
CUTAWAY**

**TOP VIEW**

- LIQUID CAPACITY: 1200 GALLONS  
TANK DESIGNED FOR NON-TRAFFIC USE WITH A MAXIMUM LOAD OF 500 PSF AND DRY SOIL CONDITIONS (WATER TABLE BELOW TANK). EARTH COVER OVER TANK NOT TO EXCEED 3'.
- THE PRECAST CONCRETE TANK SHALL BE PLACED ON LEVEL, UNDISTURBED SOIL OR APPROVED COMPACTED FILL.
- EFFLUENT FILTERS ARE AVAILABLE UPON REQUEST.
- FOR COMPLETE DESIGN AND PRODUCT INFORMATION CONTACT JENSEN PRECAST.

- j. A cross-section view of the septic tank, risers and system dimensions is attached as Figure 5.
- k. The primary and expansion leach trenches are shown on Figure 2.1. Each system shall consist of three leach lines each 45 feet in length, by three feet in width with two feet of gravel beneath the pipe. A distribution box will be needed for the system.

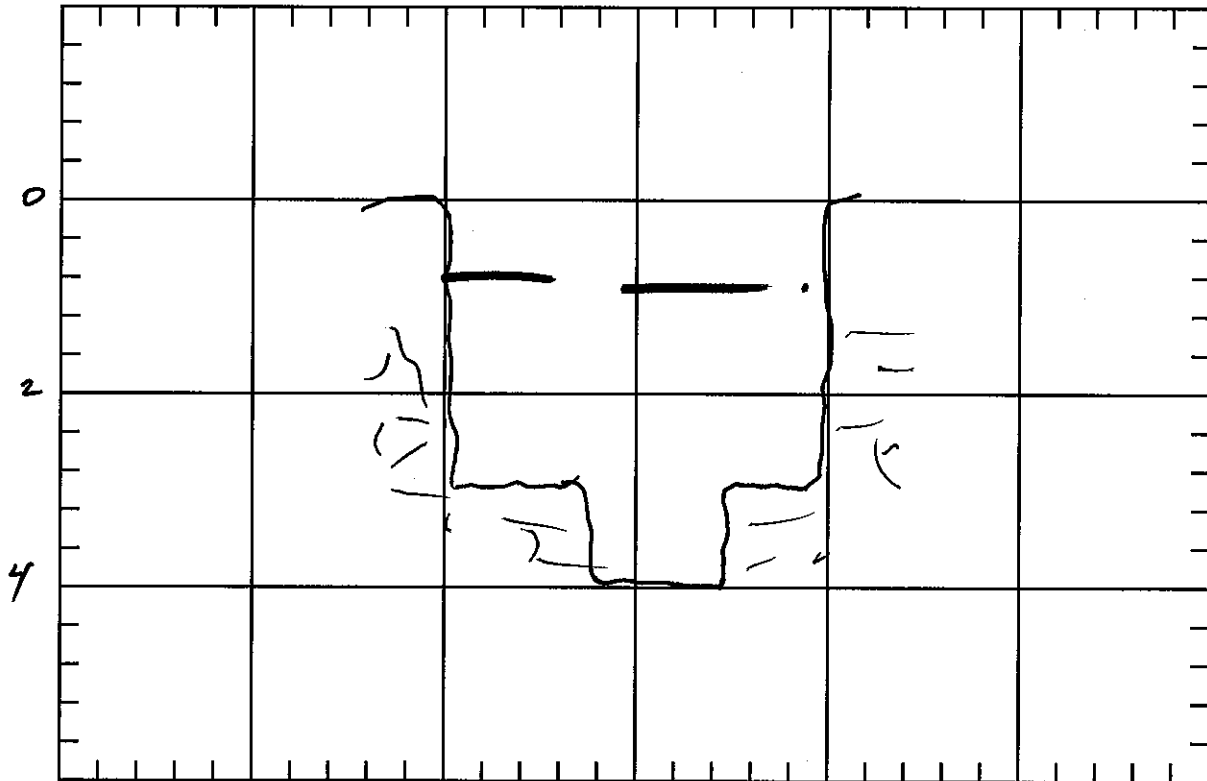
## CROSS SECTION SKETCH

Dry Density (Pcf)	Moisture (% Dry Wt.)	Samples C B	Depth (Ft.)	Description
			1	BLACK SILTY CLAY, REDDUS, DRY, ROOTS, ROCKS (Qc)
			2	TAU BUFF SILTSTONE WITH ZONES OF SANDSTONE, VERY FRACTURED WEATHERED, HARD Tm
			3	EOPC 3.0' - No H <sub>2</sub> O
			4	
			5

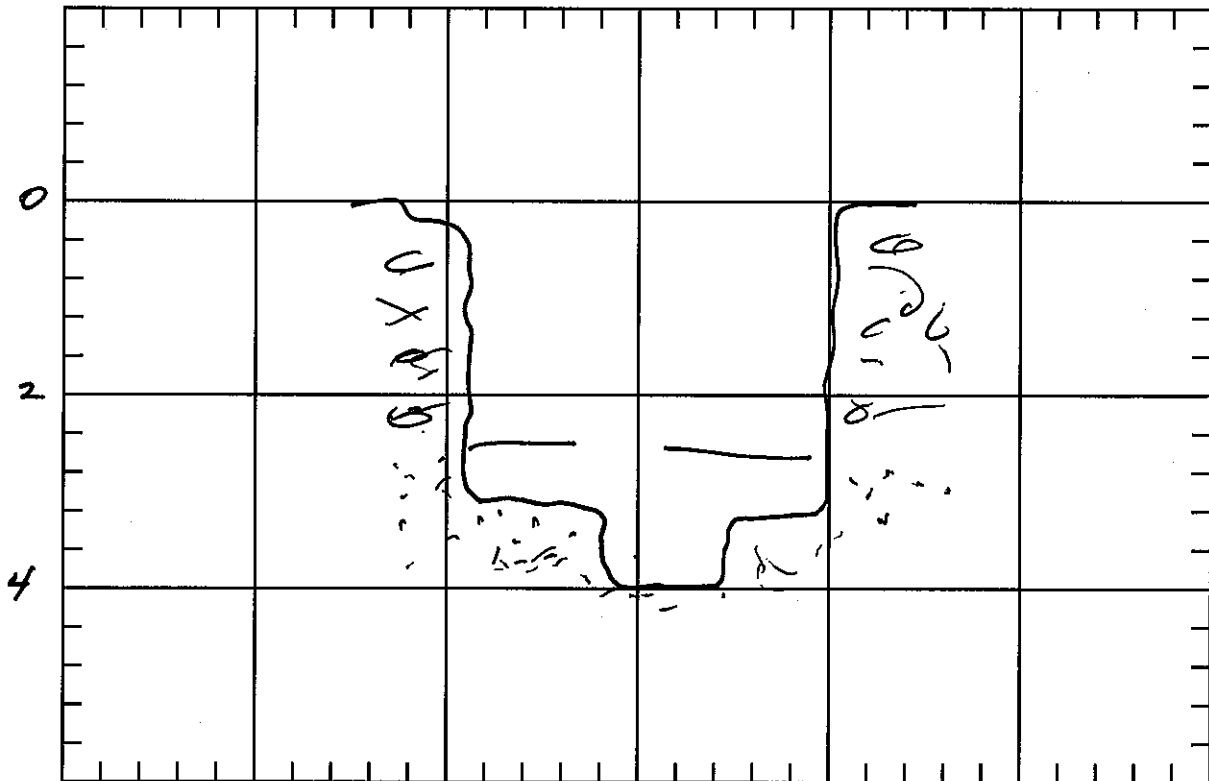
### CROSS SECTION SKETCH

Dry Density (Pcf)	Moisture (% Dry Wt.)	Samples C B	Depth (Ft.)	Description
			1	<p>GRAY BLACK SILTY CLAY. STIFF ROOTS, POORLY, FIRM</p> <p style="text-align: right;">(Qc)</p>
			2	
			3	<p>YELLOW BROWN SILTY SAND, DAMP</p> <p style="text-align: right;">(Qc)</p>
			4

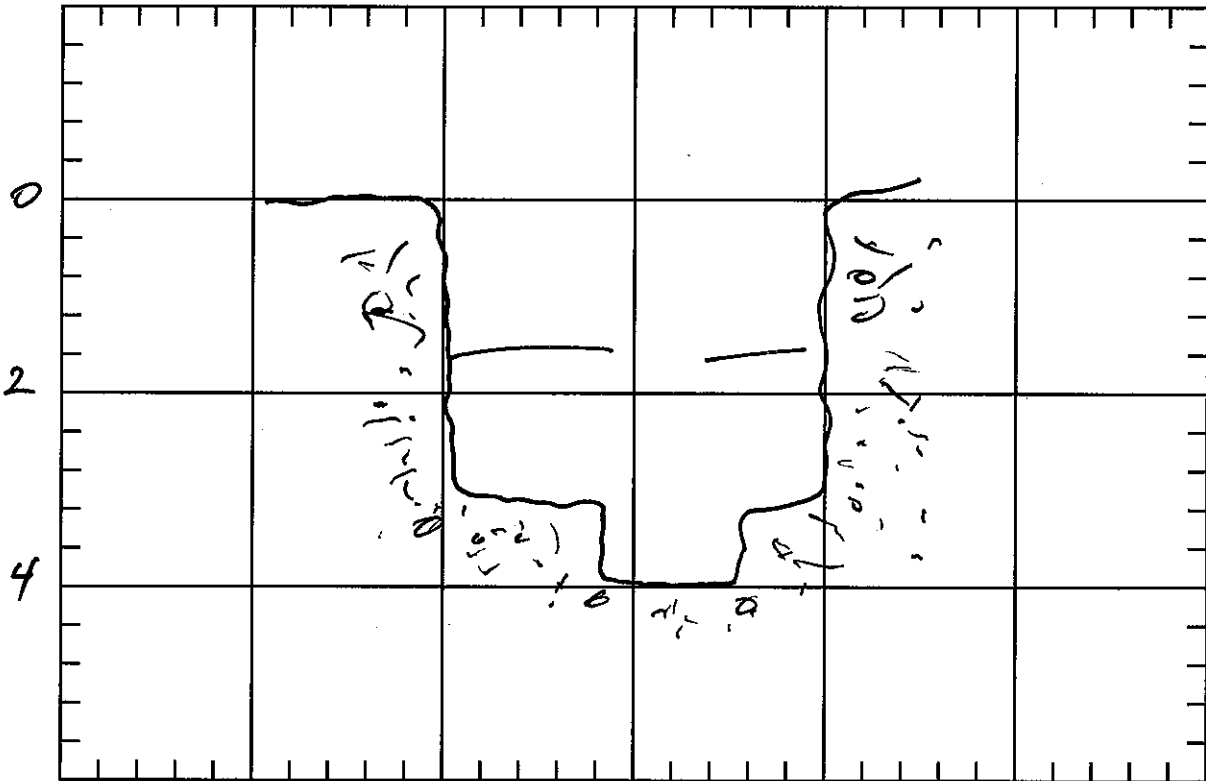
### CROSS SECTION SKETCH

Dry Density (Pcf)	Moisture (% Dry Wt.)	U B	Samples	Depth (Ft.)	Description
				1	BLACK GREY SILTY CLAY, ROCKY, POROUS, DRY, SOFT <span style="float: right;">(Qc)</span>
				2	BUFF TAN SILTY SAND WITH SMALL SUBROUND ROCKS, DRY, FIRM <span style="float: right;">(Qc)</span>
				3	ROPE 3' - No H <sub>2</sub> O <span style="float: right;">(Qc)</span>
				4	
				5

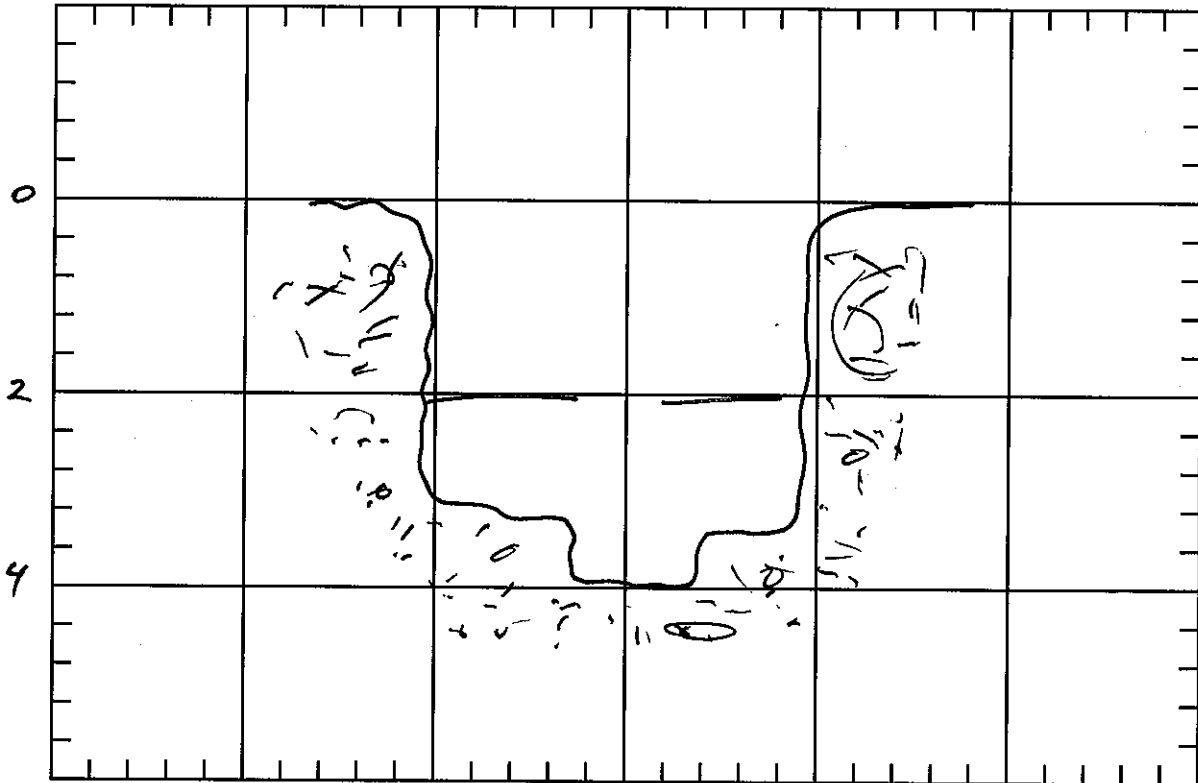
### CROSS SECTION SKETCH

Dry Density (Pcf)	Moisture (% Dry Wt.)	Samples U B	Depth (Ft.)	Description
			1	<p>GRAY BLACK SILTY CLAY, FIRM, ROOTS</p> <p style="text-align: right;">(Rc)</p>
			2	_____
			3	<p>YELLOW BROWN SILTY SAND, ROCK FRAGMENTS, MEDIUM DENSE, DAMP</p>
			4	<p>FOPC 3' - NO H<sub>2</sub>O</p> <p style="text-align: right;">(Rc)</p>

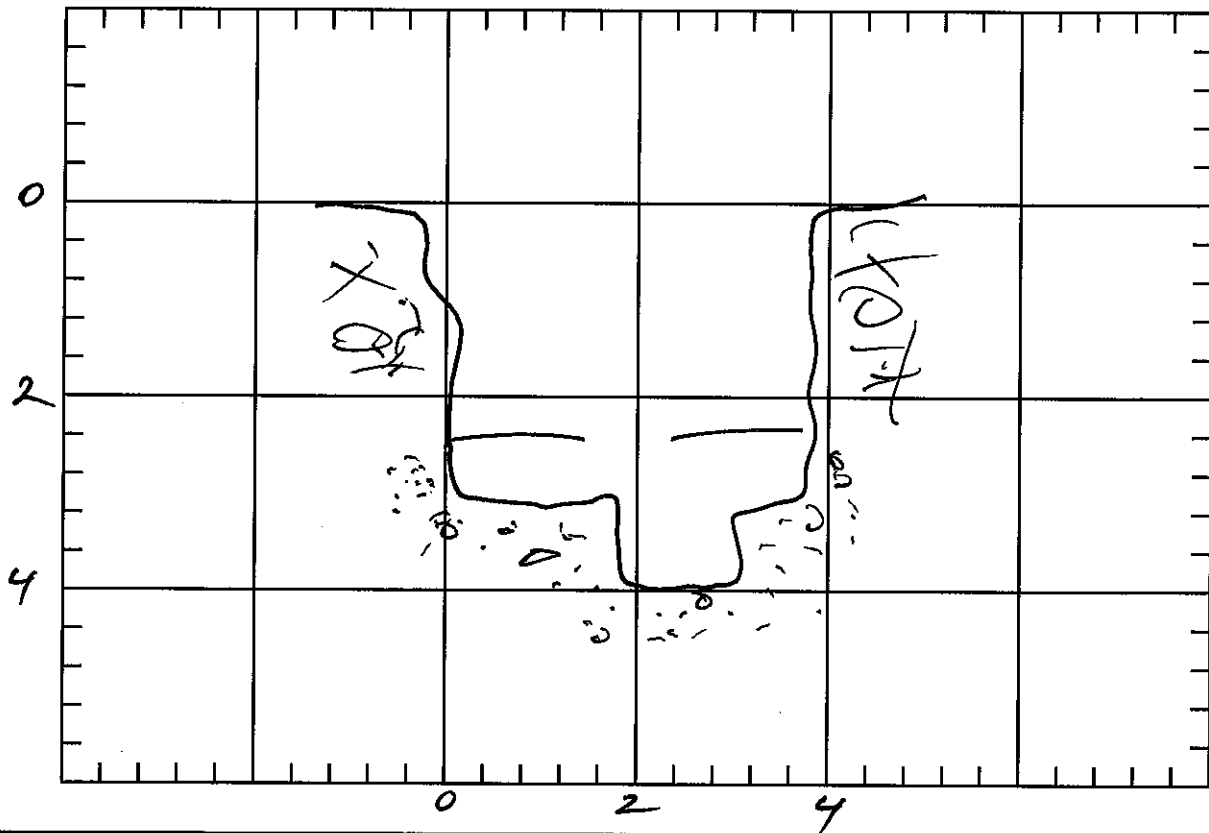
### CROSS SECTION SKETCH

Dry Density (Pcf)	Moisture (% Dry Wt.)	U B Samples	Depth (Ft.)	Description
			1	BLACK GRAY SILTY CLAY, LOOSE, ROCKS, DAMP, ROOTS
			2	(Qc)
			3	YELLOW TAN, BUFF SILTY SAND, ROUNDED ROCK FRAGMENTS, FIRM DAMP
			4	FOPE 3' - No H <sub>2</sub> O
			5

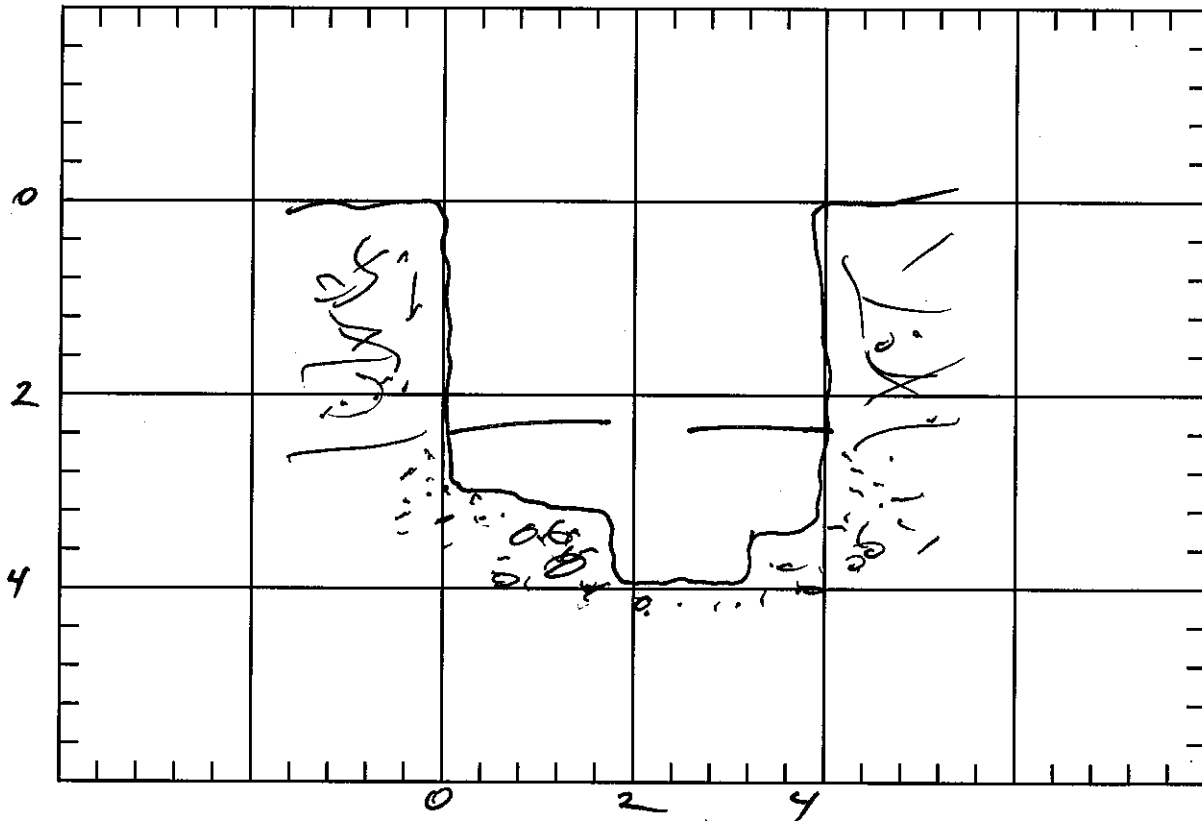
**CROSS SECTION SKETCH**

Dry Density (Pcf)	Moisture (% Dry Wt.)	Samples U B	Depth (Ft.)	Description
			1	GRAY BLACK SILTY CLAY, LOOSE, DAMP, ROOTS <span style="float: right;">(Qc)</span>
			2	
			3	YELLOW BROWN TO BUFF SILTY SAND, ABUNDANT ROCKS, FIRM, DAMP <span style="float: right;">(Qd)</span>
			4	EDGE 3' - NO HLL - NO GRAVEL
			5
