# Appendix D

Geotechnical Assessments

Subject: Preliminary Geologic Investigation of Proposed  
Residence at #77 Portuguese Bend Road, Rolling  
Hills, California

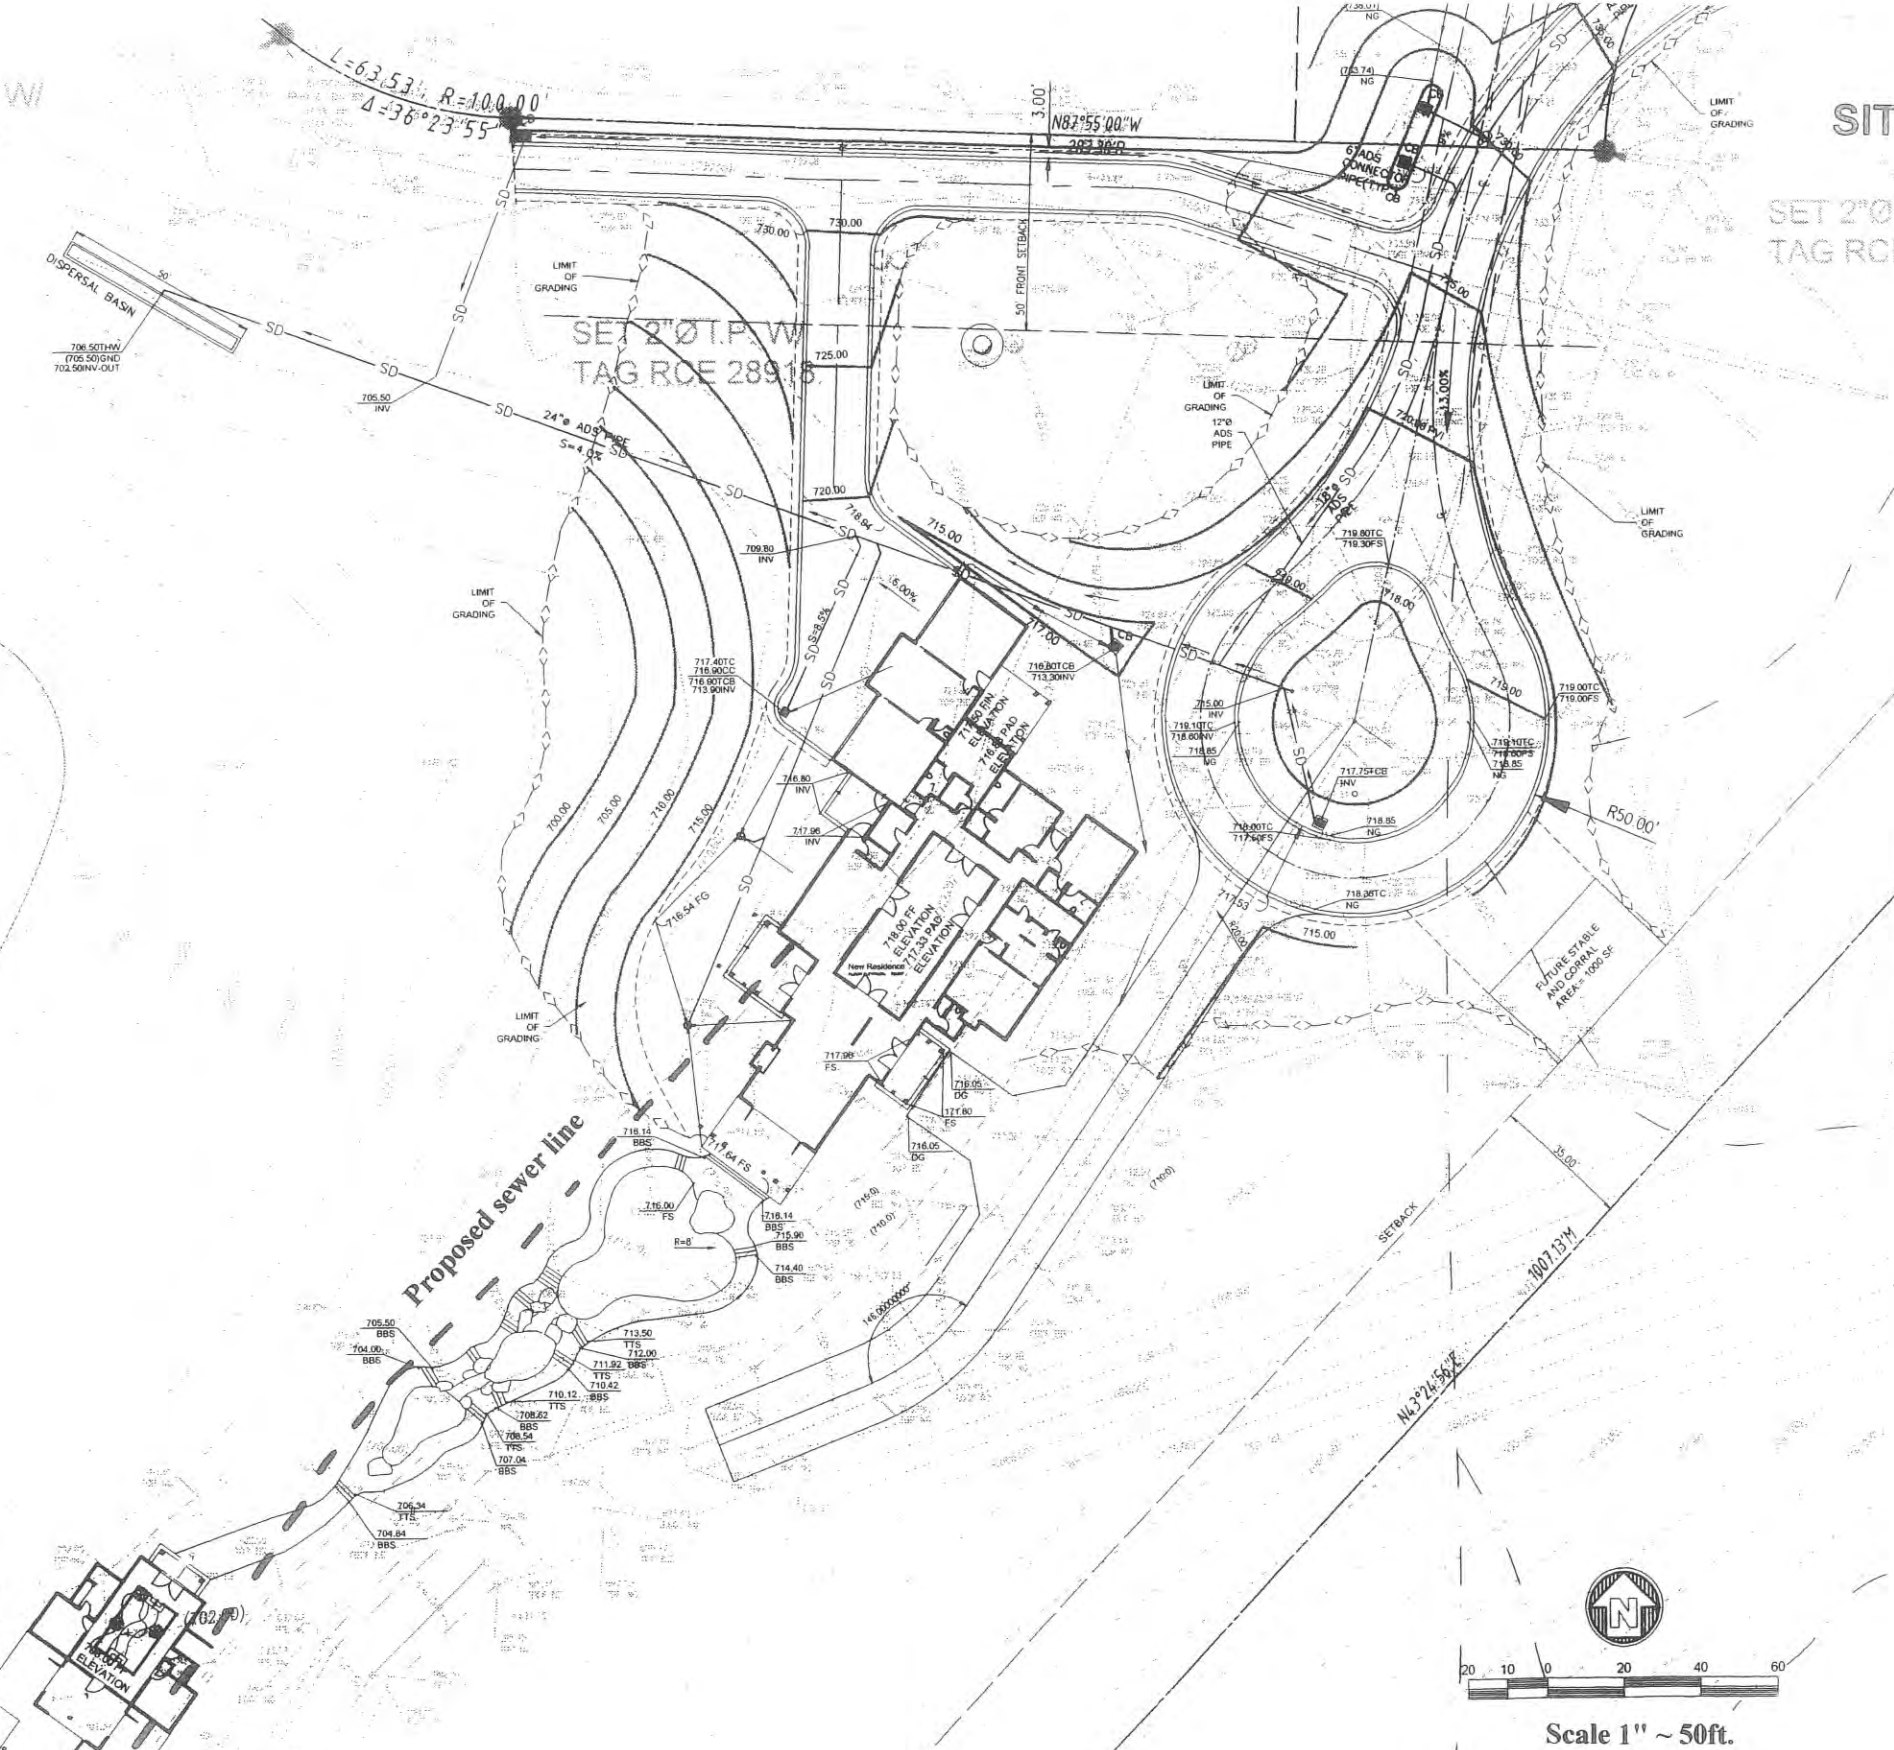
Location of proposed leach field

Scale 1" ~ 50ft.

Leach field shall consist of four 42ft. long lines by 3ft wide with 2ft of gravel beneath the pipe

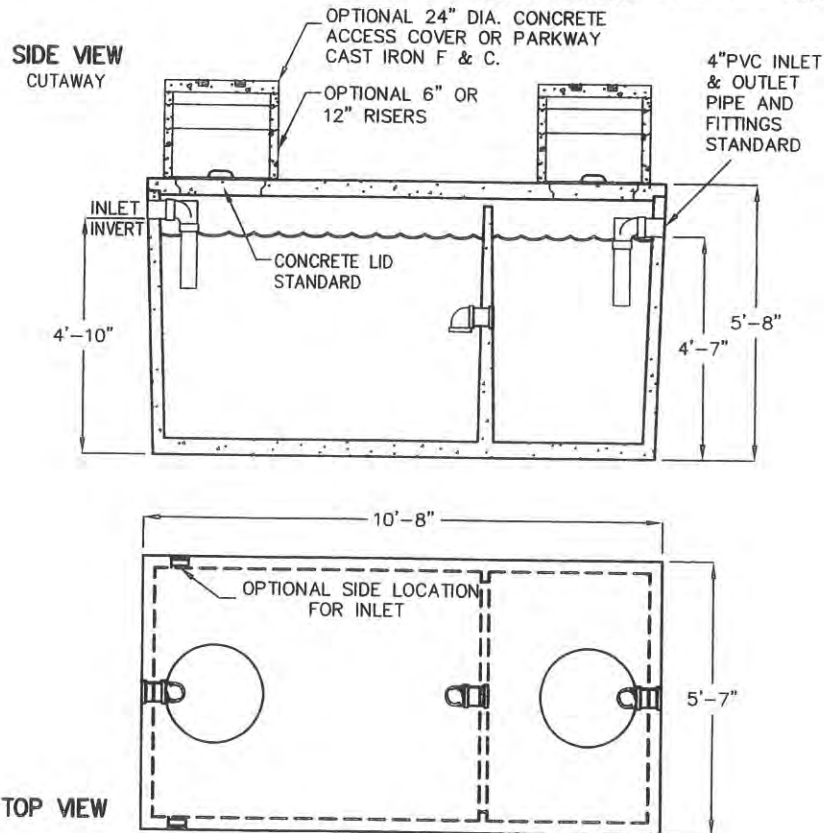
## 1500 GALLON RESIDENTIAL SEPTIC TANK MODEL JS1500

- ▣ LIQUID CAPACITY: 1500 GALLONS  
TANK DESIGNED FOR NON-TRAFFIC USE WITH A MAXIMUM LOAD OF 500 PSF AND DRY SOIL CONDITIONS (WATER TABLE BELOW TANK). EARTH COVER OVER TANK NOT TO EXCEED 3'.
- ▣ THE PRECAST CONCRETE TANK SHALL BE PLACED ON LEVEL, UNDISTURBED SOIL OR APPROVED COMPACTED FILL.
- ▣ EFFLUENT FILTERS ARE AVAILABLE UPON REQUEST.
- ▣ FOR COMPLETE DESIGN AND PRODUCT INFORMATION CONTACT JENSEN PRECAST.

MINIMUM EXCAVATION SIZE:  
6'-7" X 11'-8" X DEPTH REQ'D.

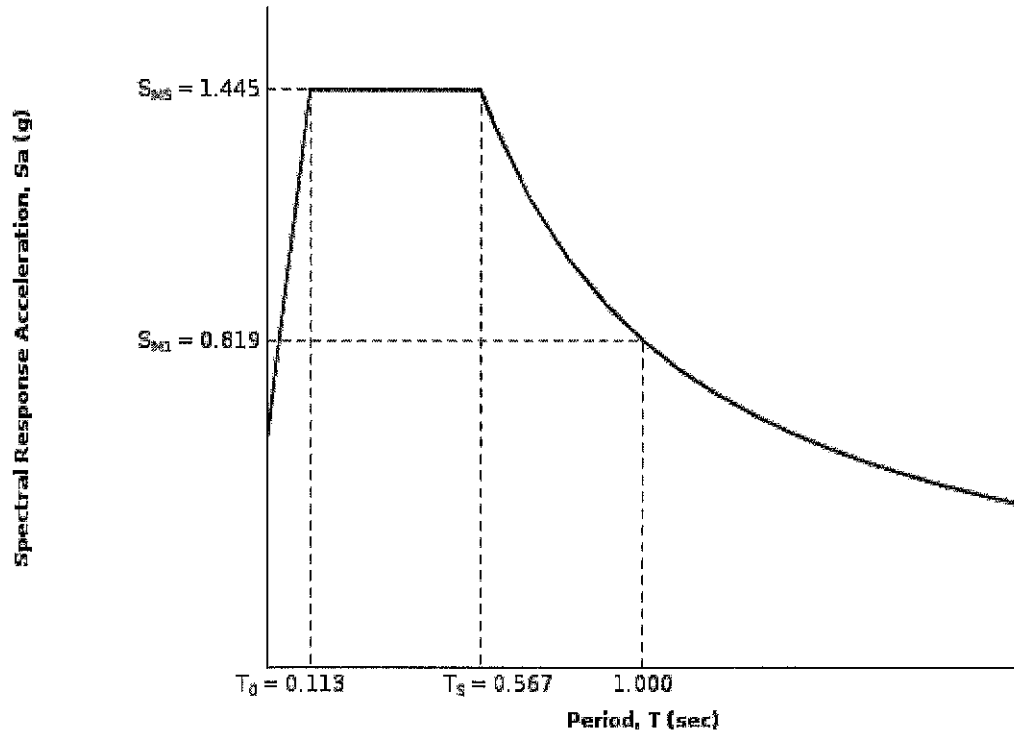
### Section 11.4.6 — Risk-Targeted Maximum Considered Earthquake (MCE<sub>R</sub>) Response Spectrum

The MCE<sub>R</sub> Response Spectrum is determined by multiplying the design response spectrum above by 1.5.

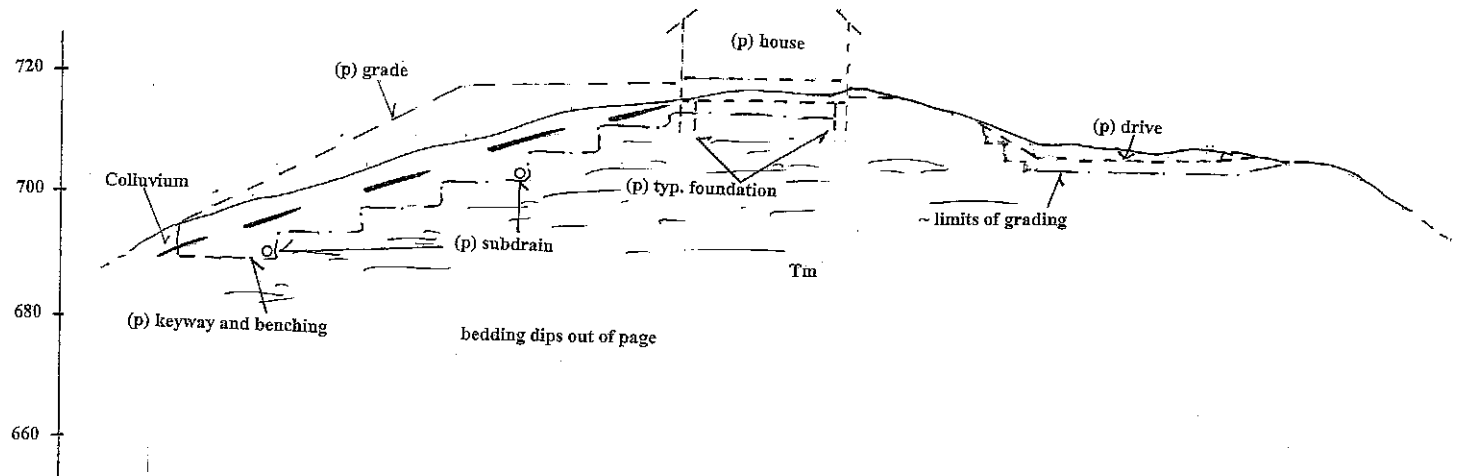
GEOLOGIC SECTION A-A'

Scale 1' ~ 20ft. (H=V)

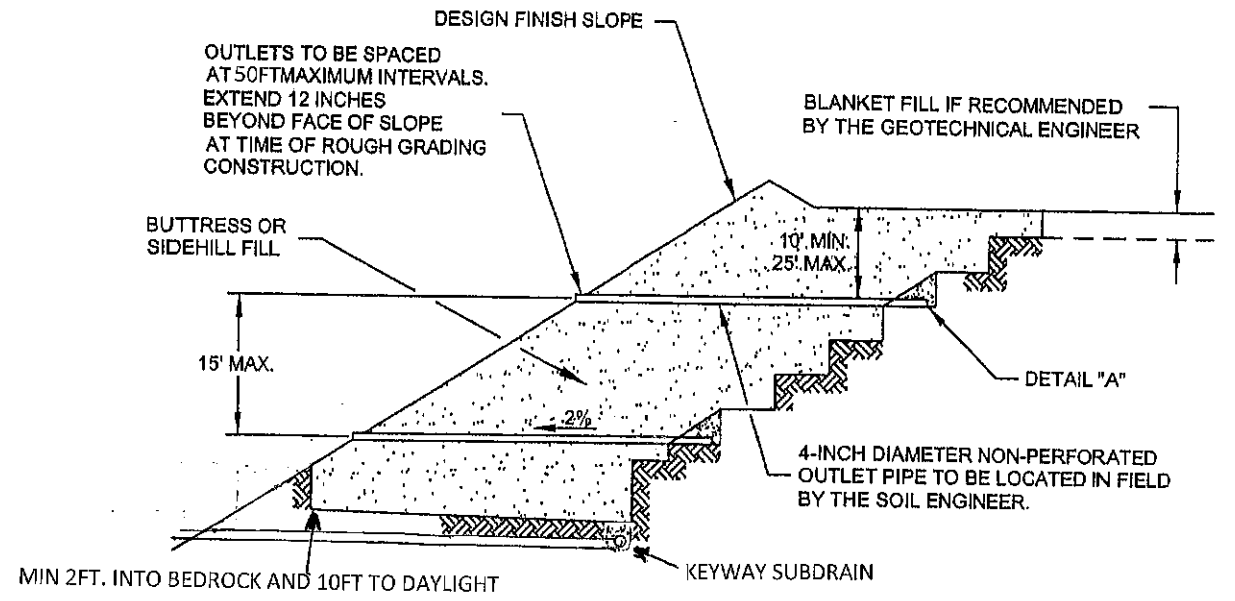
# FILL SLOPE DETAIL

"FILTER MATERIAL" TO MEET FOLLOWING SPECIFICATION OR APPROVED EQUIVALENT: (CONFORMS TO EMA STD. PLAN 323)

"GRAVEL" TO MEET FOLLOWING SPECIFICATION OR APPROVED EQUIVALENT:

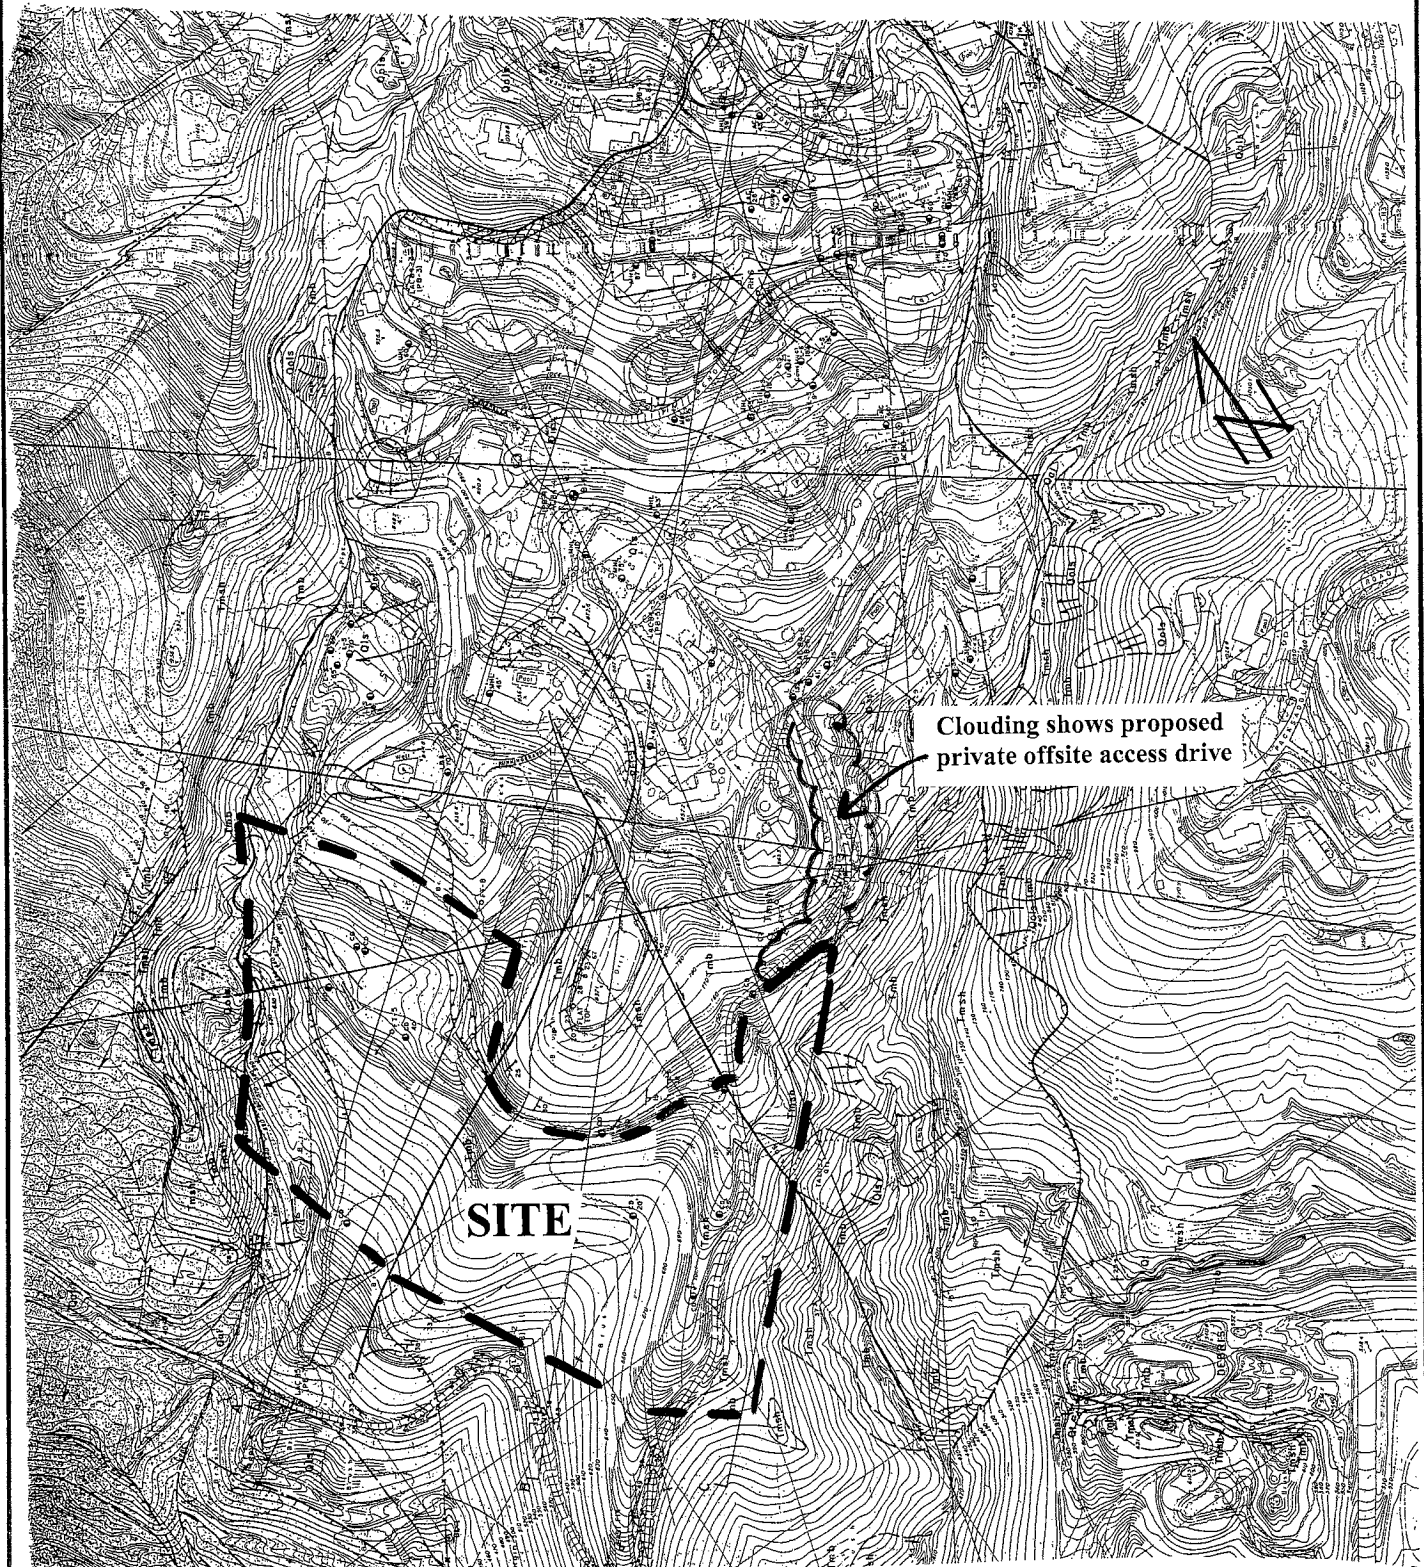
Figure 2.1

# REGIONAL GEOLOGY MAP

Clouding shows proposed private offsite access drive

A portion of the Landslide Inventory Map for the Palos Verdes Peninsula is attached as Figure 2.1. This map shows landslide masses similar to Dibblee's; although, differences in landslide geometry do occur between the two maps and the Landslide Inventory Map shows a small dormant landslide between the two lower lobes of the Flying Triangle Landslide.

Within Boring 5 a clay seam was identified at twenty feet that could be the contact of the dormant landslide identified on Figure 2.1. landslide. Based on geologic structure this plane would not daylight down slope.

A portion of the Landslide Inventory Map for the Palos Verdes Peninsula is attached as Figure 2.1. This map shows landslide masses similar to Dibblee's; although, differences in landslide geometry do occur between the two maps, and the Landslide Inventory Map shows a small dormant landslide between the two lower lobes of the Flying Triangle Landslide. This map also indicates the proposed offsite access drive to be within the Flying Triangle Landslide.

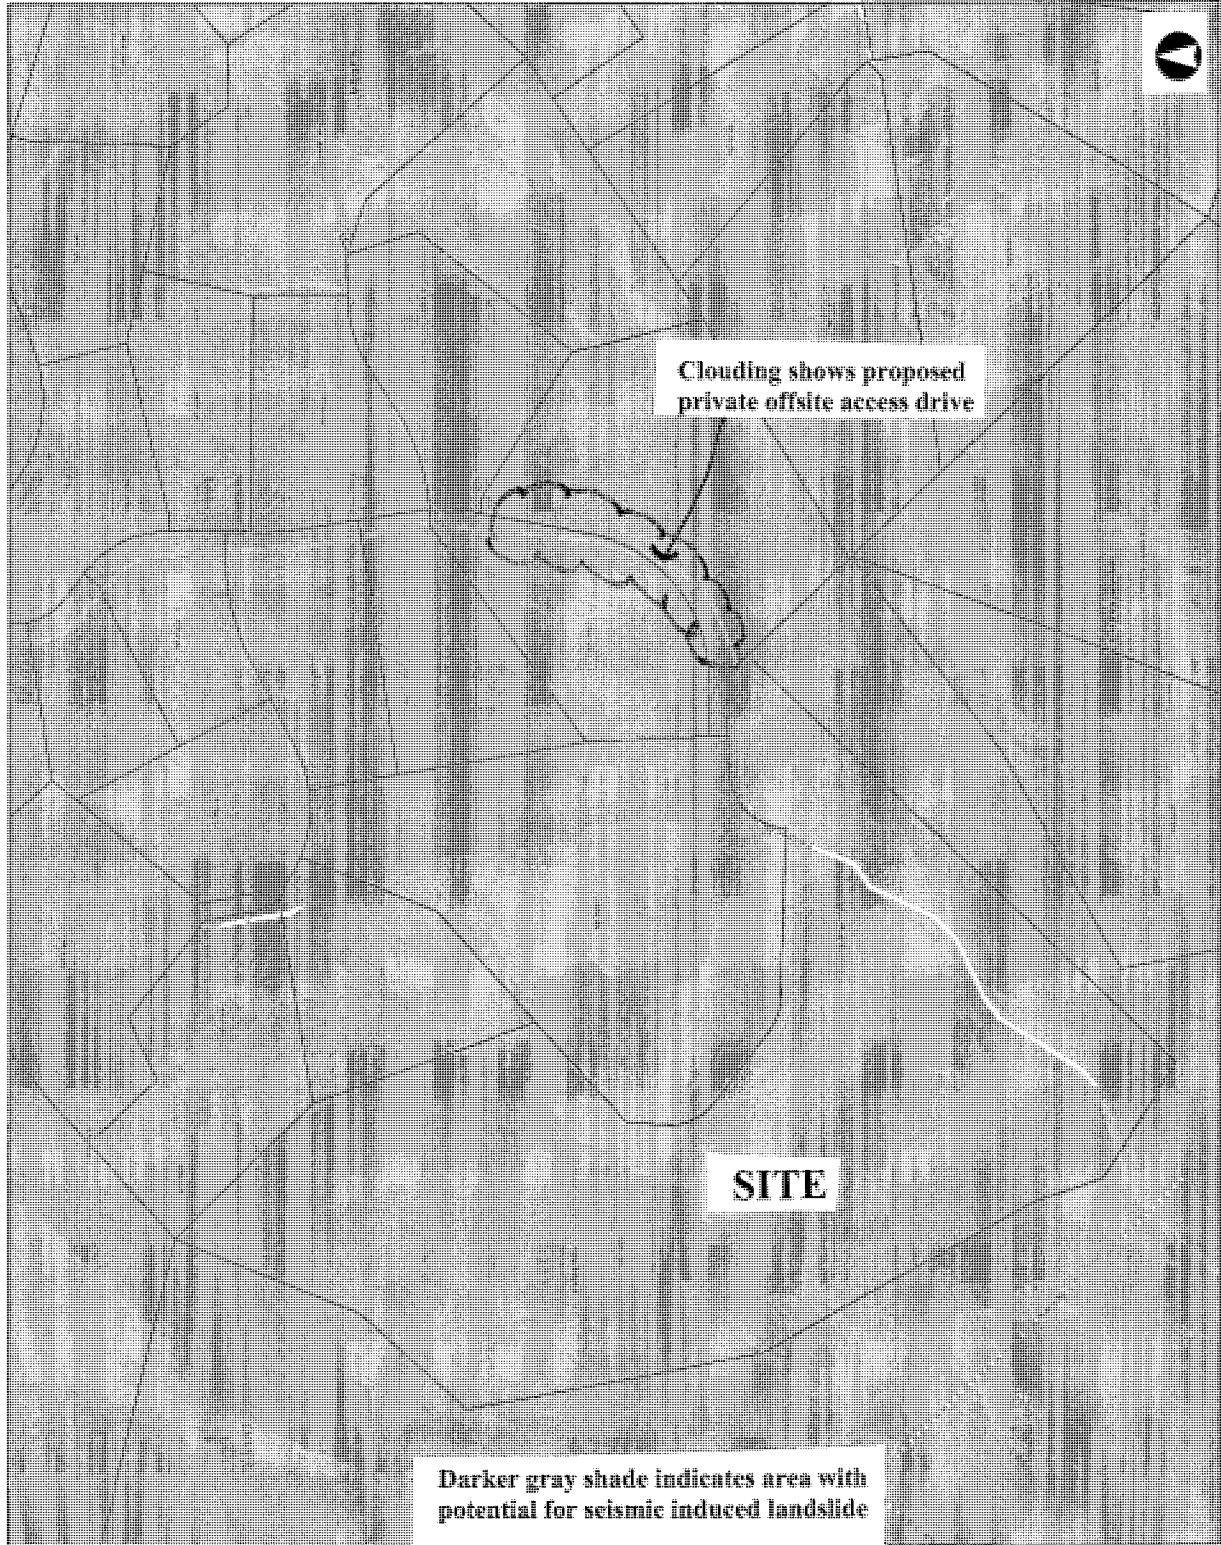
Figure 3

# Los Angeles County GIS Viewer

Darker gray shade indicates area with potential for seismic induced landslide

Clouding shows proposed private offsite access drive

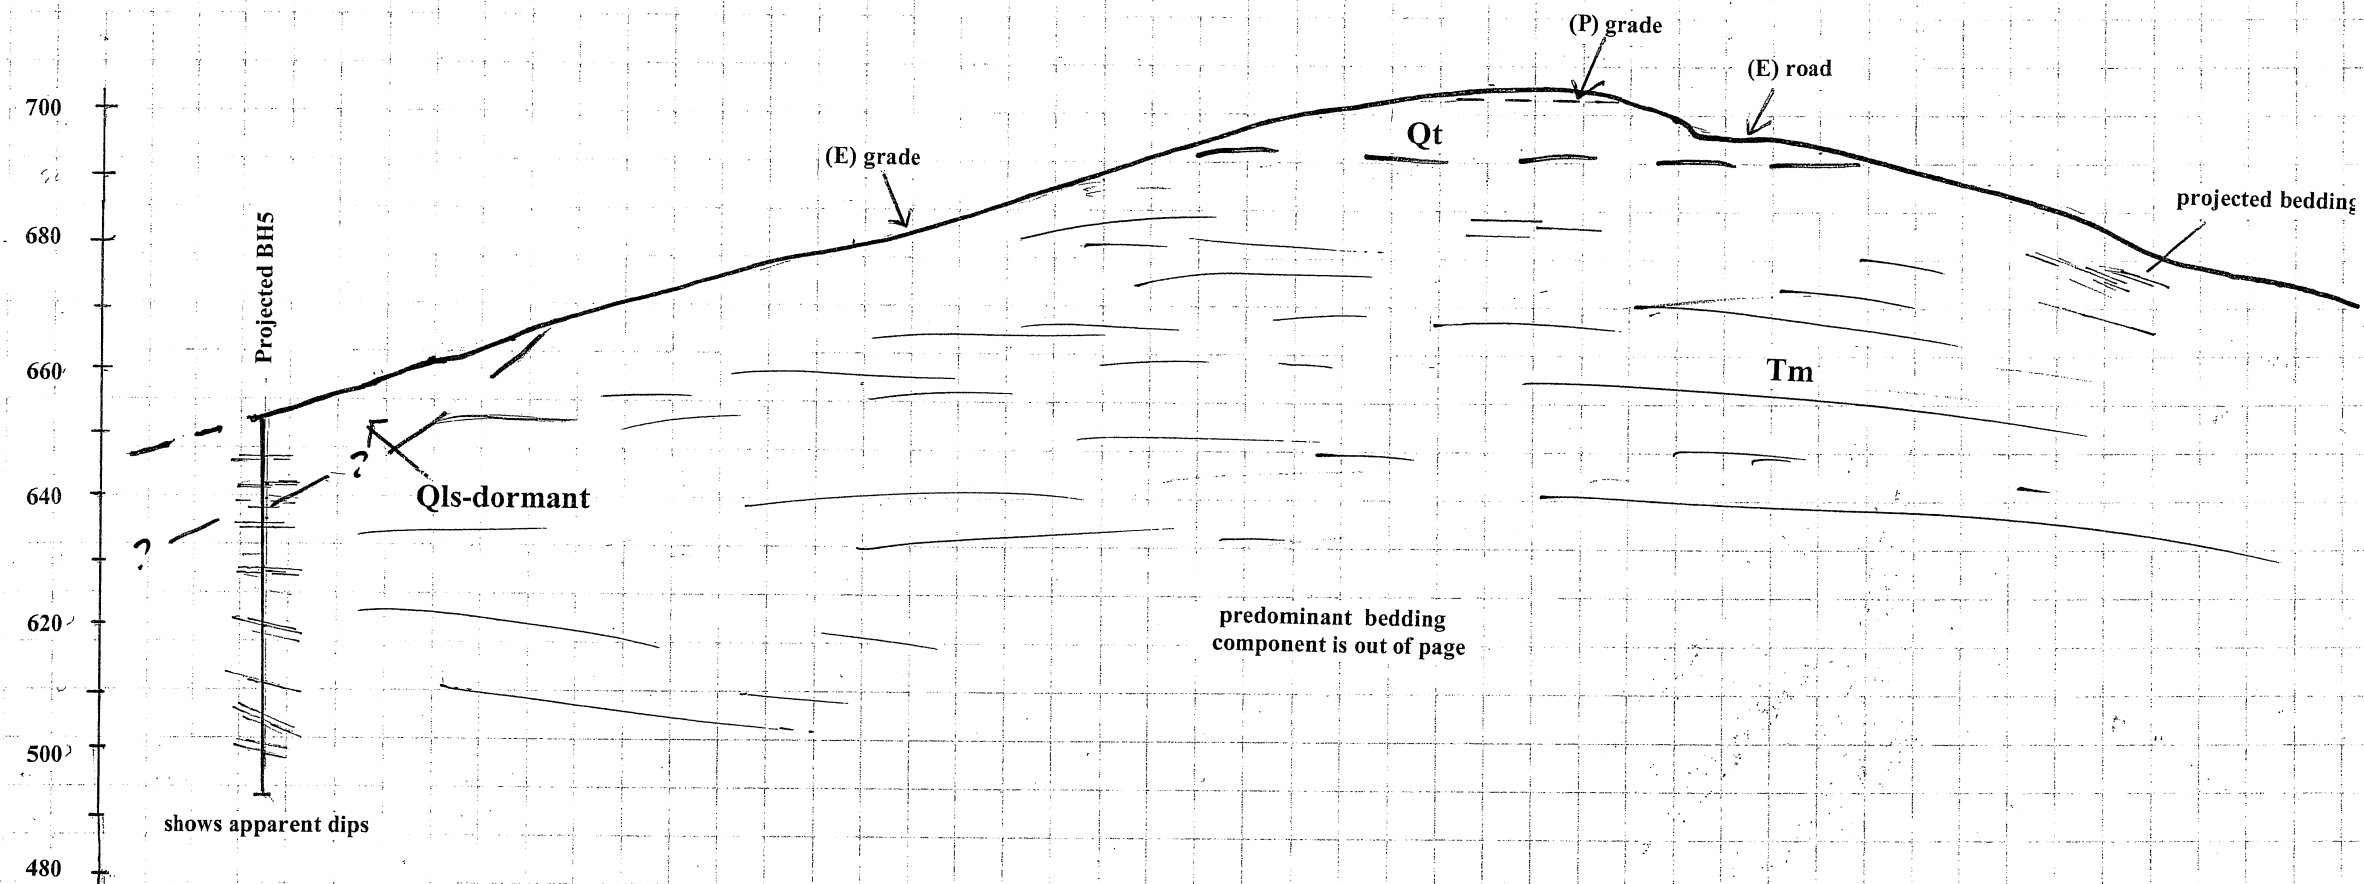
GEOLOGIC SECTION E-E'

Scale 1" ~ 30ft.(H=V)

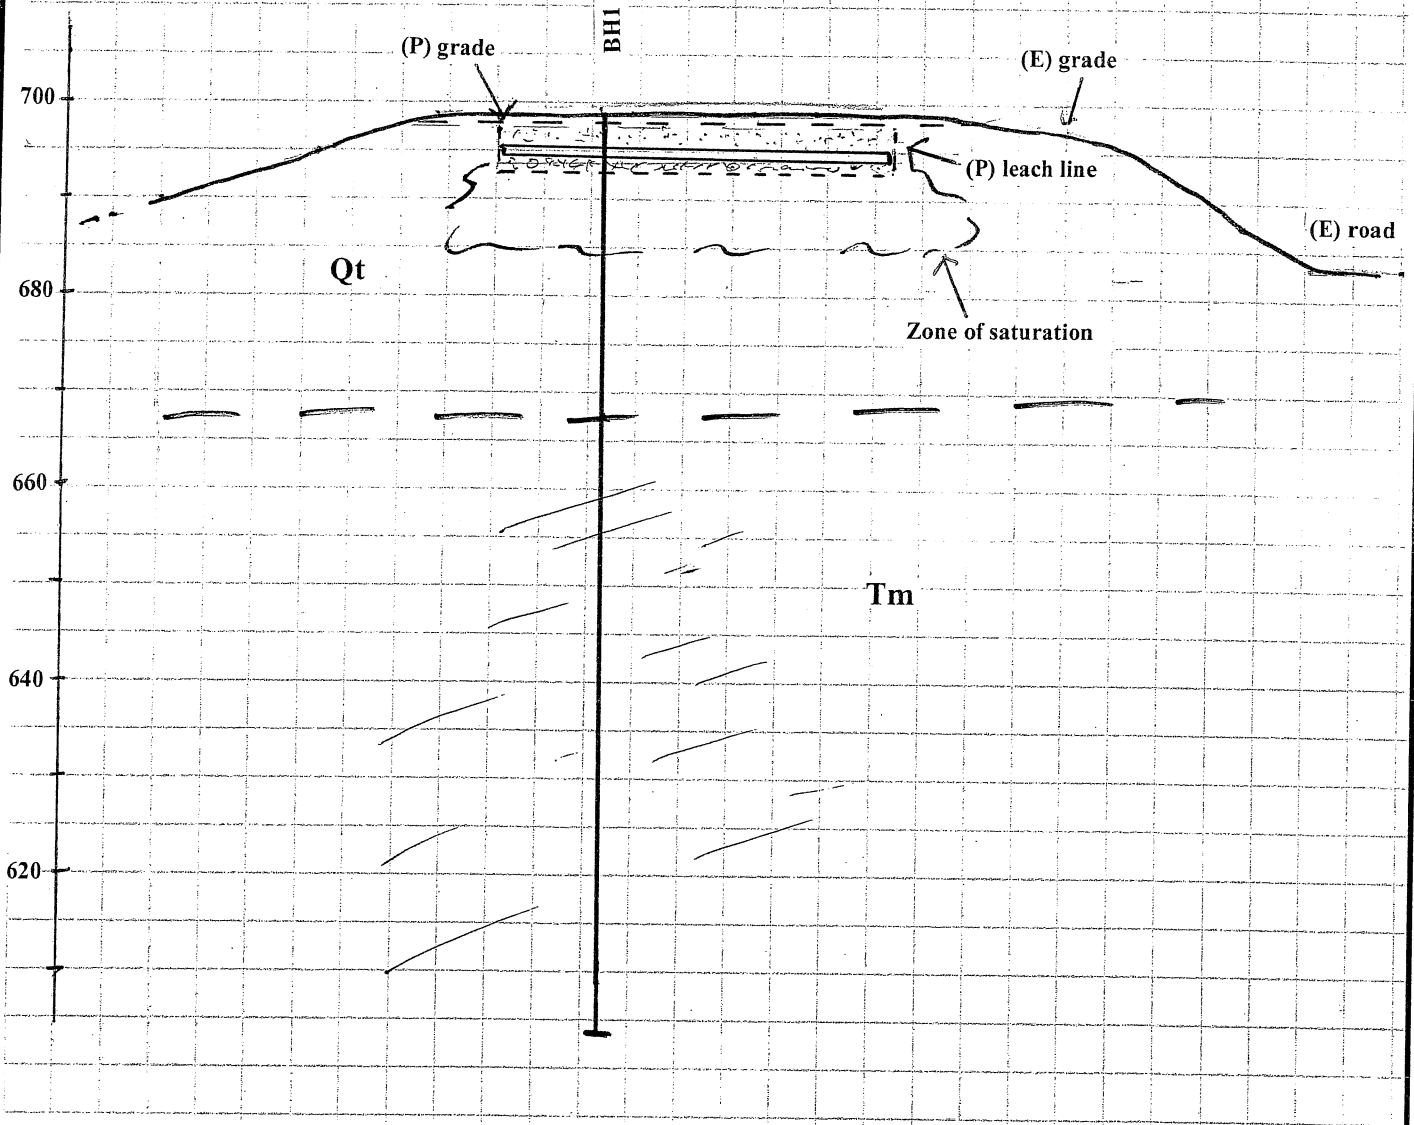
# GEOLOGIC SECTION F-F'

Scale 1" ~ 20ft.(H=V)
