# AQUATIC RESOURCE DELINEATION REPORT

LAKEVIEW ESTATES (APN 051-411-20)  
WATSONVILLE, SANTA CRUZ COUNTY, CALIFORNIA

MAY 2018

Tom Mahony, MS, PWS  
Certified Professional Wetland Scientist #2567  
Coast Range Biological LLC  
PO Box 1238  
Santa Cruz, CA 95061  
(831) 426-6226  
coastrange@sbcglobal.net

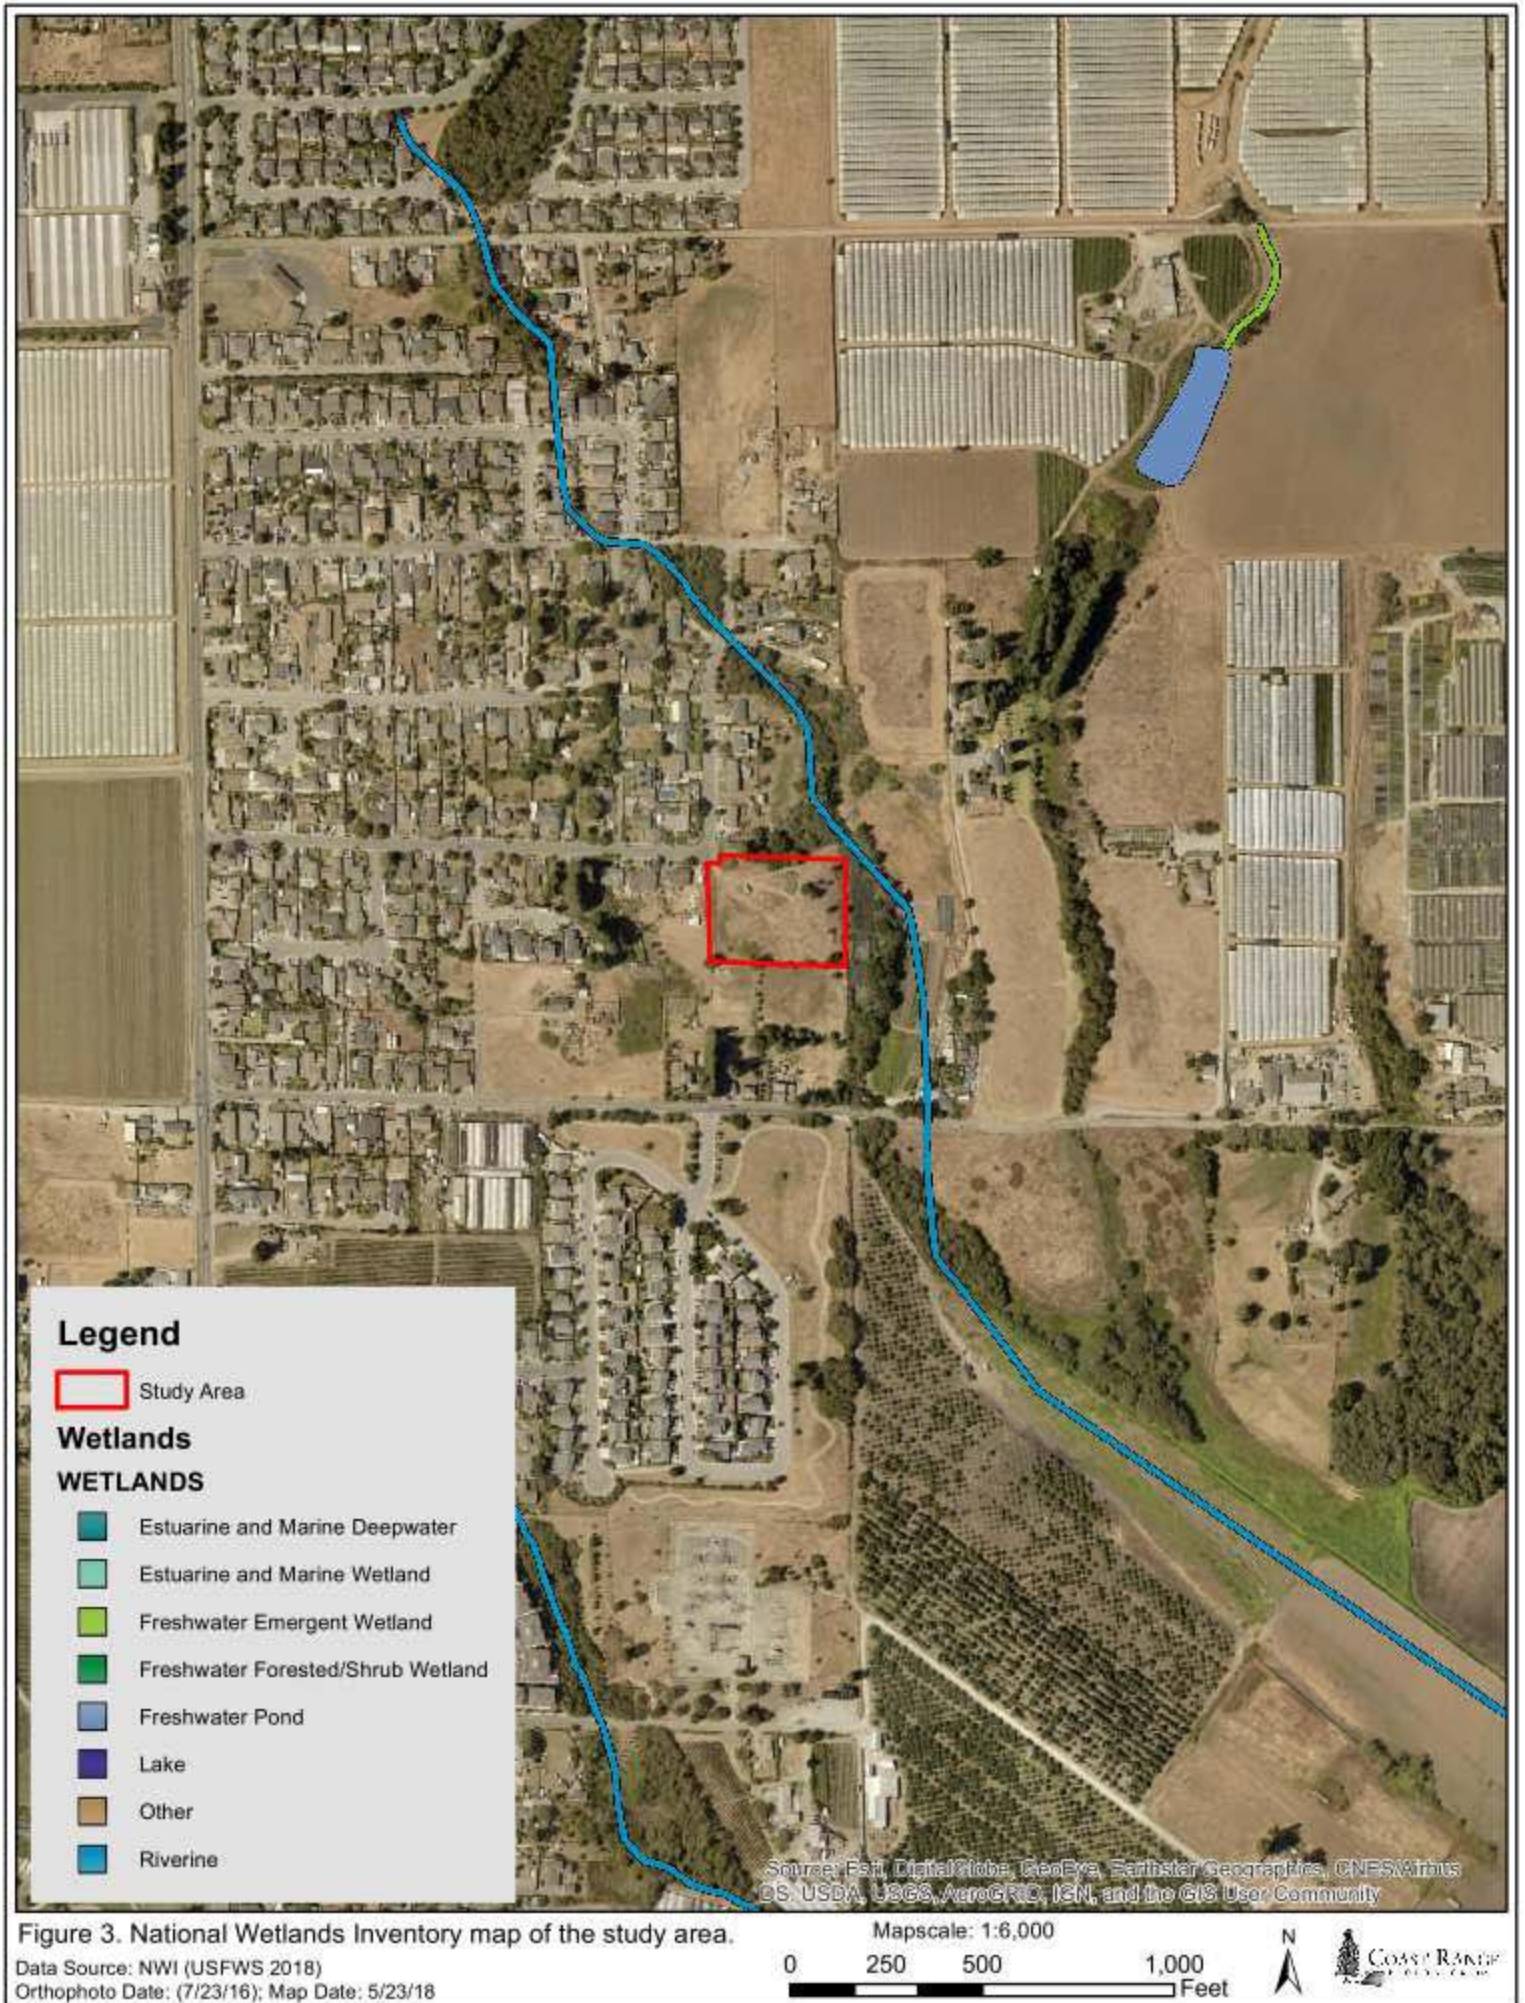
Figure 3. National Wetlands Inventory map of the study area.

Data Source: NWI (USFWS 2018)  
 Orthophoto Date: (7/23/16); Map Date: 5/23/18

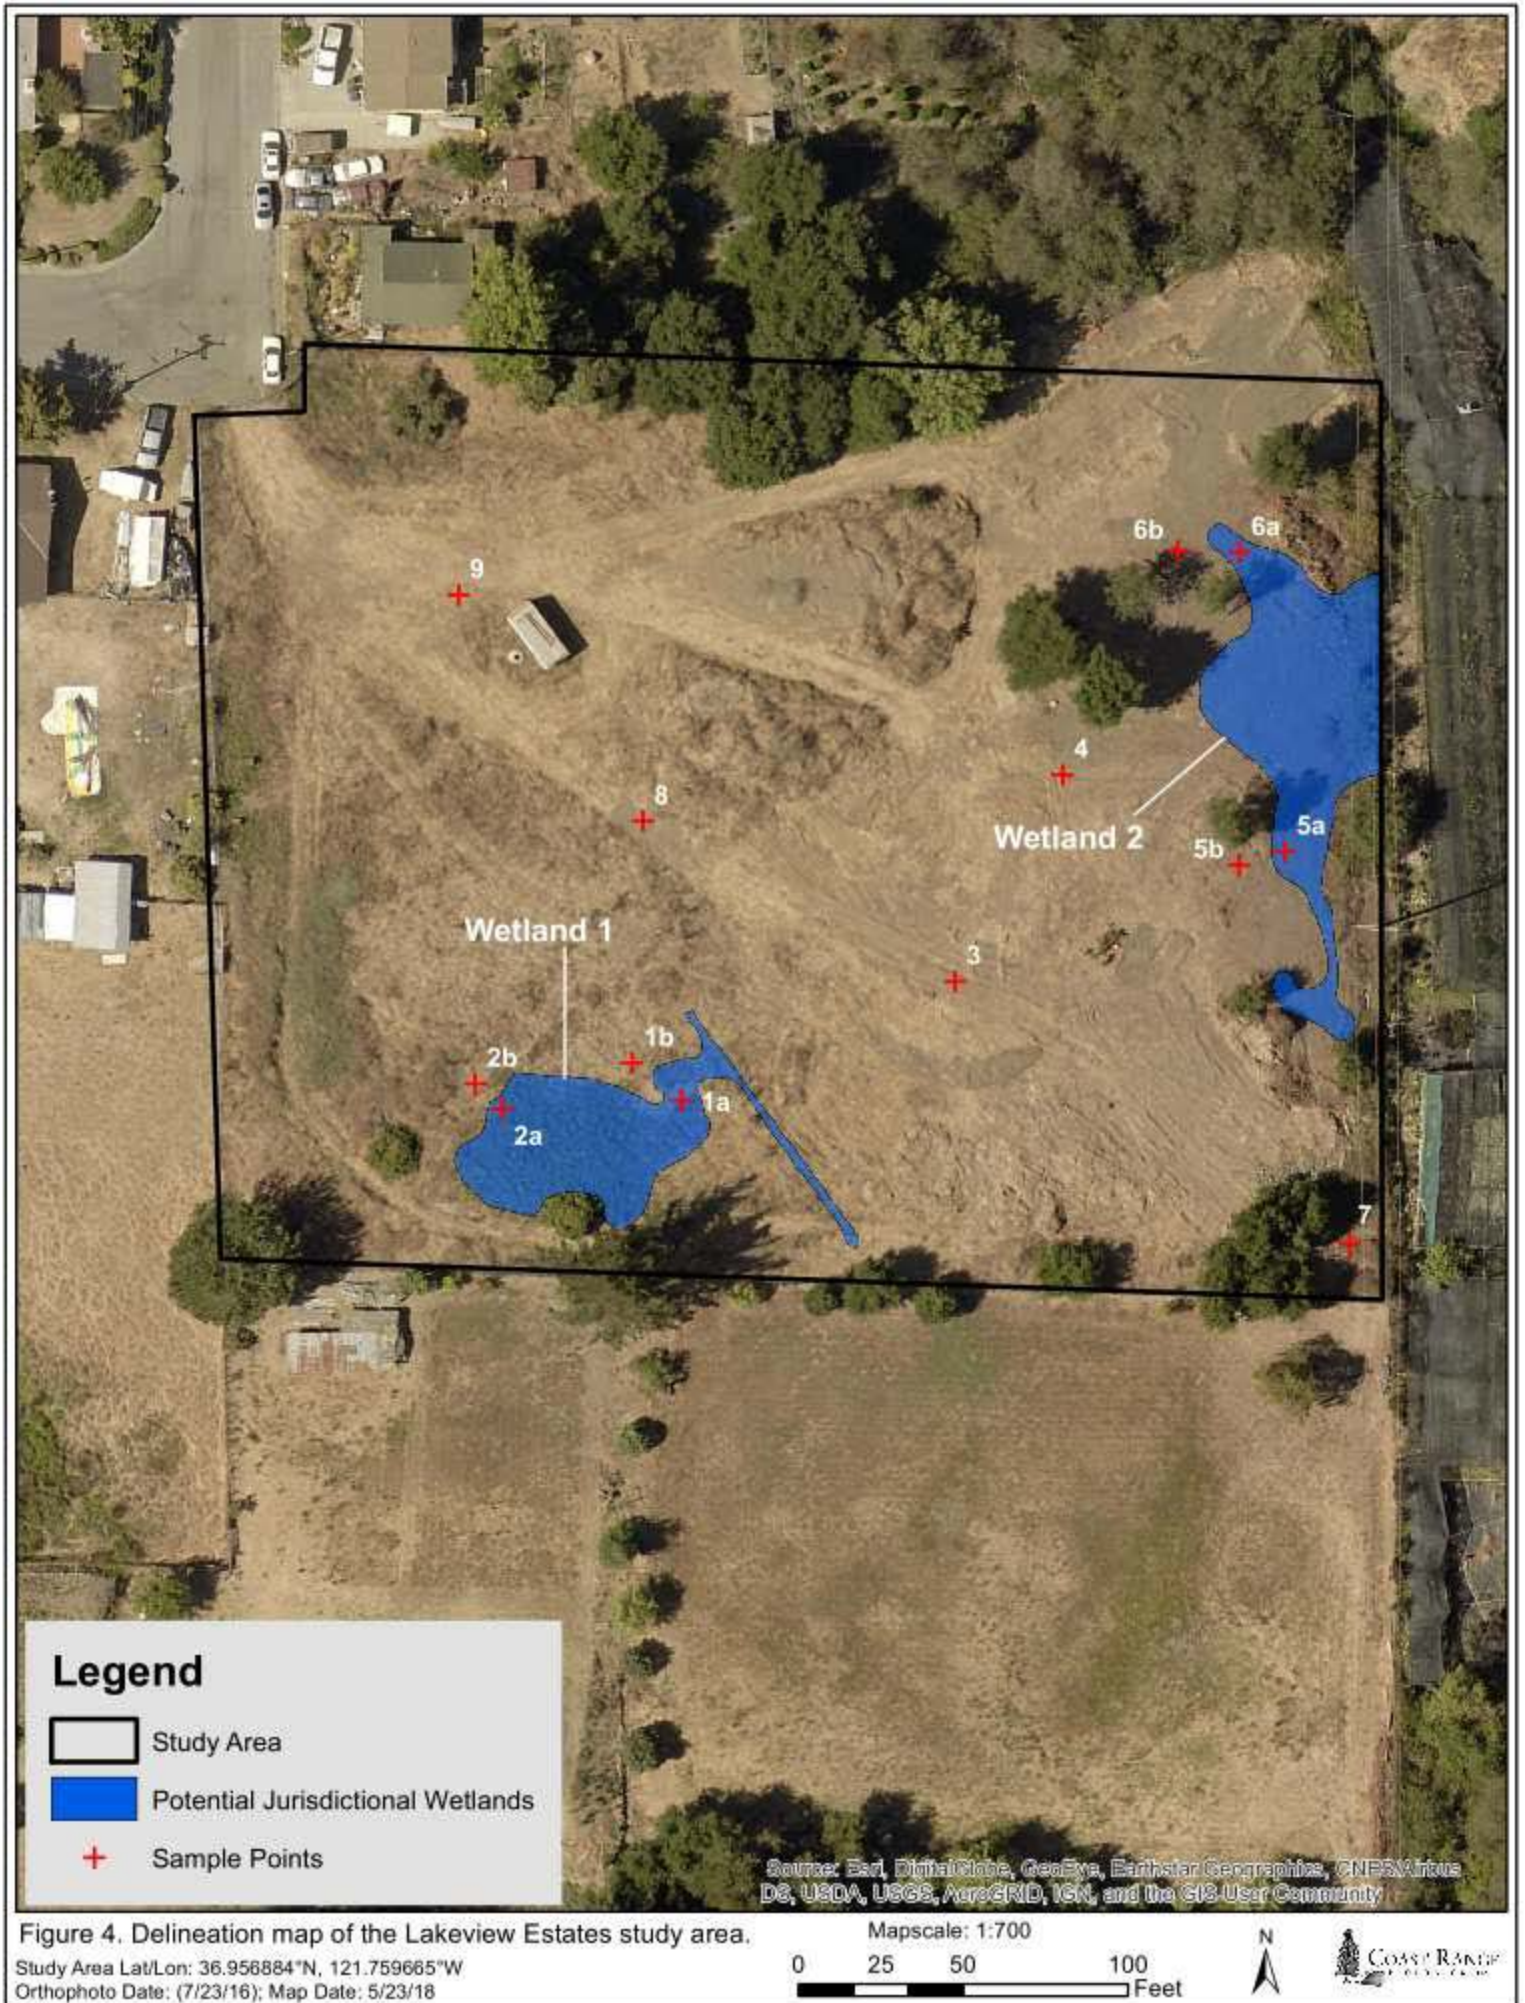
Figure 4. Delineation map of the Lakeview Estates study area.

Study Area Lat/Lon: 36.956884°N, 121.759665°W  
 Orthophoto Date: (7/23/16); Map Date: 5/23/18

Two potential jurisdictional wetlands were delineated on the study area during the May 22, 2018 delineation. These features are discussed below, summarized in Table 2, and are shown on the map in Figure 4. Delineation datasheets are included in Appendix A, study area photographs are included in Appendix C, and a list of all plant species observed on the study area, and their wetland indicator status, is included in Appendix D.

Wetland 1 covers 2,774 ft<sup>2</sup> (0.06-acre) and occurs in the southwestern portion of the study area on sloped terrain that appears to receive surface and near-surface runoff from upslope (Table 2; Figure 4; Appendix C-1, C-3). Wetland 1 is dominated by hydrophytic vegetation, including spreading rush and Himalayan blackberry (Sample Points 1a, 2a). Hydric soil indicators are present throughout Wetland 1, such as Redox Dark Surface (F6), as well as wetland hydrology indicators, including Sediment Deposits (B2), Surface Soil Cracks (B6), Drainage Patterns (B10), and Shallow Aquitard (D5). The shallow aquitard (heavy clay layer) observed in this area may be perching water and contributing to wetland hydrology. Adjacent uplands occur on slopes above the wetland, and are dominated by upland species such as wild oats, riggut brome, and hairy vetch (Appendix C-2). These uplands lack wetland hydrology and hydric soil indicators (Sample Point 2b), or contain some hydric soil indicators, presumably due to the aforementioned shallow aquitard that perches water near the surface, but of insufficient duration to produce wetland hydrology (Sample Point 1b).

Wetland 2 drains southbound along the eastern study area boundary. Though wetland indicators cease at the southern delineated wetland boundary (Figure 4), drainage likely continues as sheet flow through concave topography toward the southeastern study area boundary. No culverts, channels, or other obvious concentrated discharge areas were observed, but drainage likely continues off the study area toward the south and east as surface sheet flow and/or near-surface flow toward the offsite creek. The creek flows southbound, east of the study area, and eventually to Corralitos Creek, Salsipuedes Creek, and the Pajaro River, which discharges into the Monterey Bay, a TNW.

Two potential jurisdictional wetlands were delineated on the study area during the May 22, 2018 delineation (Table 2; Figure 4). Though no direct, concentrated hydrologic connection (such as a culvert or channel) between the wetlands and the offsite creek was observed, they could be hydrologically connected via surface sheet flow and/or near-surface or subsurface flow. However, the creek is located on private property east of the study area, and therefore a more detailed investigation of hydrologic connections was not conducted. The Corps would need to make a determination on the jurisdictional status of both potential jurisdictional wetlands.

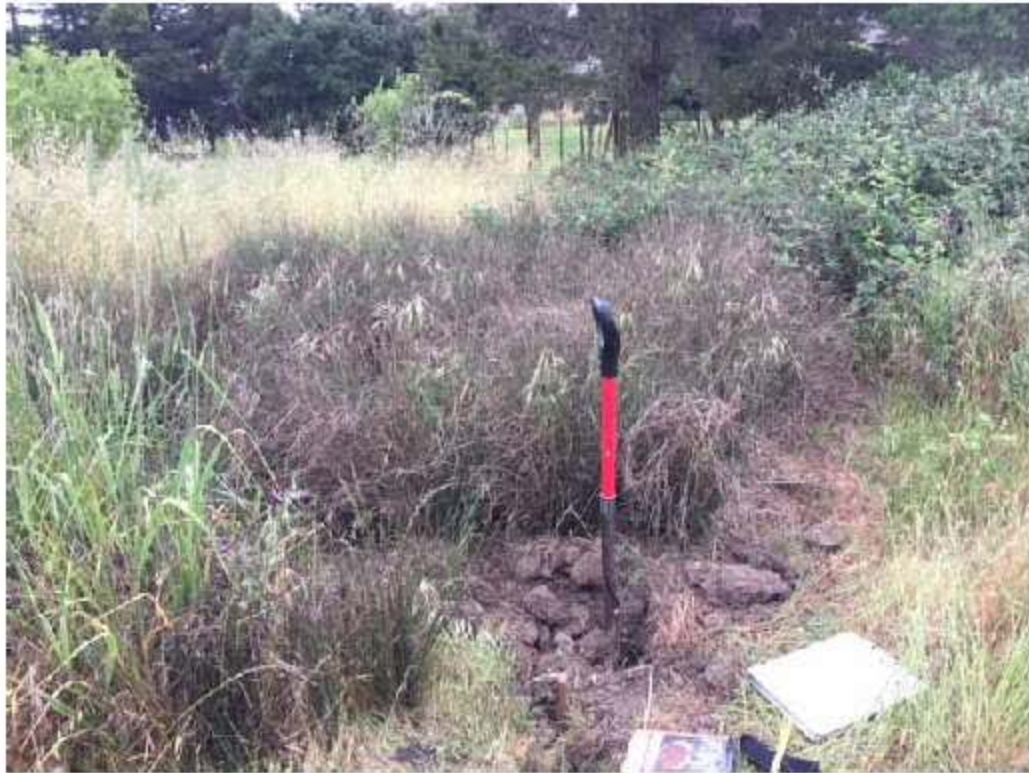
Appendix C-1. Wetland I dominated by spreading rush at Sample Point 1a.

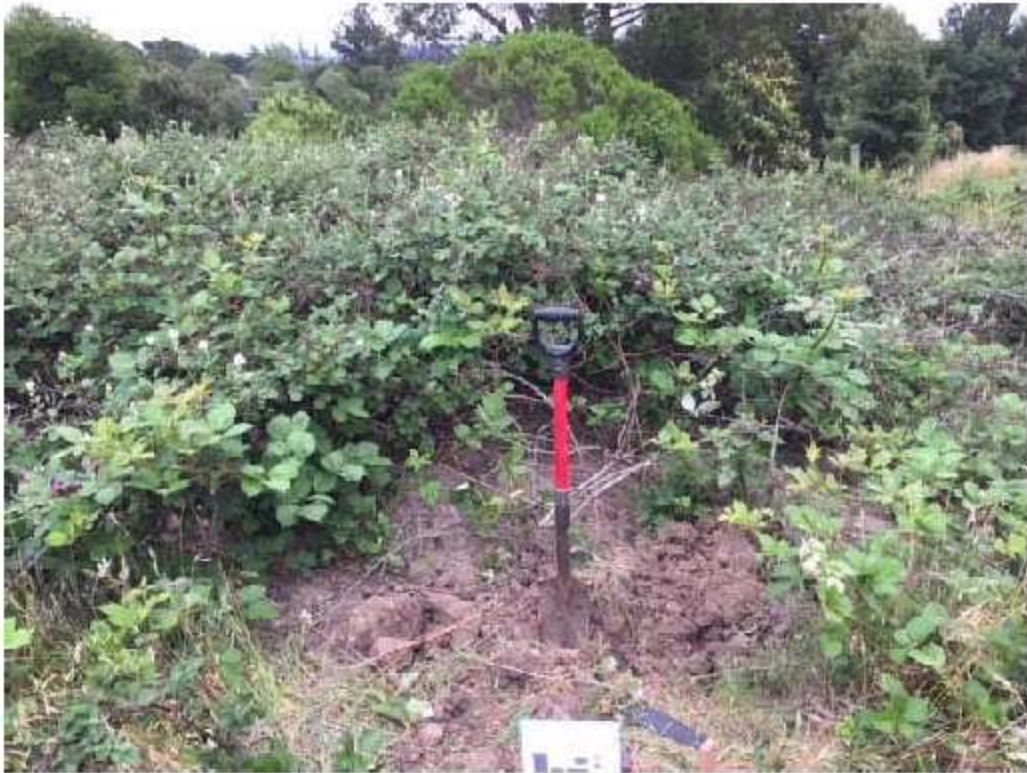
Appendix C-3. Wetland 1 dominated by Himalayan blackberry at Sample Point 2a.

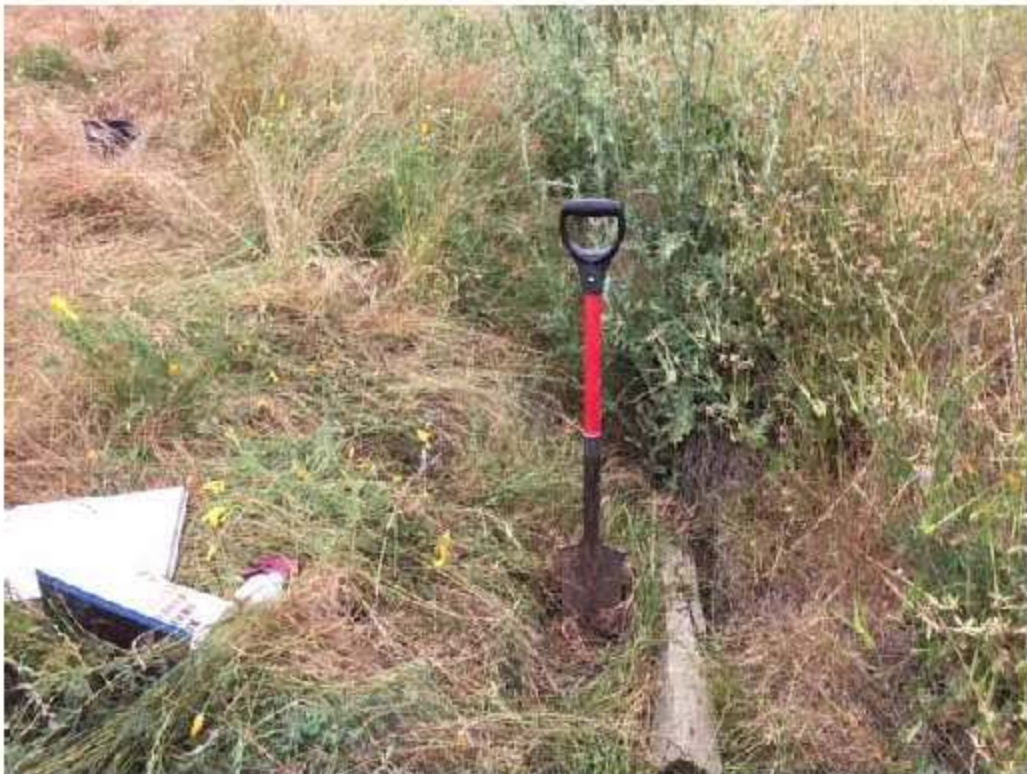
Appendix C-4. Man-made drainage ditch lacking an OHWM and positive indicators of all three wetland parameters at Sample Point 3.

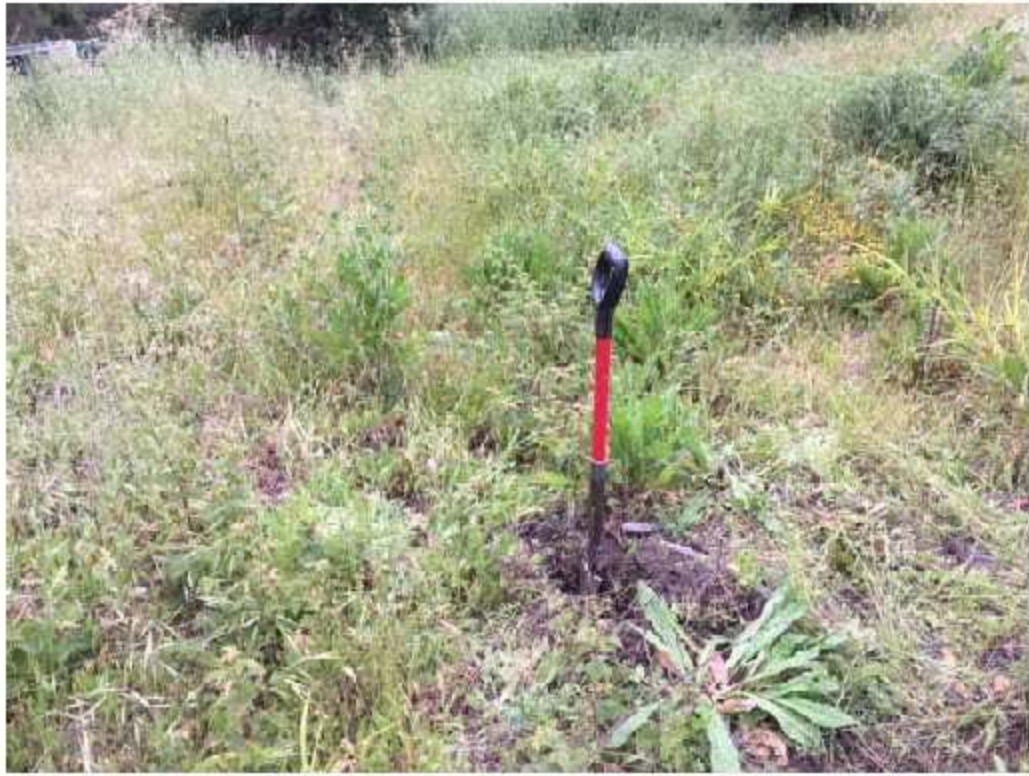
Appendix C-5. Wetland 2 in shallow swale at Sample Point 5a.

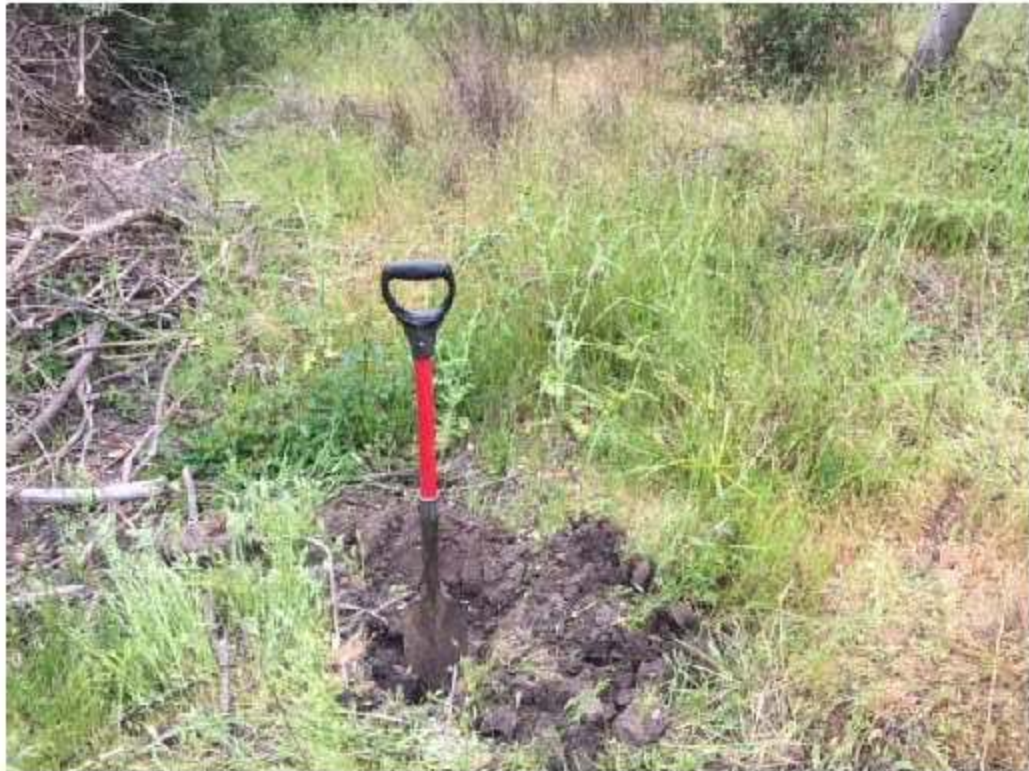
Appendix C-6. Wetland 2 in shallow swale at Sample Point 6a.

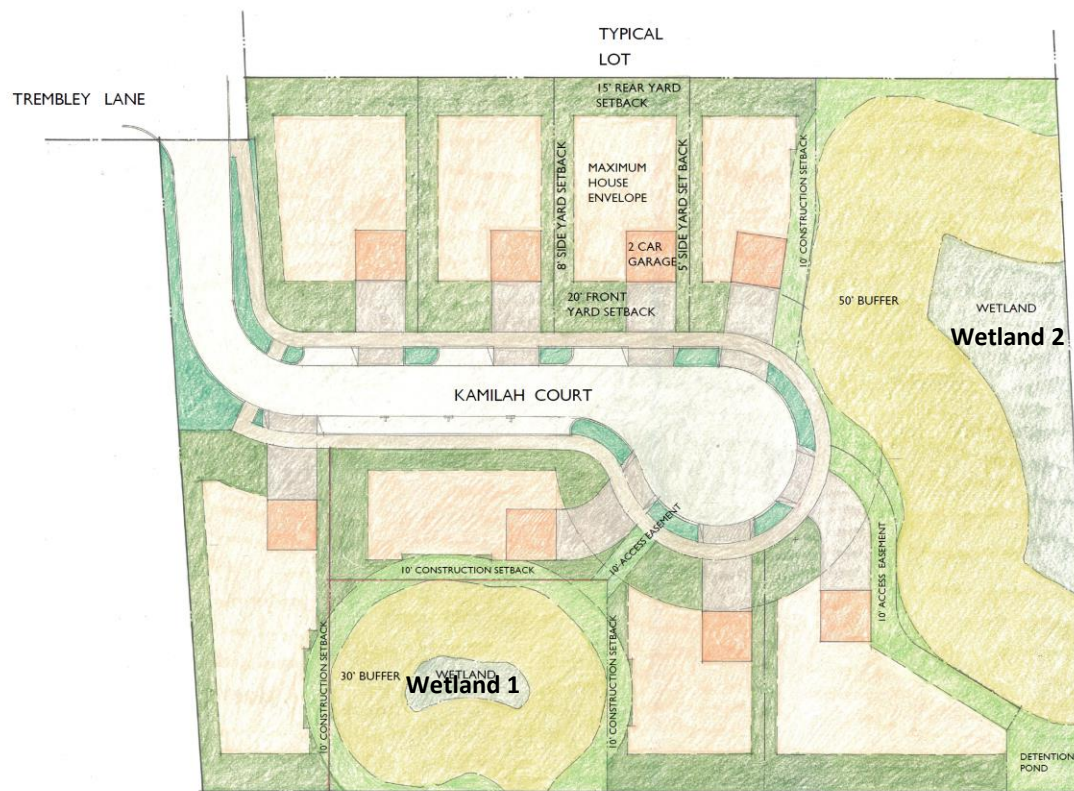
Figure 3. Applicant Site Plan, Showing Proposed Buffers to Wetland 1 and Wetland 2

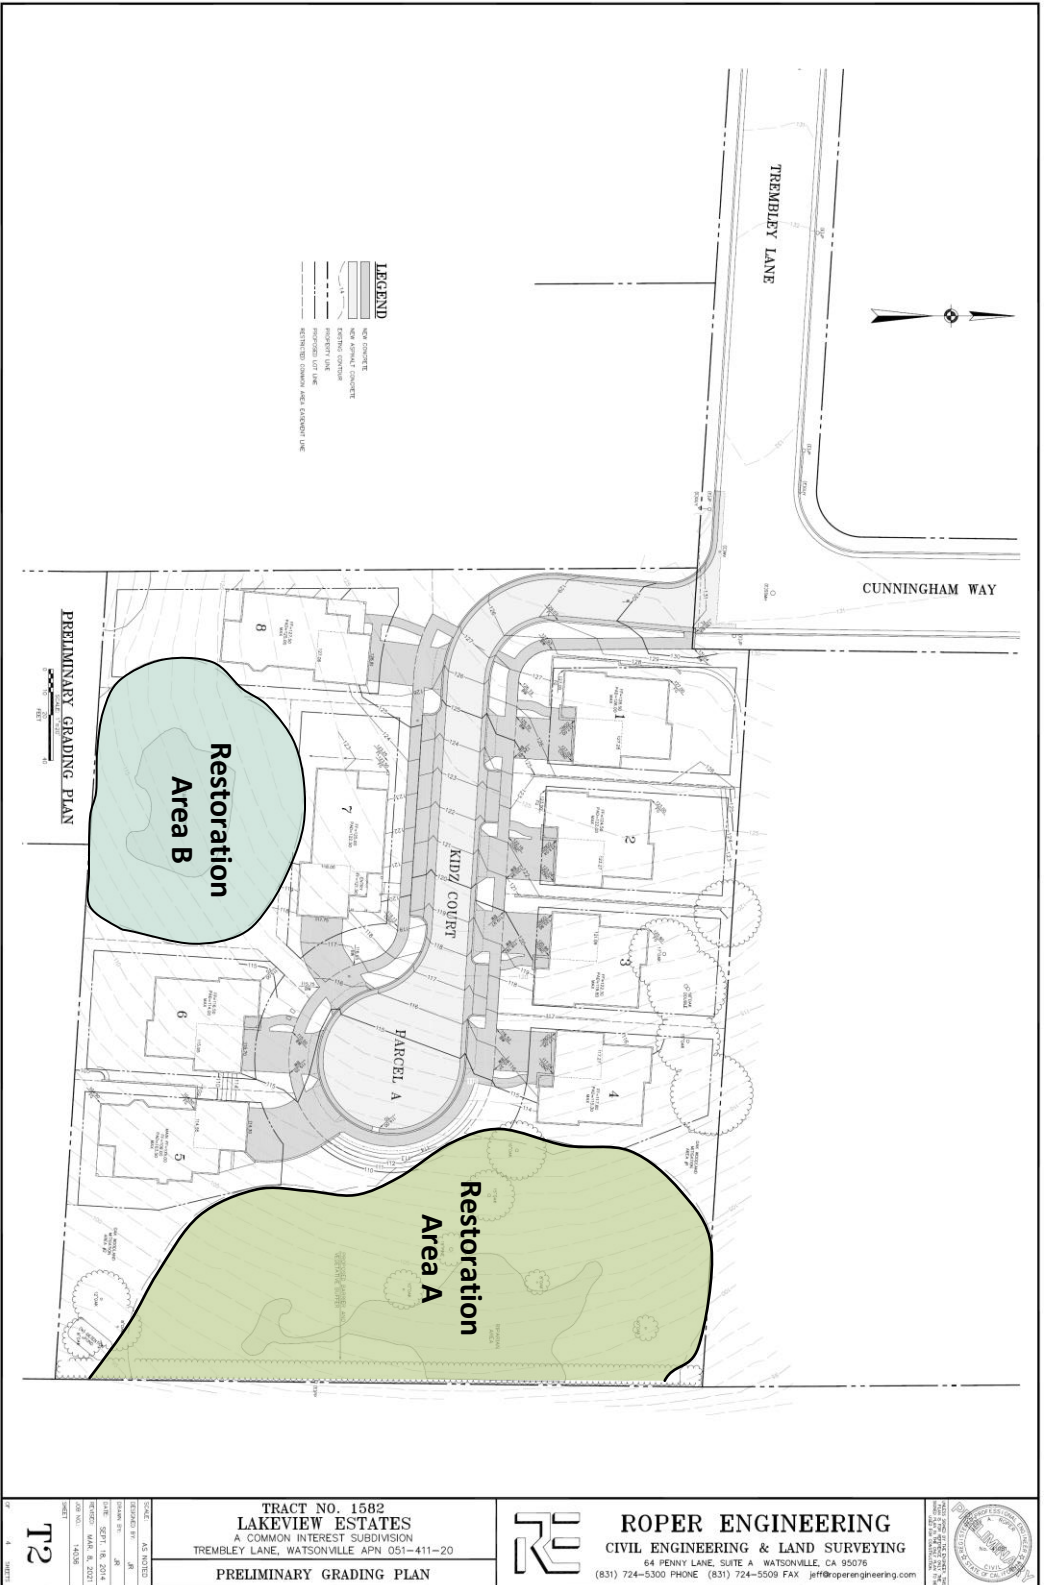
**Figure 1. Location of Restoration Areas on Project Grading Plan**  
(Map Source: Lakeview Estates Preliminary Grading Plan, Roper Engineering, dated 3-8-21)

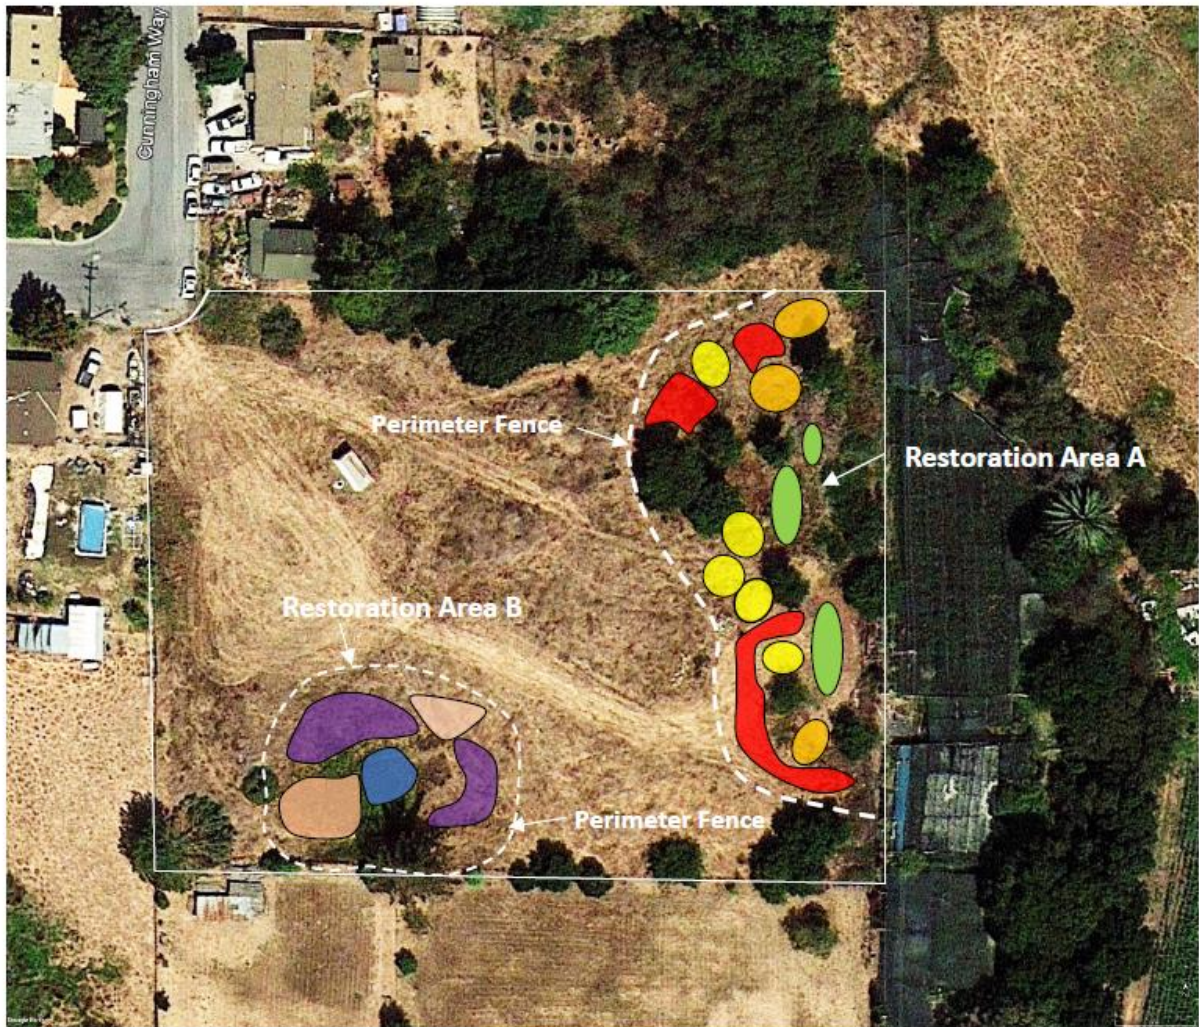
<b>Restoration Area A</b>	
<span style="color: yellow;">●</span>	Coast Live Oak
<span style="color: orange;">●</span>	Box Elder
<span style="color: red;">●</span>	Restoration Area A Shrub Mix
<span style="color: lightgreen;">●</span>	Willows
<b>Restoration Area B</b>	
<span style="color: cyan;">●</span>	Spreading Rush
<span style="color: purple;">●</span>	California Aster
<span style="color: peachpuff;">●</span>	California Rose

**Figure 3. Conceptual Revegetation Within Revegetation Areas**

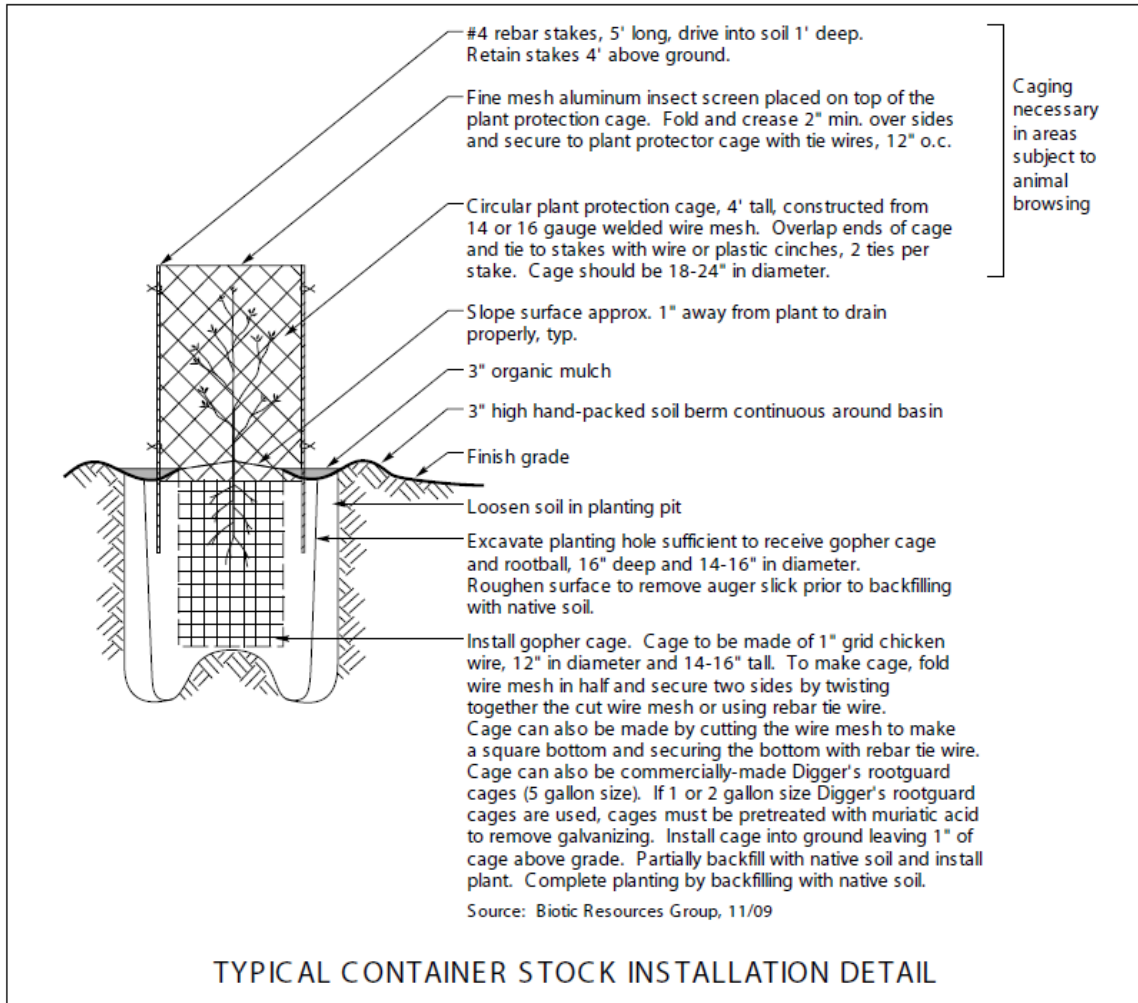
**Figure 4. Typical Plant Installation Detail**

(Note: adjust sizes to accommodate 5-gallon containers, as needed)

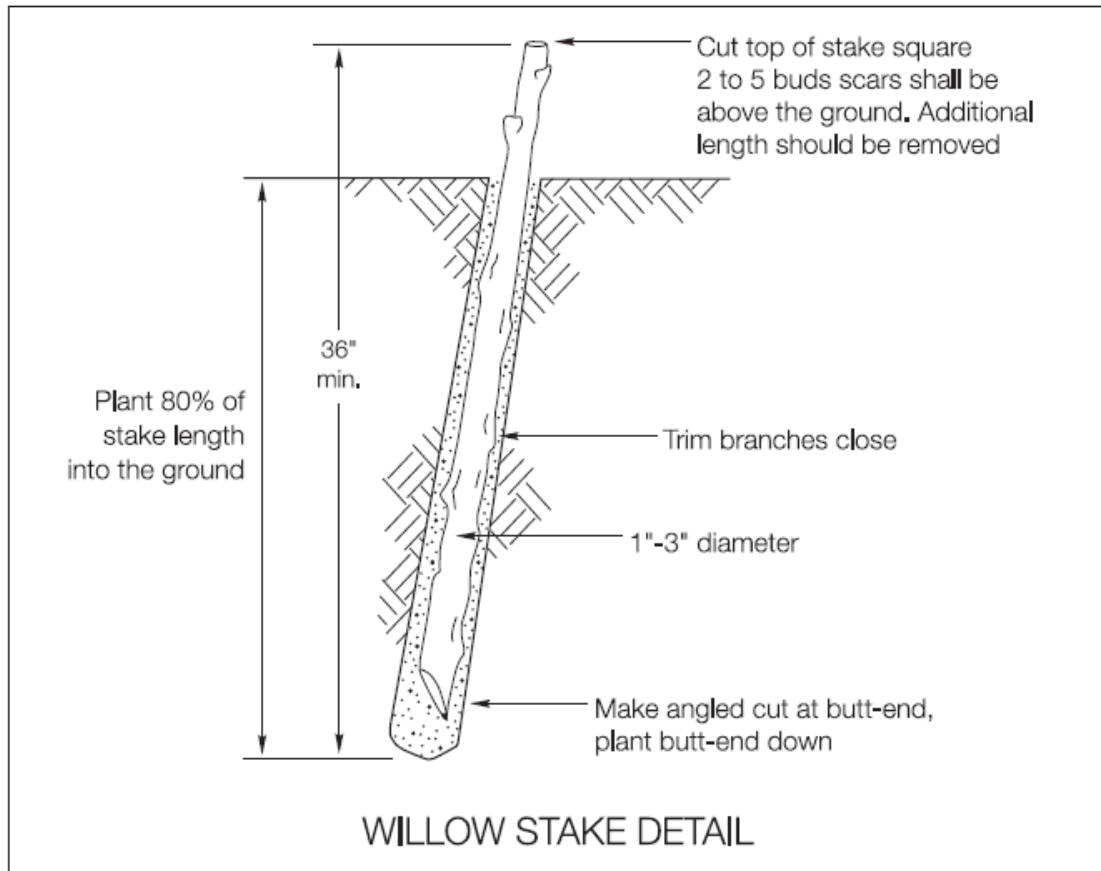
**Figure 5. Typical Willow Stake Detail**

**Willow Stake Installation.** Willow stakes will be installed on the lower slope, yet upslope and away from the overhead power lines. The willows will be installed between existing oak trees such that a continuous wooded canopy will be created along the creek. Where willows are installed amid existing California blackberry thickets, a 3-foot diameter area of blackberry will be cleared and the willow stakes installed. The stakes will be installed such that 80% of the stake is in the ground. A drip emitter will service each stake. The willow stake detail is depicted in Figure 5.

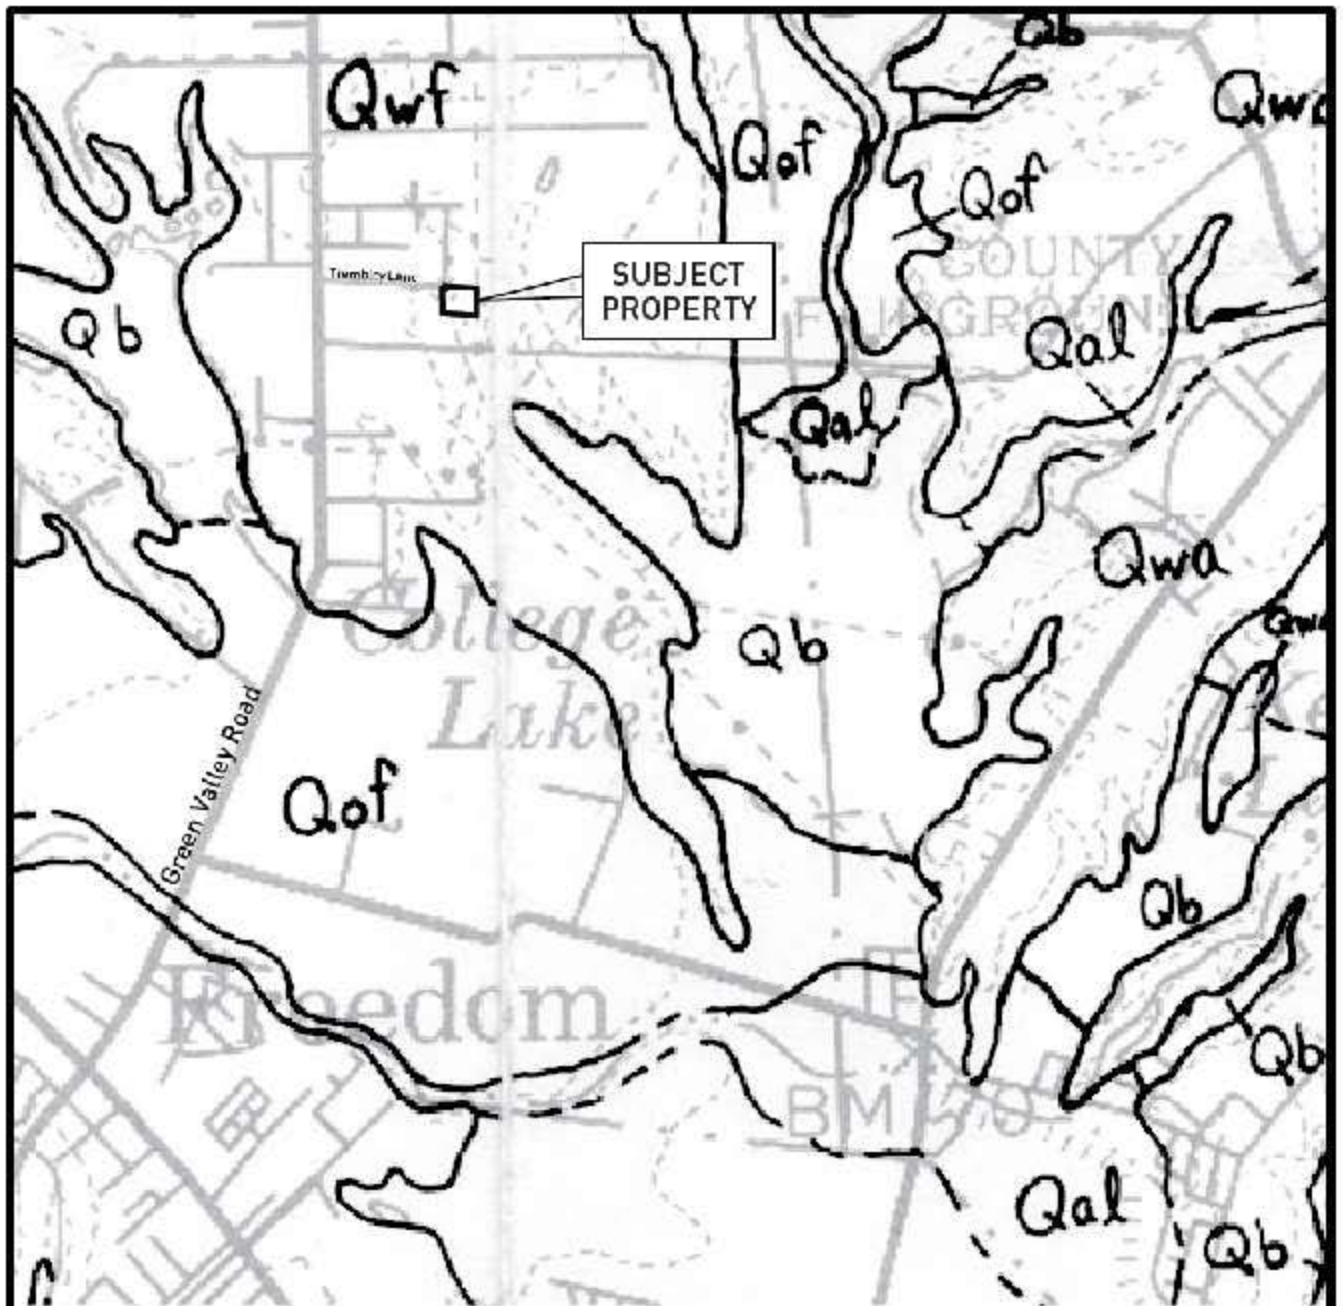
**FIGURE #**  
**3**  
 JOB #  
 G15021

- Qb Basin Deposits
- Qal Alluvial Deposits
- Qof Older Floodplain Deposits
- Qwf Terrace Deposits of Watsonville - fluvial facies
- Qwa Terrace Deposits of Watsonville - alluvial fan facies

**LOCAL GEOLOGIC MAP**  
 Farhat Property  
 Trembley Lane  
 Watsonville, California  
 Santa Cruz County APN 051-411-20

The Site Location Map (Figure 1), Local Geologic Map (Figure 3), Local Fault Map (Figure 4), Alquist-Priolo Earthquake Fault Zone Map (Figure 5), LiDAR and Air Photo Interpretation Map (Figure 6), Site Geologic Map (Plate 1), Geologic Cross Section (Plate 5) and Logs of Trenches (Plates 3 thru 5) depict the relevant topographic and geologic information on the subject property.

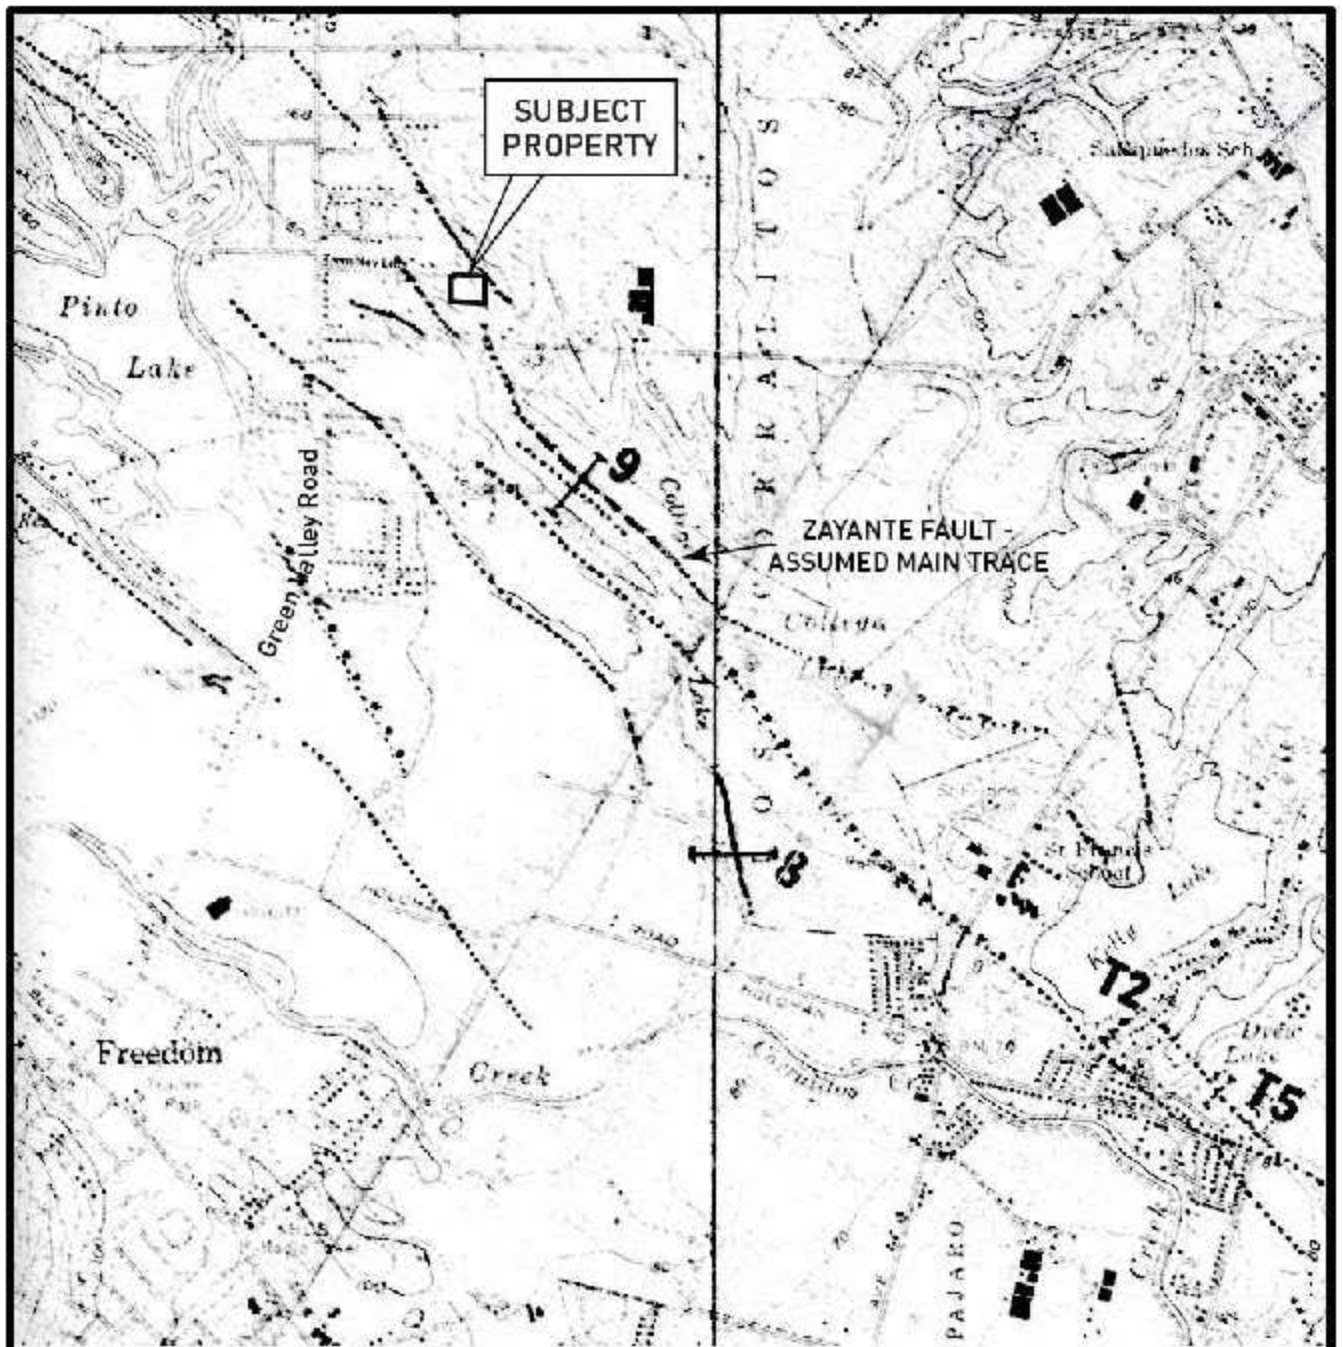
**FIGURE #**  
**4**  
 JOB #  
 G15021

-   Probable Fault Trace
-

**LOCAL FAULT MAP**  
 Farhat Property  
 Trembley Lane  
 Watsonville, California  
 Santa Cruz County APN 051-411-20
