# AQUATIC RESOURCE DELINEATION REPORT

LAKEVIEW ESTATES (APN 051-411-20)  
WATSONVILLE, SANTA CRUZ COUNTY, CALIFORNIA

MAY 2018

Tom Mahony, MS, PWS  
Certified Professional Wetland Scientist #2567  
Coast Range Biological LLC  
PO Box 1238  
Santa Cruz, CA 95061  
(831) 426-6226  
coastrange@sbcglobal.net

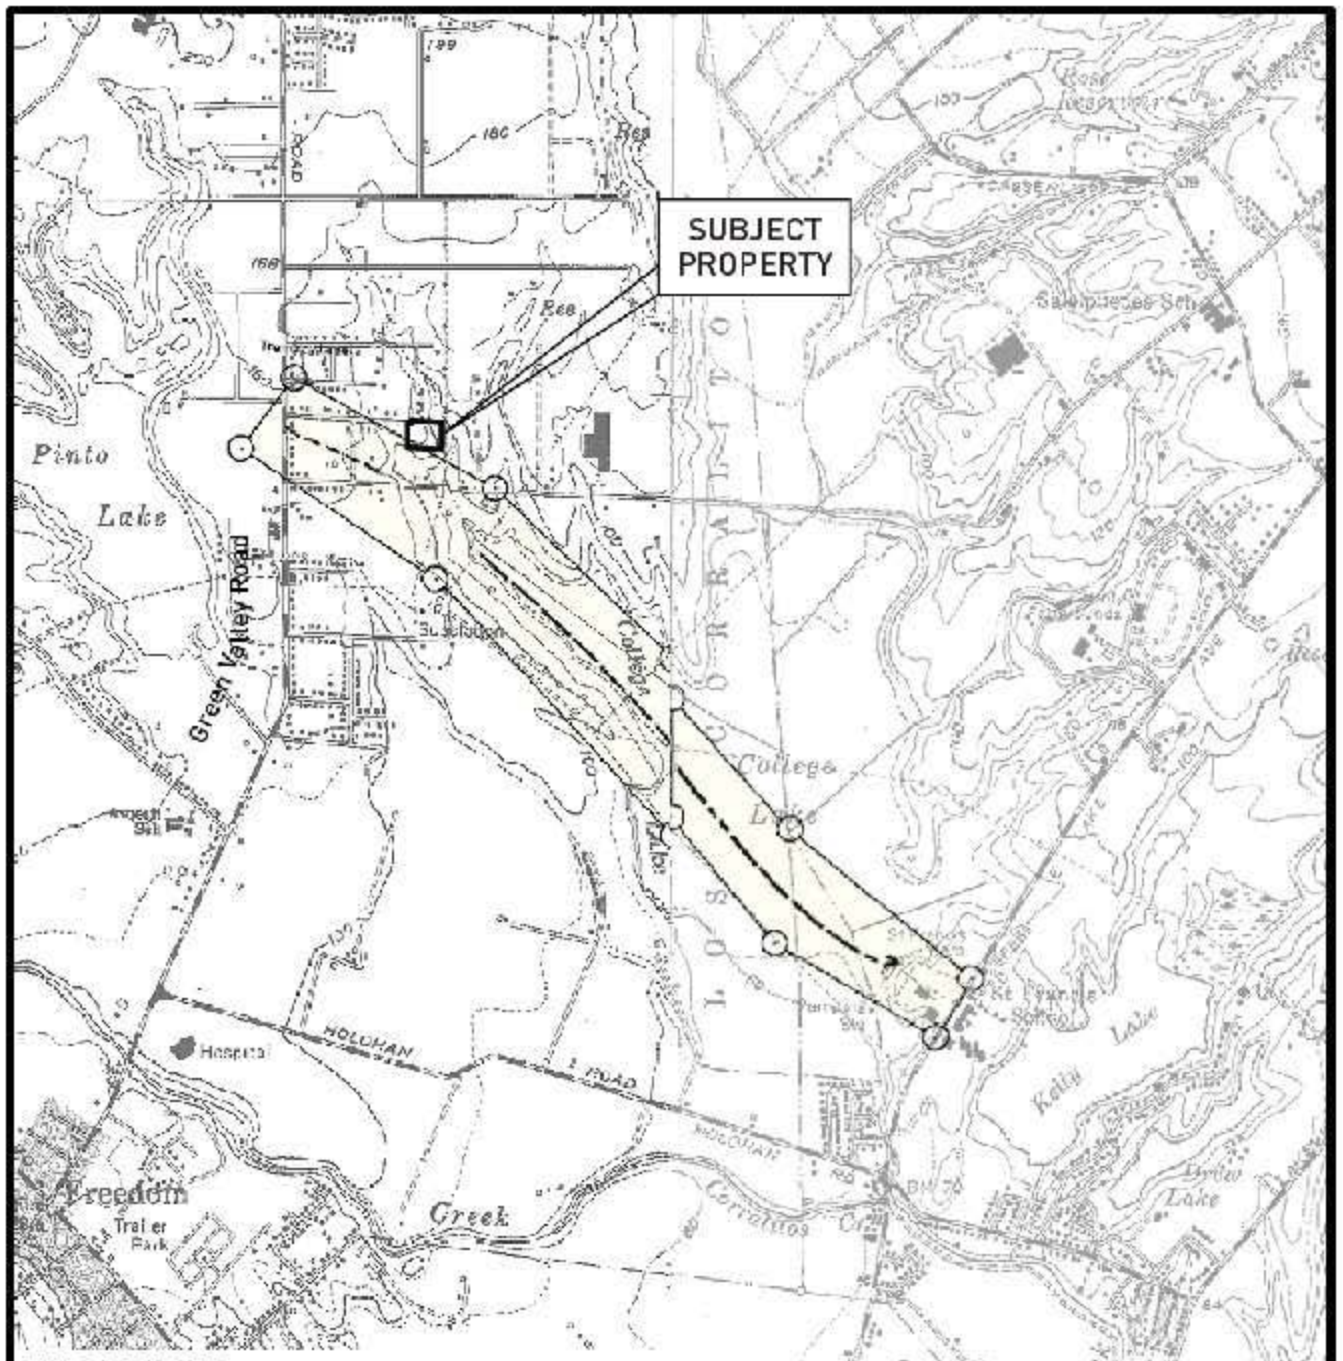
**FIGURE #**  
**5**  
 JOB #  
 G15021

-   AP Fault Zone Boundaries
-   Potentially Active Fault - approximate location
-   Potentially Active Fault - inferred location, queried where uncertain

**ALQUIST-PRIOLO EARTHQUAKE FAULT ZONE MAP**  
 Farhat Property  
 Trembley Lane  
 Watsonville, California  
 Santa Cruz County APN 051-411-20

The Zayante fault zone trends northwest-southeast, immediately southwest of the subject parcel (Figure 5). Vertical displacement across the Zayante fault has gradually lowered the region northeast of the fault, including the subject property, relative to the southwest side. With the long recurrence interval of the Zayante-Vergeles fault and long-term regional uplift and erosion of the area, fault-related surface morphology is little preserved and for the most part has been eroded and overprinted by slope and soil-forming processes.

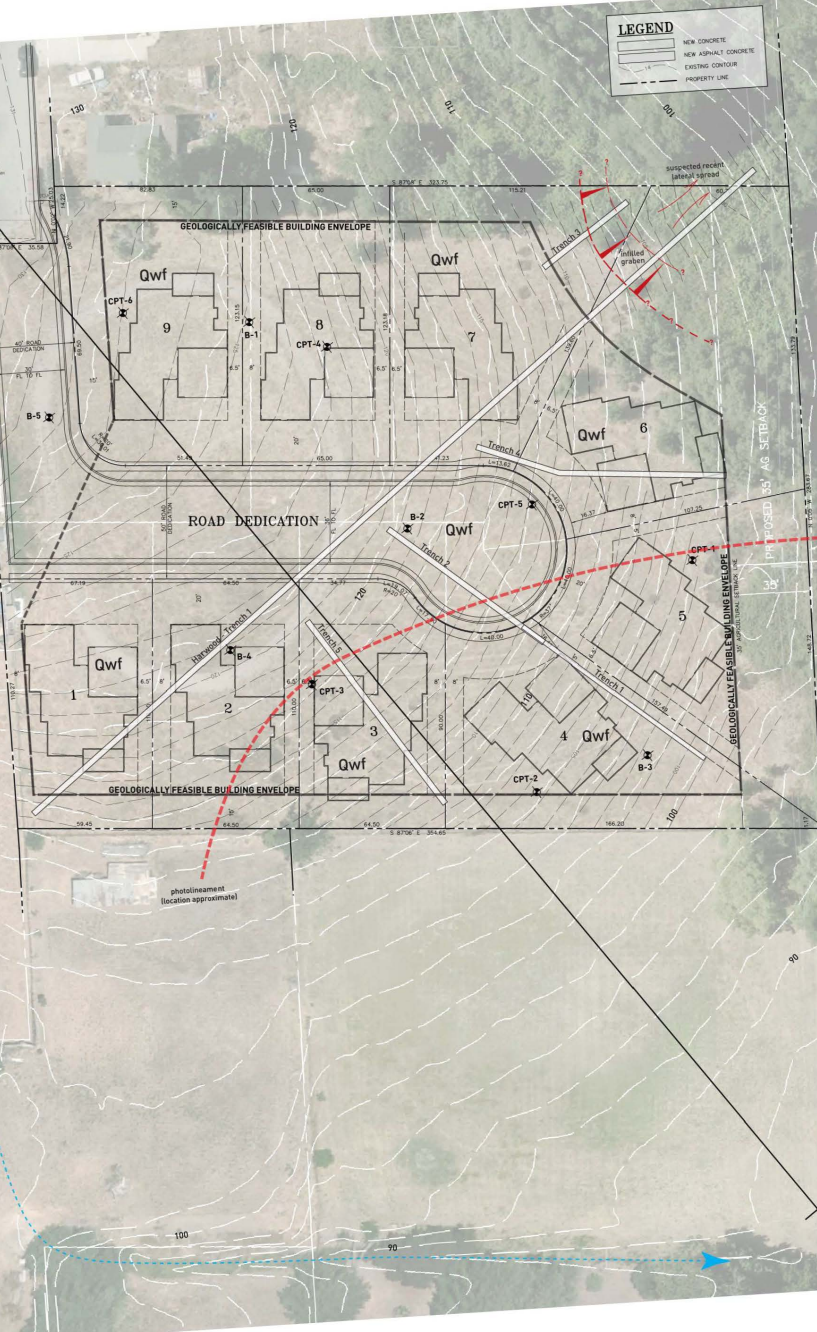
- Symbols**
- Photolineament - suspected lateral spread feature
  - Direction of movement of lateral spread
  - Exploratory trench (excavated and logged July thru October 2016, Easton Geology)
  - Excavated Trench 1 (excavated and logged August 2016, Craig Harwood)
  - Cone penetration test boring (advanced 18 February 2016, Rock Solid Engineering)
  - Exploratory boring (advanced 3 July 2014, Rock Solid Engineering)
  - Geologic cross-section line
  - Streamcourse
  - Earth Materials
  - Watsonville Terrace deposits - fluvial facies

**SITE GEOLOGIC MAP**  
 Farhat Property  
 Fremley Lane  
 Watsonville, California  
 Santa Cruz County A/E/PL 01-11-20

The Site Location Map (Figure 1), Local Geologic Map (Figure 3), Local Fault Map (Figure 4), Alquist-Priolo Earthquake Fault Zone Map (Figure 5), LiDAR and Air Photo Interpretation Map (Figure 6), Site Geologic Map (Plate 1), Geologic Cross Section (Plate 5) and Logs of Trenches (Plates 3 thru 5) depict the relevant topographic and geologic information on the subject property.

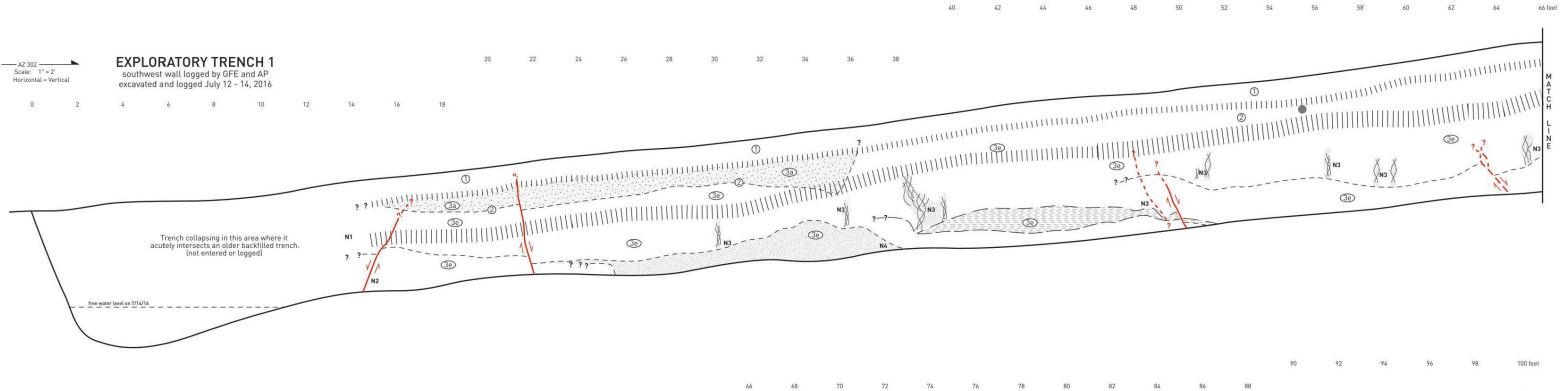
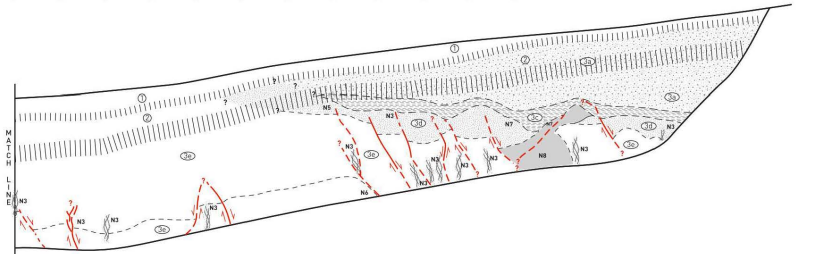
Date: 7/12/16	Scale: 1:100	Project #
By: GFE, AP, GFE	Drawn: 8/10/17	Sheet Number
		PLATE 3

**EXPLORATORY TRENCH 1**  
 southwest wall logged by GFE and AP  
 excavated and logged July 12 - 14, 2016

- EARTH MATERIALS**
- Topsoil**
- ① **A soil horizon - Silty Clayey Sand to Sandy Clay** - Light brownish gray (10YR 6/2) to dark grayish brown (10YR 4/2) silty clayey sand with occasional gravel, abundant pores and macropores, poorly to well developed crumb structure (block near ground surface, dry), frequent rootlets.

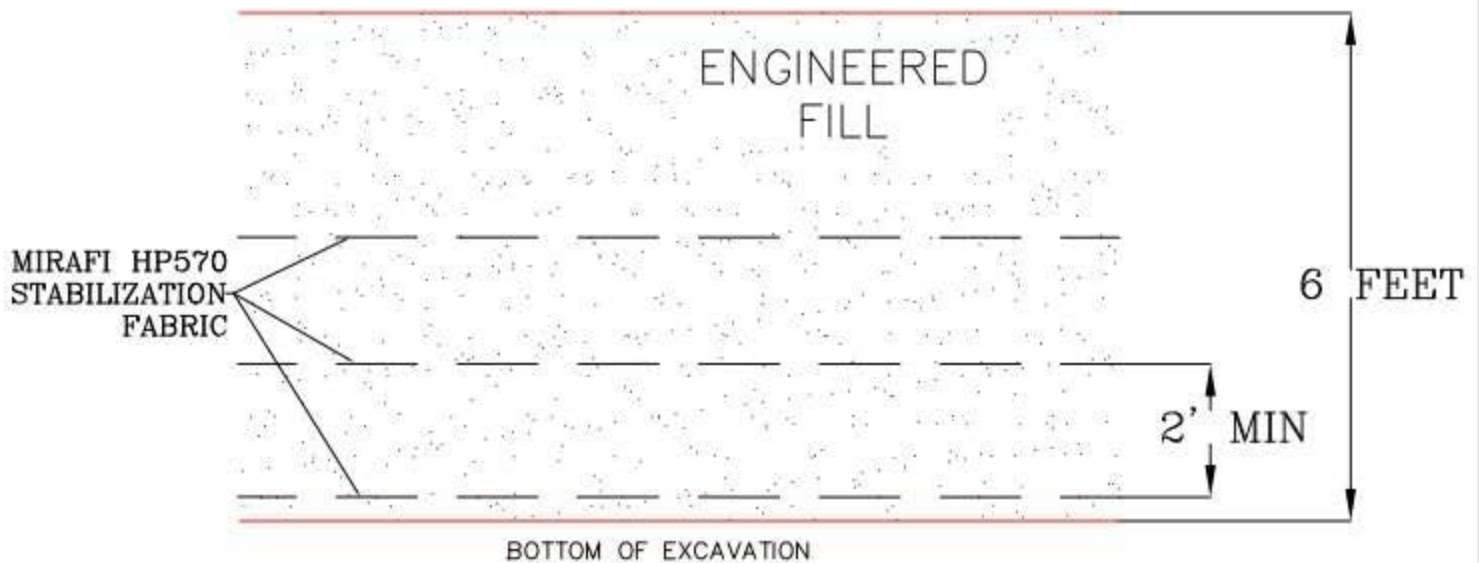
## REINFORCED FILL PAD

REINFORCED FILL PAD MUST BE CONSTRUCTED UNDER ALL PORTIONS OF ALL HABITABLE STRUCTURES. PAD SHALL EXTEND MINIMUM OF 5 FEET BEYOND THE BUILDING FOOTPRINT.

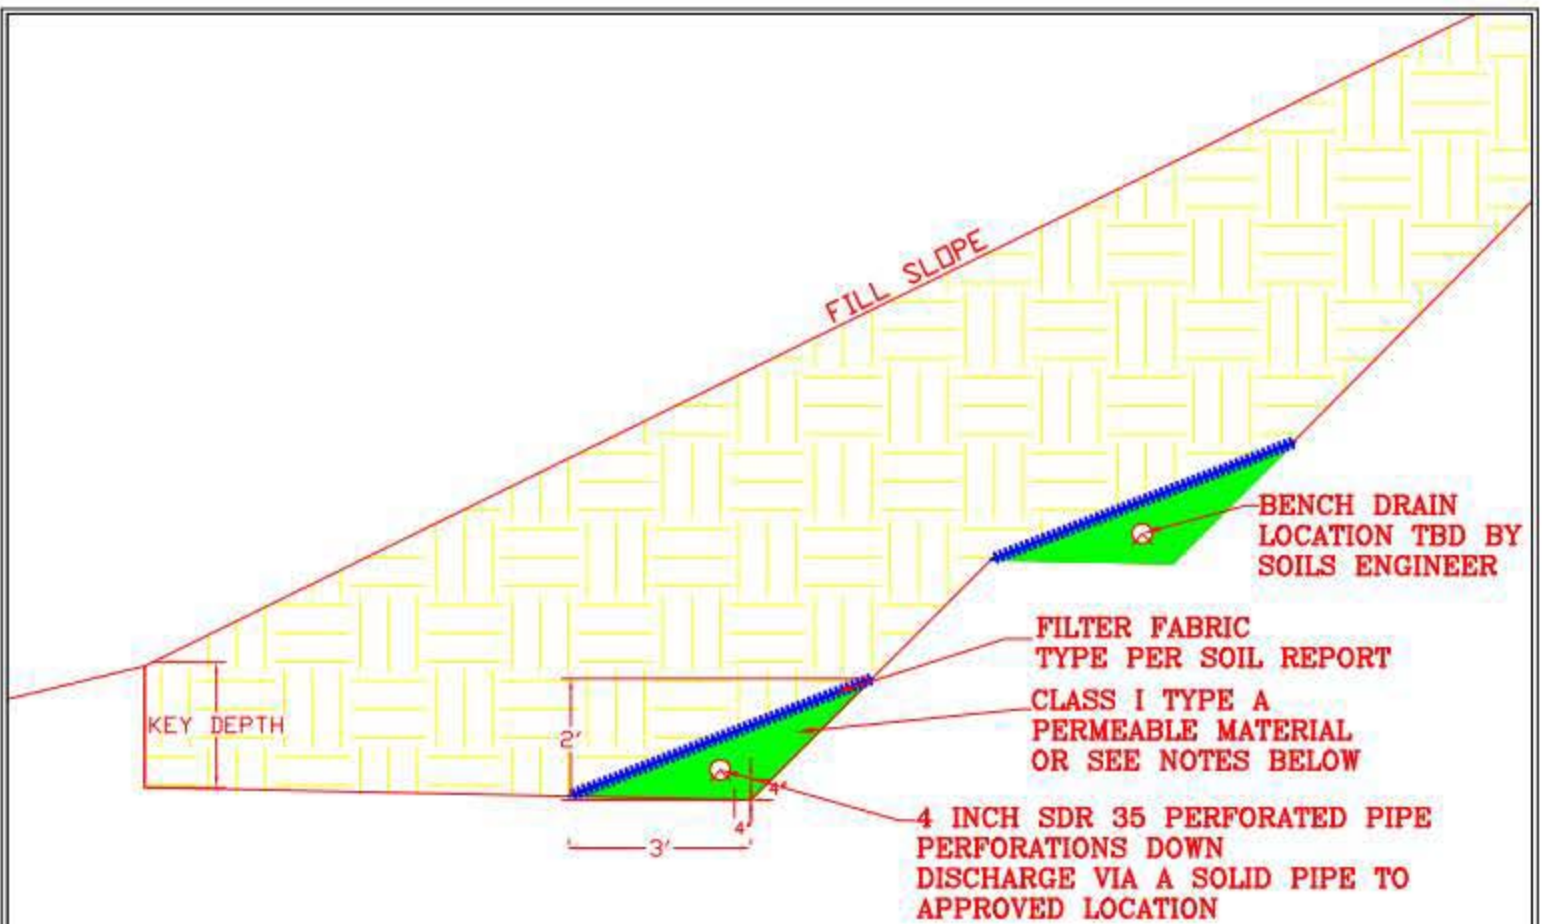
**Rock and Fabric Options**

- f. Because of the shallow perched water encountered at various depths, we anticipate the need for a keyway drain and bench drains at fill slopes. Refer to **Figure 4** for Keyway/Bench Drain Typical Detail.

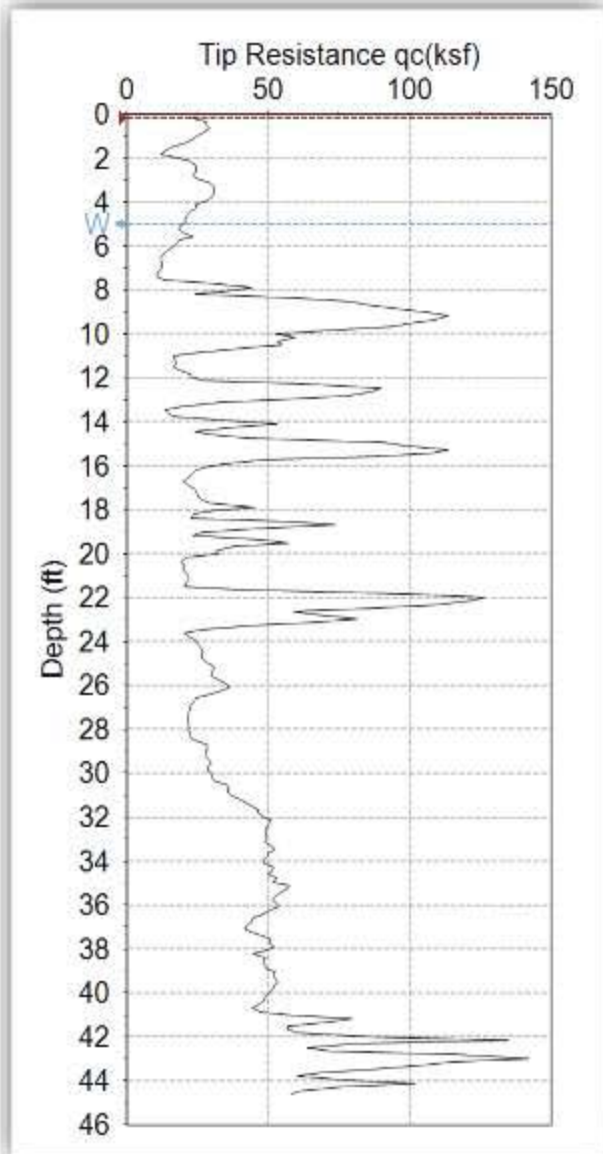
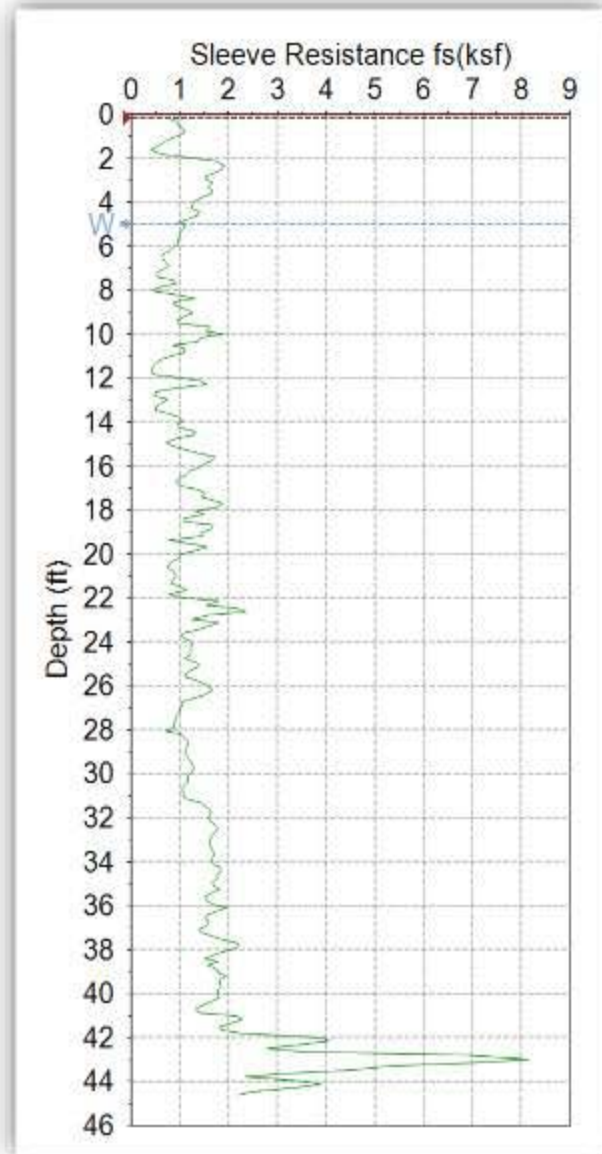
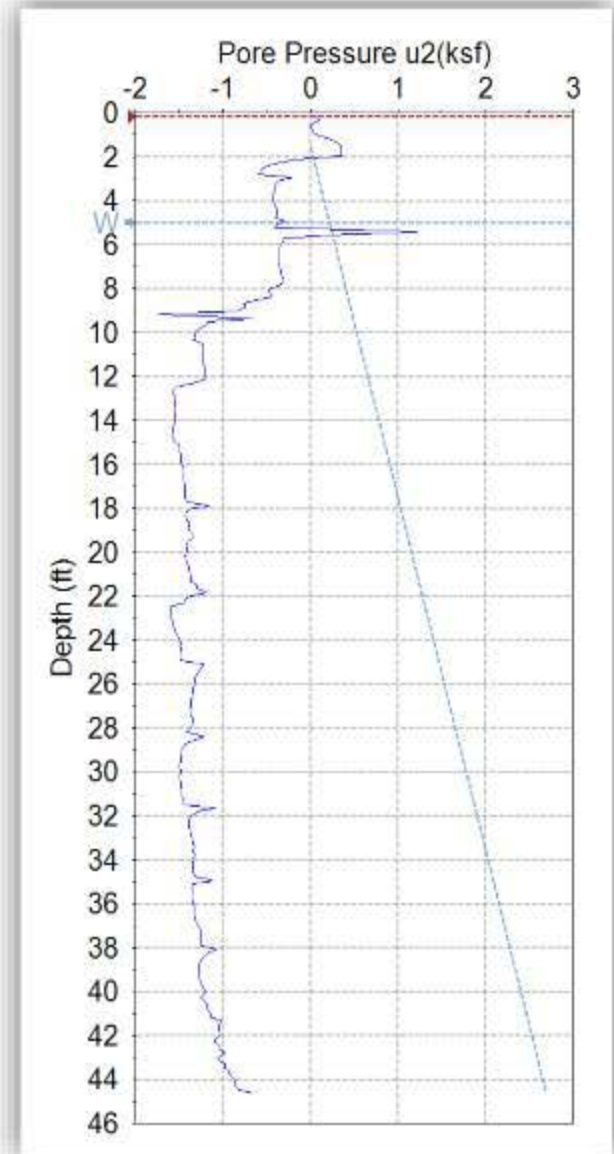
Groundwater Level: 5 Feet

Cone Area Ratio: 0.8

- a. Perched groundwater was encountered during the course of our field exploration at approximately 5 feet below the existing grade, at its closest elevation to the ground surface. The groundwater was observed to be traveling through sandier strata throughout our borings. Groundwater and wet conditions are noted on the boring and CPT logs, **Figures A-3 through A-13**.

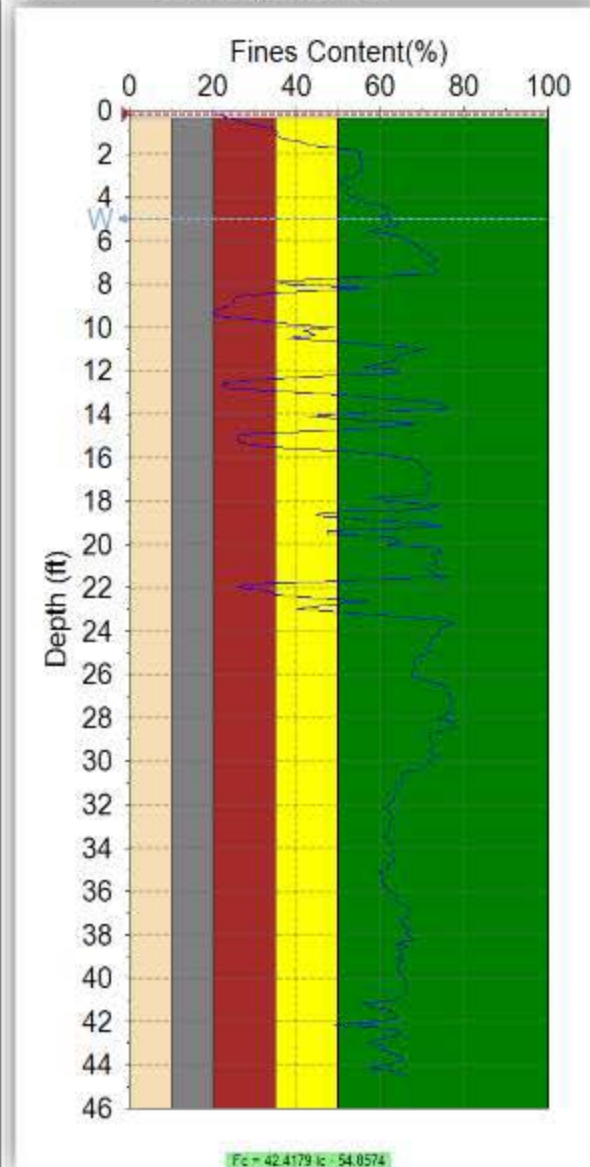
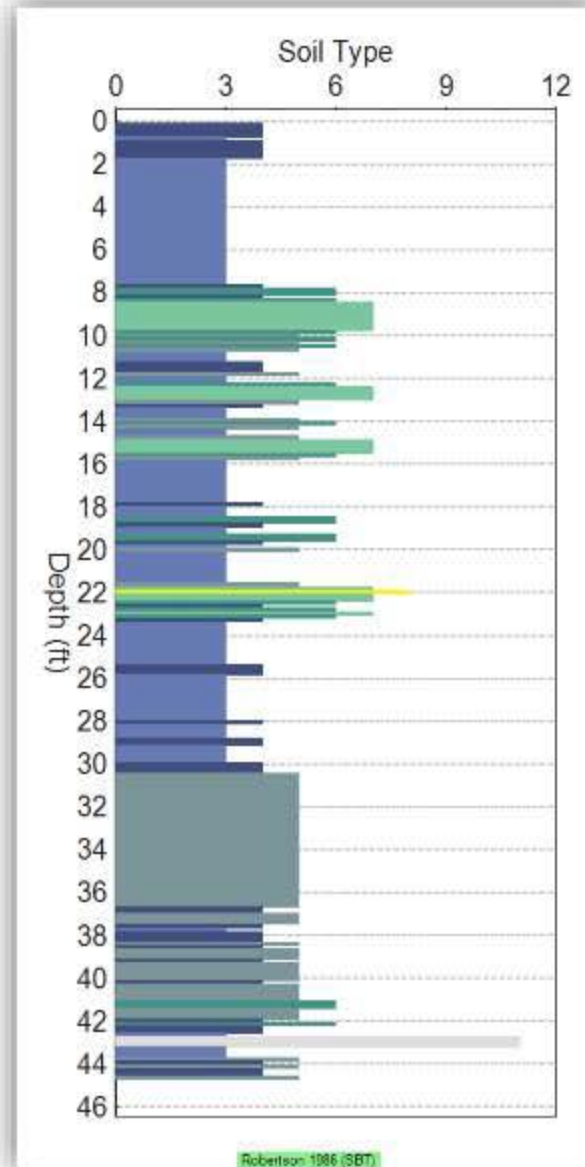
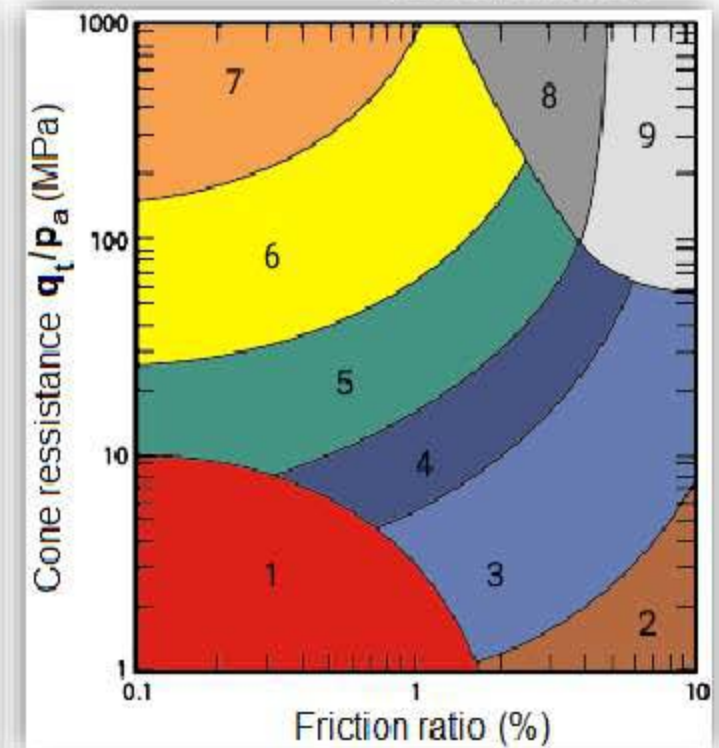
Groundwater Level: 5 Feet

Cone Area Ratio: 0.8

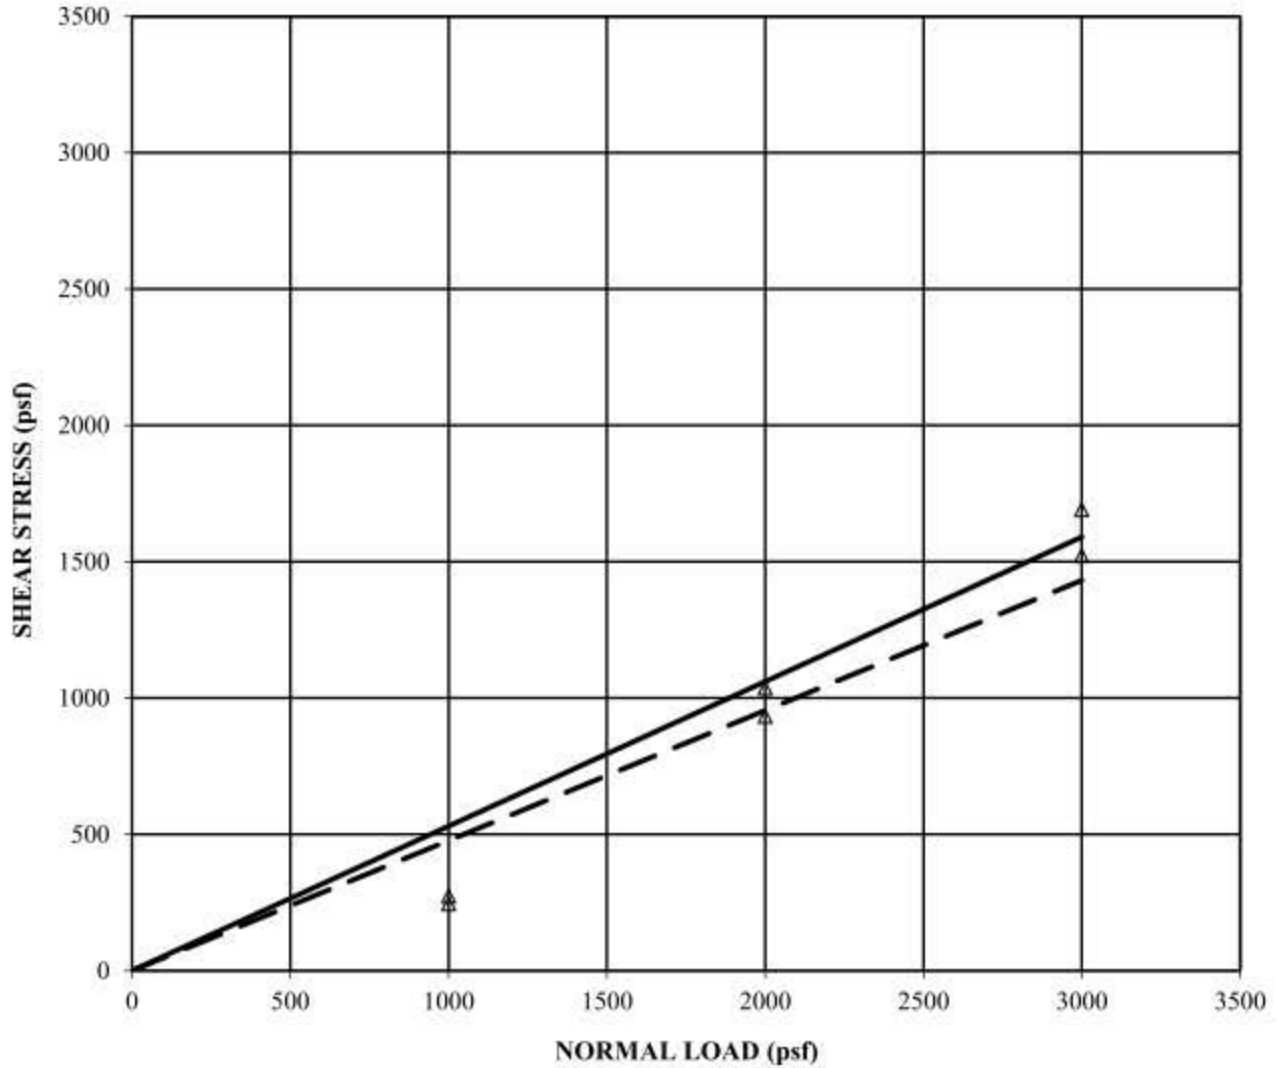
COHESION	FRICTION
DEPTH (ft):	1.0		(psf)	ANGLE
SOIL TYPE (USCS):	SC	PEAK	0	35
		RESIDUAL	0	33
TEST SAMPLE TYPE:		FIELD MOISTURE:	12.6%	
IN-SITU (SATURATED)		SATURATED MOIST:	25.7%

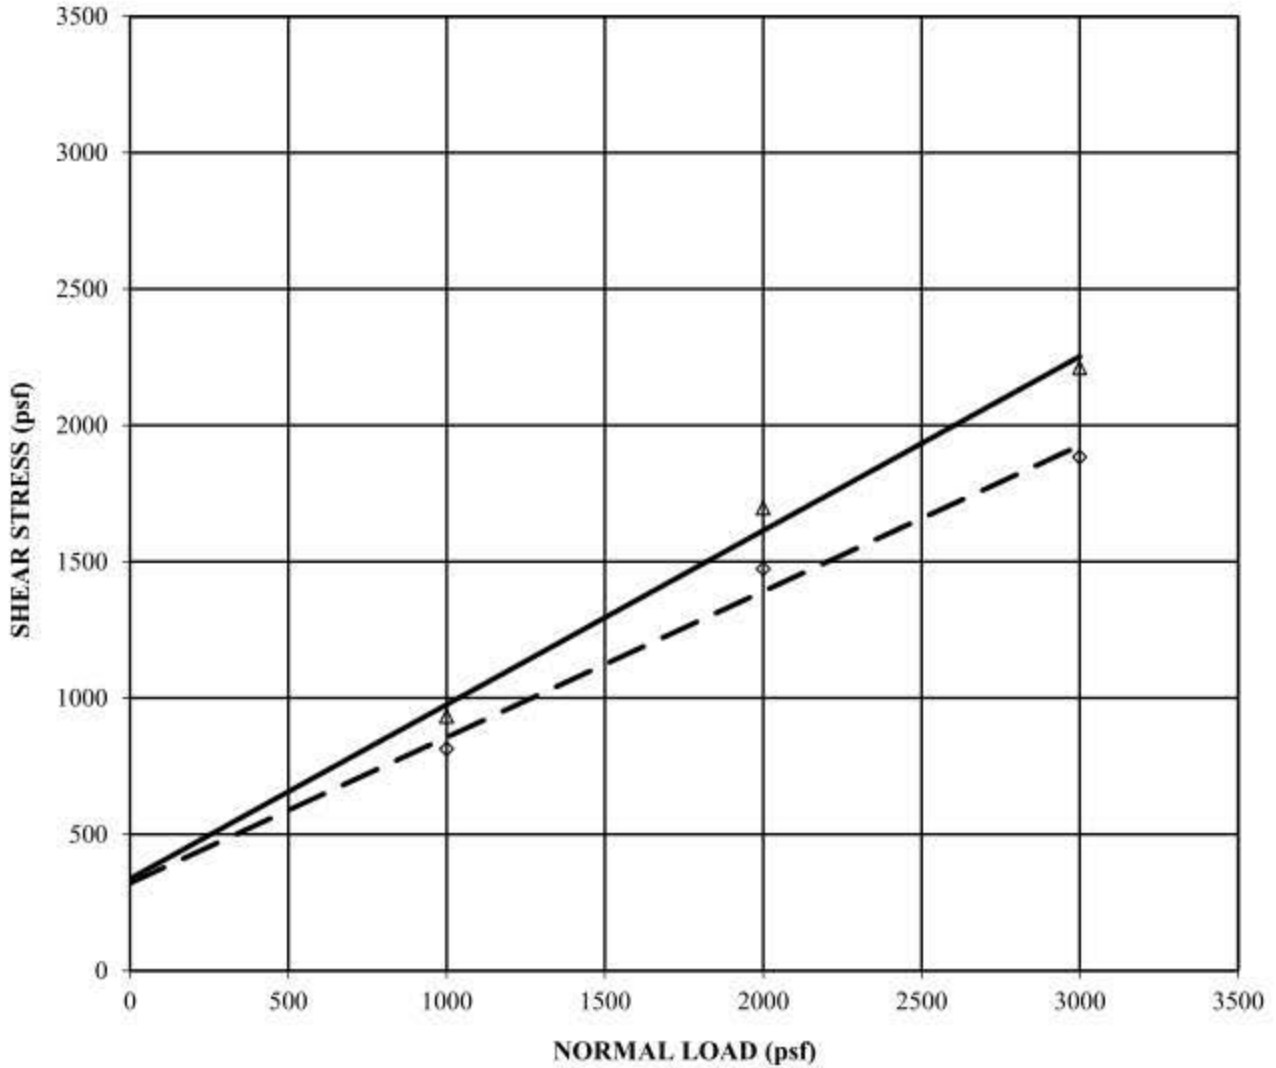
BORING:	B1		COHESION	FRICTION
DEPTH (ft):	10.0		(psf)	ANGLE
SOIL TYPE (USCS):	SC	————— PEAK	330	33
		- - - - - RESIDUAL	320	28
TEST SAMPLE TYPE:		FIELD MOISTURE:	23.6%	
IN-SITU (SATURATED)		SATURATED MOIST:	25.1%

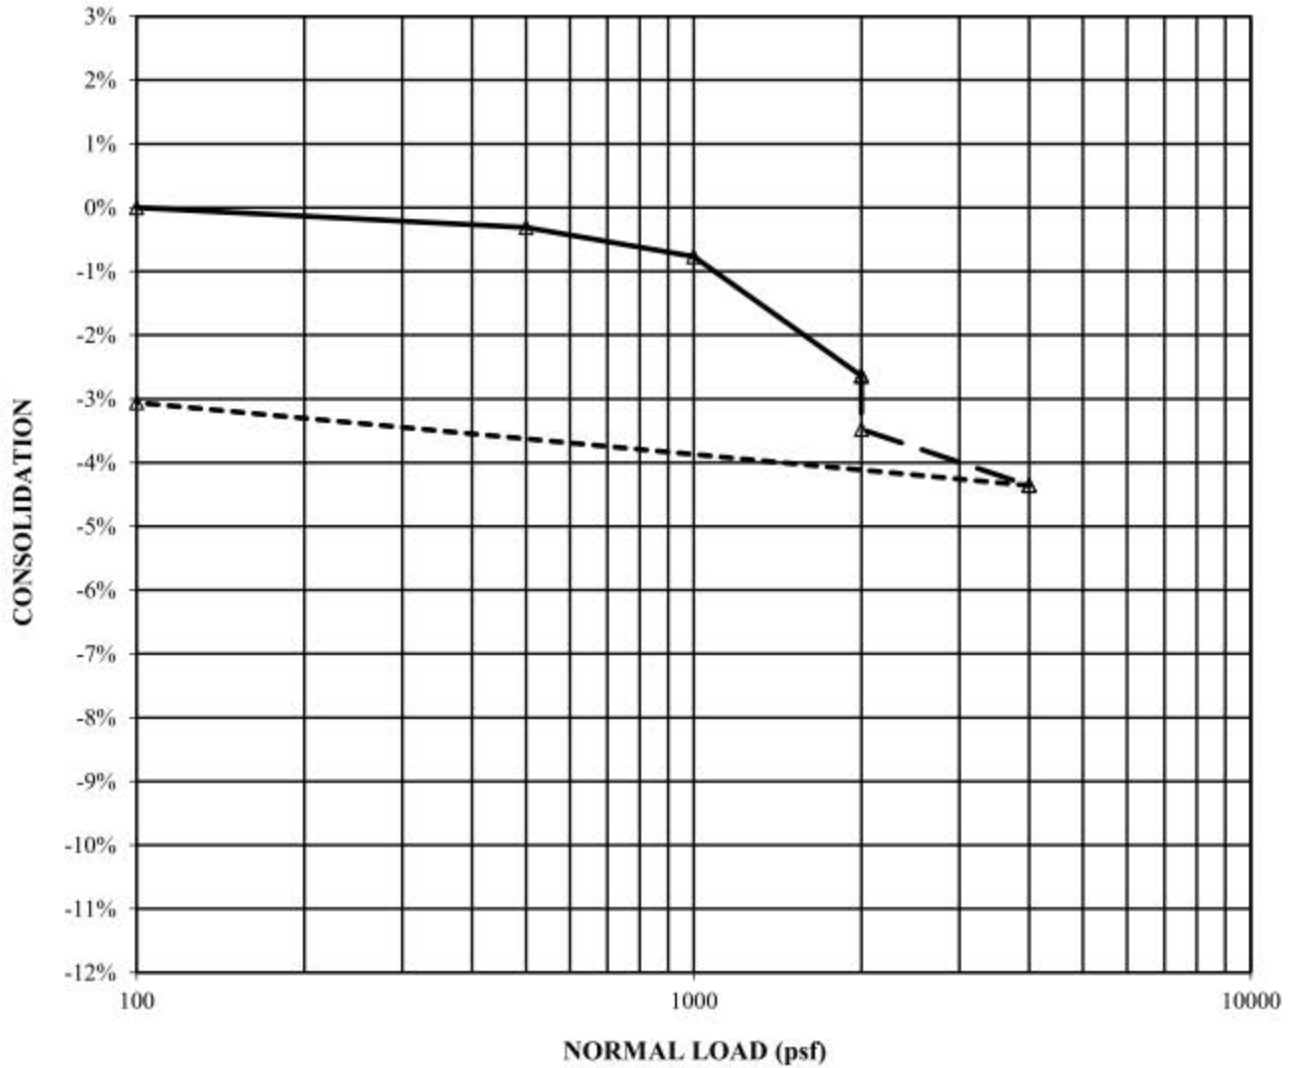
BORING:	B2	— FIELD MOISTURE	
DEPTH (ft):	1.0	- - - SATURATED	
SOIL TYPE (USCS):	SC	..... REBOUND	
SEATING WEIGHT:	250 psf	FIELD MOISTURE:	9.3%
		SATURATED MOIST:	17.1%

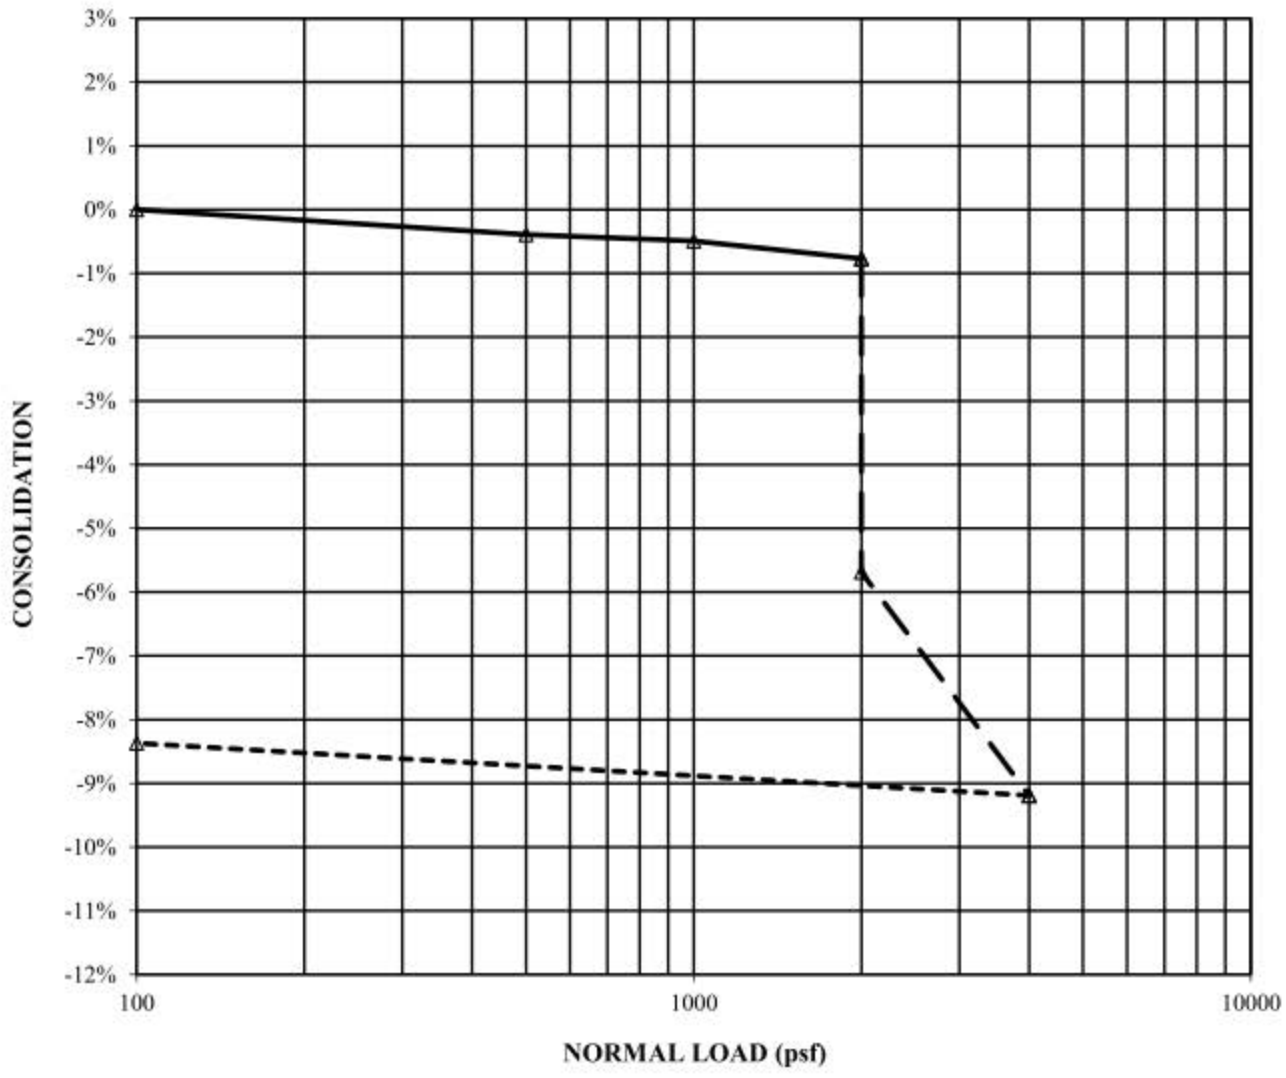
BORING:	B3	— FIELD MOISTURE	
DEPTH (ft):	0.5	- - - SATURATED	
SOIL TYPE (USCS):	SC	..... REBOUND	
SEATING WEIGHT:	220 psf	FIELD MOISTURE:	12.3%
		SATURATED MOIST:	17.9%

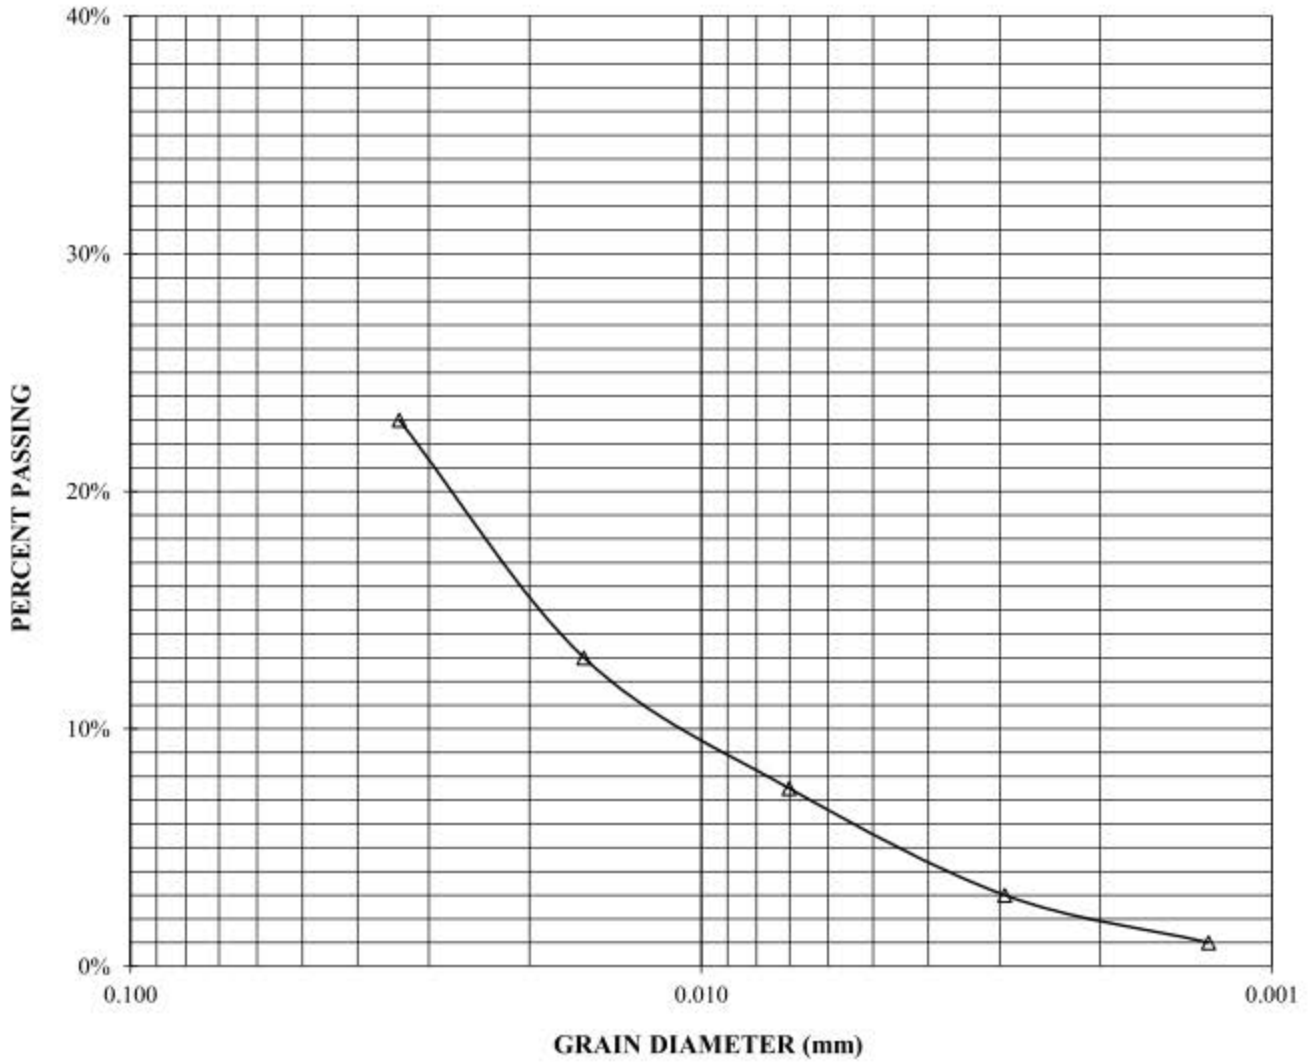
BORING:	B3
DEPTH (ft):	15.0
SOIL TYPE (USCS):	SM

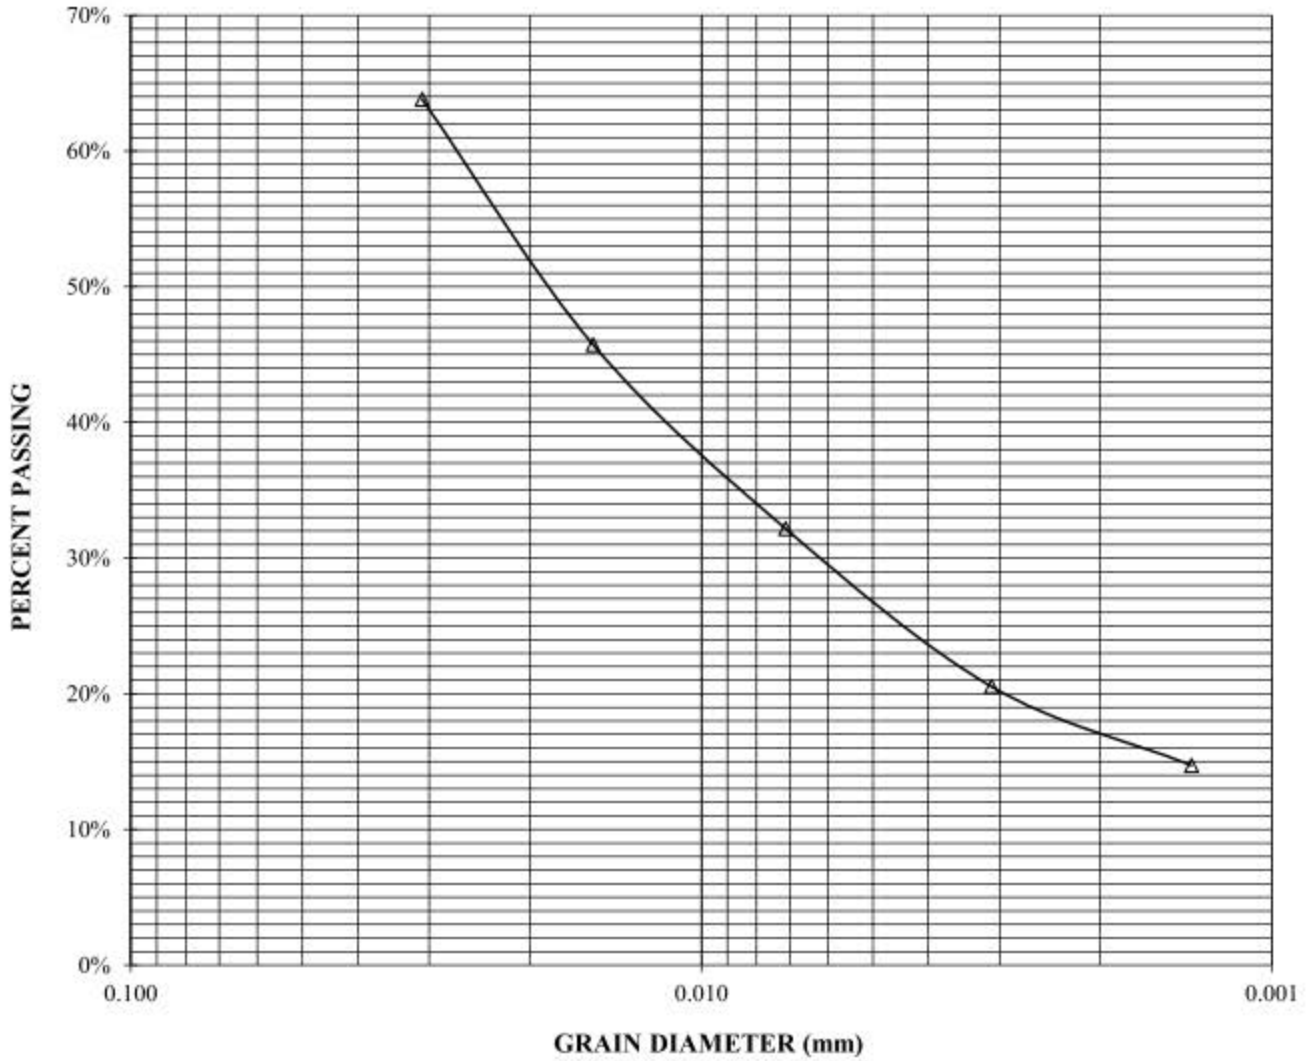
BORING:	B1
DEPTH (ft):	20.0
SOIL TYPE (USCS):	SM/SC

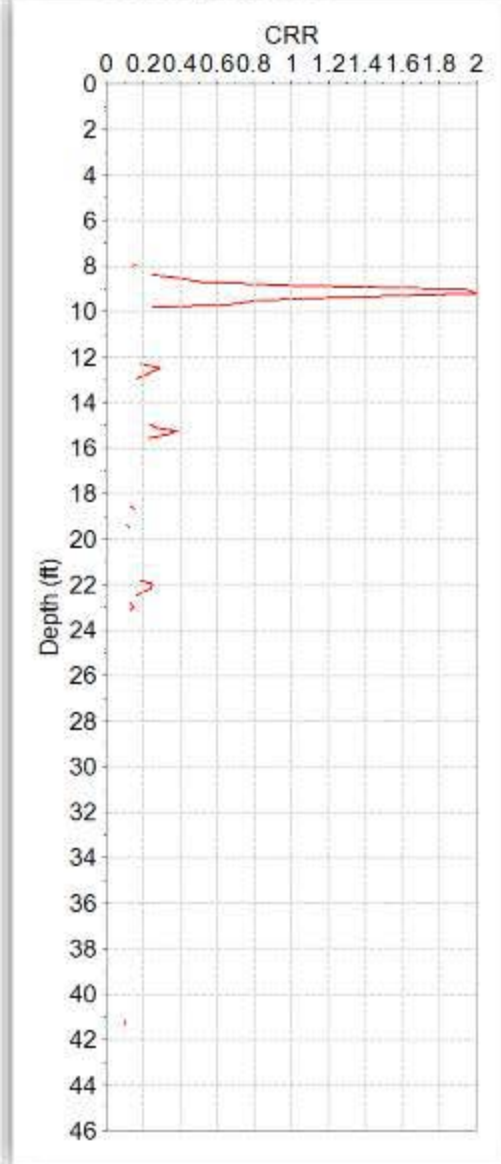
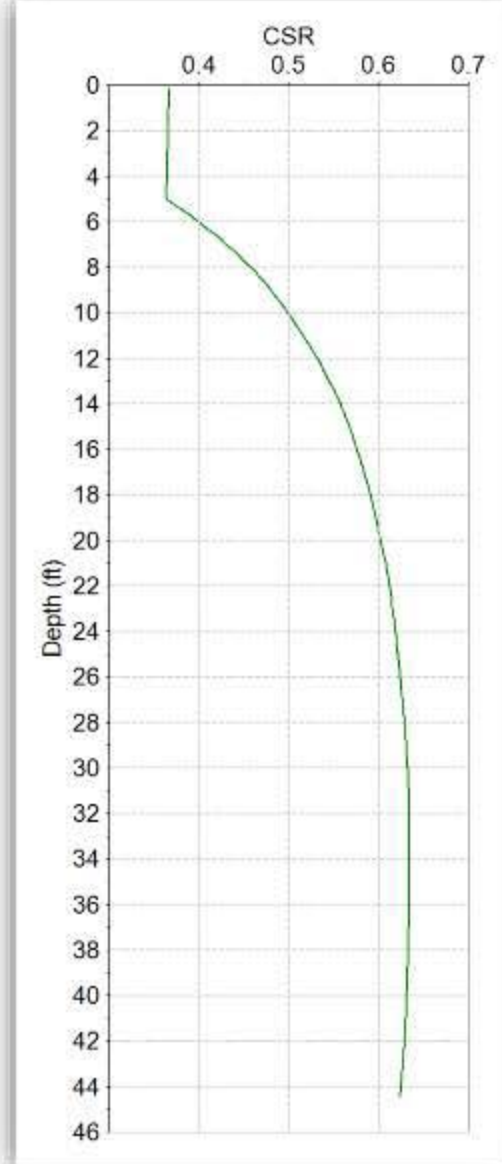
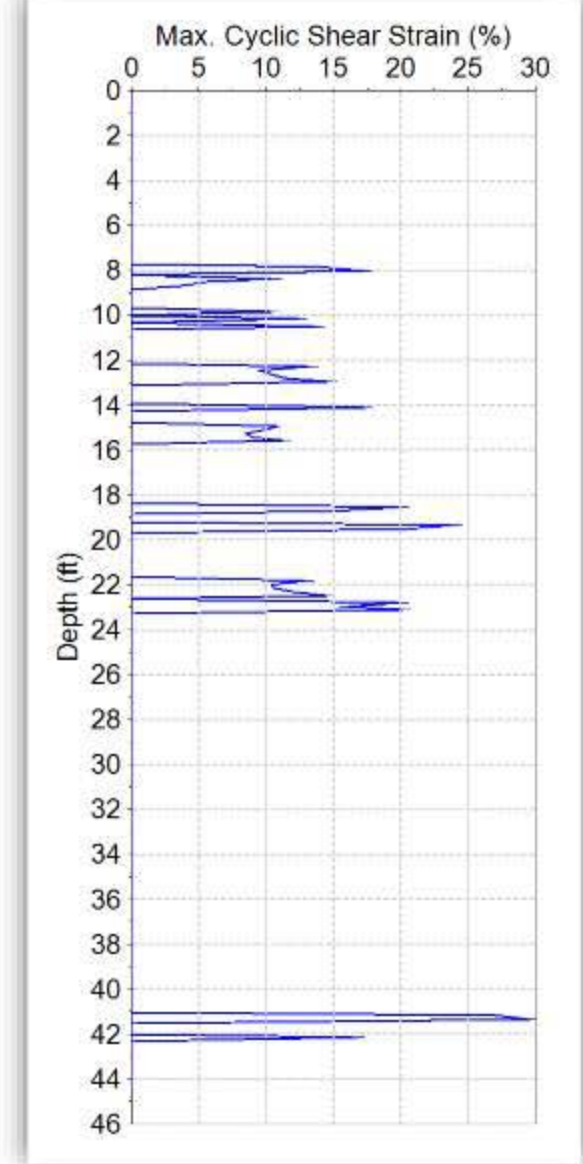
Borehole No: CPT-1

Groundwater Level: 5 Feet

- B-1. Our quantitative liquefaction analysis was performed on the observed soil configuration which is considered representative of the conditions at the subject site.

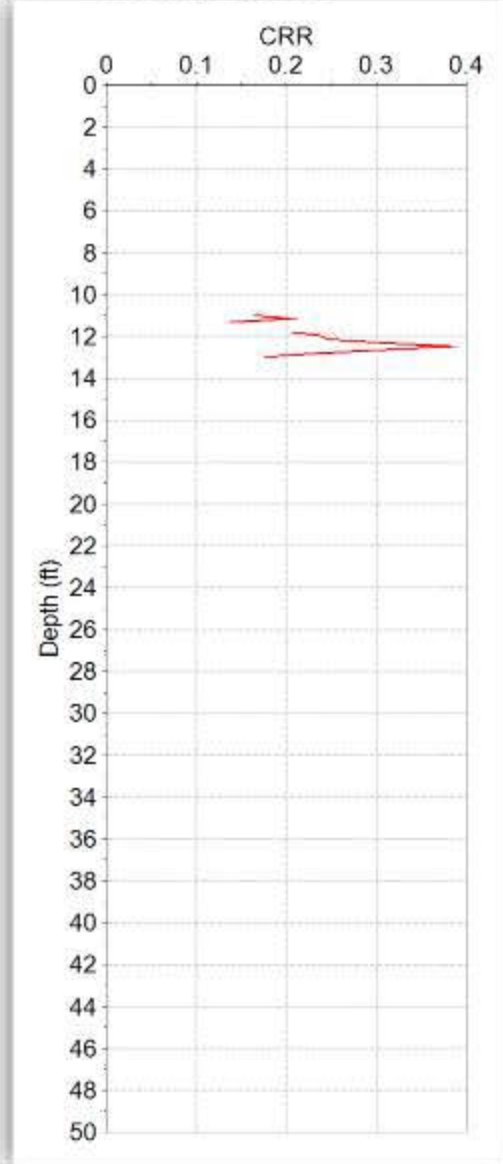
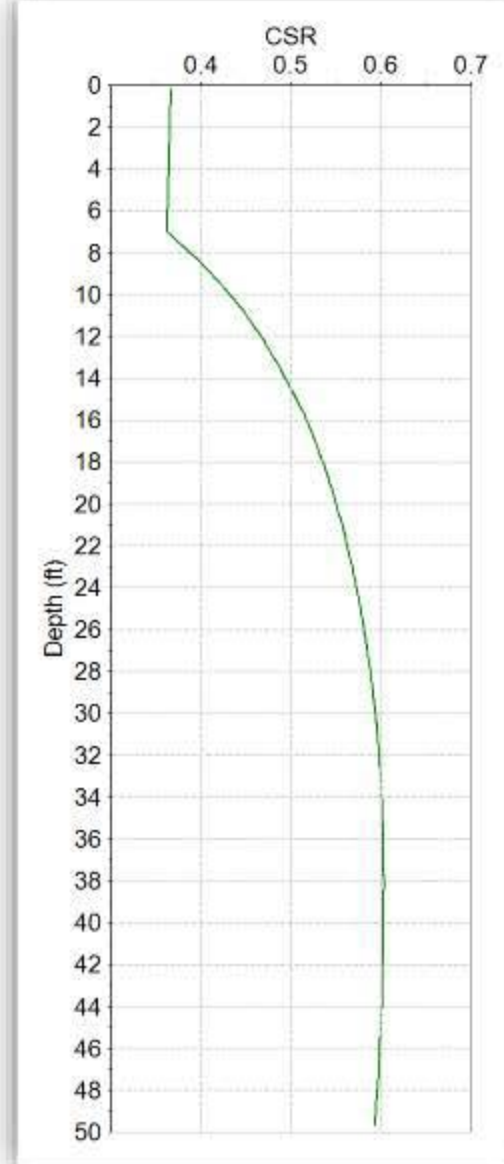
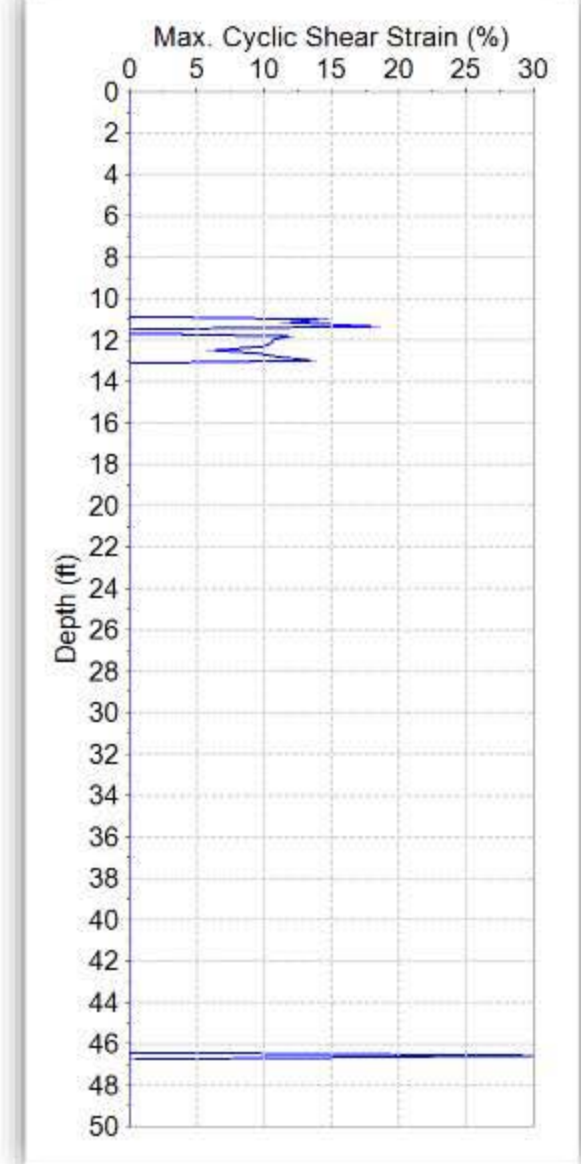
Borehole No: CPT-2

Groundwater Level: 7 Feet
