# AQUATIC RESOURCE DELINEATION REPORT

LAKEVIEW ESTATES (APN 051-411-20)  
WATSONVILLE, SANTA CRUZ COUNTY, CALIFORNIA

MAY 2018

Tom Mahony, MS, PWS  
Certified Professional Wetland Scientist #2567  
Coast Range Biological LLC  
PO Box 1238  
Santa Cruz, CA 95061  
(831) 426-6226  
coastrange@sbcglobal.net

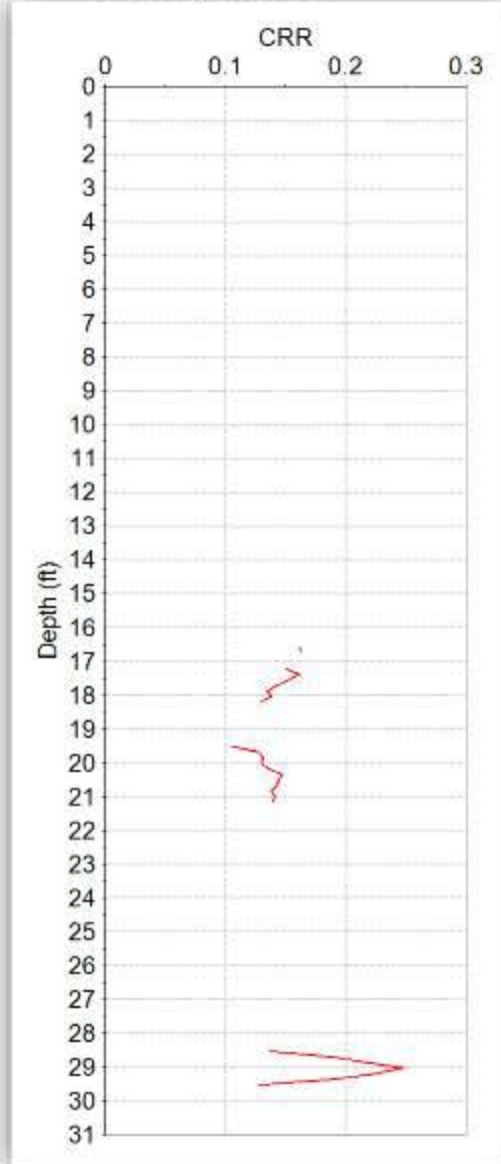
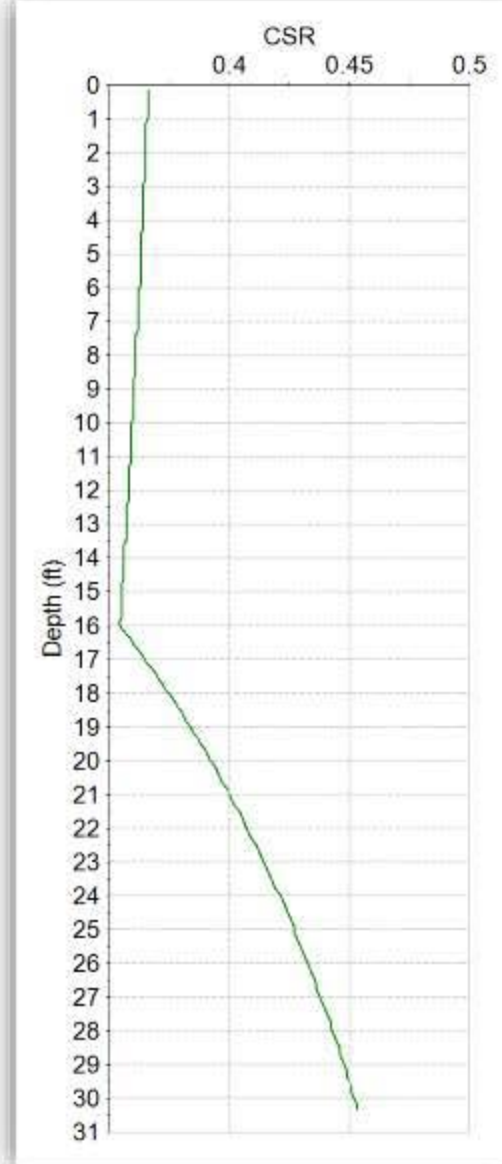
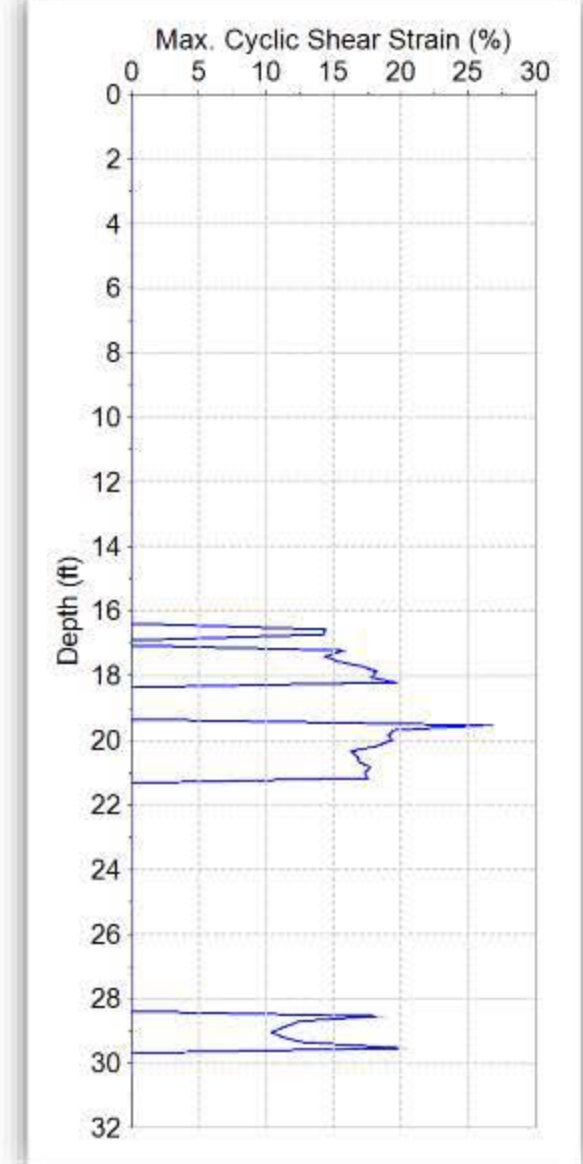
Borehole No: CPT-3

Groundwater Level: 16 Feet

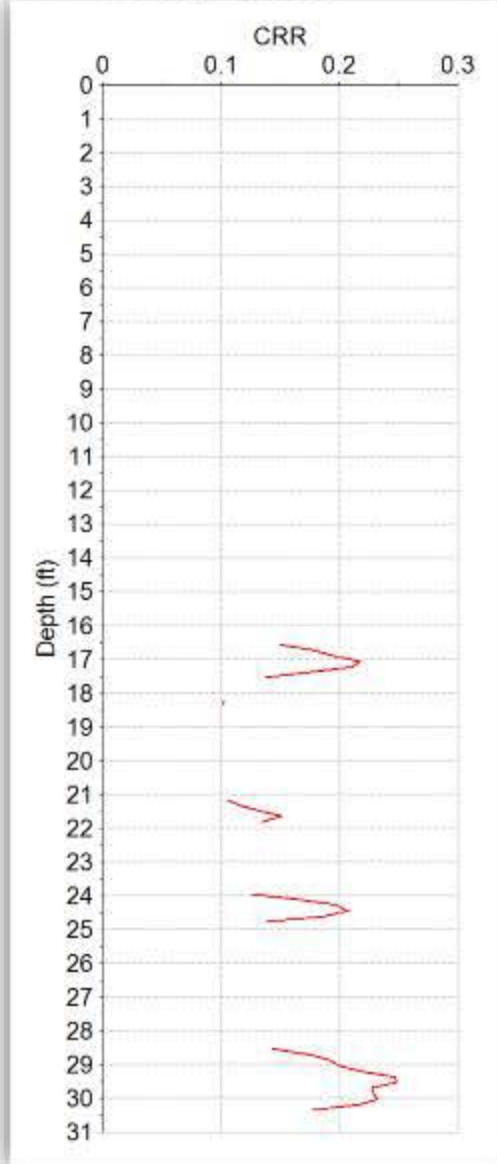
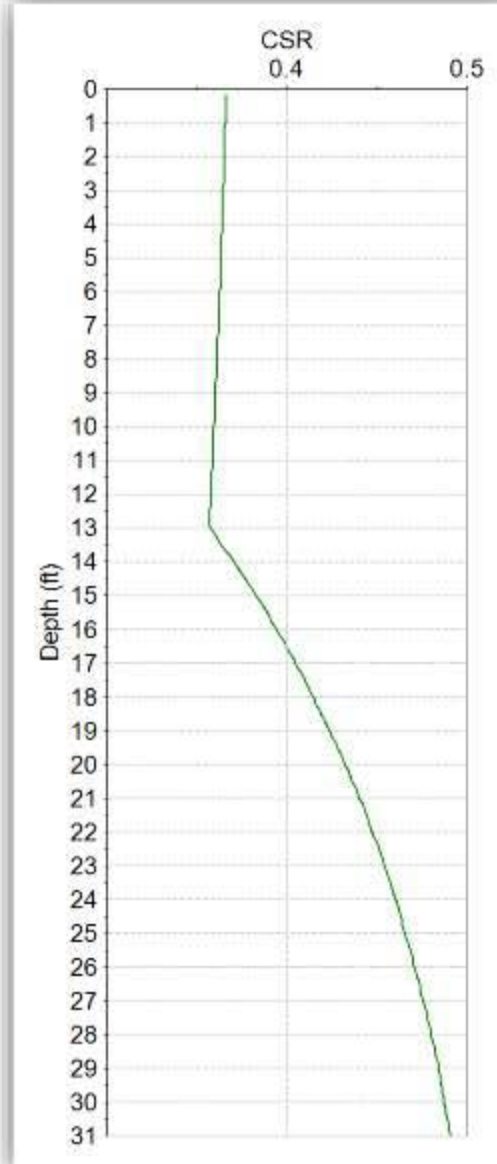
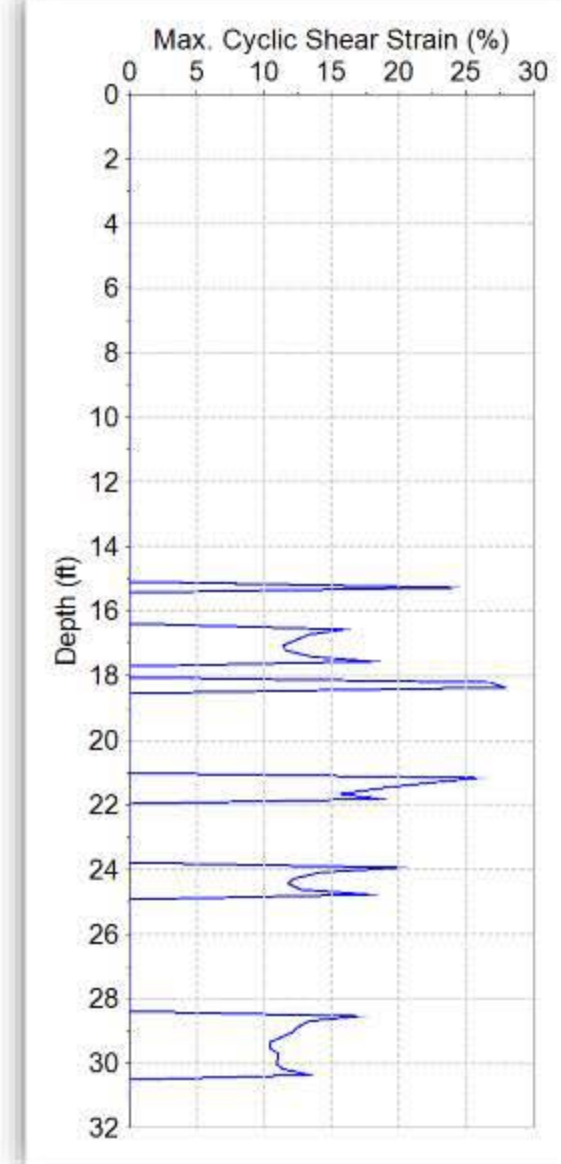
Borehole No: CPT-4

Groundwater Level: 13 Feet

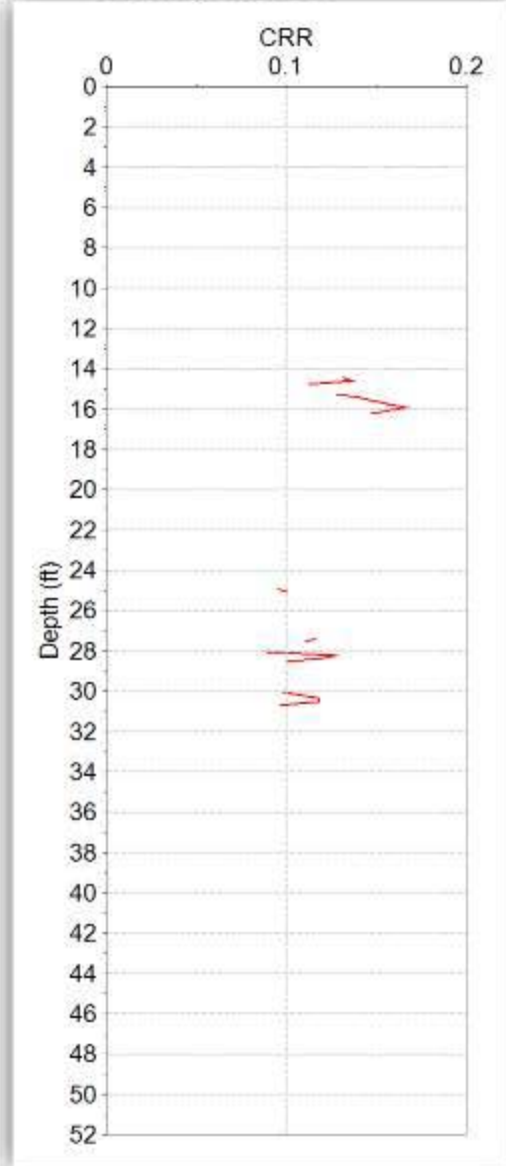
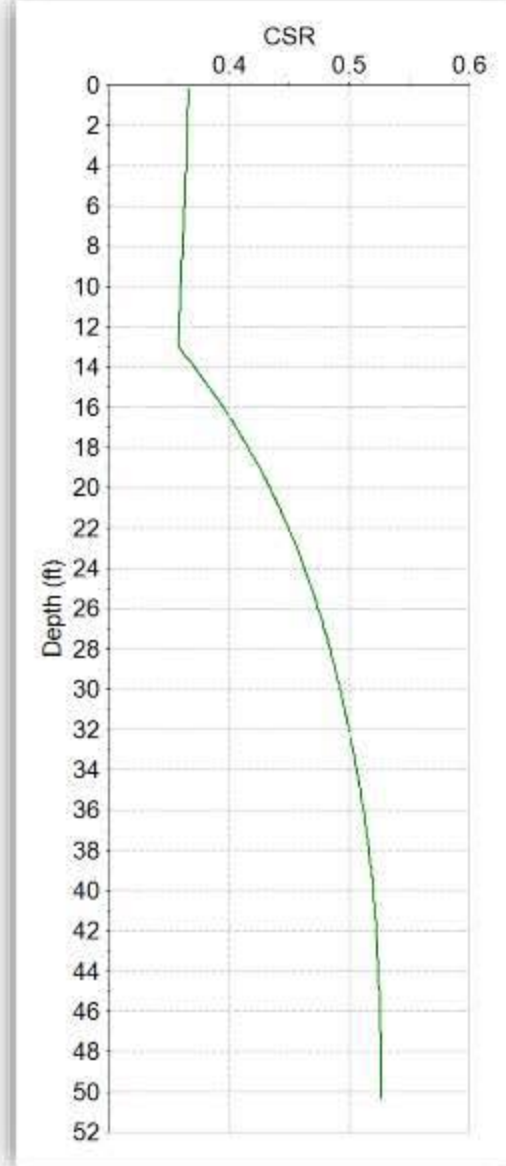
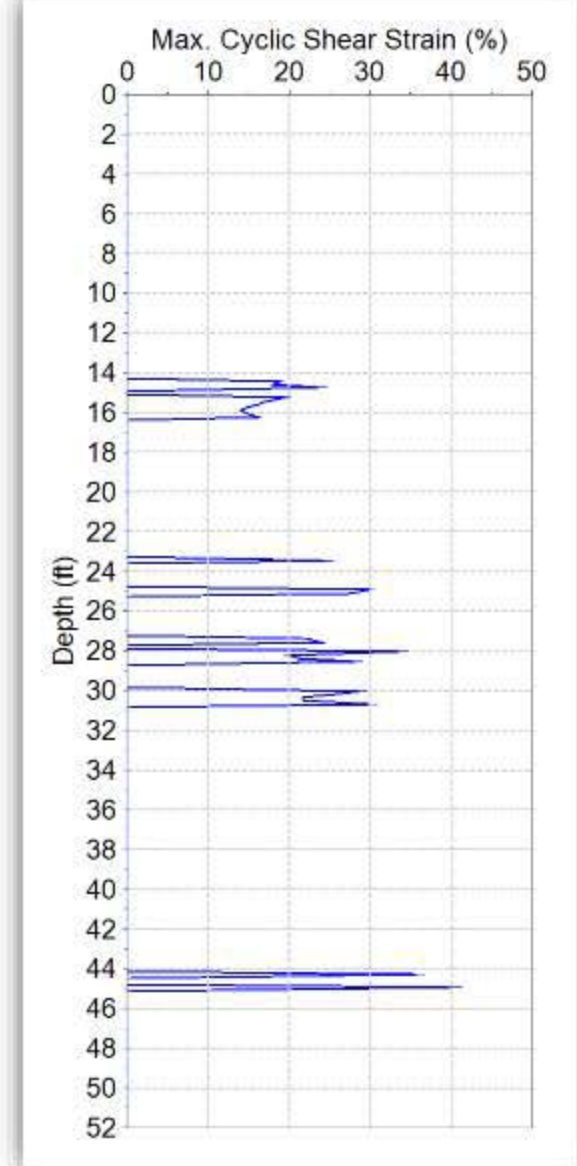
Borehole No: CPT-5

Groundwater Level: 13 Feet

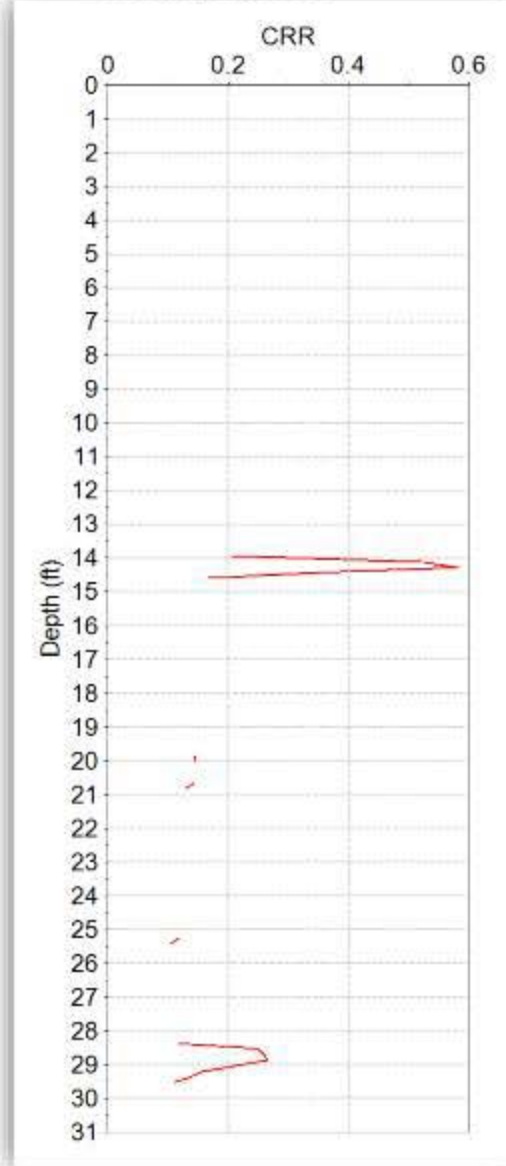
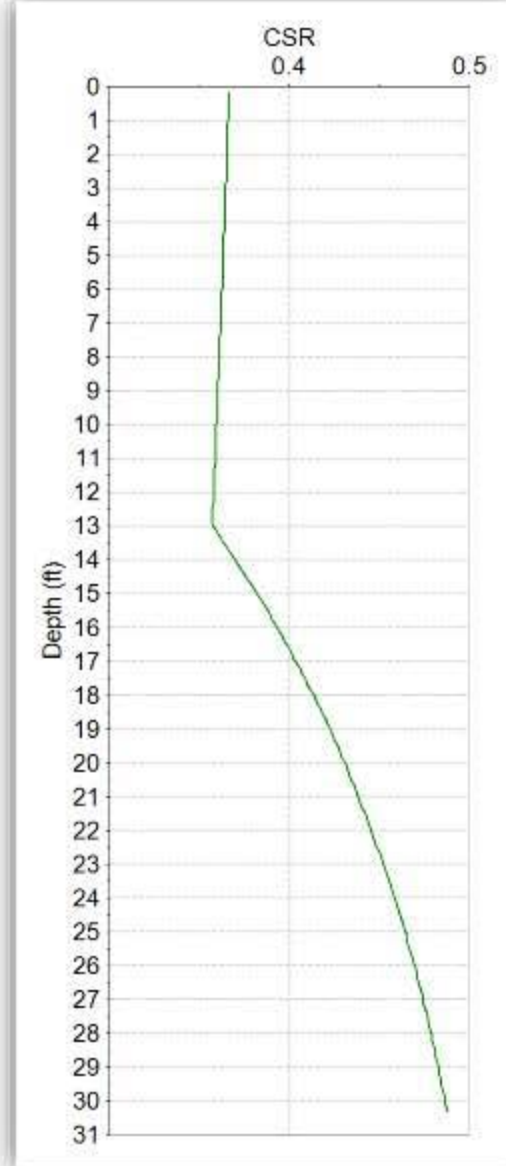
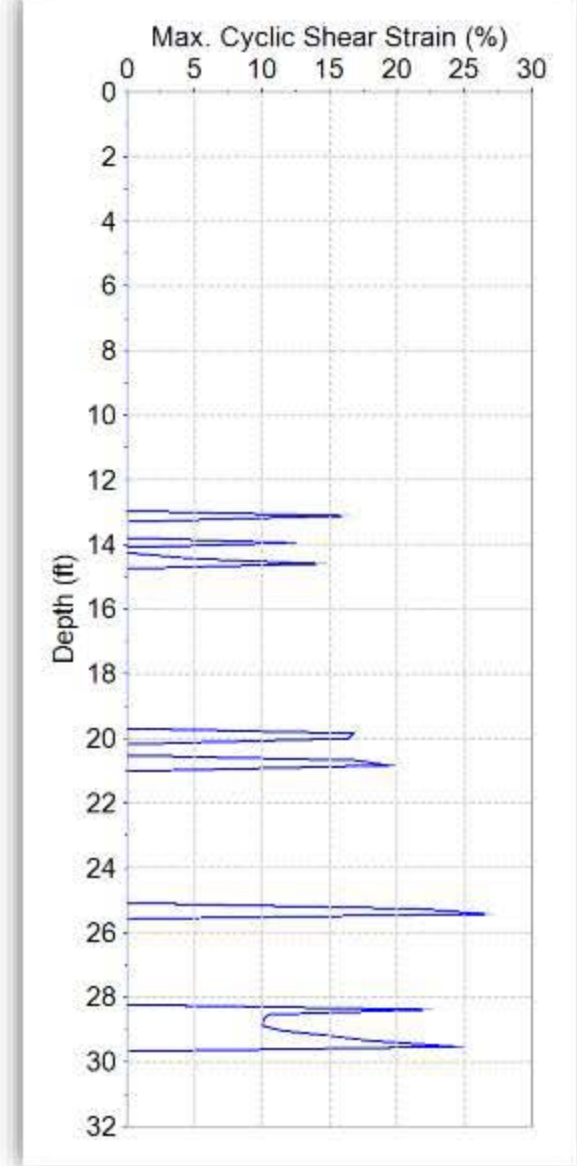
Borehole No: CPT-6

Groundwater Level: 13 Feet

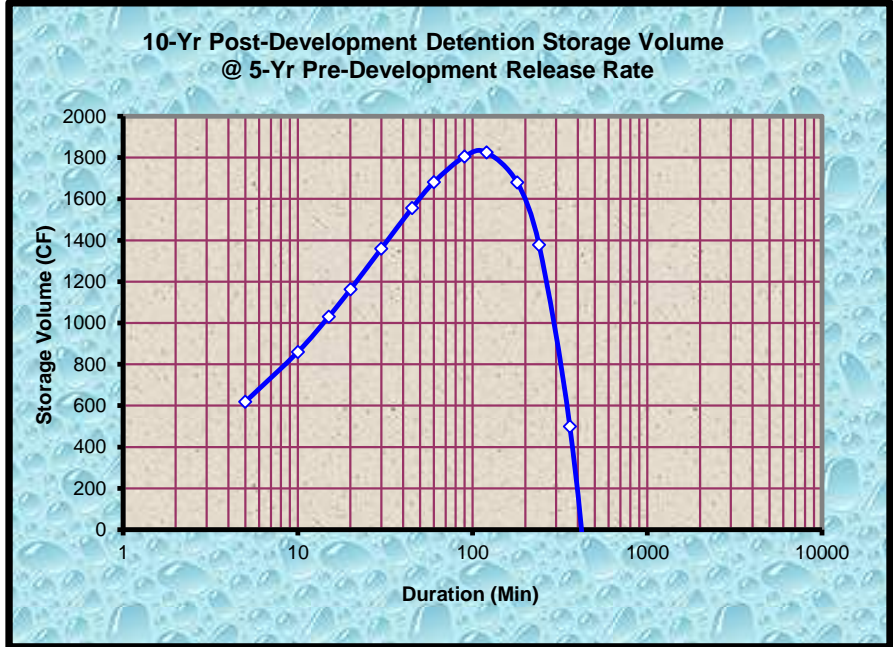
1825	ft <sup>3</sup> storage volume calculated			
100	% void space assumed			
1825	ft <sup>3</sup> excavated volume needed			
Structure Ratios	Length	Width*	Depth*	*For pipe, use the square root of the sectional area
	150.00	3.54	3.54	
Dimen. (ft)	148.54	3.51	3.51

10 - YEAR DESIGN STORM				DETENTION @ 15 MIN.	
Storm Duration (min)	10 - Year Intensity (in/hr)	5 - Yr. Release Qpre (cfs)	10 - Year Qpost (cfs)	Detention Rate To Storage (cfs)	Specified Storage Volume (cf)
1440	0.23	0.039	0.165	-0.118	-12732
1200	0.25	0.042	0.179	-0.104	-9385
960	0.28	0.046	0.197	-0.086	-6199
720	0.32	0.053	0.223	-0.060	-3234
480	0.38	0.063	0.266	-0.017	-609
360	0.43	0.071	0.302	0.018	499
240	0.51	0.085	0.360	0.077	1378
180	0.58	0.096	0.407	0.124	1679
120	0.69	0.115	0.486	0.203	1825
90	0.78	0.130	0.551	0.267	1806
60	0.93	0.155	0.656	0.373	1681
45	1.05	0.176	0.744	0.461	1555
30	1.26	0.209	0.887	0.604	1359
20	1.50	0.250	1.058	0.775	1162
15	1.70	0.283	1.199	0.916	1030
10	2.03	0.338	1.429	1.146	860
5	2.74	0.456	1.932	1.649	618

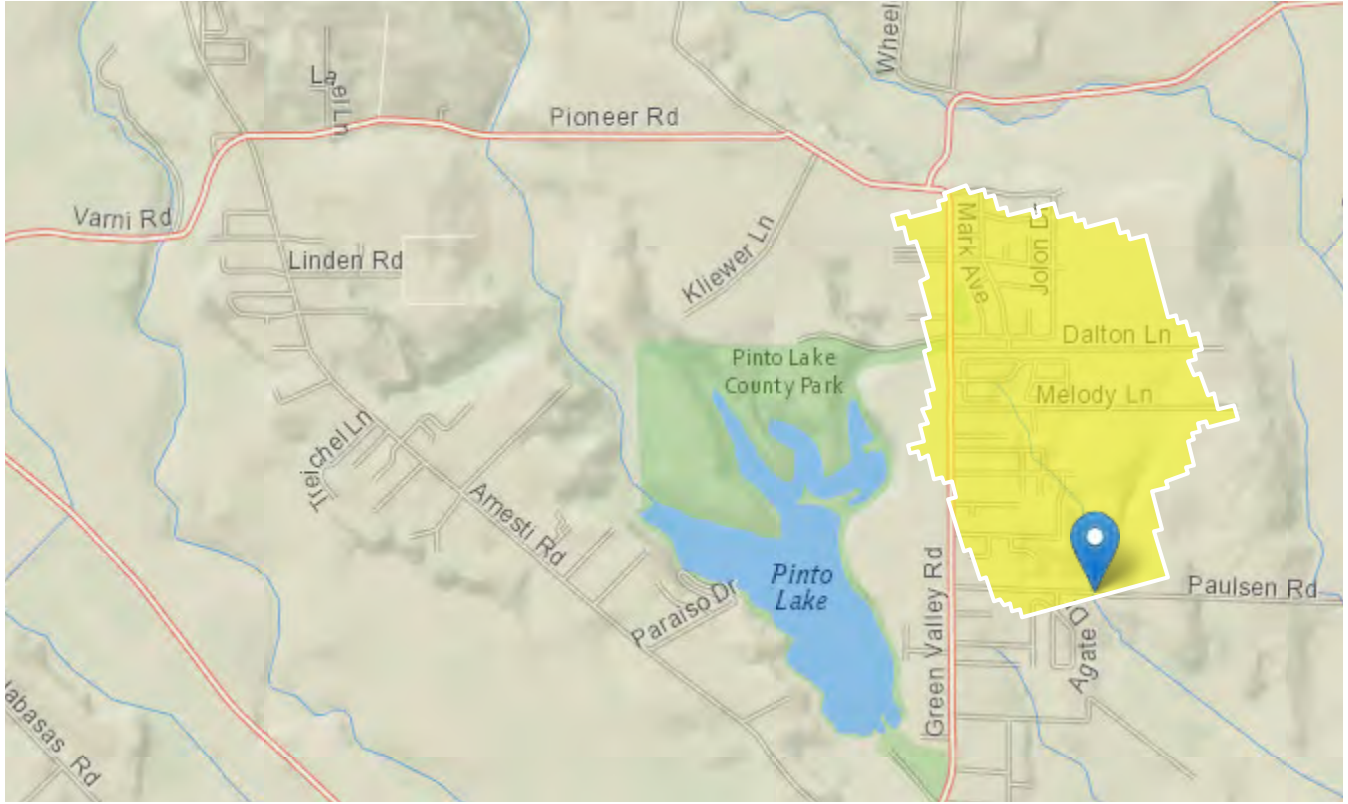
# StreamStats Report

**Region ID:** CA  
**Workspace ID:** CA20211227185928205000  
**Clicked Point (Latitude, Longitude):** 36.95555, -121.75879  
**Time:** 2021-12-27 10:59:48 -0800

Basin Characteristics

Parameter Code	Parameter Description	Value	Unit
DRNAREA	Area that drains to a point on a stream	0.5	square miles
PRECIP	Mean Annual Precipitation	23.3	inches

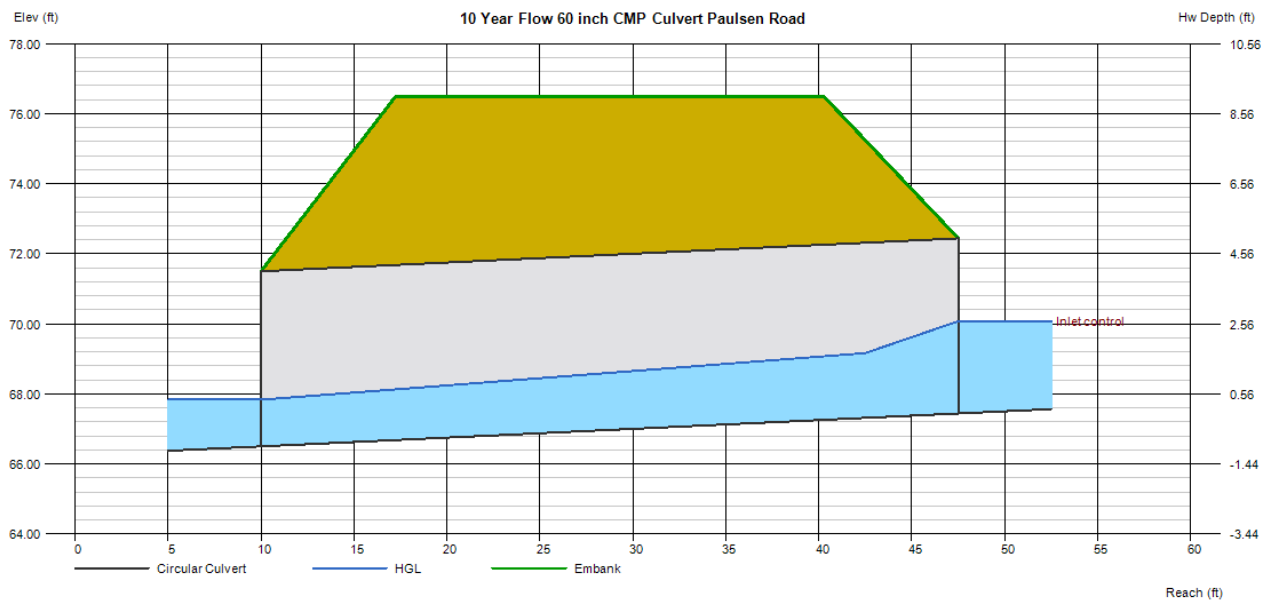
<b>Calculations</b>	
Qmin (cfs)	= 47.60
Qmax (cfs)	= 47.60
Tailwater Elev (ft)	= Normal

<b>Highlighted</b>	
Qtotal (cfs)	= 47.60
Qpipe (cfs)	= 47.60
Qovertop (cfs)	= 0.00
Veloc Dn (ft/s)	= 11.33
Veloc Up (ft/s)	= 6.81
HGL Dn (ft)	= 67.83
HGL Up (ft)	= 69.37
Hw Elev (ft)	= 70.07
Hw/D (ft)	= 0.53
Flow Regime	= Inlet Control

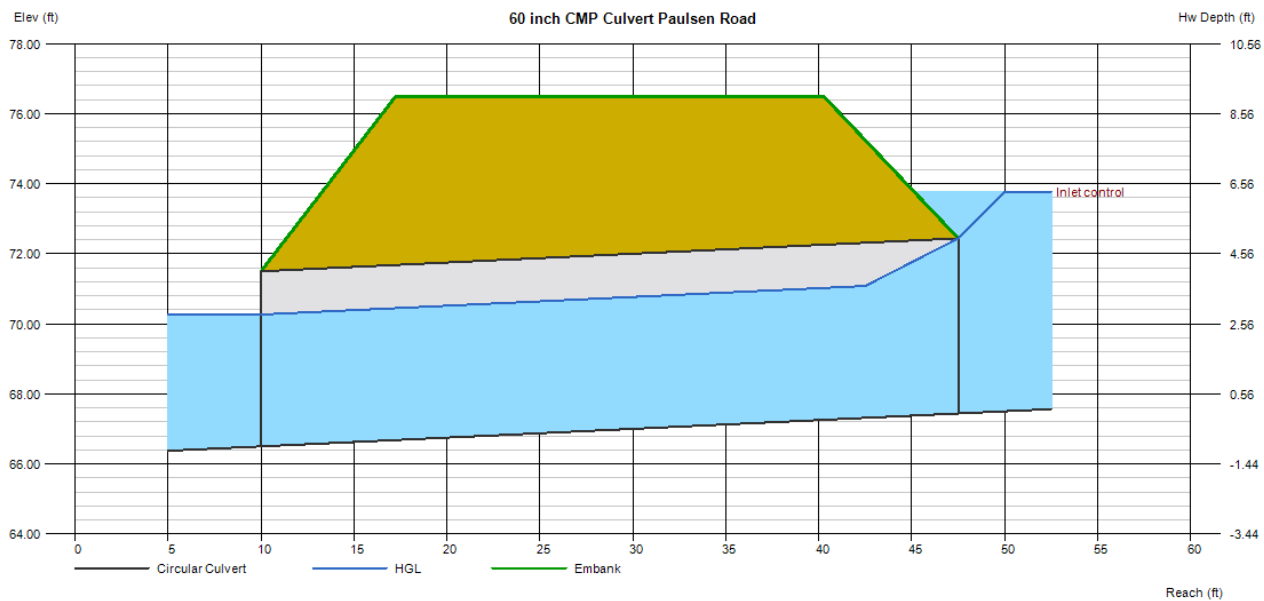
## 100 Year Flow 60 inch CMP Culvert Paulsen Road

**Calculations**  
 Qmin (cfs) = 173.00  
 Qmax (cfs) = 173.00  
 Tailwater Elev (ft) = Normal

**Highlighted**  
 Qtotal (cfs) = 173.00  
 Qpipe (cfs) = 173.00  
 Qovertop (cfs) = 0.00  
 Veloc Dn (ft/s) = 10.90  
 Veloc Up (ft/s) = 10.90  
 HGL Dn (ft) = 70.27  
 HGL Up (ft) = 71.21  
 Hw Elev (ft) = 73.77  
 Hw/D (ft) = 1.27  
 Flow Regime = Inlet Control
