GEOTECHNICAL INVESTIGATION
PROPOSED CULTIVATION FACILITY
PARKING LOT AND GUARD HOUSE
APN'S 432-130-002, 008 & 009
SAN JACINTO, CALIFORNIA

April 30, 2019 (Revised July 22, 2019) Project No. 644-19012 19-04-030

Geotechnical Investigation

Proposed Cultivation Facility Parking Lot and Guard House APN's 432-130-02, 008 & 009

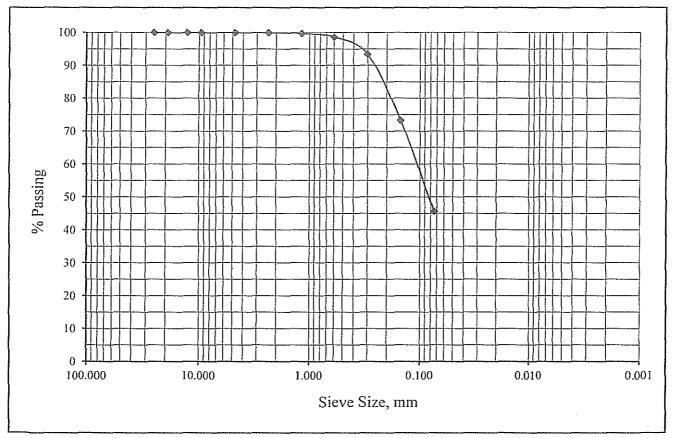
Soil Classification: SM

Sieve	Sieve	Percent
Size, in	Size, mm	Passing
1"	25.4	100.0
3/4"	19.1	100.0
1/2"	12.7	100.0
3/8"	9.53	100.0
#4	4.75	100.0
#8	2.36	99.9
#16	1.18	99.7
#30	0.60	98.6
#50	0.30	93.4
#100	0.15	73.3
#200	0.074	45.6
