# Report Geotechnical Investigation

## La Valencia Mixed-Use Building Herschel Avenue, La Jolla, CA

NOVA Project 2020093  
July 15, 2020

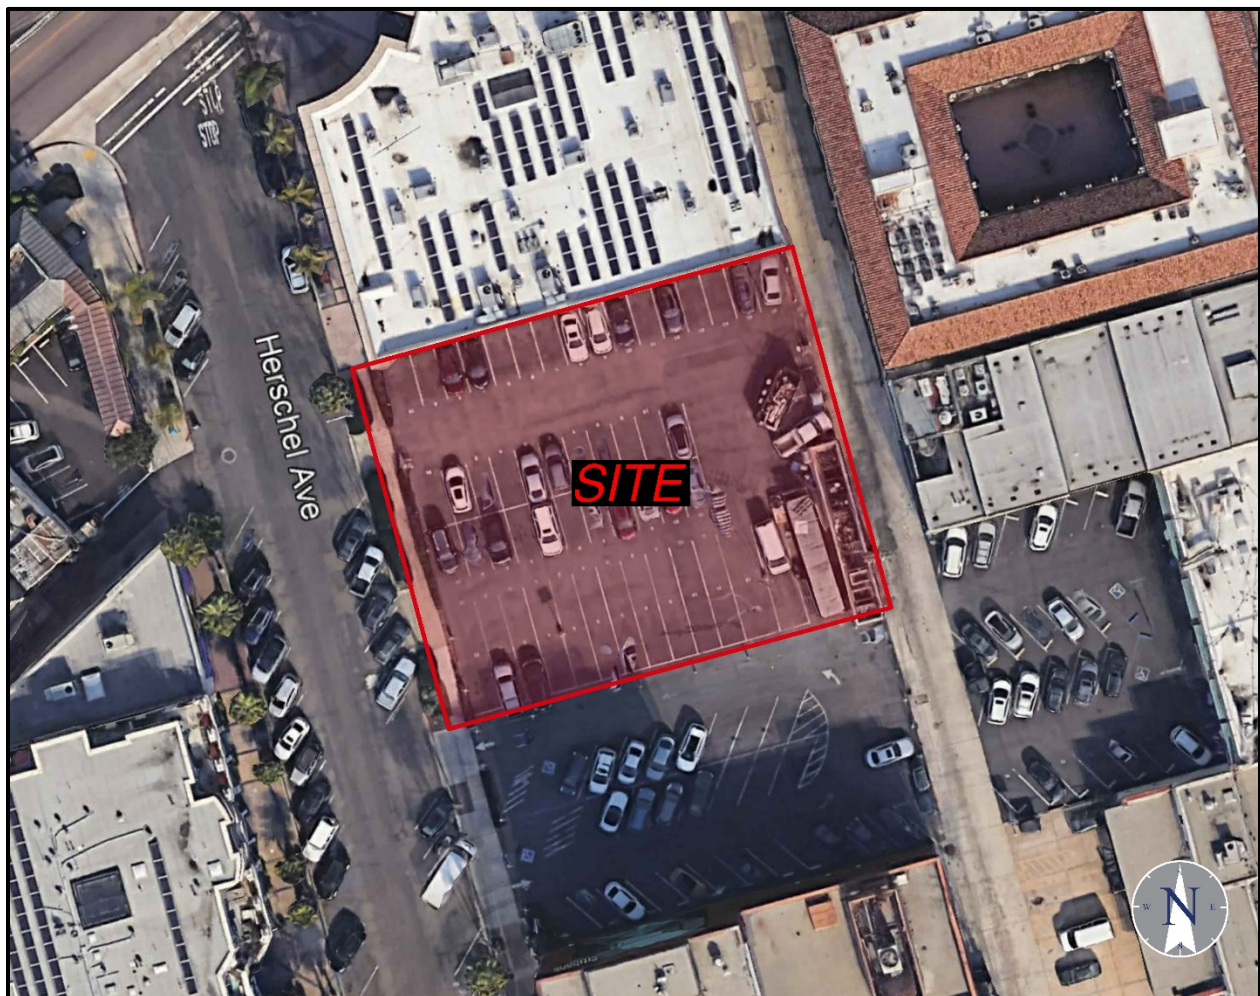
Figure 2-1. Site Location and Limits

Figure 2-1 shows the location and limits of the site on a recent aerial view

The site is currently an at-grade parking lot, surfaced with asphalt. It is generally level, with surface elevations ranging from +115 feet mean sea level (msl) at the eastern property line, to about +111 feet msl at the west.

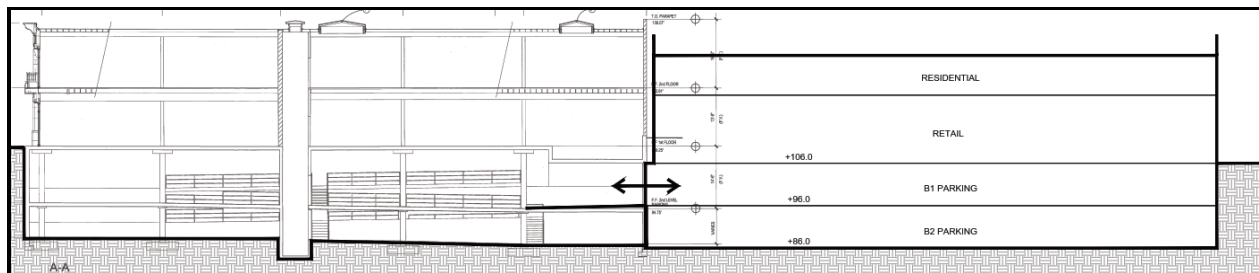
**Figure 2-3. Access Connection at the First Below Grade Level**  
 (source: JWDA 2019)

Planning is currently considering an access connection with the existing retail structure to the north, connecting at the first below grade level. Structural framing concepts have not yet been developed, though it is anticipated that this design feature will be associated with higher foundation loads in the vicinity of the opening. Figure 2-3 depicts this concept.

La Valencia will bound existing structures on its north side. This proximity is depicted graphically on Figure 2-3. Figure 2-4 (following page) depicts this existing structure in a recent photograph.

As is depicted on Figure 2-3, an elevator may extend to the parking garage and may require a pit that extend below the lowest garage slab level. An elevator pit slab and related retaining wall footings will derive suitable support from the Unit 3 Point Loma Formation around it. Design for the elevator pit walls should consider the circumstances and conditions described below.

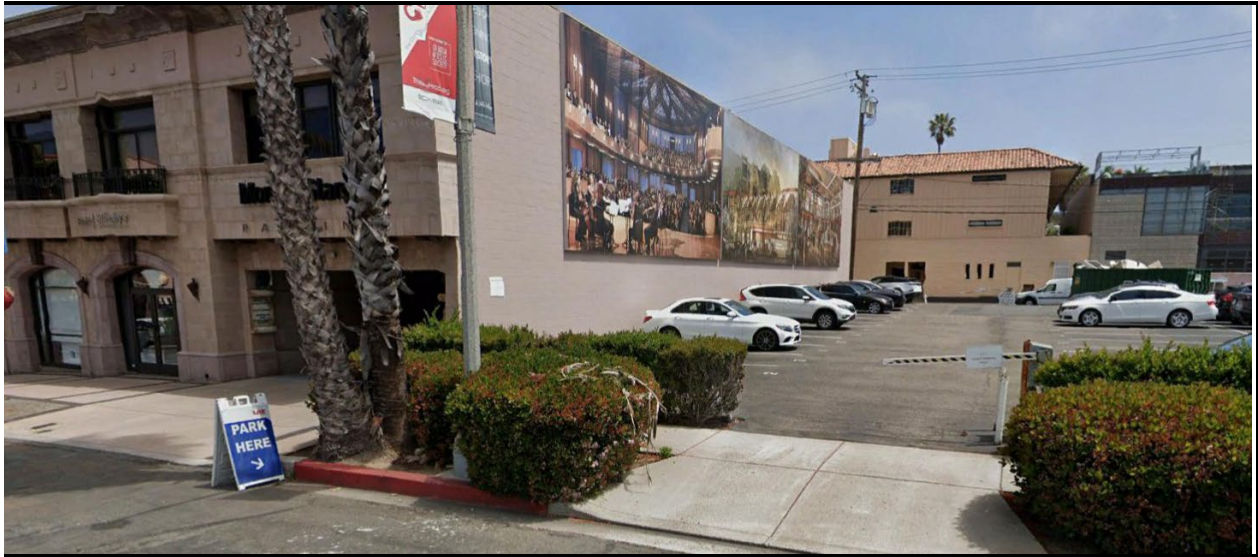
**Figure 2-4. Structure of Potential Concern to the North**

The proximity of the existing structure will limit options for external bracing of temporary shoring. Section 7 addresses design of internal bracing (rakers) for temporary shoring.

The site vicinity is well developed with commercial properties. As may be seen by review of Figure 2-4, a two commercial building adjoins the site along its northern boundary. This building has two-levels of below-grade parking. Current planning intends to connect the first level of below-grade parking at La Valencia with the first-level of below-grade parking at the existing building.

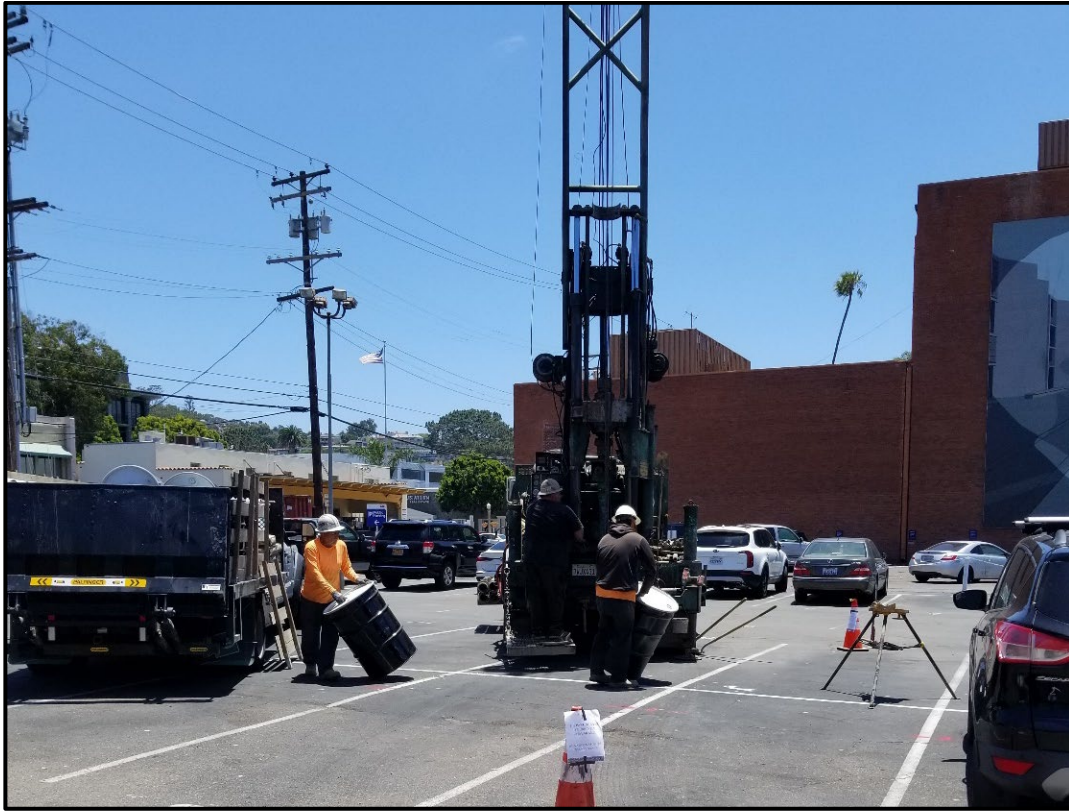
Figure 3-2. Drilling Operations, June 18, 2020

The engineering borings were advanced by a truck-mounted drilling rig utilizing hollow-stem auger drilling techniques. Boring locations were determined by the geologist based on the proposed building configuration. Table 3-1 provides an abstract of the engineering borings. Figure 3-2 (following page) depicts drilling operations on June 18.

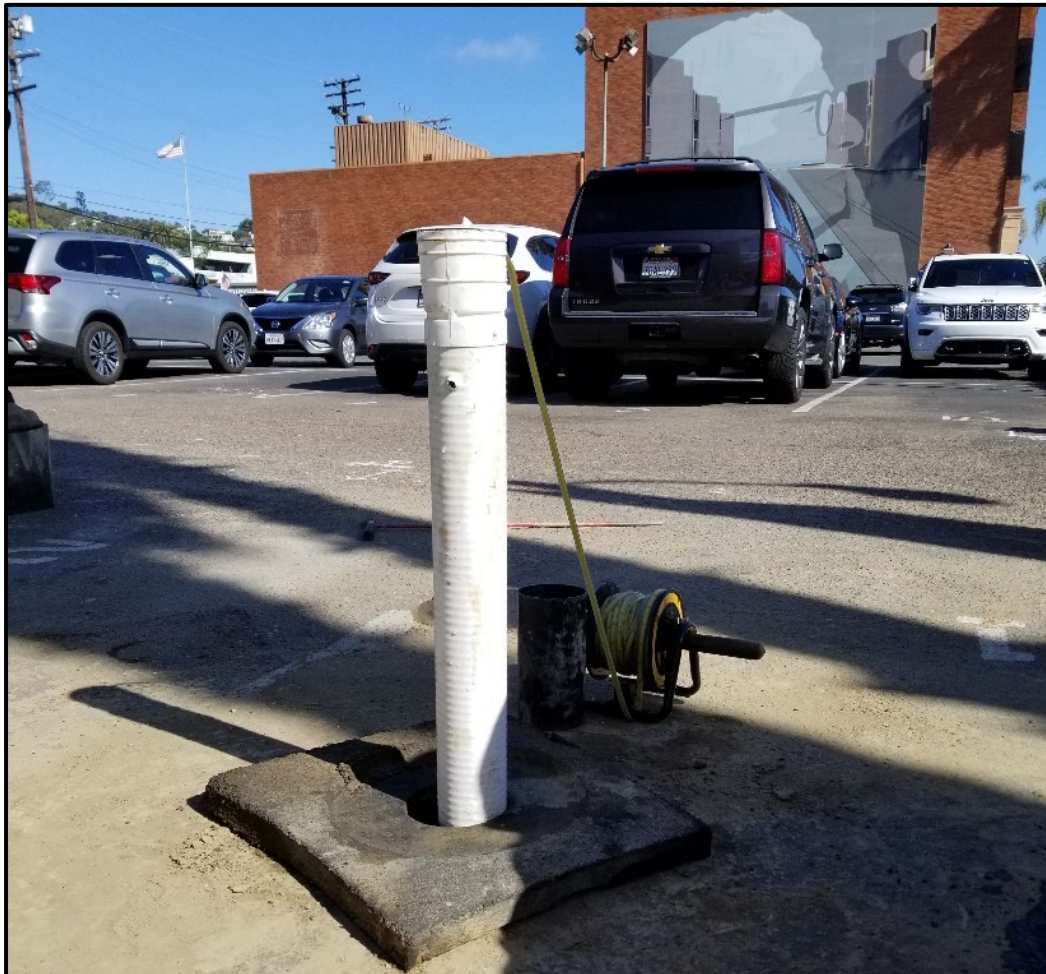
Figure 3-3. Percolation Testing at Boring P-2

Once the borings were drilled to the desired depths, the borings were converted to percolation test wells by placing an approximately 2-inch layer of  $\frac{3}{4}$ -inch gravel on the bottom, then extending 3-inch diameter Schedule 40 perforated PVC pipe to the ground surface. The  $\frac{3}{4}$ -inch gravel was used to partially fill the annular space around the perforated pipe below the existing finish grade to minimize the potential of soil caving. Figure 3-3 depicts the completed construction and percolation testing at well P-2.

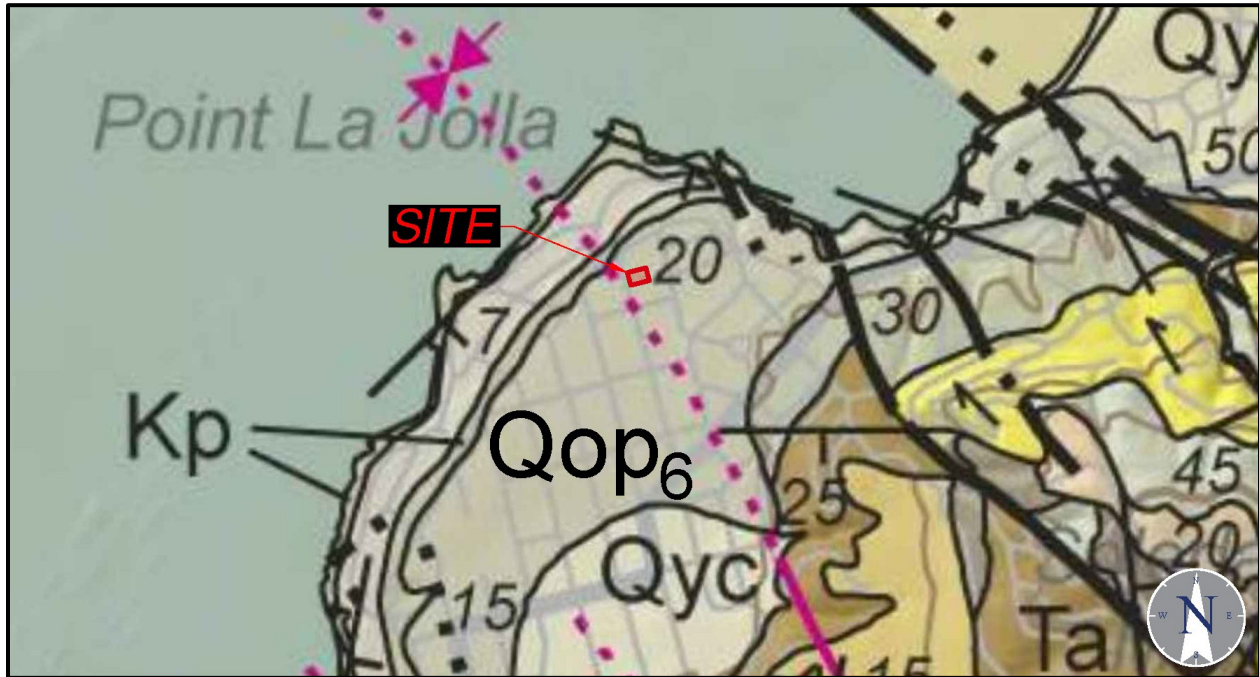
**Figure 4-1. Geologic Mapping of the Site Vicinity**

The old paralic deposits extend to a depth of about 10 to 12 feet, below which occurs the Point Loma Formation (Kp). The Point Loma Formation was encountered as interbedded fine-grained, olive-gray sandstone and siltstone. These sedimentary rocks will provide foundation support for the planned structure and will be competent as a foundation material - of relatively high-strength and low compressibility.

Figure 4-1 (following page) reproduces geologic mapping of the site area.

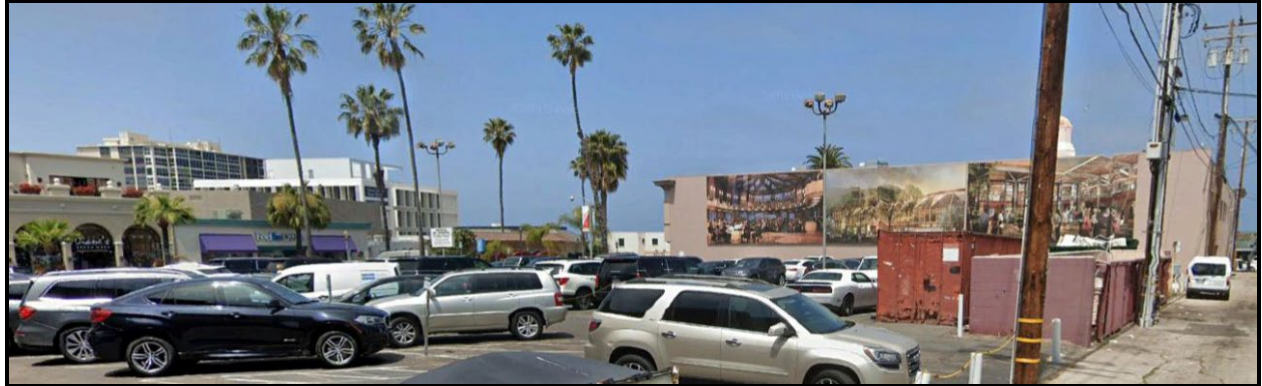
Figure 4-2. Surface Conditions, Looking Northwest from the Alley

The site comprises about 1-acre. The site is currently an at-grade parking lot, surfaced with asphalt. It is generally level, with surface elevations ranging from +113 feet mean sea level (msl) at the eastern property line, to about +111 feet msl at the west. Figure 4-2 (following page) depicts surface conditions.

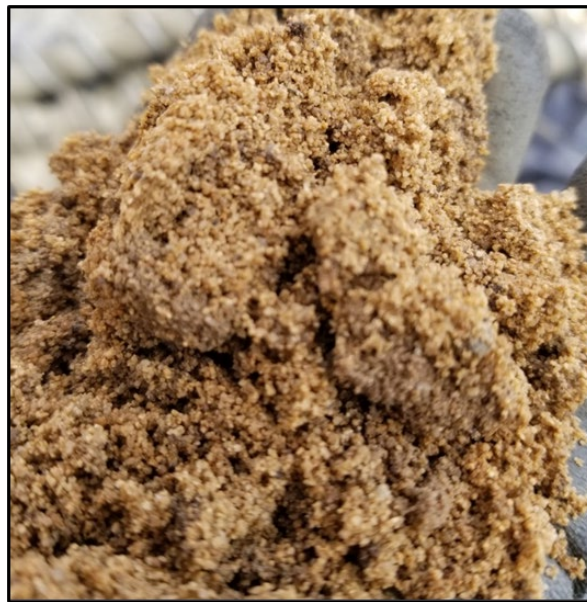
Figure 4-3. Unit 1 Fill

1. Unit 1, Fill. The site is covered by artificial fill (Qaf) that ranges from 7 to 15 feet in thickness, comprised of poorly graded ('well sorted') fine to medium sands of medium dense consistency. The fill was likely emplaced in two separate grading events. The fill encountered in Borings 2 and 3 was likely emplaced prior to 1953 (first available aerial photos of the site) to bring the project to its present grade. During construction of the subterranean parking lot to the north (between 1966 and 1980, according to photos), the northern portion of this site was likely cut, to accommodate a layback for construction of the foundations and walls of the structure. This is supported by the deep fill thickness within B-1A, compared to the depth of fill encountered in B-2 and B-3.

All onsite fill is 'undocumented,' and at risk for wide variations in quality. Figure 4-3 depicts this fill.

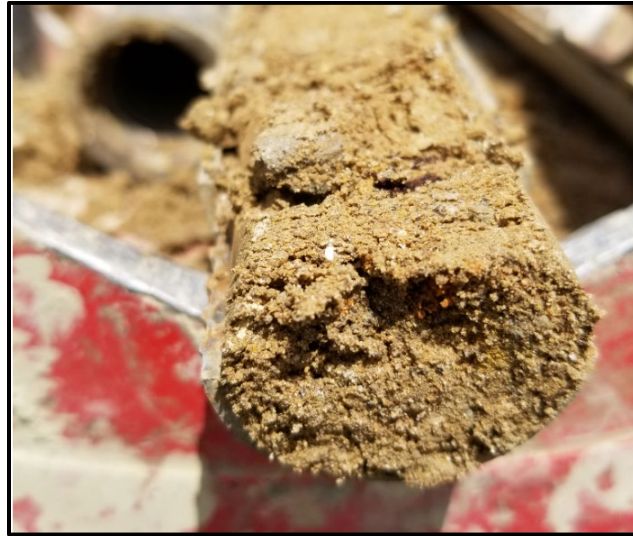
Figure 4-4. Unit 2 Old Paralic Deposits

2. Unit 2, Old Paralic Deposits. Beneath the fill, the site is underlain by Quaternary-aged old paralic deposits (Qop). The unit is characteristically of very dense consistency, composed of layers of brown to orange-brown cemented silty and clayey sandstone with some gravel. Figure 4-4 depicts this unit.

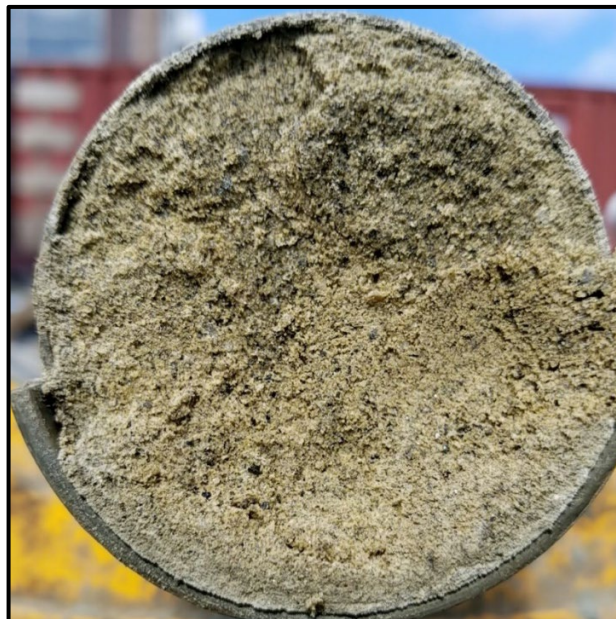
Figure 4-5. Unit 3 Point Loma Formation

3. Unit 3, Point Loma. Beneath the old paralic deposits, the site is underlain by Cretaceous-aged Point Loma Formation (Kp). The unit is composed of layers of sandstone and siltstone of very dense consistency. Standard Penetration Test blow counts ('N', blows/foot, after ASTM D1586) are characteristically  $N \geq 100$ . Figure 4-5 depicts this unit.

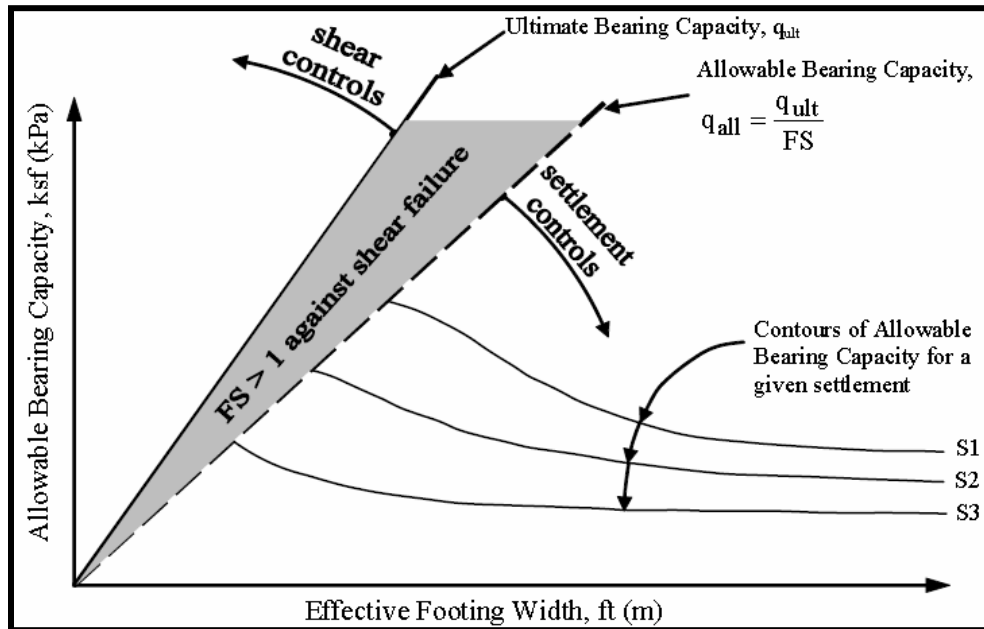
Figure 4-6. Relationships of Allowable Bearing Capacity

Figure 4-6 depicts the relationship between the factors that control allowable bearing capacity. The intent of the graphic is to demonstrate that allowable bearing capacity is rarely a single value and is rarely controlled by limit criterion. Settlement controls determination of allowable bearing capacity in almost all cases.

It is exceedingly rare that the limit criterion (i.e., the shearing capacity of the soils) controls determination of allowable bearing capacity. In almost all cases, the tolerable differential and total settlement of the structure supported by the footing controls the allowable settlement. The tolerable differential and total settlement of the structure is a question best resolved by the structural engineer in consideration of the tolerable differential deformations, the time of construction, and certain serviceability constraints.

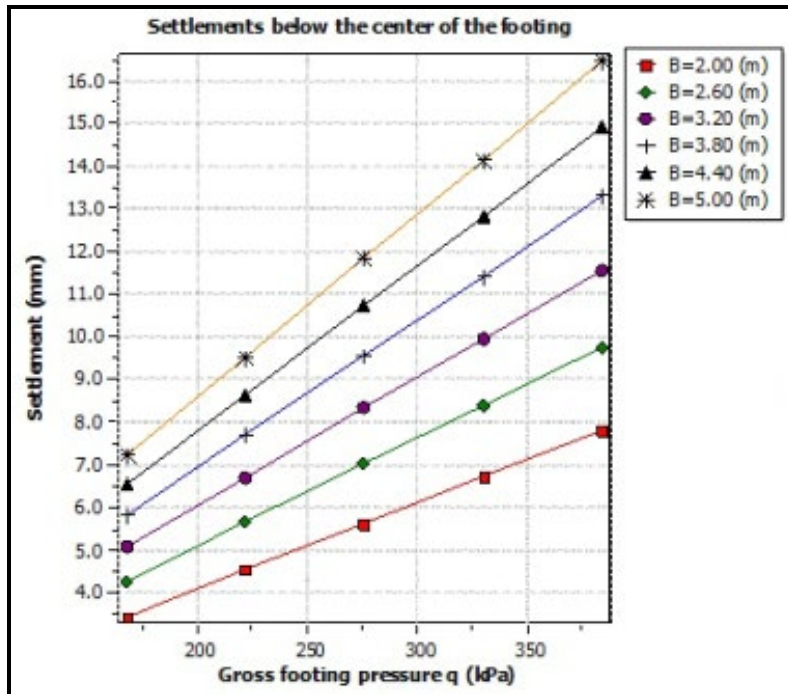
For the purposes of this report, NOVA has completed analyses of the expected elastic settlement of foundations that would be associated with a variety of allowable bearing pressures ( $q_a$ ), up to  $q_a \sim 8,000$  psf. Figure 4-7 (on the following page) abstracts a family of curves of footing bearing stress and settlement for a variety of square ( $L/B = 1$ ) footings.

Figure 4-7. Settlement Performance of Shallow Foundations Set in Unit 3  
 (note the units in this graphic are metric, 384 kPa ~ 8,000 psf)

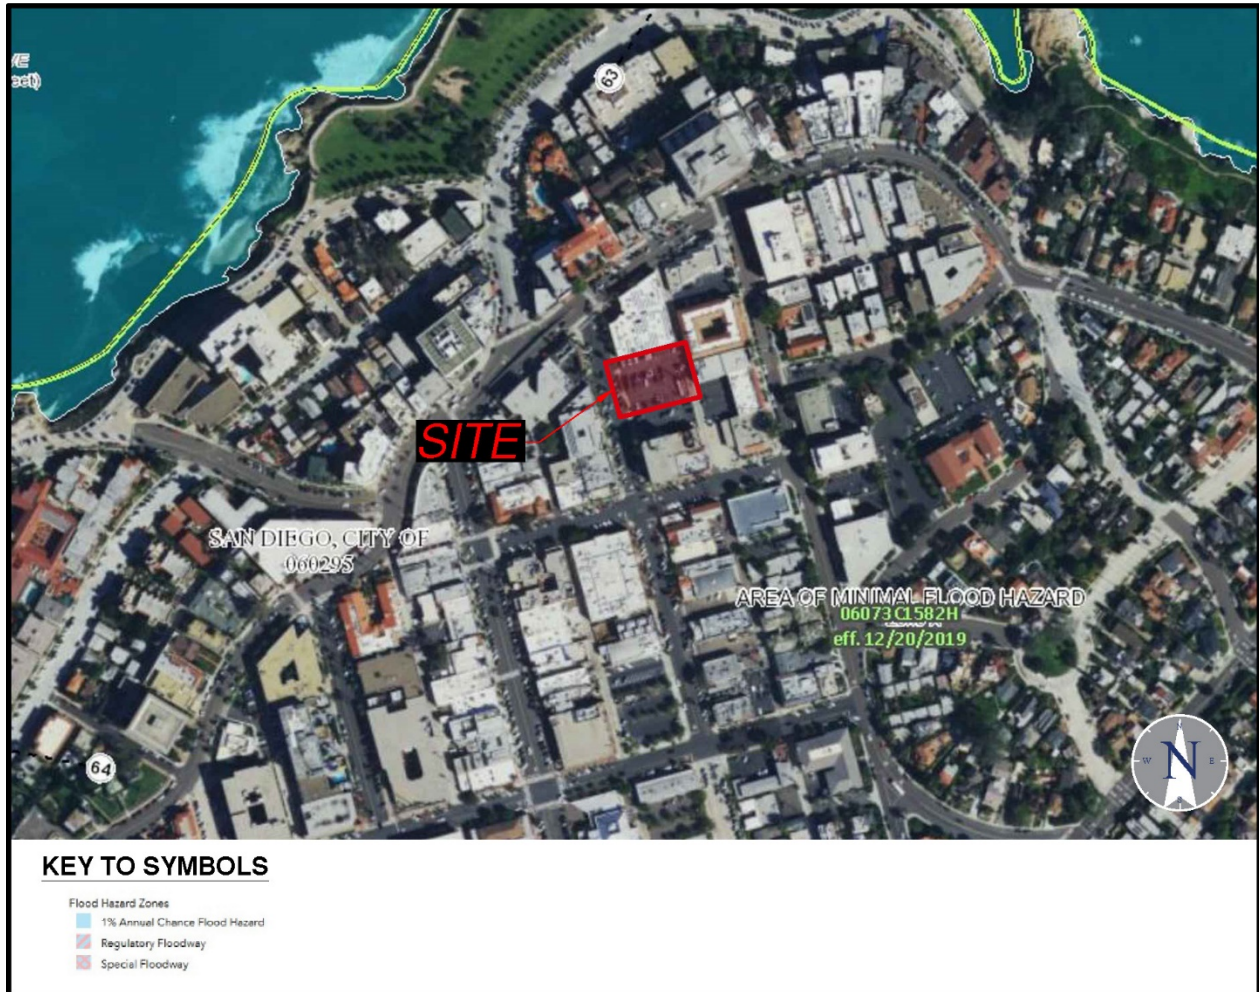
**Figure 5-3. Portion of the Flood Mapping That Includes the Site**  
 (source: FEMA 2019, found at <https://msc.fema.gov/portal/>)

The site is not located within a FEMA-designated flood zone, designated as Flood “Zone X” (FEMA, Map 06073C1582H, effective 12/20/2019). Zone X describes “Areas of 0.2% annual chance flood; areas of 1% annual chance flood with average depths of less than 1 foot or with drainage areas less than 1 square mile; and areas protected by levees from 1% annual chance flood.”

Figure 5-3 (following page) reproduces the portion of FEMA Map that includes the site.

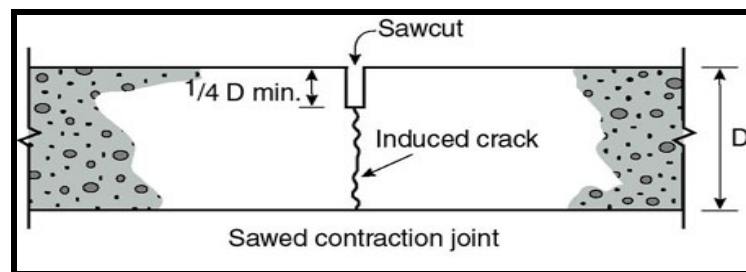
**Figure 6-1. Sawed Contraction Joint**

Proper joint spacing and depth are essential to effective control of random cracking. Joints are commonly spaced at distances equal to 24 to 30 times the slab thickness. Joint spacing that is greater than 15 feet should include the use of load transfer devices (dowels or diamond plates). Contraction/control joints should be established to a depth of  $\frac{1}{4}$  the slab thickness, as depicted in Figure 6-1.

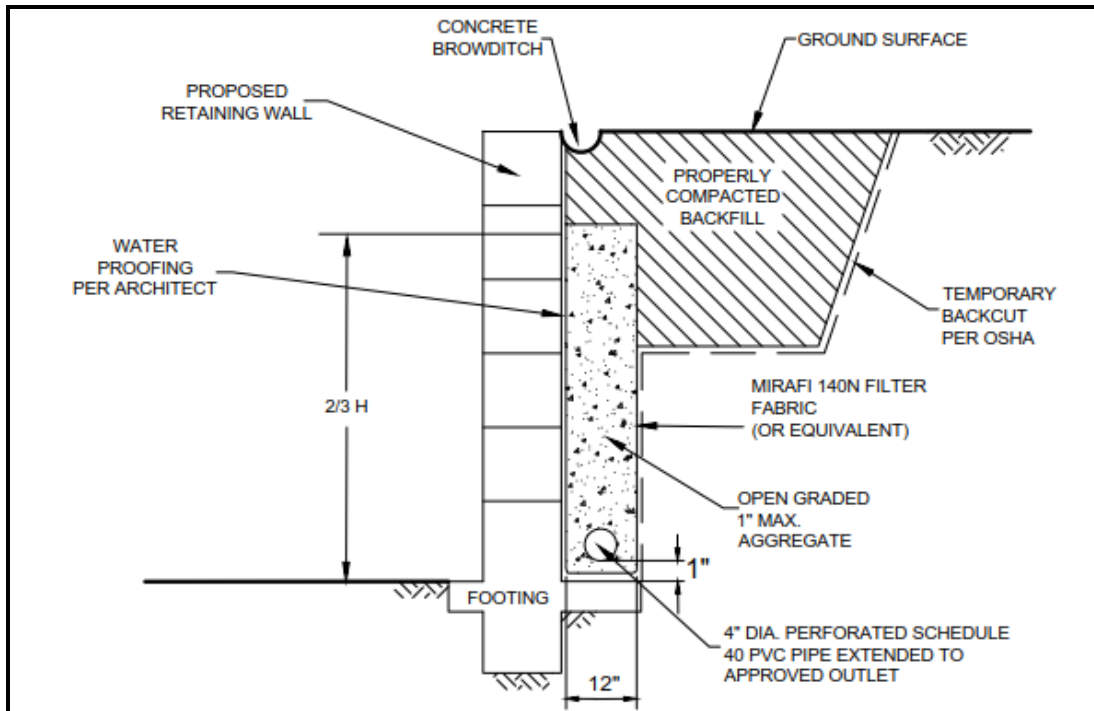
Figure 6-2. Conceptual Design for Wall Drainage

Design for permanent walls should include drainage to limit accumulation of water behind the wall. Figure 6-2 (following page) provides guidance for such design. Note that the guidance provided on Figure 6-2 is conceptual. A variety of options are available to drain permanent below-grade walls.

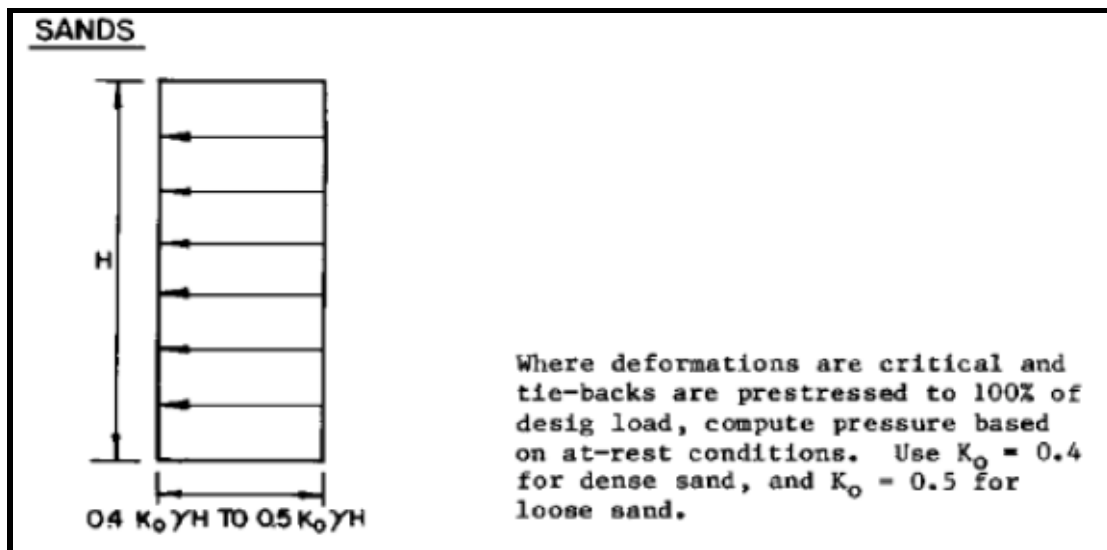
Figure 7-1. 'At Rest' Wall Pressure Distribution in Sands  
 (source: NAVFAC 1986)

Design to resist the Condition 1 'at rest' (i.e., ' $K_o$ ') earth pressures employs a rectangular wall pressure distribution that is more conservative than the Condition 2 loading. Figure 7-1 provides

Design for the 'at rest' wall pressure diagram depicted in Figure 7-1 using the parameters would yield:

$$P = 0.45 \times 0.47 \times 120 \times H = 25H$$

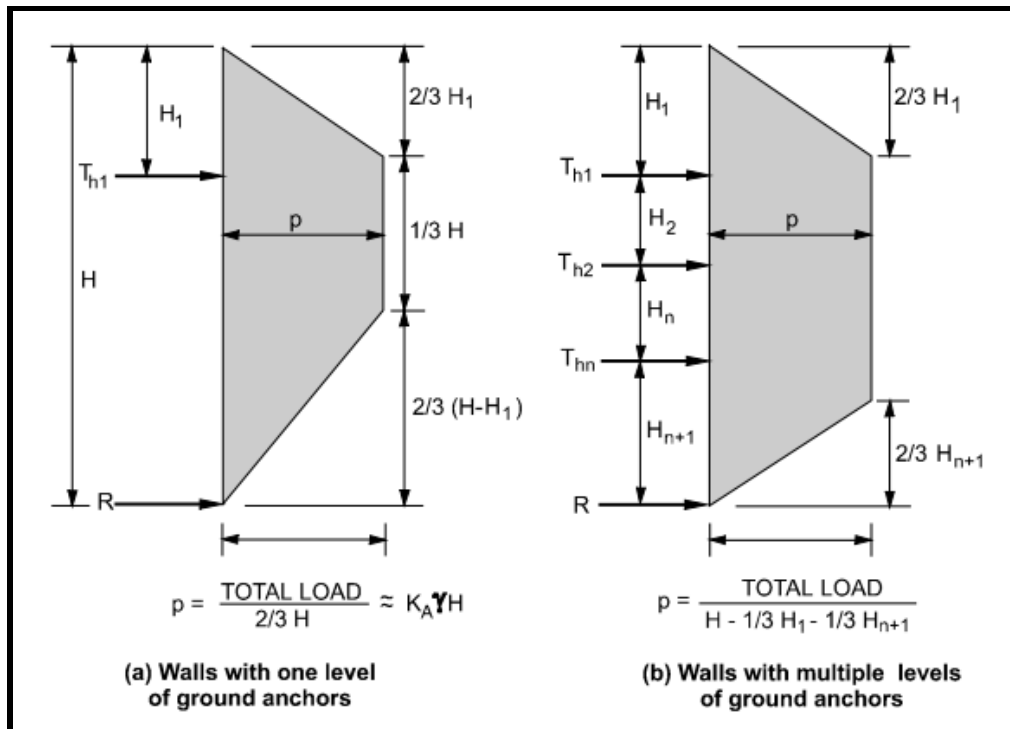
Figure 7-2. 'Active' Lateral Earth Pressures

With the above perspective, NOVA recommends that wall design using active earth pressures should be computed as described by the trapezoidal active earth pressure distribution of Figure 7-2(a) (following page). The magnitude of the maximum trapezoidal pressure may be calculated as:

For a variety of assumptions regarding  $\gamma$ ,  $\phi$ , and  $K_a$ , the maximum magnitude of lateral pressure for a tied back soldier beam and lagging wall system will normalize to be in the range 20H to 23H, where 'H' is the height of the wall in feet.

NOVA recommends employing the trapezoidal distribution of Figure 7-2(a), using 22H for determination of the maximum wall pressure.

It should be noted that the pressure distribution of Figure 7-2(a) are empirical, derived from experience. The recommendation for this pressure distribution follows guidance provided by FHWA 1999.

It should be understood that other empirical pressure distributions may be preferred by others. However, it is NOVA's experience that the pressure distribution of Figure 7-2 works well to predict wall loads/anchor loads in this area.

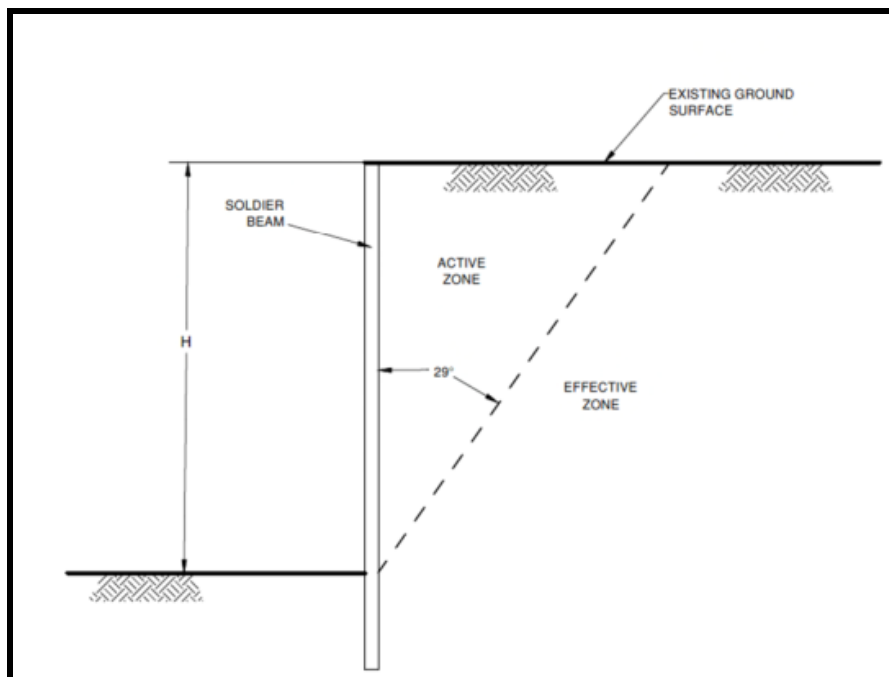
**Figure 7-3. Recommended Effective Zone for Tieback Anchors**

Design should assume that the failure wedge adjacent to the shoring is defined by a plane drawn at 29° from the vertical from the toe of the wall. Figure 7-3 depicts this wedge graphically.

Tieback anchors should extend at least 20 feet beyond the failure wedge (i.e., the “bonded” zone) depicted in Figure 7-3. The intent of this provision is to provide global stability for the shored wall. The bonded length should commence at least 5 feet beyond the failure wedge.

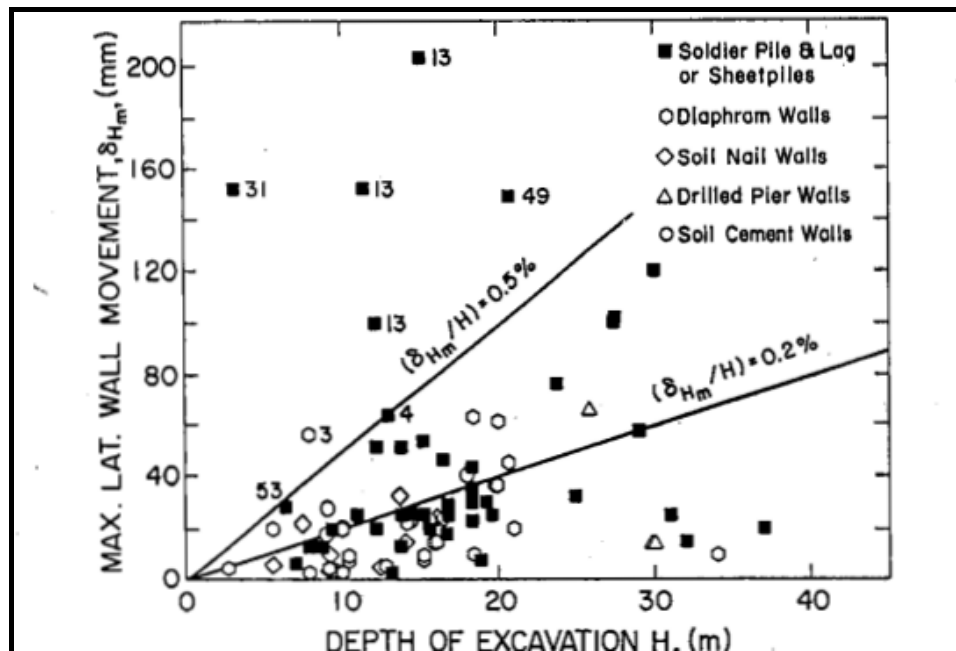
Figure 7-4. Observed Maximum Lateral Movements for *In Situ* Walls in Stiff Clays, Residual Soils and Sands (source: Clough and O'Rourke 1990)

Design for Condition 1 wall will limit wall movement, though the 'at rest' wall condition will not eliminate all wall movement. Because of the reliance on a wide variety of parameters, including workmanship, it is difficult to rigorously predict wall performance during the design stage. Expectations in this regard are primarily empirical. Figure 7-4 provides a published summary of project experiences.

By review of Figure 7-4, it can be seen that a well-constructed soldier pile wall- that is, a wall similar to that anticipated to be constructed for this project- might expect to have a horizontal movement ( $\delta_{Hm}$ ) of about 0.2% of the wall height (H). Assuming H ~20 feet, design might anticipate  $\delta_{Hm} \sim 0.5$ -inch.

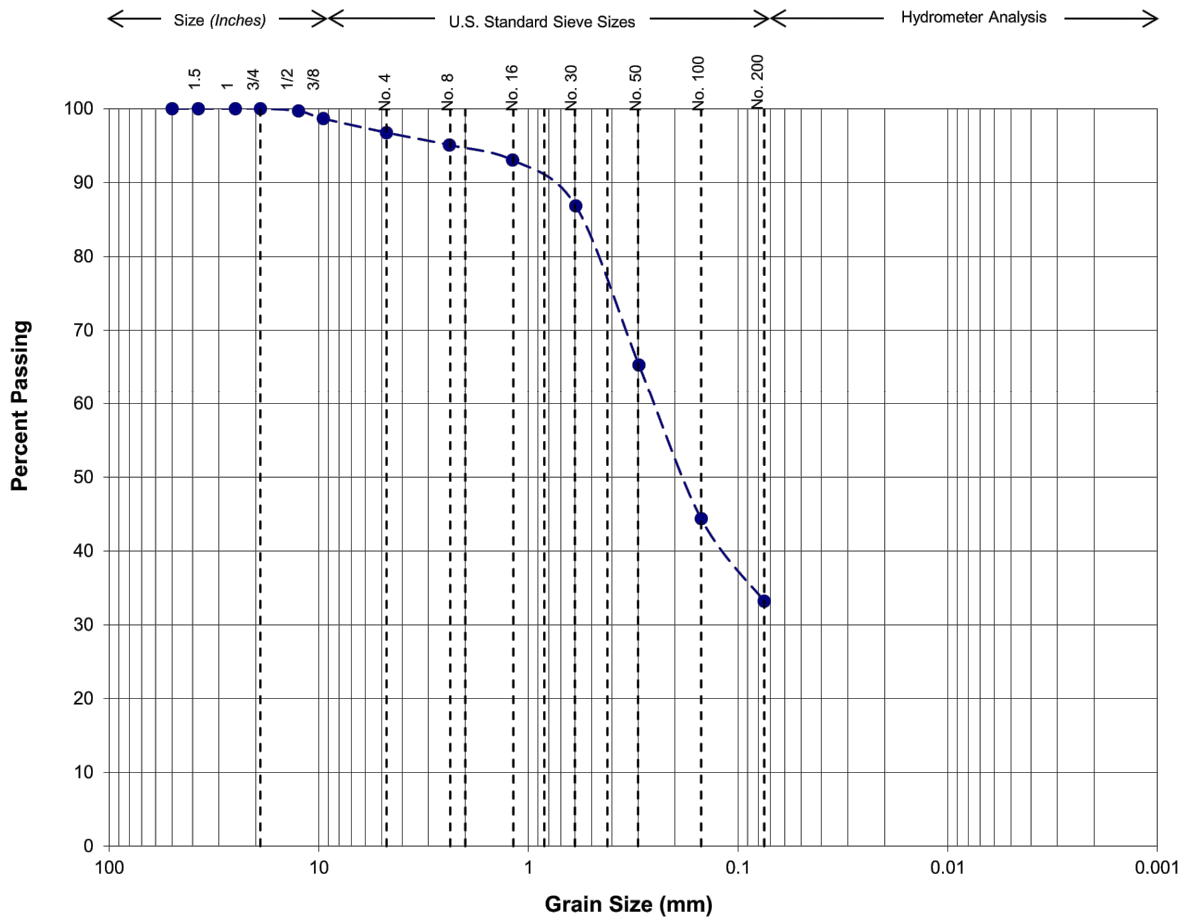
APPENDIX: C.2

Sample Location: B-1A  
 Depth (ft): 5 - 6.5  
 USCS Soil Type: SC-SM  
 Passing No. 200 (%): 33

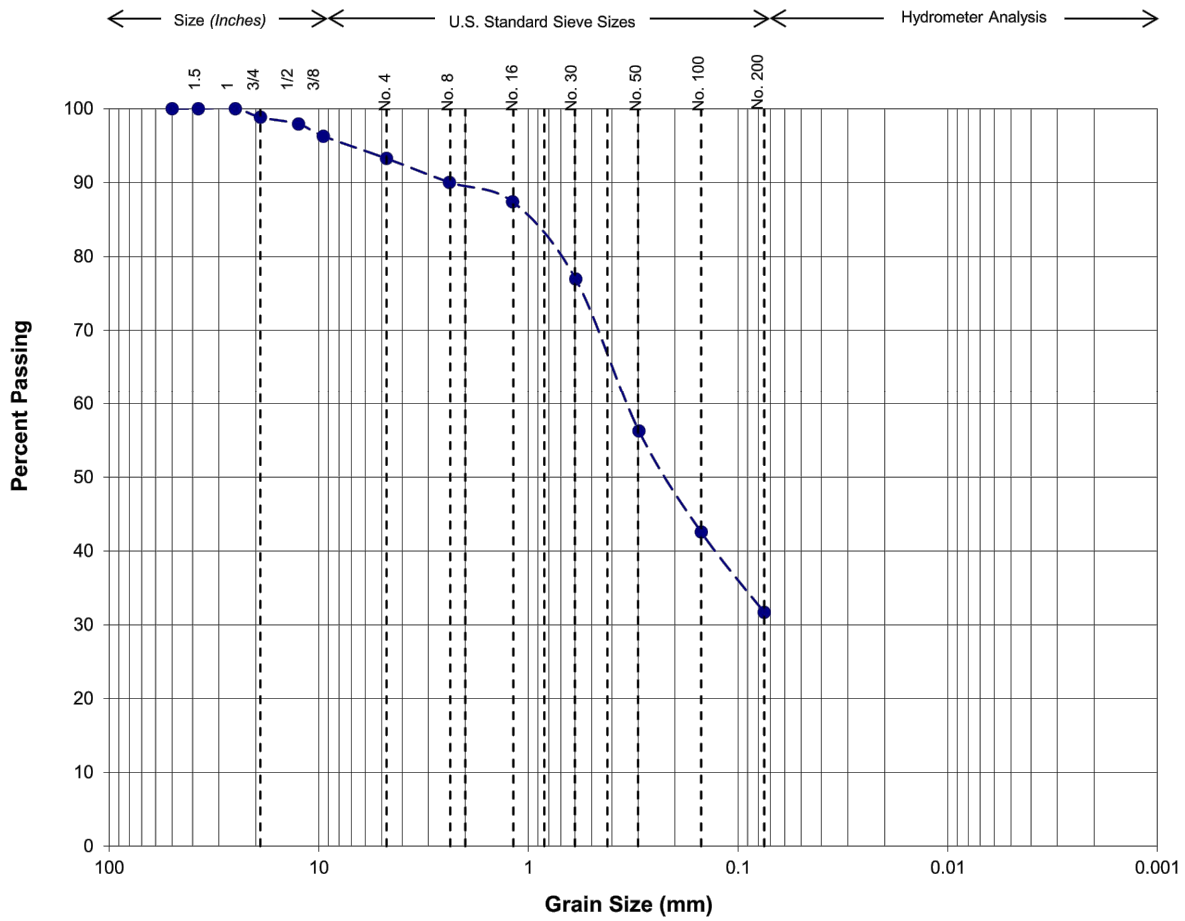
APPENDIX: C.3

Sample Location: B-1A  
 Depth (ft): 10 - 11.5  
 USCS Soil Type: SC-SM  
 Passing No. 200 (%): 32

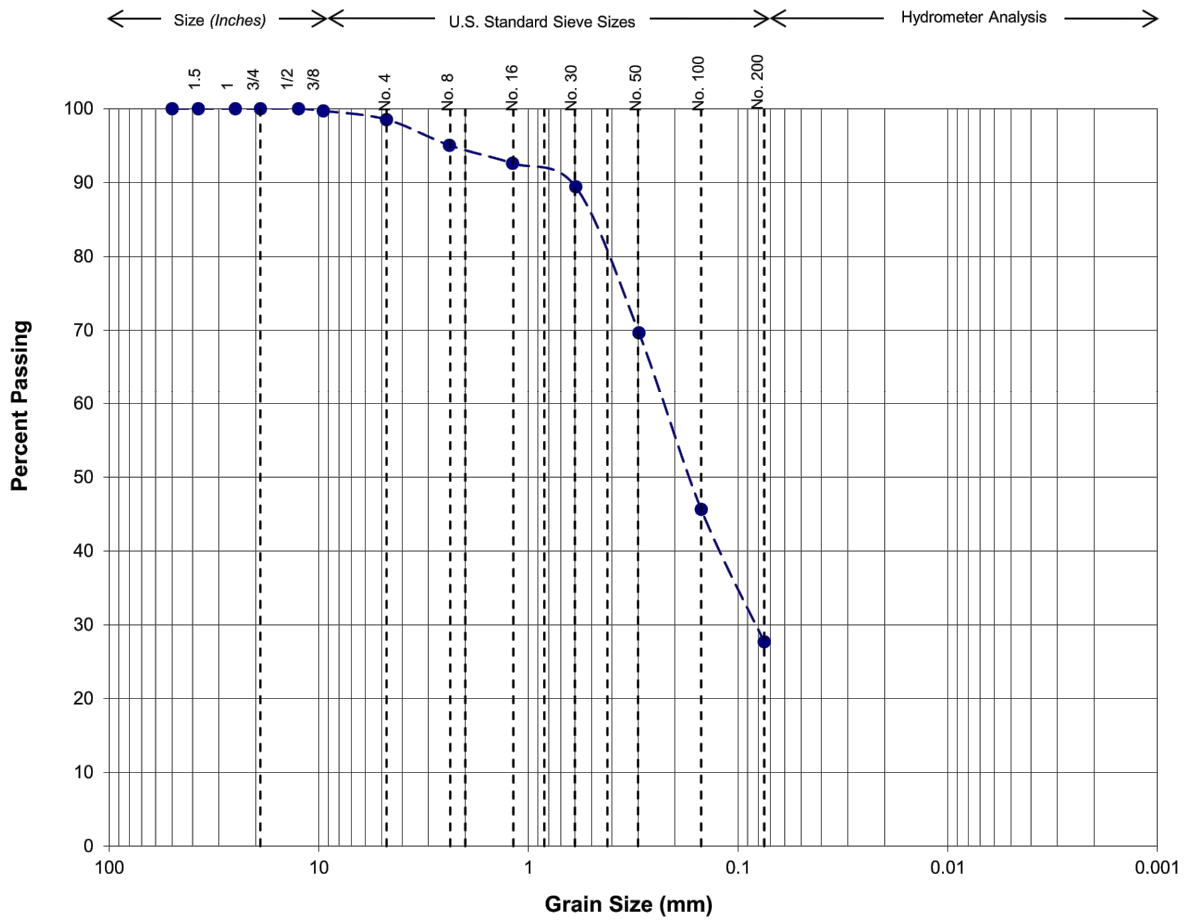
APPENDIX: C.4

Sample Location: B-1A  
 Depth (ft): 15 - 16.5  
 USCS Soil Type: SC-SM  
 Passing No. 200 (%): 28

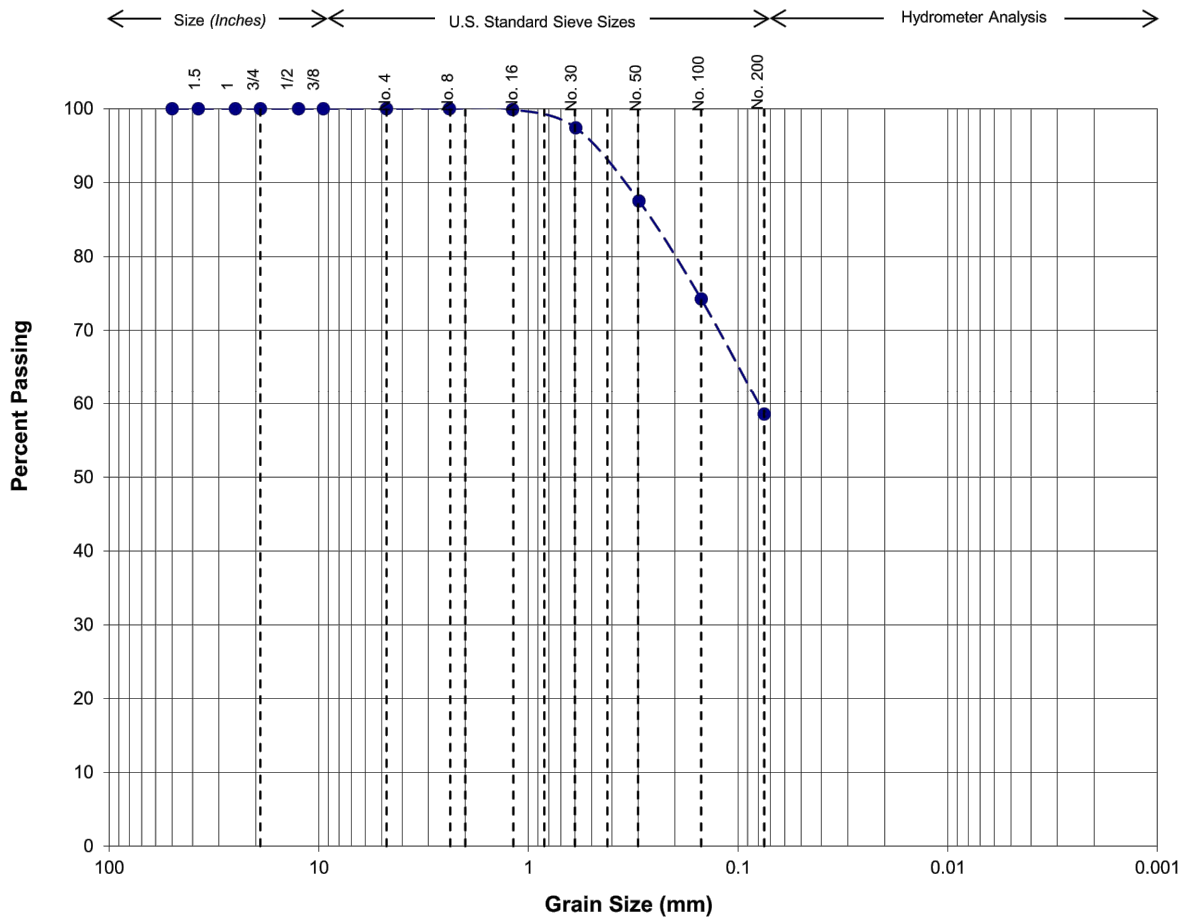
APPENDIX: C.5

Sample Location: B-1A  
 Depth (ft): 20 - 21  
 USCS Soil Type: CL  
 Passing No. 200 (%): 59

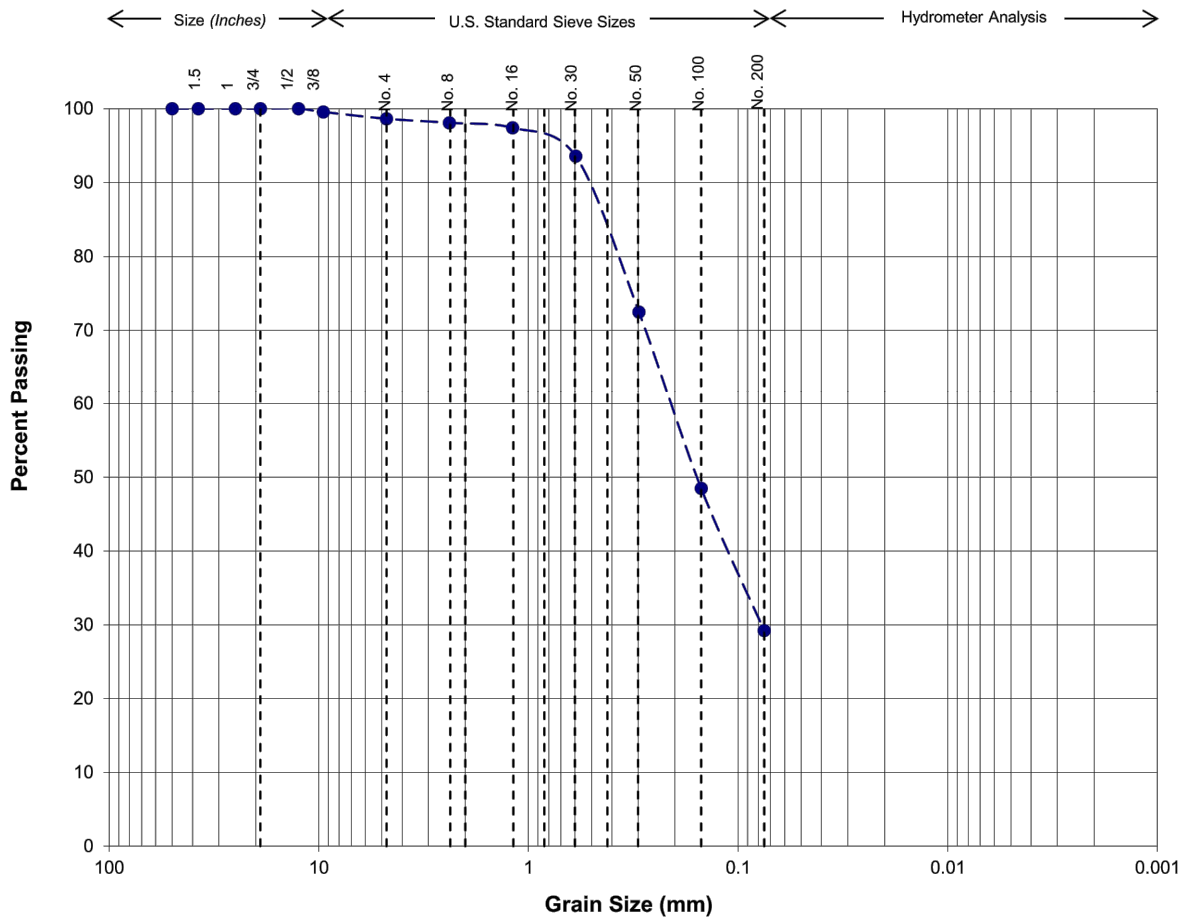
BY: CLS	DATE: JUL 2020	PROJECT: 2020093	APPENDIX: C.6
---------	----------------	------------------	---------------

Sample Location: B-1B  
 Depth (ft): 25 - 26  
 USCS Soil Type: SC-SM  
 Passing No. 200 (%): 29
