**REPORT OF GEOTECHNICAL INVESTIGATION  
PROPOSED RETAIL BUILDINGS AND PARKING**

6326 Mission Blvd  
Jurupa Valley, California

**Subject: Report for Geotechnical Investigation  
Proposed Retail Buildings and Parking  
6326 Mission Blvd  
Jurupa Valley, California  
Project No.: G21-034/1**

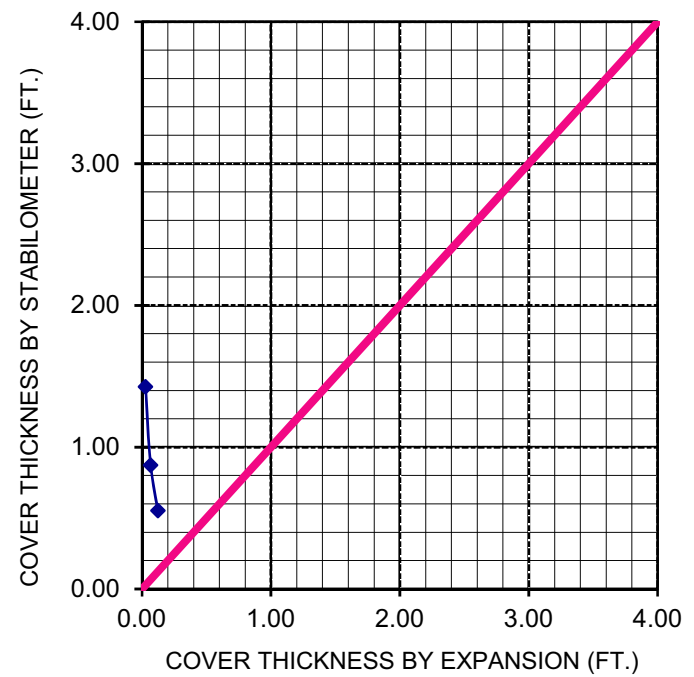
Mold Number	D	F	E	
Water Added, g	0	25	0	
Compact Moisture(%)	11.3	10.4	9.5	
Compaction Gage Pressure, psi	100	150	250	
Exudation Pressure, psi	270	383	502	
Sample Height, Inches	2.6	2.6	2.6	
Gross Weight Mold, g	3148	3052	3126	
Tare Weight Mold, g	1965	1869	1955	
Net Sample Weight, g	1184	1183	1171	
Expansion, inchesx10 <sup>-4</sup>	8	20	37	
Stability 2,000 (160 psi)	46/99	30/55	18/34	
Turns Displacement	4.77	4.38	4.12	
R-Value Uncorrected	24	52	69	
R-Value Corrected	25	54	71	
Dry Density, pcf	123.9	124.8	124.6	
Traffic Index	8.0	8.0	8.0	
G.E. by Stability	1.43	0.87	0.55	
G.E. by Expansion	0.03	0.07	0.12

<b>R-VALUE</b>	By Exudation:	33
	By Expansion:	*N/A
	At Equilibrium: (by Exudation)	33
<b>Remarks</b>	Gf = 1.34, and 0.0 % Retained on the 3/4" *Not Applicable
