# FINAL GEOTECHNICAL INVESTIGATION REPORT

RESERVOIR No. 3A, COUNTY SERVICE AREA 70, ZONE 1  
East of Columbine Road  
Oak Hills Area, San Bernardino County, California

CONVERSE PROJECT No. 19-81-275-01

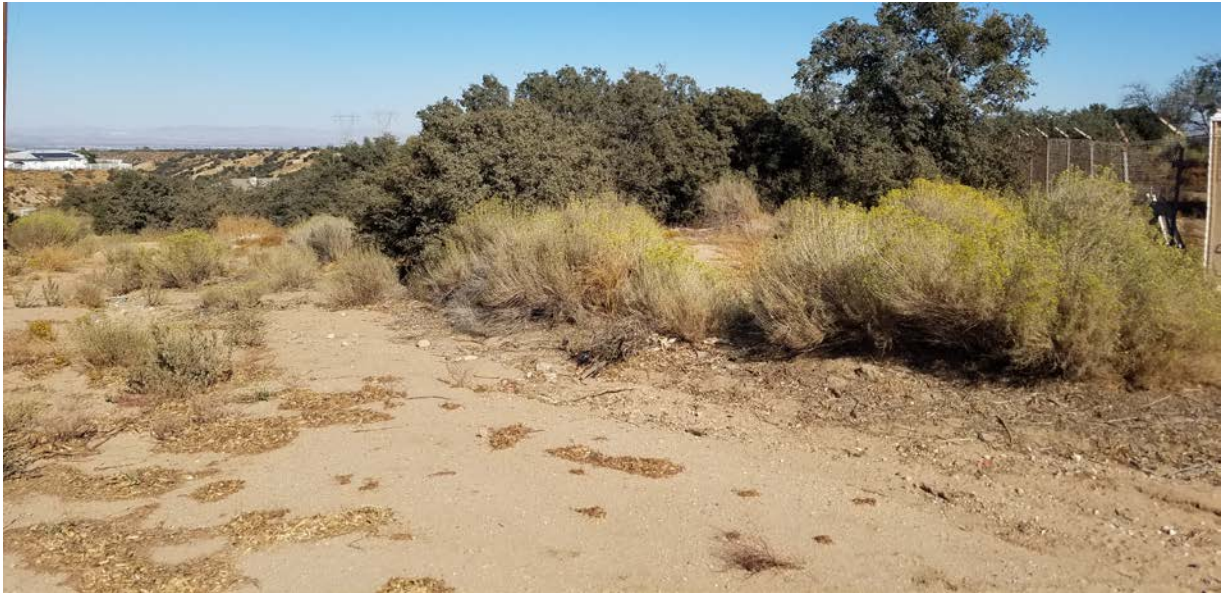
*Photograph No. 1: Project site showing proposed reservoir location, facing north.*

Elevation of the ground surface varies within the site and generally slopes to the north from between approximately 4,060 feet above mean sea level (amsl) to approximately 4,020 feet amsl. Present site conditions are shown in the photographs no. 1 through 5.

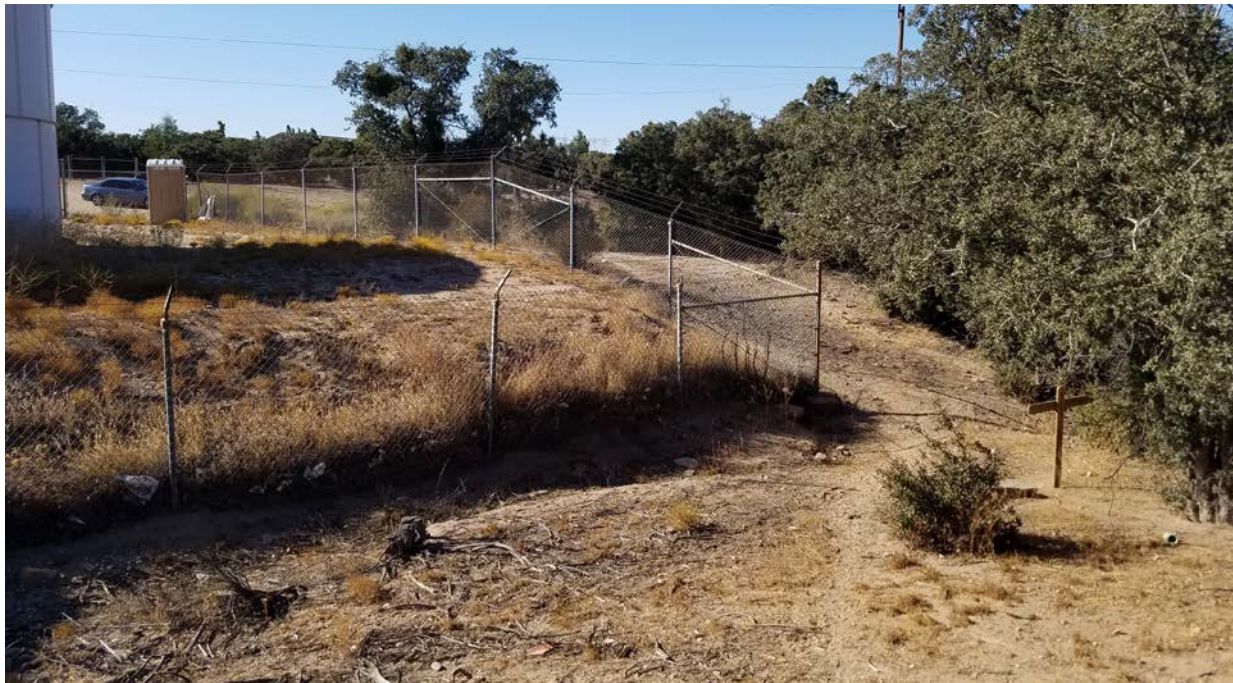
*Photograph No. 2: Project site location showing proposed reservoir location, facing west.*

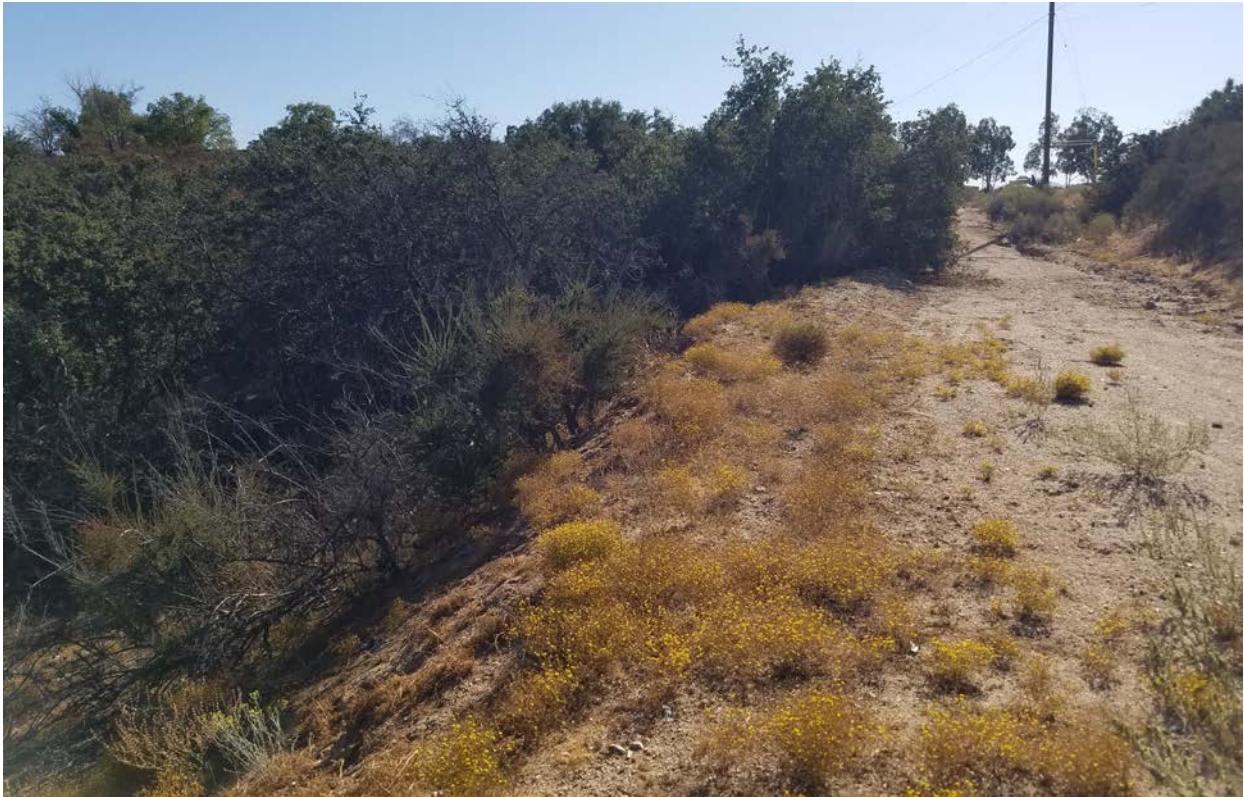
*Photograph No. 3: Project site showing existing access road and overhead utilities facing south.*

Overhead electricity lines traverse in a northeast/southwest direction just beyond the western edge of the project site property boundary.

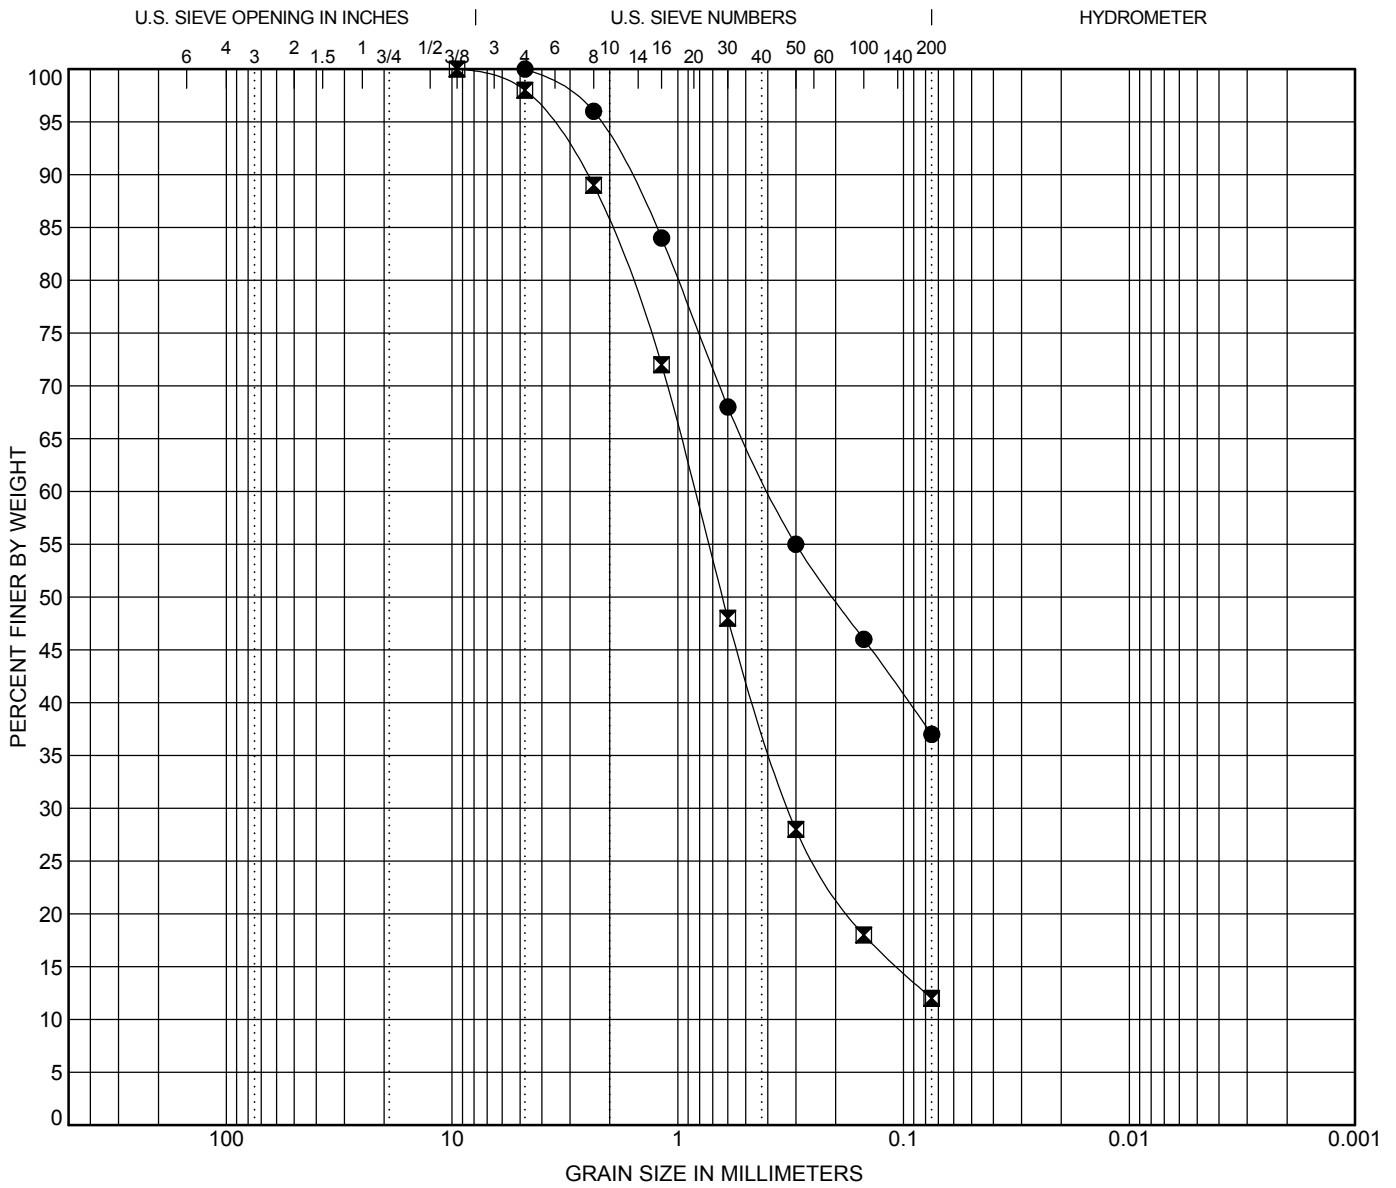
Drawing No.  
**B-1**

COBBLES	GRAVEL		SAND			SILT OR CLAY
	coarse	fine	coarse	medium	fine

Boring No.	Depth (ft)	Description	LL	PL	PI	Cc	Cu		
● TP-03	0.0 to 5.0	Silty Sand (SM)							
☒ TP-06	0.0 to 3.0	Sand with Silt (SP-SM)				2.06	14.14		
Boring No.	Depth (ft)	D100	D60	D30	D10	%Gravel	%Sand	%Silt	%Clay
● TP-03	0.0 to 5.0	4.75	0.392			0.0	63.0	37.0	
☒ TP-06	1.0 to 2.0	9.5	0.841	0.322		2.0	86.0	12.0

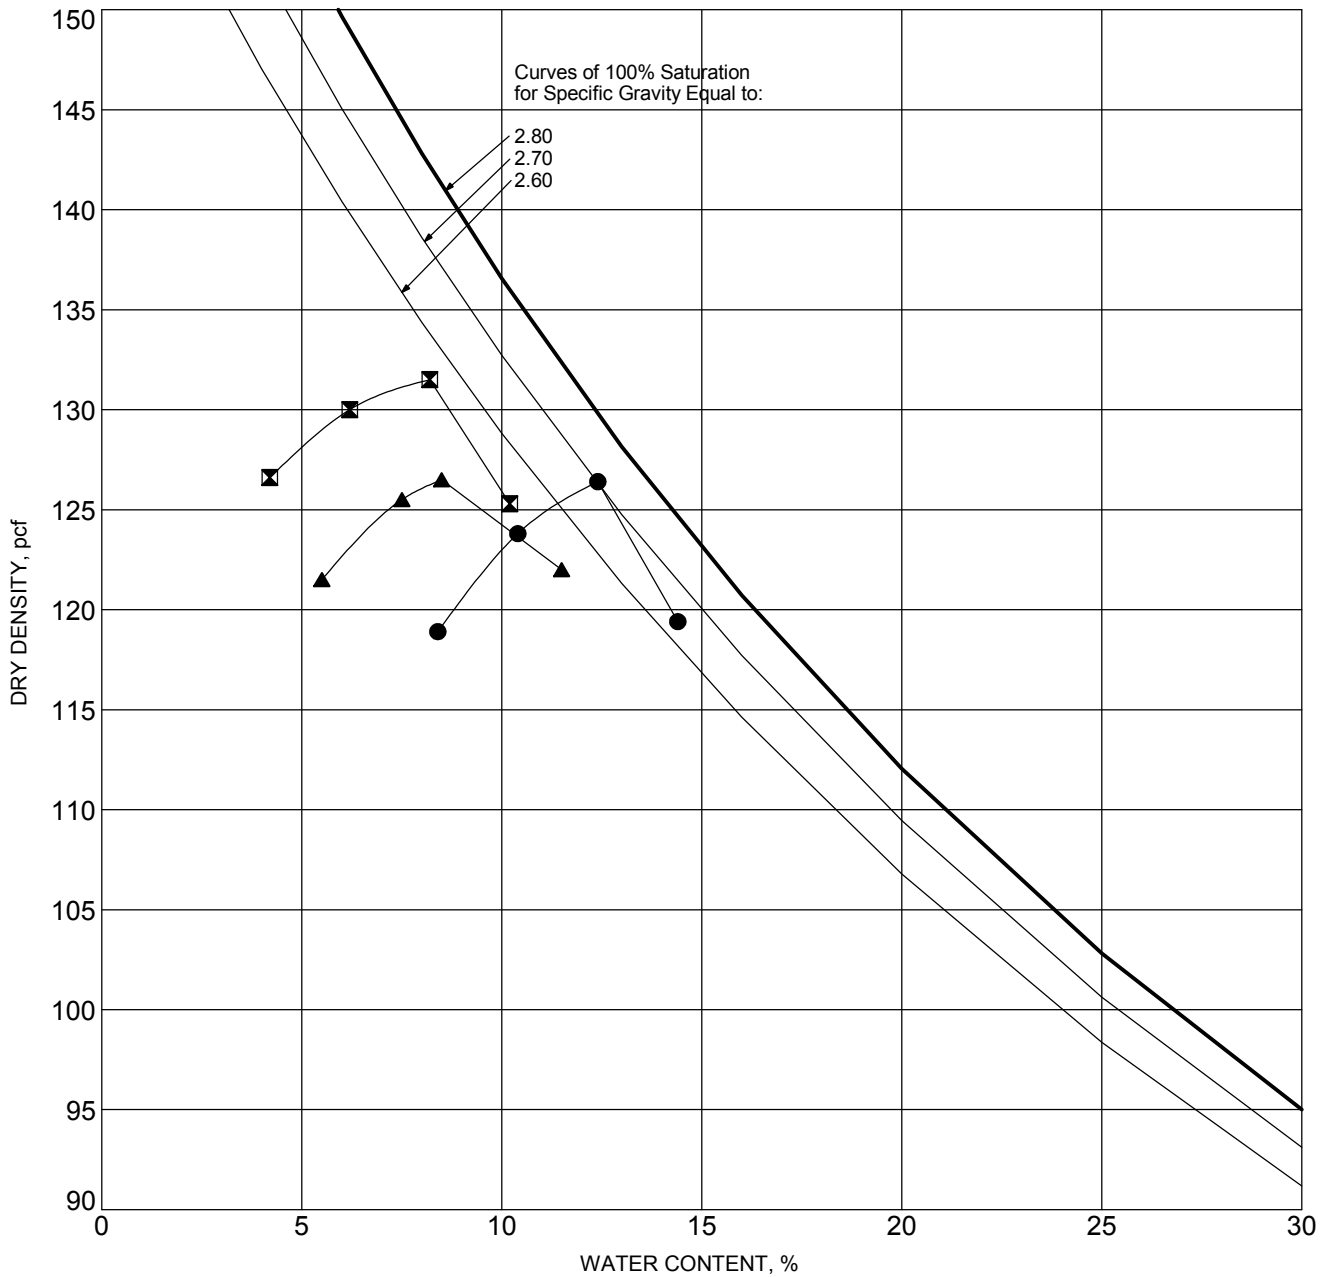
Drawing No.  
**B-2**

SYMBOL	BORING NO.	DEPTH (ft)	DESCRIPTION	ASTM TEST METHOD	OPTIMUM WATER, %	MAXIMUM DRY DENSITY, pcf
●	TP-03	0 to 5	Silty Sand (SM), reddish brown	D1557 - A	12	126.4
☒	TP-04	0 to 3	Silty Sand (SM), orangish brown	D1557 - A	7.5	131.5
▲	TP-06	1 to 2	Silty Sand (SM), brown	D1557 - A	8.5 (8.1*)	126.1 (127.7*)

(\*with rock correction 5.4%)

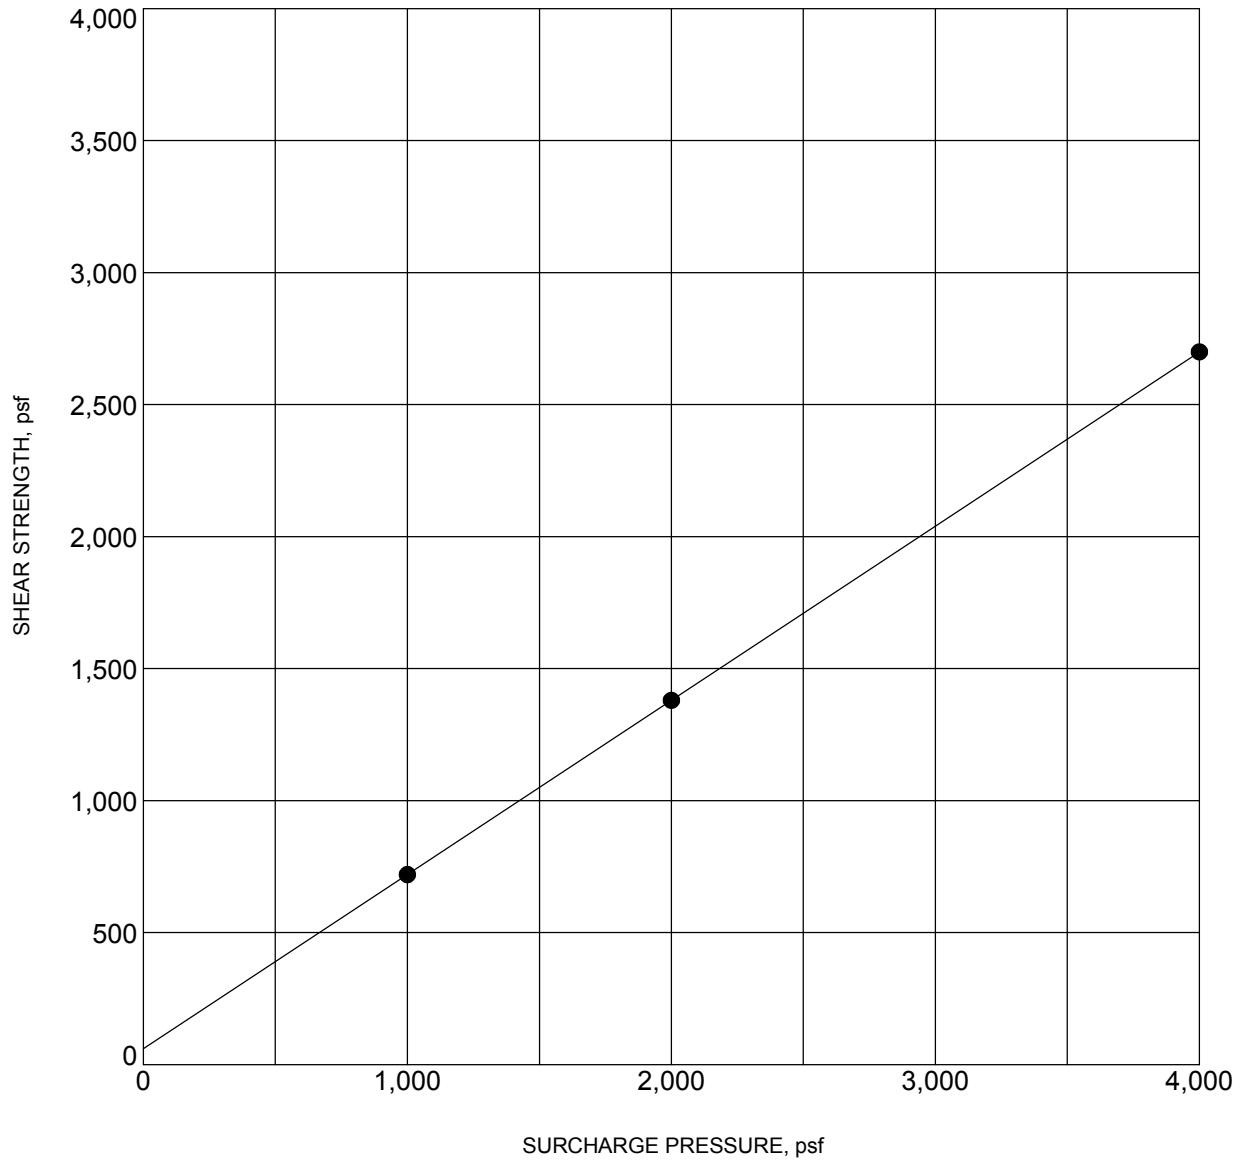
Drawing No.  
**B-3**

BORING NO. :	<b>TP-03*</b>	DEPTH (ft) :	<b>0.0 to 5.0</b>
DESCRIPTION :	<b>Silty Sand (SM)</b>		
COHESION (psf) :	<b>60</b>	FRICTION ANGLE (degrees):	<b>33</b>
MOISTURE CONTENT (%) :	<b>5.0</b>	DRY DENSITY (pcf) :	<b>115.0</b>

(\*Remolded to 90% of the maximum dry density)

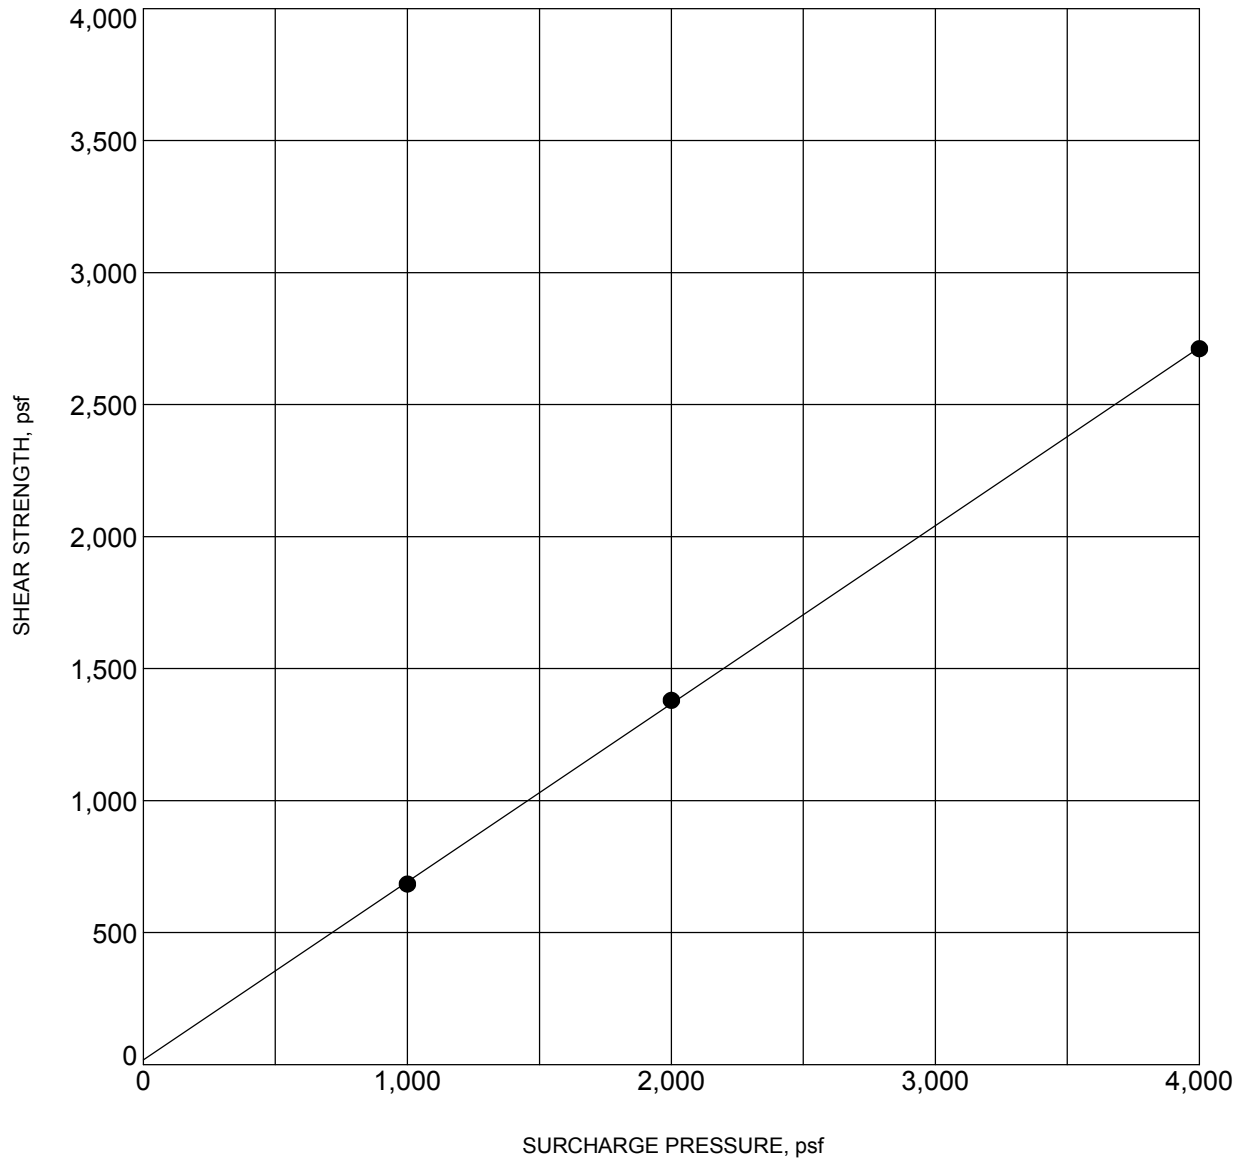
Drawing No.  
**B-4**

BORING NO. :	<b>TP-05*</b>	DEPTH (ft) :	<b>6.0 to 7.0</b>
DESCRIPTION :	<b>Silty Sand (SM)</b>		
COHESION (psf) :	<b>20</b>	FRICTION ANGLE (degrees):	<b>34</b>
MOISTURE CONTENT (%) :	<b>8.0</b>	DRY DENSITY (pcf) :	<b>118.0</b>

(\*Remolded to in-situ density)

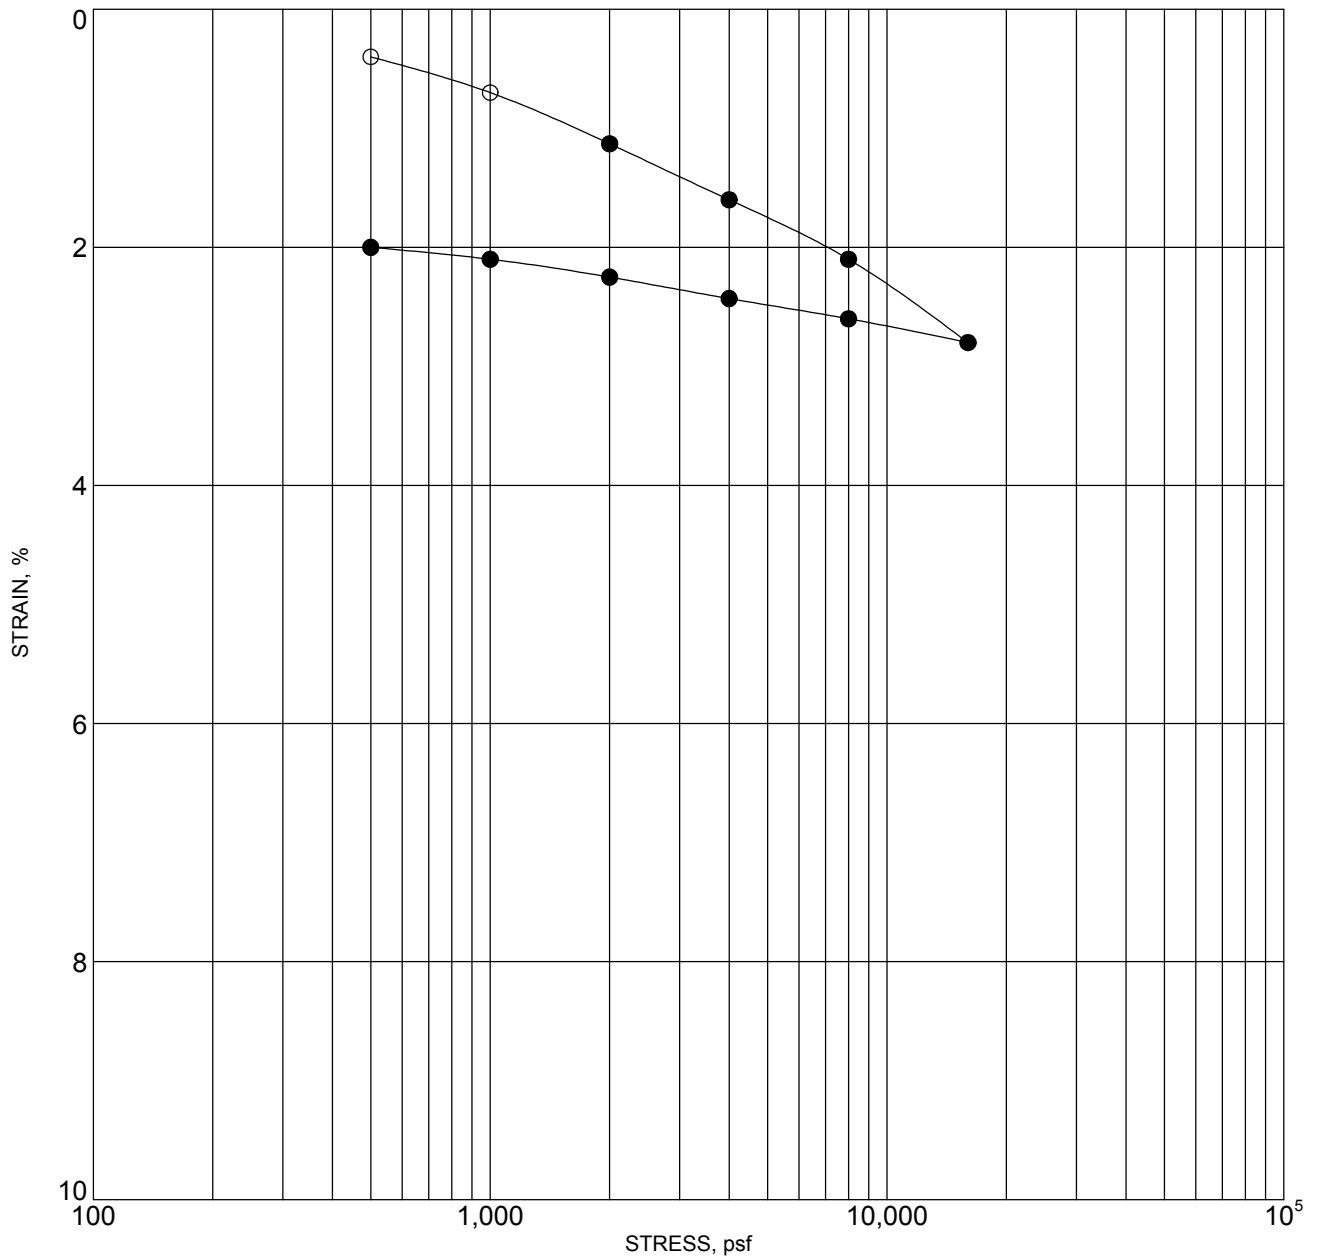
BORING NO. :		TP-07		DEPTH (ft) :		3.0 to 4.0	
DESCRIPTION :				Silty Sand (SM)			
MOISTURE CONTENT (%)		DRY DENSITY (pcf)		PERCENT SATURATION		VOID RATIO	
INITIAL	6.6	118		44		0.396

NOTE: SOLID CIRCLES INDICATE READINGS AFTER ADDITION OF WATER

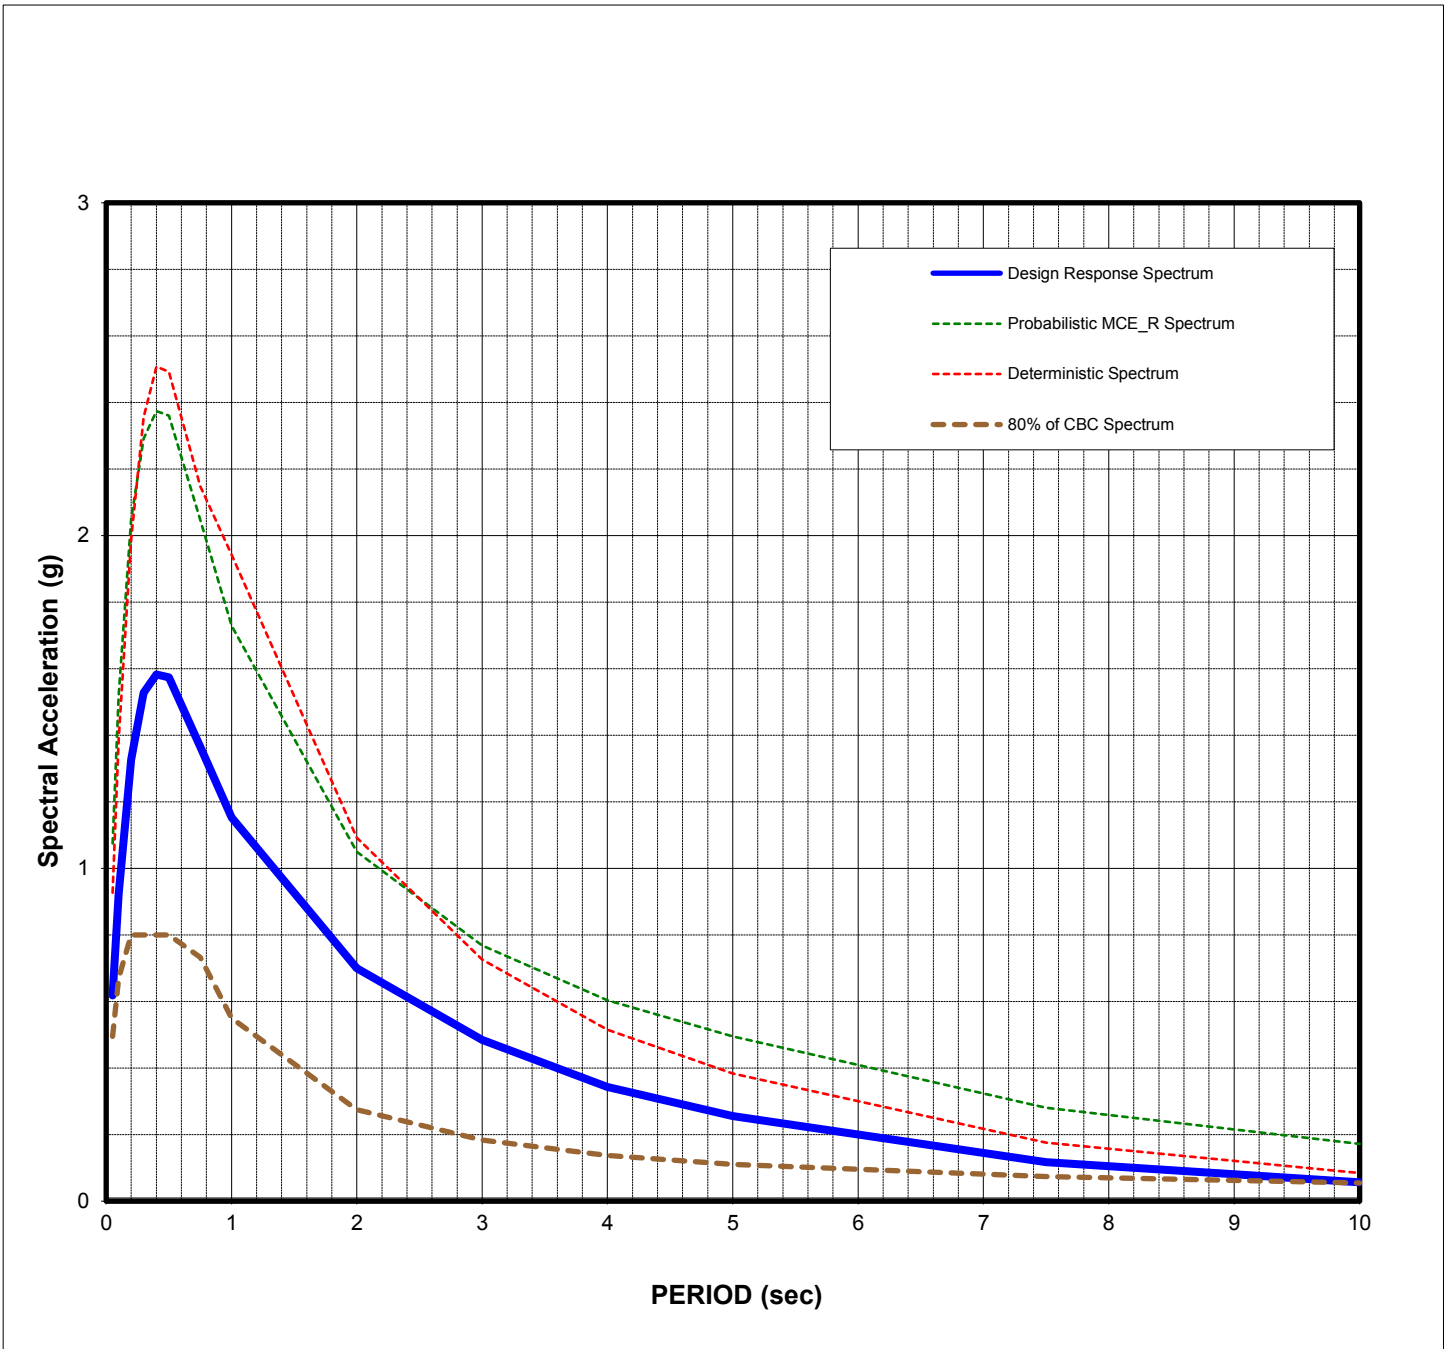
### SITE SPECIFIC DESIGN RESPONSE SPECTRUM

Note: Calculated using EZFRISK program Risk Engineering, version 8.06 and NGAW2\_GMPE Spreadsheets V5.7

Parameter	Value (5% Damping)	Lower Limit, 80% of CBC Design Spectra
Site-Specific 0.2-second period Spectral Response Acceleration, $S_{MS}$	2.137	1.200
Site-Specific 1-second period Spectral Response Acceleration, $S_{M1}$	2.177	0.824
Site-Specific Design Spectral Response Acceleration for short period $S_{DS}$	1.425	0.800
Site-Specific Design Spectral Response Acceleration for 1-second period, $S_{D1}$	1.451	0.549
